Cornwall Archaeological Unit Report No: 2021R090

Gwynearth, Rosudgeon, Cornwall

Historic Building Record and Archaeological watching brief

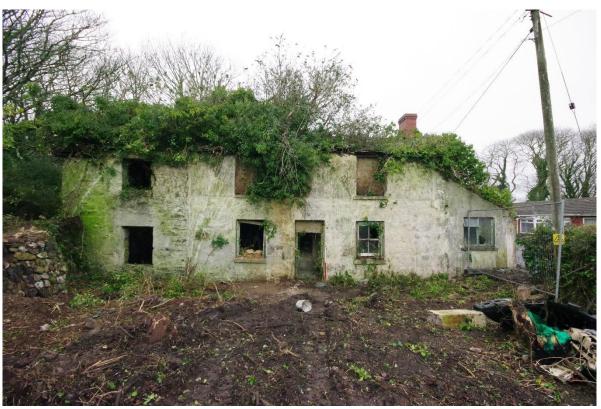
The central part of the south elevation (Figs 7, 54 and 57) is the original frontage of the phase 1 house. The central section is double fronted with four windows with granite sills and a central door. The ground floor east window retains its replacement early-mid 20th century four-paned, sash window with horns (Fig 8). The ground floor window opening to the west retains the frame of a matching replacement sash window. The two windows at first floor level of the central part of the house are boarded over but the same replacement early-mid 20th century sash windows survive behind the boarding. The

Fig 7 South (front) elevation.

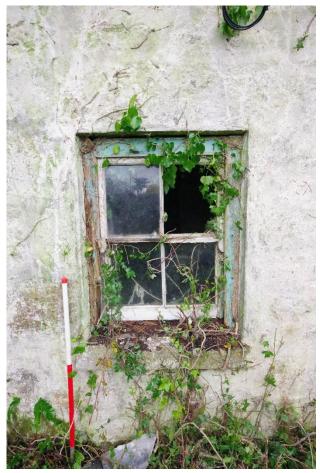
Fig 8 Early-mid 20th century replacement sash window to east of front door in south elevation.

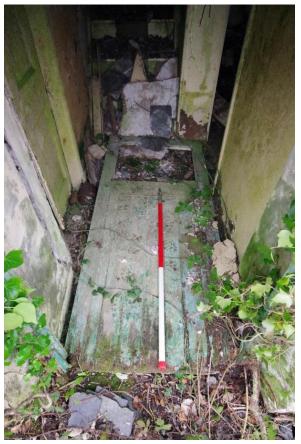
replacement early-mid 20th century timber front door with a glazed light in upper part is detached from its frame and lies flat in the hallway (Fig 9). A scar runs horizontally along the central section of walling, between the two floor levels indicating the change from granite rubble construction at ground floor level and cob at first floor level. The elevation is rendered and painted white.

Fig 9 Detached early-mid 20th century front door in south elevation.

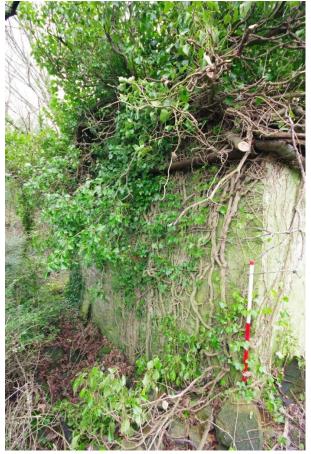
Fig 10 West elevation of western phase 2 extension, showing iron/steel guttering.

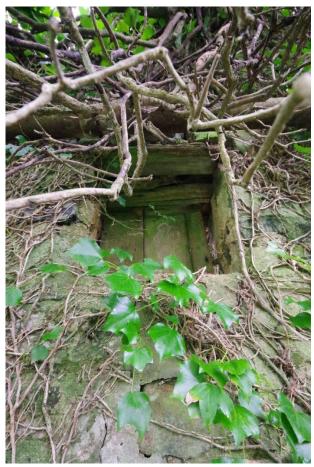
Fig 11 Small timber shuttered window opening in west elevation of phase 2 western extension.

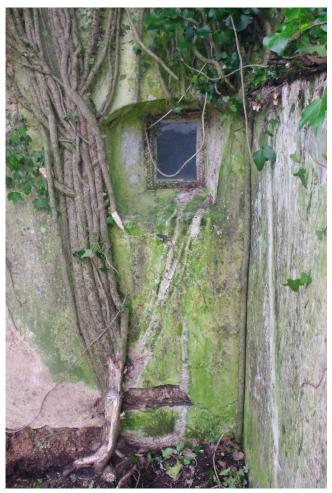
Fig 13 Blocked phase 1 back door opening.

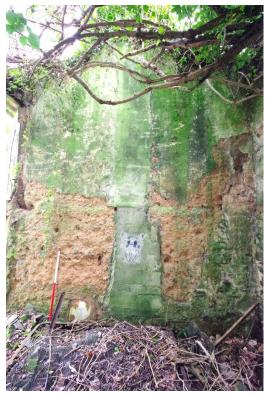
Fig 16 Room 1 east wall. Showing inserted concrete flue.

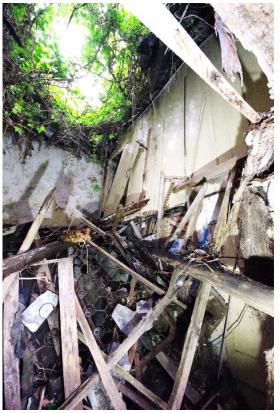
Fig 18 Room 2 north and east walls showing first floor plank and muntin partition wall to the east.

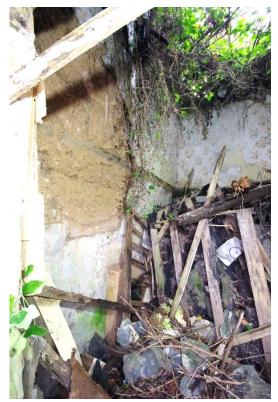
Fig 19 Room 2 north and west walls. Tiled fire surround just seen to left of collapsed timbers.

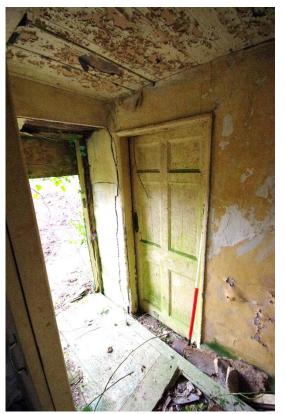
The west wall at ground floor level is an original lath and earth plaster partition wall. At the south end there is a door opening to the parlour containing a six-panelled 18th or early 19th century door with a thumb latch and contemporary architrave (Fig 21). This door appears to have been inserted during phase 2 to replace a blocked door opening at the north end of the wall. At first floor level there is a phase 2 plank and beaded muntin partition wall containing a phase 2, ledged, three plank door with H hinges at the northern end.

Fig 21 Room 3 front door opening in south wall and 18th or early 19th century six-panelled door in the west wall.

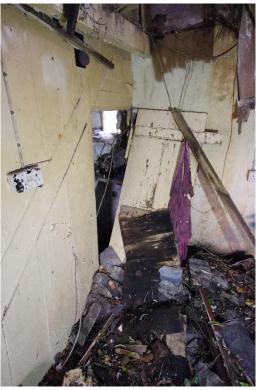
Fig 27 Room 4 door opening to Room 5 with detached door ledged door.

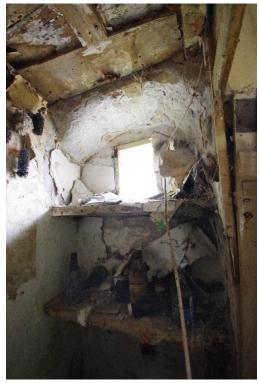
Fig 31 Room 5 blocked phase 1 door opening in north wall.

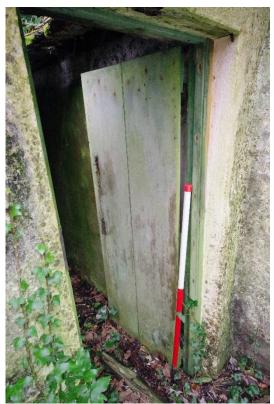
Fig 35 Room 7 reused 18th or 19th century door.

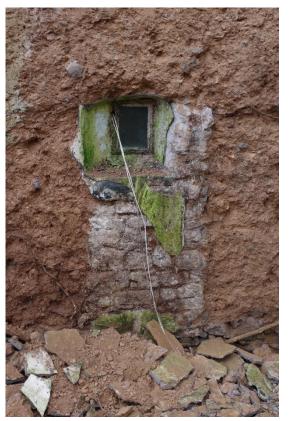
Fig 41 Blocked back door opening in north wall of phase 1 house.

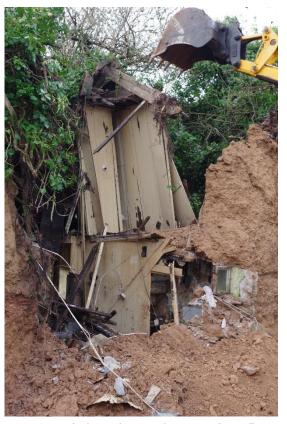
Fig 42 Mid-demolition showing first floor phase 2 plank and muntin partition walls.

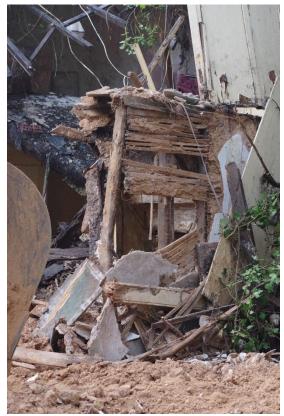
Fig 43 Lath and earth plaster partition wall between rooms 2 and 5 showing position of blocked door opening.

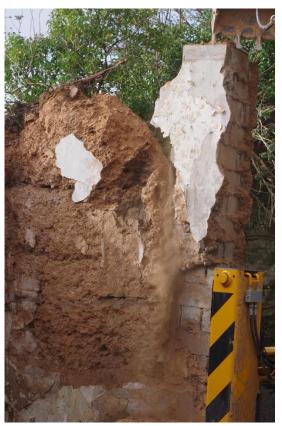
Demolition confirmed that the replacement early-mid 20th century sash window was still present in the upper floor of Room 2. It also revealed a narrow fireplace on the west wall of Room 2, at first floor level, which had been cut into the cob, and subsequently blocked with cob (Figs 46 and 47).

Fig 46 Blocked original first floor fireplace (centre) and modern concrete block flue in west wall of room 2.

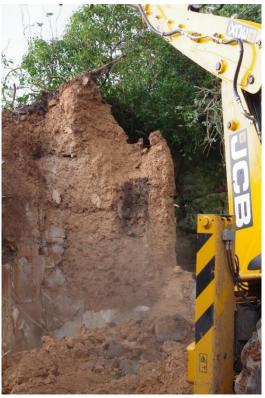
Fig 47 Blocking removed from fireplace in west wall of room 2, showing soot on cob.

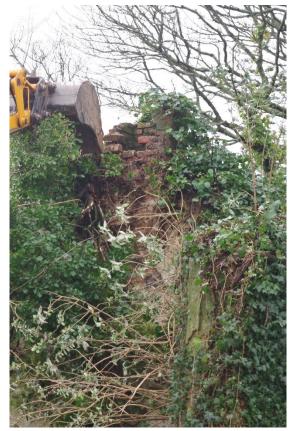
Fig 49 Demolition revealed a brick chimney stack in the west gable which had previously been obscured.
