Storm Tower, Compass Point, Bude, Cornwall, Historic Building Record

Client	Donald Martin Countryside Team Cornwall Council
Report Number	2021R077
Date	22/07/2021
Status	Final
Report author(s)	Jo Sturgess
Checked by	Jo Sturgess
Approved by	Andy Jones
Project number	147137
Data location	\\CAU\Archive\Sites\B\Bude Storm Tower Preservation by Record HBR 2021
Historic England / ADS OASIS online reference	cornwall2-426593
Planning reference	N/A

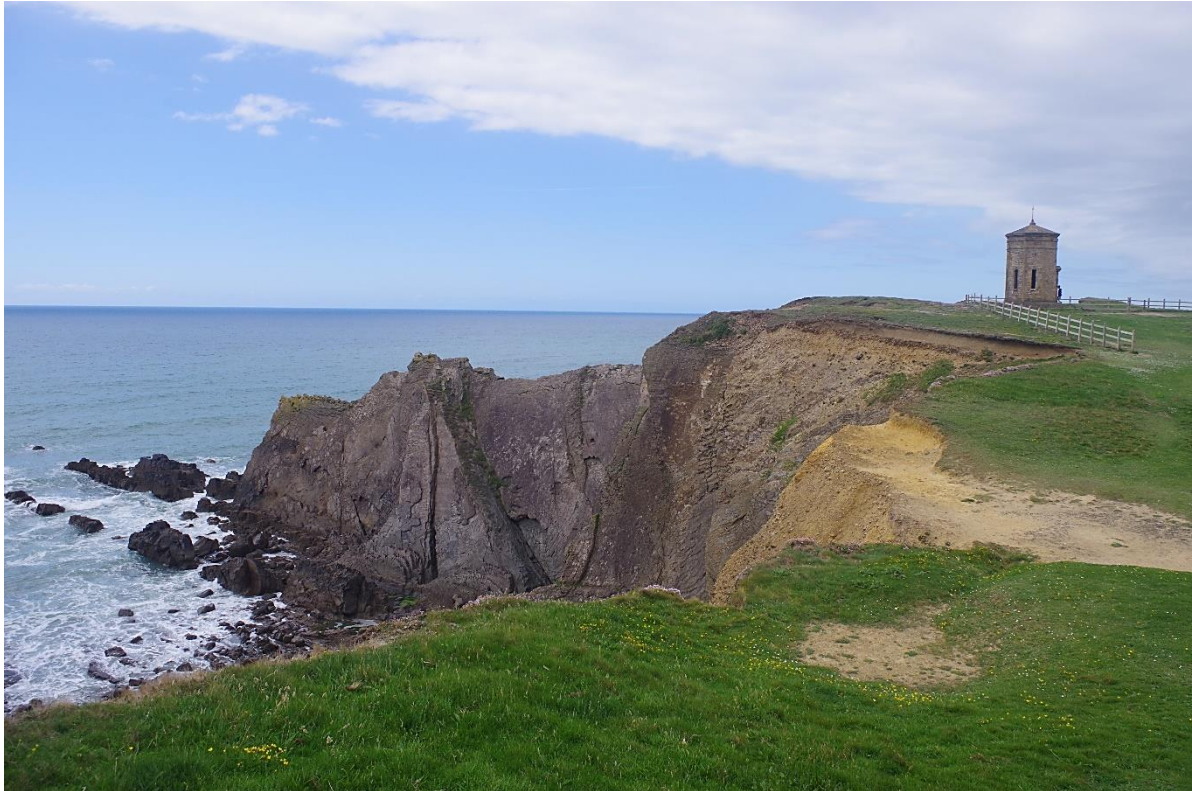
Fig 10 Storm tower looking north east.

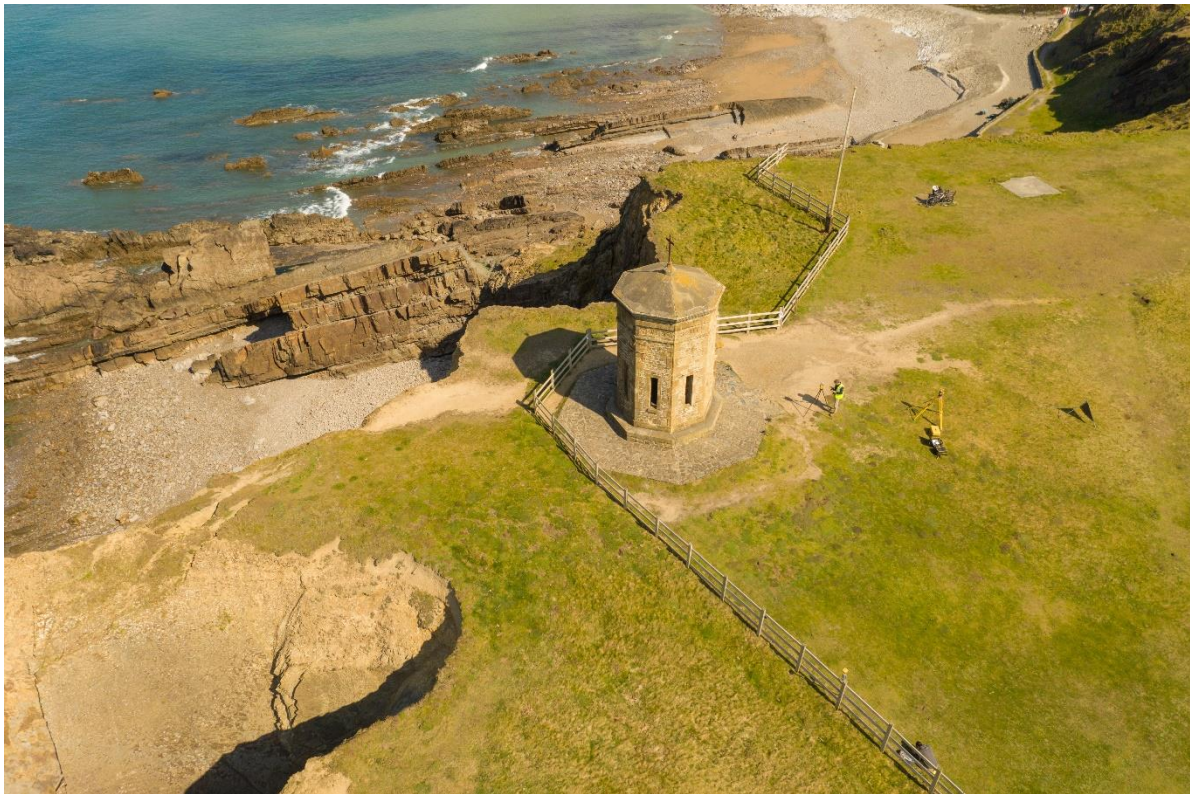
Fig 12 Aerial view of Storm Tower showing concrete roof (supplied by Mark Trewin).

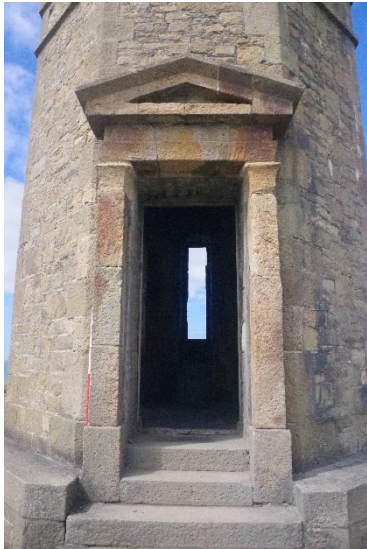
Fig 15 Detail of doorway in east elevation.

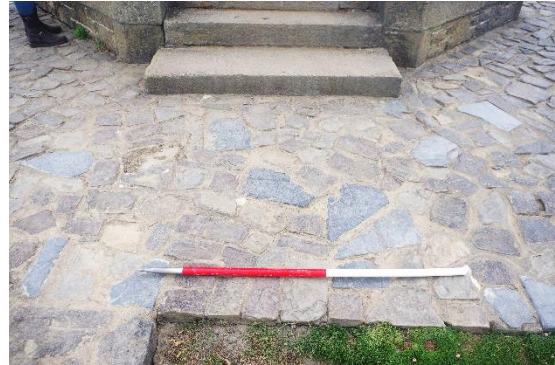
Fig 23 Detail of phase 5 paved surface.

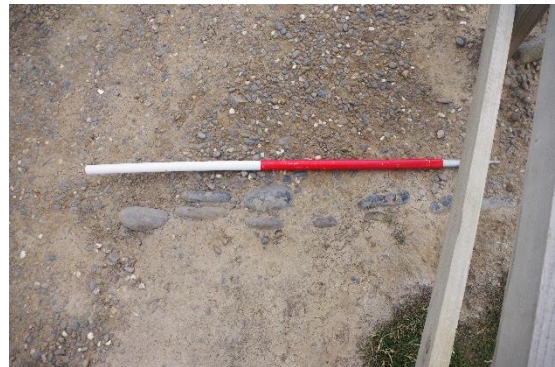
Fig 24 Detail of phase 1 or 2 pebble metalled surface and edging.

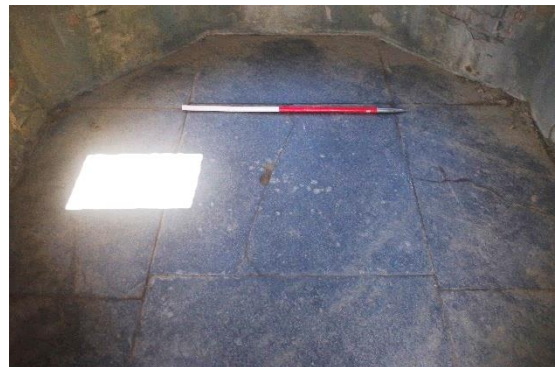
Fig 25 Interior slate flagstone floor looking west.

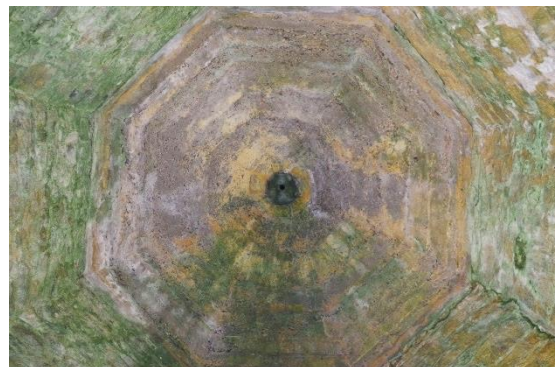
Fig 26 Interior shuttered concrete domed ceiling.

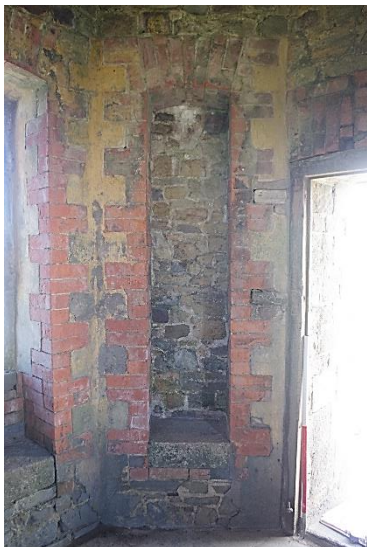
Fig 29 Interior north east wall with blind window.

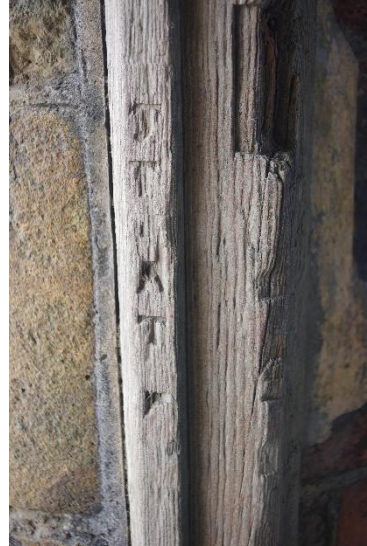
Fig 42 Detail of graffiti on door frame.

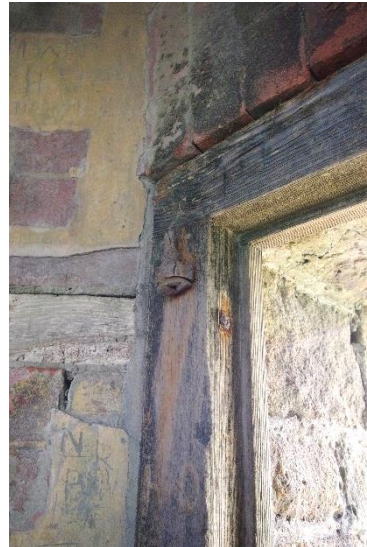
Fig 43 Detail of iron pintle on door frame.

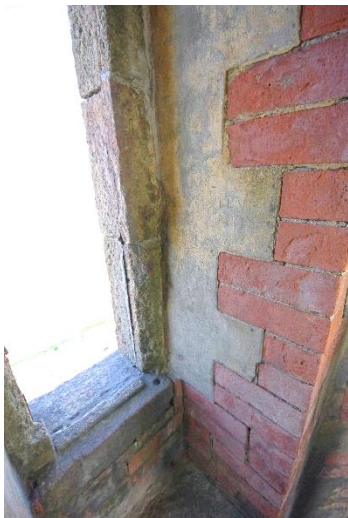
Fig 41 Detail of window reveal and elvan frame showing scars where the windows have been removed.

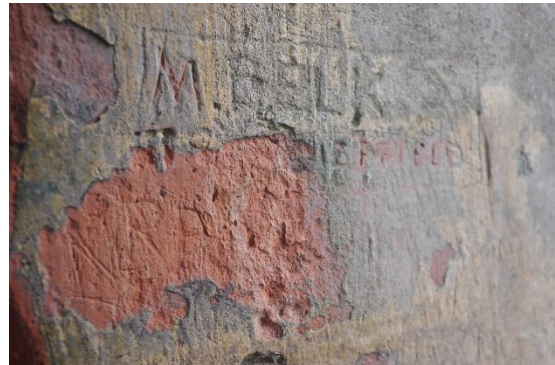
Fig 44 Detail of general graffiti on internal walls.
