Miners' Dry, South Wheal Frances,
Piece, Cornwall
Historic Building Record

Report No: 2022R010

Client	Cormac Solutions Ltd
Report Number	2022R010
Date	24/03/22
Status	Final
Report author(s)	Connor Motley and Jo Sturgess
Checked by	Jo Sturgess
Approved by	Andy Jones
Project number	147146
Data location	\\CAU\Archive\Sites\R\Redruth Miners Dry South Wheal Frances HBR 2021
Historic England / ADS OASIS online reference	cornwall2-504956
Planning reference	PA20/09145

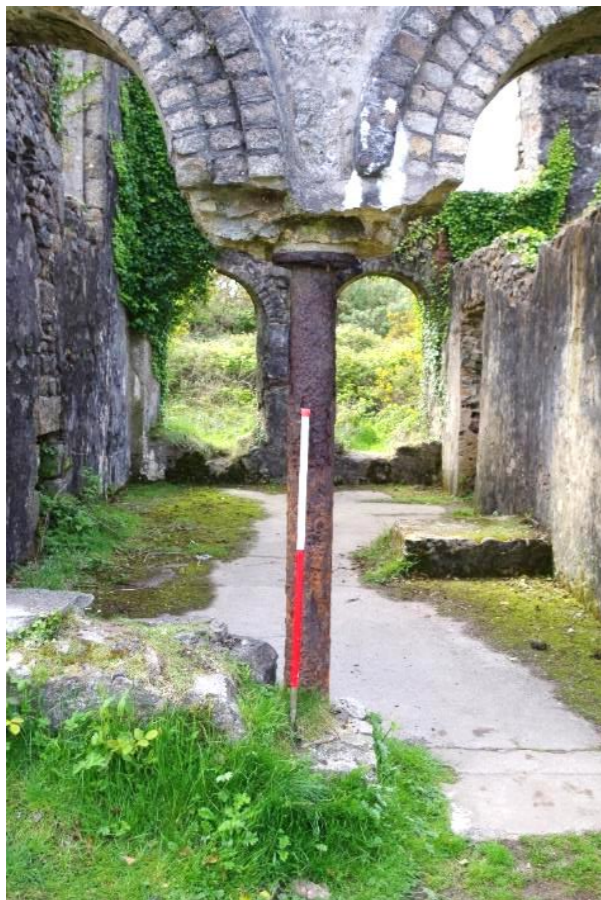
Fig 11 North elevation, east end showing reused iron pipe for missing window and door jambs.

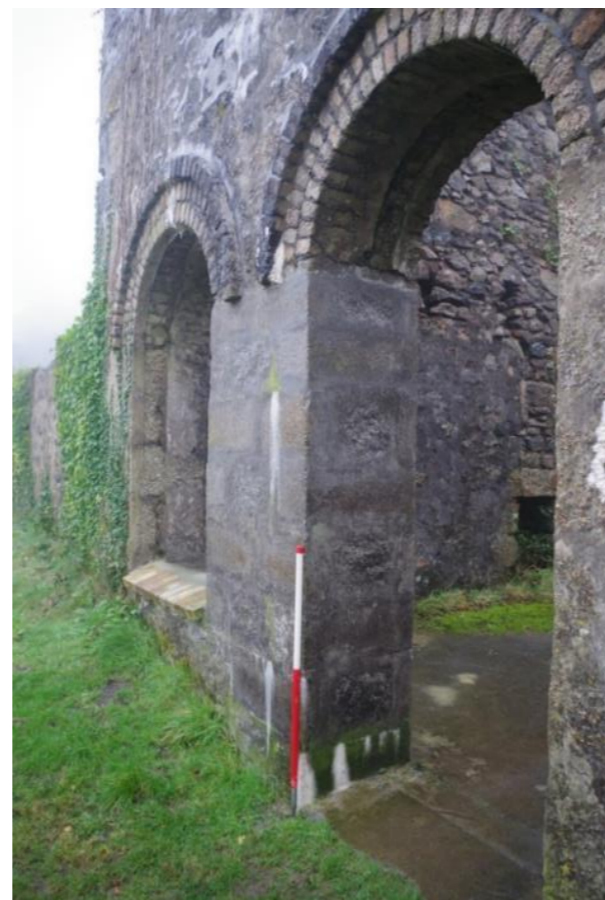
Fig 12 North elevation, east end following repairs, showing rebuilt window and door jambs around iron pipe.

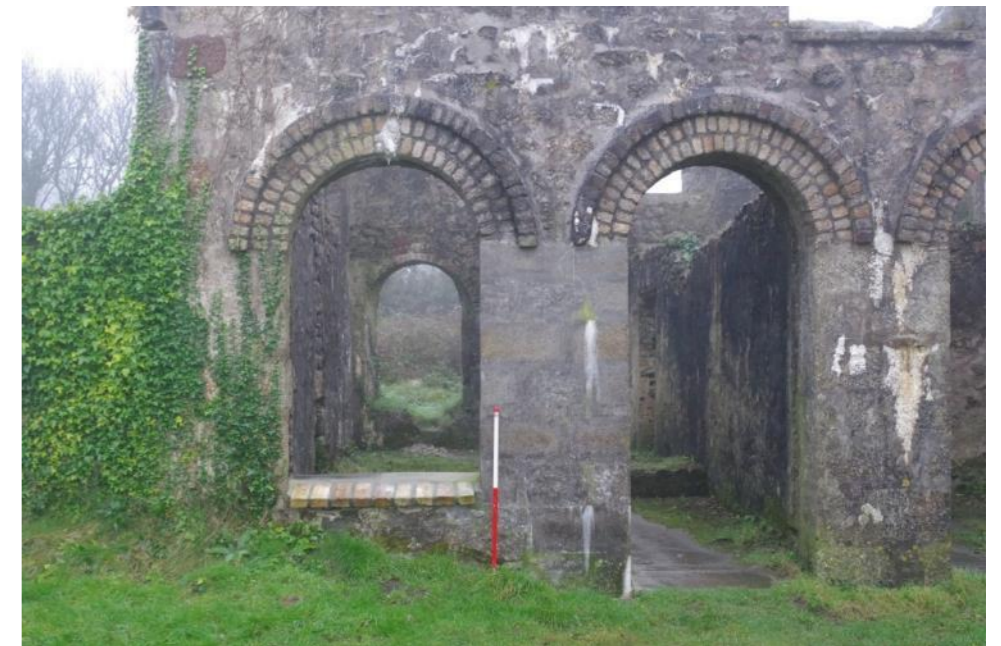
Fig 13 North elevation, east end following repairs, showing rebuilt window and door jambs around iron pipe and new brick sill.

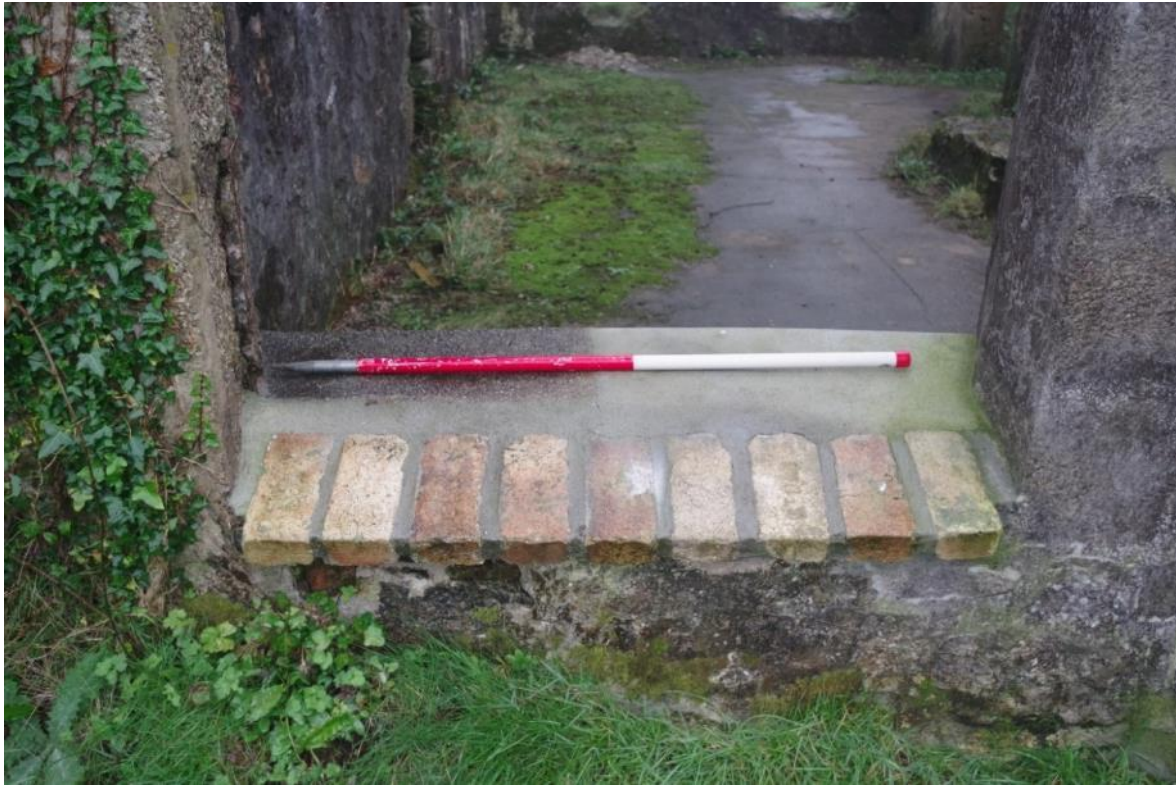
Fig 14 North elevation, east end following repairs to the window sill of room 9.

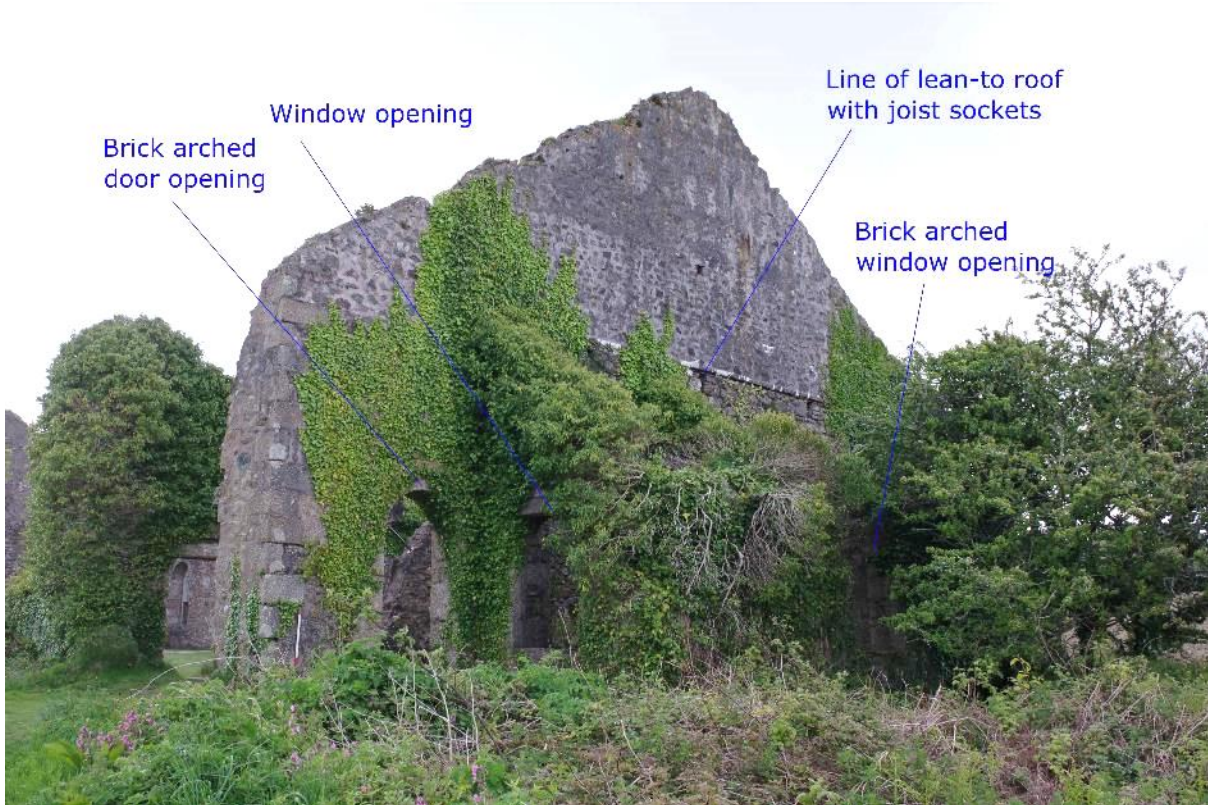
Fig 20 West elevation before vegetation clearance.

Along the whole of the west end of the building the vegetation was cleared and the tops of the single storey walls of rooms 1, 2 and 3 were capped with lime mortar (see Figs 20 and 21 for before and after repairs).

Another repair included the upper part of damaged quoin at the west end of the north exterior elevation of room 3. This was rebuilt to match the existing and bonded with lime mortar (see Figs 20, 21 and 22 for before and after repairs).

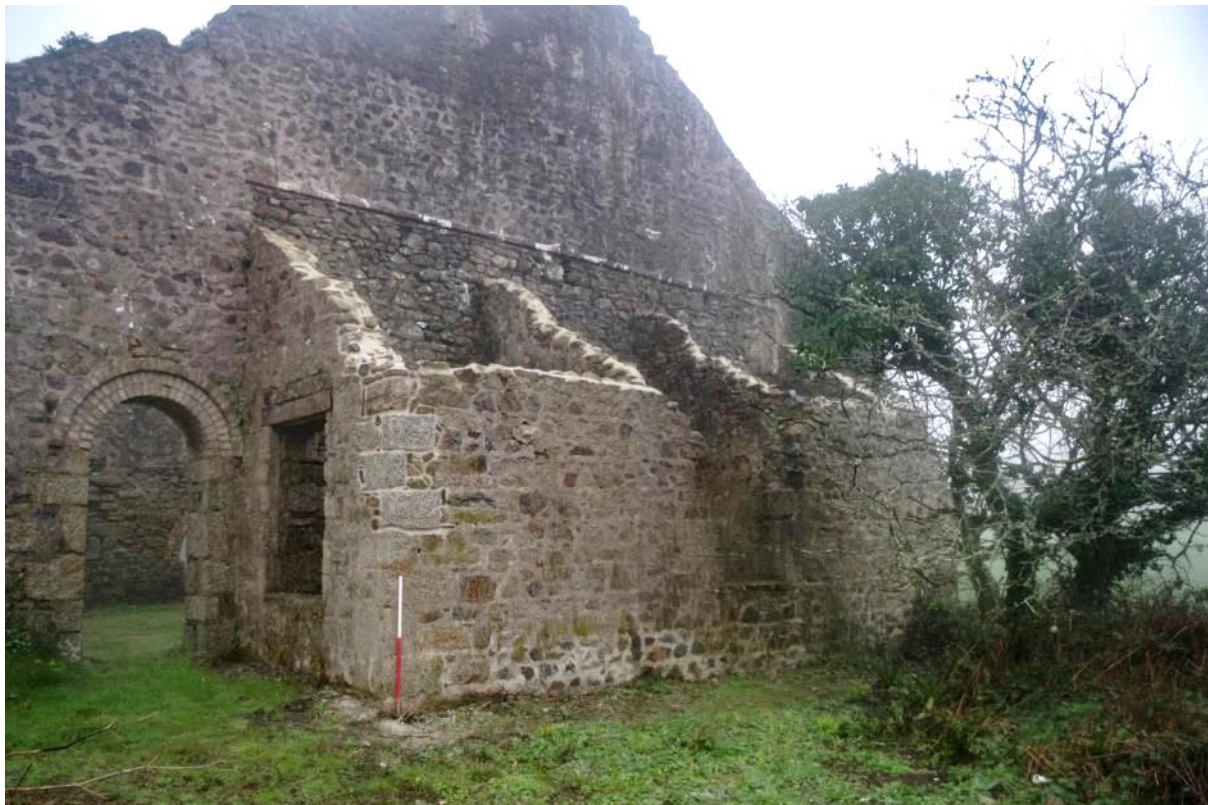
Fig 21 West elevation following vegetation clearance and repair work.

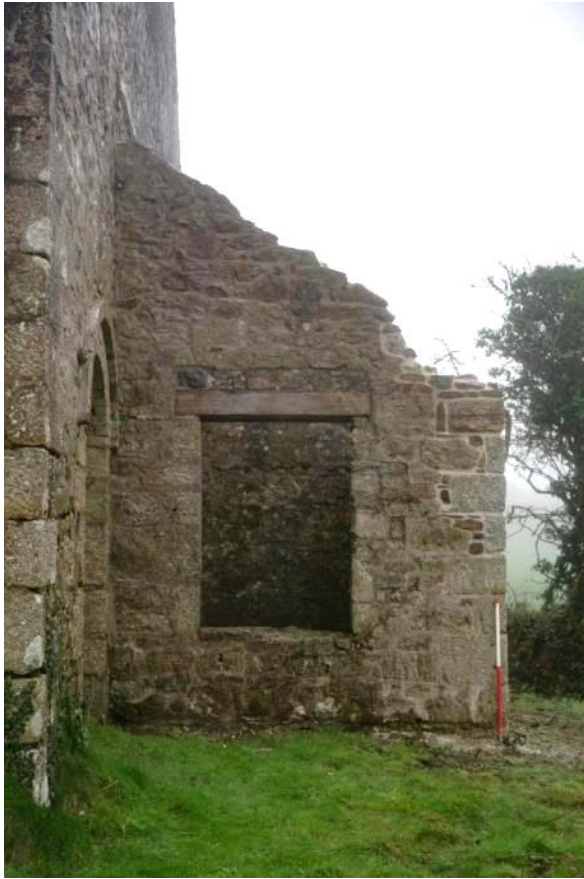
Fig 22 North exterior elevation of Room 3 following repair of the quoin and lintel.

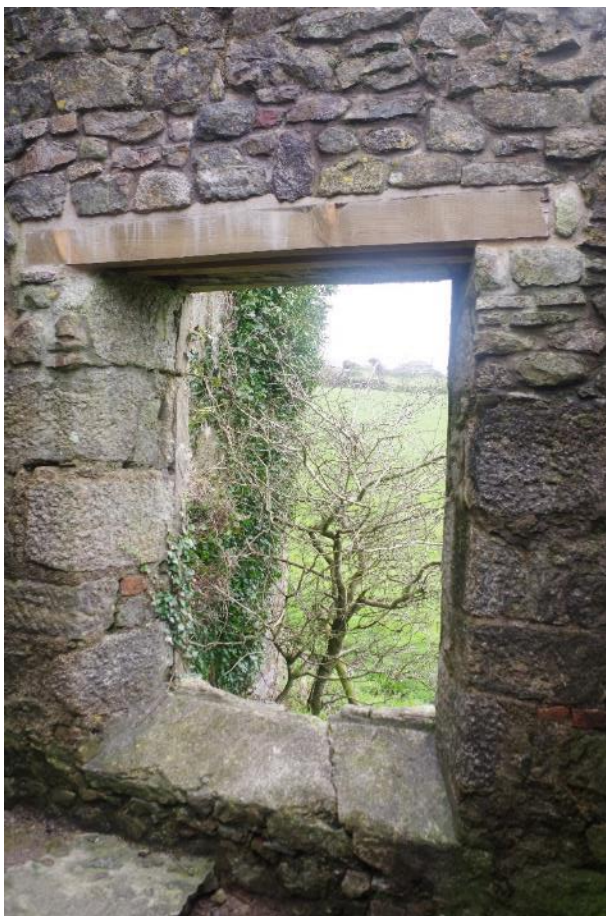
Fig 27 Room 1 south wall following replacement of lintel.

Two of the timber lintels over the window opening in the south wall were replaced due to rot with similar sized timber lintels made from oak and were mortared in as necessary (see Figs 26 and 27 for before and after repairs).

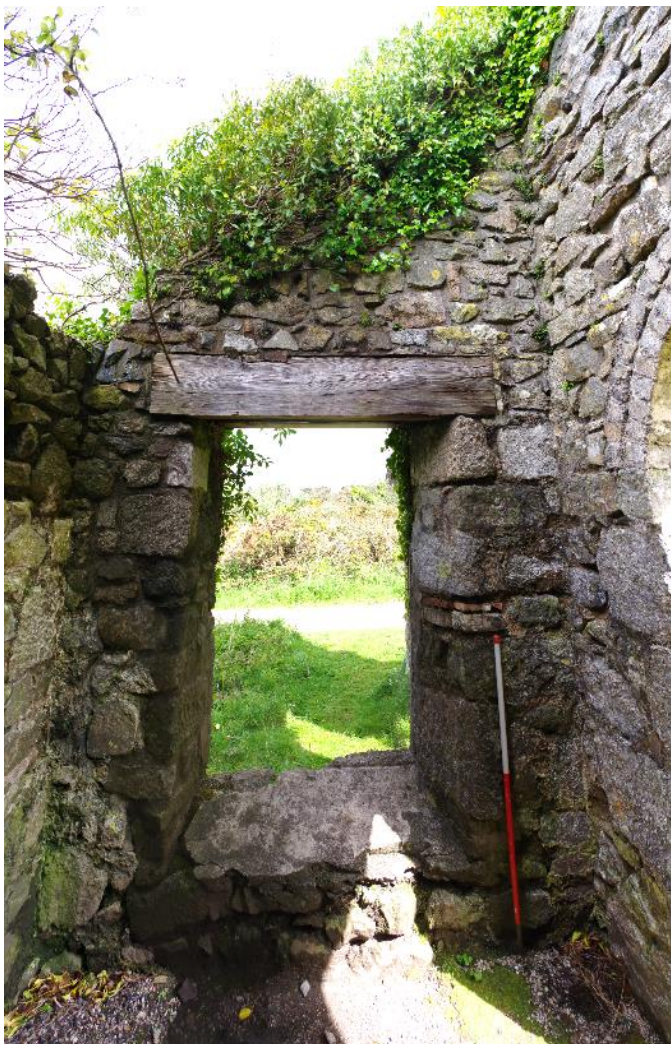
Fig 35 Room 3 north wall before repairs.

The lintel and stonework above the window in the north wall of room 3 were also replaced as part of the repair works using an oak lintel and the walling above repaired using lime mortar (see Figs 35 and 36 for before and after repairs).

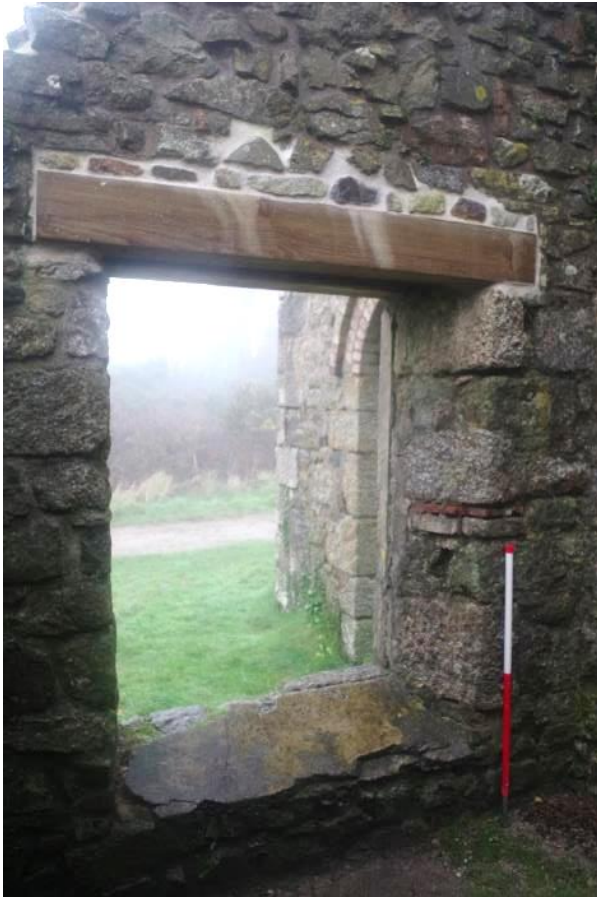
Fig 36 Room 3 north wall following insertion of new lintel and repairs.

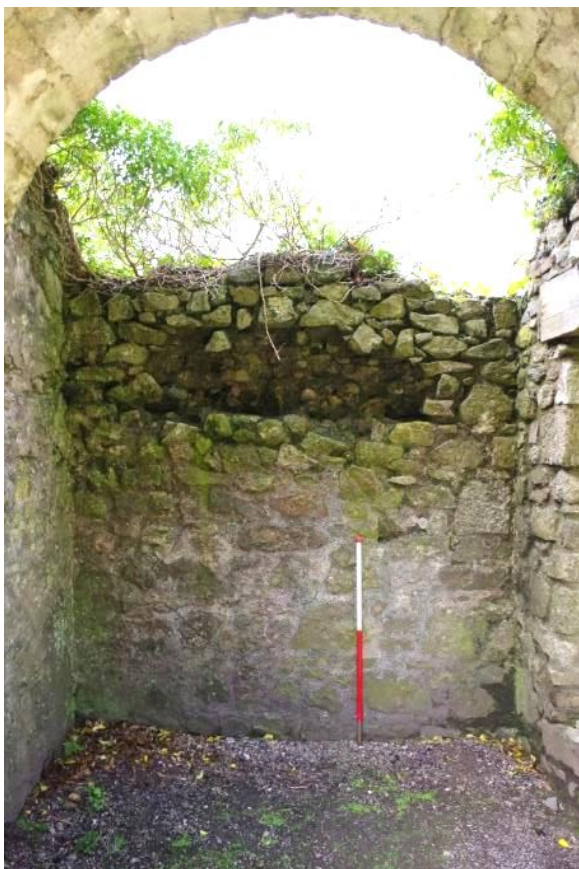
An area of stonework in the west wall of room 3 had been lost, possibly caused by the removal or rotting out of a timber feature in the wall. This has now been repaired by infilling with lime mortared local stone rubble above, recessed by 25 – 50mm (see Figs 39 and 40 for before and after repairs).

Fig 39 Room 3 west wall before repairs.

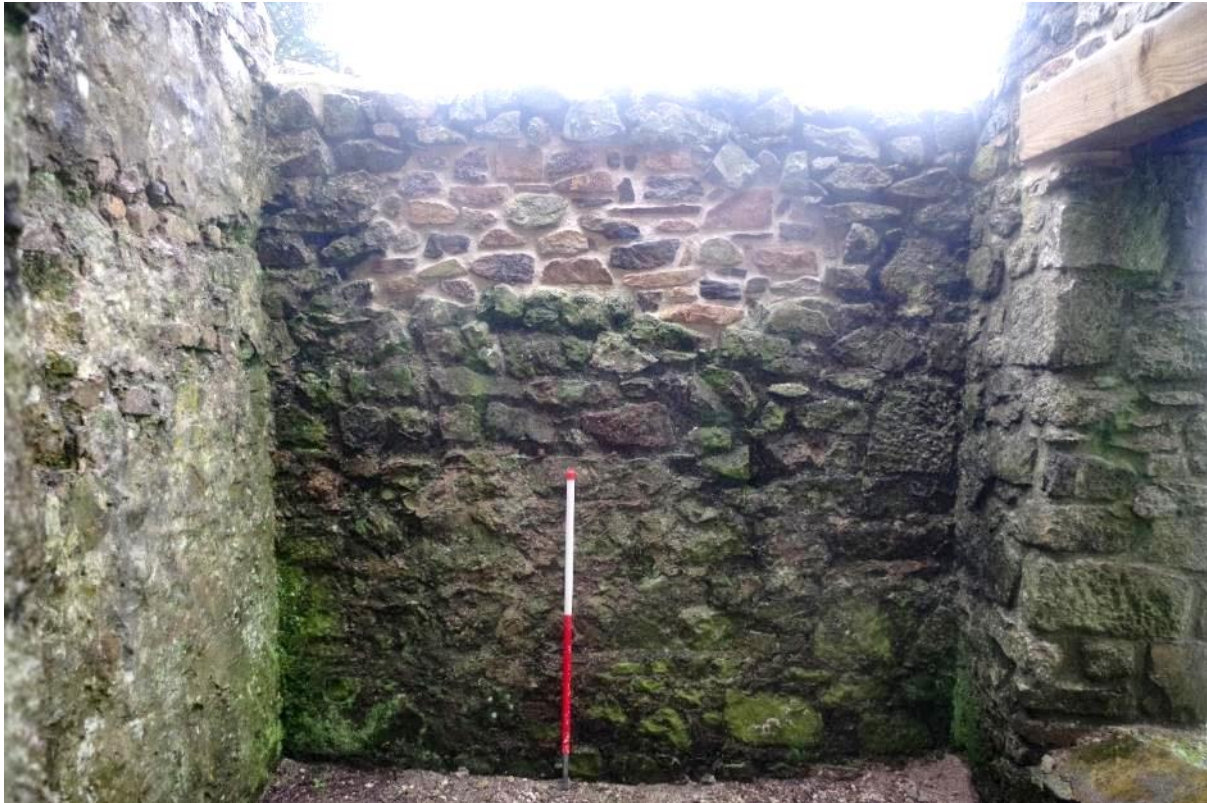
Fig 40 Room 3 west wall following masonry repairs.

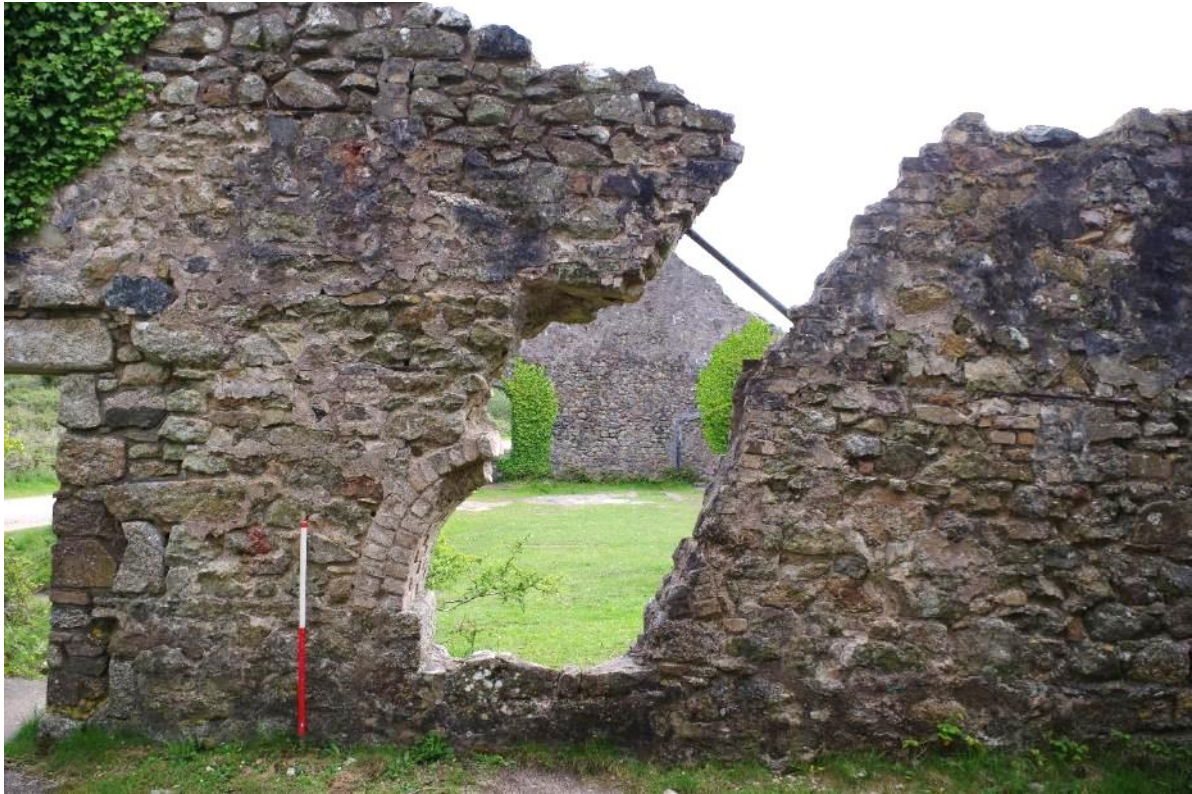
A section of the dividing wall between rooms 4 and 5 had collapsed above the northern steam pipe opening including part of the brick arch of the opening. A previous repair using a tubular steel prop had been undertaken to stabilise the unsupported masonry, but the masonry was continuing to fail. This area has now been repaired by rebuilding the brick arch for the steam pipe opening and filling the void above with local stone rubble bonded with lime mortar. The face of the new walling has been inset from the existing wall by 25 – 50mm and the new masonry has been constructed around the existing prop. The base of the steam pipe opening has also been consolidated using stone rubble bonded with lime mortar (see Figs 44, 45, 58, 59 and 60 for before and after repairs). In addition, the top of the partition wall dividing room 4 from room 5 has been capped with lime mortar.

Fig 44 Room 4 east wall, northern steam pipe opening before repairs.

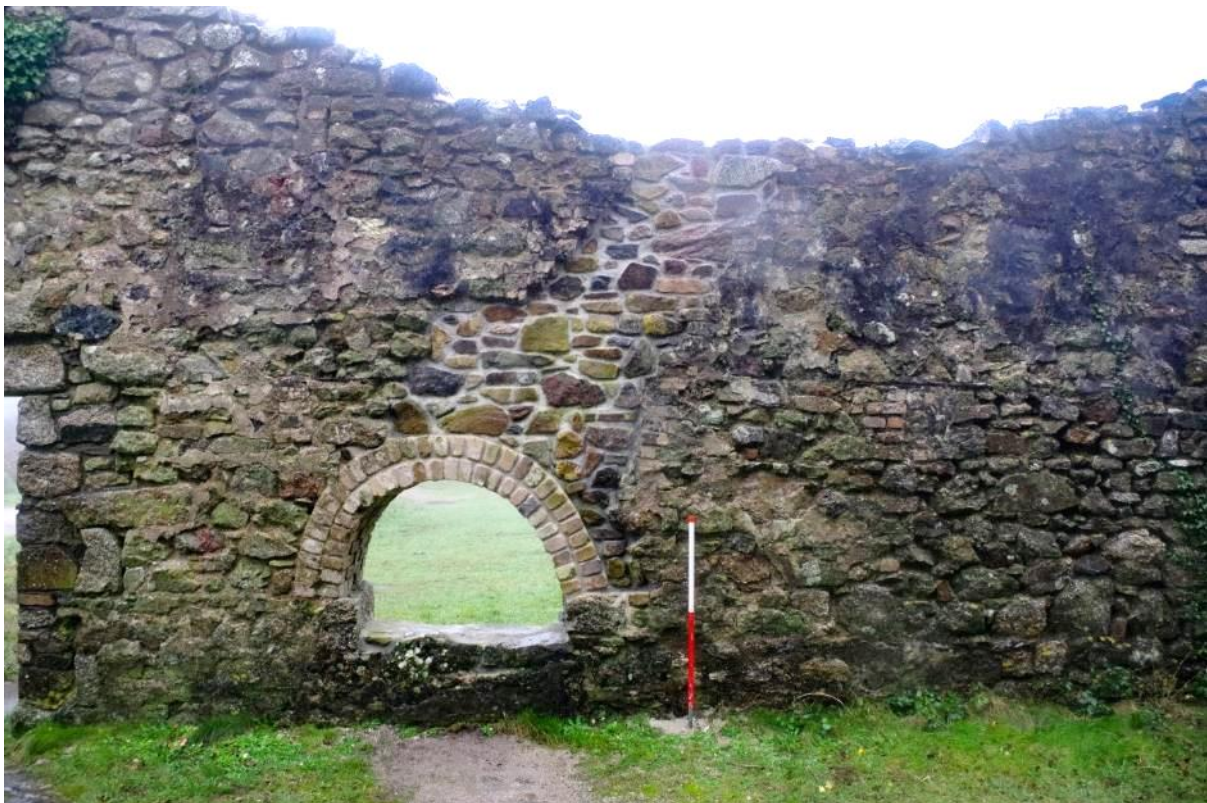
Fig 45 Room 4 east wall following reconstruction of missing wall and brick arch for northern steam pipe opening.

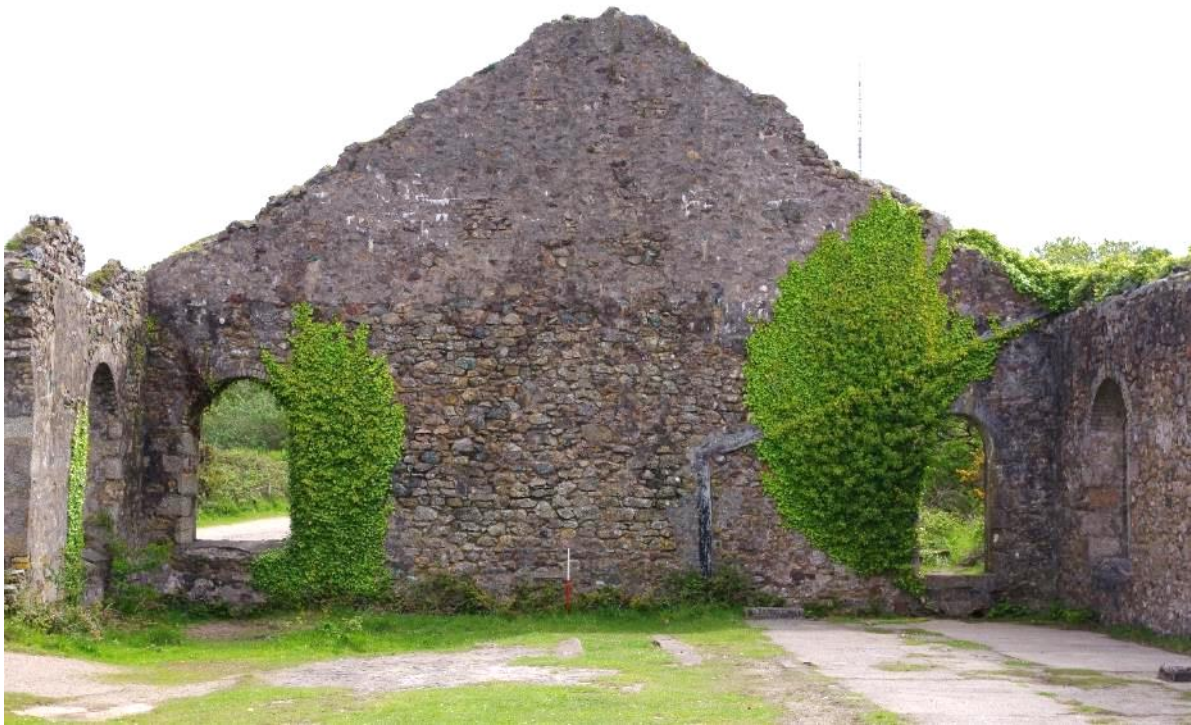
Fig 54 Room 5 east wall, showing location of former, inserted phase 3 lean-to to the right.

A small patch repair was also undertaken on the east wall of room 5 using lime mortar (see Figs 54 and 55 for before and after repairs).

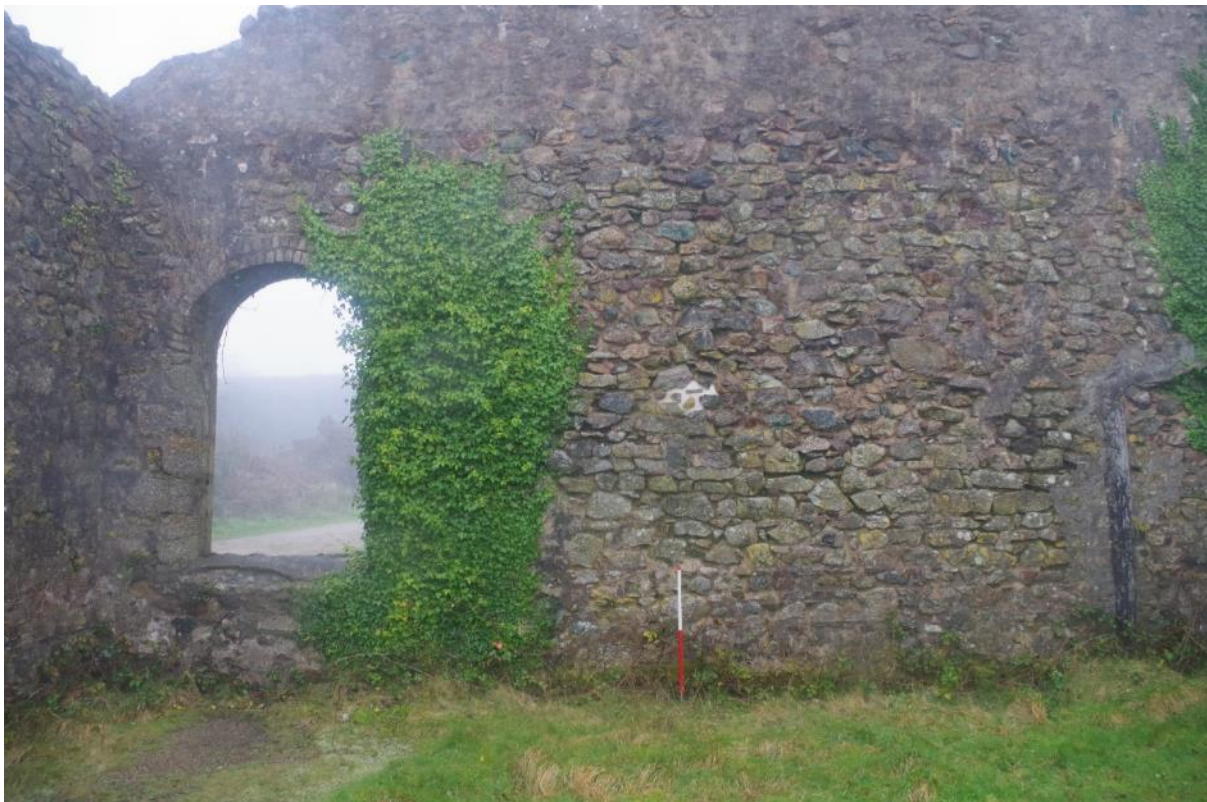
Fig 55 Room 5 east wall following repairs, showing small patch repair.

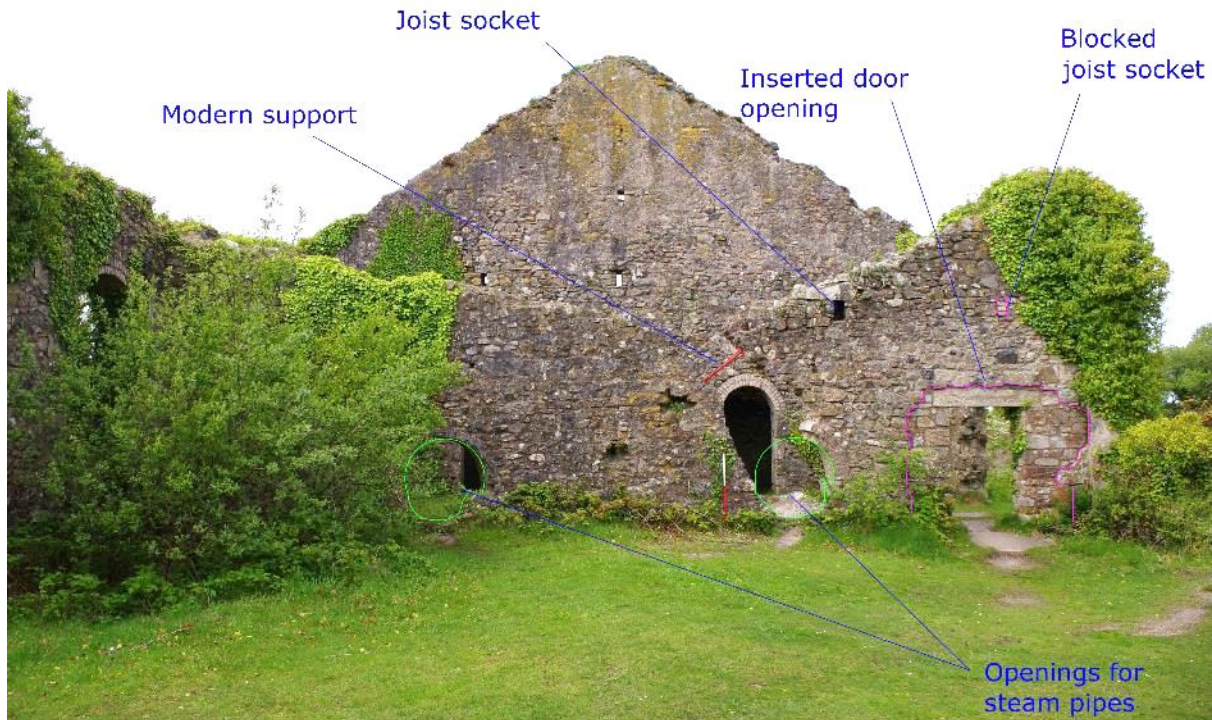
Fig 58 Room 5 west wall before repairs.

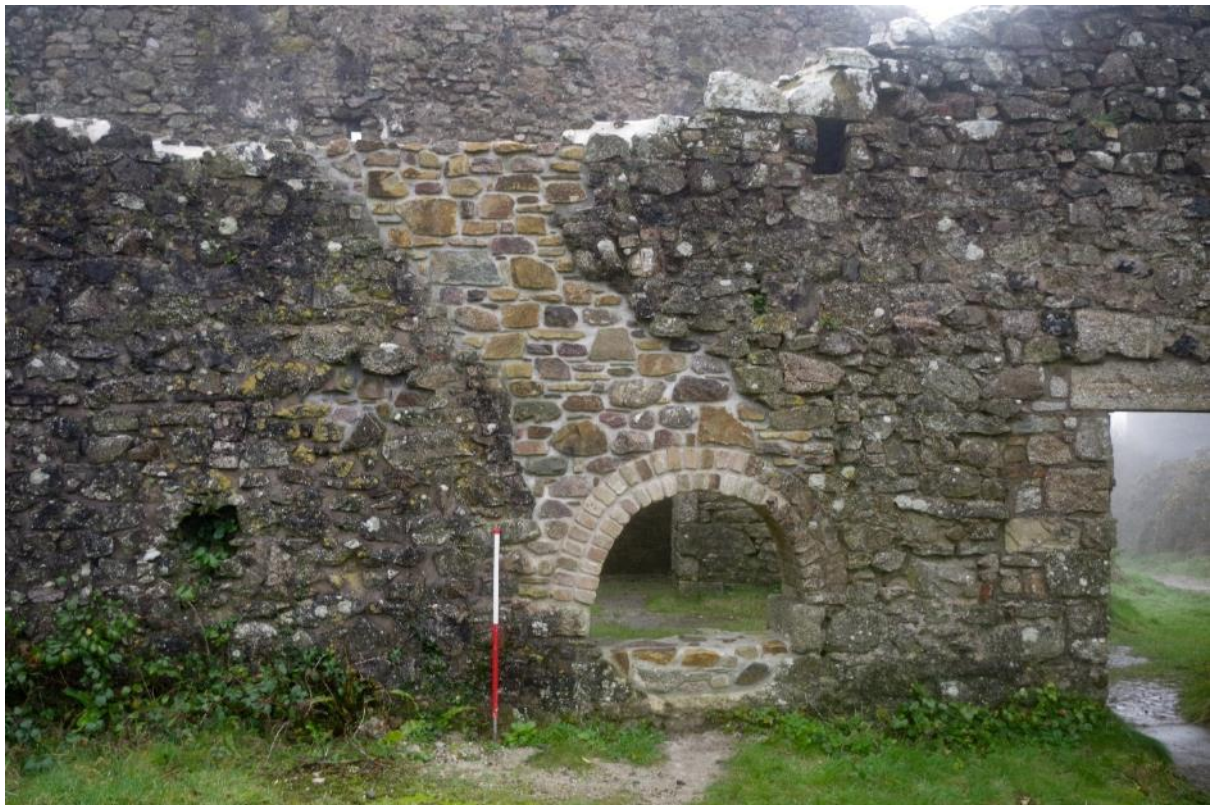
Fig 59 Room 5 west wall following reconstruction of missing wall and brick arch for northern steam pipe opening.

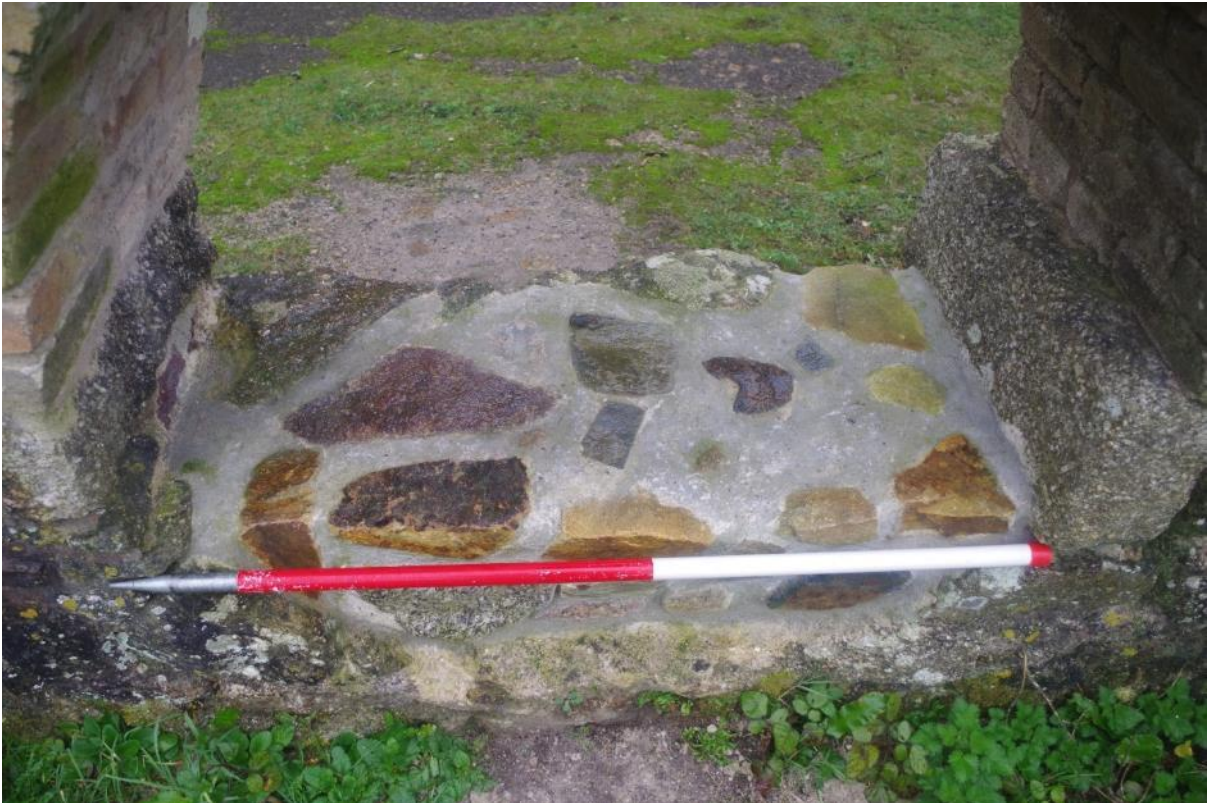
Fig 60 Room 5 west wall following repair to the base of the northern steam pipe opening.

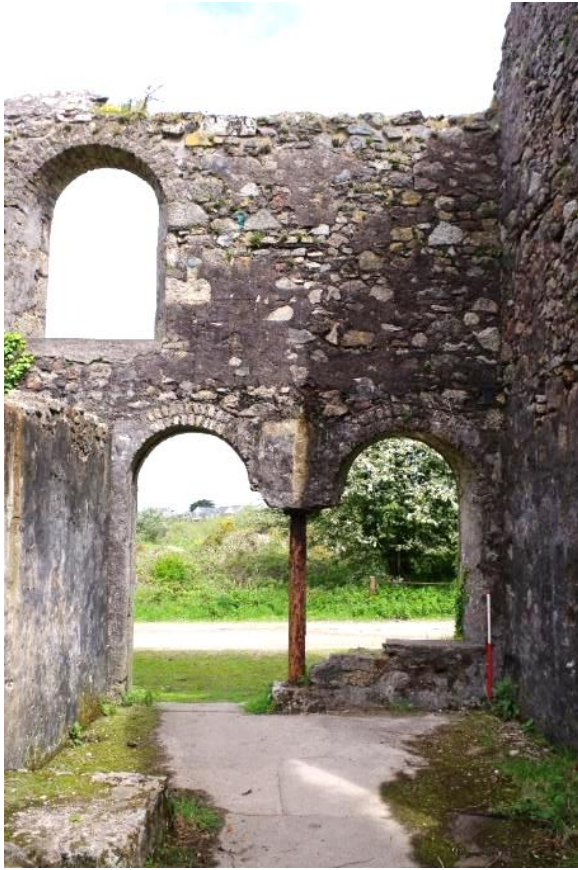
Fig 76 Room 9 north wall showing iron pipe reused as pillar to replace former window and door jambs. Room 10 is at first floor level.

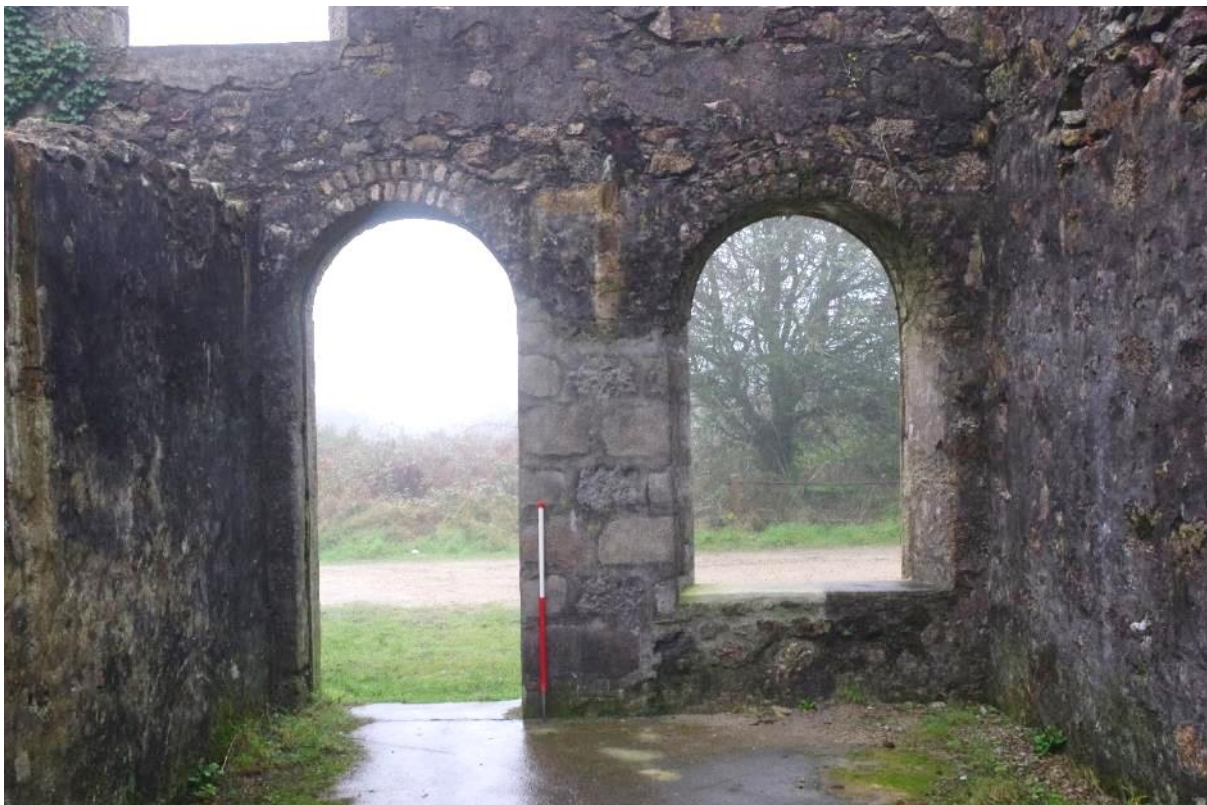
Fig 77 Room 9, north wall following repairs and showing rebuilt jambs around iron pipe.

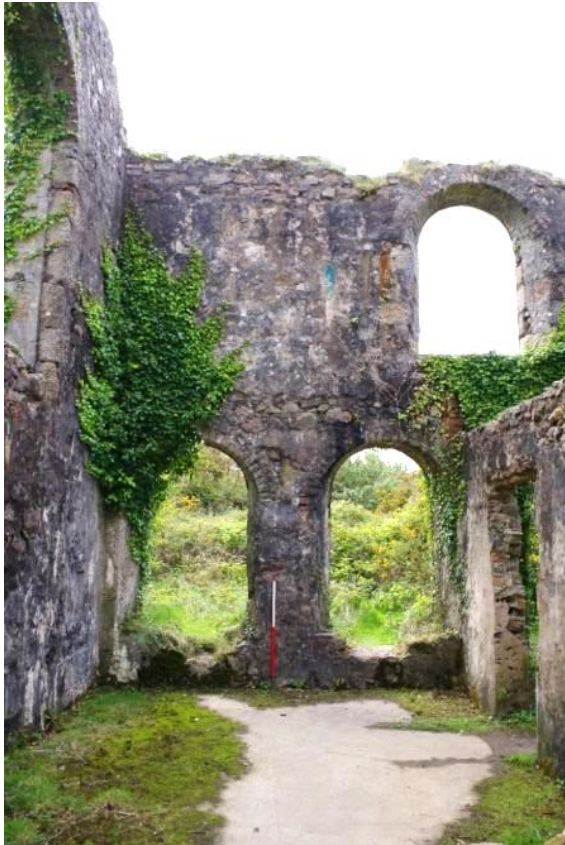
Fig 80 Room 9 south wall before repairs, with room 10 at first floor level.

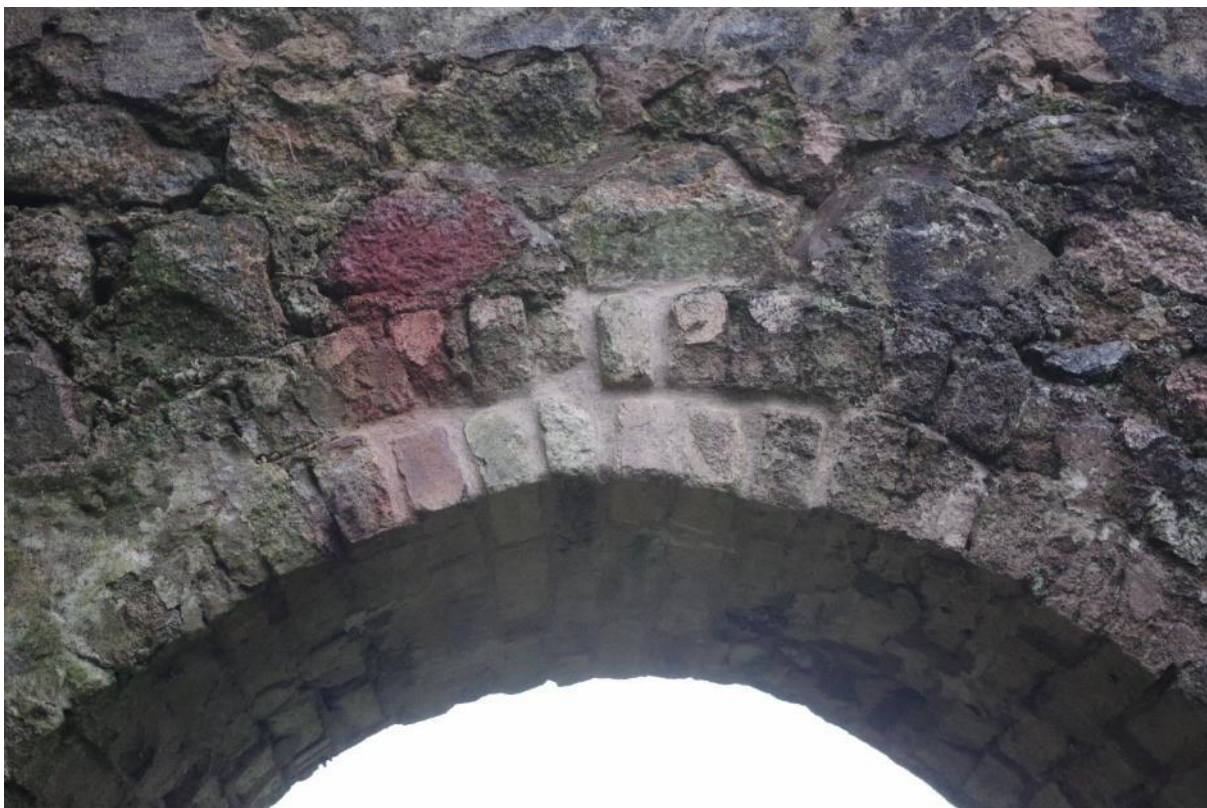
Fig 81 Room 9 south wall following repair of the window arch.

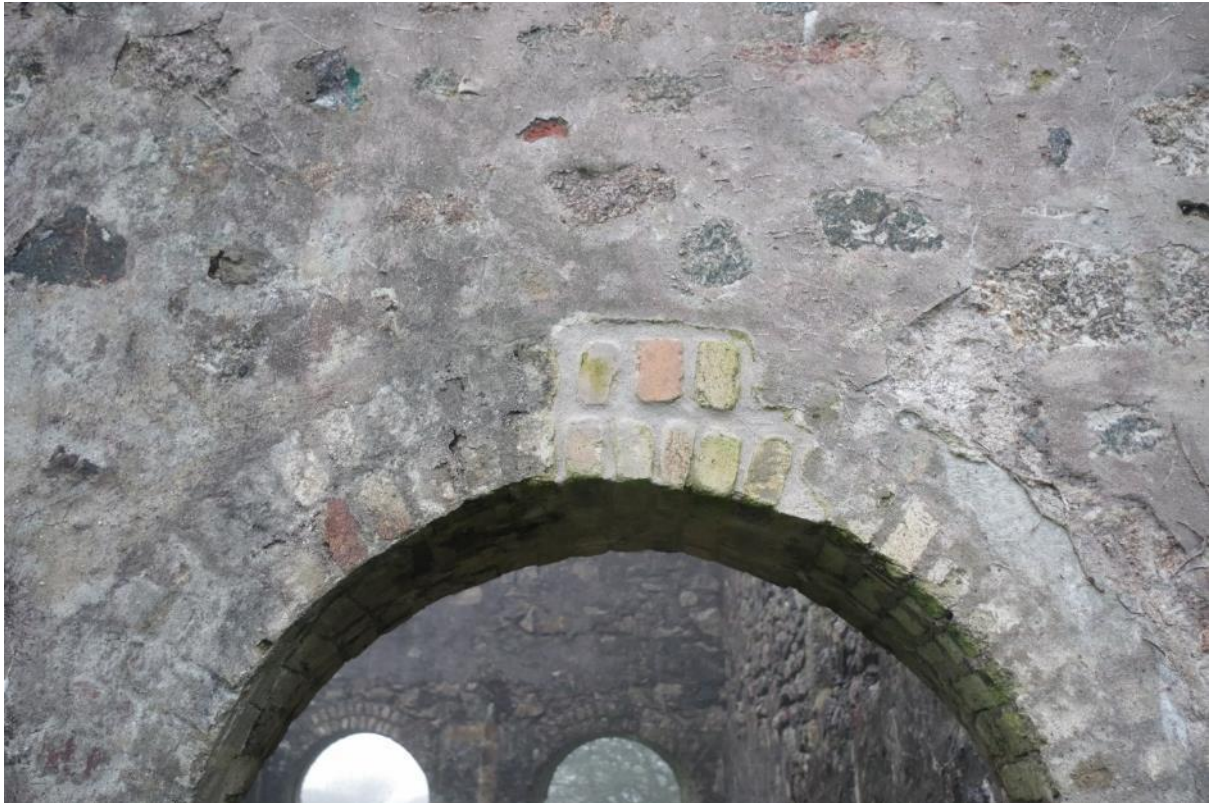
Fig 82 South exterior elevation of the window arch of room 9 following repair.

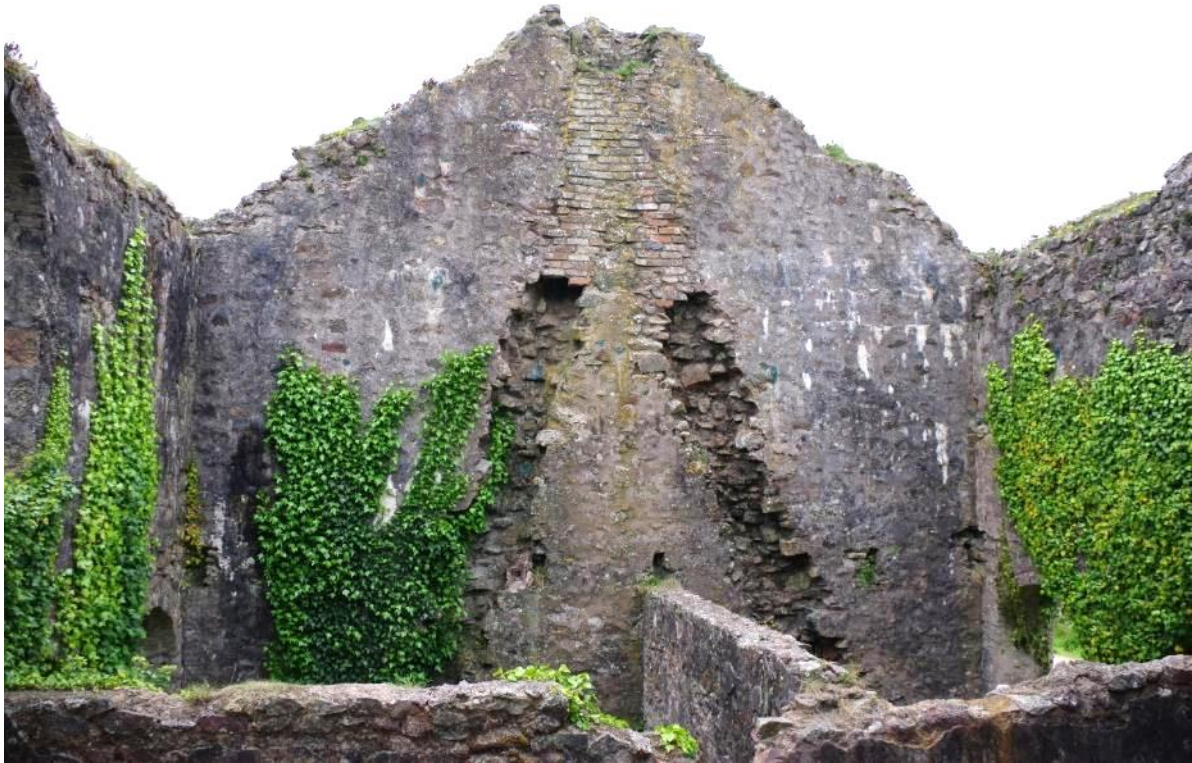
The two chimney flues in the west wall of rooms 7, 8 and 10 have lost most of the brickwork in their lower halves. Because there was potential for bricks to continue to fall, the bases of the remaining brickwork in both flues were consolidated using lime mortar and supported from below by the insertion of steel brackets (see Figs 84 and 85 for before and after repairs).

Fig 84 Room 10 before the repair of the flues in the west wall.

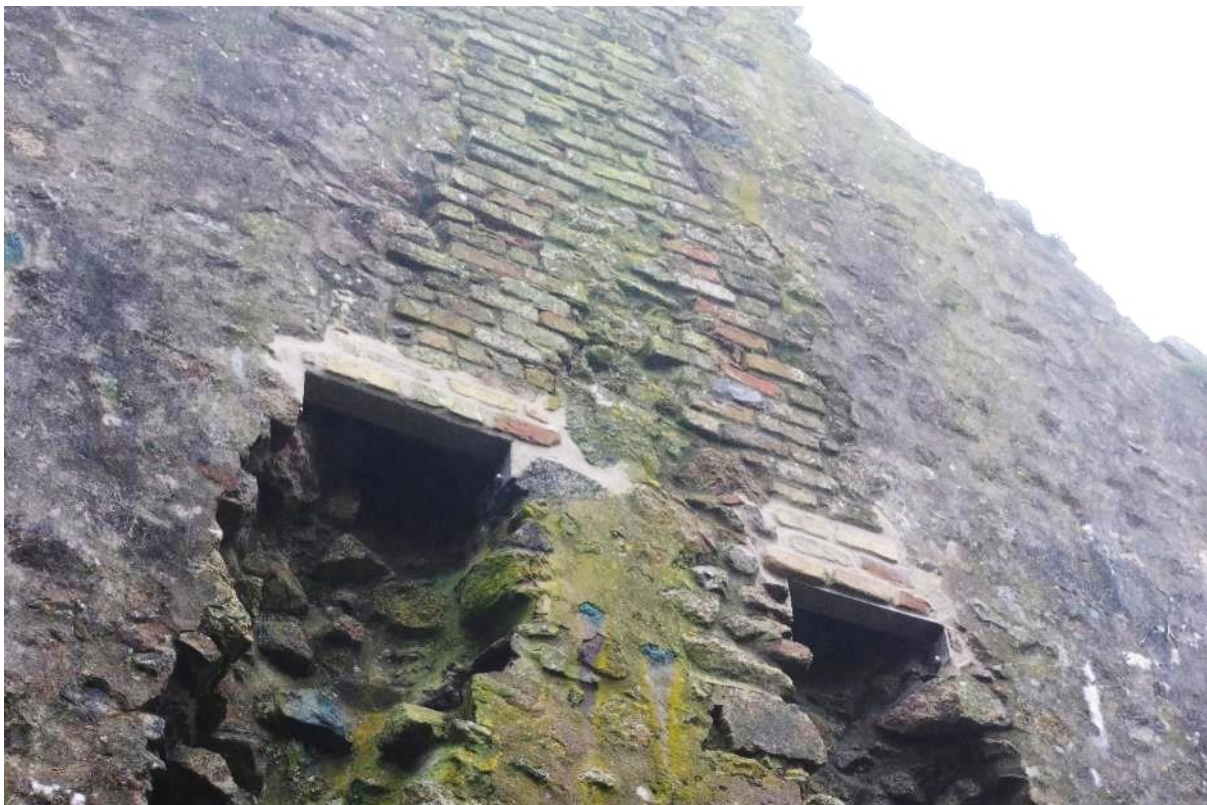
Fig 85 Room 10 following repairs to the brickwork of the flues in the west wall.
