Helland Bridge, Cornwall
Archaeological recording and
watching brief

Archaeological recording and watching brief

Client	Cormac Solutions Ltd
Report Number	2022R047
Date	October 2022
Status	Final
Report author(s)	Jo Sturgess and Connor Motley
Checked by	Jo Sturgess
Approved by	Andy Jones
Project number	147188
Site code	N/A
Data location	\\CAU\Archive\Sites\H\Helland Bridge recording and WB 2022
Historic England / ADS OASIS online reference	cornwall2-509550
Planning reference	PA22/05523

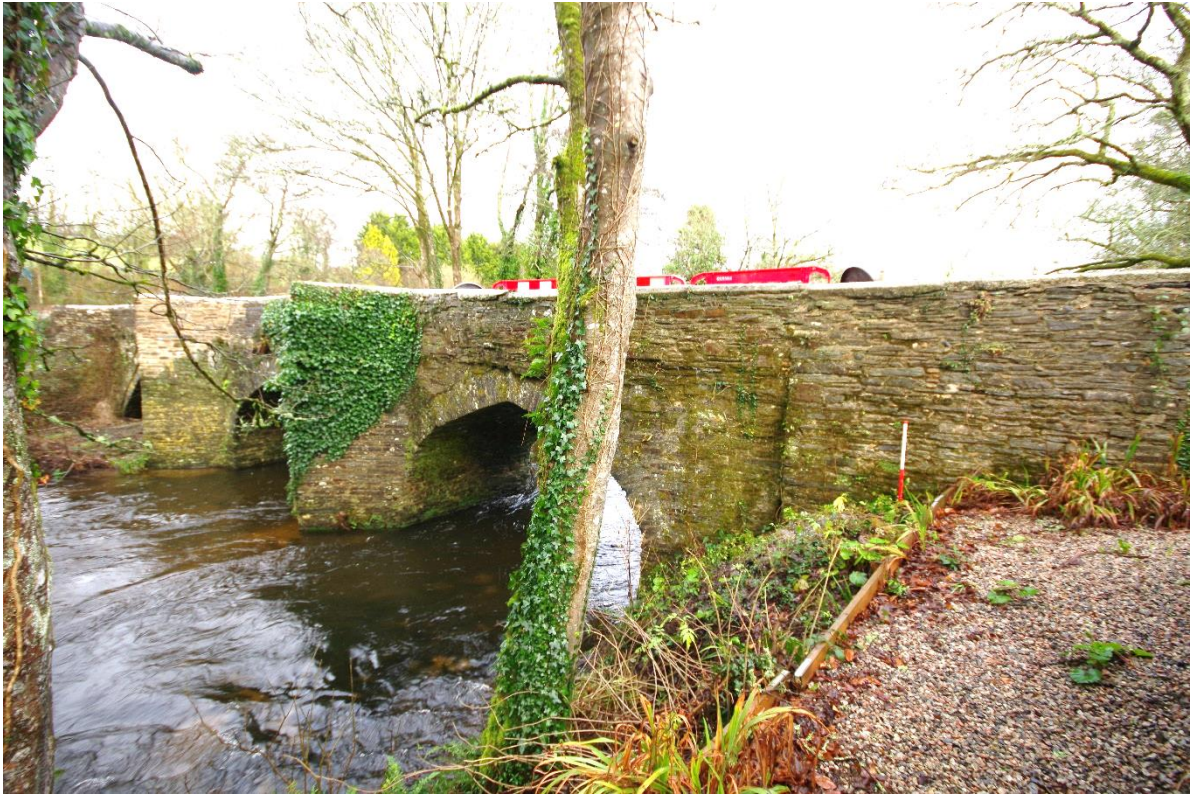
Fig 13 (05) Southern part of the west elevation showing pushed out walling over the arch and straight joint to the right.

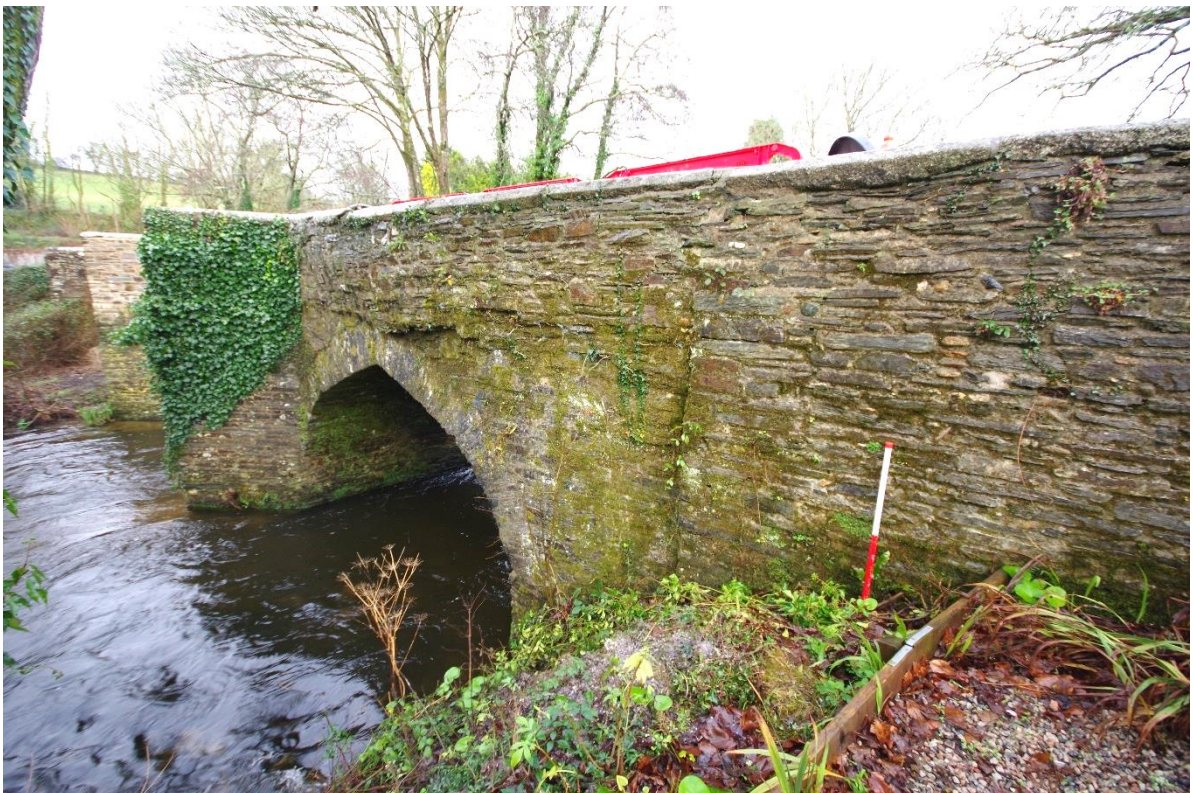
Fig 16 (01) South end of the west elevation showing pushed out walling over the arch.

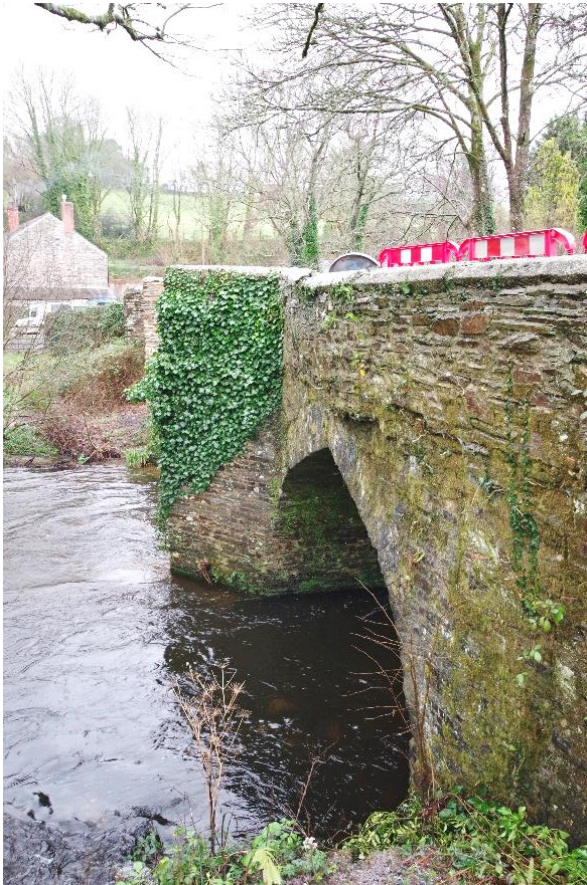
Fig 17 (07) South end of the west elevation showing pushed out parapet wall.

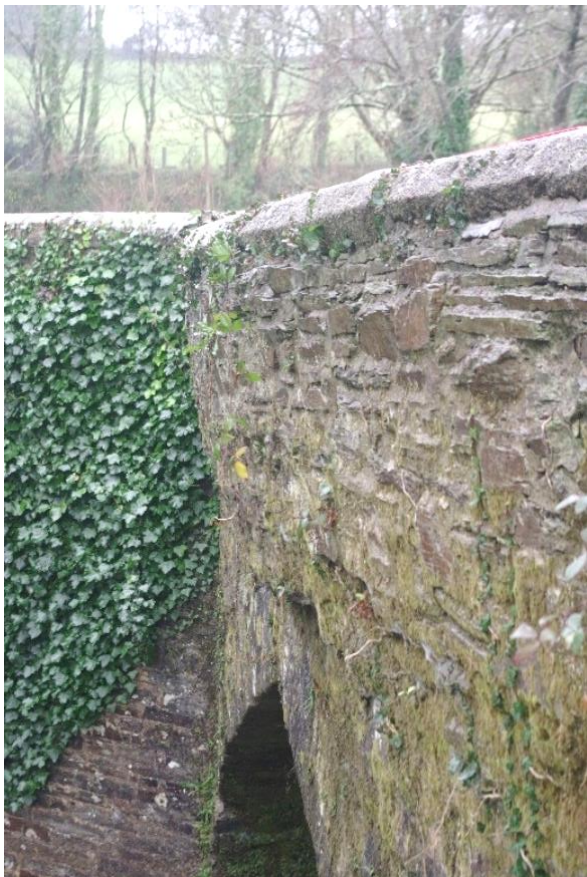
Fig 18 (10) Close up of pushed out parapet wall.

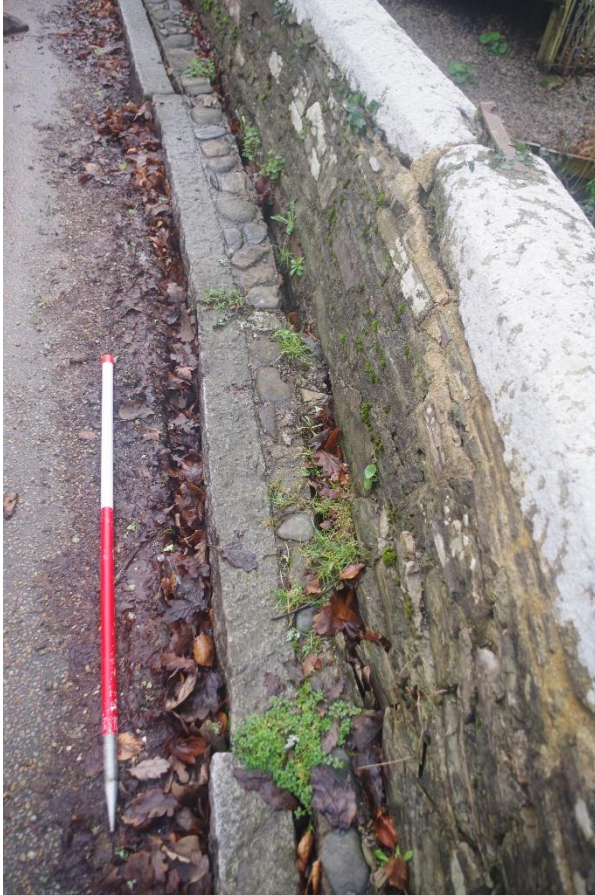
Fig 19 Gaps created by the collision on either side of the modern kerbing adjacent to the pushed out parapet wall.

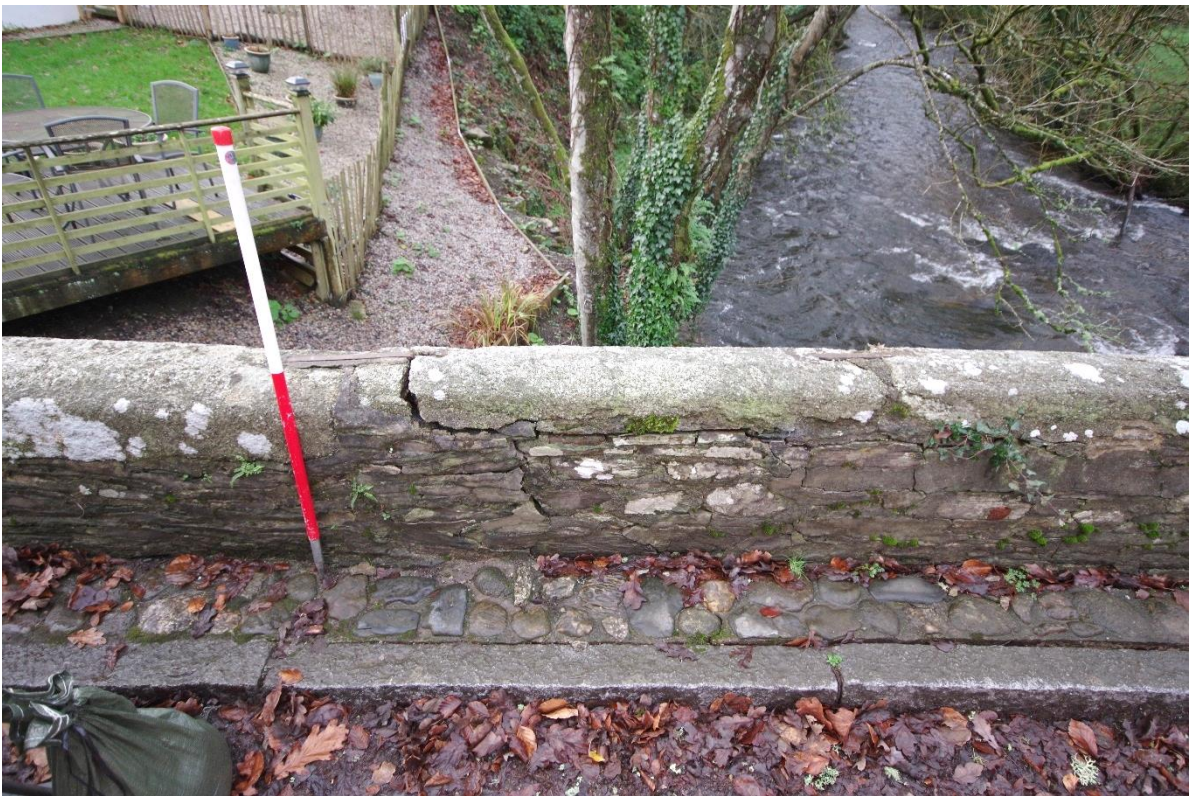
Fig 20 (23) Southern end of the east elevation of the damaged area of parapet wall.

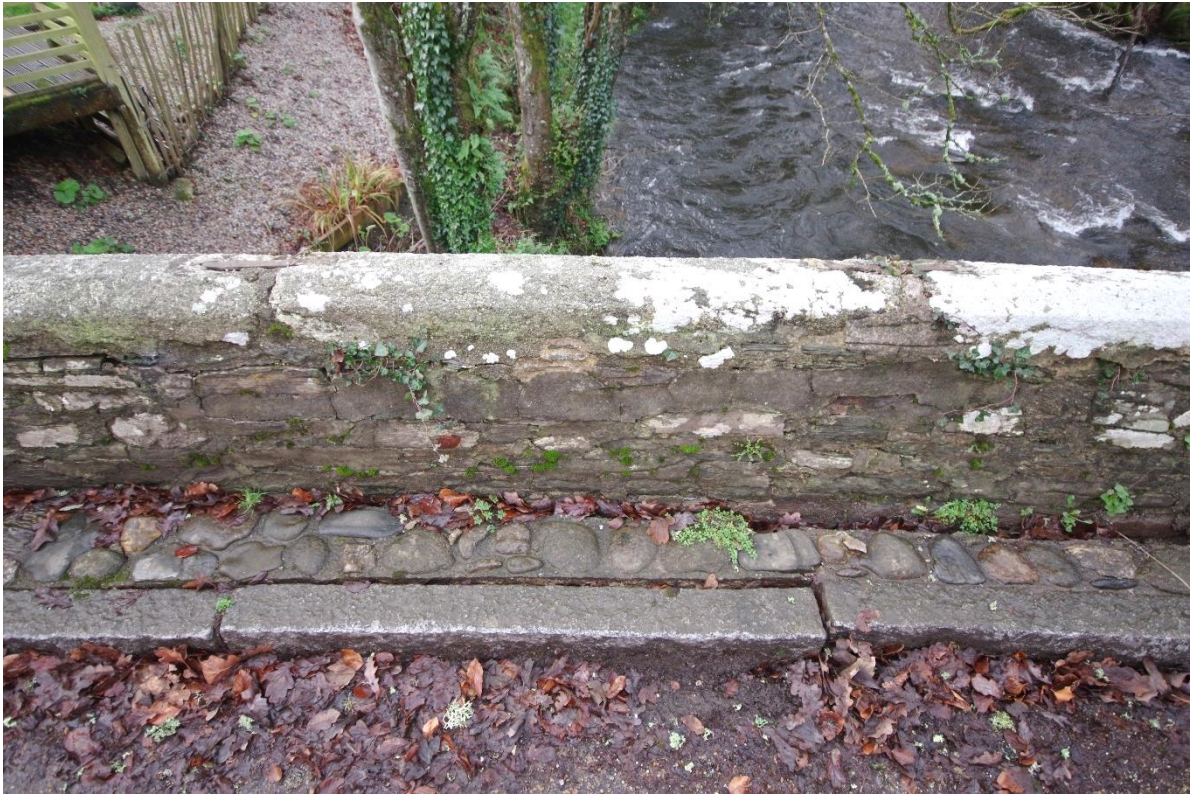
Fig 21 (24) East elevation of the damaged area of parapet wall immediately north of Figure 20.

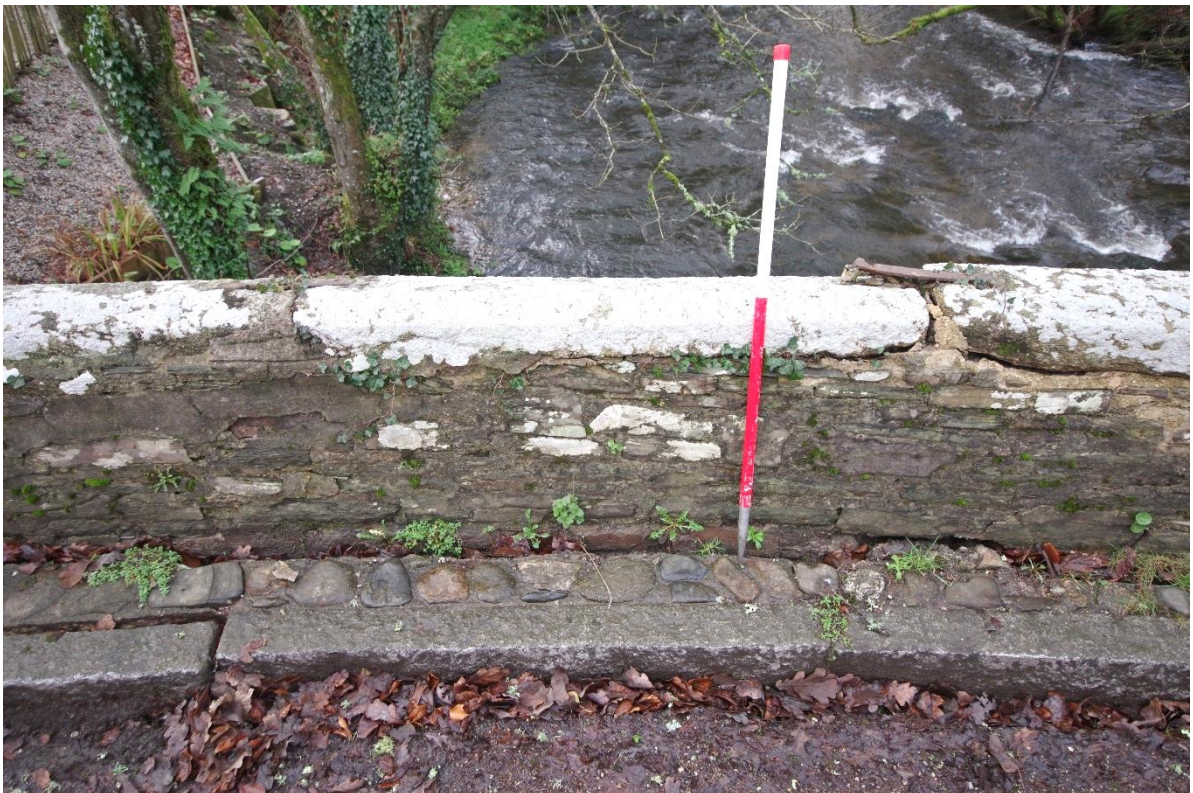
Fig 22 (25) East elevation of the damaged area of parapet wall immediately north of Figure 21.

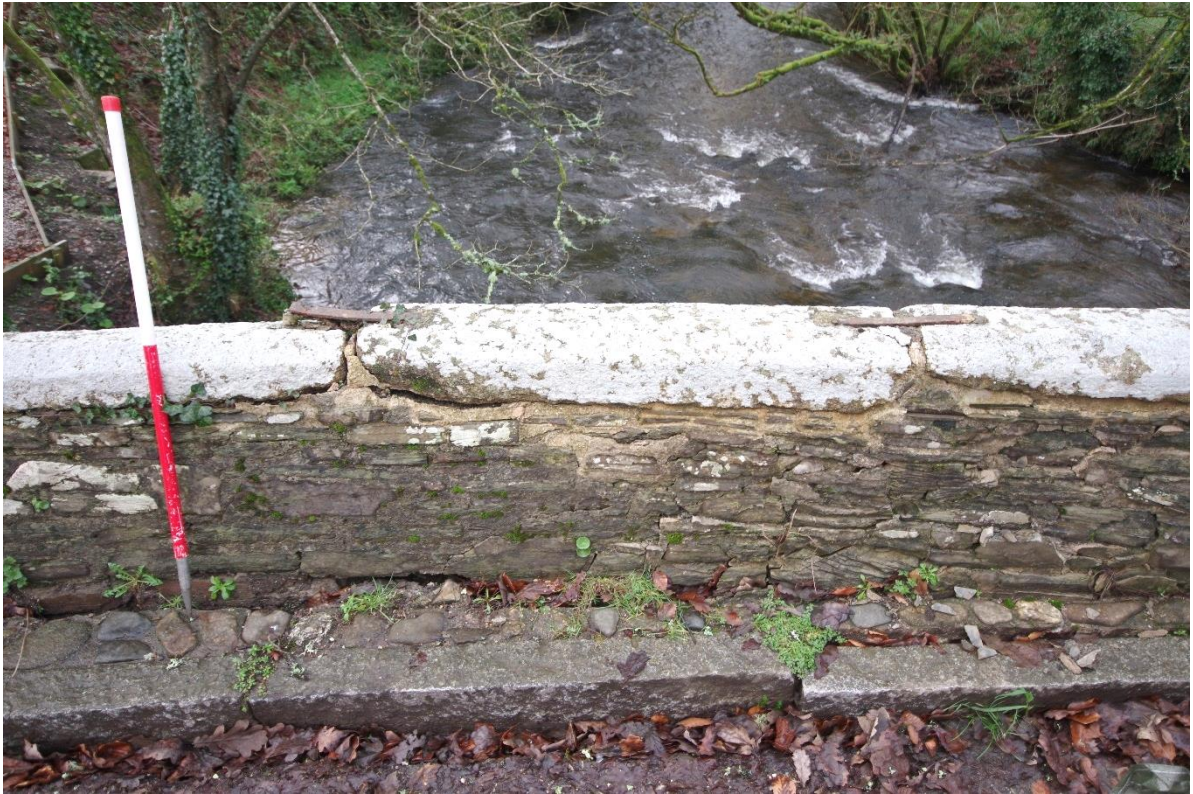
Fig 23 (26) East elevation of the damaged area of parapet wall immediately north of Figure 22.

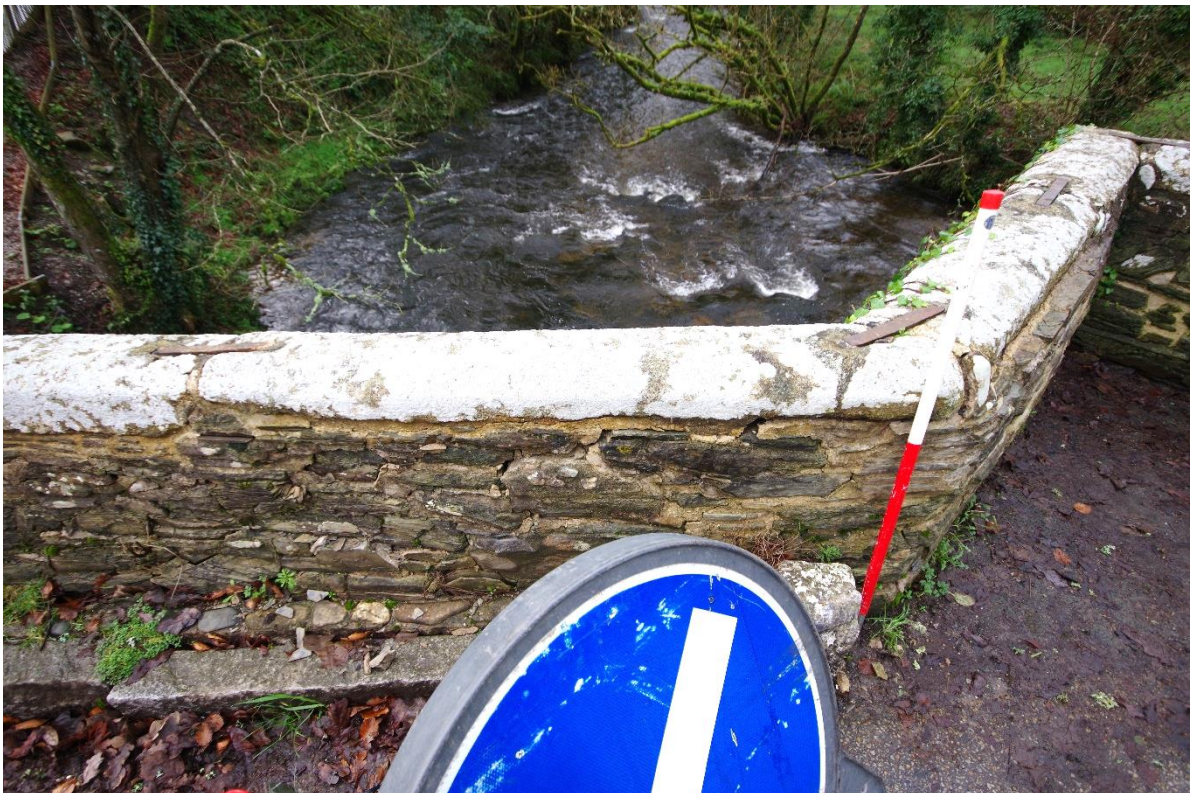
Fig 24 (28) East elevation of the damaged area of parapet wall immediately north of Figure 23.

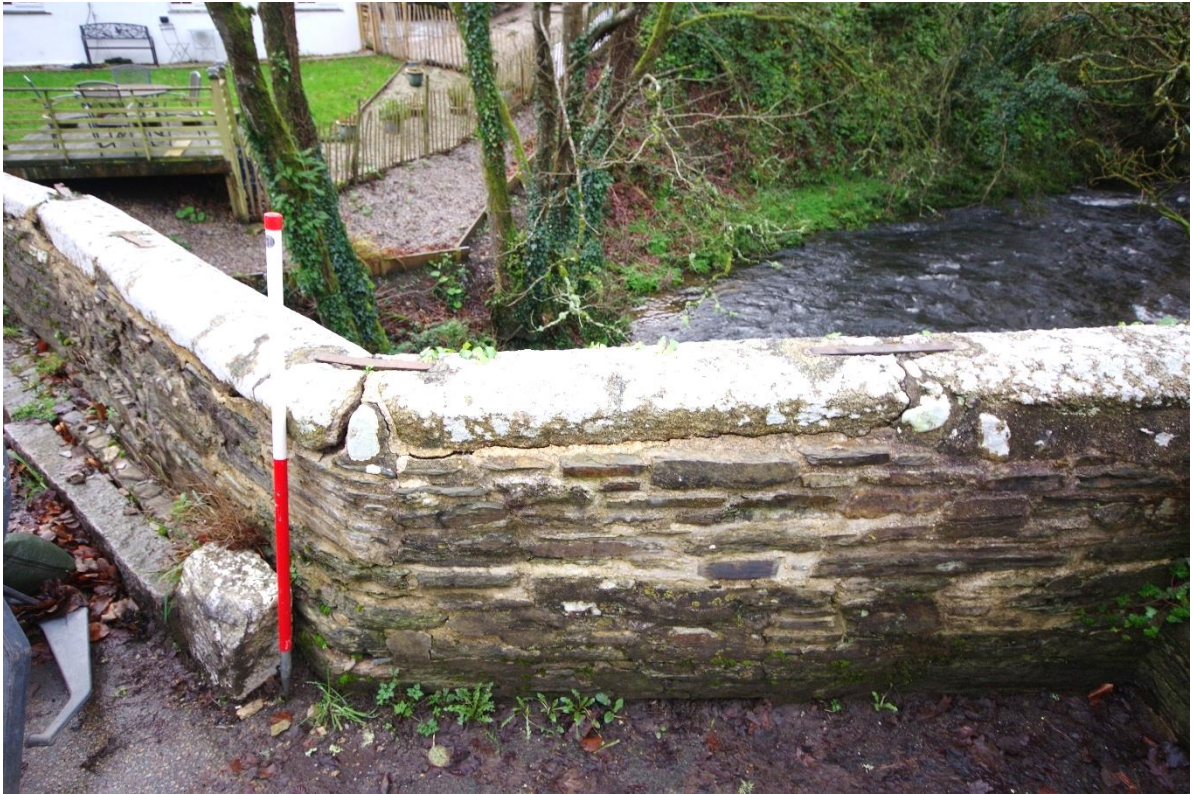
Fig 25 (31) Recently repaired (2021) parapet wall in the refuge immediately north of the damaged area.

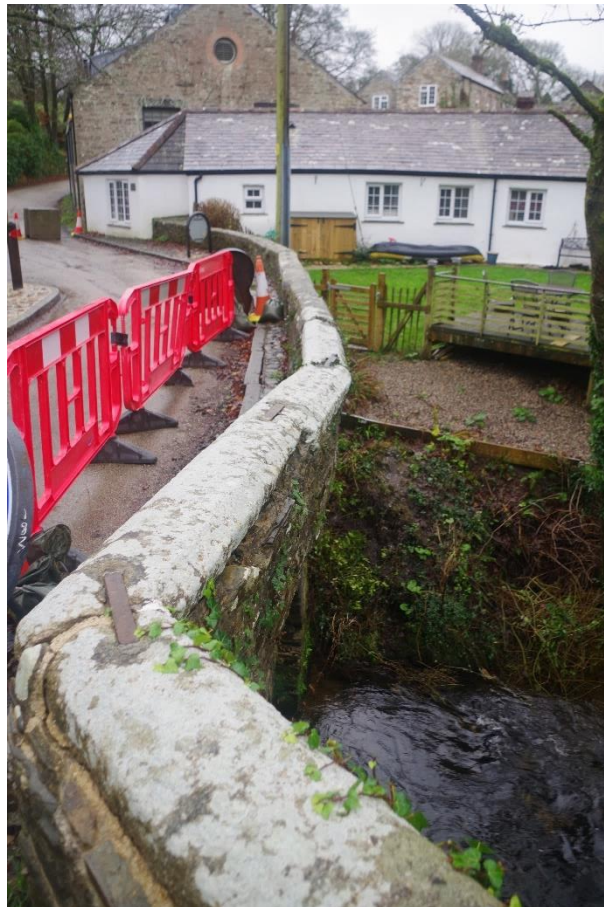
Fig 26 (14) View looking south along the top of the damaged parapet wall.

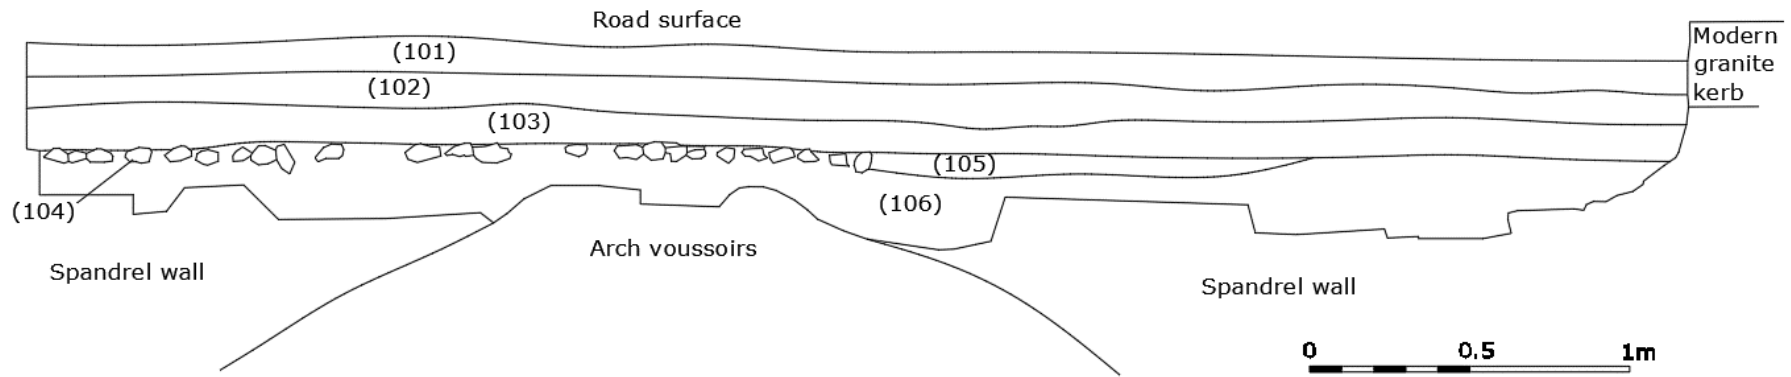
Following the dismantling of the damaged area of walling, a section was exposed showing the make-up below the modern Tarmac road surface (see Figs 27, 30, 31 and 32). In the exposed, west facing section the modern Tarmac road (101) was seen to be approximately 0.1m deep and overlay a compact layer of crushed slatestone fragments in a dark grey silt matrix containing occasional patches of lime (102) approximately 0.09m deep. This in turn overlay a layer of mid greyish brown

clayey silt containing frequent small pebbles and small fragments of slatestone (103), 0.12m deep. Directly below (103) in the northern half of the section were the remains of a former cobbled road surface (104) at a depth of approximately 0.3m below the present road surface. The average dimension of a cobble was 0.05m x 0.07m x 0.1m. Adjoining the south side of the cobbled surface was a thin layer of slatestone fragments 0.06m deep (105). This had possibly been laid as a repair of the cobbled surface (104). Both (104) and (105) overlay bridge fill (106), a mid greyish brown clayey silt containing frequent small slatestone fragments and small stones. The bridge fill (106) was visible to a depth of approximately 0.26m but continued below this level.

Fig 27 West facing section through road and bridge deck exposed after dismantling.

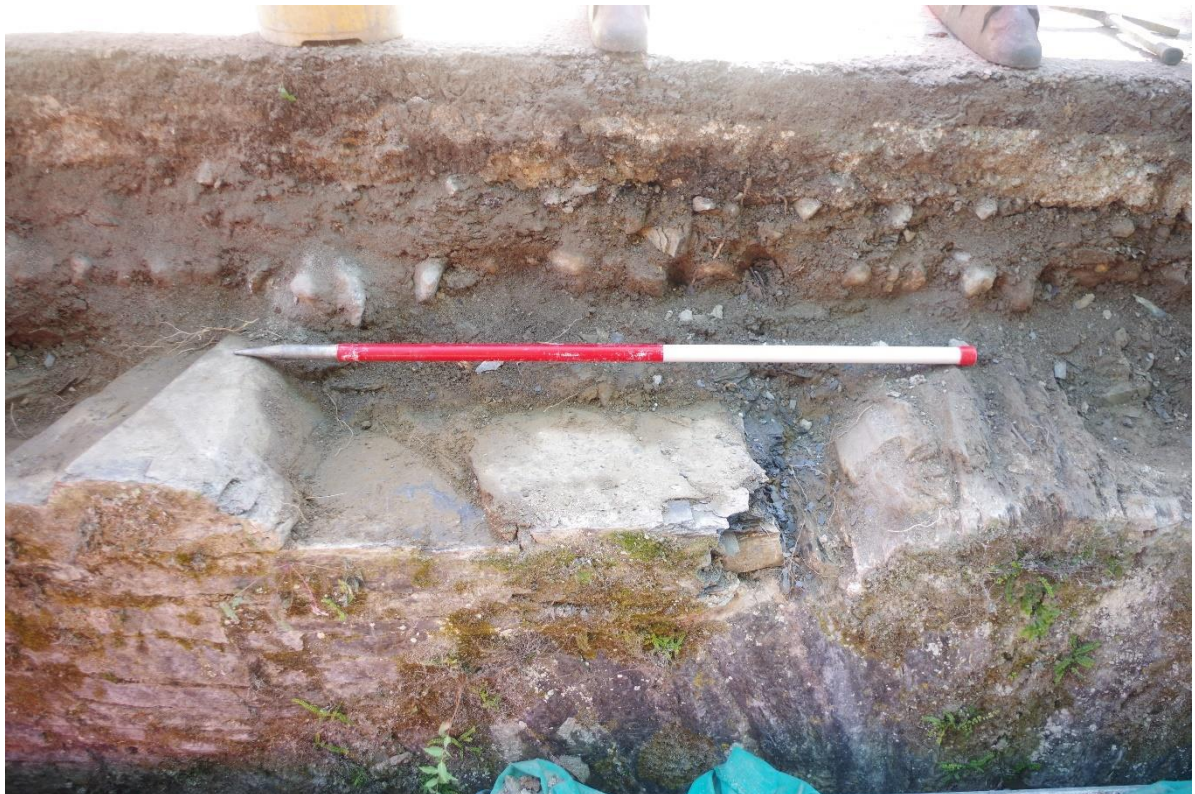
Fig 30 (37) West facing section exposed beneath the road surface, showing former cobbled road surface.

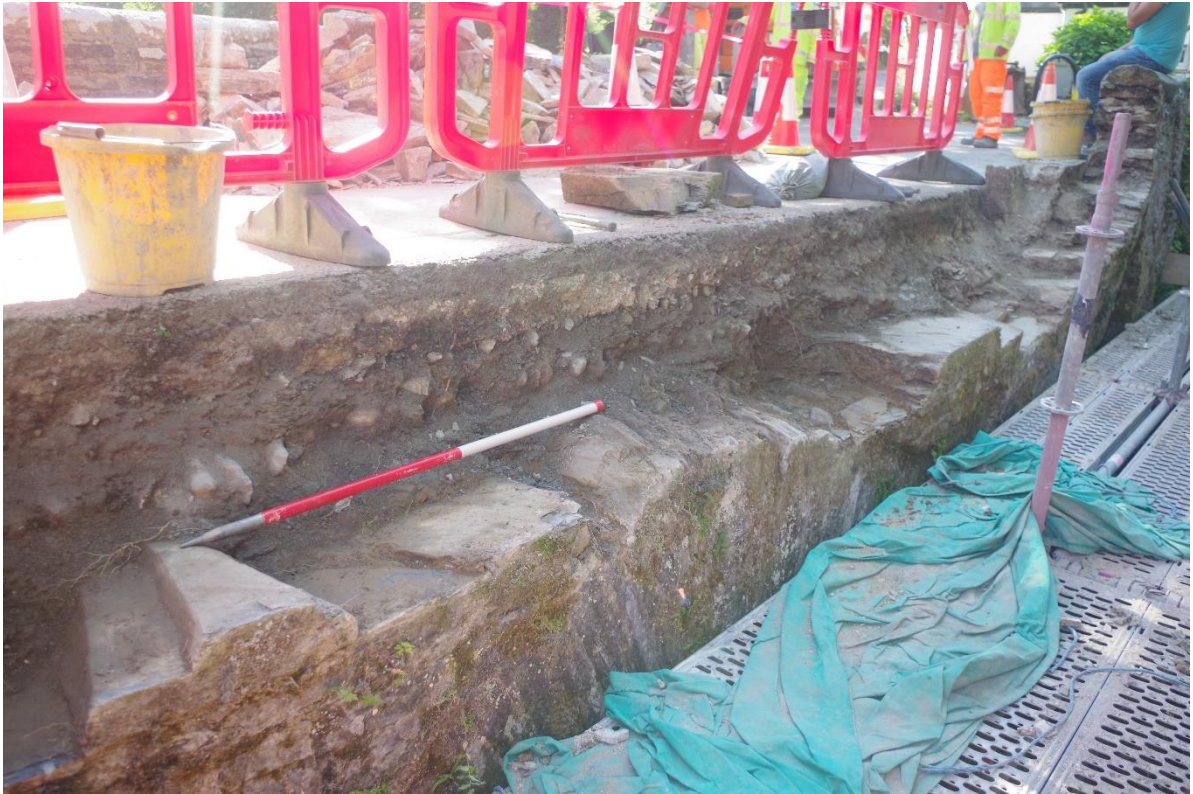
Fig 31 (38) West facing section exposed beneath the road surface, also showing the top of the arch and spandrel walls.

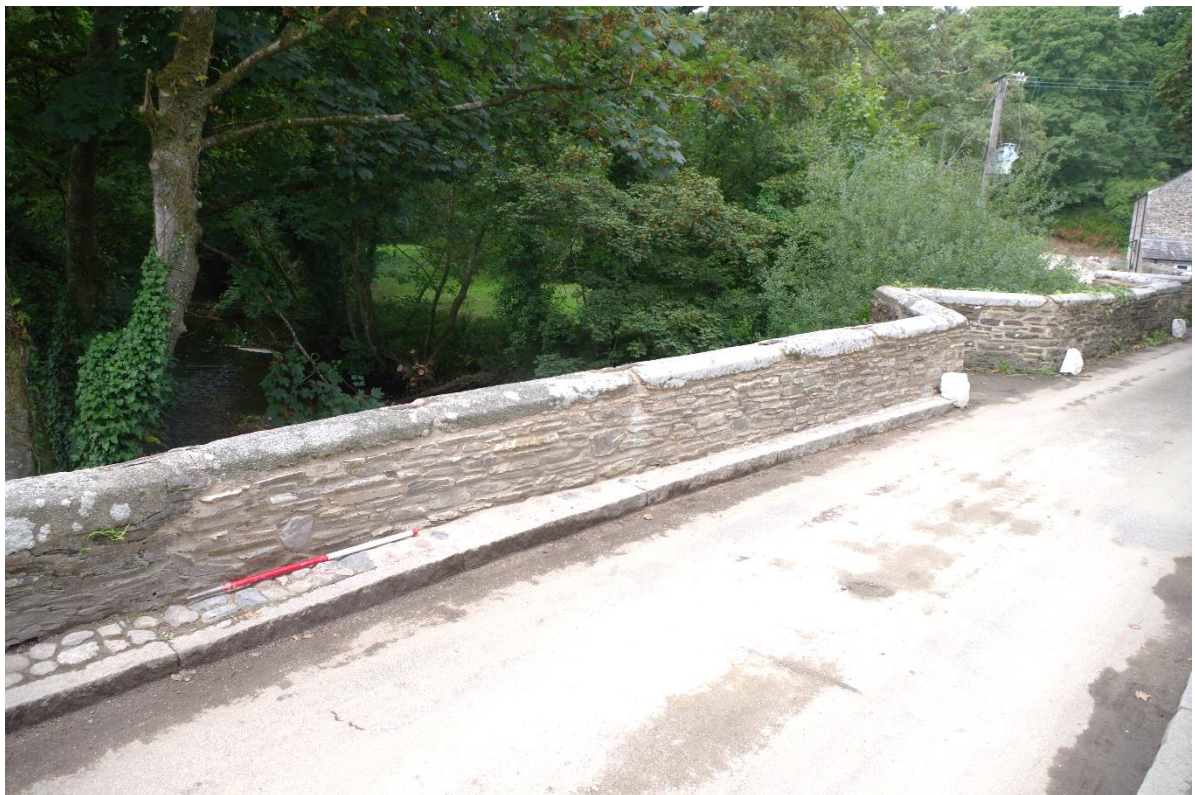
Fig 34 (41) East elevation of new parapet wall following reconstruction looking north west.

Much of the dismantled masonry was found to have decayed to a point where it could not be reused in the new walling. However, all of the original stone which was found to be sound was reused to create the external faces of the rebuilt walling with some new locally-sourced stone used to replace the decayed masonry.

The new walling was bonded and pointed with lime mortar and the granite coping stones replaced in their original positions.

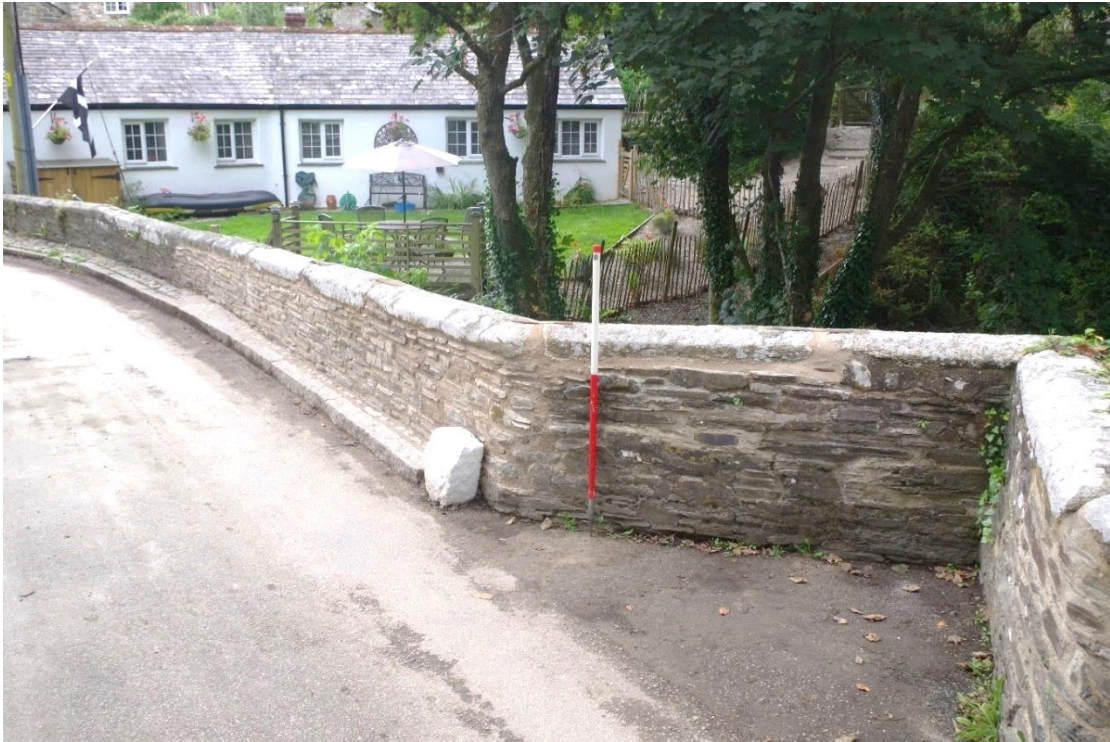
Fig 35 (42) East elevation of new parapet wall following reconstruction looking south west.

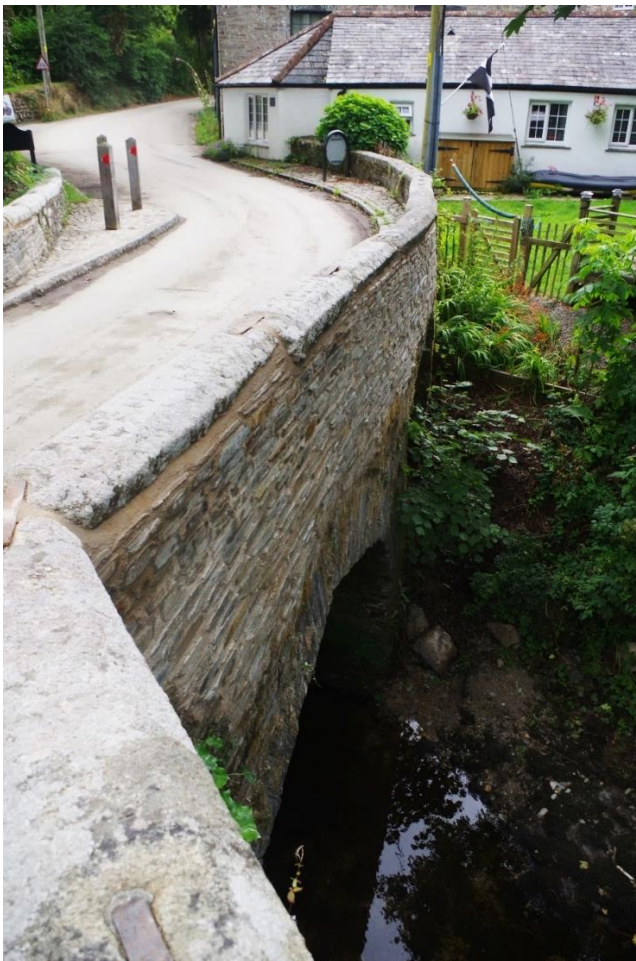
Fig 36 (43) West elevation of new parapet and spandrel wall following reconstruction looking south.

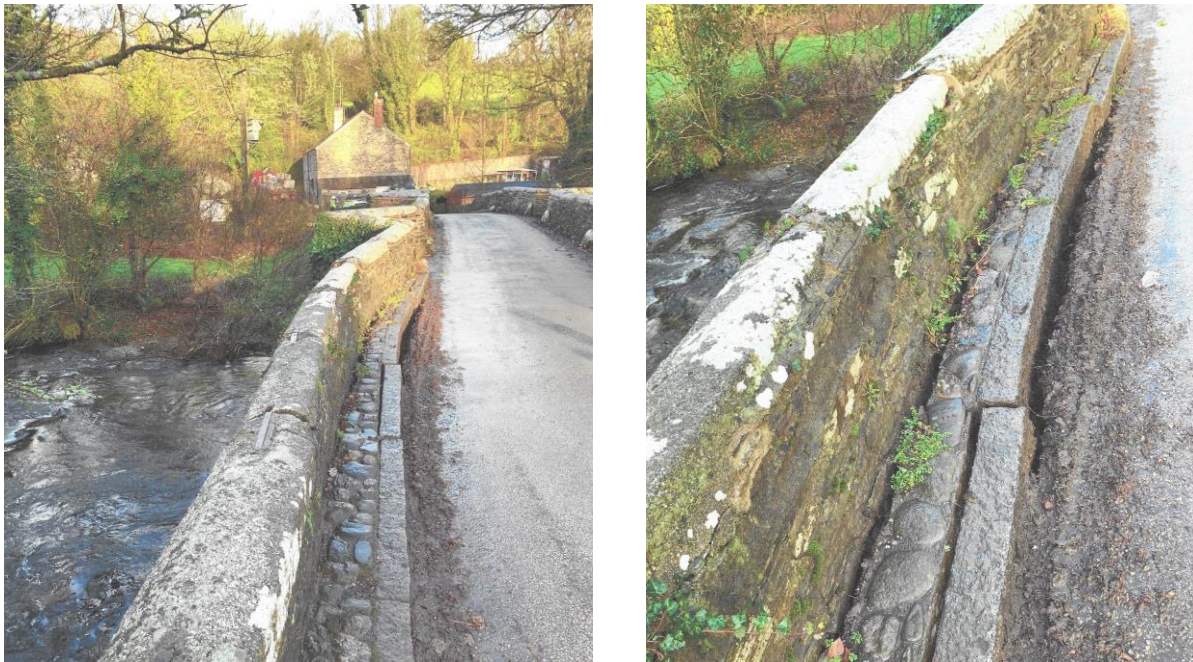
The recent collision has caused an area of the western (downstream) parapet and walling below to be pushed outwards so that it now leans out over the river (Fig 4), it has also caused a vertical linear crack to appear on the bridge deck between the Tarmac road surface and an inserted 20th century kerb (Fig 3).

Figure 3 Photographs of recent damage, looking north along the western side of the bridge.

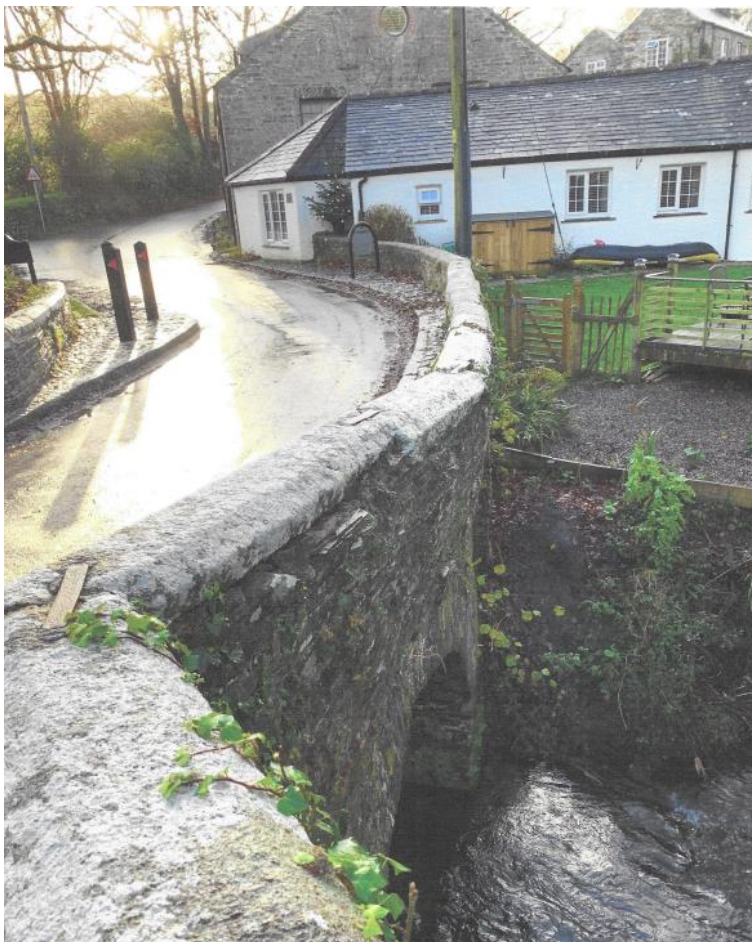
Figure 4 Photograph of recent damage, looking south along the western side of the bridge showing the parapet and walling below pushed outwards.
