Pascoe's Shaft Pumping and Winding
Engine Houses, South Wheal Frances,
Piece, Cornwall
Historic Building Record

Cornwall Archaeological Unit

Report No: 2022R022

Historic Building Record

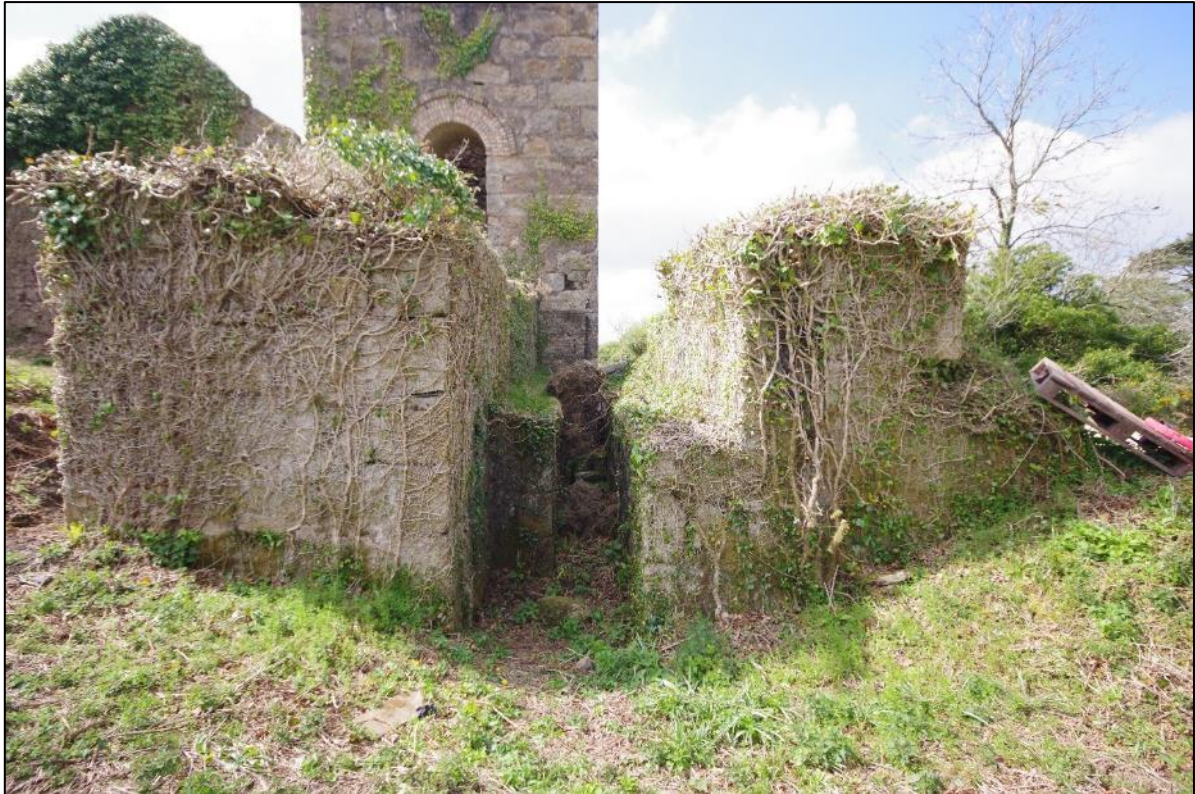
Fig 14 North-east elevation following vegetation clearance and repair work to the boiler house window opening.

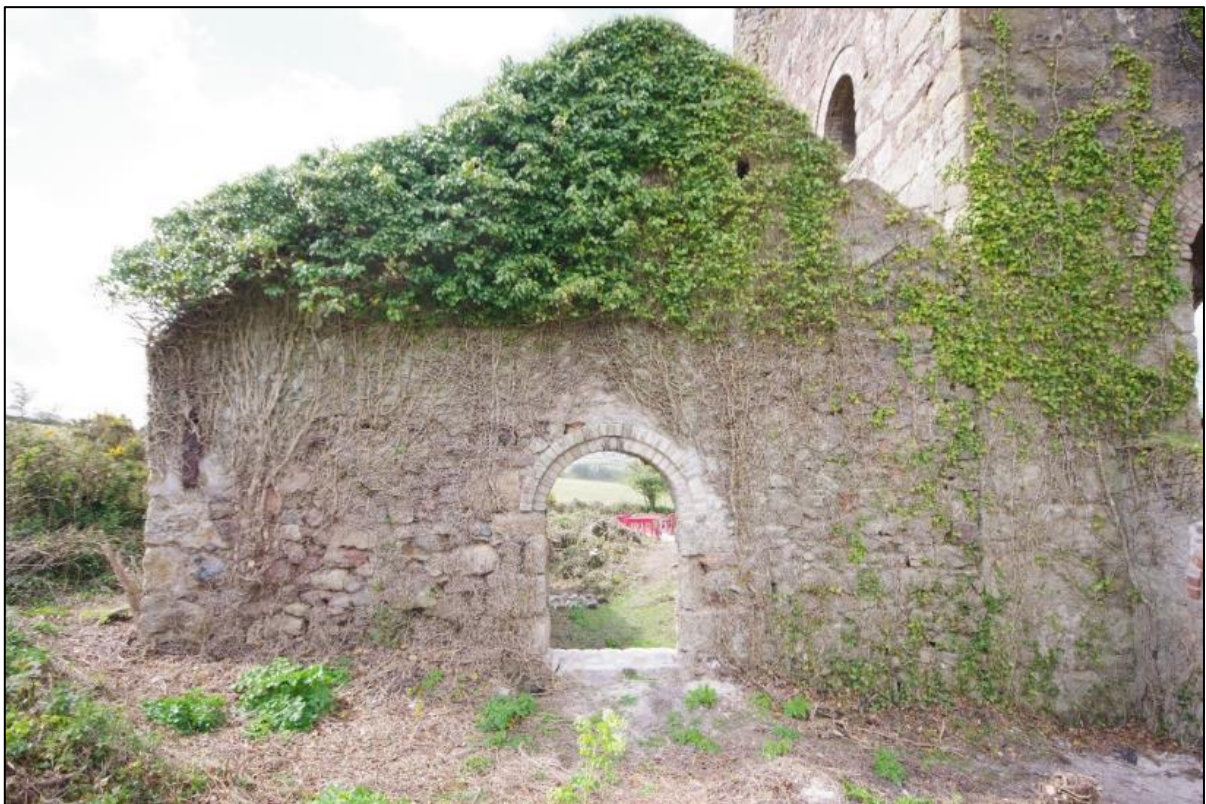
Fig 15 North-east elevation following vegetation clearance.

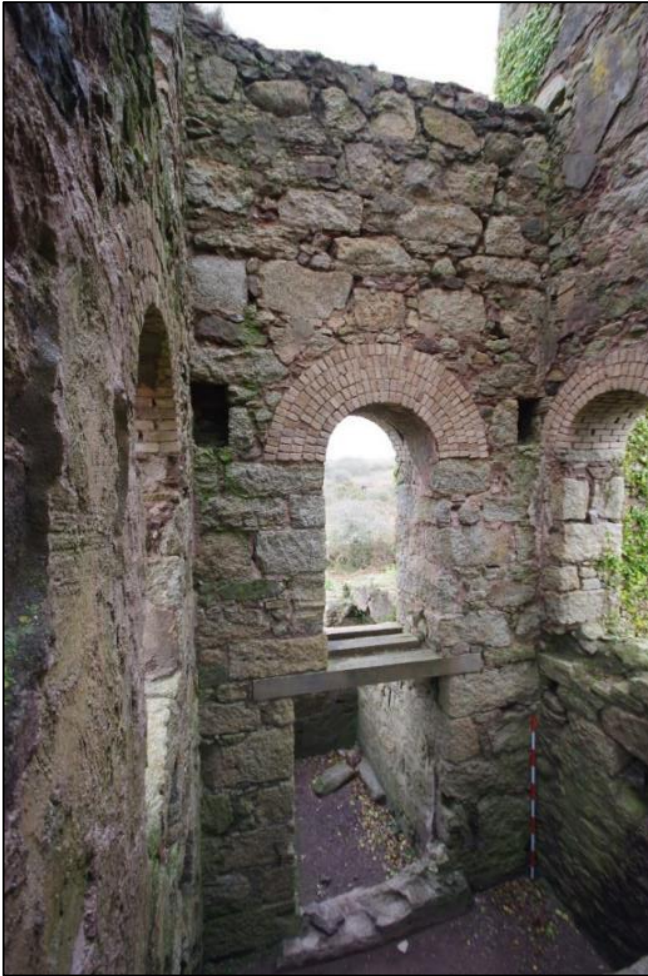
Fig 16 North-east elevation following vegetation clearance and repair work to the arch over the boiler house window opening.

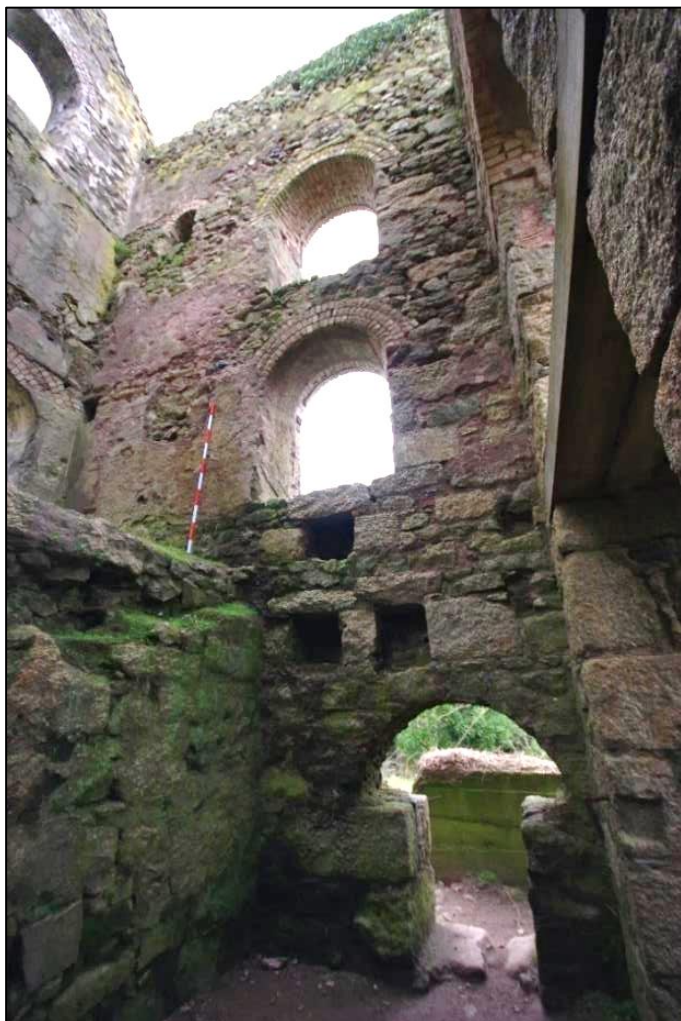
Fig 23 North-west elevation of engine house: arch leading to cataract pit following repair work.

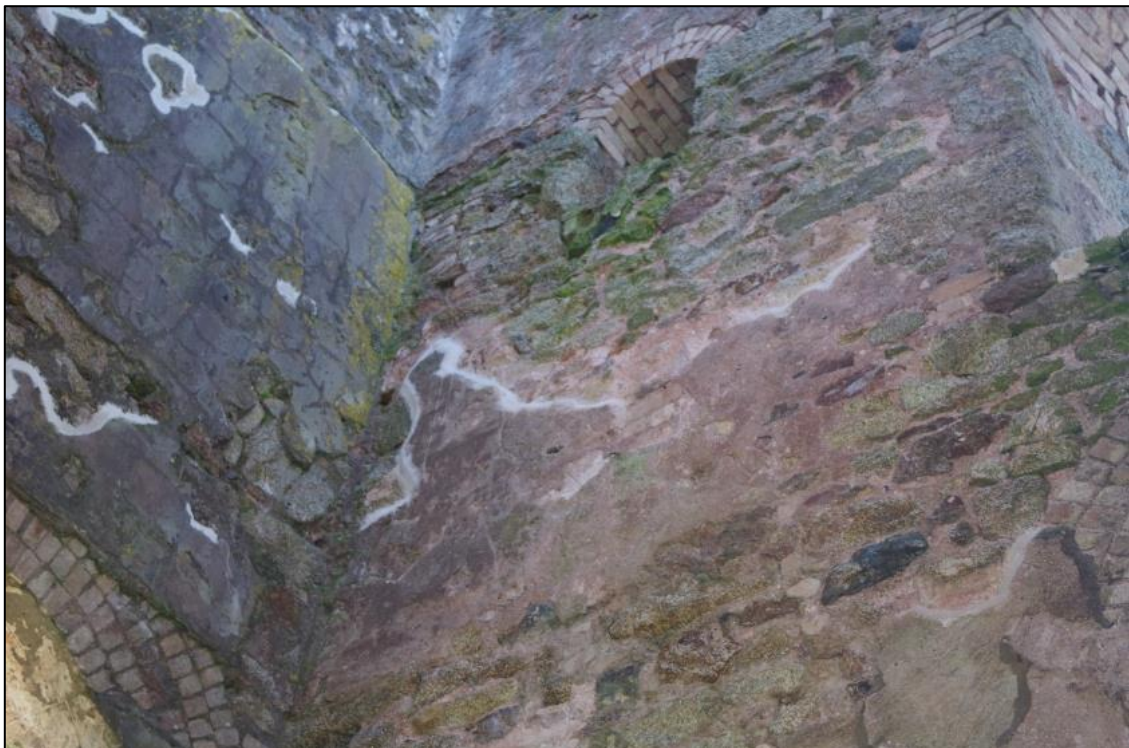
Fig 25 Interior north-west cataract pit wall following reconstruction of brick arch.

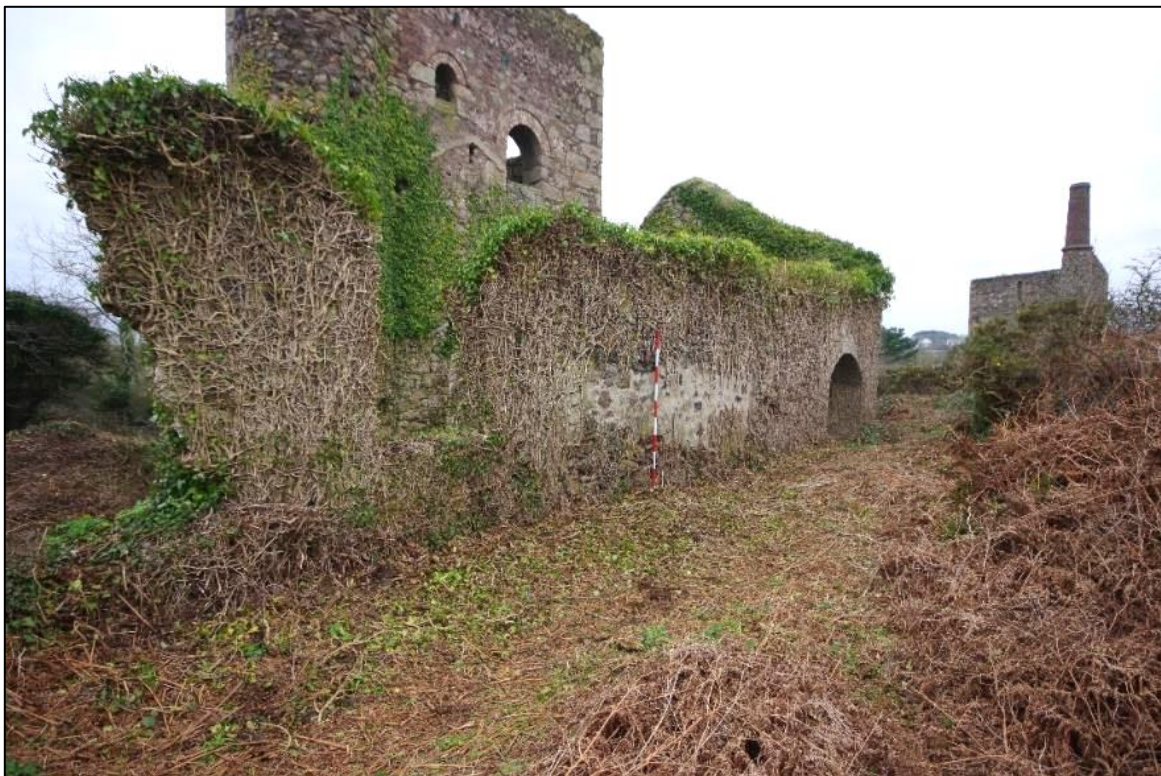
Fig 33 South-east elevation following patch repairs to chimney stack.

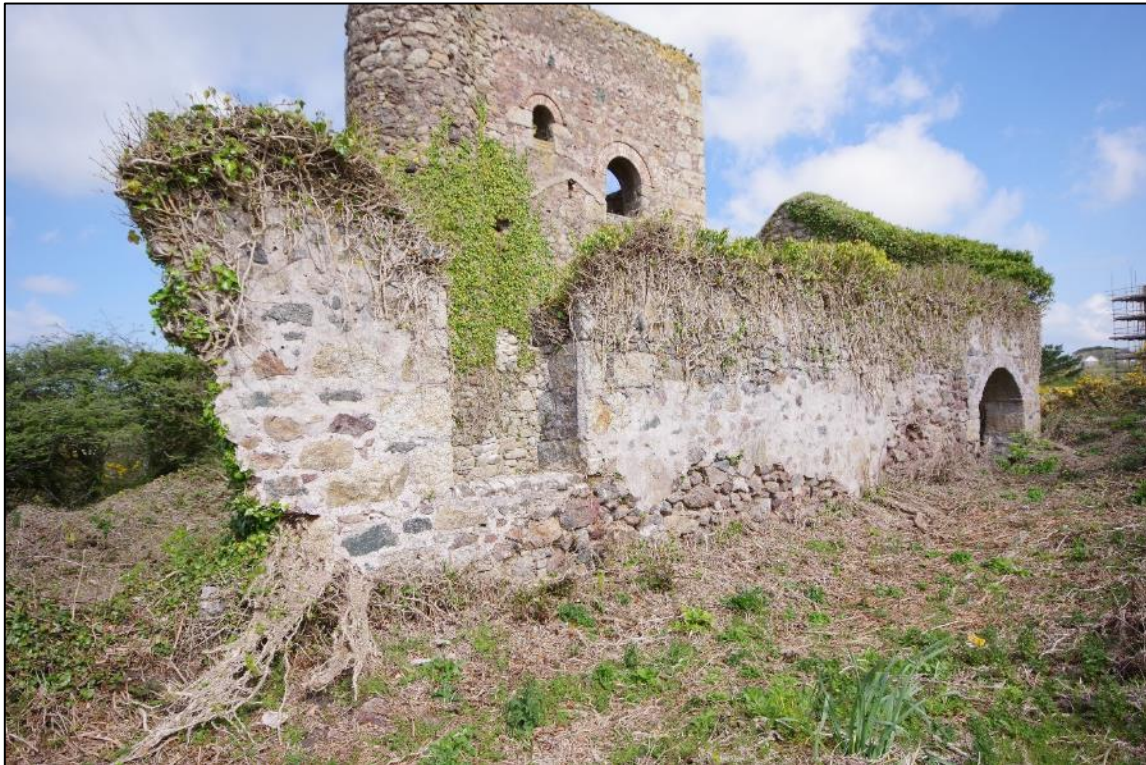
The south-eastern elevation of the boiler house largely survives although the wall is fragmented at the south-west end and is densely covered in ivy. There is a wide arch comprising three courses of brick voussoirs at the north-east end of the elevation and the remains of a window opening towards the south-west end which is now missing its arch.

Fig 34 South-east elevation of the boiler house before remedial works.

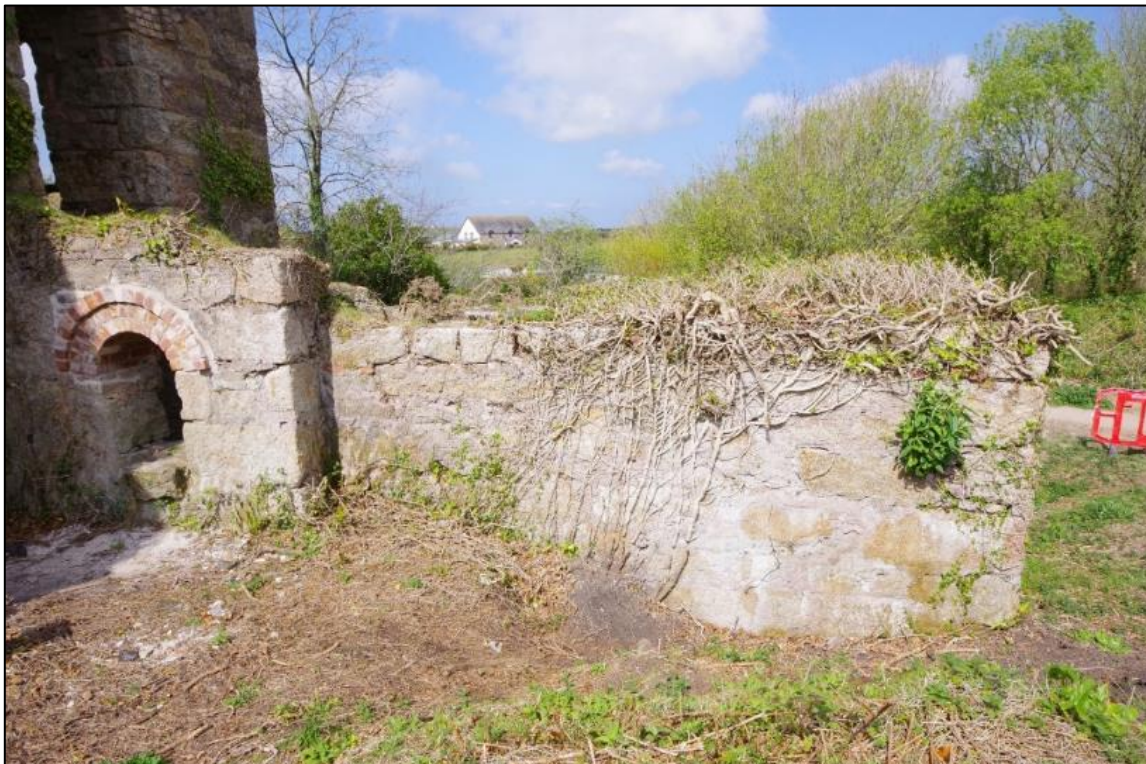
Fig 35 South-east elevation of the boiler house following patch repairs and some ivy clearance.

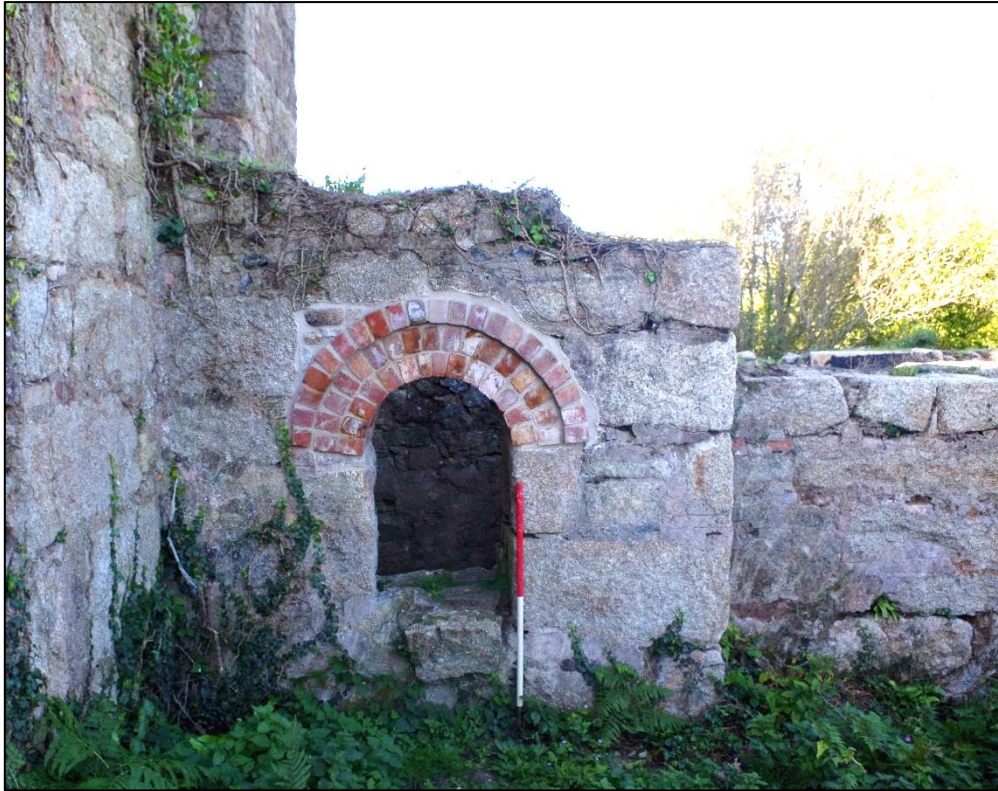
Fig 36 South-east elevation of the loadings following patch repairs and some ivy clearance.

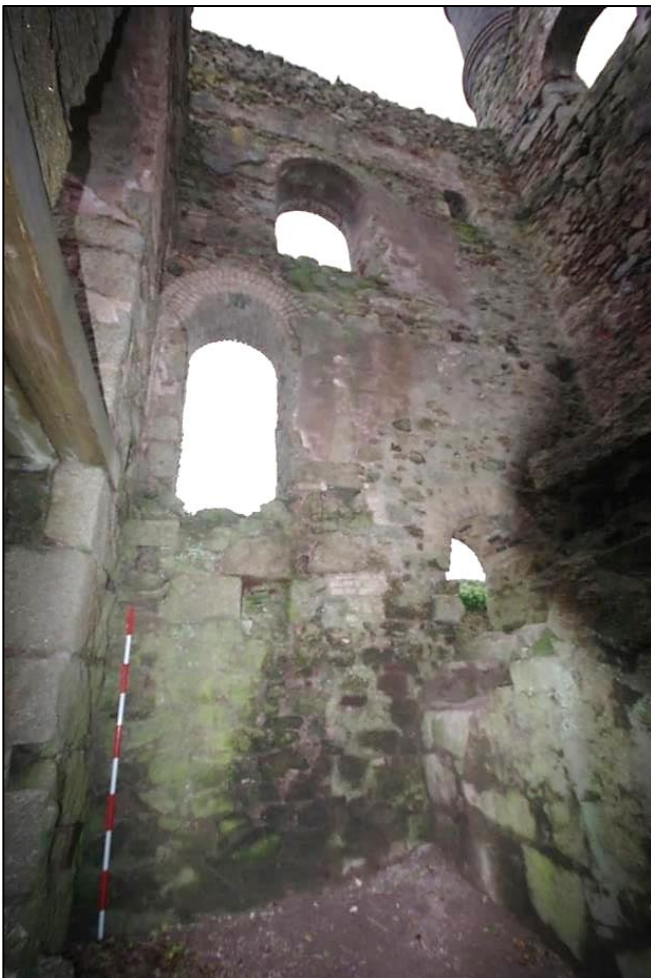
Fig 37 South-east elevation of the loadings: repaired arch of the condenser pit opening.

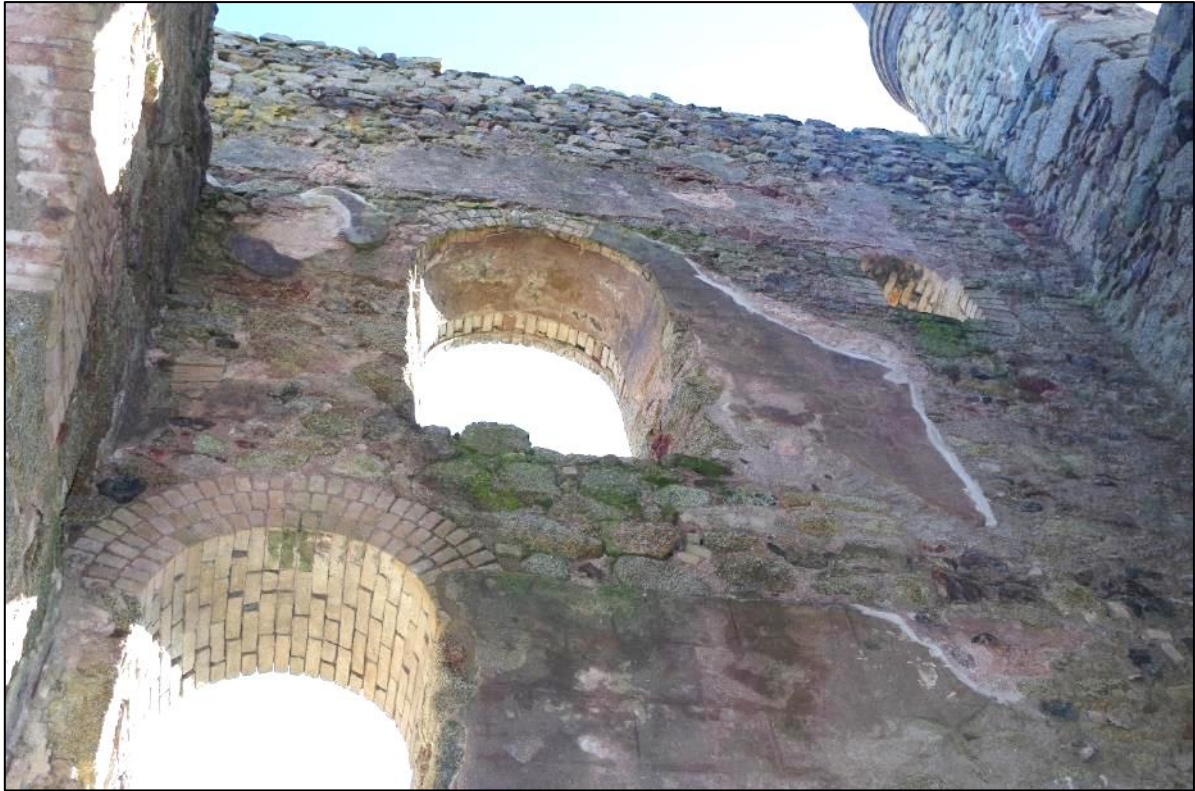
Fig 38 Interior south-east wall before remedial works.

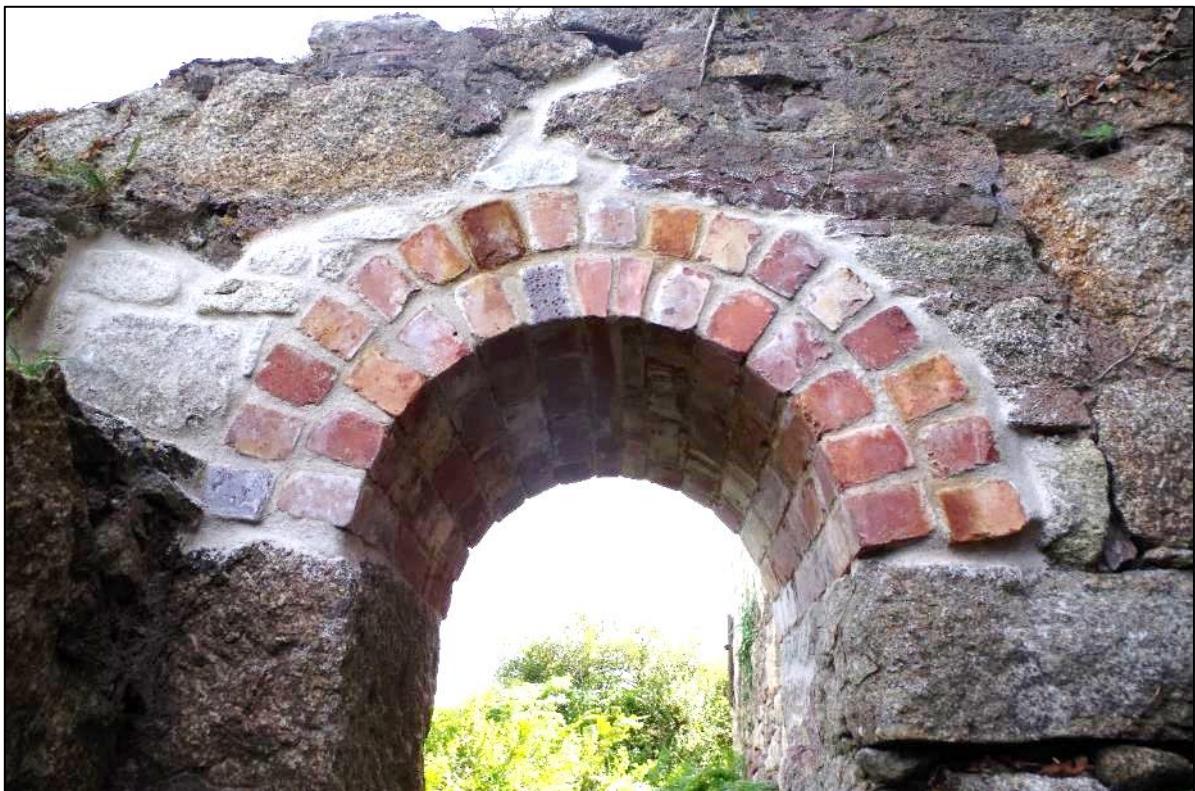
Fig 41 Interior south-east wall of the condenser pit before remedial works.

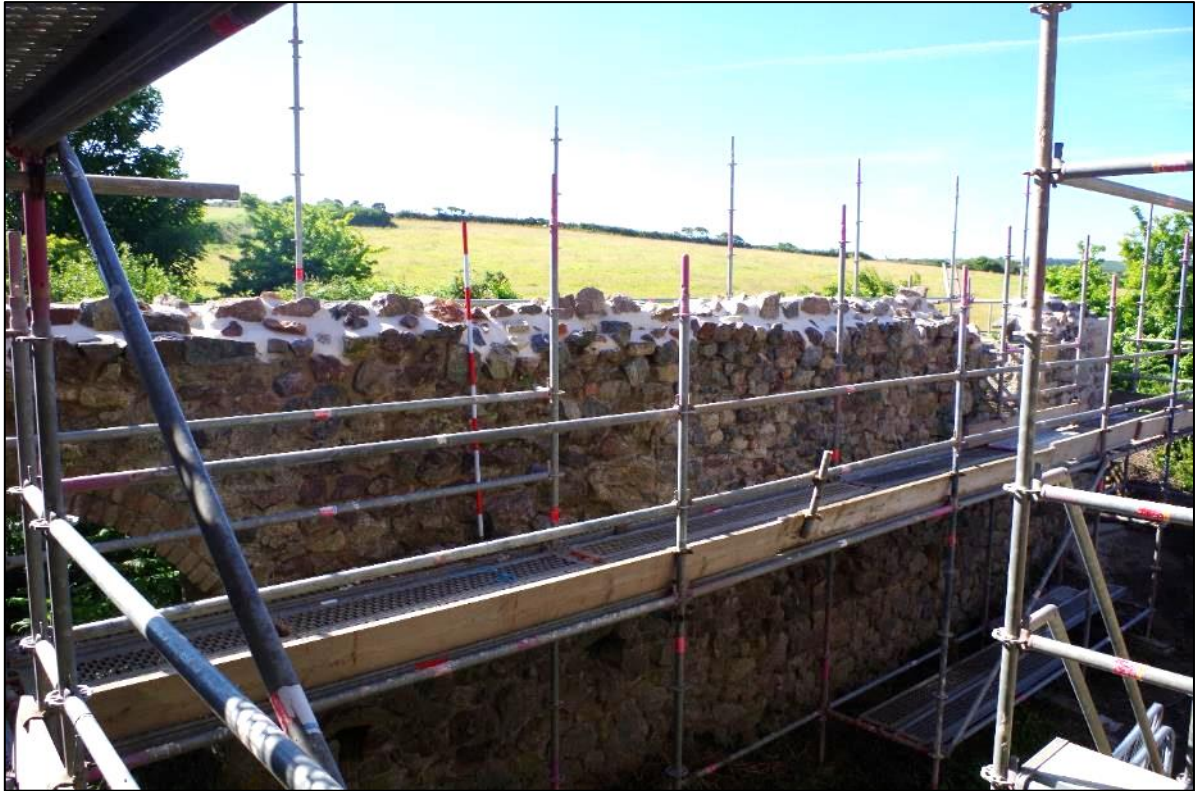
Fig 42 Interior south-east wall of the condenser pit showing repaired arch over opening.

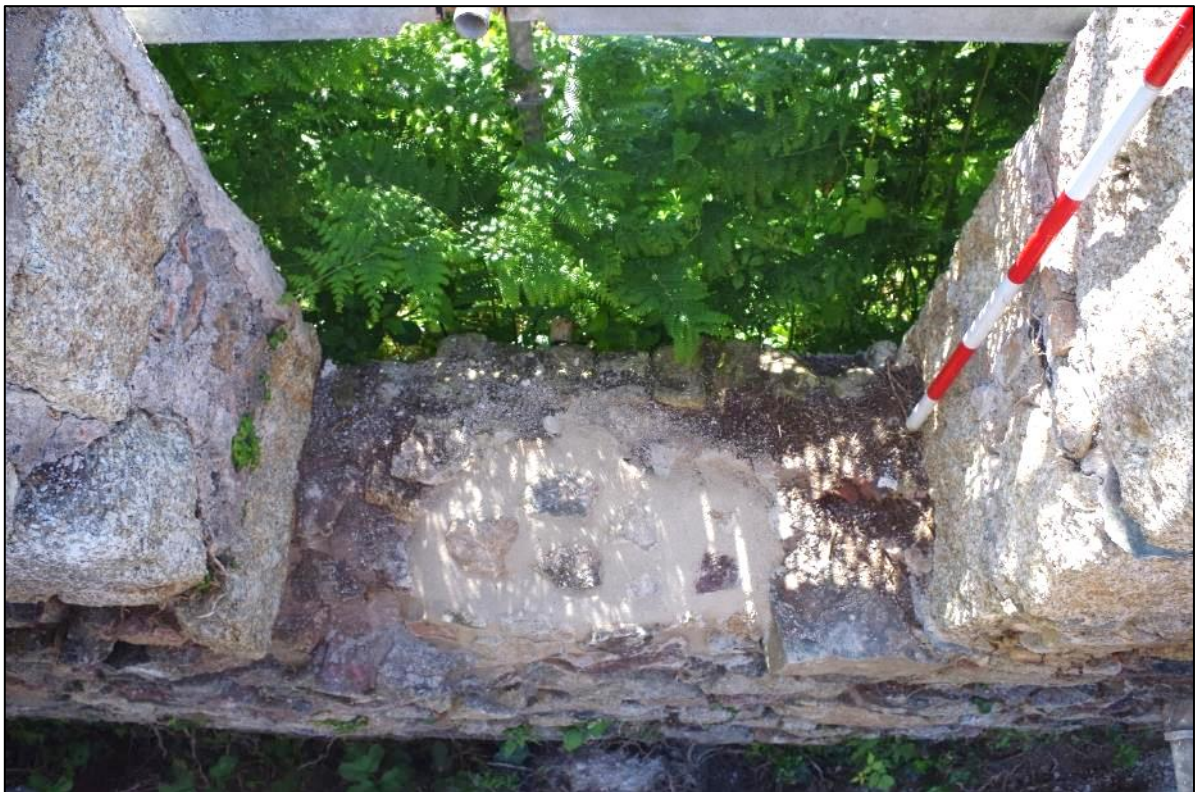
Fig 45 South-east wall of the boiler house following lime mortar capping.

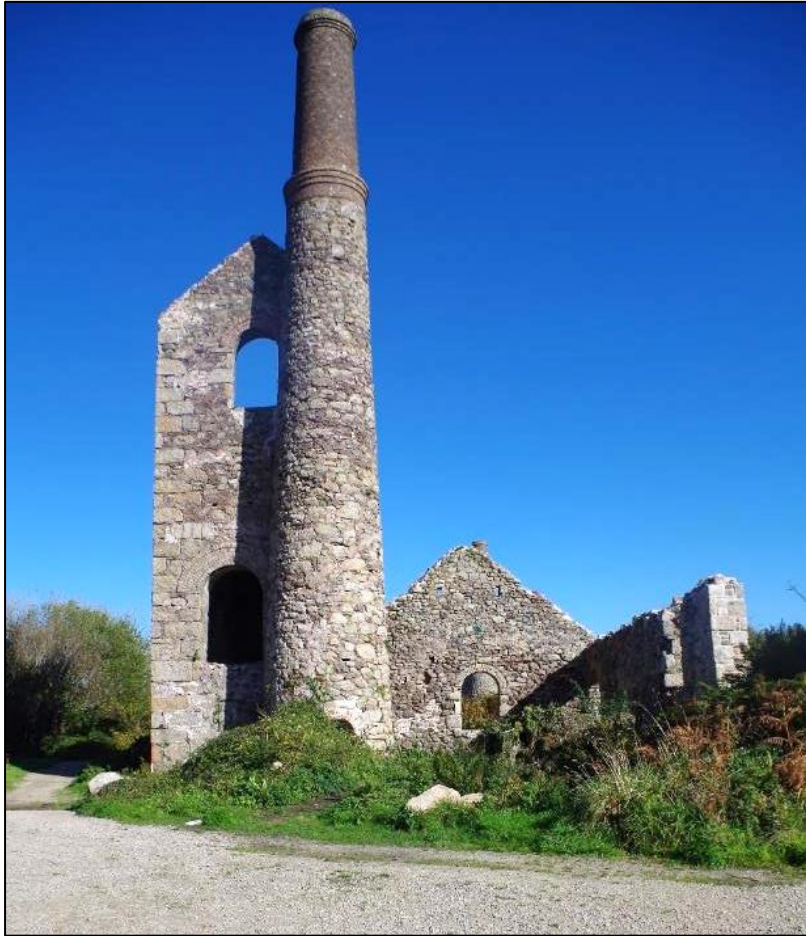
Fig 50 South-west elevation of the engine house before remedial works.

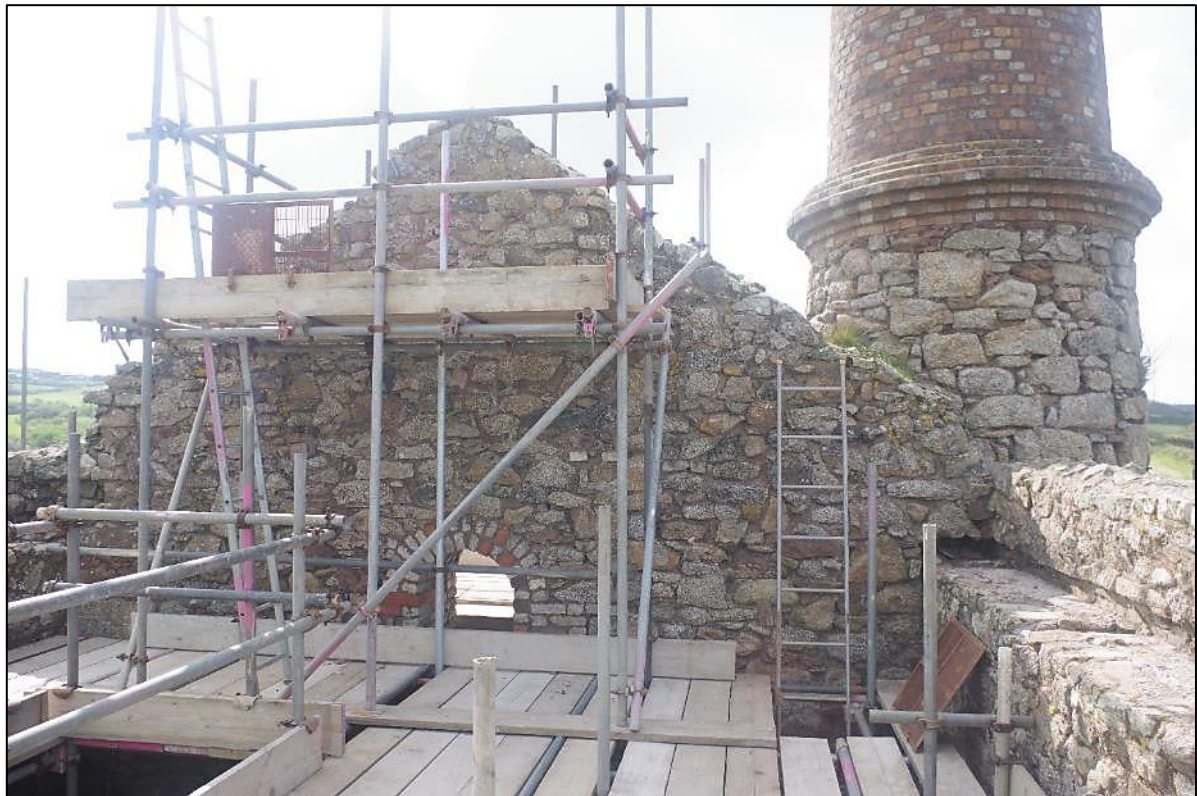
Fig 51 South-west elevation of the engine house following ivy clearance, patch repairs and capping of gable ends.

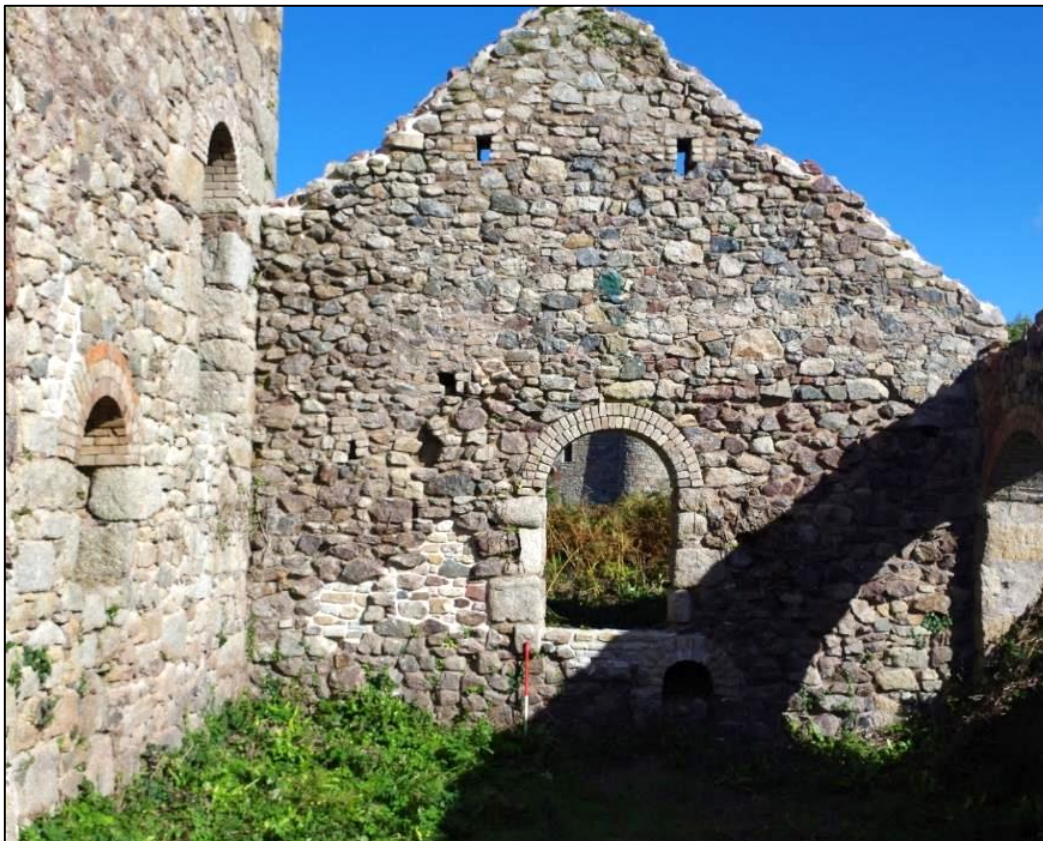
Fig 59 Interior south-west wall of boiler house before remedial works.

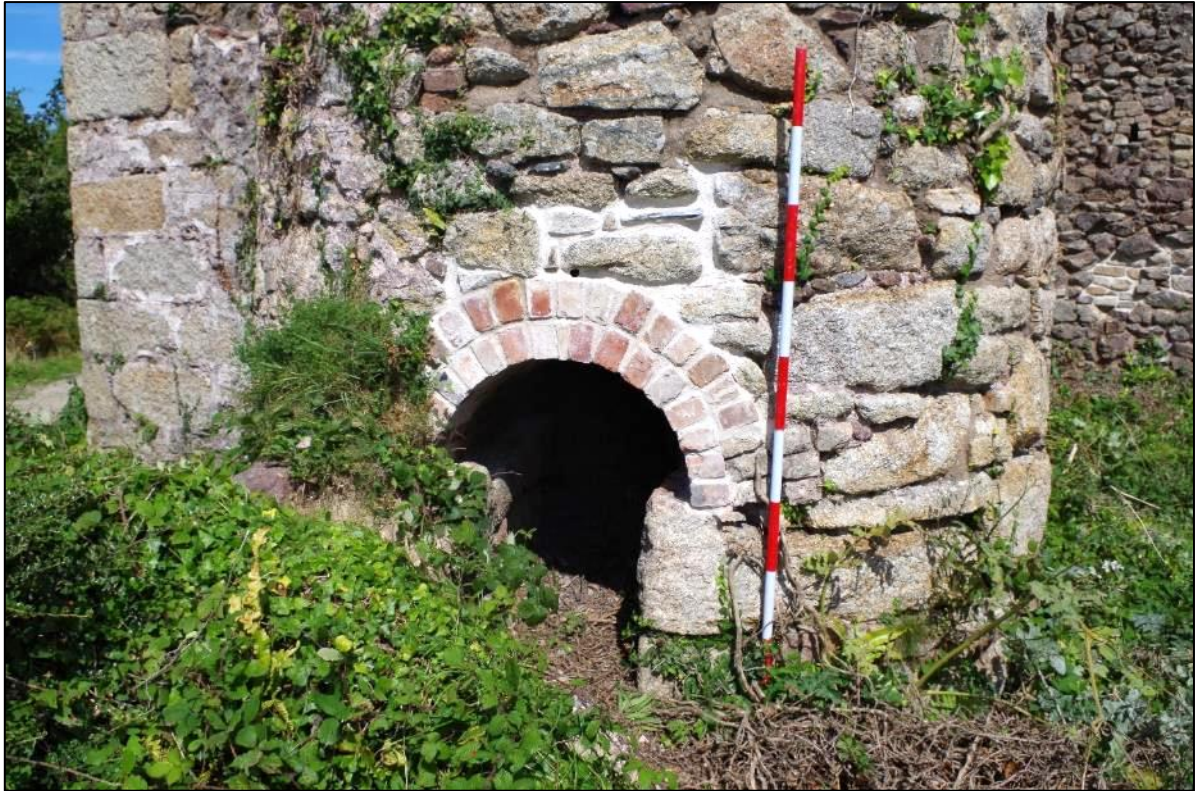
Fig 62 South-west external boiler house gable end following capping.

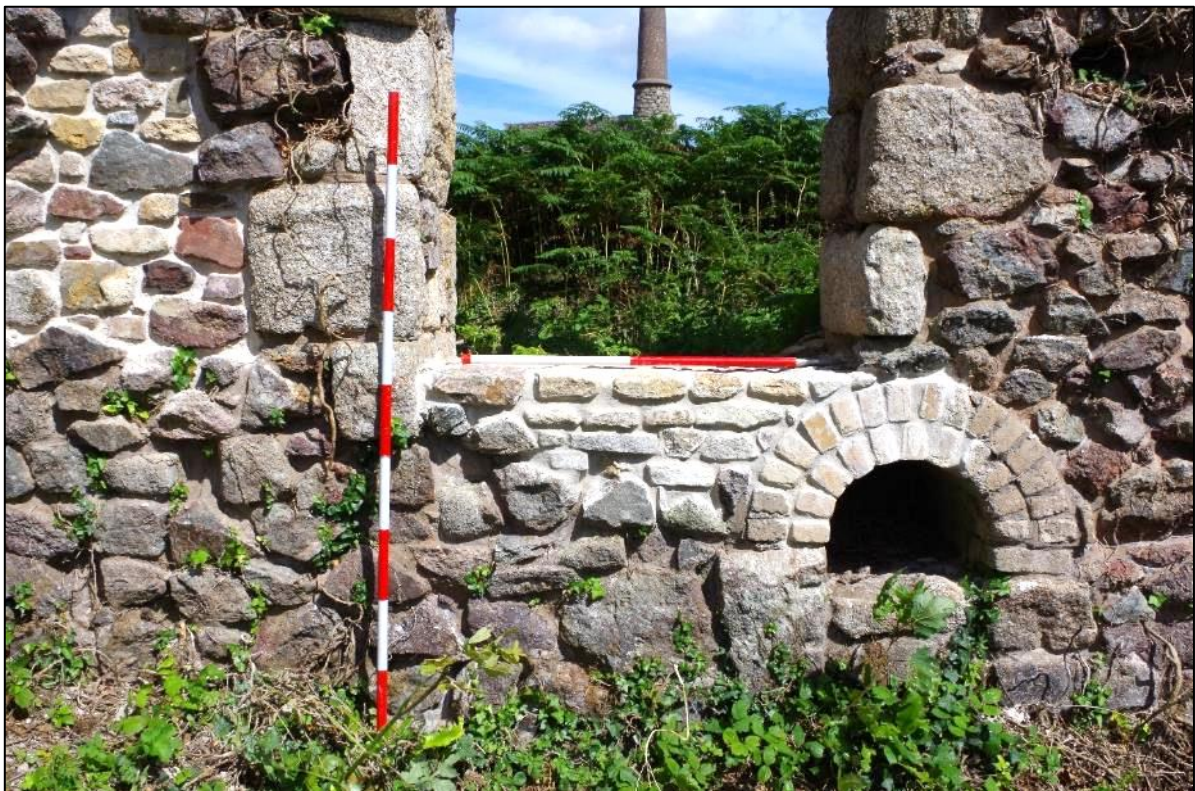
Fig 63 Repairs to the arch of the boiler flue opening at the base of the chimney stack.

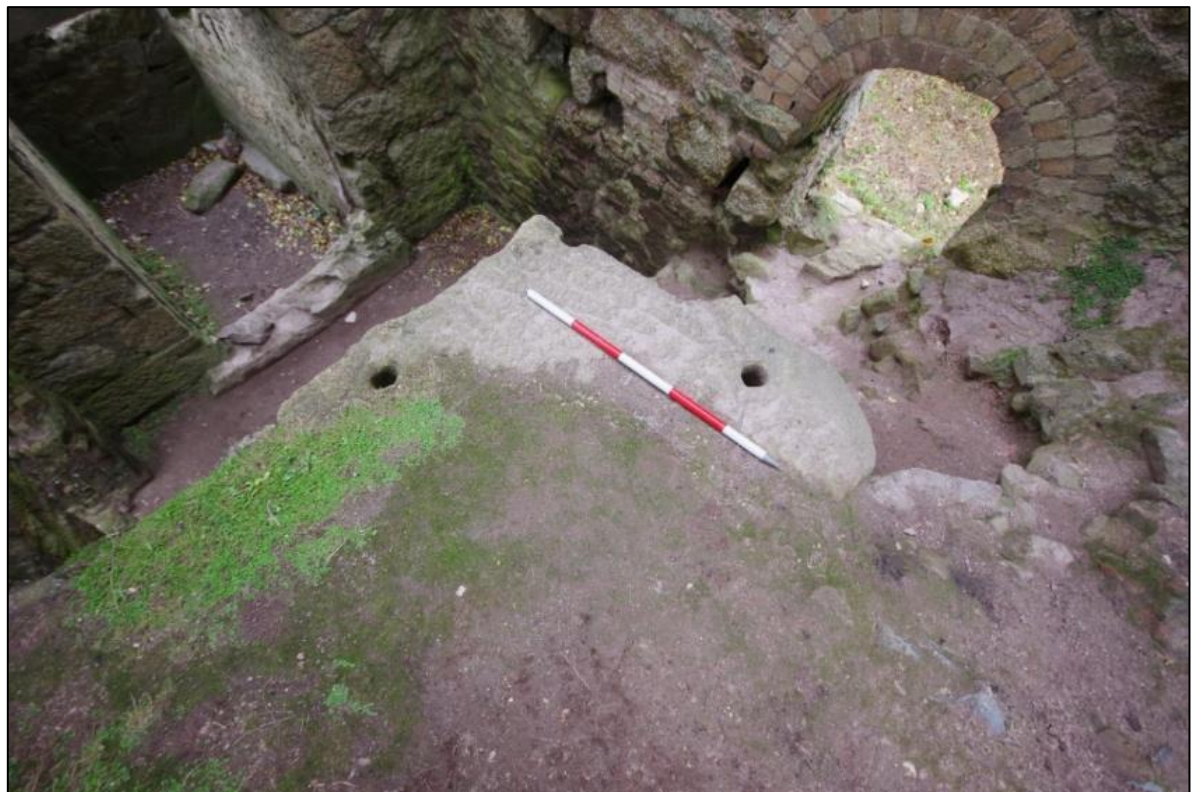
Fig 69 Interior cylinder bed following remedial works.

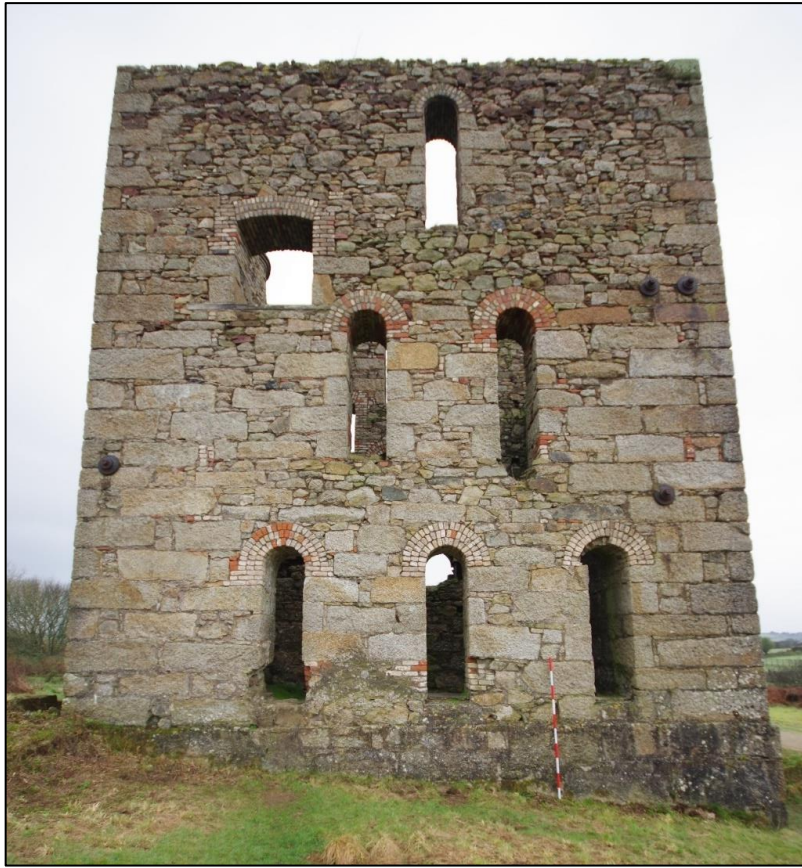
Fig 71 North-east elevation before remedial works.

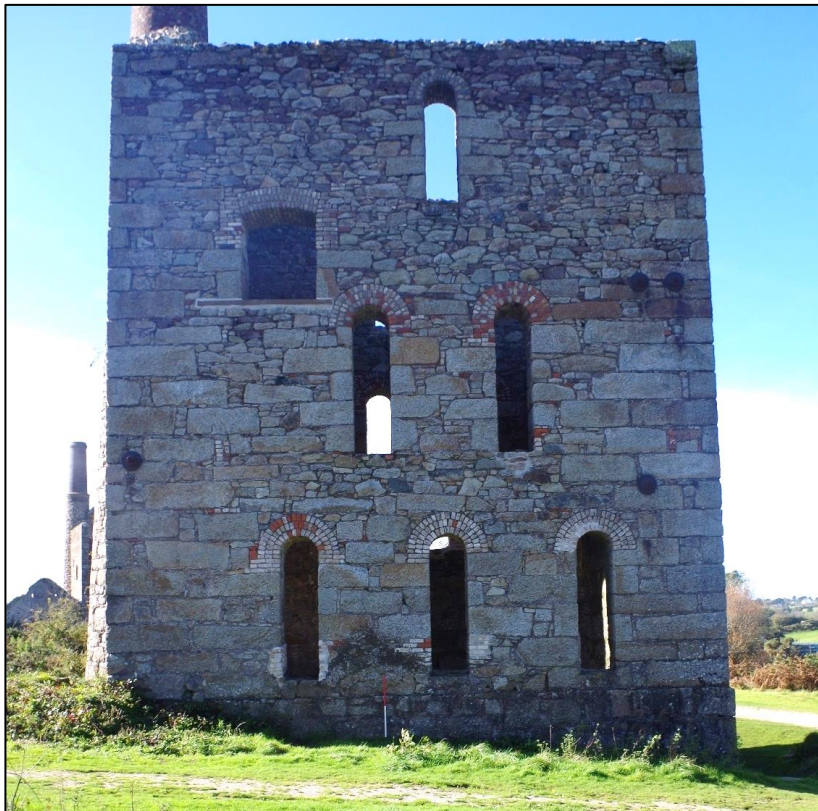
Fig 72 North-east elevation following the installation of a new lintel and repairs to window arches and jambs.

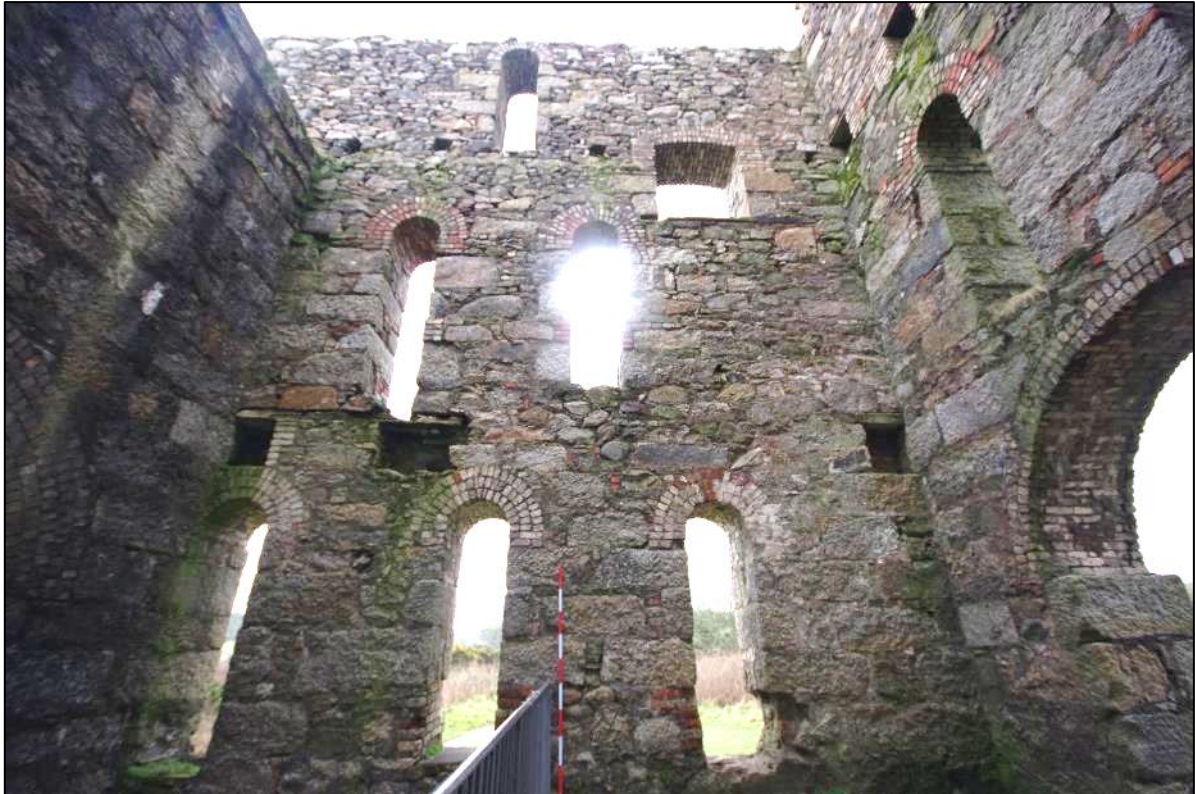
Fig 73 Interior north-east wall before remedial works.

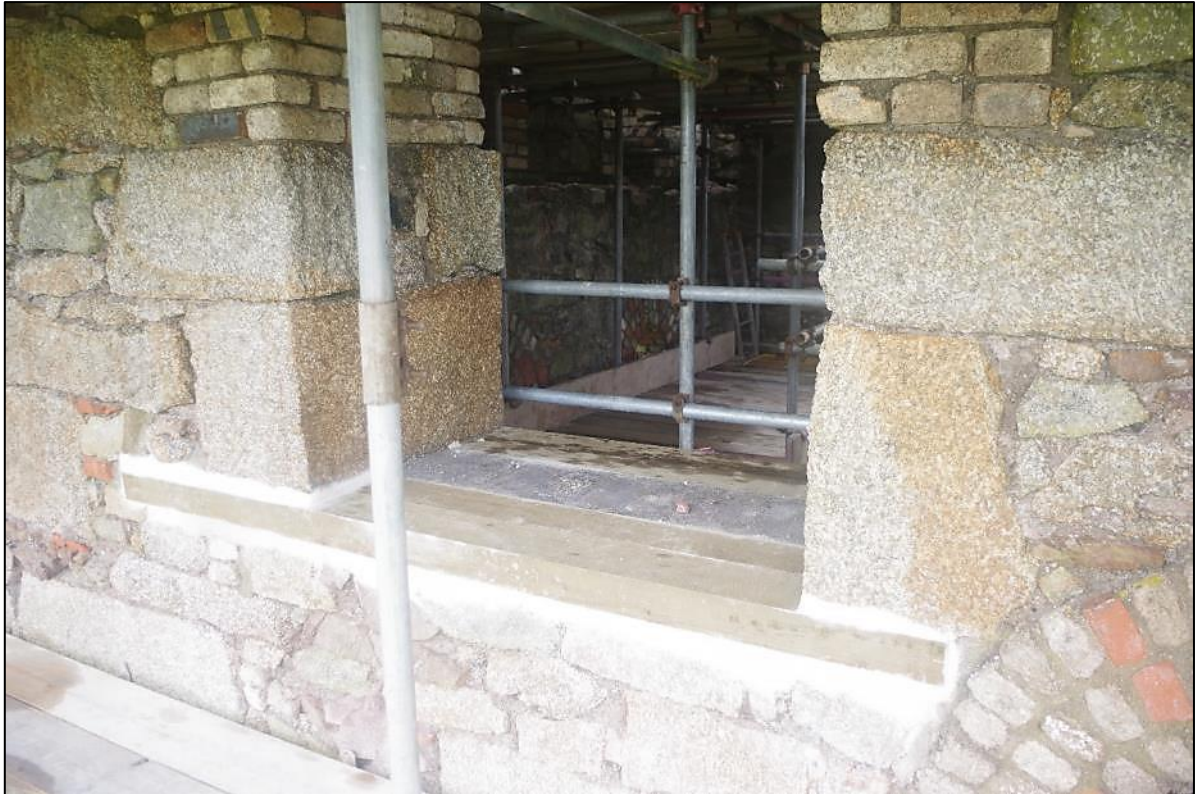
Fig 79 Exterior north-east elevation, repairs to main girder slot sill.

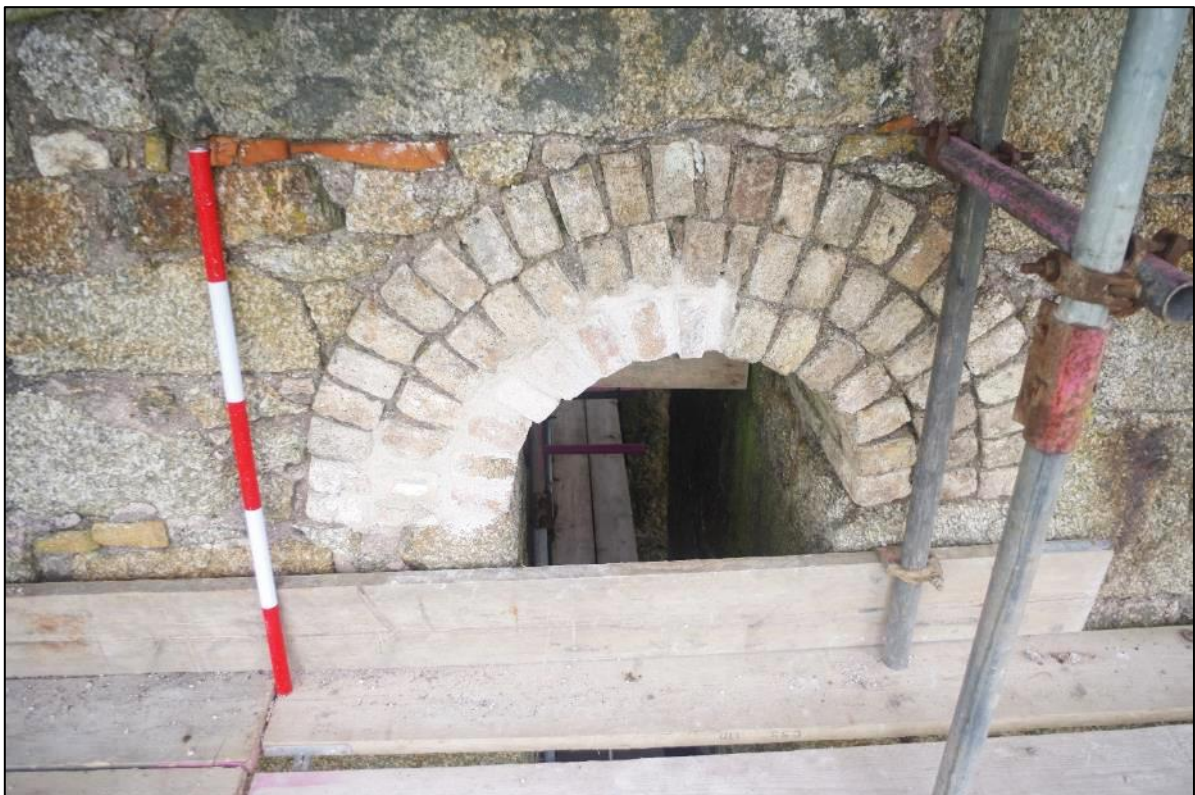
Fig 80 Exterior north-east elevation, repairs to window arch.

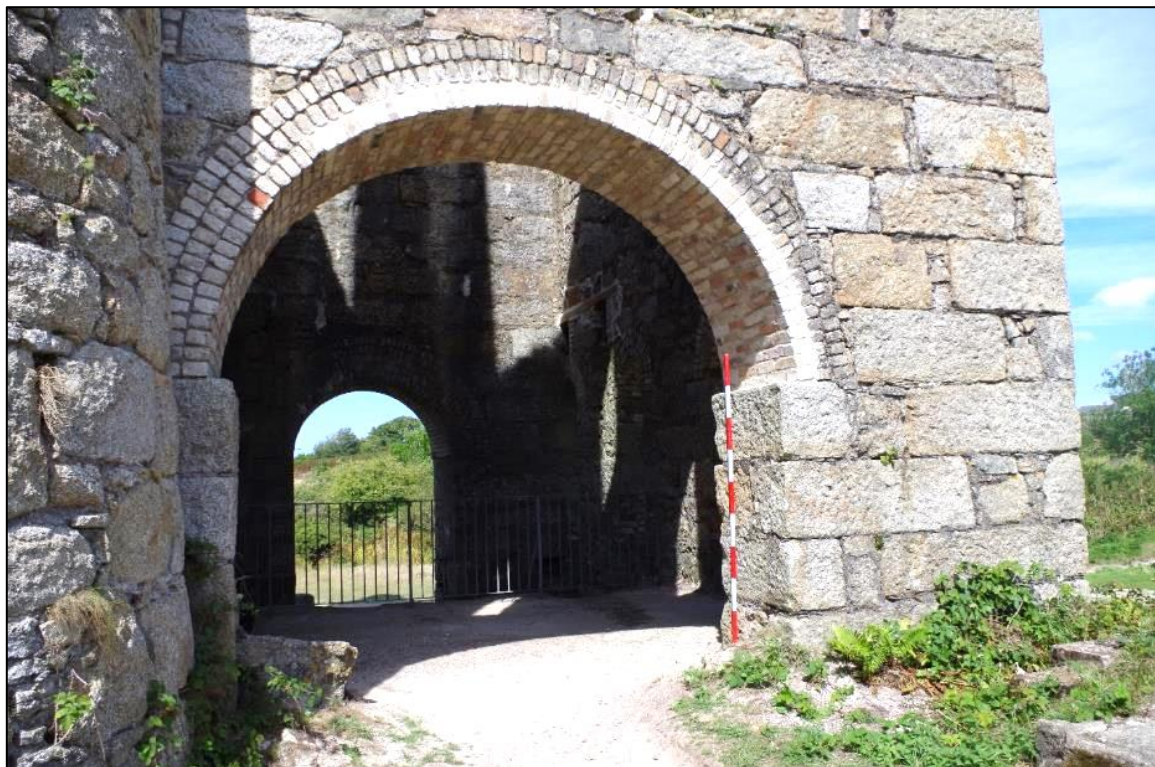
Fig 86 South-east elevation following reconstruction of the lower course of cylinder arch.
