Pascoe's Shaft Pumping and Winding
Engine Houses, South Wheal Frances,
Piece, Cornwall
Historic Building Record

Cornwall Archaeological Unit

Report No: 2022R022

Historic Building Record

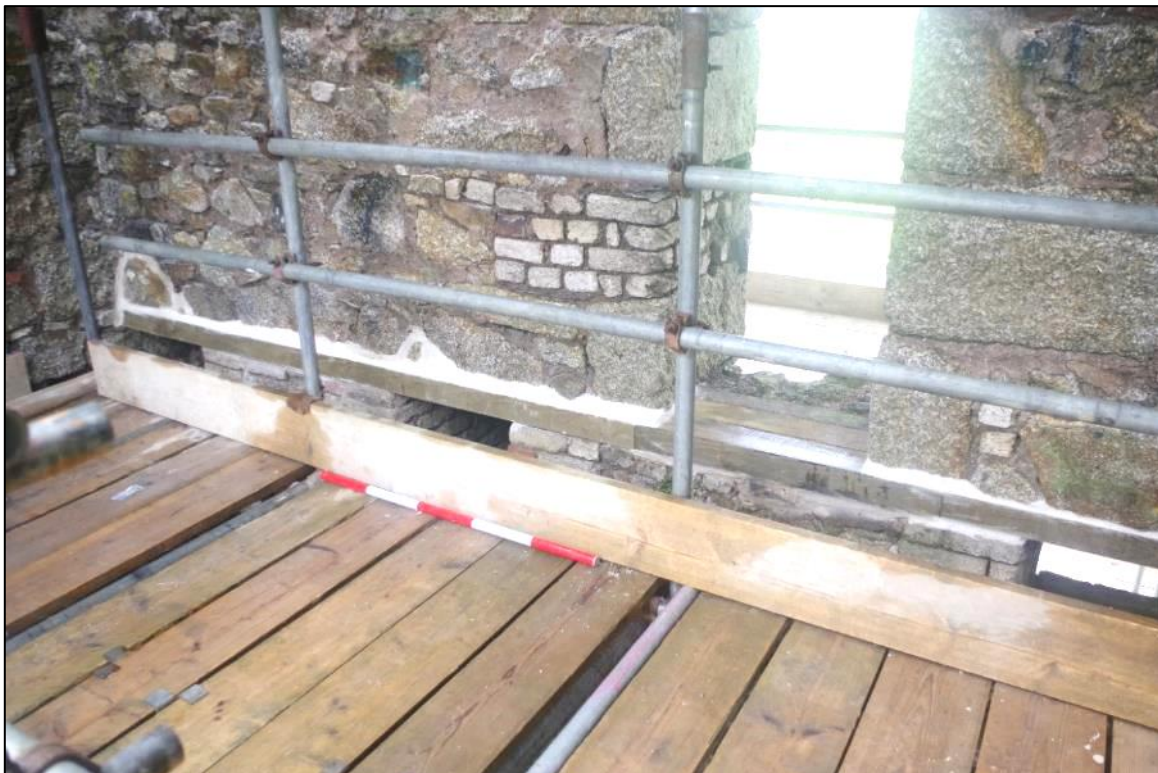
Fig 92 Interior south-east gable wall following replacement of lintel above spring beam slots.

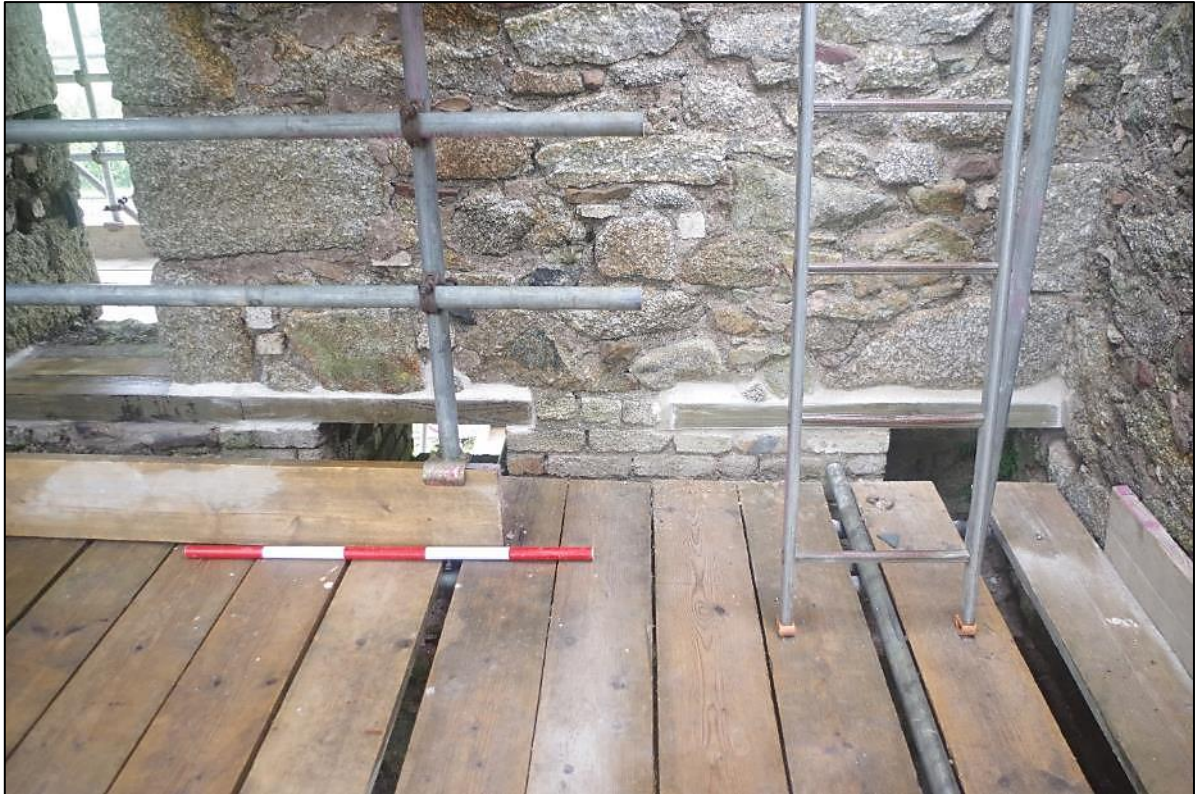
Fig 93 Interior south-east gable wall following replacement of lintel above spring beam slots.

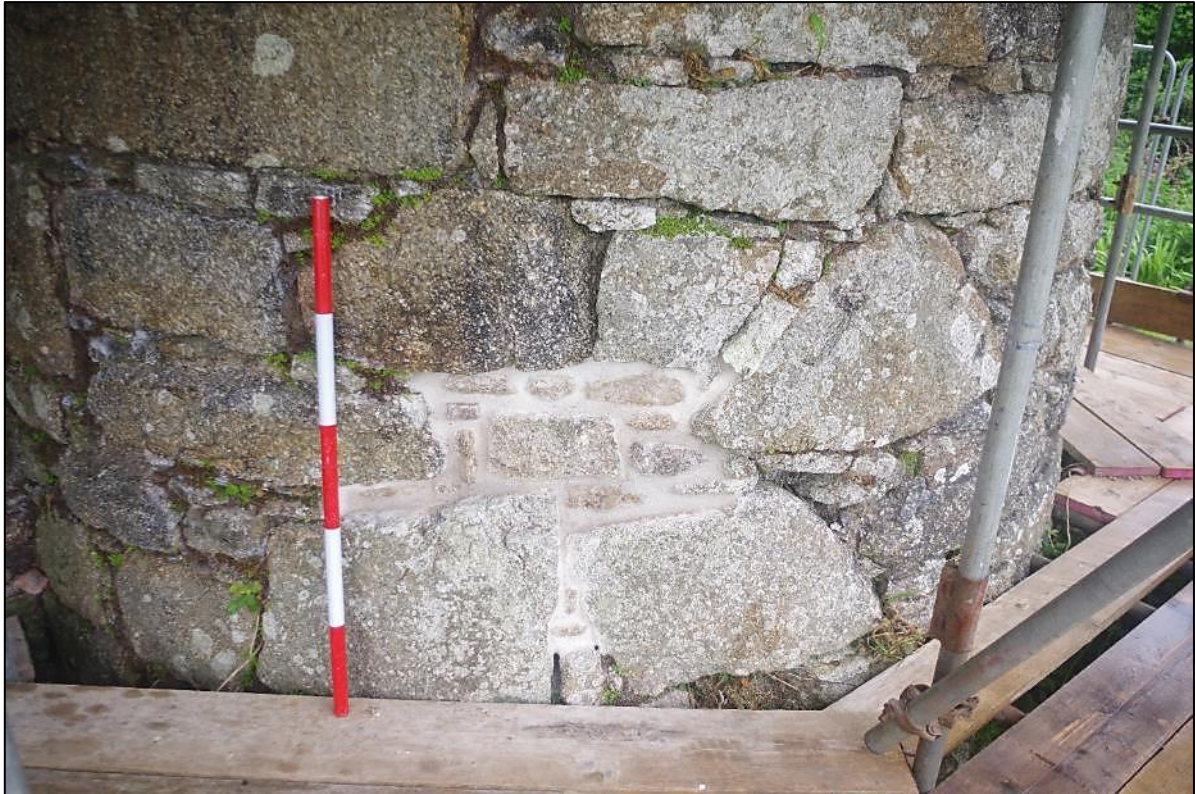
Fig 99 Small patch repair to chimney stack.

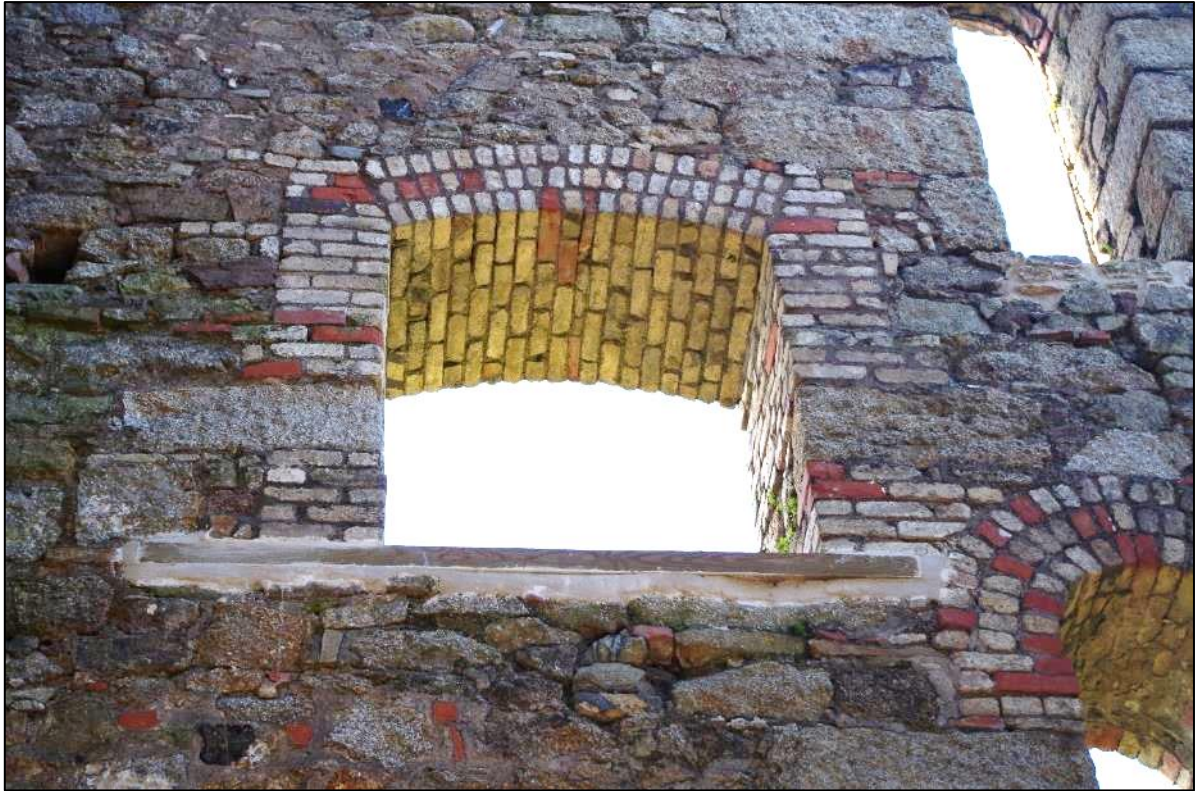
Fig 101 Interior south-west wall, replacement sill of main girder slot opening.

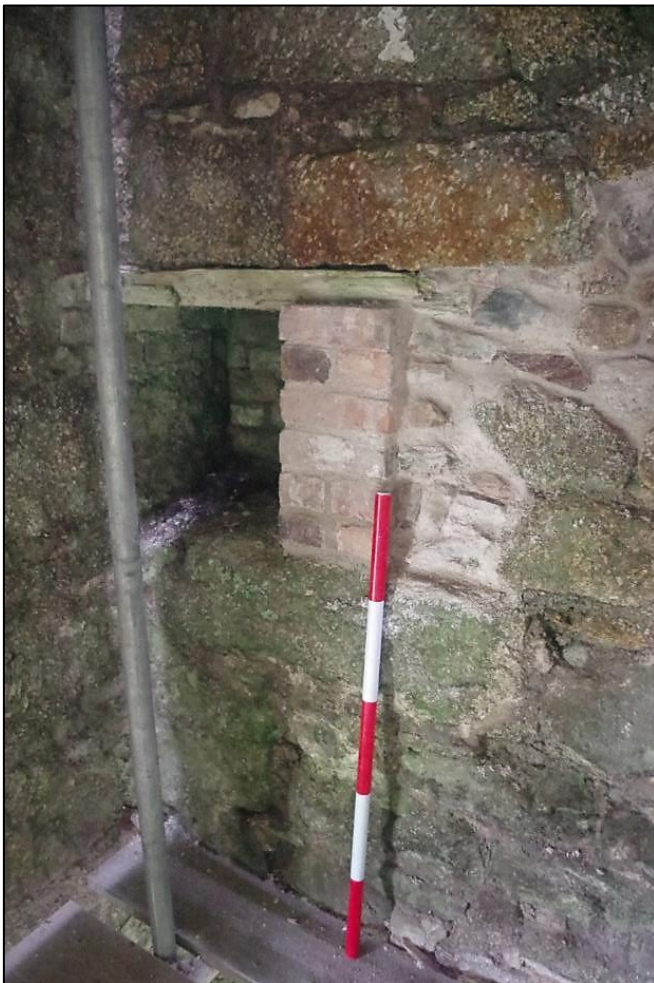
Fig 102 Interior south-west wall, repair to joist socket.

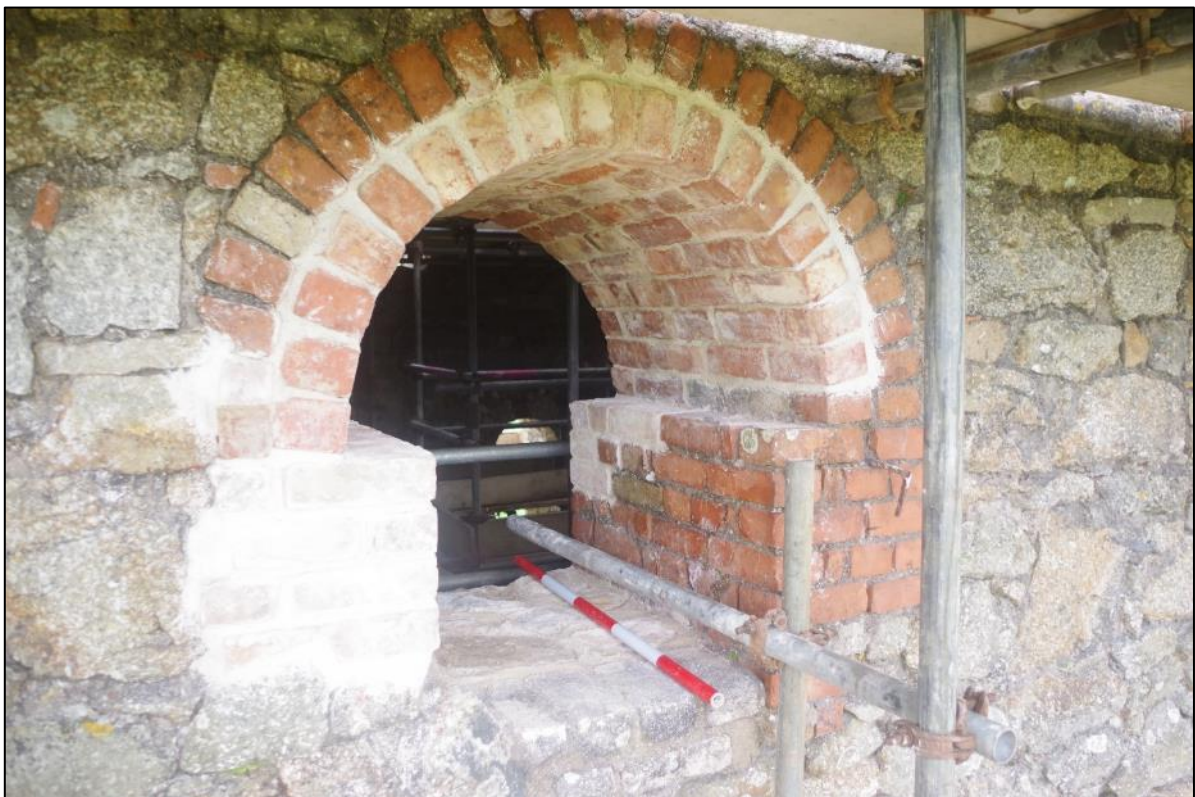
Fig 106 South-west elevation, view of arch reconstruction.

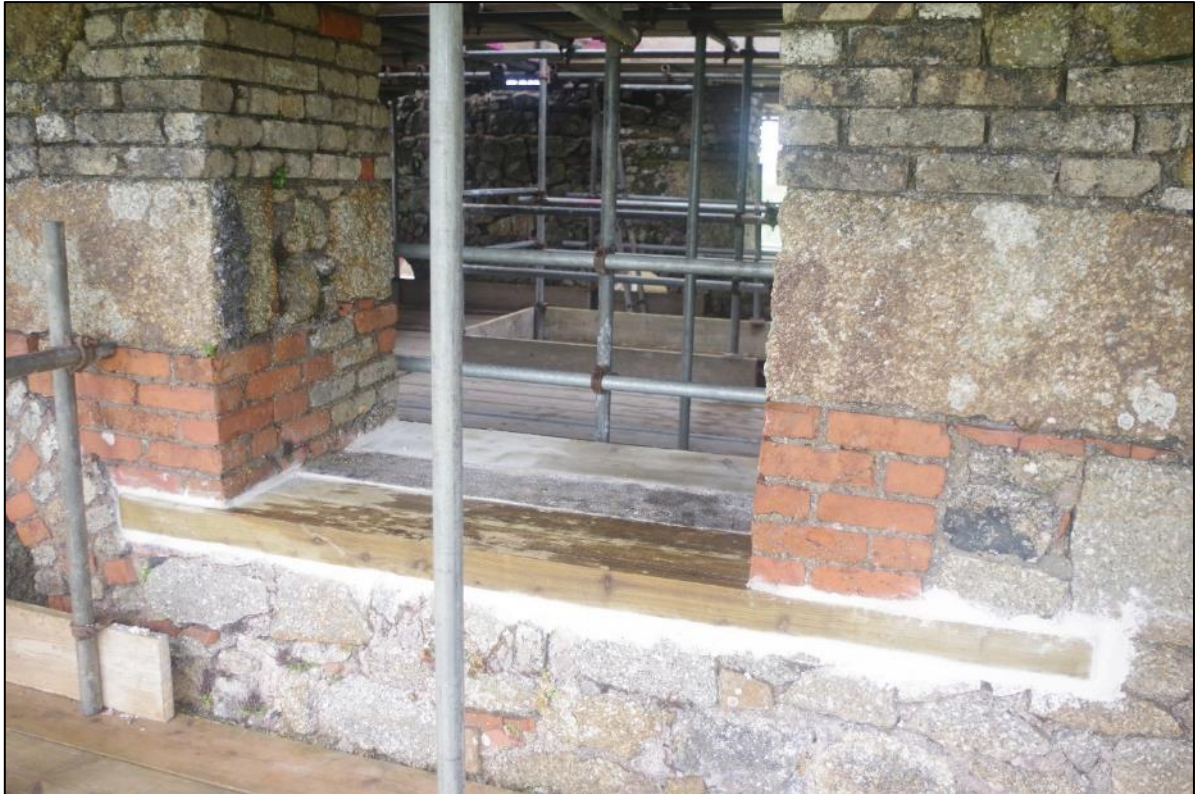
Fig 107 South-west elevation, replacement sill of main girder slot.
