Saltash Gridirons, Clearance and Recording 2023 Saltash, Cornwall

Client	Tamar Valley AONB	
Report Number	2023R003	
Date	February 2023	
Status	Final	
Report author	Antony Angove	
Checked by	James Gossip	
Approved by	Andy Jones	
Project number	147226	
Site code	Sal23	
Data location	\CAU\Archive\Sites\S\Saltash Gridirons 147226	
Historic England / ADS OASIS online reference

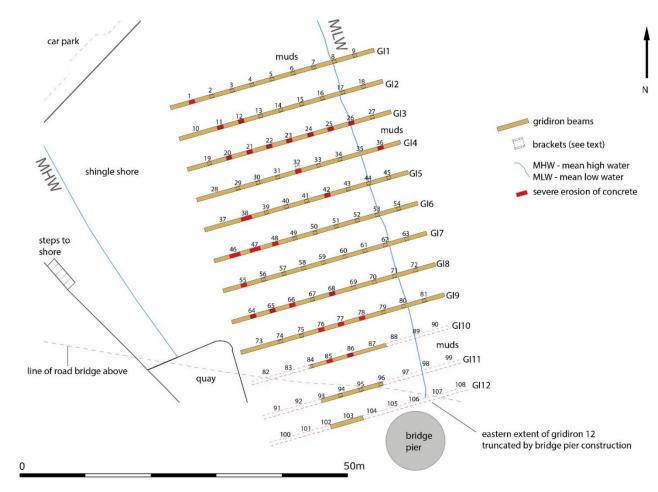
Fig 13 Plan of gridirons (using GPS/Total Station survey data).

A summary of each gridiron beam is listed below as follows. Gridirons labelled GI1 – GI12, brackets labelled 1 - 108 (Figs 13 and 14).

- GI1 Bracket 1 is not present and severe erosion was recorded within its former
 position on the gridiron beam. The remaining brackets were recorded in situ, with
 erosion ranging from minimal to severe on each bracket base. The southern face
 has a better level of preservation than the northern face. The top of the gridiron
 is severely eroded.

- GI2 Bracket 10 is not present and severe erosion was recorded within its former
 position on the gridiron beam. The remaining brackets were recorded in situ, with
 erosion of the bracket bases most severely eroded at the eastern end and bracket
 18 largely covered in mud. The southern face has a better level of preservation
 than the northern face. The top of the gridiron is severely eroded. However, it is
 likely to be the best preserved gridiron beam.

- GI3 All brackets remain in situ, but with severe erosion occurring where they
 were positioned along the length of the gridiron beam. There is evidence of later
 reuse with rope tied to bracket 20. An additional iron plate has been added to
 bracket 24. The southern face has a better level of preservation than the northern
 face.

- GI4 Brackets 28 and 35 are not present and severely eroded where positioned on the gridiron beam. The remaining brackets were recorded *in situ*, however, bracket 32 has been displaced away from the beam. The southern face has a better level of preservation than the northern face. There is evidence of later reuse with rope tied to bracket 30. The top of the gridiron is severely eroded.

- GI5 Brackets 37 and 38 are not present and severely eroded around their former positions on the gridiron beam. The remaining brackets were recorded *in situ*, with minimal to severe erosion on each bracket base. Bracket 42 was damaged, with the northern edge snapped off next the gridiron beam.

- GI6 Brackets 46, 47 and 48 are not present and severely truncated between these former bracket positions. Brackets 51 and 52 are severely bent and the top of the gridiron severely eroded.

- GI7 Bracket 55 is not present and severe erosion recorded around its former position on the gridiron beam. The remaining brackets were recorded *in situ*, with erosion ranging from minimal to severe on each bracket base. There is evidence of later reuse with rope tied to bracket 57. The top of the gridiron is severely eroded. Brackets 57 to 63 were not clearly visible due to mud.

- GI8 Bracket 66 is not present and severe erosion was recorded around its former on the gridiron beam. The remaining brackets were recorded *in situ*, with erosion ranging from minimal to severe on each bracket base. There is evidence of later reuse with rope tied to bracket 65. 68 is slightly displaced from is positioning and

is severely eroded. Brackets 69 to 72 were not clearly visible due to mud. The top of the gridiron is severely eroded.

- GI9 Brackets 73, 76, 77 and 78 are not present and minimal to severe erosion was recorded where they had been positioned on the gridiron beam. The remaining brackets were recorded *in situ*, however, brackets 79 to 81 were not clearly visible due to mud. The top of the gridiron is severely eroded.

- GI10 Brackets 82, 83, and 85 are not present with severe erosion was recorded where they had been positioned on the gridiron beam. The remaining brackets were recorded *in situ*, however, brackets 87 to 91 were not clearly visible due to mud. The top of the gridiron is severely eroded.

- GI11 Bracket 91 to 93 are not present with severe erosion was recorded where
 they had been positioned on the gridiron beam. There is severe damage to bracket
 96, with the top of the fixing torn. Brackets 97 to 99 were recorded in situ,
 however, were not clearly visible due to mud. The top of the gridiron is severely
 eroded.

- GI12 The gridiron beam has been severely truncated by the construction of the Tamar Bridge. No brackets remained or were visible due to mud.

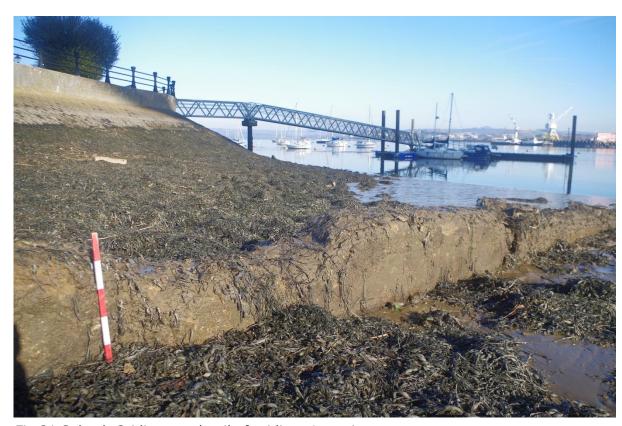
Fig 31 Saltash Gridirons – detail of gridiron 1 erosion.

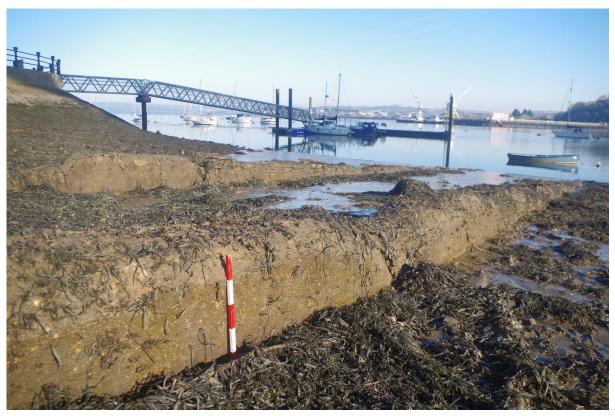
Fig 32 Saltash Gridirons – well-preserved south face of gridiron 2 with adjacent erosion.

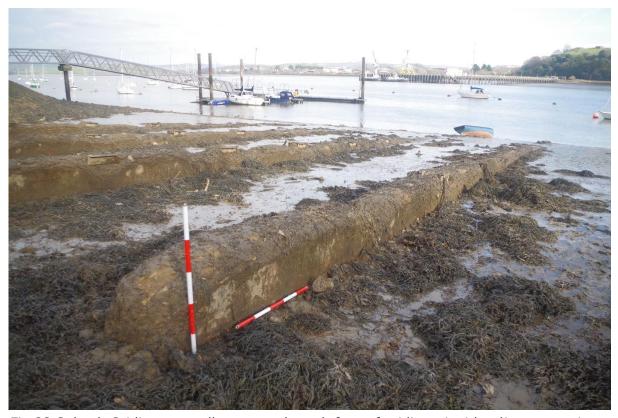
Fig 33 Saltash Gridirons - well-preserved south face of gridiron 4 with adjacent erosion.

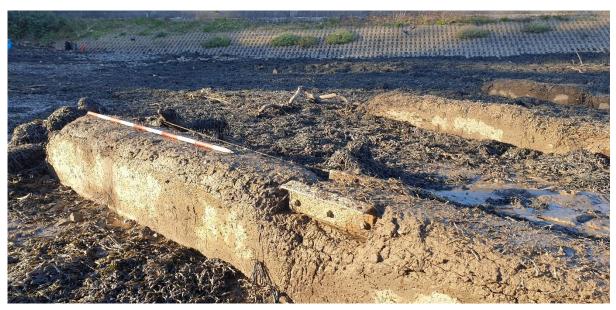
Fig 34 Saltash Gridirons – well-preserved south face of gridiron 3 with erosion around bracket.

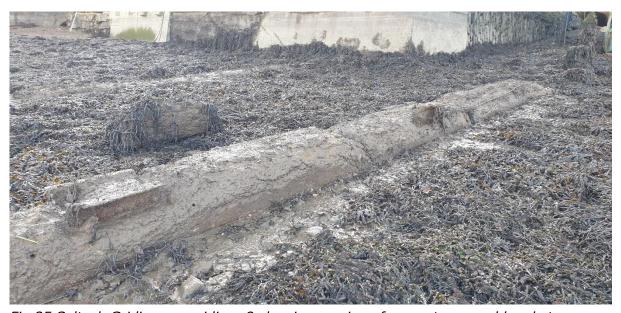
Fig 35 Saltash Gridirons – gridiron 8 showing erosion of concrete around brackets.

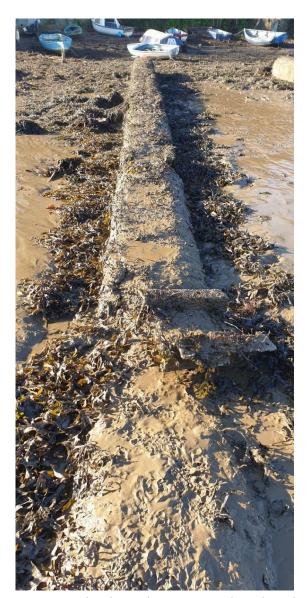
Fig 36: Saltash Gridirons - Displaced gridiron (32) on gridiron 4.

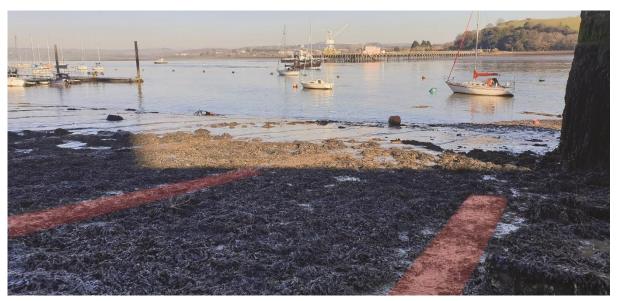
Fig 37 Saltash Gridirons – poorly preserved gridirons 11 and 12.

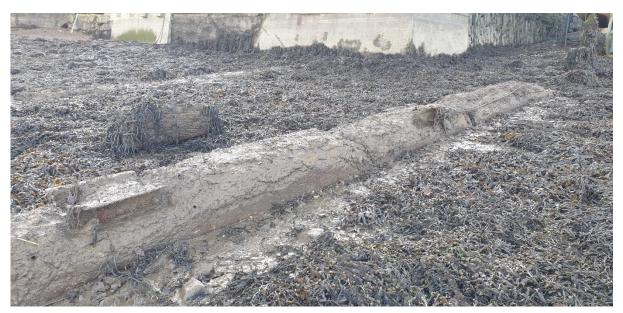
Fig 38 Saltash Gridirons – brackets with eroding concrete on gridiron 8.

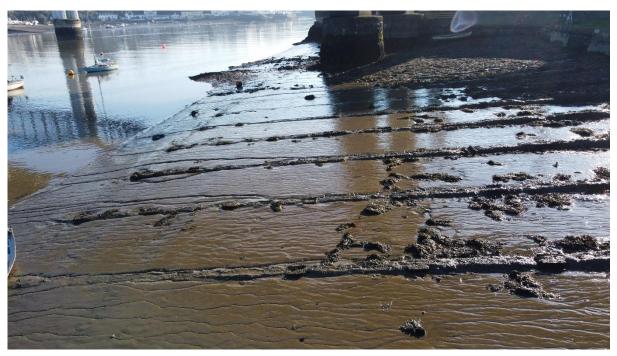
Fig 40 Saltash Gridirons – Lower sections submerged in river mud.

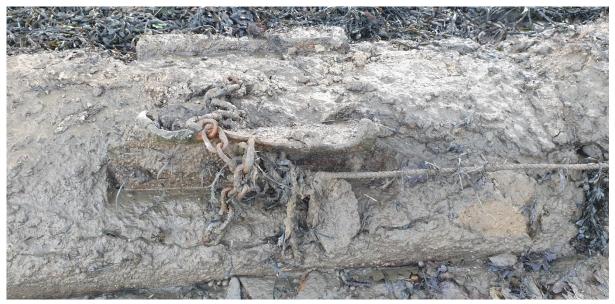
The gridirons have been used as moorings for local boats since it was decommissioned after the Second World War. This has had a detrimental impact upon the site, damaging both gridiron beams and brackets, accelerating erosion of the concrete. The constant ebb and flow of the tide, seaweed growth and movement of mud and shingle has also contributed to the gradual degradation of the monument.

Fig 41 Saltash Gridirons – gridiron 8 mooring chain and rope secured to bracket.

- Regular clearance events by local volunteers.
- Encourage local boat owners to use alternative moorings installation of mooring posts or rings?
- Ongoing monitoring of monument by volunteers.

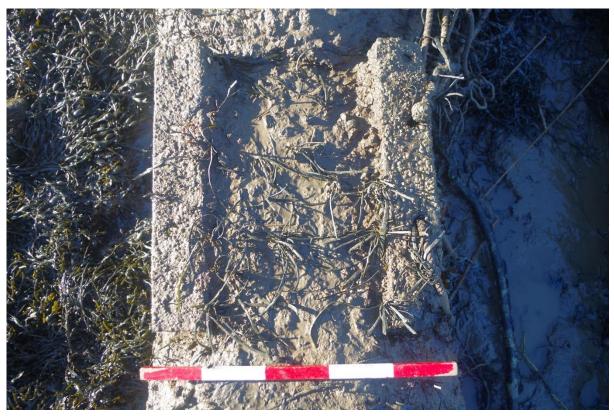
Fig 42 Saltash Gridirons – bracket re-used as a boat mooring.

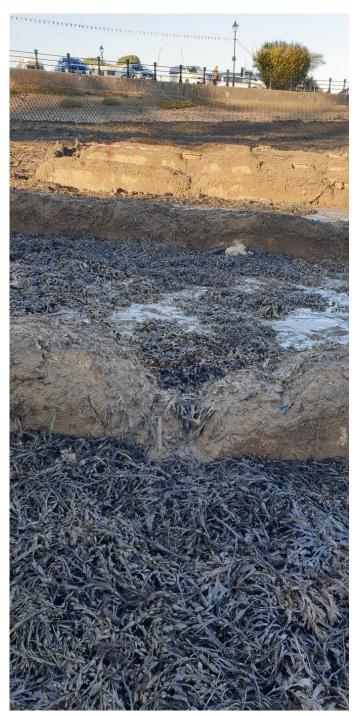
Fig 44 Saltash Gridirons – foreground showing extensive damage western end gridiron 6.
