South Hooe Mine, Bere Alston, Devon

Report on building conservation works

Client	Trish Dugmore
Report Number	2010R0124
Date	September 2010
Status	Final
Report author	Colin Buck MIFA
Checked by	Peter Rose
Approved by	Peter Rose

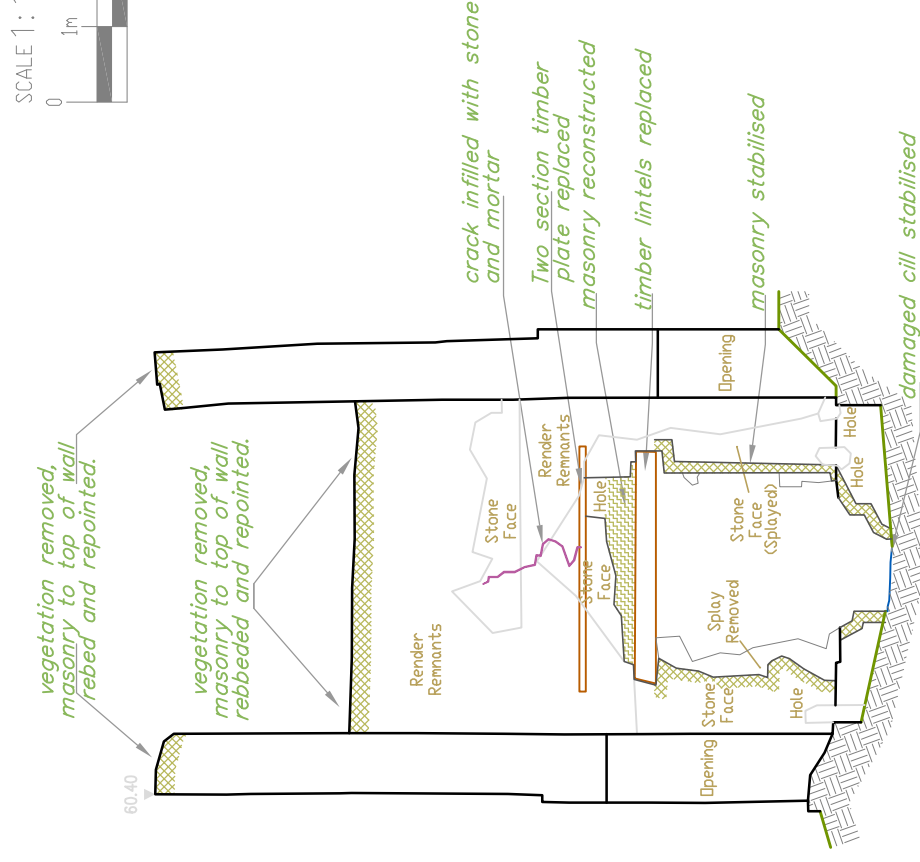
ENGINE HOUSE
SOUTH ELEVATION (INTERNAL)
3m² OF ELEVATION REPOINTED

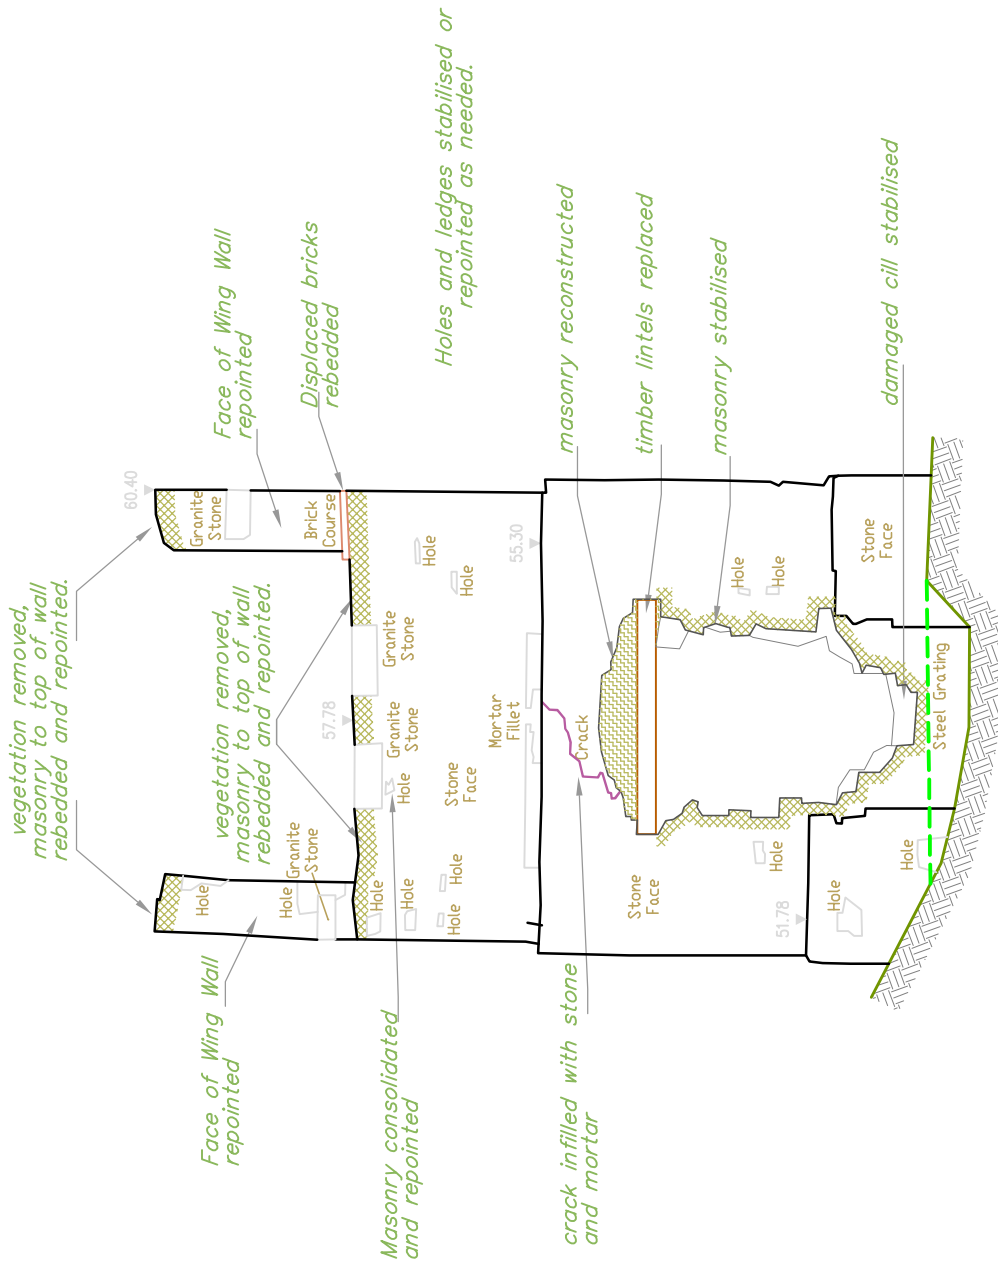
ENGINE HOUSE
SOUTH ELEVATION (EXTERNAL)
3m² OF ELEVATION REPOINTED

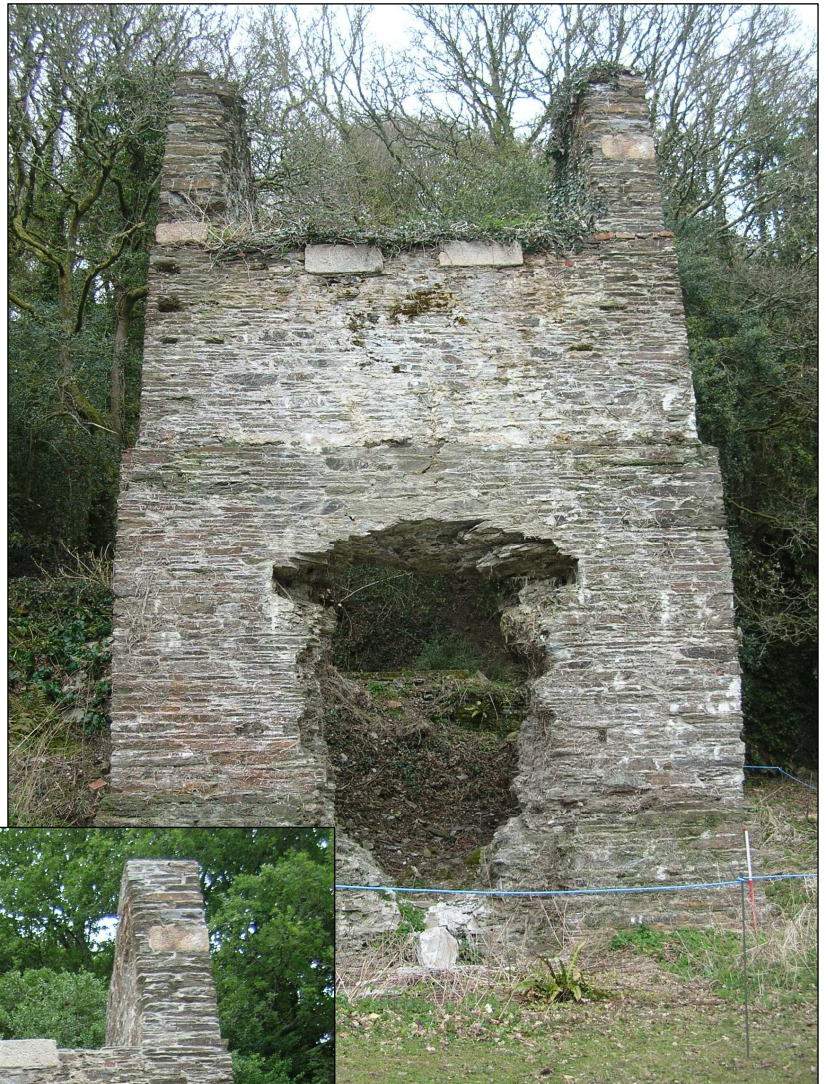
*Fig 6 South side view of the Pumping Engine House before works:
(Site 1) C. Buck 2010© CC HE*

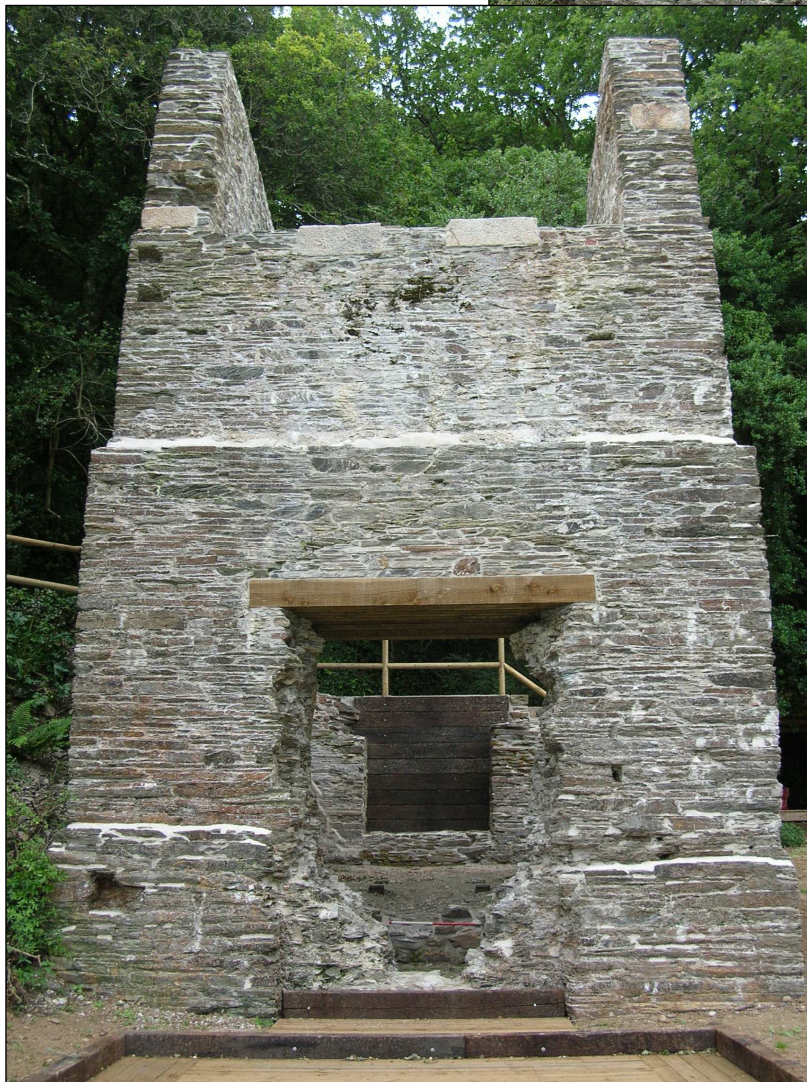
*Fig 7 South side view of the
pumping Engine
House after works:
(Site 1) C. Buck
2010© CC HE*

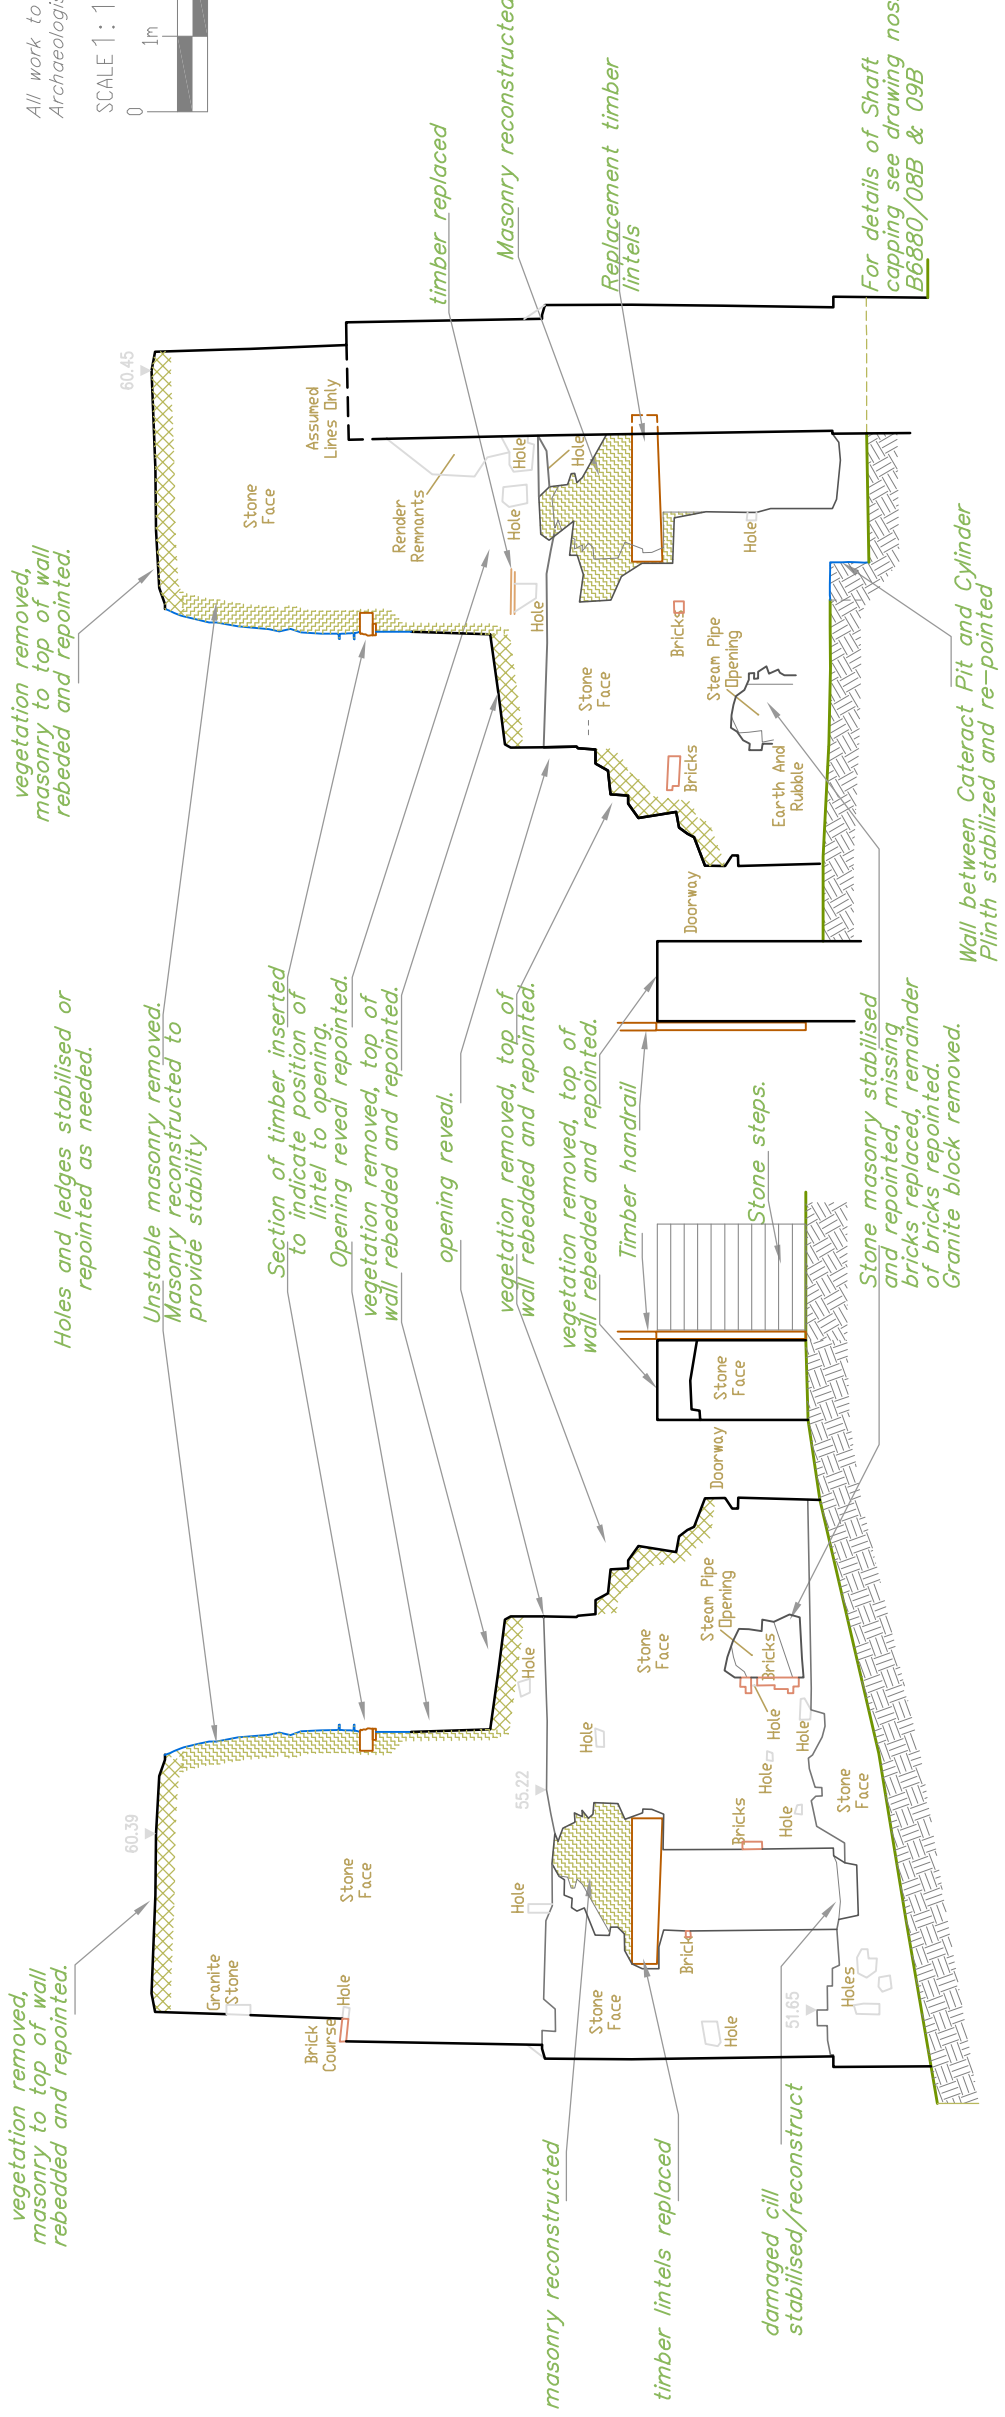
FIG 8 (Site no. 1)

**ENGINE HOUSE
EAST ELEVATION (EXTERNAL)**
10m² OF ELEVATION REPOINTED

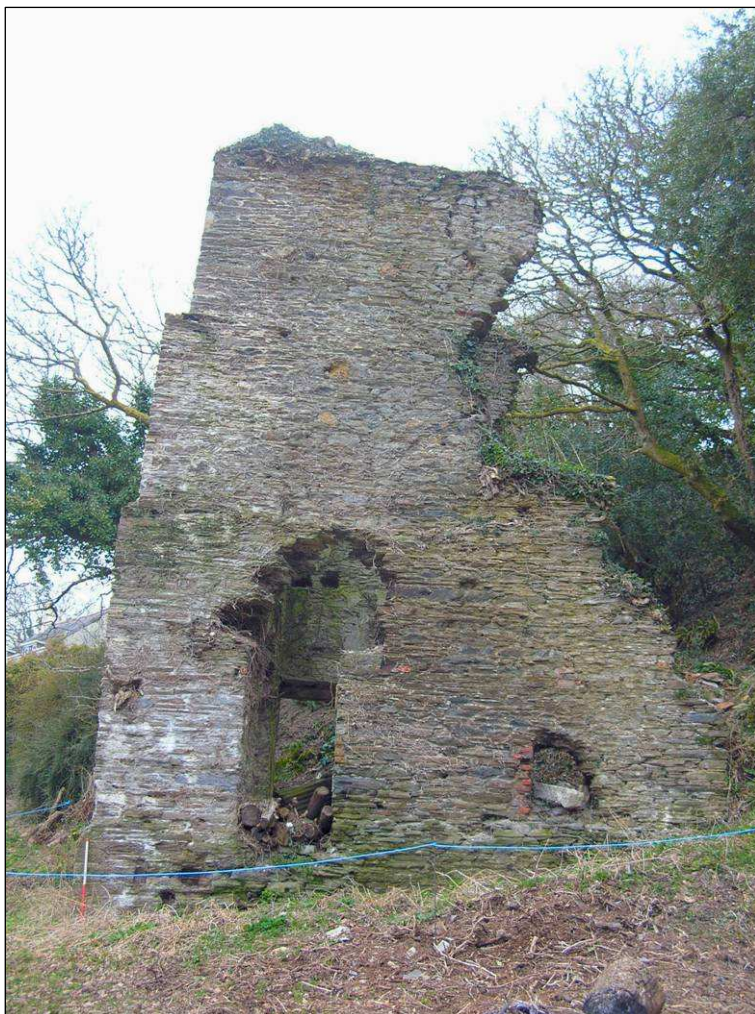
Fig 9 East side view of the Pumping Engine House before works C Buck 2010© CC HE

However, following removal of the dense ivy, it was apparent that the northern end of the upper east wing wall and to less of an extent, the west wing wall, were both unsafe, as a section of masonry from each wall could be seen to be falling away (see Buck 2009, Fig 12). It was therefore decided in the pre-contract meeting (17/3/2010), that the scaffolding would initially be erected around the outside of the building. This would allow further and more detailed site inspection by the buildings consultant, structural engineer and contractor. A decision was taken that the unsafe section of masonry would be removed from each wing wall before any further works were allowed to proceed inside the building. In addition, scaffolding could not be erected internally until the floor was cleared of earth and stone etc (to an agreed floor level). Thus, the building conservation works were undertaken in two stages, firstly the works to the exterior of the building (wall capping/wall repointing where necessary/replacement of structural items), and secondly (following clearance of earth/rubble etc), conservation works to the inside of the building.

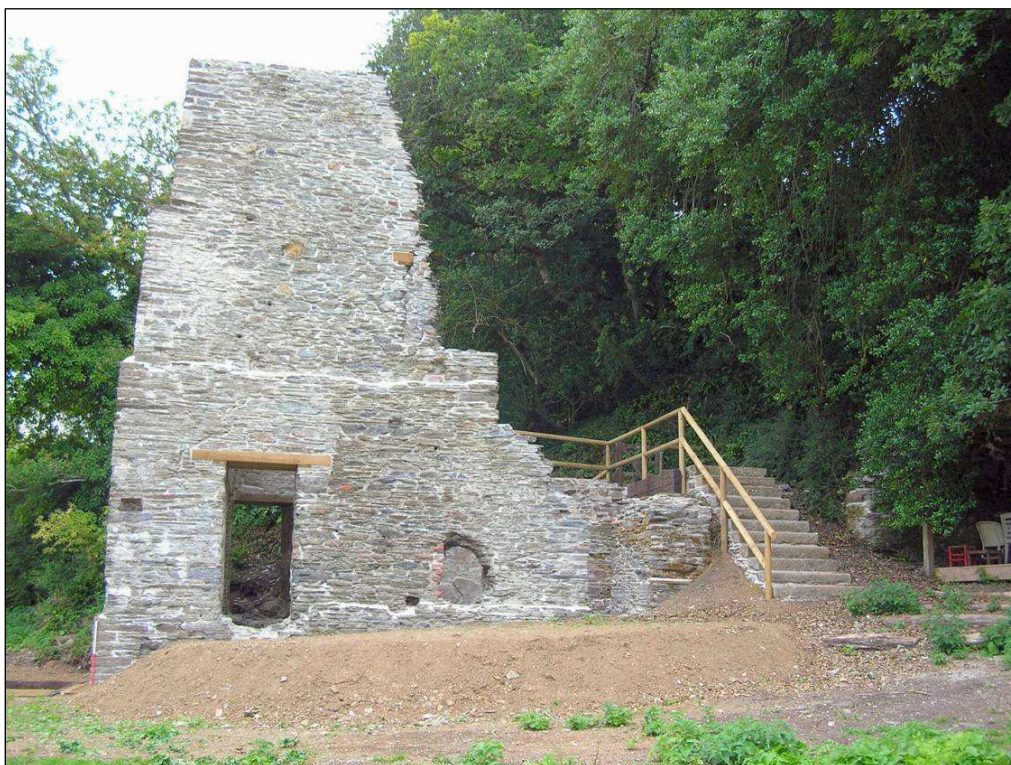
Fig 10 East side view of the Pumping Engine House after works C Buck 2010© CC HE

By early June 2010 all the major conservation works to the engine house bob wall had been completed. However, the excavation of the engine house internally had resulted in a 3.0m drop in ground level into the engine house, which (given occasional pre-arranged public access and the close proximity of a public right of way), was an obvious health and safety hazard. After discussion, a fencing specification of round profile timber post and rail was agreed which would span the northern end of the engine house and run out to the west side of the building. A small gate was also added for the landowner's use. In addition, the landowner had used some old timber steps to go around the north side of the engine house to go down to the garden on the east side. It was not thought that these steps were safe for public access, therefore it was agreed that more permanent steps (with a fence hand rail) would be built to replace the old timber steps. Wide second hand granite steps were purchased and constructed with a masonry side wall (see Figs 10 and 17).

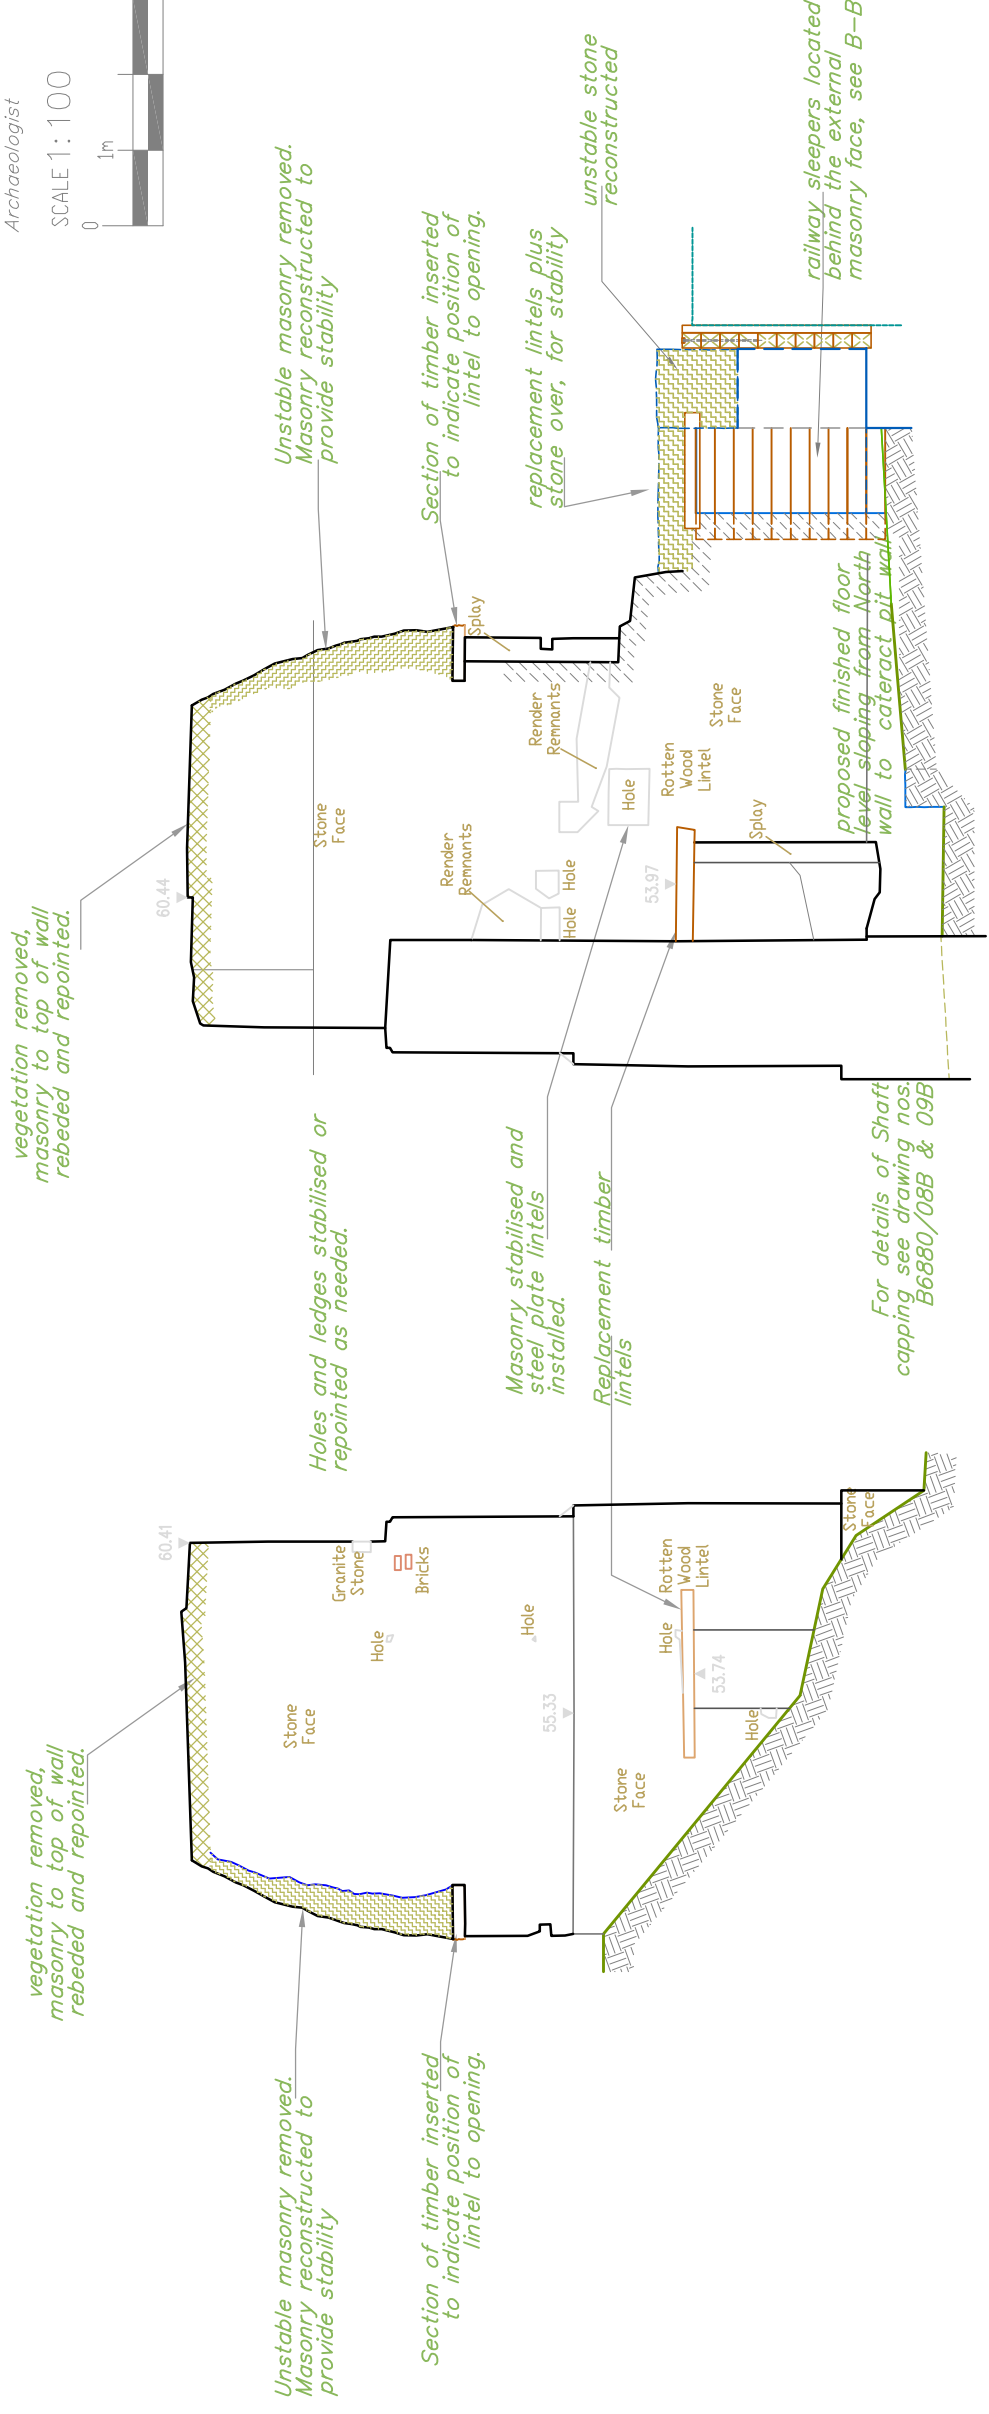
FIG 11 (Site no. 1)

**ENGINE HOUSE
WEST ELEVATION (EXTERNAL)**
11m² OF ELEVATION REPOINTED

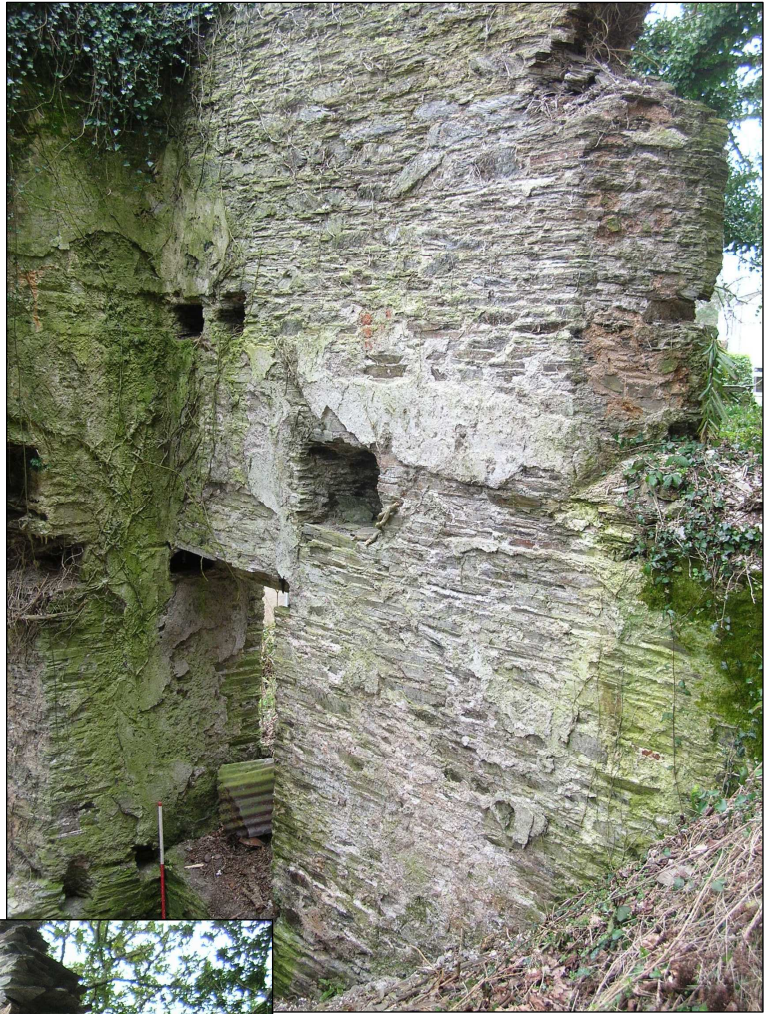
Fig 12 West (internal) view of the Pumping engine house before works (Site 1) C. Buck 2010© CCHE

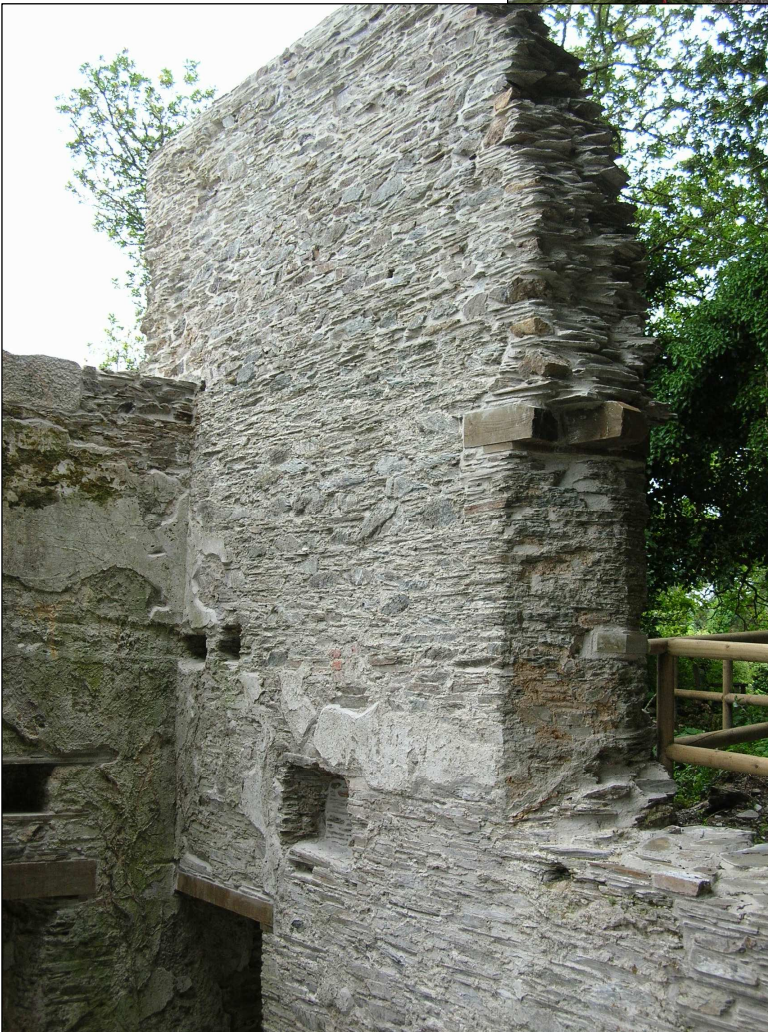
Fig 13 West (internal) view of the Pumping engine house after works (Site 1) C. Buck 2010© CCHE

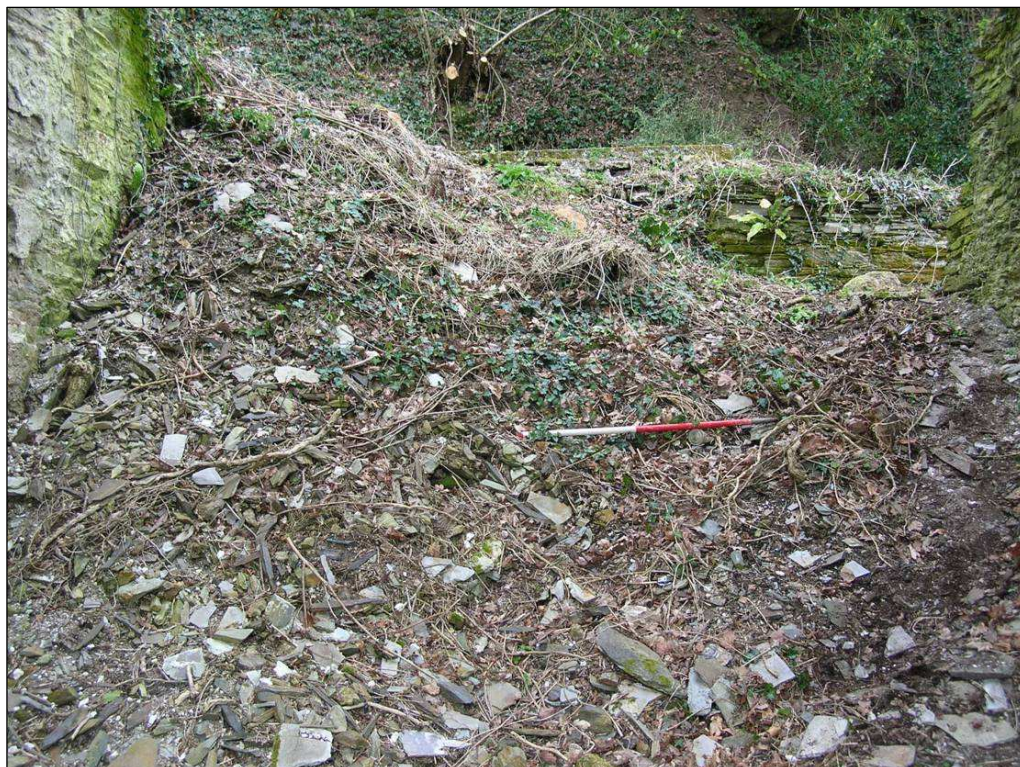
Fig 15 North (internal) view of the Pumping Engine House before works C Buck 2010© CC HE

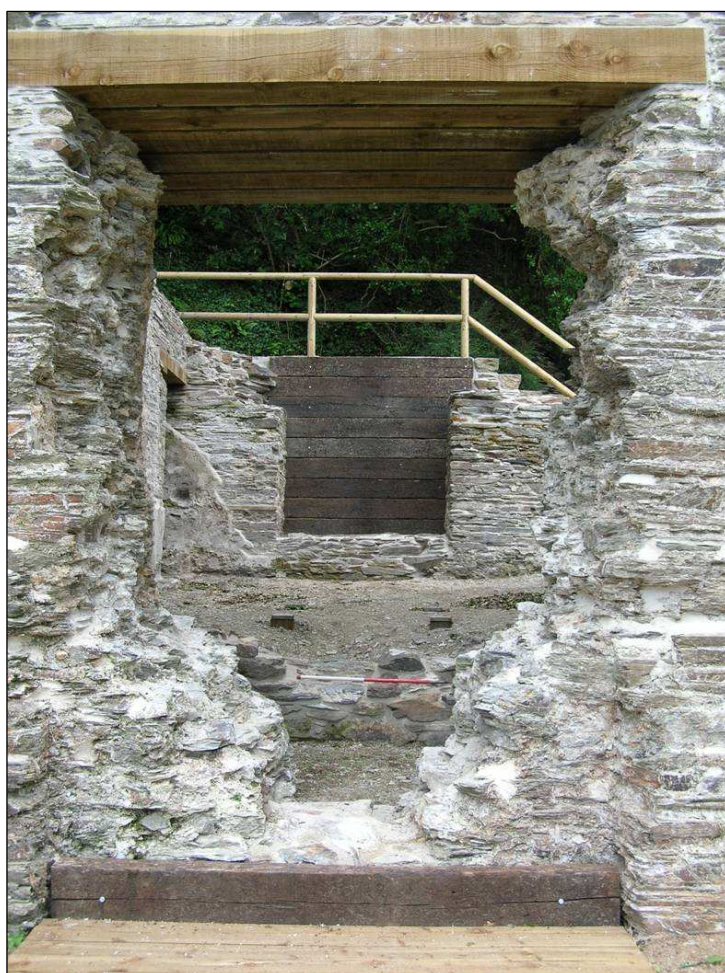
Fig 16 North (internal) view of the Pumping Engine House after works C Buck 2010© CC HE

Clearance of the earth/stone rubble build up against (and over) the north (rear) wall, down to what was taken as the original internal ground level (the building would have had a timber tongue and grooved floor on joists), revealed the sides of the cylinder door and just outside this opening, the vertical concrete block side of the landowner’s sewage septic tank. In addition, on the west side of the northern internal end of the engine house another doorway was found (with original plastered walls) – which was completely unexpected (see Fig 11). The existing ground level is now 3.0m higher on the west and north sides of the engine house, than the original engine house ground floor level. This 3.0m high build up of ground appears to be mainly rubble, earth and mortar from what would have been the collapsed rear gable wall of the engine house and parts of each of the wing walls. After a variety of options, it was decided to use old railway sleepers laid horizontally which spanned both sides of each of the two openings. This solution was deemed to be cost effective, structurally sound, and to retain the character of the building (see Fig 16).

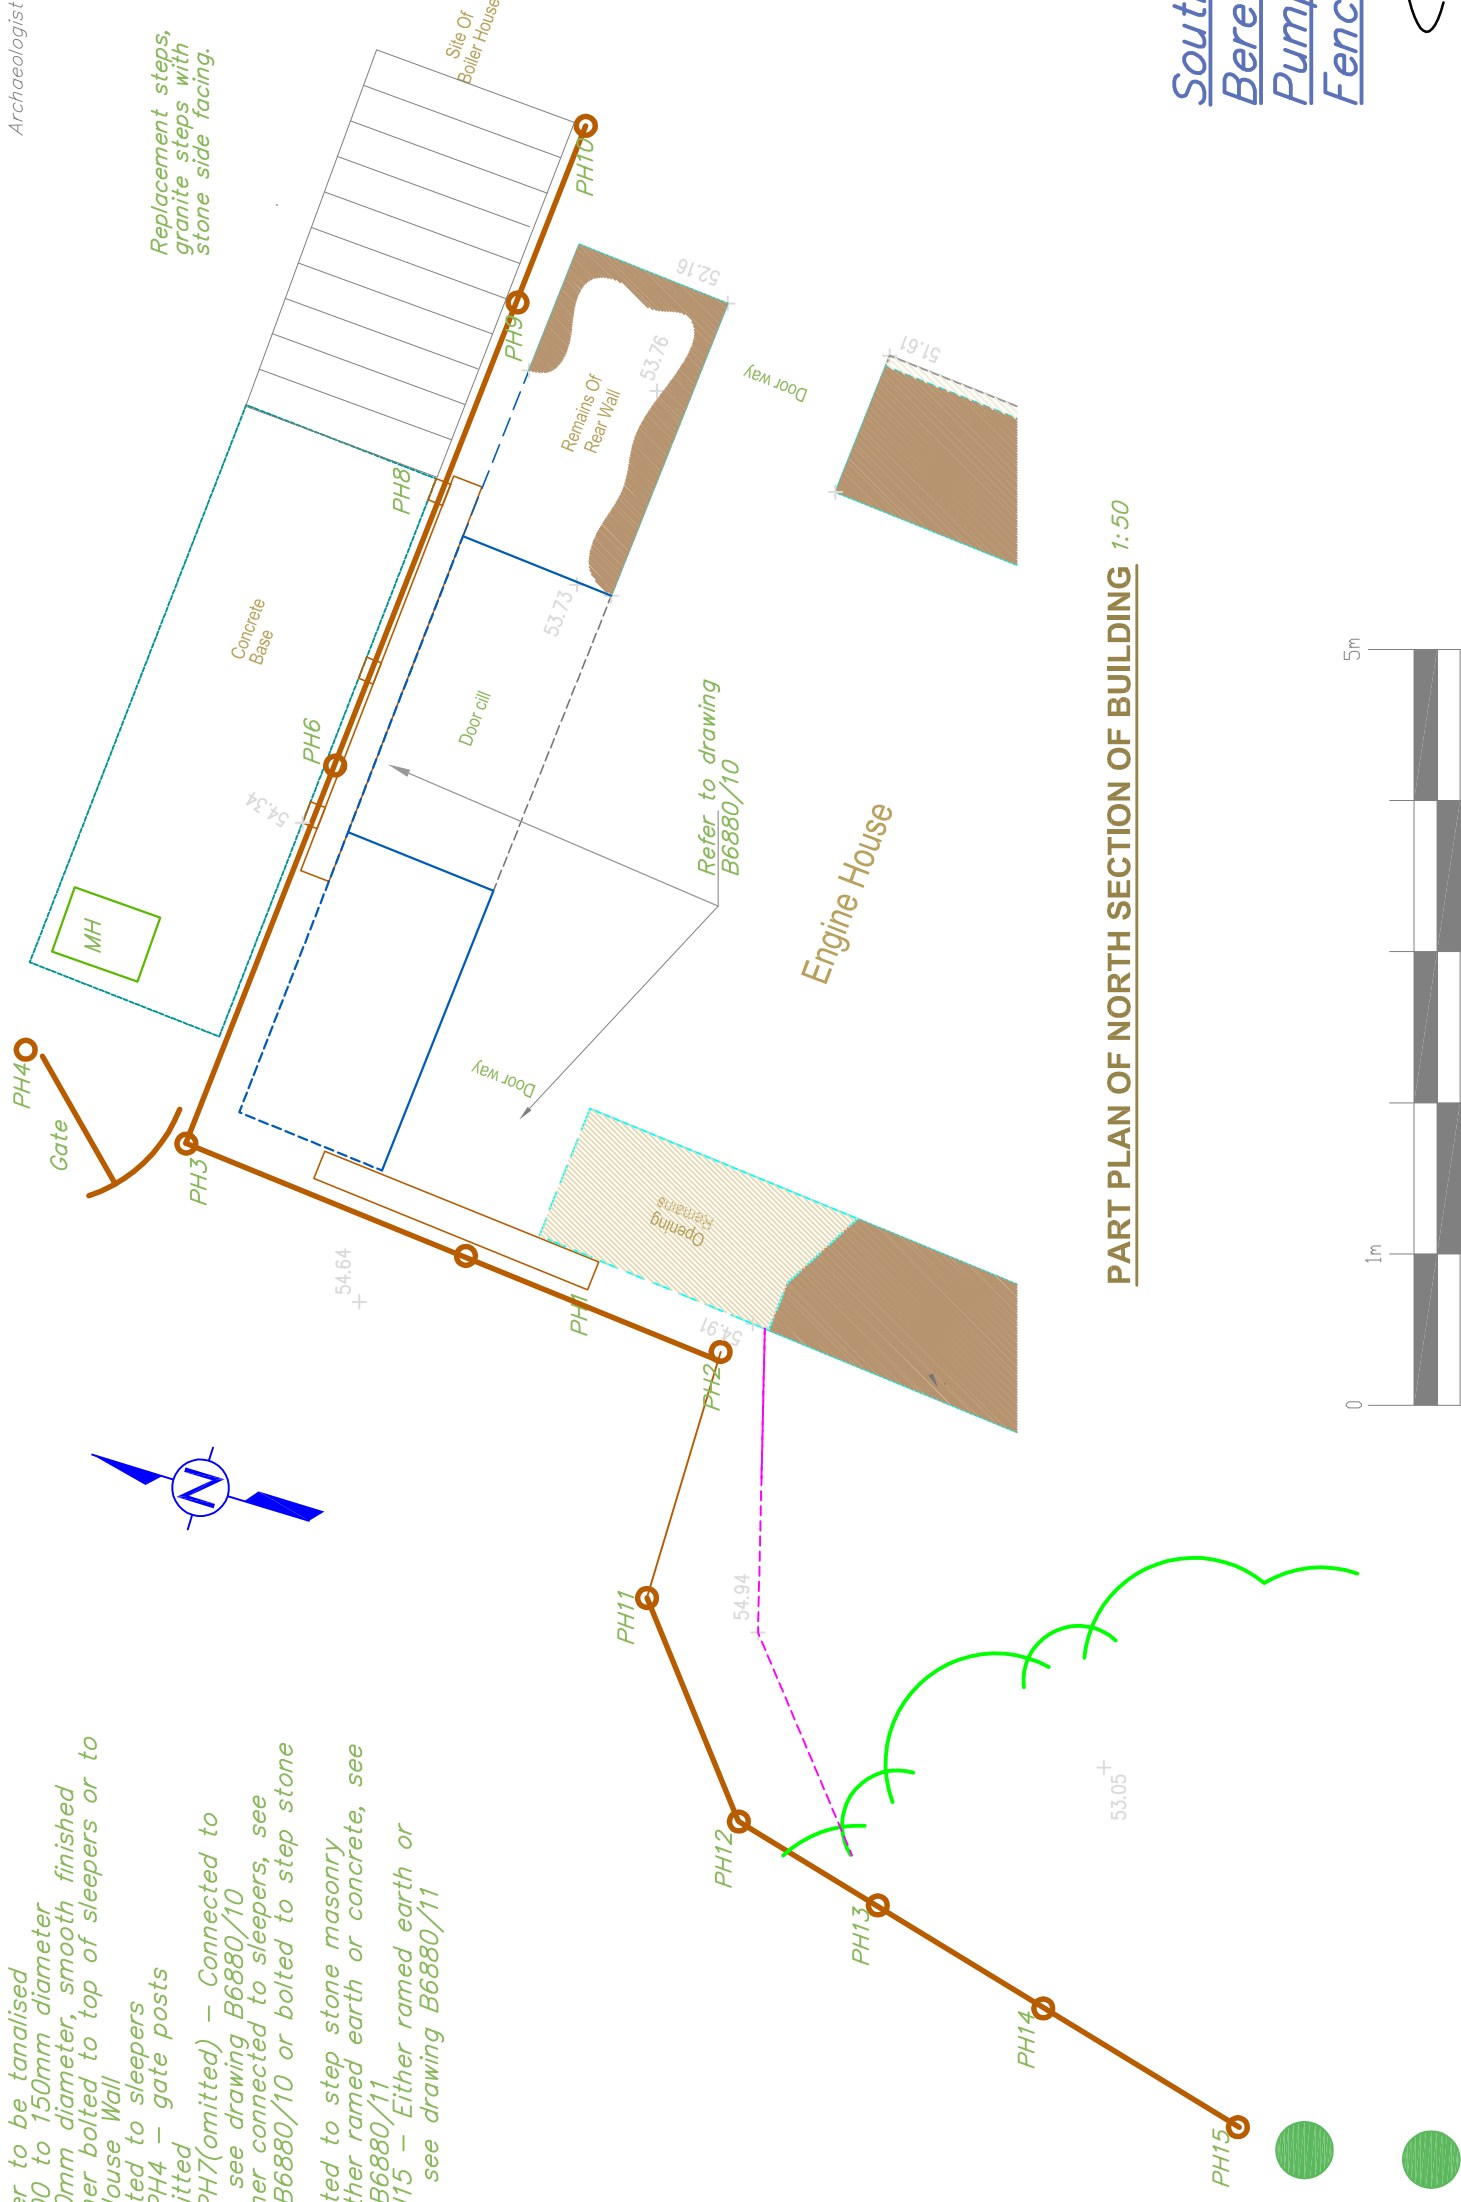
**South Hooe Mine
Bere Alston, Devon
Pumping Engine House
Fence Layout**

Fencing/granite steps	42470 65596	Following removal of the interior earth/rubble fill from the inside of the rear of the engine house, given the existing ground levels outside the north side of the engine house, a steep drop into the engine house was a severe safety hazard, necessitating a timber post and rail fence. In addition, second hand granite steps were installed to replace steep timber steps in order to form safe passage around the north side of the engine house.

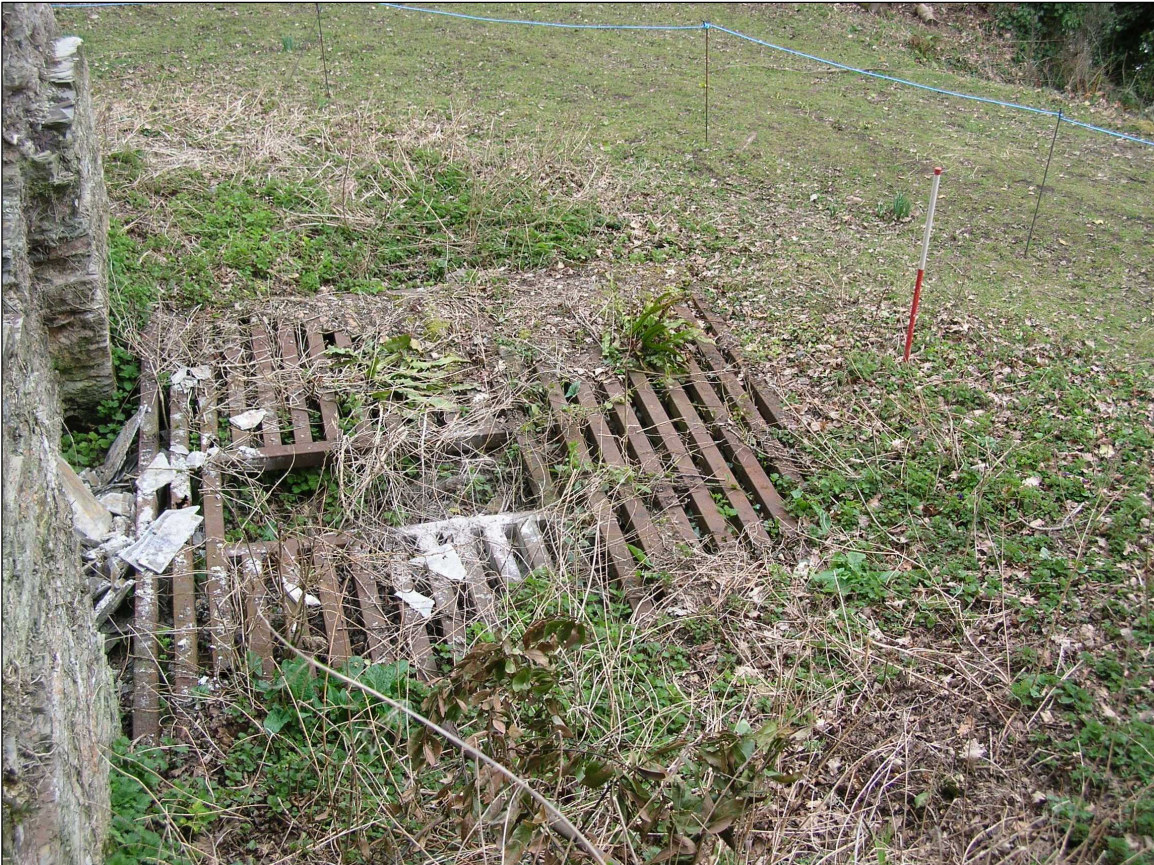
Fig 20 View of the Pumping Engine Shaft before works C Buck 2010© CC HE

The mine and shaft site is likely to be viewed by members of the public who visit the site, as part of limited pre-arranged guided tours by Trish Dugmore, the landowner. The specification, design and form of any shaft surface treatment has not yet been agreed with the structural engineer, landowner and project funders (NE). It is recommended that the landowner is aware of the Health and Safety implications of an un-capped mine shaft and the possible instability of the shaft surface choke/blockage, by the commissioning of a ‘desk based’ geotechnical investigation of the project area, in particular the two mine shafts; this site and Incline Shaft (Site 14).

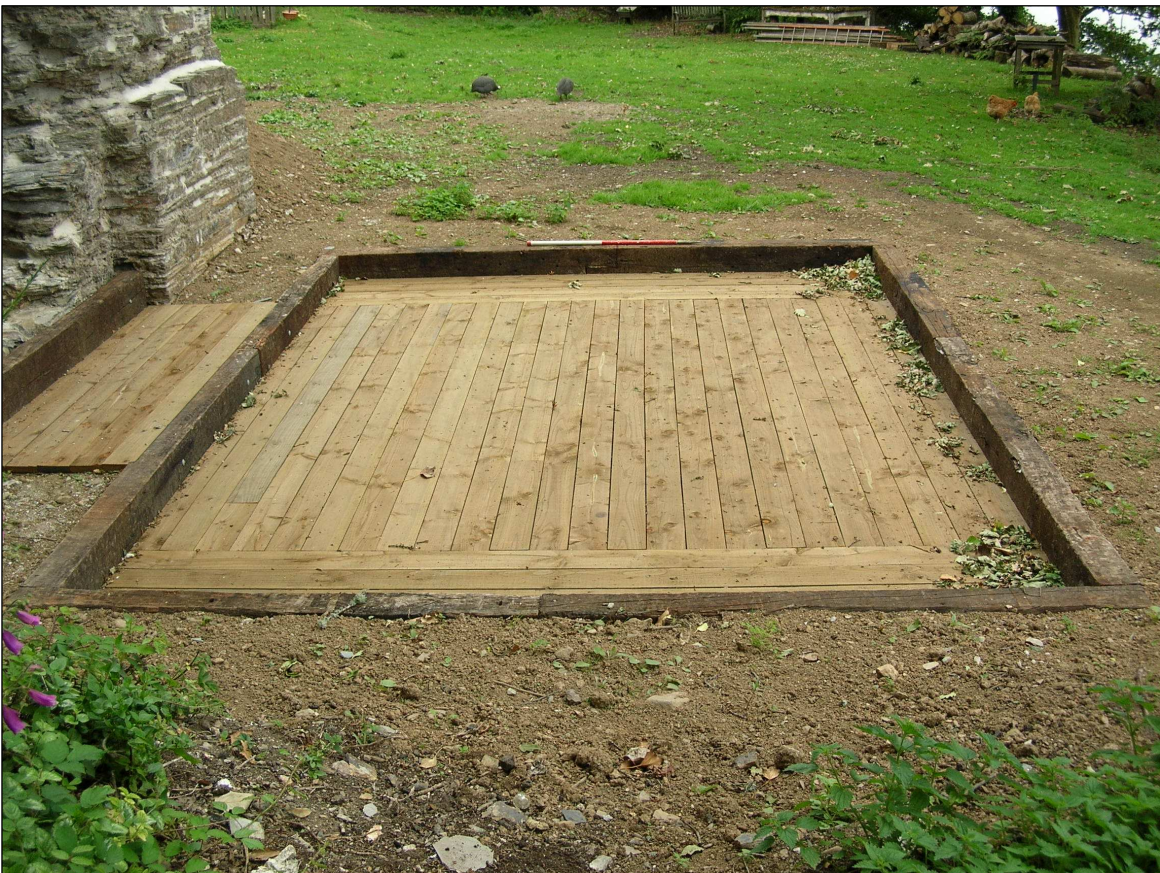
Fig 21 View of the Pumping Engine Shaft after works C Buck 2010© CC HE

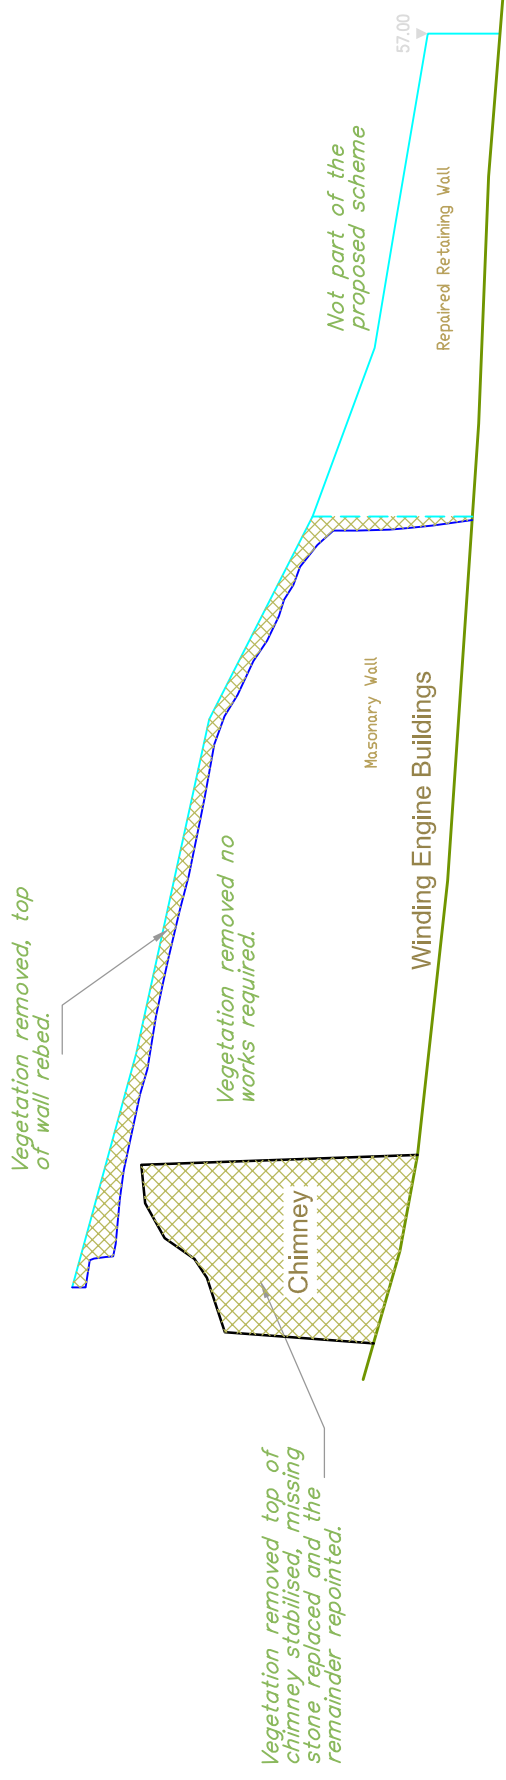
FIG 22 (Site nos. 12b/13)

WINDING BOILER HOUSE CHIMNEY
and Winding Engine Buildings
100% OF CHIMNEY REPOINTED

Following removal of the ivy and if necessary a structural assessment, it is recommended that the chimney is repointed where necessary with a lime mortar. Given the low height of the chimney it does not appear necessary to attach a lightning conductor.

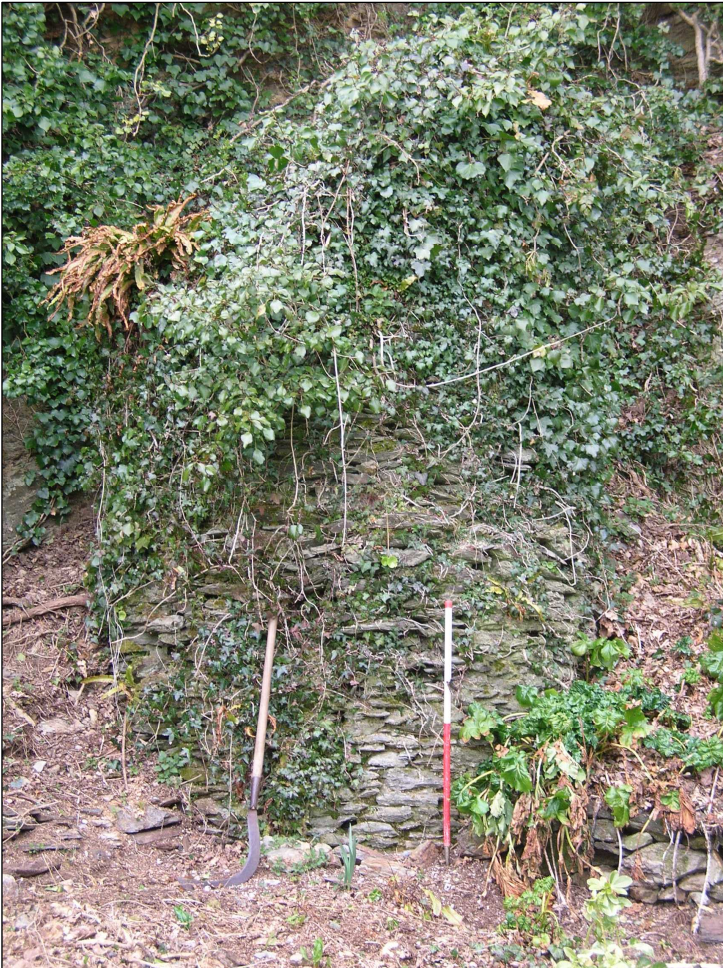
Fig 23 View of the winding engine boiler house chimney before works C Buck 2010© CC HE

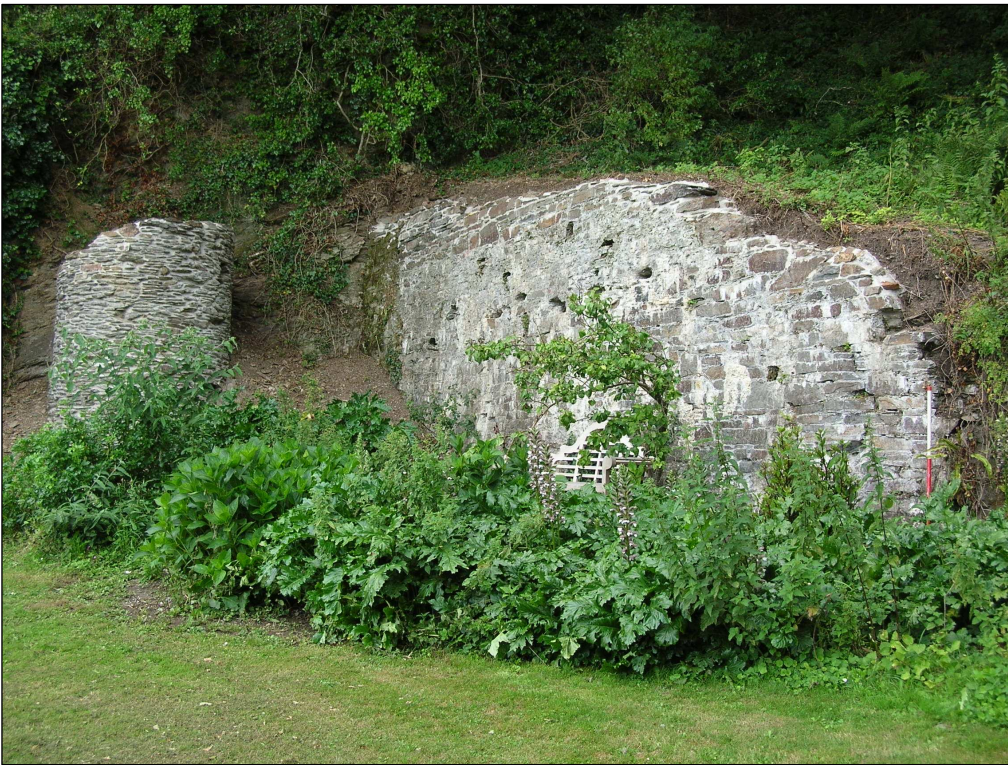
Fig 24 View of the winding engine boiler house chimney/buildings after works C Buck 2010© CC HE
