Trevaney farm buildings, Constantine, Cornwall

Historic Buildings Record

Client	Mr Hamish Mcleod
Report Number	2010R131
Date	October 2010
Status	Final
Report author(s)	Eric Berry
Checked by	Nigel Thomas
Approved by	Peter Rose

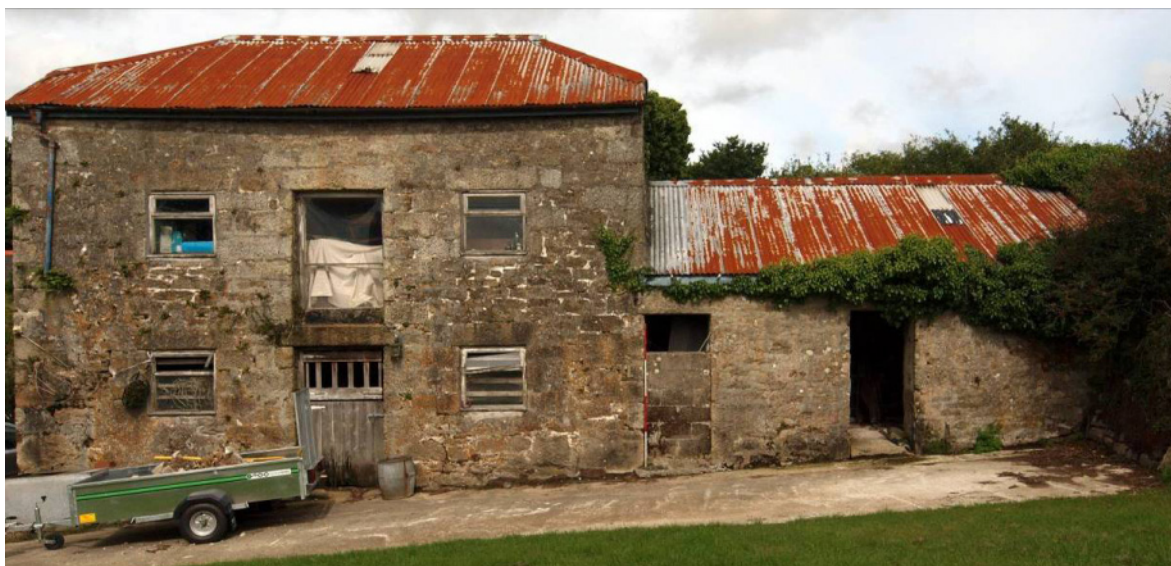
The front (SW) elevation of the barn (Fig 7) is symmetrical, with central doorway below loading/threshing doorway, and flanking window openings to each floor. The doorway contains an old ledged door with ventilation slits.

Fig 7 Barn and attached later shippon (SW front)

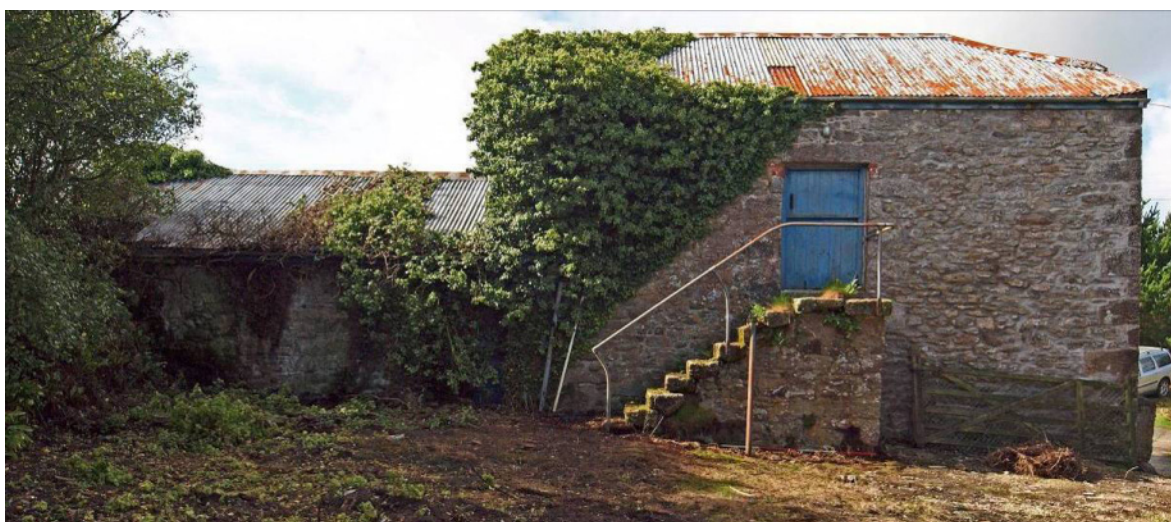
The rear elevation (Fig 8) has a doorway at far right of the shippon, its right-hand jamb added to the east corner of the barn. There is a flight of granite steps at the rear of the barn. The steps lead up from the left to a central loading/threshing doorway. The steps are detached from the barn except for the landing stones that meet the wall of the barn. The loading doorway (Fig 17) has an old, possibly original, split ledged door. Brick blocking above the stone jambs of the doorway is evidence for a former shelter hood that was originally supported on timber corbels. Low down in the rear wall left of the steps is a reused granite head or cill of a former mullioned window, probably originally part of the farmhouse (Fig 16).

Fig 8 Barn and attached shippon (NE rear)

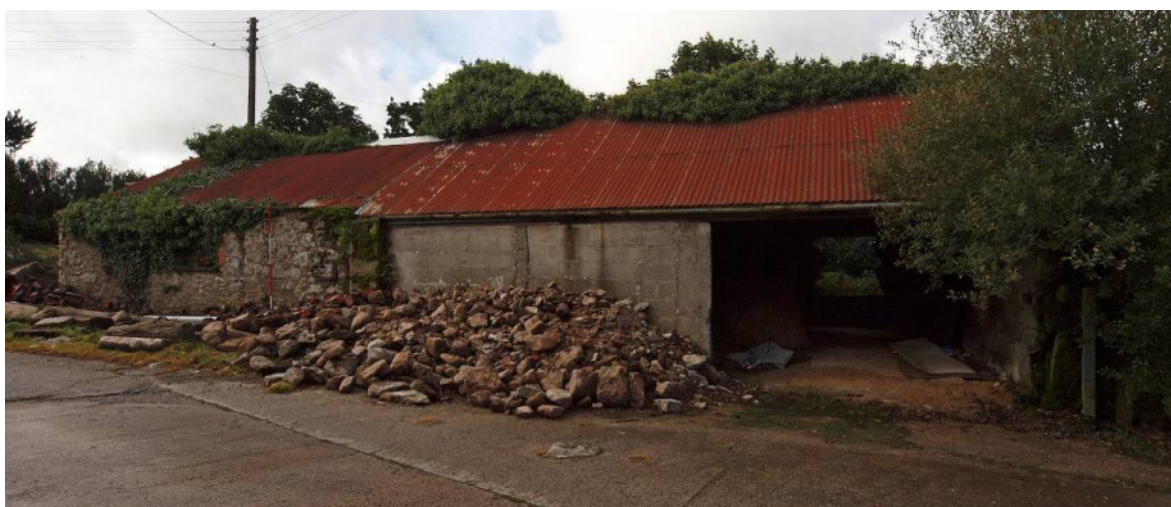
The east elevation (Fig 9) is divided into two distinct halves: the stone side wall of the southern wagon house on the left, and the slightly-projecting open front of the northern wagon house to the right. The part to the left has an approximately central window opening fitted with a modern 8-pane fixed light. The open front to the right is divided into three bays: two narrower bays on the left and a wider bay on the right, the bays divided by granite monolith posts and the narrower bays later in-filled with concrete block-work.

Fig 9 Wagon houses east elevation

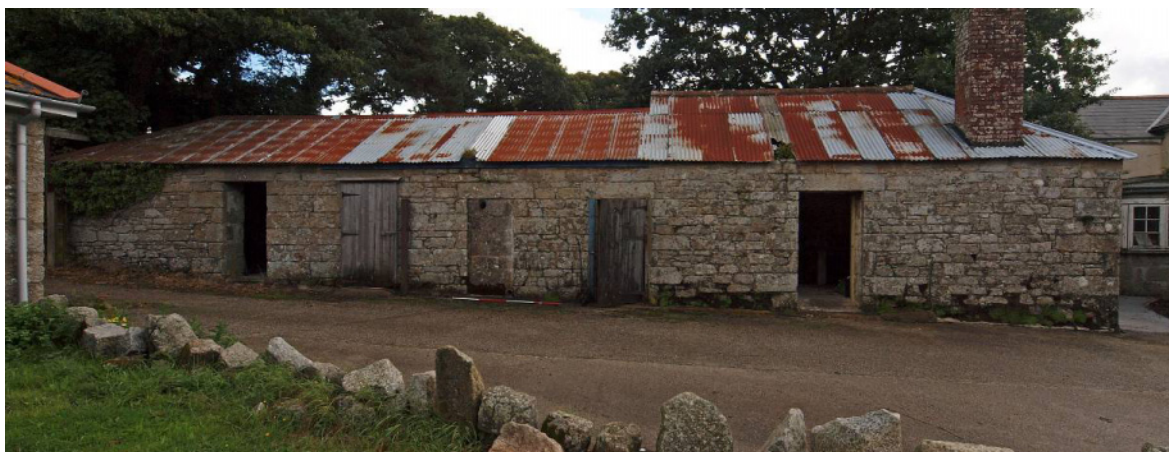
The west (front) elevation (Fig 10) has five doorways. The four doorways of the loose boxes are fairly regularly spaced but the two doorways left of centre have their lintels at a higher level. The wash-house doorway is located towards the left of its front wall. Within the length of walling to the right of the doorway there is a ragged phase joint relating to where some of the upper part of the front wall was rebuilt when an extra flue was added.

Fig 10 Loose boxes and wash-house west front

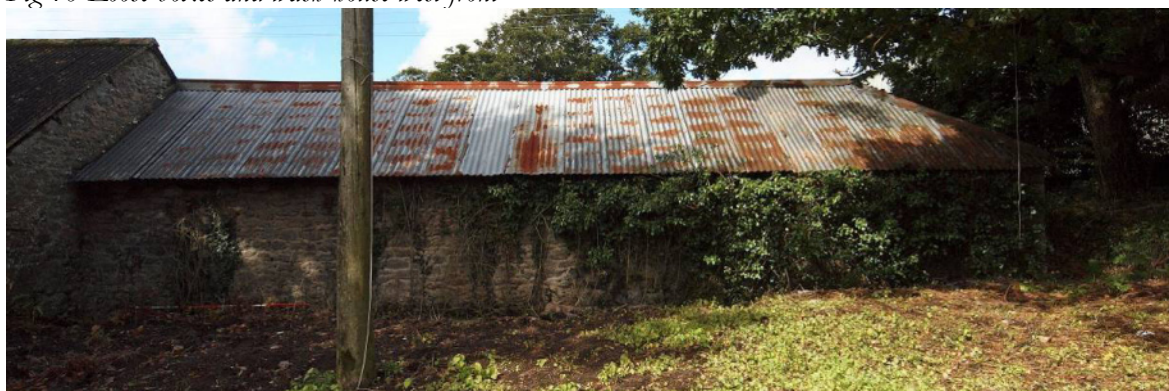
The rear (east) elevation of the wash-house has a window opening towards the left, fitted with an original 6-pane tilt-opening window (Fig 29). The rear elevation of the loose boxes (Fig 11) has no openings.

Fig 11 Loose boxes rear (east) elevation

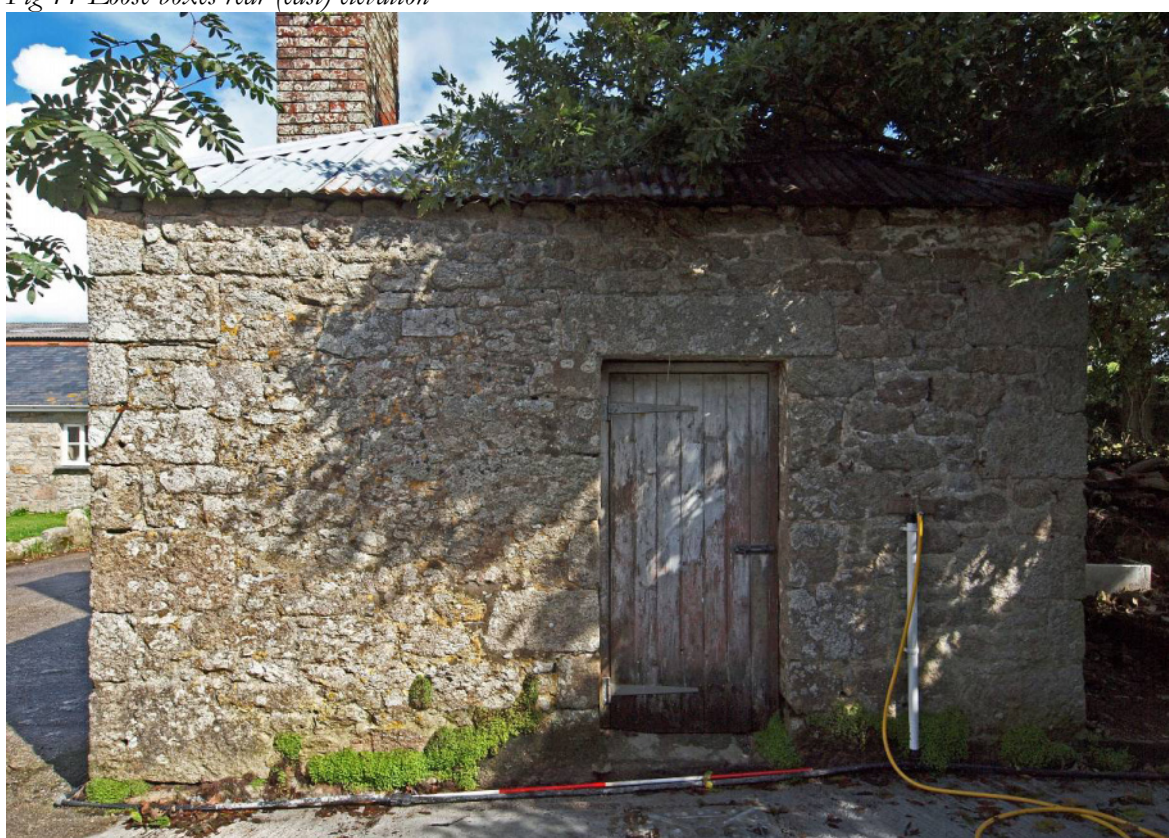
The south elevation of the wash-house includes a granite lintelled doorway, slightly right of centre beneath the hip-ended roof (Fig 12). This doorway provided access to the rear of the farmhouse. The surviving planked door is supported on strap hinges. The north elevation of the loose boxes has no openings.

Fig 12 Wash-house south (end) elevation

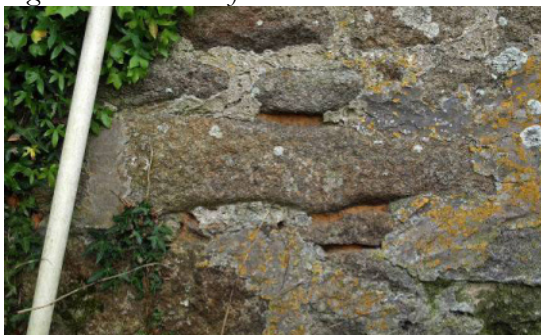
Fig 16 Reused 17th C fragment in rear wall of barn

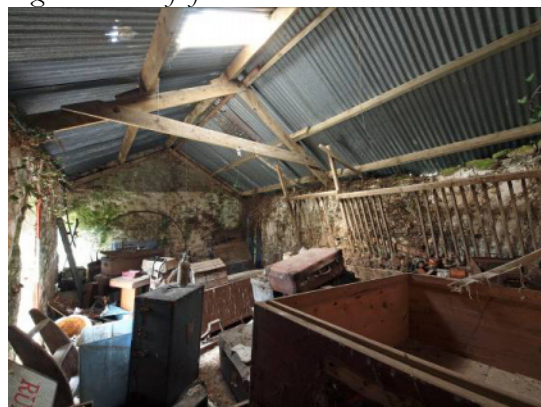
Within the later adjoining shippon (Fig 19) the floor is probably cobbled throughout but was largely obscured by storage at the time of the survey. A wooden hayrack fitted to the rear wall is part of fitting out for later use of the shippon as a loose box. The 2-bay roof structure appears to date from when the present roof covering was added, probably in the mid-late 20th century.

Fig 19 Shippon interior from SSE

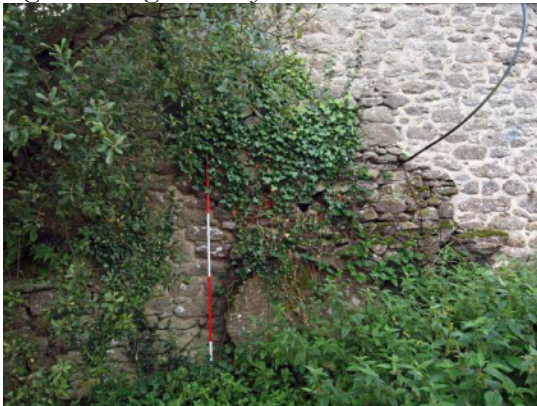
The north elevation (Fig 21) has no openings. The central part of the wall (approximately 2.3 metres in length) projects slightly from the main line of the wall and is very irregular in its construction and includes a projecting stone at far right that may be evidence that this length of wall is the remains of a chimney breast with fireplace on its north side relating to a former building, possibly a small house, demolished between c1880 and c1907.

Fig 21 N wagon house, N wall

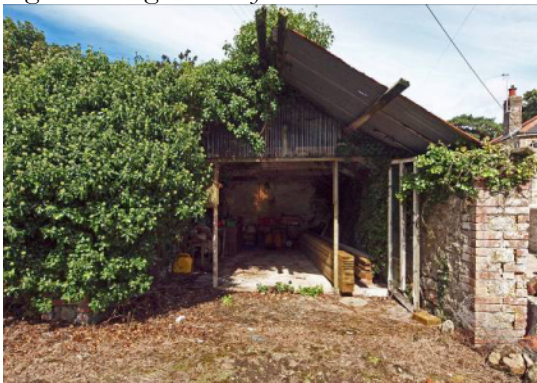
The south elevation (Fig 23) is completely open and flanked by the brick combined jambs/quoins of the ends of the side walls.

Fig 23 S wagon house from south

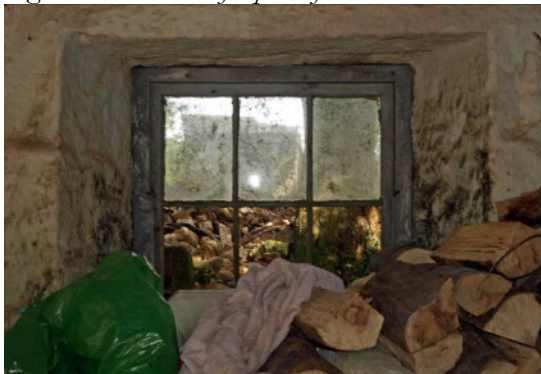
Fig 29 Wash-house window from west

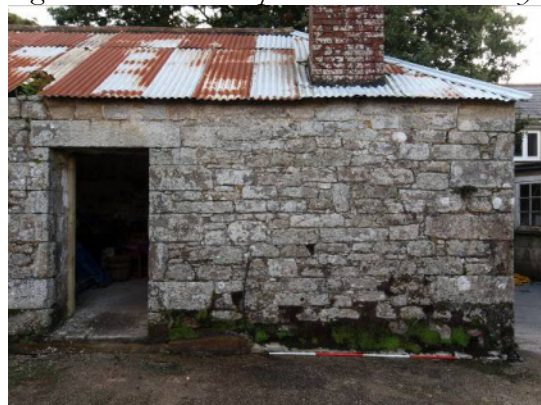
*Fig 33 Wash-house chimney wall
Note an area of rebuilt walling Phase joint
beneath the chimney relating to insertion of extra
flue*

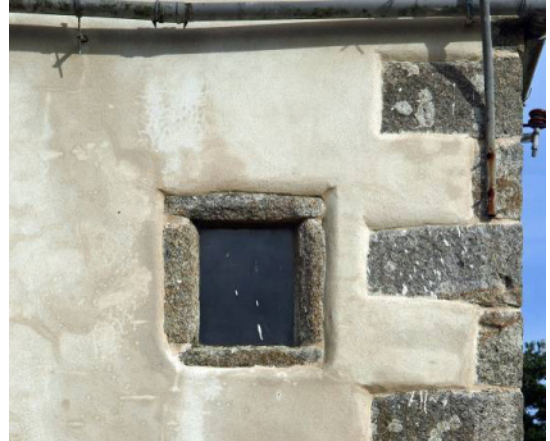
The barn and wagon houses are shown on the 1841 Tithe Map (Fig 2). The 2-phase wash-house and loose-box building is first shown on the 1880 OS map (Fig 3). The farmhouse contains 17th century features including a chamfered granite window (Fig 38) and chamfered plinth masonry *in situ*. It is possible that parts of the wagon houses are 18th century in origin. The barn probably dates from the early 19th century and its shippon extension was built by 1841. The wash-house is probably mid 19th century and the four loose boxes to its north were added in the mid-late 19th century.

Fig 38 17th C window in W end of farmhouse
