Wreck of the Barque *Antoinette* Camel Estuary, Padstow, Cornwall

Undesignated Site Assessment and Emergency Recording

Client	English Heritage
Report Number	2010R101
Date	14/03/2011
Status	Final
Report author(s)	Charles Johns, Kevin Camidge and Peter Northover
Checked by	Peter Rose
Approved by	Helen Keeley

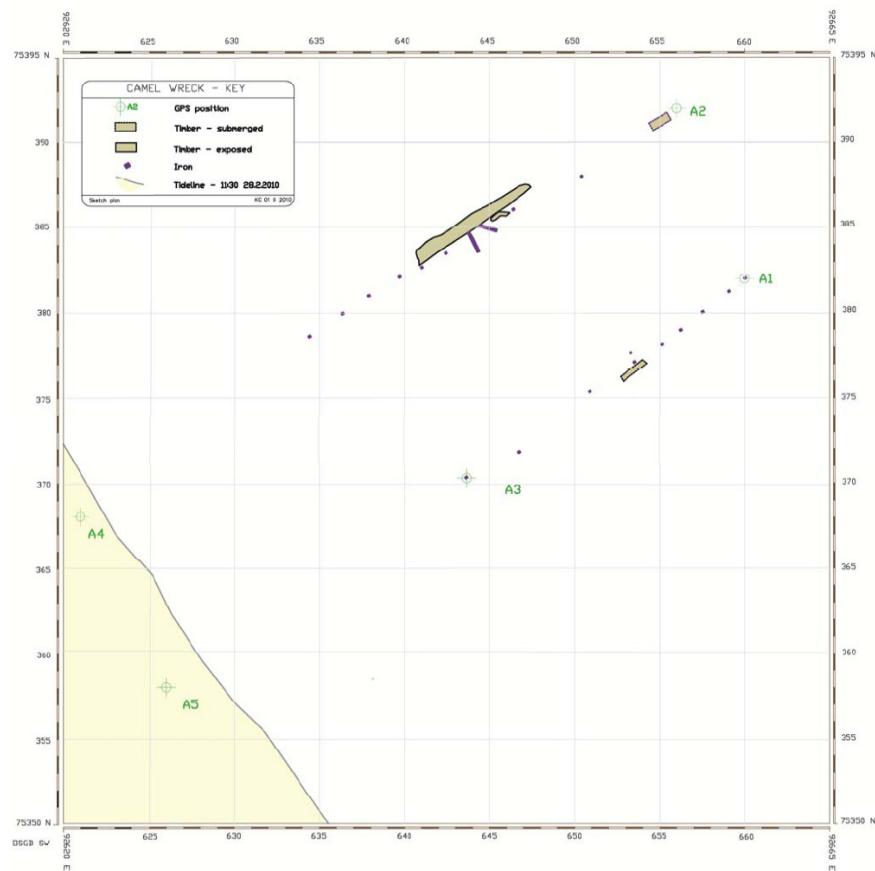
Fig 3 Sketch plan of the exposed remains as visible at 11:30am on 28 February 2010. The plan was produced from a rectified overhead digital photograph and the five temporary control points fixed by GPS positions

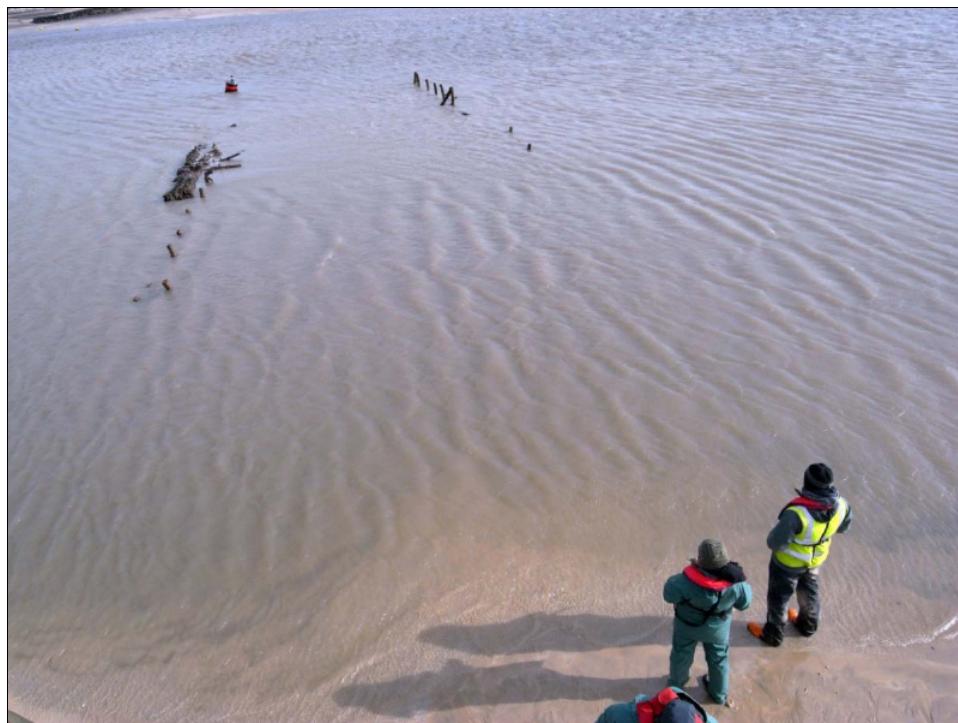
Fig 4 The exposed wreckage at low tide (11.33) on 28 February 2010. Taken with a camera attached to a 5m Sopwith staff (photo: Kevin Camidge)

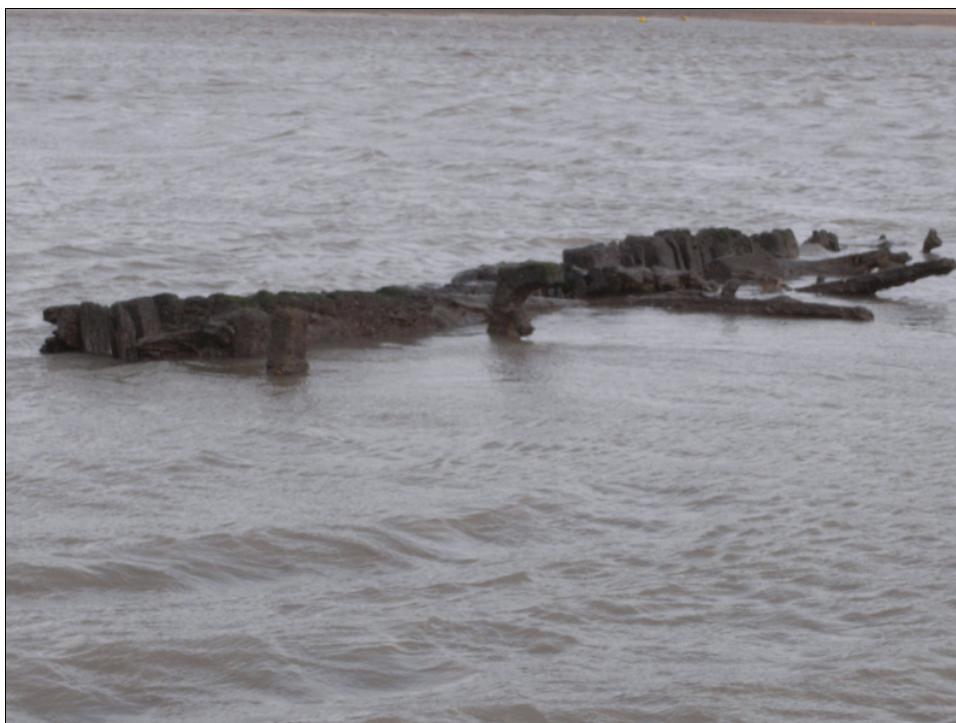
Fig 6 Detail looking north-east showing the exposed timber, note the iron knees in the background (photo: Kevin Camidge)

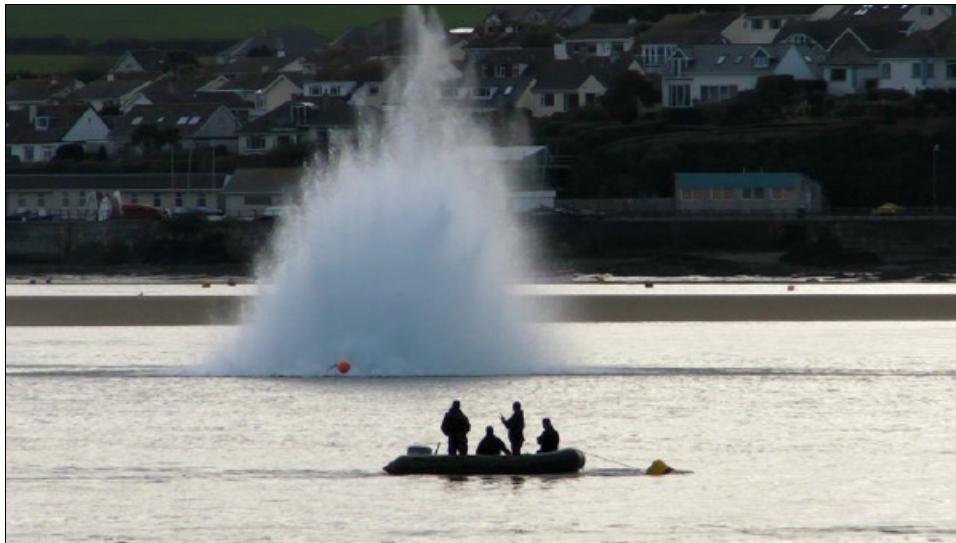
The wreck was broken up with explosives by the Royal Navy bomb disposal team from Plymouth on the 1 and 2 March (Fig 7). Apparently this was not as successful as anticipated and further work to break up the wreck has been scheduled for the next extreme spring tides in September 2010.

Fig 7 Using explosives to break up the wreck (photo: Kevin Camidge)

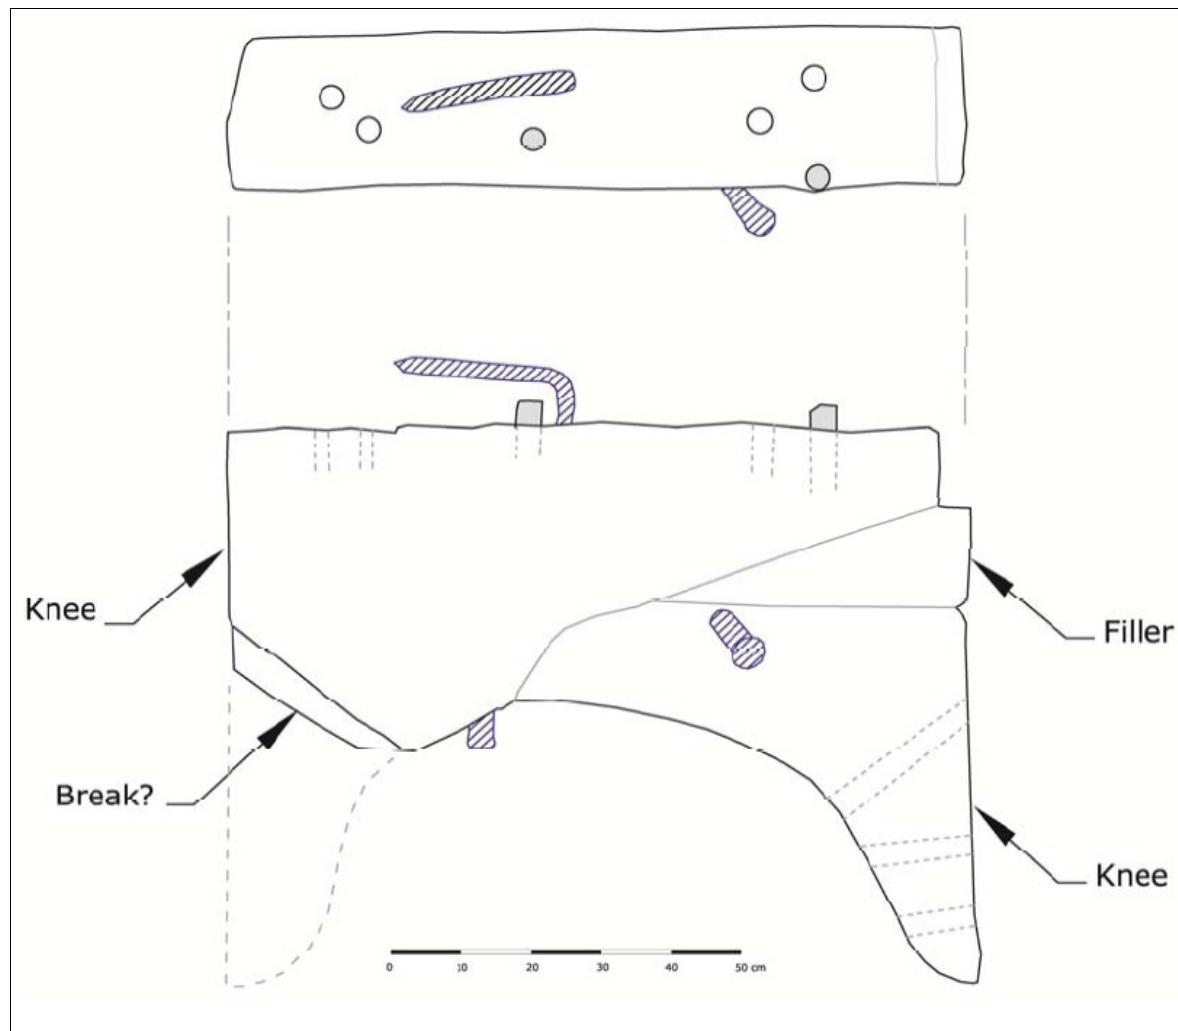
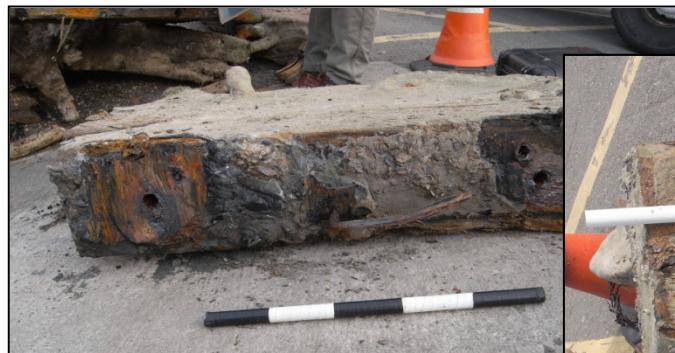
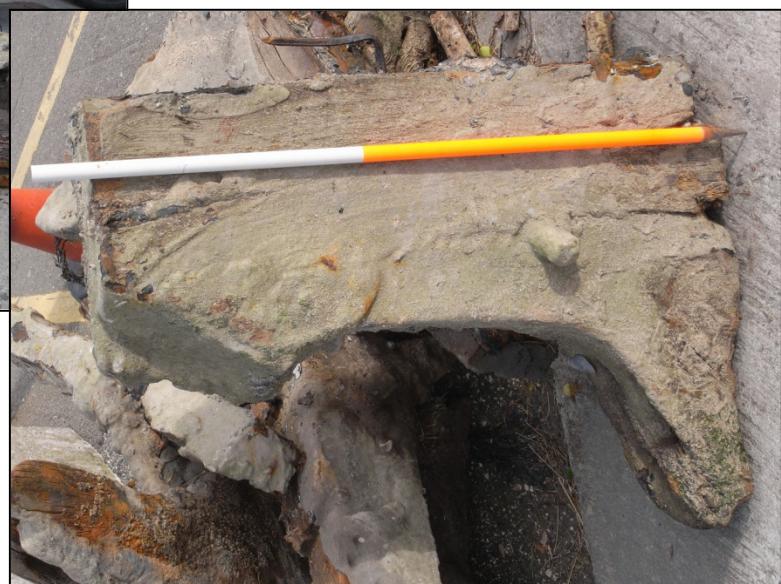
Fig 11 CE1 Timber lodging knees from the Camel Estuary wreck

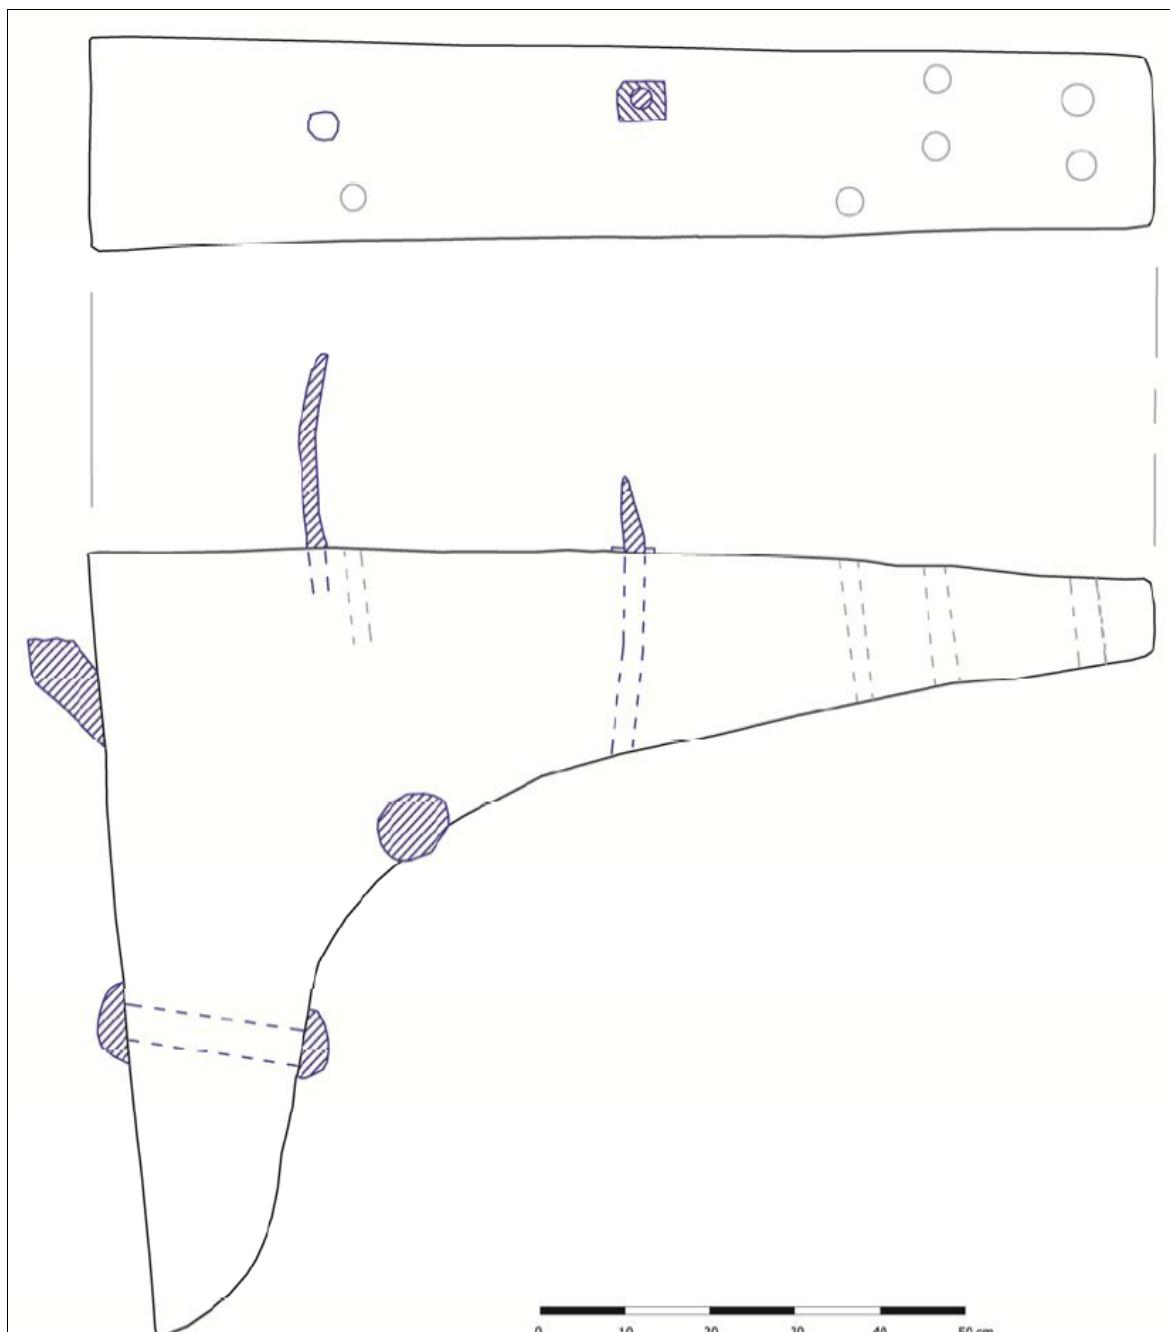
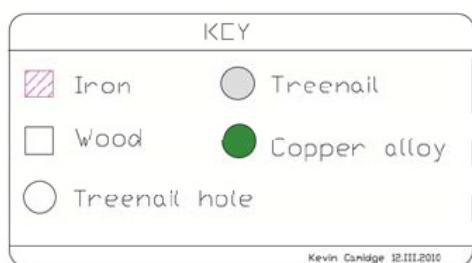
Fig 12 CE3 Timber lodging knee

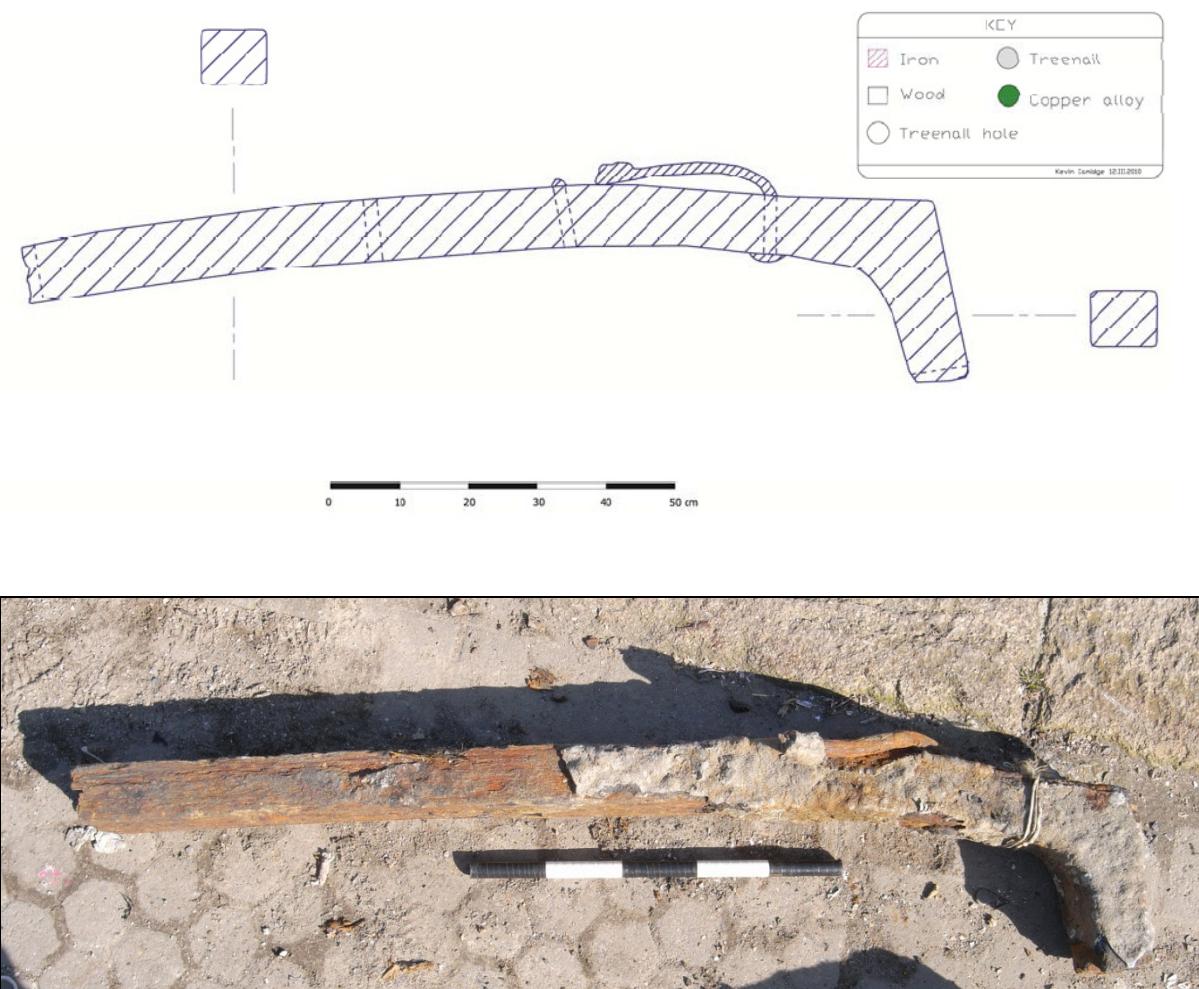
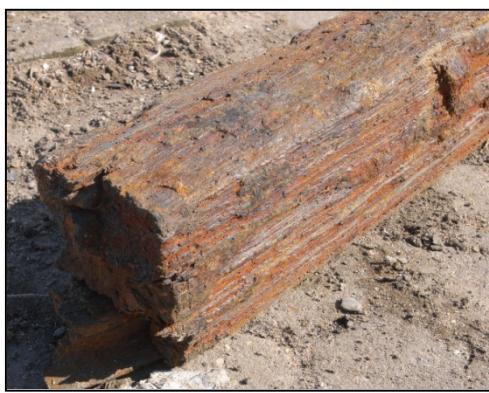
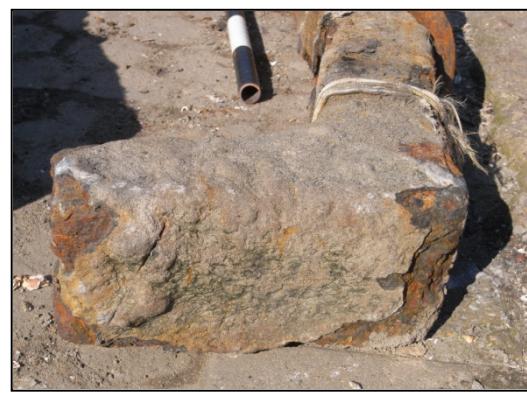
Fig 13 CE4, a wrought iron knee: note the bolt holes and the surviving iron bolt

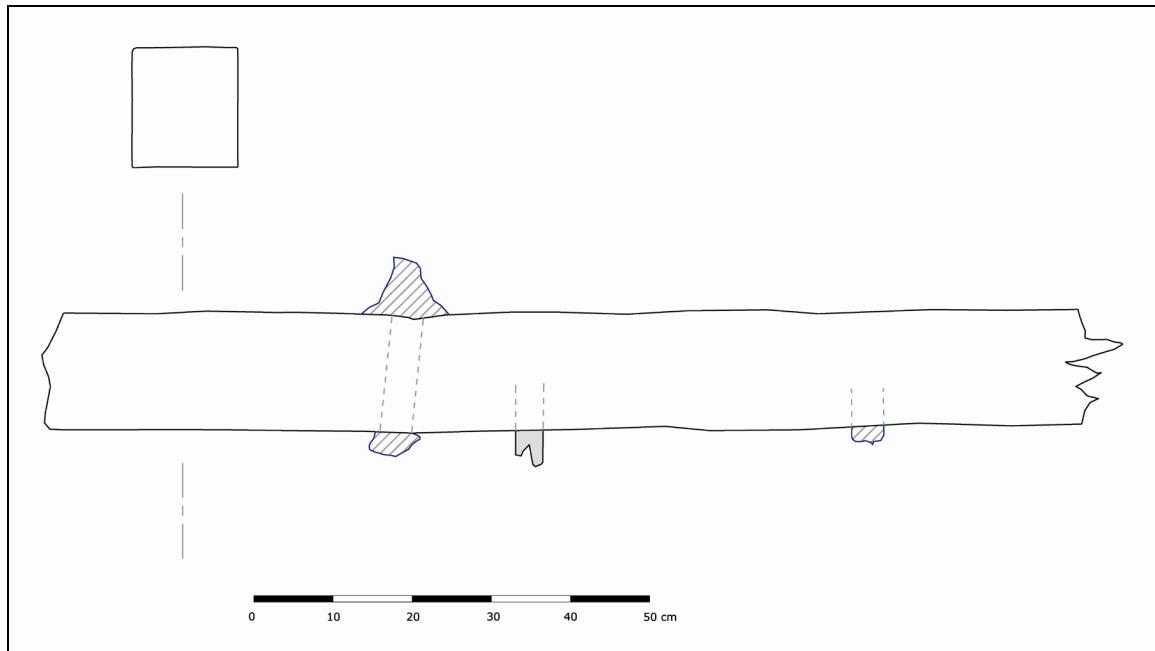
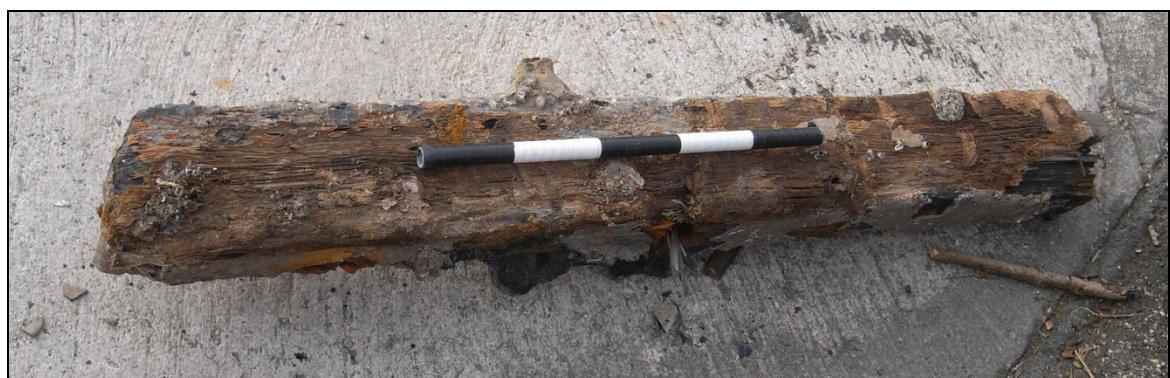
Fig 14 CE2 a beam with iron bolts and treenail fastenings

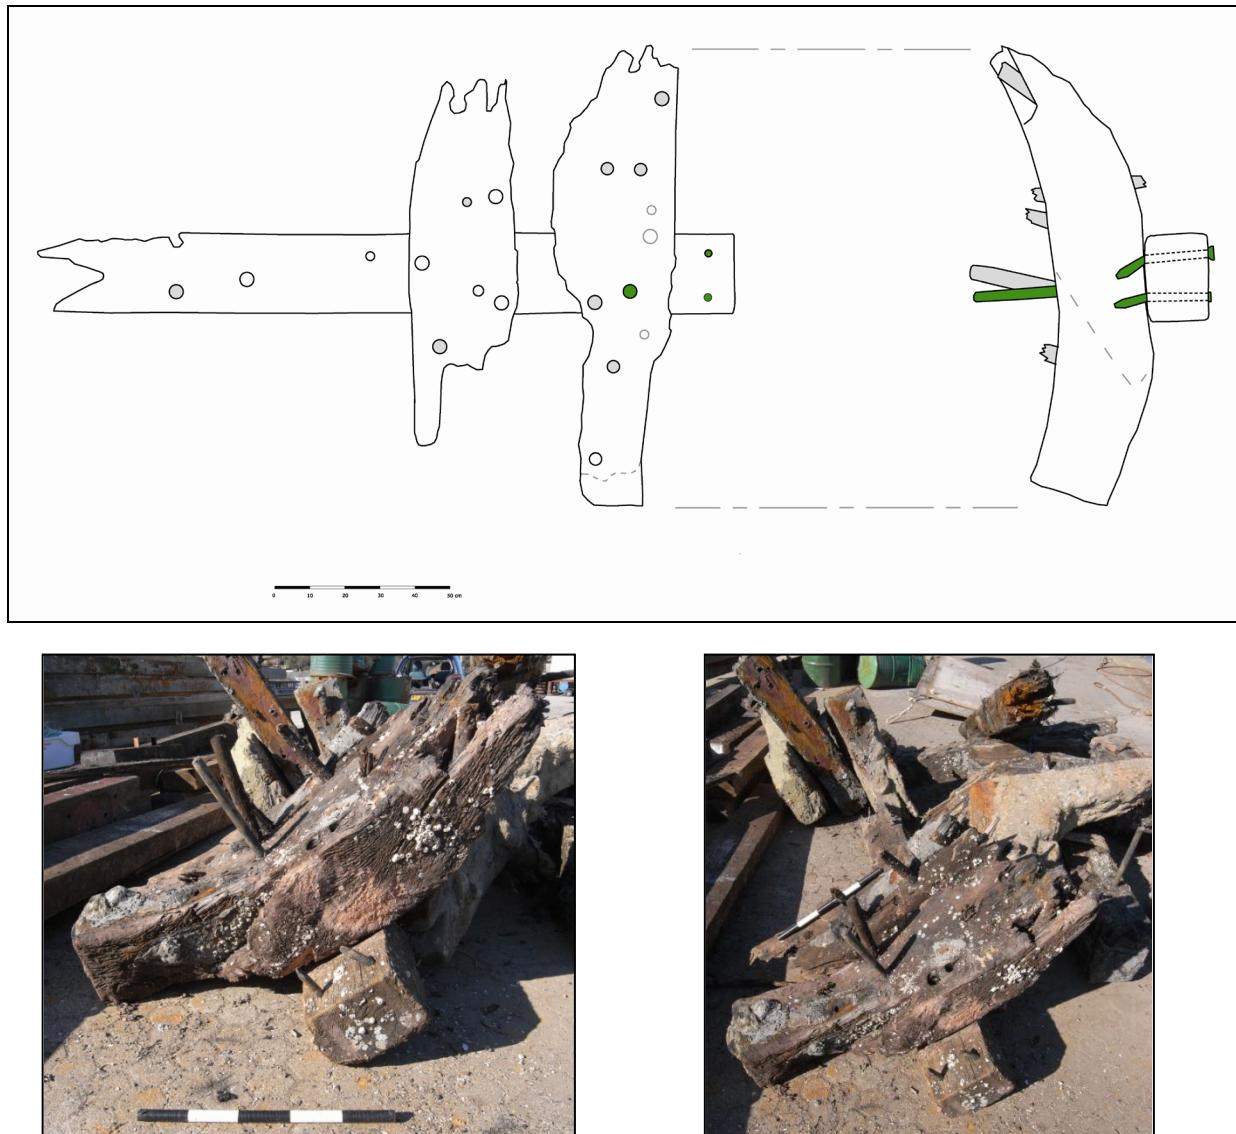
Four fragments of frame timbers were recovered. Two of these (CE5, Fig 15) were still attached to a longitudinal piece of timber, probably an outer hull plank or wale. Of particular interest are the copper fastenings present as these indicate that the vessel was copper-sheathed. Copper hull fastenings were only used below the waterline when copper sheathing was used on the outside of the hull. This is because the traditional iron fastenings, which are stronger and cheaper, corrode very quickly due to electrolysis if the hull is copper-sheathed. Even where copper sheathing is used, iron fastenings will be employed above the waterline (Lavery 1987) - as seen in CE1 and CE3.

Fig 15 CE5 Two frame fragments and attached plank; includes copper fastenings and treenails. Note the two 'wedged' copper spikes (also called dumps) in the end of the plank – these were common in the 19th century

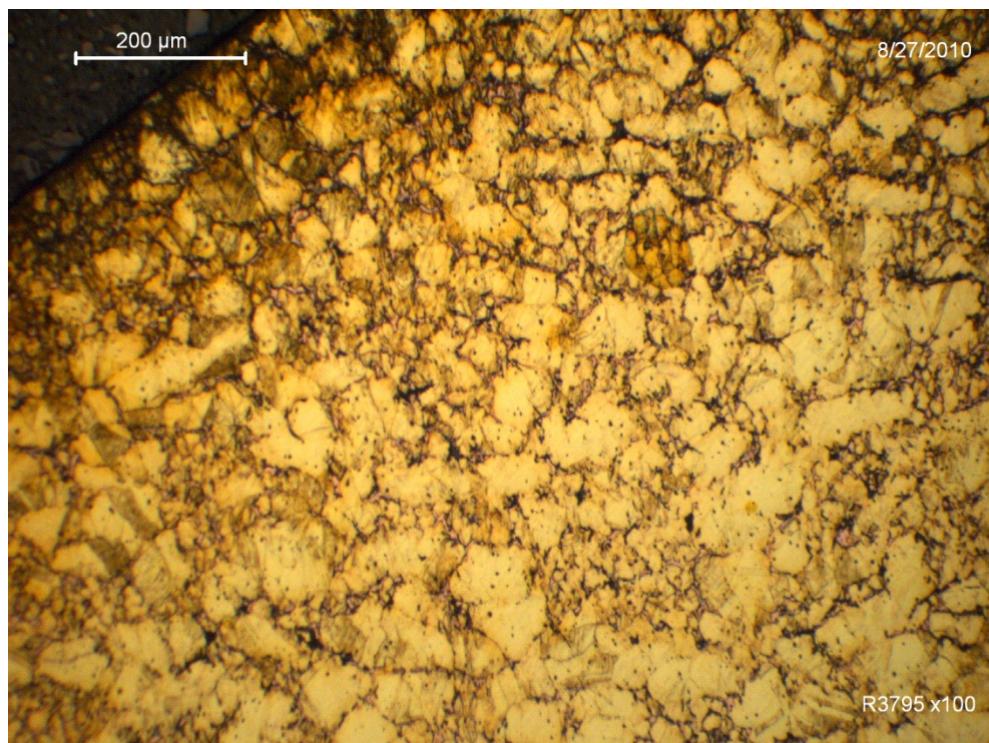
Figures 20 and 21 show that the bolt has a fully recrystallised equiaxed grain structure with annealing twins but little visible cold work. An originally ab cast brass structure has become partially homogenised during hot rolling, and the remaining b phase has been penetrated by corrosion in the form of de-zincification. This appearance is also shown by the bolts from the *Flowers of Ugie*, although there the extent of dezincification is greater: there is a suggestion in the literature that dezincification proceeds more rapidly under anaerobic conditions and is accelerated by high chloride contents, and high temperatures (McCarthy 2001, 140-10. Dark particles are small oxide and lead inclusions.

The bolt is made from a yellow brass, implying a date no earlier than 1832, and almost certainly later than 1840. Comparison with other brass analyses suggests the date could well be other c 1860. The microstructure is also typical for the period, and shows the dezincification of the b phase in an ab brass.

Fig 20 Brass bolt sample #R3795, etched

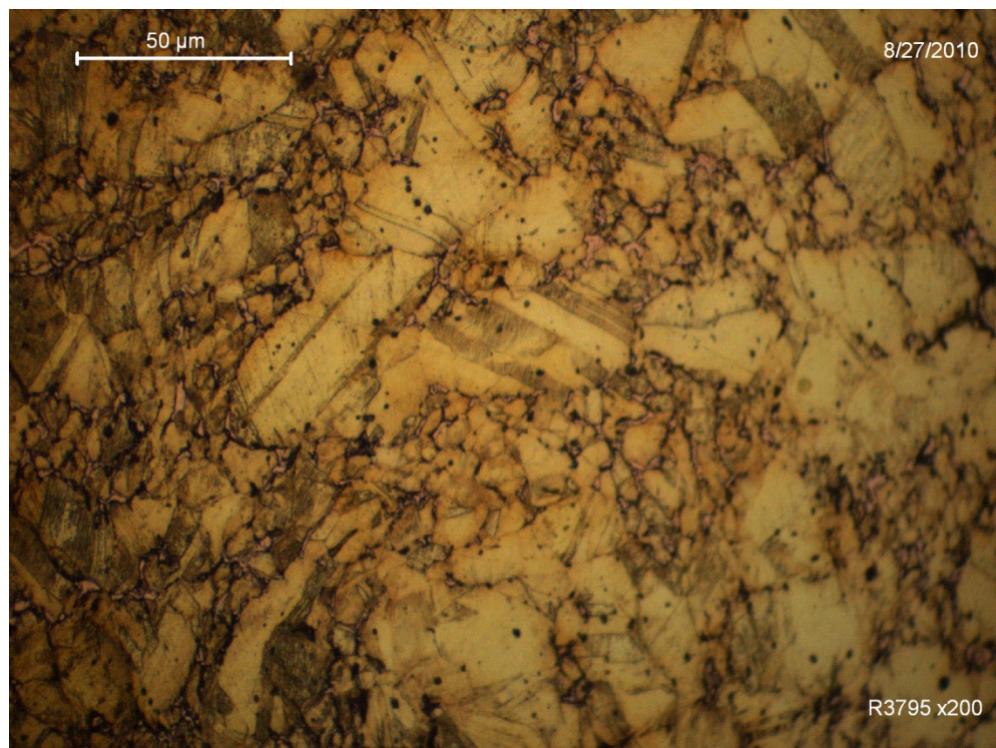
Fig 21 Brass bolt sample #R3795 etched
