# Shell seat at Gyllyngdune Gardens, Falmouth, Cornwall

## Historic building record

2011R003

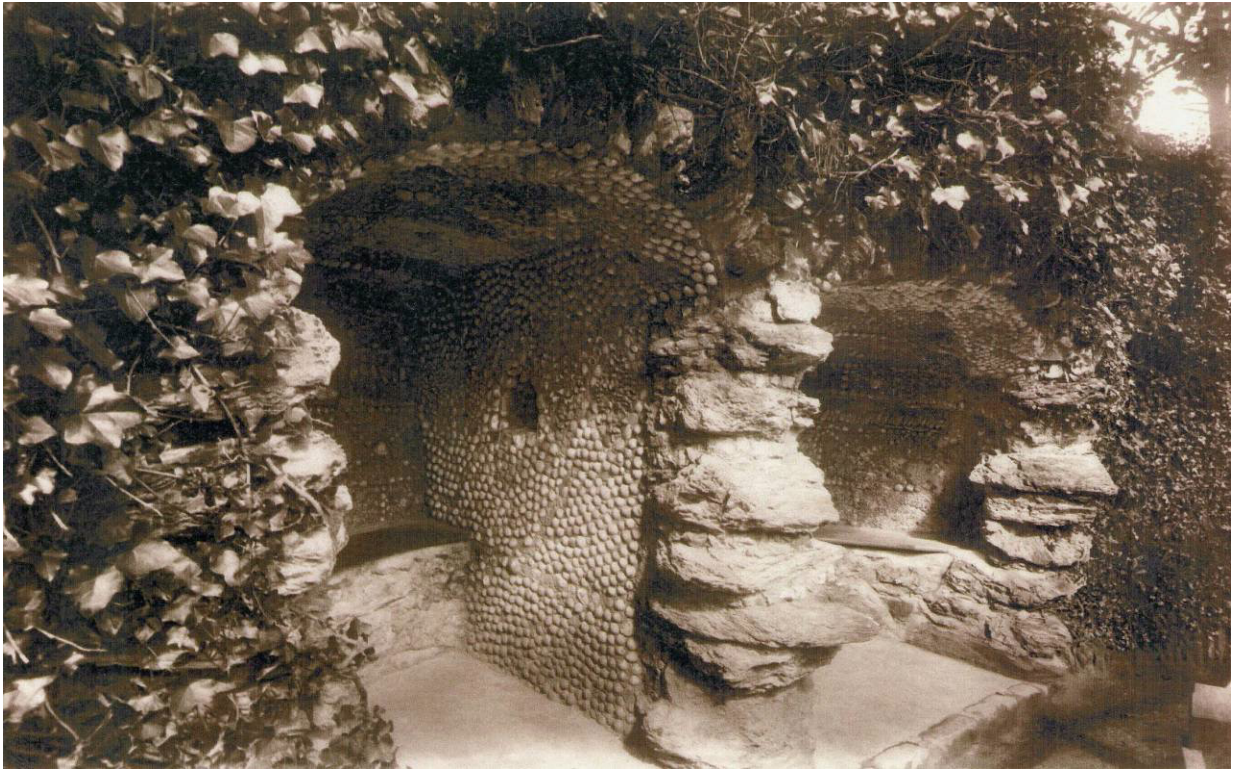
Fig 5: Francis Frith postcard of shell seat, photograph taken in 1908

The shell seat in Gyllyngdune Gardens (located at NGR SW 81266 31888) is first recorded in a photograph taken in 1908 (Fig 5). It is not a large enough structure to be shown on any of the historic maps, but is likely to have been constructed at some point during the early to mid 19<sup>th</sup> century. It comprises a semi-circular open fronted room space (now divided in two) cut into an earth bank overlooking the quarry garden and sea beyond. The fieldwork has revealed that the structure contains at least four separate construction and alteration phases.

At some point before 1908 (see Fig 5) an internal dividing wall was inserted, presumably to add stability to the wide single span vaulted ceiling. This is a slate rubble-built wall rendered with lime mortar and decorated with shells. It contains a small pointed arch opening in its upper half. The shell decoration on this inserted wall is very different from that on the original structure. It comprises friezes of diamond and triangular shaped panels rather than rectangular or square panels. The materials used in these decorative panels include the following:

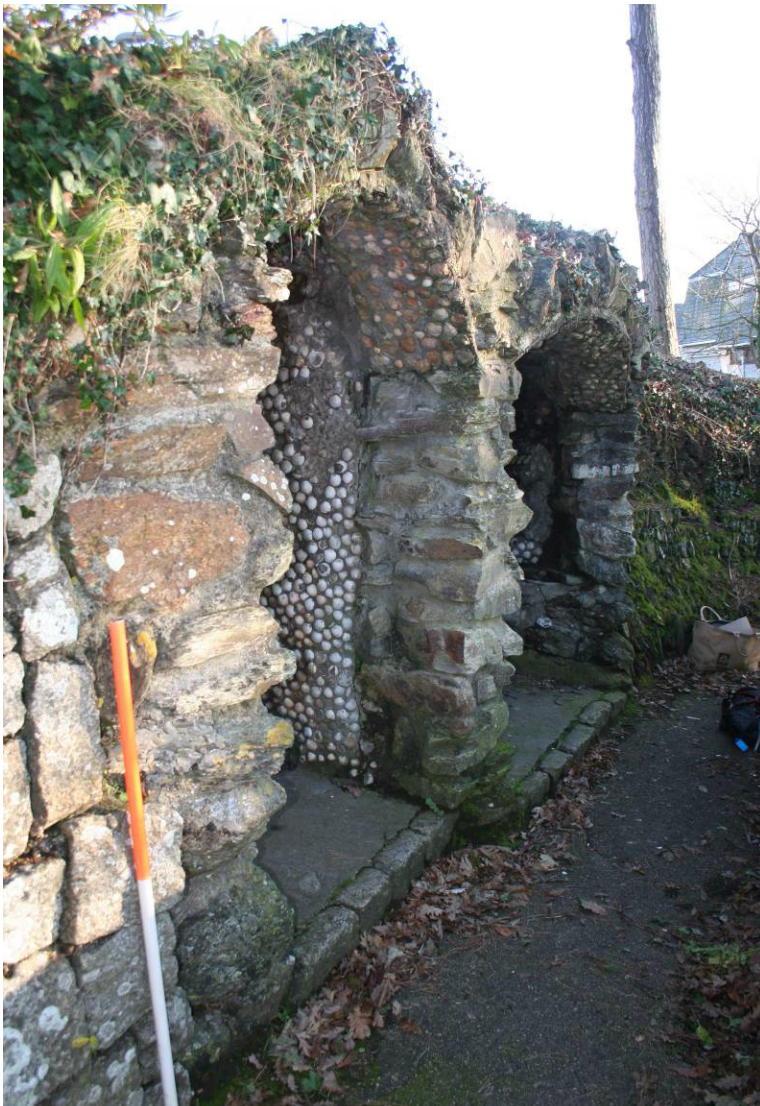
Fig 6: Present view of the front elevation looking north-east

The original structure included the reinforced roof that exists today and double arched opening with supporting pillar to the front (although this was rebuilt in the 20<sup>th</sup> century, compare Figs 5 and 6). It also included the slate rubble-built seat. Much of the original shell decoration survives in the form of rectangular and square panels with internal decoration outlined with rows of limpets particularly on the rear wall. Some of the original panels are also visible on the ceiling although more extensive (phase 4) repair work here has hidden most of the original decoration. The materials used in the original decorative panels include the following:

At some point after 1908 the jambs of the front openings along with the central support pillar were rebuilt using smaller slate rubble bonded with a cement mortar (compare Figs 5 and 6). It is unclear whether or not the two arches were also rebuilt at this date, but the shells on the inner faces of the arches have clearly been replaced after 1908. The stone structure of the seat was also either rebuilt or repointed with a cement mortar during this phase and a new timber top inserted.

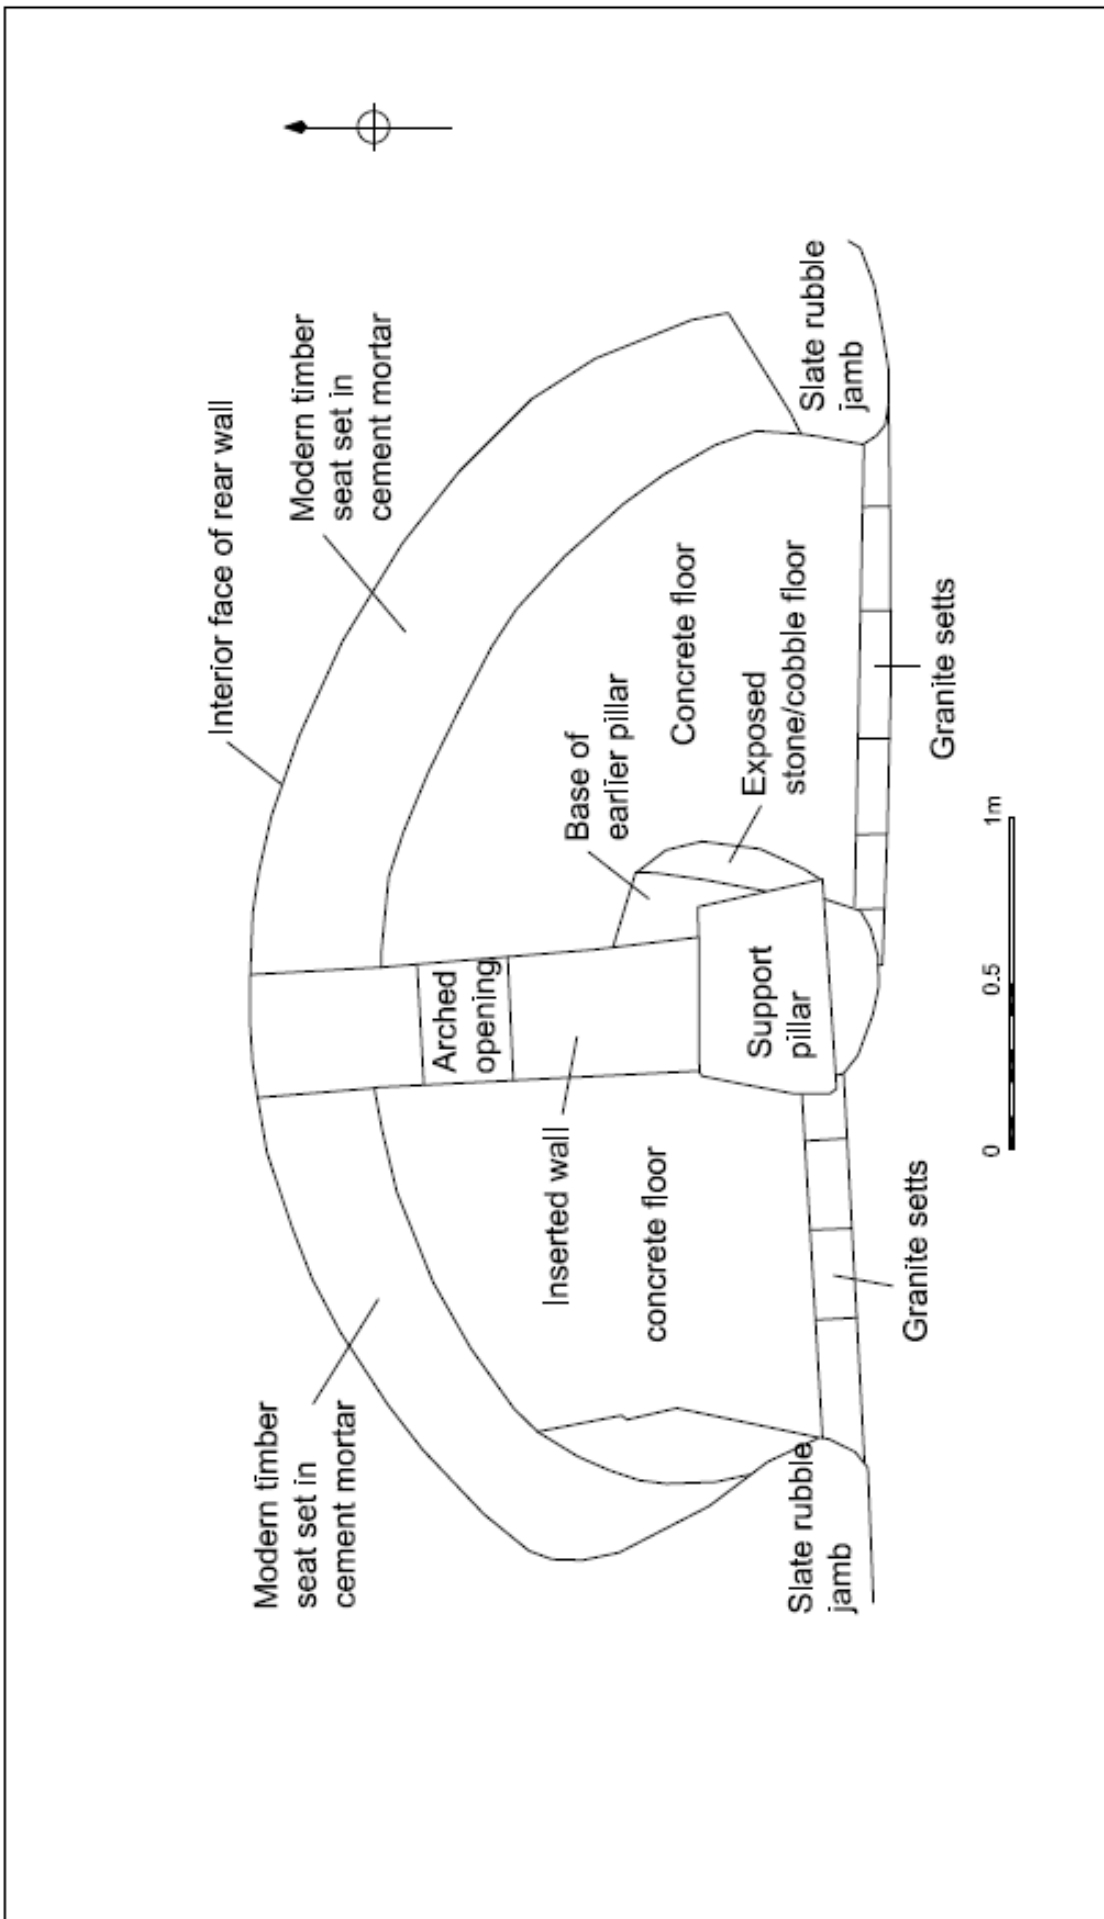
Fig 19: Plan of shell seat  
(scale 1:20 at A4)

The structure is located on the northern side of the upper path of the quarry garden facing the sea. It comprises an open-fronted, roughly semi-circular chamber, hollowed out of a south-facing bank and roofed over with an off-central pillar supporting both the roof and two arched openings at the front. A dividing wall containing a small pointed arch opening has been added at a later date and splits the original room space into two. The seat structure is an integral part of the curving rear retaining wall. It is constructed from slate rubble with occasional quartz and granite, and has a timber planked top. The walls, vaulted ceiling, pillar and jambs are all constructed from slate (killas) rubble originally bonded with lime mortar although some rebuilt areas are now bonded with cement mortar. The roof and top of the rear wall are reinforced with a basket framework of iron straps concealed immediately below the internal lime mortar render. The decoration comprises shells, stone chips, pebbles, coral and slag all pressed into the lime render.
