Hallgarden Farm outbuildings, Otterham, Cornwall

Historic building record

Client	Mr and Mrs D Thompson
Report Number	2011R024
Date	February 2011
Status	Draft/2nd draft/Final
Report author(s)	Eric Berry
Contributions from	Jo Sturgess and Nigel Thomas
Checked by	
Approved by

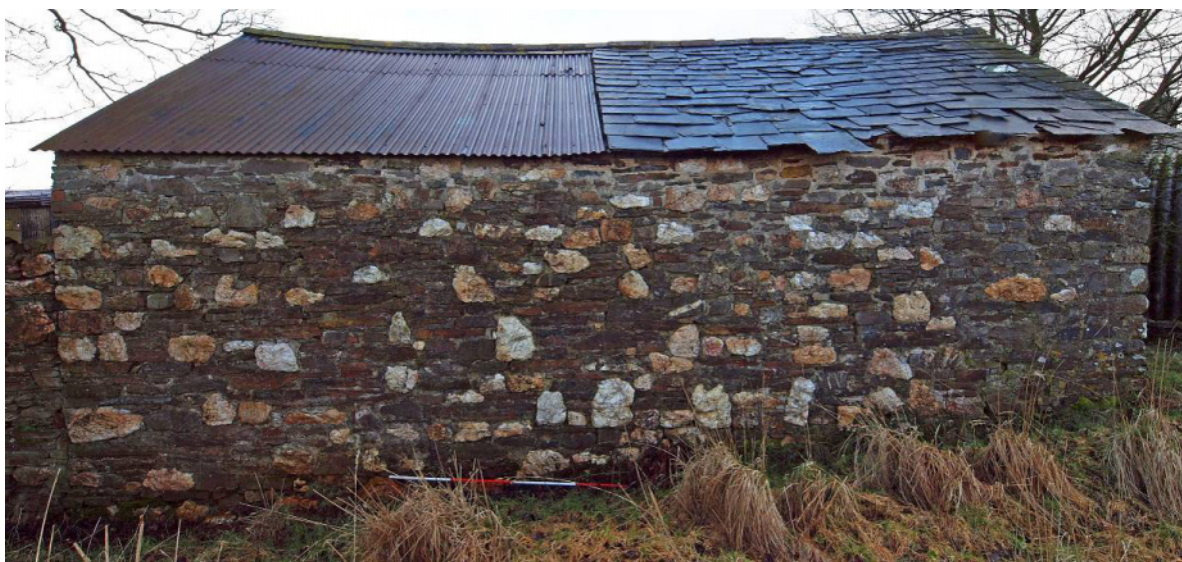
Fig 10 Building 1: rear (west) elevation (right-hand end and eaves walling rebuilt)

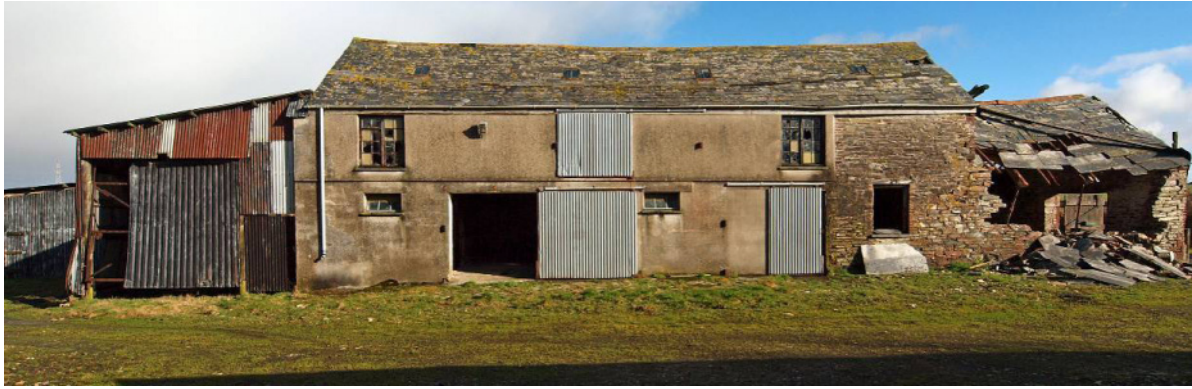
Fig 12 Building 2 (shippon with loft above and cartshed/feed store): front elevation

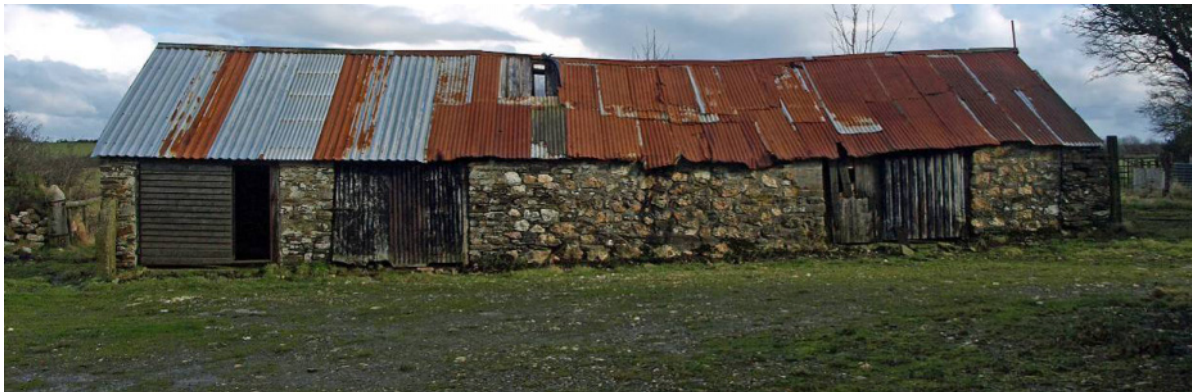
The front (west) elevation (Figures 13 and 71) has a pair of wide doorways to the left, fronting the mid 19th century extension. Stonework associated with this extension is well-built rubble masonry. This is in stark contrast to the irregular pre-1840 masonry of the original frontage to the right. The original wide doorway has been repaired to its jambs with slatestone used for the repairs, plus a small patch of concrete block to the upper part of the left-hand jamb. Also, within the original wall-face, both externally and internally, there is evidence for some re-facing, plus repairs at either end of the main wall length.

Fig 13 Building 3: cart-sheds and shippon, built in at least 2 principal phases

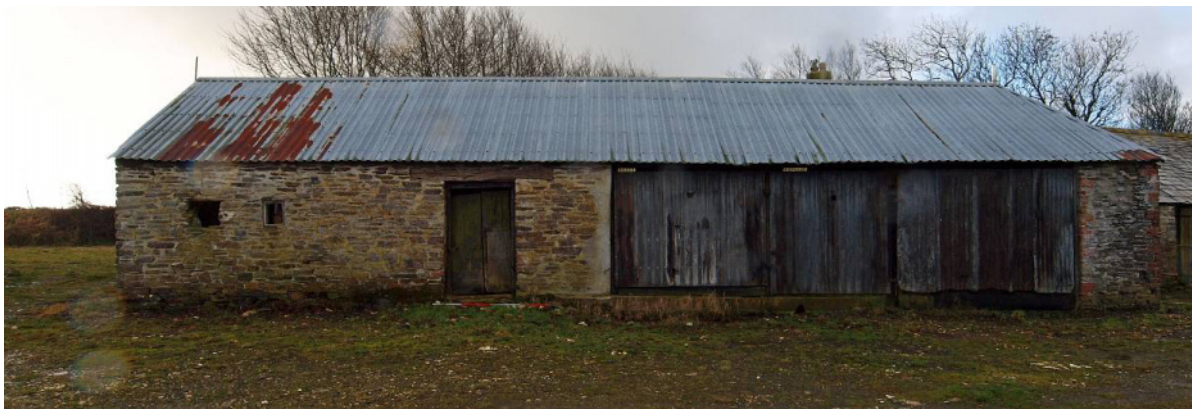
Fig 14 Building 4: shippon, built in 2 phases

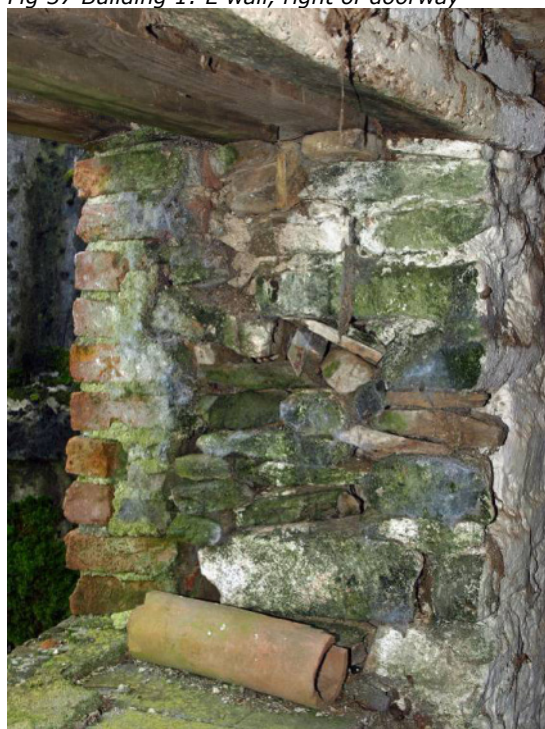
Fig 38 Building 1: east wall, S window jamb rebuilt

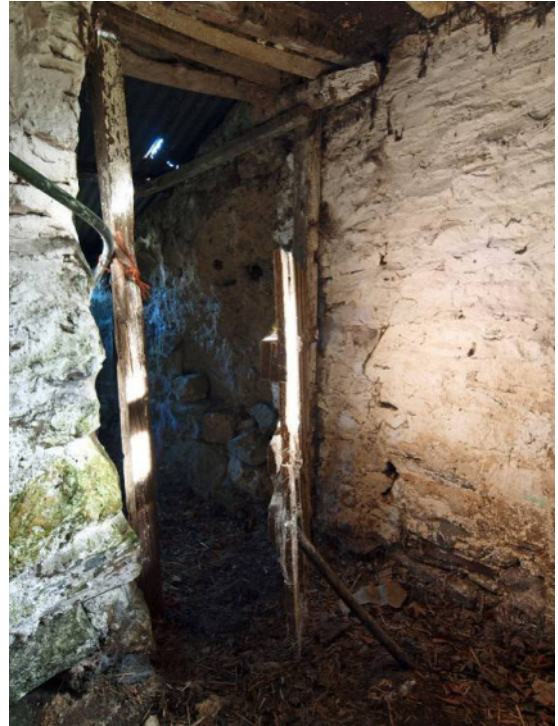
At ground-floor level the internal wall surfaces of the original building are mostly lime-washed over stone rubble construction. The loft has exposed rubble walling with generous lime pointing. The floor is cobbled to drain downwards from the rear and front walls to a linear surface drain aligned with the rear of the standings. The flooring addresses the rear wall at below foundation level, evidence that the floor has been lowered from its original position. The original ceiling construction (Figures 19-22, 24-32, 32-37 and 39) is the most interesting surviving historic fabric within the building. It is strong evidence for the building having been constructed as a domestic dwelling, presumably a small farmhouse. Seven original ceiling joists (at approx. 0.7 m apart) are chamfered and have run-out stops near their ends. Most of the floorboards are also original. The ceiling generally slopes down from the rear, a probable consequence of former structural failure of the front wall before rebuilding. At far right, corresponding to the north standing, the greater amount of displacement downwards towards the front of the building gives the impression that this area of flooring was constructed at a lower level. Blocked timber sockets (Figures 34-36) in the rear wall relating to the north standing, slightly below original floor level, possibly relate to a former landing level (see plan description) or possibly they may relate to former machinery. Towards the left in the south wall (Figure 23) is a probably blocked ventilator opening. There is one partly enclosed standing (Figure 25), in front of, and to the right of the doorway. Left of this, two open standings are separated by a vertical tethering post (Figure 24). A further post has been added right of the tethering post, probably as a floor support. There is a further standing at far right (Figure 26). A chamfered and stopped timber lintel (Figure 33) over the front doorway is a probable 19th century feature. Its right-hand (south) end is carried on a timber corbel. At the north end of the original building a doorway has been cut through at far right to access the later lean-to. Evidence in the masonry of the walling to either side of the doorway (Figures 43, 47 and 48) is consistent with making good after the cutting-through.

Fig 43 Building 1: NE corner, inserted doorway

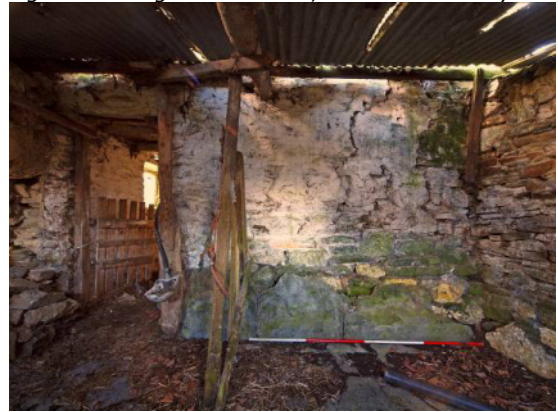
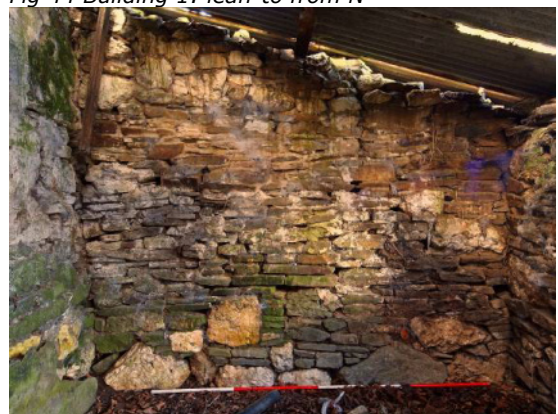
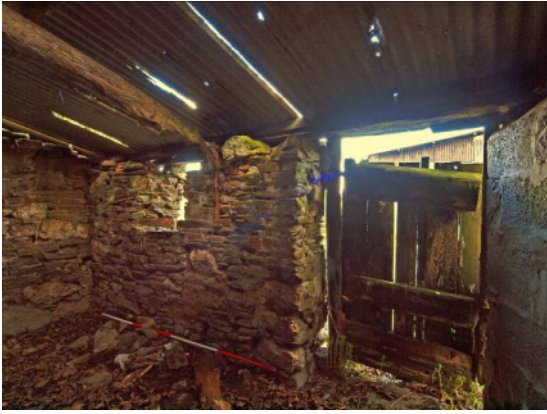
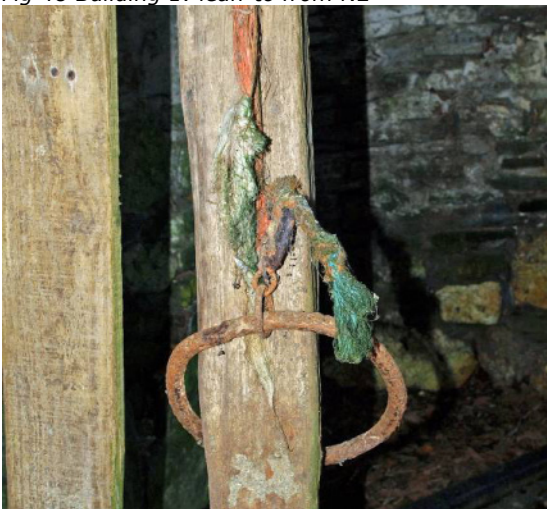
The interior of the lean-to (Figures 44-49) is lime-washed only to its south wall, the original external north wall of the probable house. The other walls are lime-pointed on stone rubble, except for the east wall that is built of cob on a stone rubble plinth. The inner face of the cob has been much eroded, probably through animal rubbing, and some rubble stonework has been added to protect the lower part of the wall and at far left there has been later repair using concrete blocks as re-facing. Some irregular vertical slate against the south wall was added to form the back of a feeder, the floor of the feeder, part of the original slate floor formed from irregular slate slabs. There is a tethering post with tethering ring right of the doorway that leads to the original building.

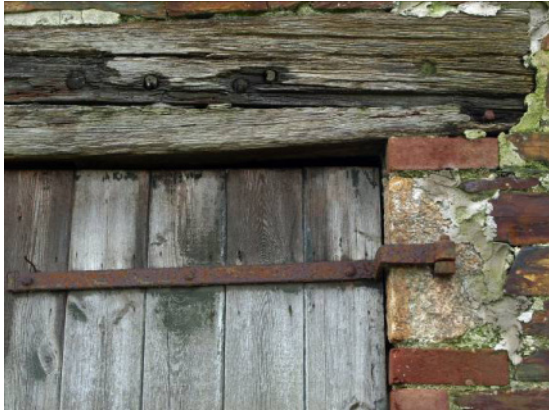
Fig 54 Building 2: E doorway (ship's timber)

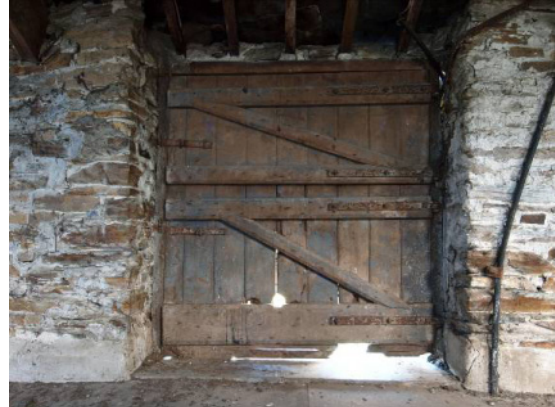
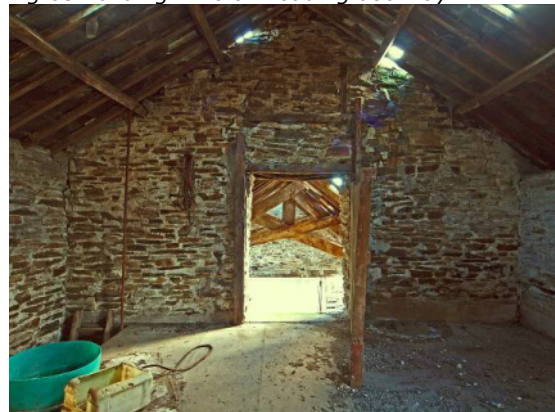
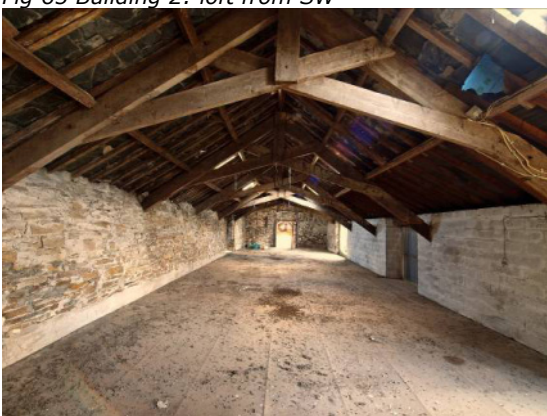
The loft (Figures 65-69) has walls that are exposed rubble stone that do not appear to have been lime-washed. The original 6-bay roof structure has scissor trusses with crown posts and original purlins and common rafters. The trusses slope down towards the front, a consequence of former structural failure to the front wall. The north doorway has its original ledge and braced door-over-door.

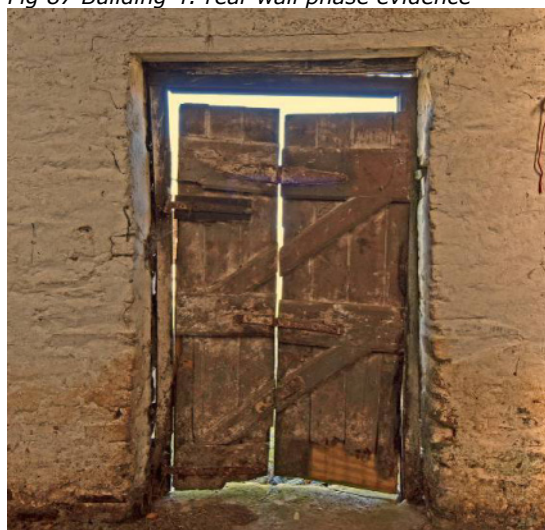
Fig 88 Building 4: N wall, altered door

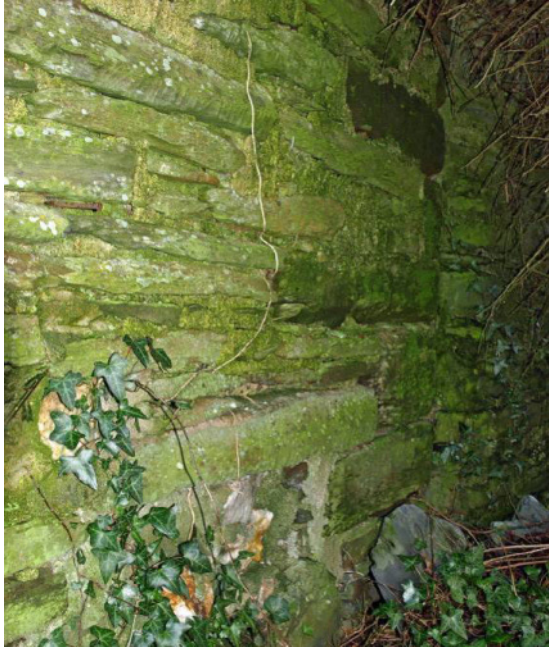
Fig 90 Building 5: rear wall phase joint

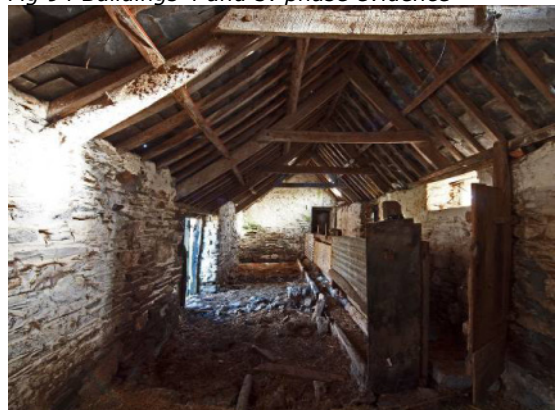
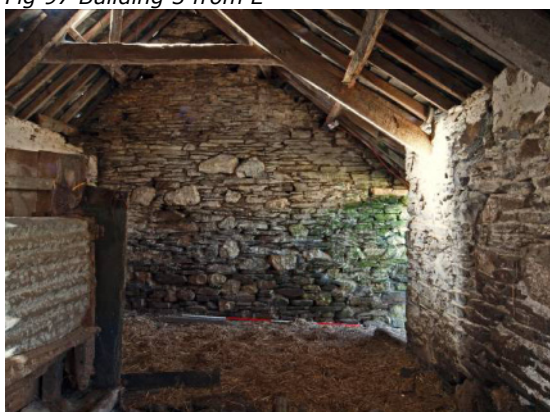
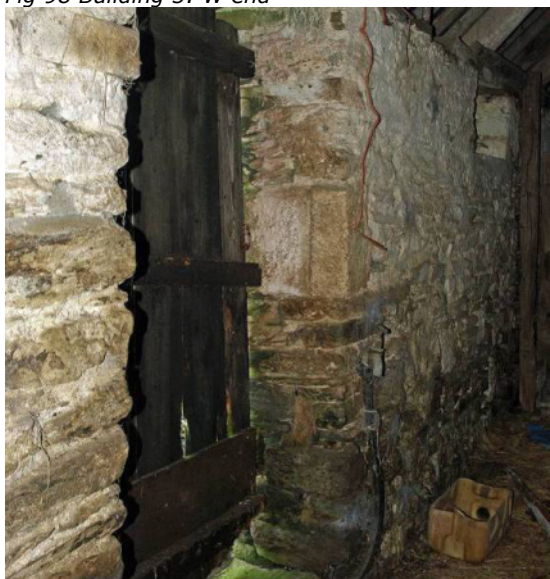
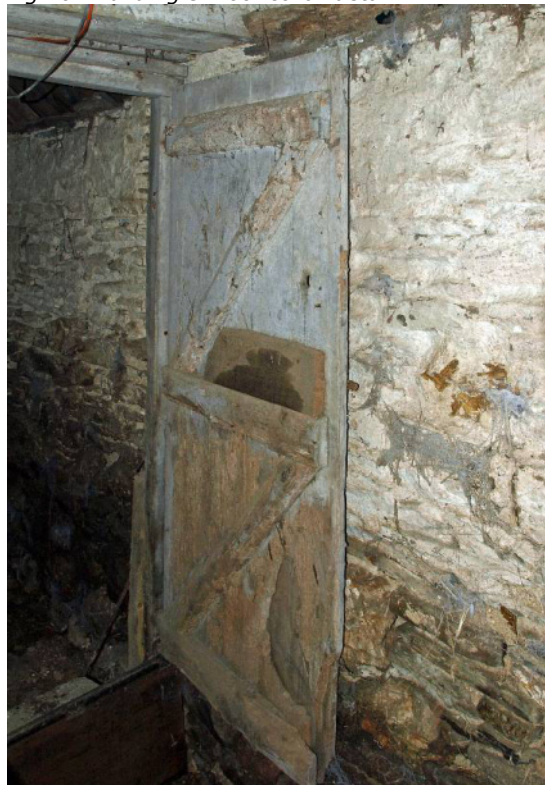
The interior of Building 5 (Figures 95-103) has lime-washed walls. Cobbled floors have been damaged when original slate slab partitions relating to the pig pens have been robbed-out of their foundations, now leaving cobbles loose on the surface where the slate monoliths formerly stood. A single vertical slate monolith (figure 95) survives at the south-west corner of the western sty. The original roof structure has asymmetrical trusses with longer rafters to the north side. This design exploits the existing slope of the land and allows greater headroom for the feeding passage. Where the roof runs lower there is still plenty of headroom for the pigs! Original purlins and common rafters also survive, some of the purlins staggered where they meet over the trusses. The trusses are nailed at their joints and also bolted, the bolts probably added later. There are five trusses to the 6-bay roof at the long end of the building and one truss to the 2-bay roof over the feed store.
