## **Kilvickeon Church, near Bunessan, Isle of Mull**

### **Photographic and Measured Surveys**

**2013-14/KVC13**

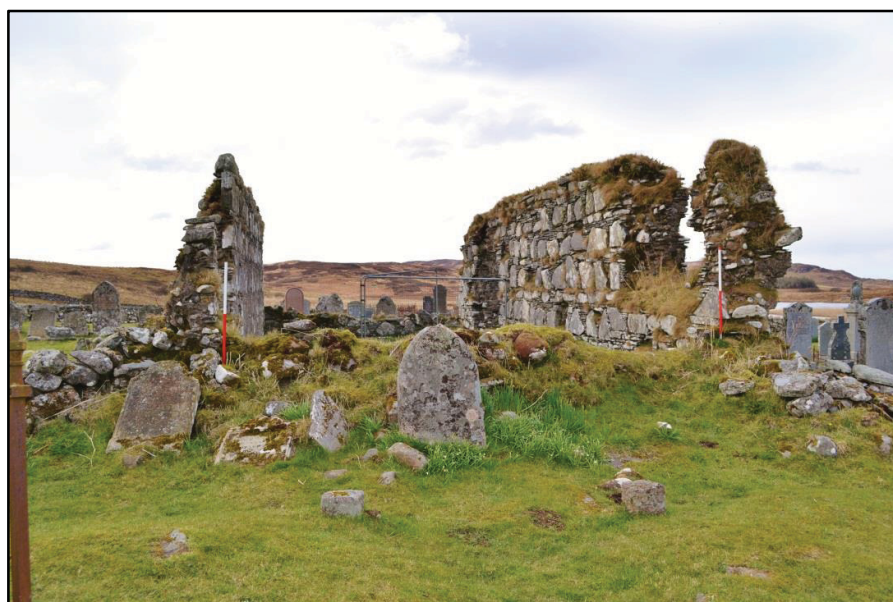
The church is a rectangular building aligned east-west, measuring 13.15m x 5.6m internally. It is surrounded by graves of varying ages (Plate 1), with the graveyard being enclosed by a Post-Medieval wall. The remnants of a former extent to the east-southeast enclosure wall and an earlier sub-circular enclosure were also recorded (Figure 3). The church is in a ruinous condition. The north and south walls stand approximately to their original height (about 3.5m from the current ground level internally), while the east and west walls now only stand to approximately 0.6m high (Plate 2).

**Plate 2:** East end of the church showing the extent to which the walls stand

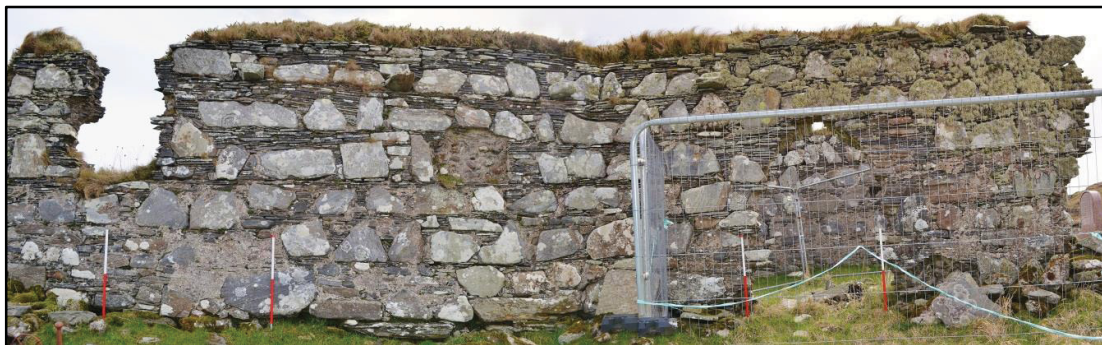
The external face of the north wall is in relatively good condition and an arched doorway is located at its west end (Plate 3), although the structural element of the arch has collapsed. It is approximately 2.5m high and would have been 1.34m wide (Plate 4). To the east of the door's apex is a much eroded fragment of carved sandstone projecting from the outer face of the wall (Plate 5). This thought to be a type of carving known as a *sheela-na-gig*<sup>16</sup>. A window is located at the east end of the north wall (Plate 3), which currently measures 0.93m at its external base. Stones projecting out of the wall below the wall-head would have been use to tie down the thatched roof (Plates 3 and 5). The internal face of the wall is exposed to the prevailing wind and is not so well preserved with some of the wall's cladding stones having fallen out (Plate 6).

**Plate 3:** Panoramic view of the north wall showing the window and door apertures (scale 1m)

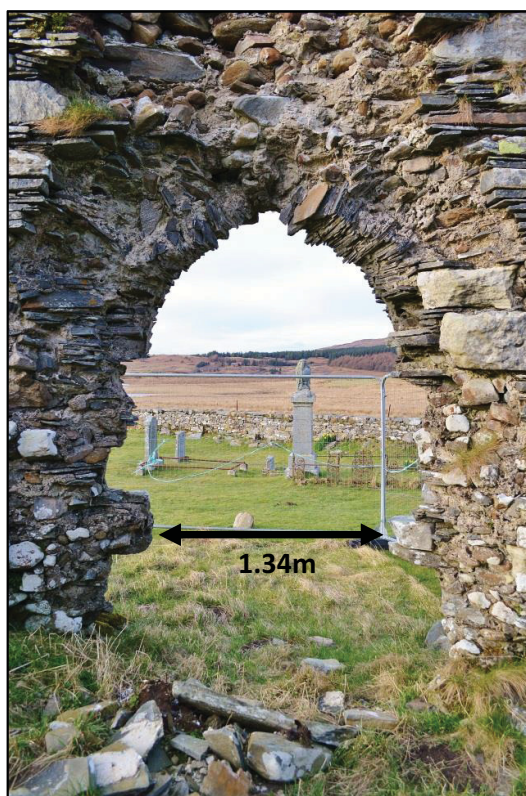
**Plate 4:** Interior view of the arched doorway showing the stones, which indicate the original width of the doorway

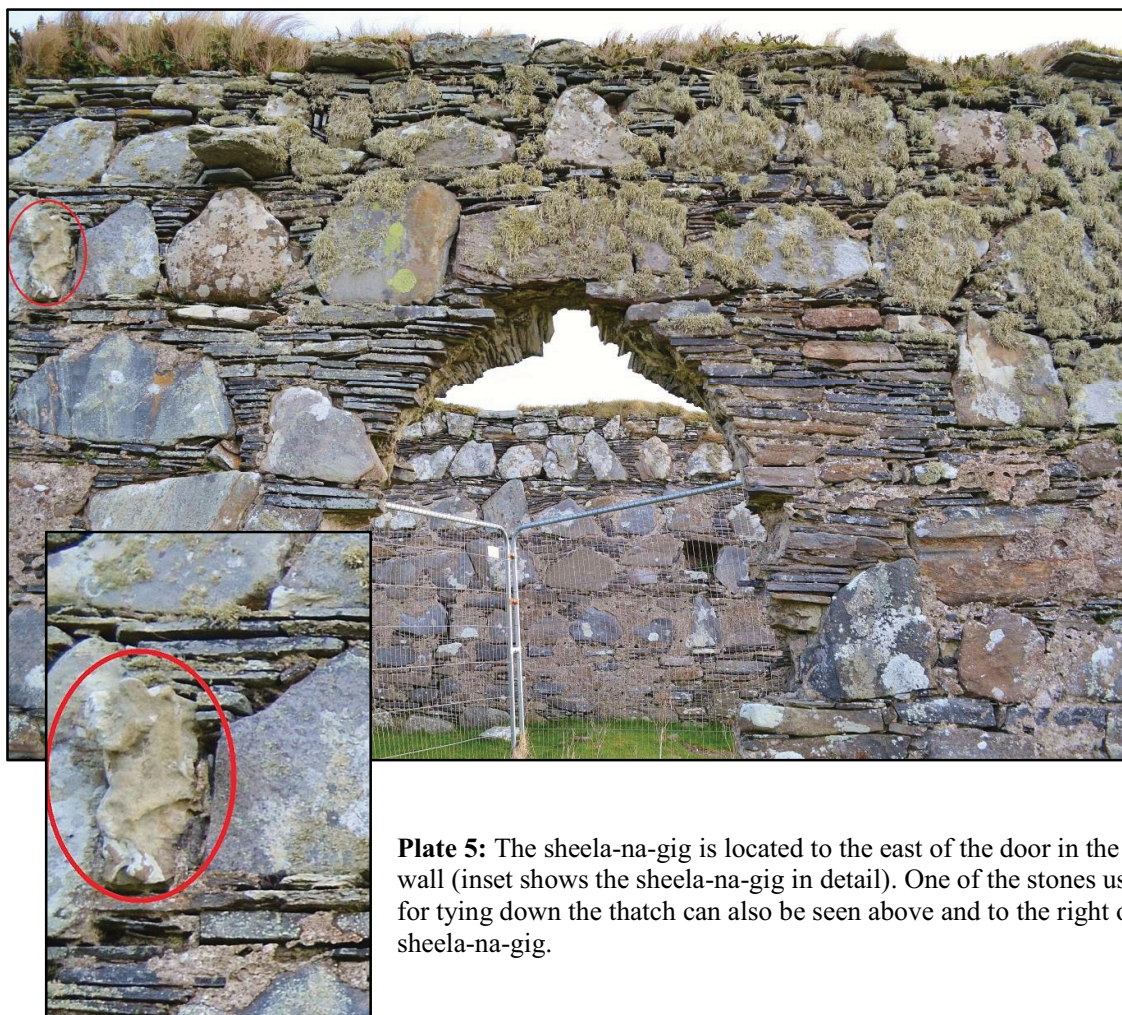
**Plate 5:** The sheela-na-gig is located to the east of the door in the north wall (inset shows the sheela-na-gig in detail). One of the stones used for tying down the thatch can also be seen above and to the right of the sheela-na-gig.

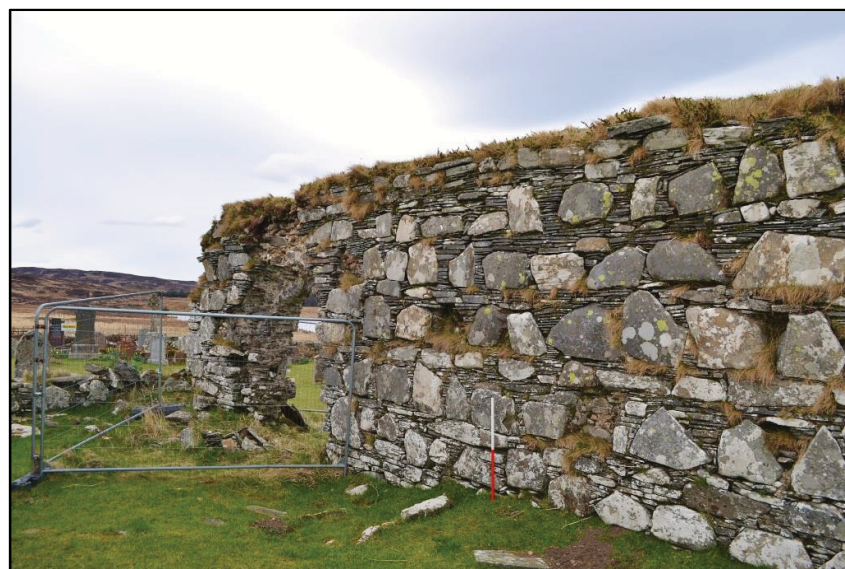
**Plate 6:** The internal face of the north wall; note the missing cladding stones (scale 1m)

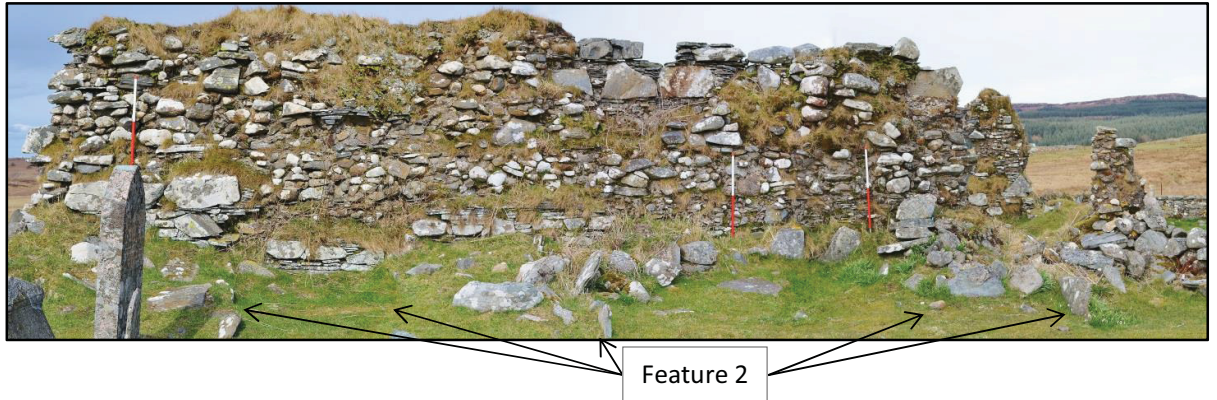
The south wall is less well preserved with its external facing having eroded away and the base of the wall now obscured by tumble along its length. It is likely that there was a window at the east end of the south wall, opposing the window in the north wall, but this has fallen away (Plate 7). Five lines of stones set on edge of varying length were noted running perpendicular to the south wall (Feature 2; Plate 7). Due to the tumble it was not possible to determine whether they ran to the foot of the wall or ascertain their purpose. The internal face of the south wall is better preserved than the external as it is protected from the prevailing weather and is relatively intact (Plate 8).

**Plate 7:** A panoramic view of the external face of the south wall, which is in a much eroded state (scale 1m)

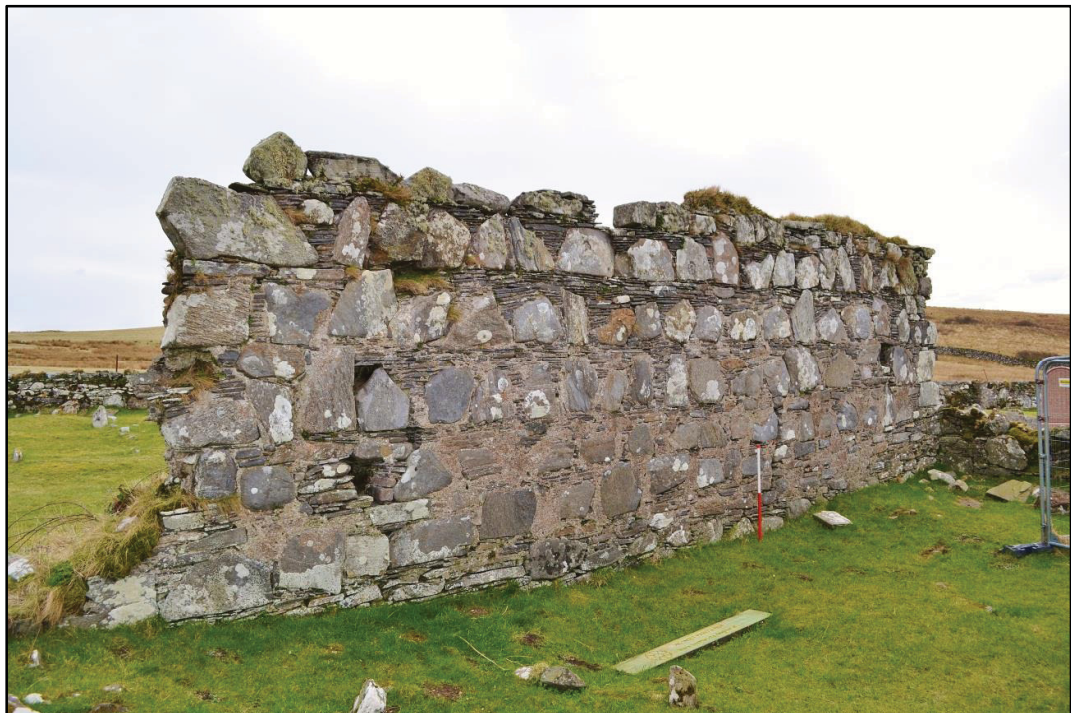
**Plate 8:** The interior face of the south wall, which is relatively intact (scale 1m)

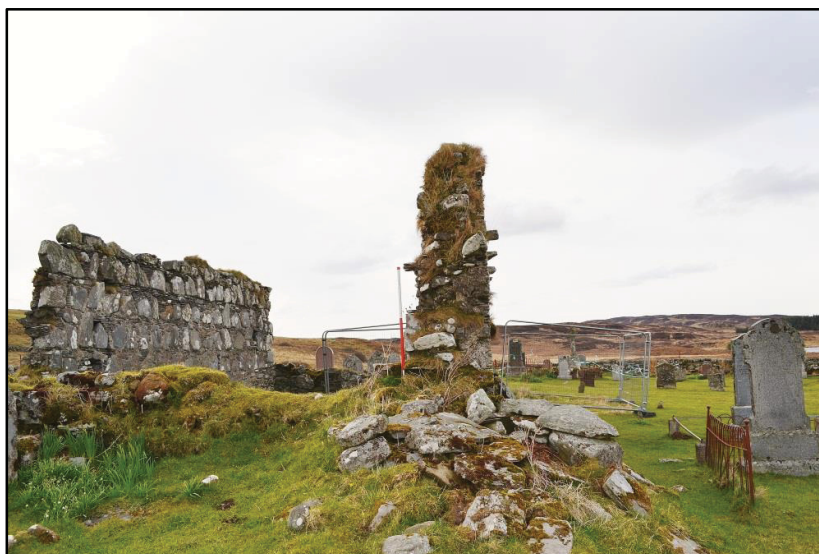
The east (Plate 9) and west (Plate 10) walls only stand to a height of about 0.6m and both are partially covered by turf and tumble.

**Plate 9:** View of the exterior of the east wall (scale 1m)

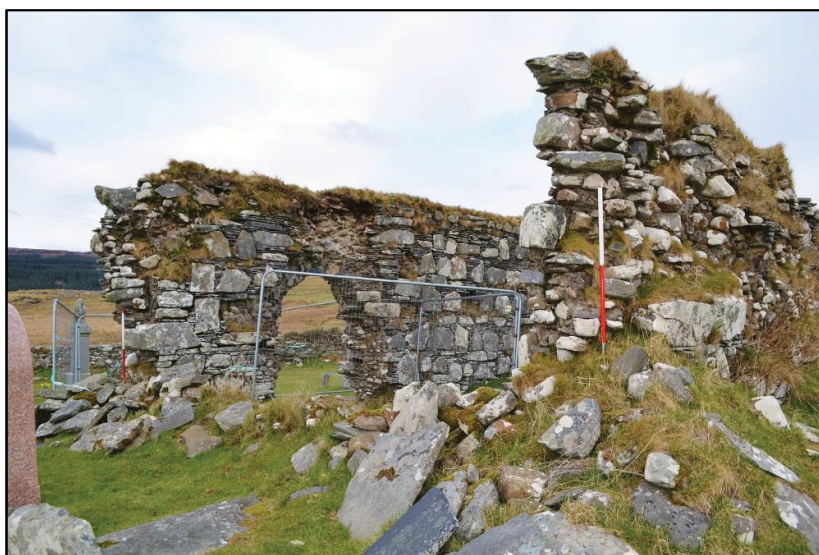
**Plate 10:** View of the exterior of the west wall (scale 1m)

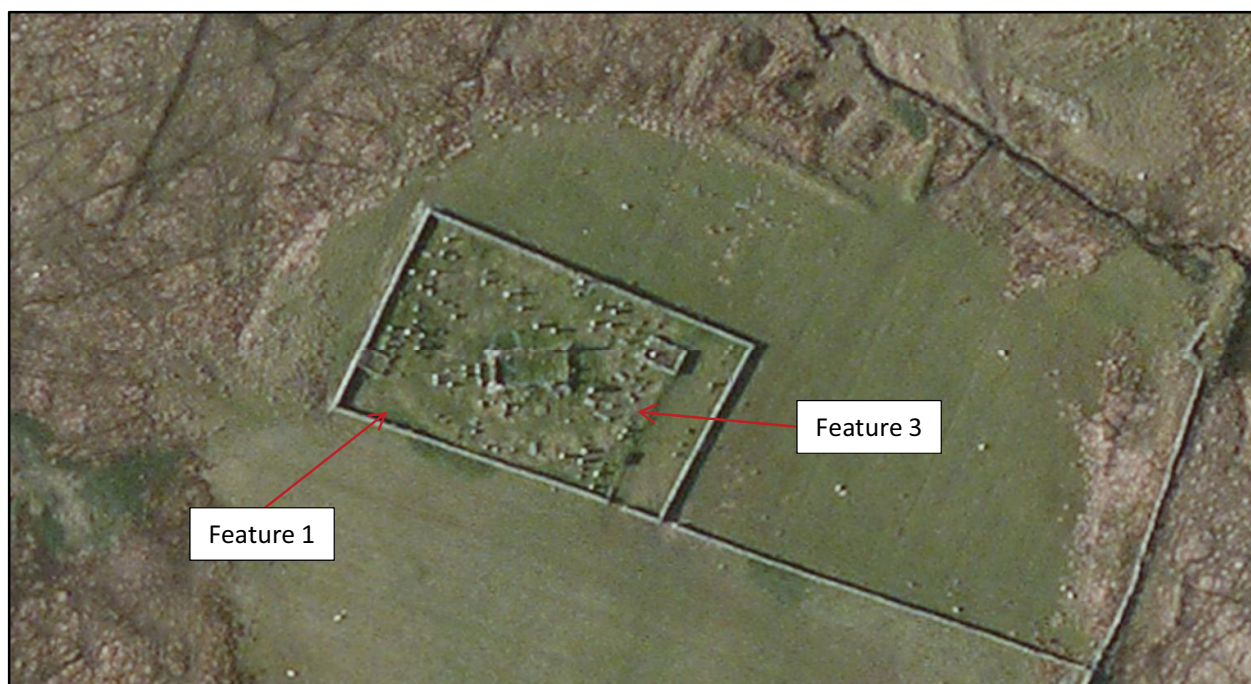
Survey of the graveyard revealed evidence of two different enclosures both of which are visible on aerial imagery (Plate 11). Feature 1 is the remnant of a sub-circular enclosure running from the southeast round to the west of the church. This is described by Historic Scotland as “fitting within the present rectangular enclosure,” however the survey shows that the enclosure in fact runs beneath the south-southwest wall of the more recent enclosure. It is most defined on the ground in the southwest quadrant of the graveyard. Feature 3 is a low mound, which runs as a

**Plate 11:** Aerial image of the church and graveyard showing features 1 and 3

continuation of the short tag of wall, which is perpendicular to the gate (Figure 2). The present east-southeast wall of the rectangular enclosure wall extends further beyond the east-southeast wall shown on the 1st Edition OS map and it can be deduced that Feature 3 is all that remains of that original wall.
