ROSS & CROMARTY ARCHAEOLOGICAL SERVICES

Craft House, Plockton

Building Survey

CHP13: Building Survey of Craft House, Plockton

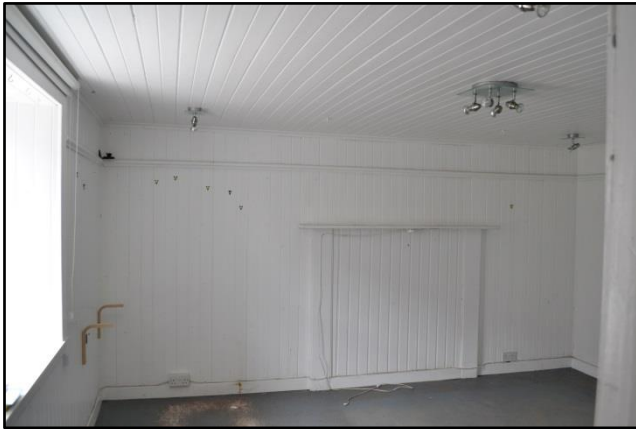
This room measures 4.17m (N-S) x 3.6m. There is one window in the southern wall, which looks out onto Cooper Street and a fireplace on the west (gable) wall (Plate 1). The walls and ceiling are clad in tongue and groove panelling with the exception of the west wall to the south of the fireplace. This was planked suggesting a repair prior to the fitting of the current skirting, possibly relating to water damage to the tongue and groove panelling here. A wooden cornice runs around the room and there is a dado rail at a height of 1.82m (to the top of the rail), both white in common with the rest of the room. The doorway into the room is set in the east (partition) wall, but the door itself has been removed. There is evidence of a second doorway in the northern end of the partition wall, which has been blocked off with tongue and groove panelling (Plate 2), perhaps at the time the panelling was affixed to the whole room. This would suggest that the panelling does not date to the original construction of the house. The panelling was certainly done before the skirting was attached to the walls as this is continuous around the room. The fireplace with mantelpiece is also blocked off with tongue and groove panelling, but this is a different size suggesting it was done at a different, perhaps later, time. Two rings are set into the

Plate 1: Room 1 with blocked fireplace in west wall.

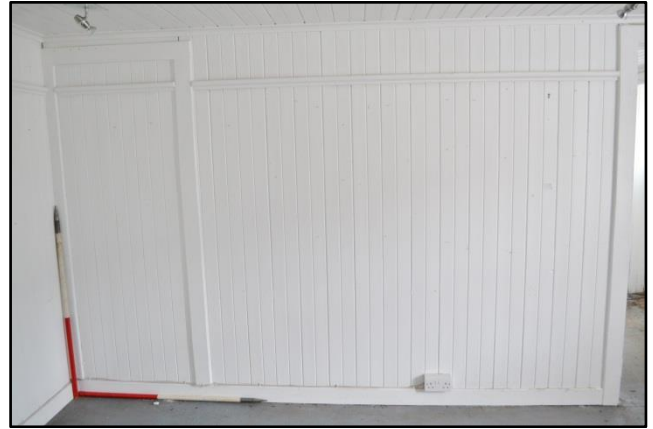
Plate 2: Room 1 with blocked doorway in east wall.

ceiling 0.63m from the gable wall in front of the fireplace. The window recess has splayed walls decreasing in size from 1.0m at the wall to 0.76m at the window. The window timber is sash and case with sash weights still present. The room has numerous picture hooks and nails in the walls attesting to its use as a gallery and, perhaps, accounts for the removal of the door.

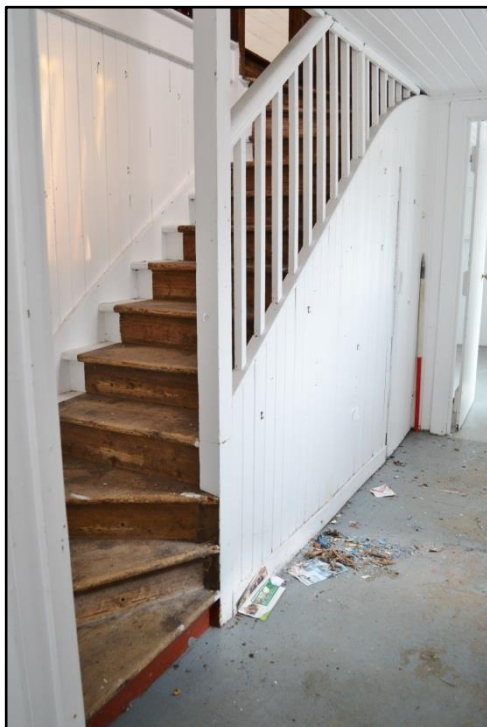
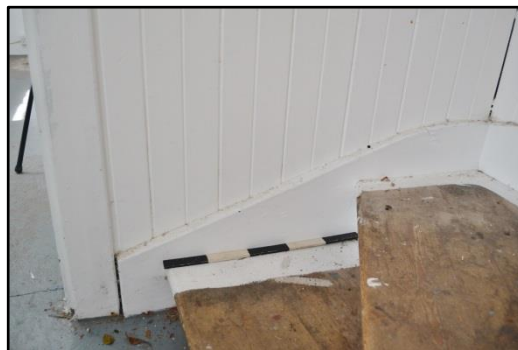
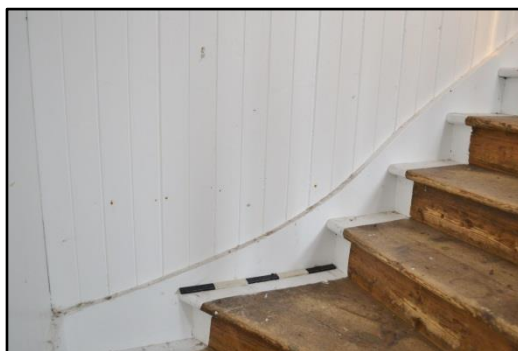
Plates 3, 4 and 5: (clockwise) these pictures show the staircase with curved panelling, the curved and re-curved skirting at the bottom of the stairs.

clockwise 90 degrees to the landing. The inner skirting at the bottom of the staircase has been cut with a curve and re-curve design around the 90 degree turn (Plates 4 and 5).

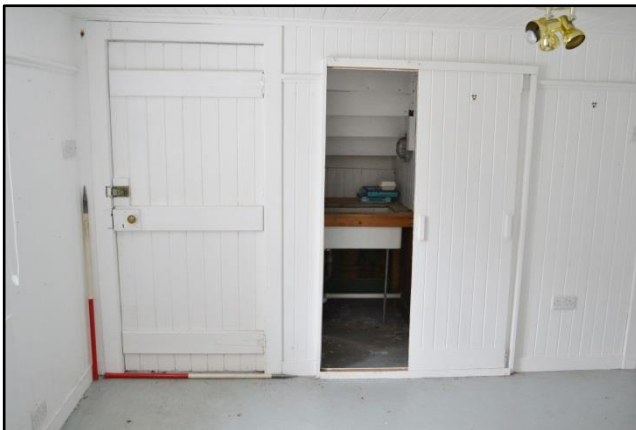
Plate 6: Room 2 showing two of the doors on W wall

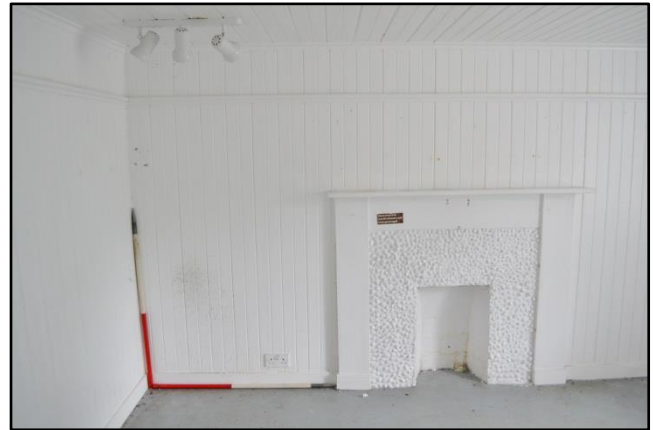
Plate 7: Fireplace in Room 2

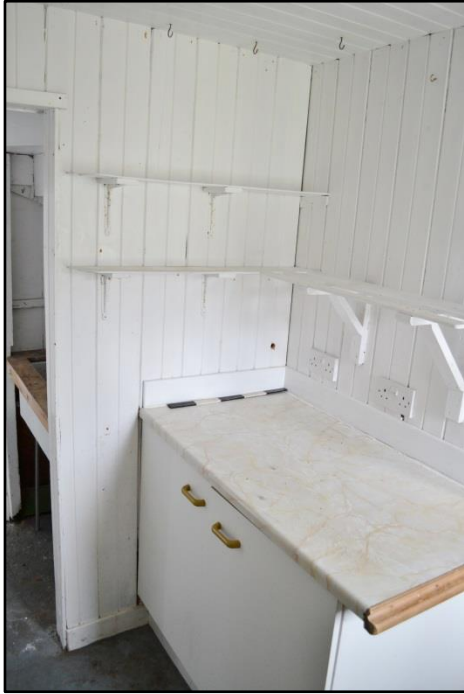
Plate 8: Base unit in the pantry

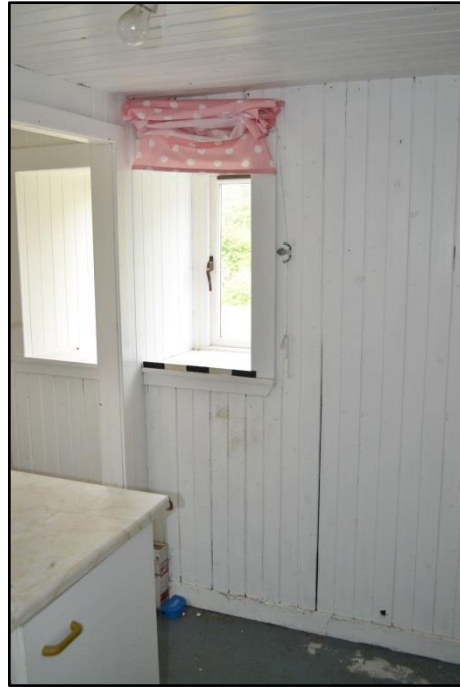
Plate 9: The window aperture shared with the toilet

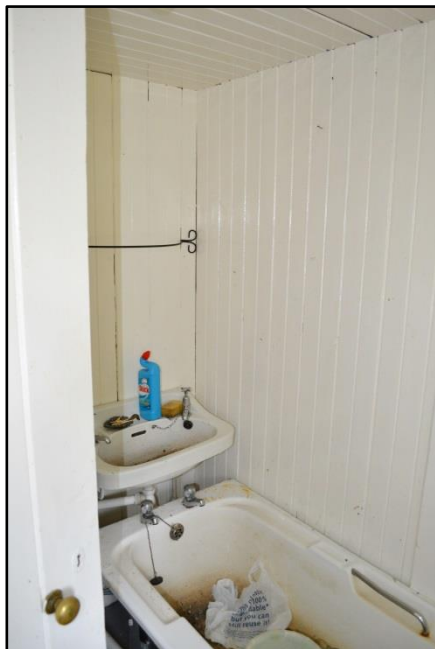
Plate 10: The bath inserted under the sink.

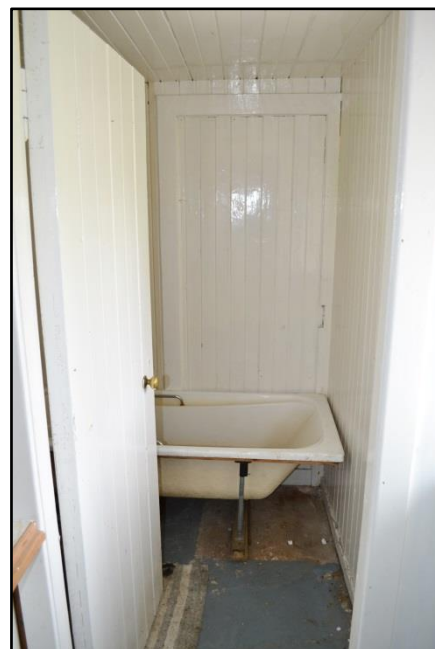
Plate 11: The blocked doorway leading through to Room 1.

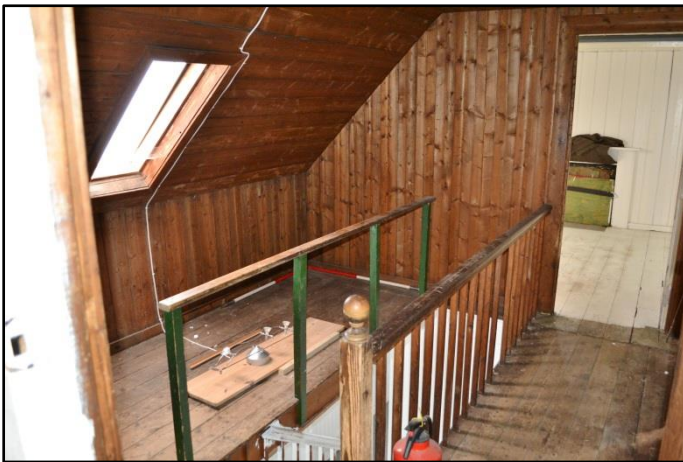
Plate 12: (above left) Landing area on both sides of the staircase.

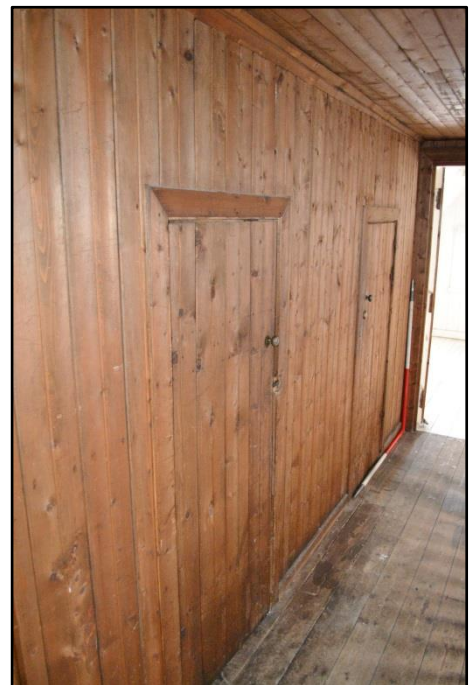
There are two cupboards under the eaves on the north side of the corridor (Plate 13). Cupboard 1 measures 1.7m (E-W) x 1.11m and houses a water tank and fuse box. Cupboard 2 measures 1.68m (E-W) x 1.11m and has a corrugated plastic skylight window. A lead weight (Plate 14), apparently cast in a foil dish, was found in this cupboard and is possibly connected with the weaving activities that took place in the house.

Plate 13: (above) Cupboards on the north side of the corridor.

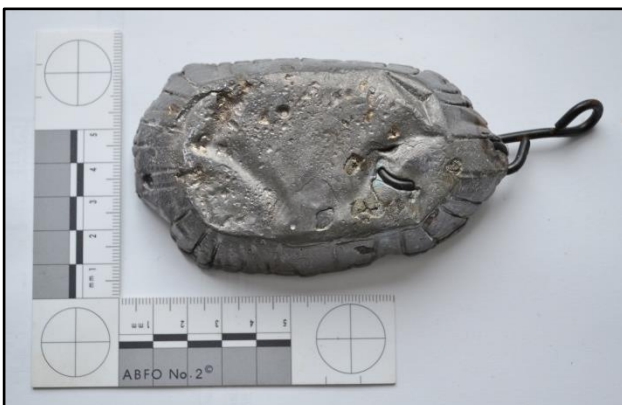
Plate 14: (left) Lead weight.

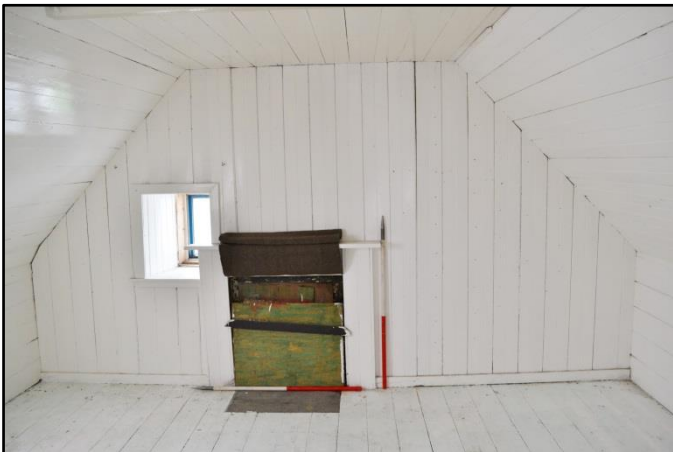
Plate 15: Fireplace and window in Room 3.

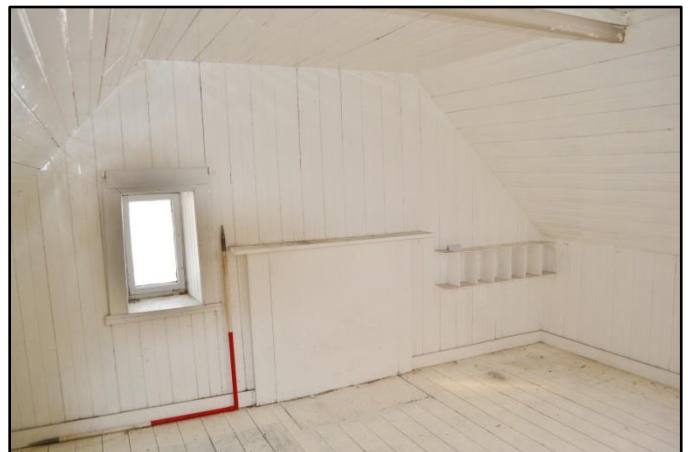
Plate 16: Window, fireplace and shelving in Room 4 with a fluorescent strip light visible top right

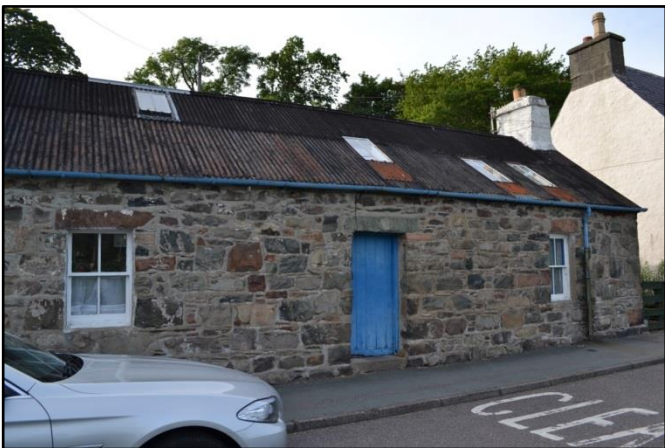
Plate 17: 23 Harbour Street

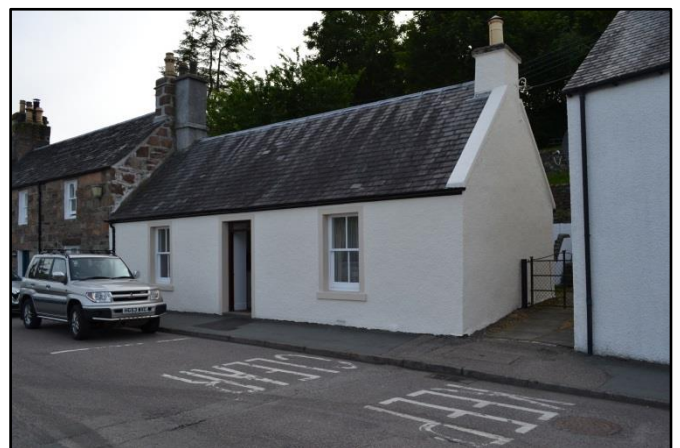
Plate 18: 37 Harbour Street

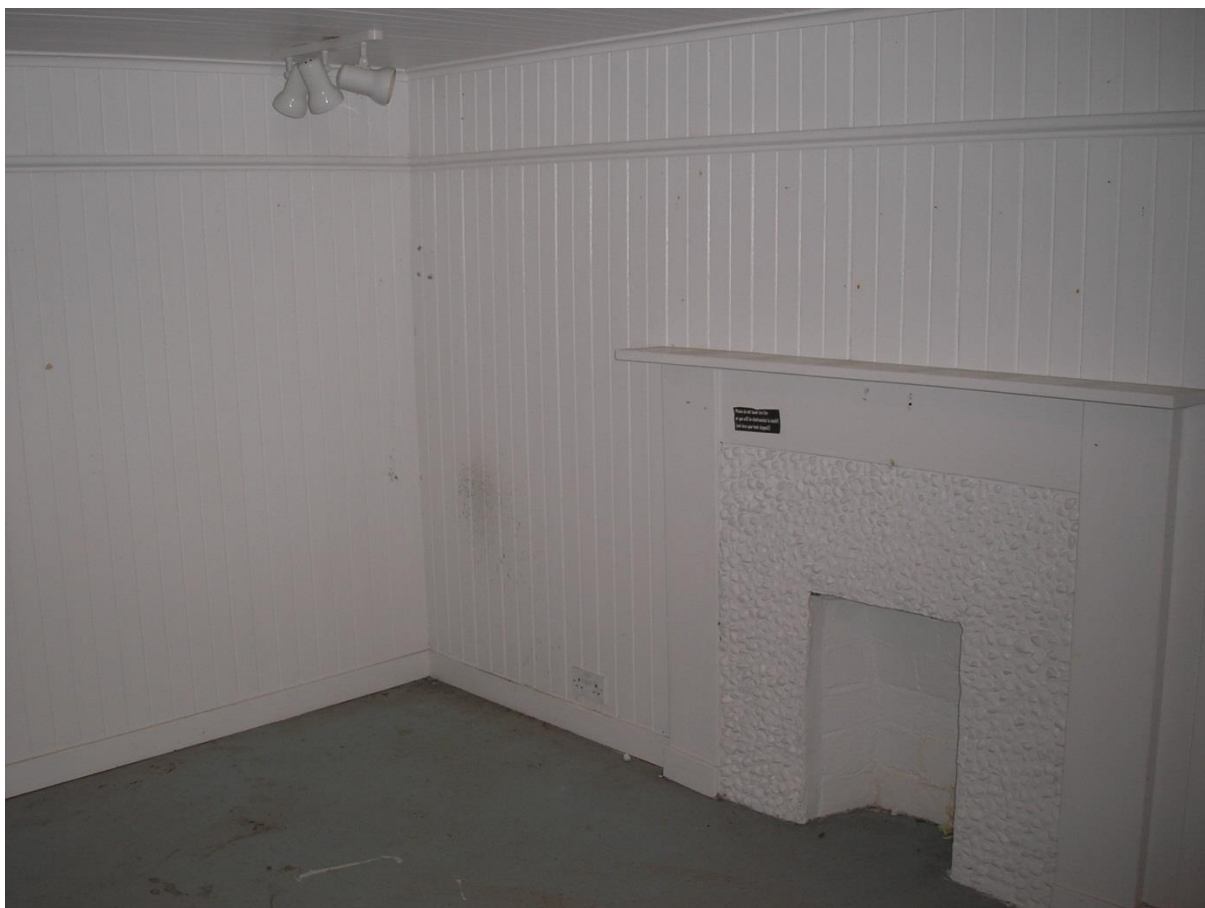
Detail of interior showing tongue'n'groove wood panelling

The building itself is not listed but it does lie within the Plockton Conservation Area. The building also retains some interesting internal features but these are in poor condition and of limited heritage significance. The property has never been extended or altered in any significant manner. Its overall conservation status is not particularly high but it is considered to be important that any redevelopment of the property, should ideally, attempt to maintain the general style and amenity of the area.
