Archaeological Observation at
St Luke's Church,
Thurnby, Leicestershire

Report 0607

February 2006

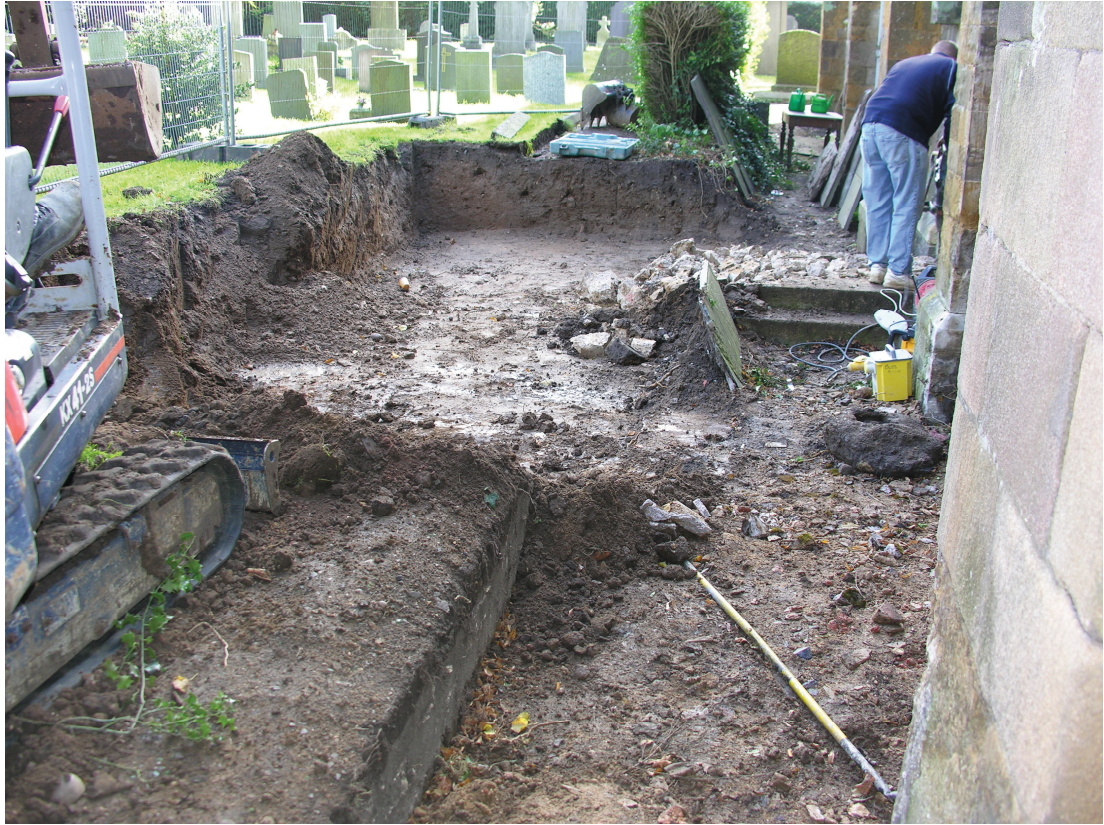
4.2 The ground reduction in the area of the new extension revealed topsoil over part of the site to a depth of c.0.13m (1). Below this was a layer of mid-brown silty loam (7), a disturbed churchyard soil containing a few disarticulated human skeletal remains. A degraded wooden coffin (11) and a partial skeleton (12) were aligned with a line of burials in the adjacent part of the churchyard.

Fig. 2: Ground reduction looking east

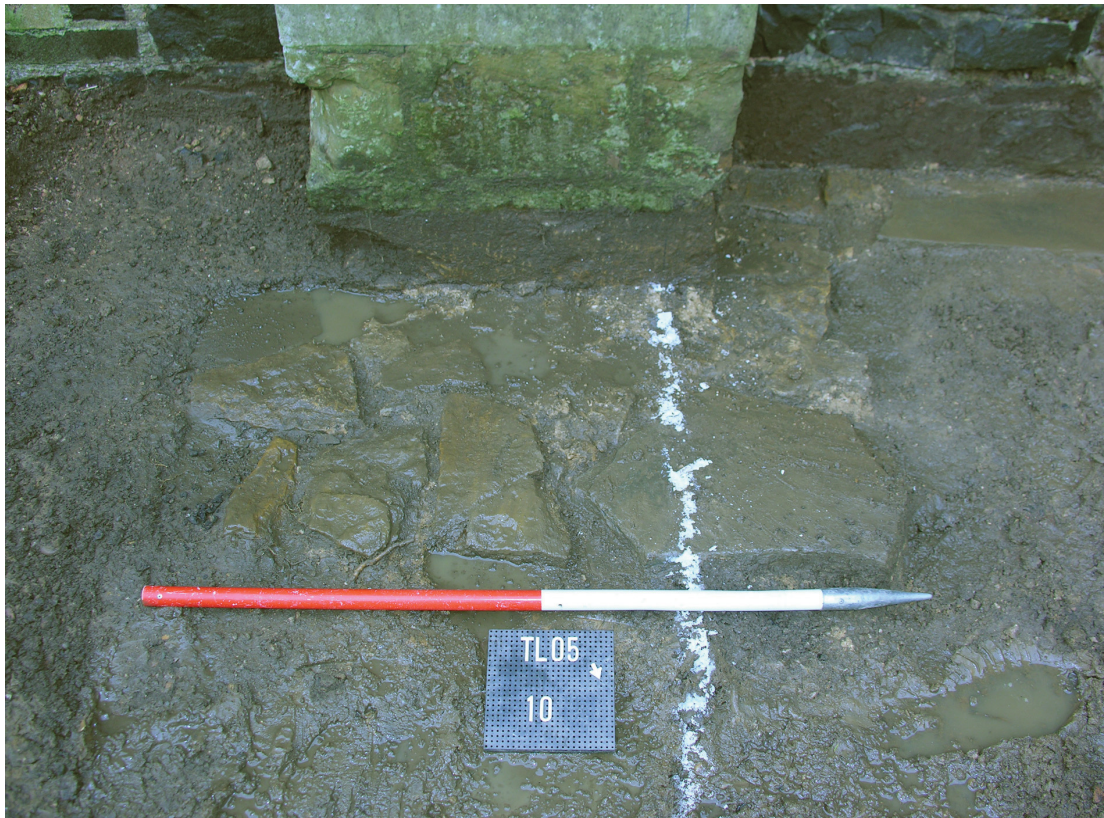
4.4 The removal of the soil and modern concrete against the wall of the current church revealed part of its foundations. The upper layer of the foundation comprised a single course of masonry (10), mostly of sandstone with occasional slate (Figs. 1, 3). Observation of the foundation trench excavation adjacent to the church wall showed that the masonry (10) was set on concrete. This suggests that structural improvements were made below ground during the Victorian rebuilding of the north aisle, and that little if anything of the original north aisle construction remains *in situ*. Observation of the foundation trench was curtailed at the point when it could be determined with reasonable confidence that no further structural features were likely to be encountered.

Fig. 3: Wall foundation masonry 10

5.1 All the observed foundation elements were 19th-century, and correspond to historical records about the Victorian rebuilding of the north aisle in 1870-3. The presence of concrete as the lowest element of the present foundation indicates that the rebuilding was comprehensive, and included strengthening or replacement of the original foundations. No archaeological finds, features or structural elements were noted that could be related to earlier building phases, suggesting that little if any of the original aisle structure survives.

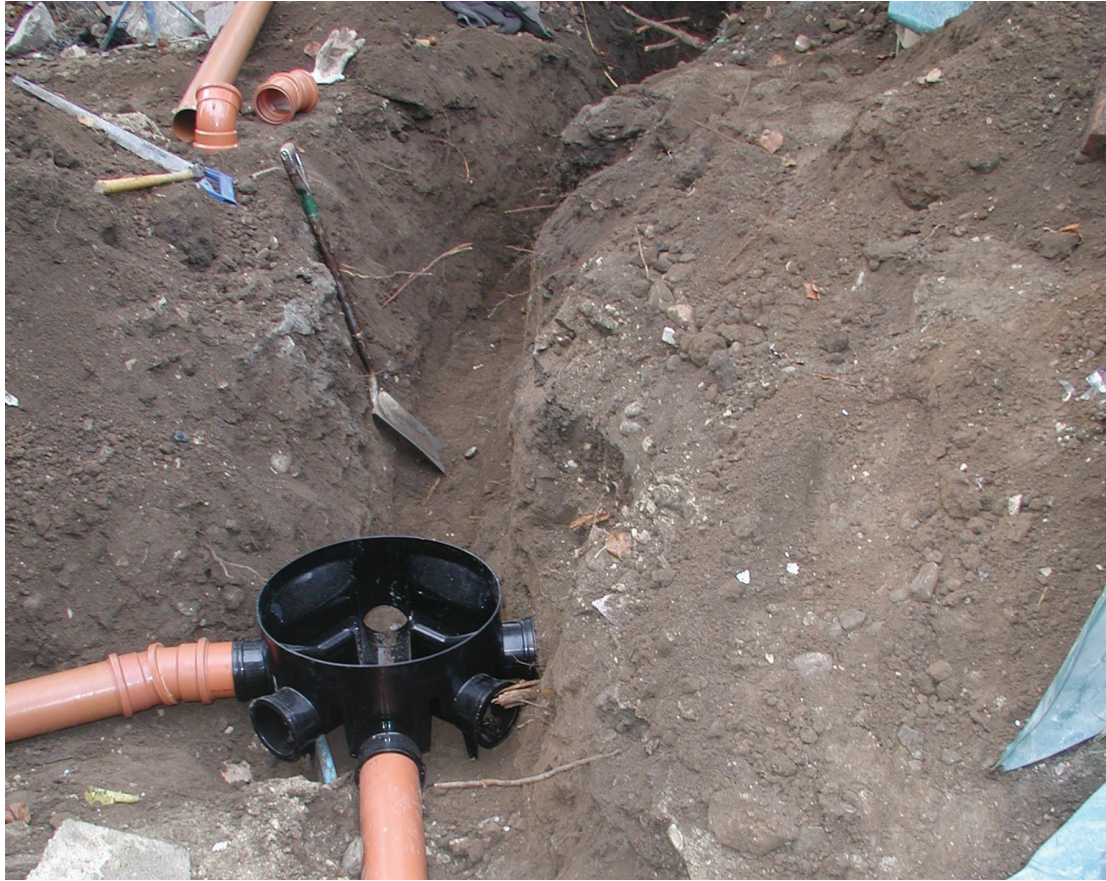
Fig. 4: Service trench

4.7 The service trench running westwards from the new extension to Church Lane was observed after its completion (Fig. 4). It was *c.*0.75m deep, widening from 0.5m at the base up to *c.*1m at the top due to slumping. Only topsoil and disturbed churchyard soil (13) was visible, and no significant archaeological deposits or finds were recovered.
