A Report to Brown and Buttrick Chartered Architects on behalf of Messrs RJ and AE Godfrey April 2012

SEARBY TOP FARM, SEARBY WOLD LANE, SEARBY, LINCOLNSHIRE

Historic Building Recording

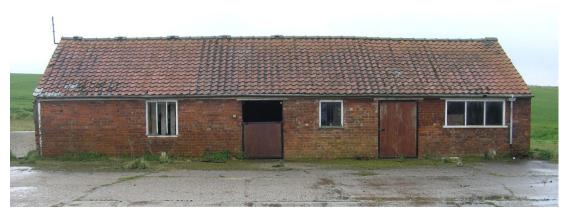
Two doorways placed centrally in the front elevation (*Plate 2*) give access to each of the two main areas of the building. There are modern windows at mid height in each of the units and a smaller window in the central area.

Plate 2: Building 1, front elevation, looking southeast

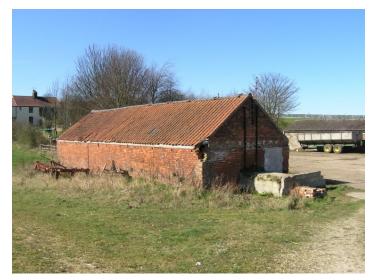
The rear of the building (*Plate 3*) is plain except for ventilation holes at just below eaves level.

Plate 3: Building 1, looking south

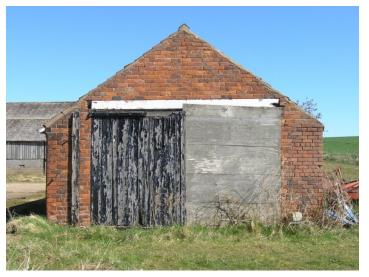
A large doorway occupies the southwest facing elevation to the level of the gable (*Plate 4*). A plank door survives on one side; the other is boarded.

Plate 4: Building1, southwest facing elevation

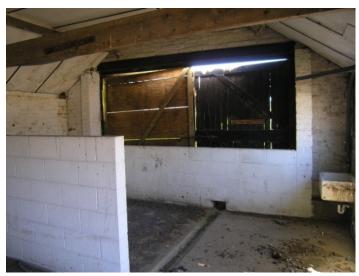
Internally, the unit to the southwest (*Plates 8 and 9*) has been subject to considerable alteration. It has a concrete floor and centrally positioned drainage channel aligned with the long axis of the building.

Plate 9: Interior of Building 1: southwest side

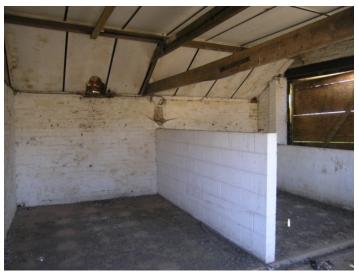
Plate 8: Interior of Building 1, southwest side

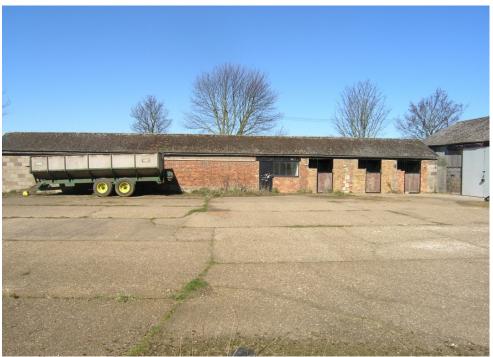
Ends of stone walls relating to a 19th century shelter shed and loose box(es) are visible in the southeast facing elevation of Building 2 (*Plate 11*), along with part of the rear wall (in brick) of a slightly later cartshed/implement store (see Fig. 12). The fronts of the shelter shed and the probable loose box contain modern brick infill, to form stables, while much of cartshed/implement store (southwest end) has been rebuilt in modern concrete blocks. The stable doors are modern (identical to those in Building 3), comprising planks below and iron above.

Plate 11: Building 2: southeast facing elevation

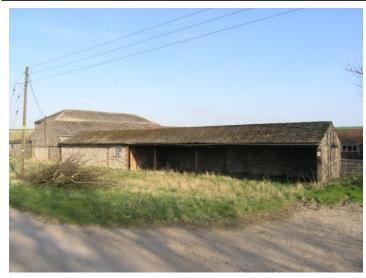
The northwest facing elevation of Building 2 (*Plates 15, 16 and 17*) includes the rear wall of the 19th century shelter shed and loose box, in stone with brick detail at the corners and eaves, the rear wall of the office (further loose box?) in stone to match, and the cartshed to the southwest. The cartshed is in 4-bays formed by iron uprights and trusses supporting the asbestos sheet roof covering

Plate 15: Building 2, northwest facing elevation

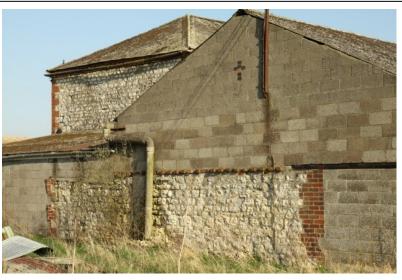
Plate 16: Building 2: surviving fragment of original shelter shed

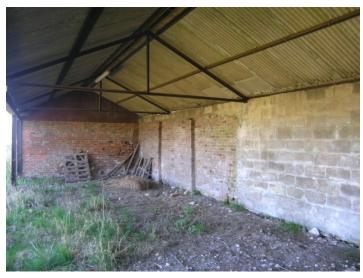
(see *Plate 18*). The height of the 19^{th} century structure has been raised with concrete blocks to match the height of the rebuilt part of the cartshed. The northeast end of Building 2 has been rebuilt using concrete blocks.

Plate 18: Building 2, interior of cartshed, looking northeast

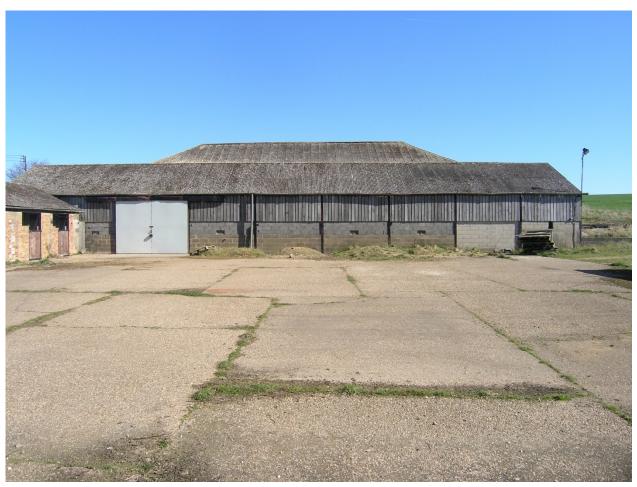
Building 3 (*Plate 19*) is a large modern shed, built against the southwest side of the barn/granary (Building 5). Built in concrete blocks with timber slats above, it incorporates, on its northwest side, part of the rear wall of a shelter shed, standing to a height of 1.88m and extending over a distance of c. 9m (see *Plate 16*) to the point where it has been demolished and finished in brick.

Plate 19: Building 3: southwest facing elevation

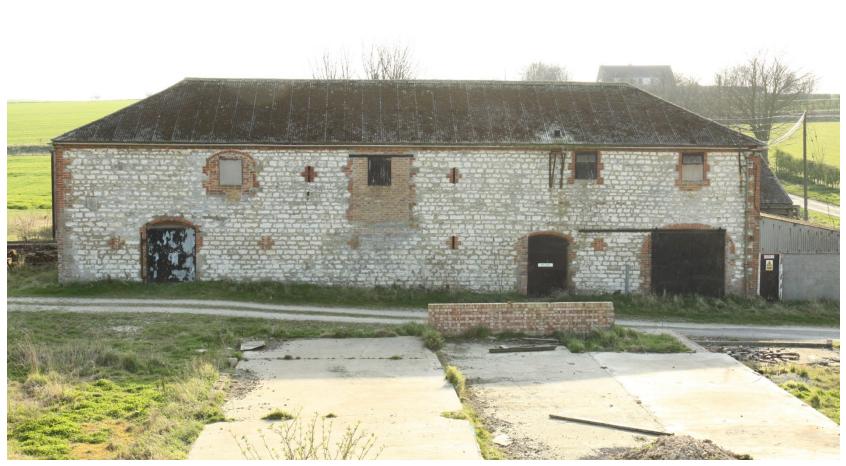
The northeast facing elevation (*Plate 23*) has three original door openings at ground floor level, all with arches detailed in brick. The largest (situated at the northwest end of the elevation) has a sliding metal door. The other doorways – one placed immediately adjacent to the main door, the other located at the southeast end of the elevation – are identical in size and appearance, except for brick infill reducing the width of the middle doorway. Both openings contain hinged metal doors.

Plate 23: Northeast facing elevation of the barn and granary

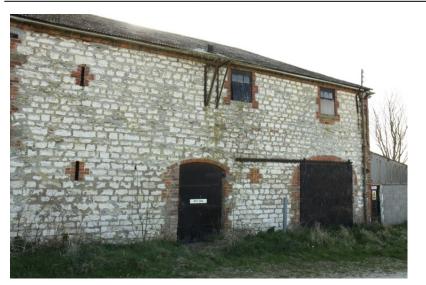
Two identical openings at first floor level on the northwest side of the elevation (*Plate 24*) may be interpreted as vents to an overhead granary. The openings are glazed in their upper extents (three light windows in timber frames) with planked doors beneath (one replaced by board). The doors open outwards from the base of the opening.

Plate 24: Northeast facing elevation – main door and granary

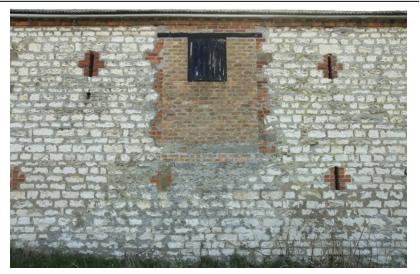
Towards the centre of the elevation, a large area of recent brickwork indicates the position of an original door to the first floor (*Plate 25*). Detailing around the opening is less regular (particularly on the southeast side) than that seen elsewhere in the building, which raises the possibility that the door

represents a modification to the original structure. More convincingly, a threshold or step at the base of the feature appears to indicate the position of a narrower opening - later enlarged to the southeast. There is a small opening in the brick infill, containing a planked door or shutter.

Plate 25: Building 5 - door to 1st floor

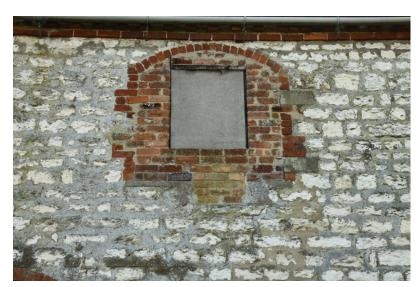
A large, arched, bricked in opening at first storey level near the southeast end of the building may be interpreted as a pitching door (*Plate 26*). The brickwork incorporates a small opening comparable to the one in the adjacent door.

Plate 26: Building 5 – pitching door

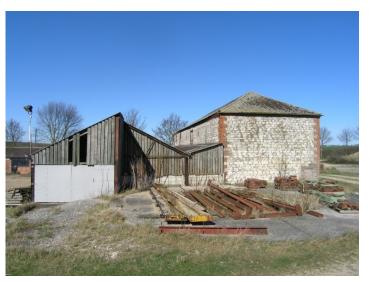
The only feature evident in the southeast facing elevation is a flat-sided opening at the lower right corner (*Plate 27;* for interior see *Plate 39*). The opening, with a brick and concrete surround, is probably a late insertion and has been infilled with brick. The feature would probably have accommodated the drive shaft for an engine sited outside the barn (see below).

Plate 27: Buildings 3 and 5, southeast facing elevation

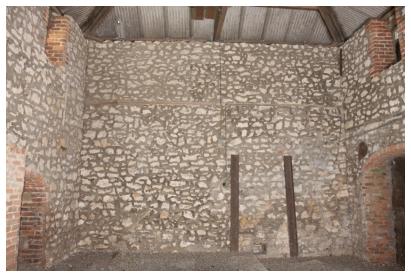
Evidence for flooring at the northeast end of the building is less clearcut than in the central section. The remnants of joists and a floor are visible in the end wall (*Plate 31*), set at a higher level than flooring in the central area. Set at a lower level in the northeast wall (extending over the main door) are further possible remains of a floor, while upright skims of plaster (extending approximately from the level of the latter floor remnant) indicating possible partitions, are visible on both long walls in this area.

Plate 31: Building 5, northwest end with 'floor' remains

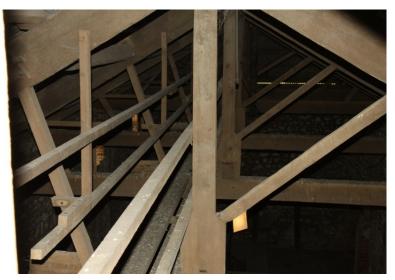
Struts on the southwest sides of the trusses have been modified to receive a wooden walkaway (see *Plate 48*) extending along the long axis of the building. The walkway - reached via a platform (see *Plate 47*) constructed in concrete blocks and ladders placed against the northeast wall of the building – provided access to grain drying and storage equipment which was installed during the late 20^{th} century (since removed). An indentation in the concrete floor at the southeast end of the building would probably have held a receptor for the grain.

Plate 48: Building 5 - roof structure and modern walkway – looking NW
