A Report to G. R. Merchant Ltd, Architectural and Planning Consultants on behalf of Mr and Mrs Hartfill

AGRICULTURAL BUILDINGS ON LAND ADJACENT TO ABENDBLOEM, TOWN DAM LANE, DONINGTON, LINCOLNSHIRE

Historic Building Recording

Site Code: TDLD12
LCCM Accession No.: LCNCC 2012.112
OASIS ID: withamar1-132339
South Holland Planning Application No.: H04-0626--09
NGR: TF 2054 3505

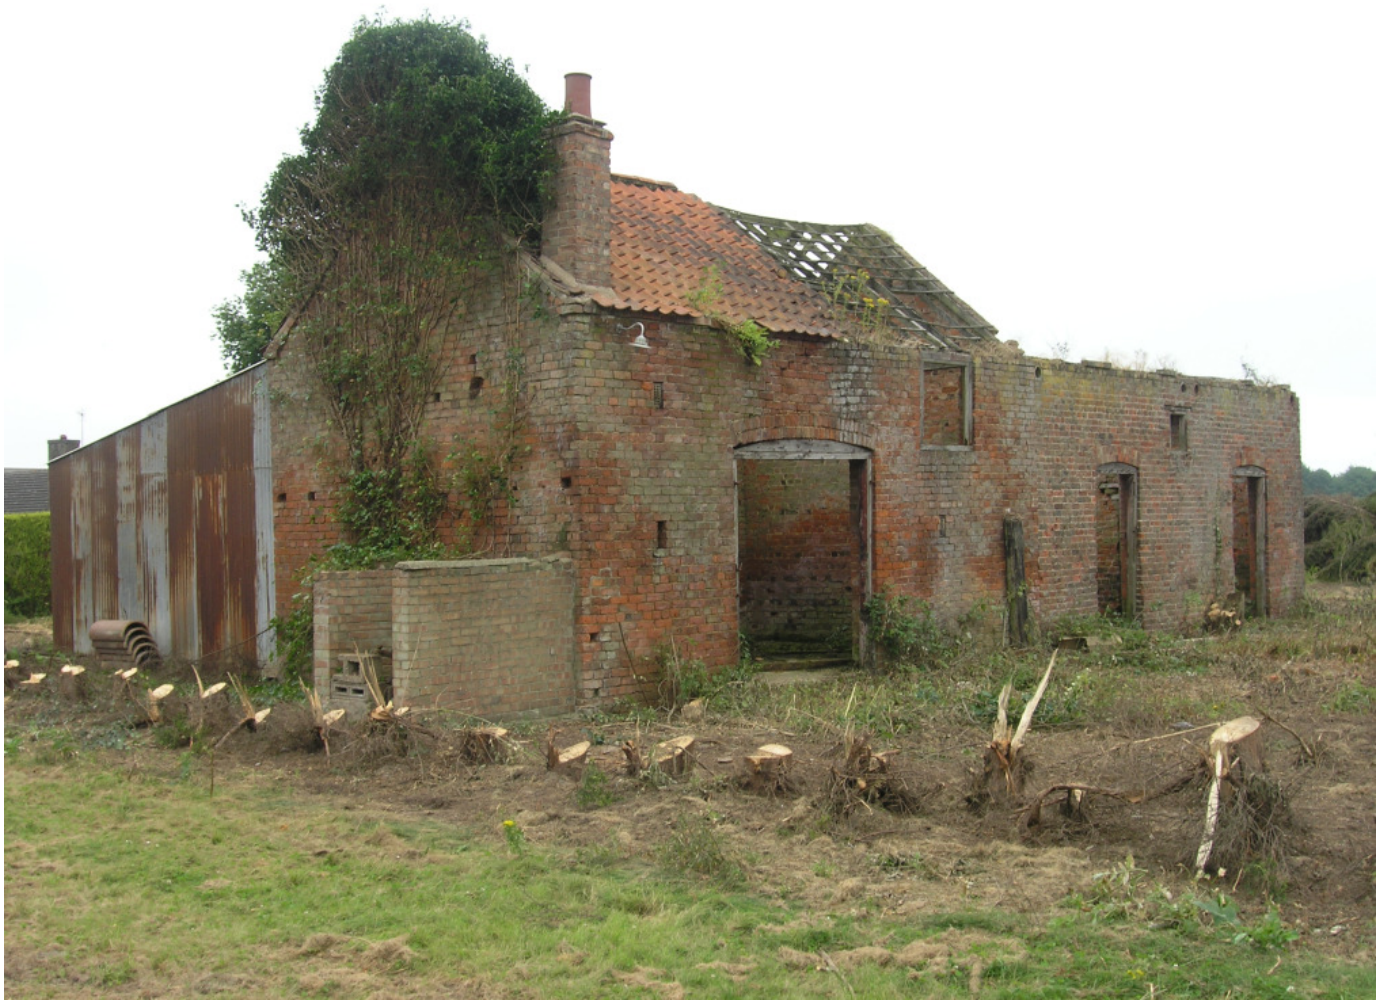
Plate 1: Buildings on land adjacent to Abendbloem from the west, looking east

The northwest end of the building (see Plate 1), closest to Town Dam Lane, is partly obscured by ivy but appears to be plain. Occasional holes in the brickwork, indicate the positions of timbers which must have formed part the abutting structure seen on the aerial photograph taken in 1971 (see Section 6.0 above). A brick-built plinth for a fuel tank abuts one of the corners of the building.

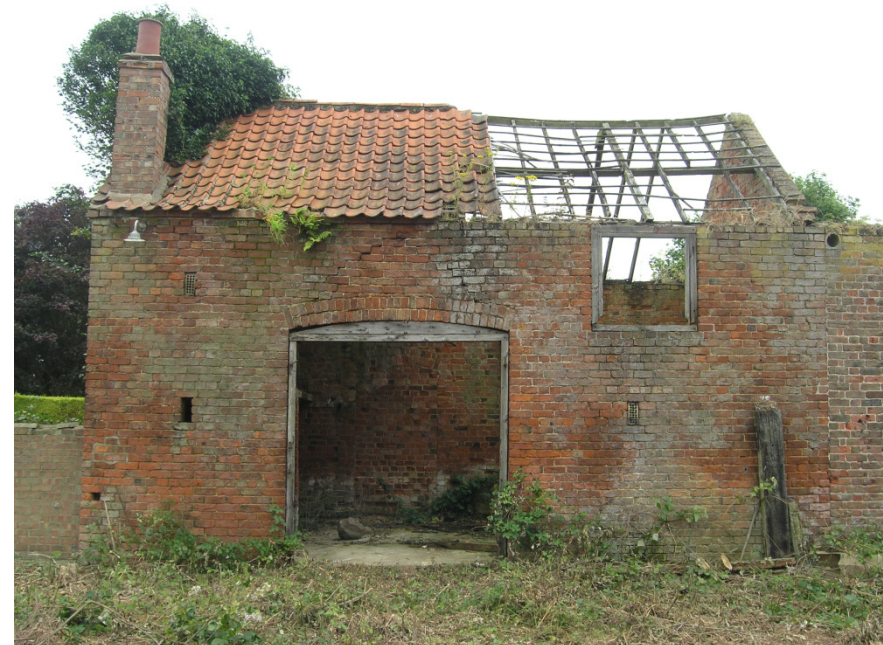
Plate 3: Front elevation of Building 1

The front elevation (Plate 3) features a barn door with a shallow arch detailed in brick (two courses of headers set on edge) and a pitching door situated at high level; timber frames are present in both openings but the doors are missing. There are three ventilation slots – two at low level, placed either side of the barn door and one at high level on the opposite side to the pitching door. Two of the slots contain air-bricks.

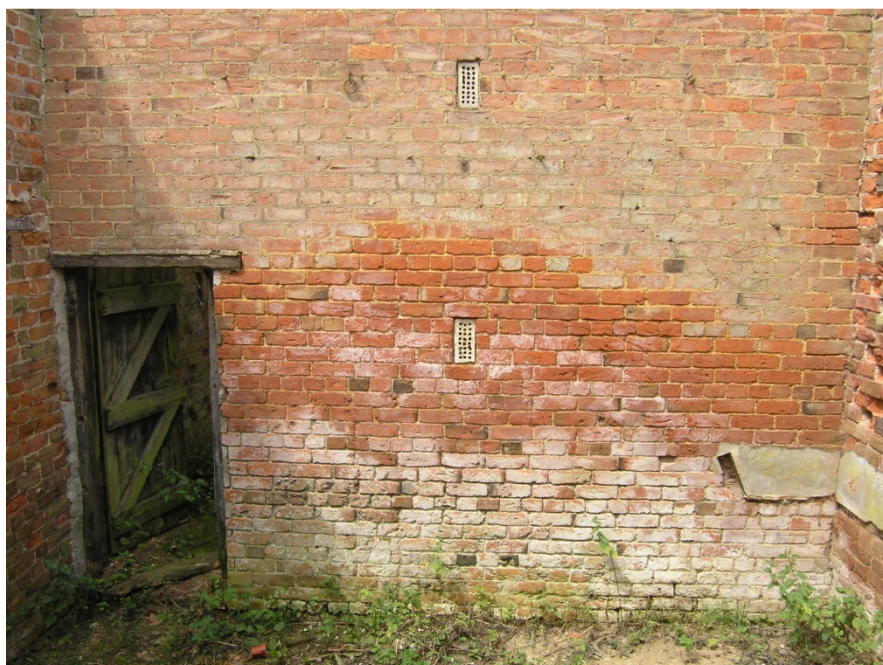
Plate 4: Building 1 – lower extent of southeast wall as seen from inside Building 2

The southeast end of Building 1 is visible from the inside of Building 2 (Plate 4). The wall is plain except for two ventilation slots (both containing air-bricks) which are aligned vertically. A door providing access between Buildings 1 and 2 is probably an alteration, inserted after the construction of Building 2 (see below).

There are several nails in the gable wall at the end of Building 1, presumably relating to the use of Unit A. The nails occur in rows situated above the level of the door and below the upper ventilation slot (see Plate 4).

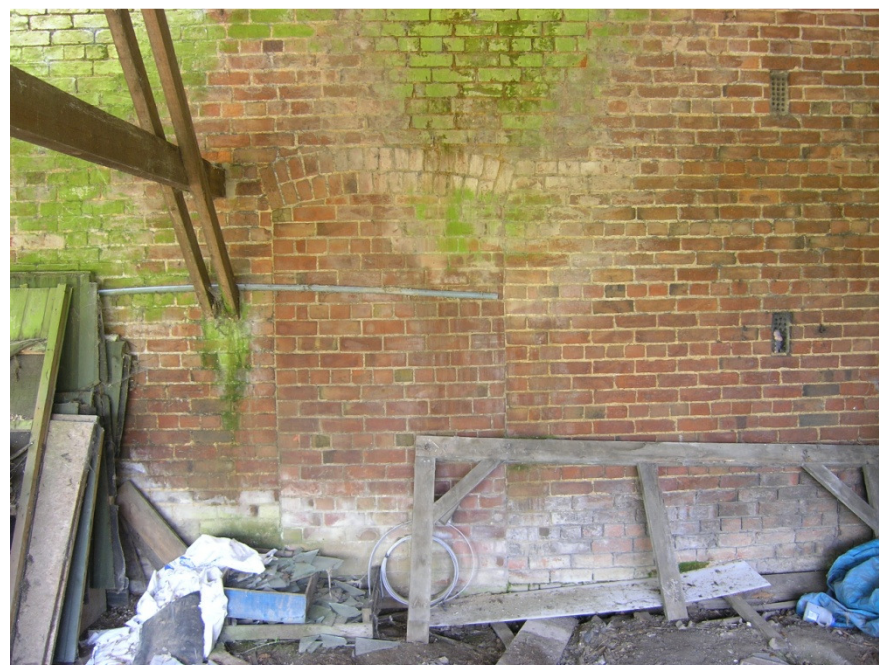
Plate 5: Blocked in doorway to rear of Building 1 (view from Building 3)

The large door in the main elevation is opposed by a much narrower door in the rear wall. The latter, which is bricked up, can be seen from the interior of Building 3 (Plate 5). It is consistent in style with the barn door, with a shallow arch and identical brick detail, and is clearly an original feature. There are four ventilation slots in the rear wall, arranged symmetrically in pairs either side of the door.

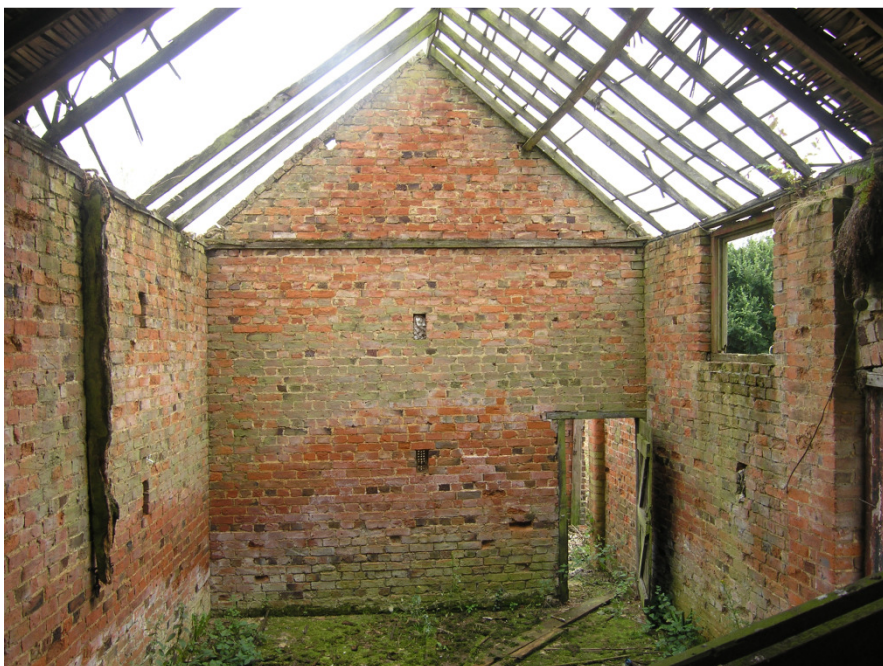
Plate 6: Interior of Building 1, southeast end

Concrete flooring extends throughout the interior of the structure and the doorway communicating with Building 2 (lower right in Plate 6) retains its wooden plank door.

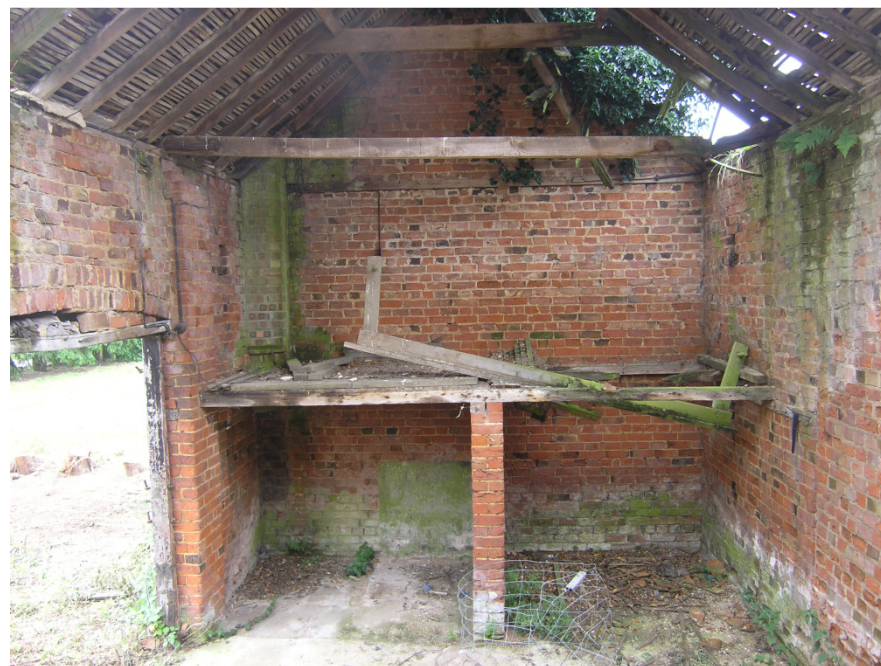
Plate 7: Interior of Building 1 – northwest end

The northwest end of the barn, beyond the opposing barn doors, is occupied by a mezzanine type structure (Plate 7). The floor structure of joists and plank boards rests upon a brick plinth and timber battens on the walls (Plates 9 & 10).

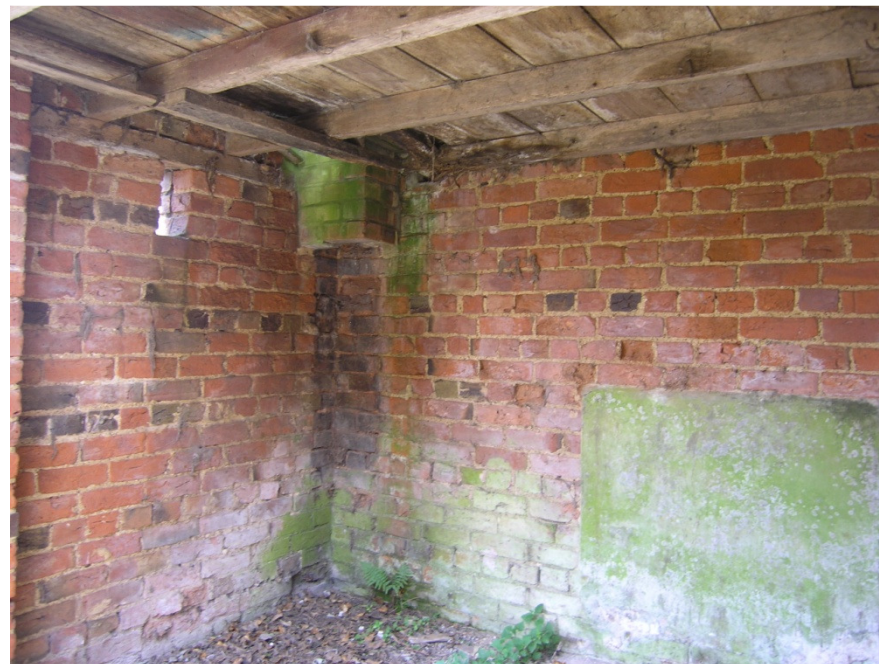
Plate 9: Base of chimney at western corner of Building 1

A chimney (see *Plate 9* and chimney on *Plate 1*) rises through the mezzanine floor at the western corner of the building. The lower extent of the structure has been demolished but dark staining on the walls indicates the position of the flue. Built from machine made bricks, the structure does not appear to be an original feature and is not keyed into the wall. The most likely function of the feature would have been as the flue for equipment used in fodder preparation, probably located in the adjacent area where the walls are lined with cement (*Plates 9 & 10*).

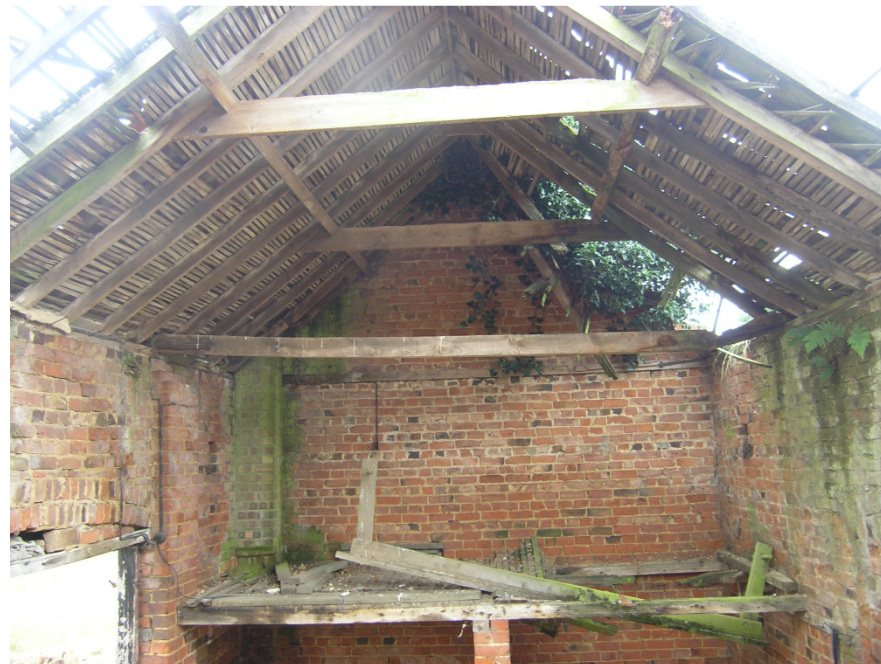
Plate 11: Surviving part of the roof in Building 1

The roof is in poor condition and only survives in relatively complete form in the north-western part of the building. The structure rests upon timber wall plates and comprises rafters and purlins with collar ties at approximately mid height (*Plate 11*); the surviving collar ties are set 5 rafters apart. A complete tie-beam remains in position at the northwest end of the building (see *Plate 11*) and part of another hangs from an attachment on the northeast wall (see *Plate 6*).

The rafters are covered by laths in the surviving part of the roof and fragments of plaster occur in areas near the wall plate (see *Plate 11*, left of frame), which would suggest that the areas between the rafters were originally plastered.

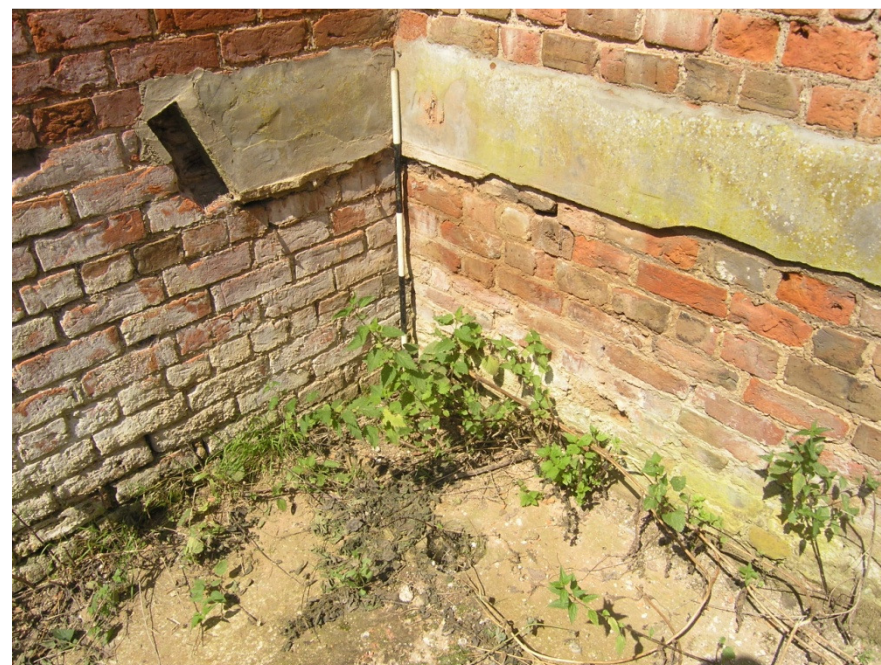
Plate 16: Building 2 – northwest end of the manger in Unit A (1m scale)

In Unit A the manger was approximately 0.75m above floor level, resting upon supports indicated by three sockets beneath; two of the sockets contain the sawn off ends of timbers. Sloping recesses in the adjacent walls (*Plate 15*) mark the position of the front of the manger while three sockets in the concrete floor indicate the positions of upright supports (one shown in *Plate 16*).

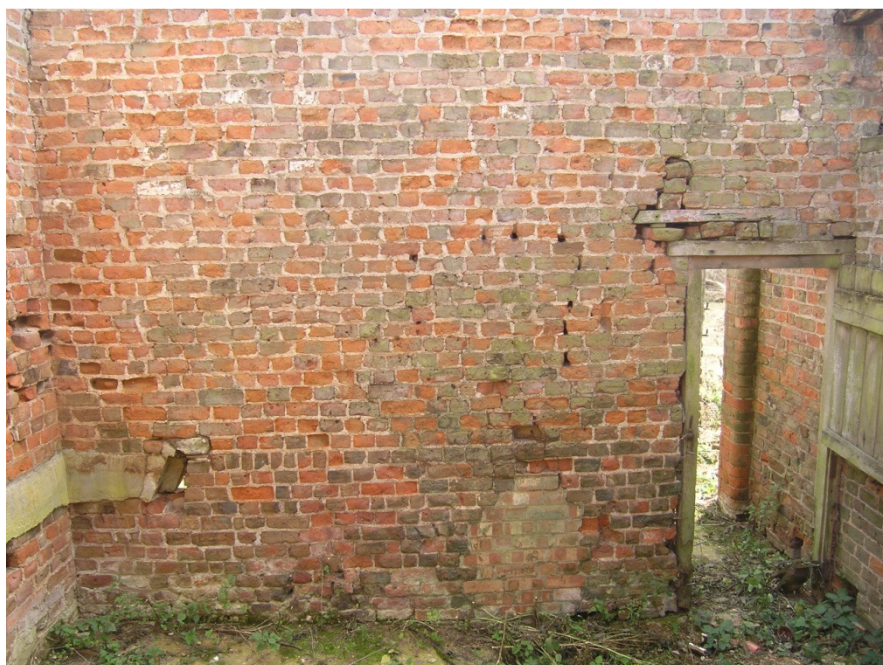
Plate 17: Building 2, Unit A – internal wall and door to Unit B

The internal wall (Plate 17) contains a doorway connecting to Unit B, which also aligns with the door into Building 1. There is a repair in modern brick at the base of the wall.

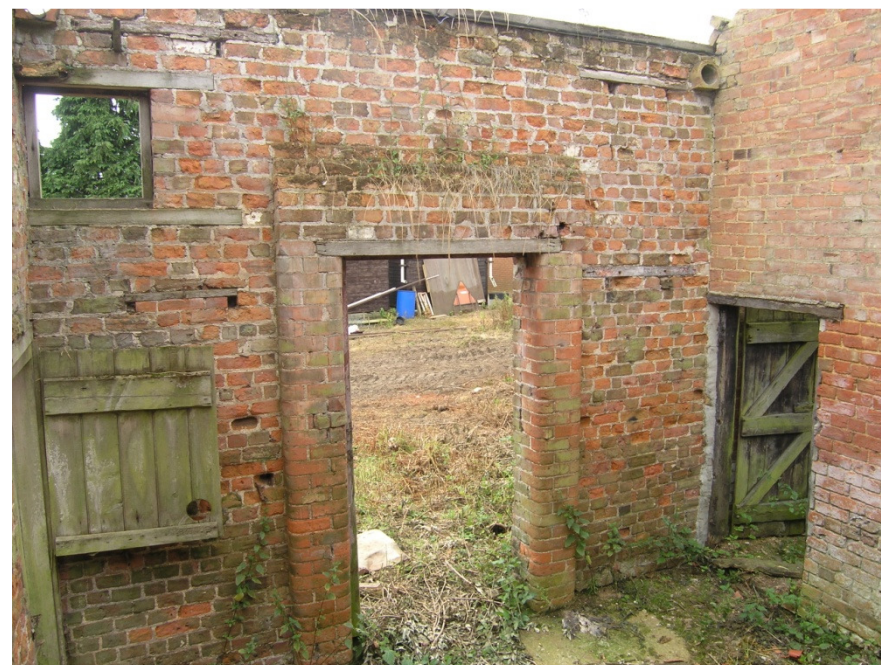
Plate 18: Building 2, Unit A – southwest side

The sides of the doorway, formed from machine made, bullnosed bricks, project from the face of wall. There is a stepped out plinth above (built in hand made brick) resting upon a timber lintel over the door (Plate 18).

Horizontal timbers are let into the wall either side of the door and at the level of the cylindrical vents (Plate 18). Another timber extends above the internal door connecting A and B (Plate 17). There is also a timber projecting from a socket located high in the wall, above the internal door (just visible in top right of Plate 17), continuing from Unit B (see below).

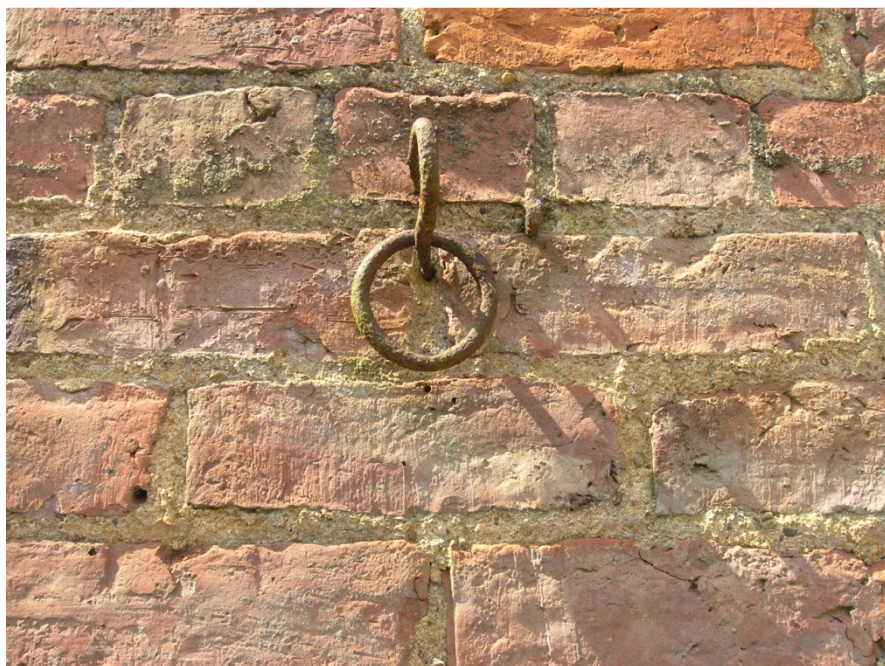
Plate 19: Building 2, Unit A – tethering ring attached to northwest wall

A tethering ring is located to the side of the ventilation slot just mentioned (*Plates 4 and 19*)

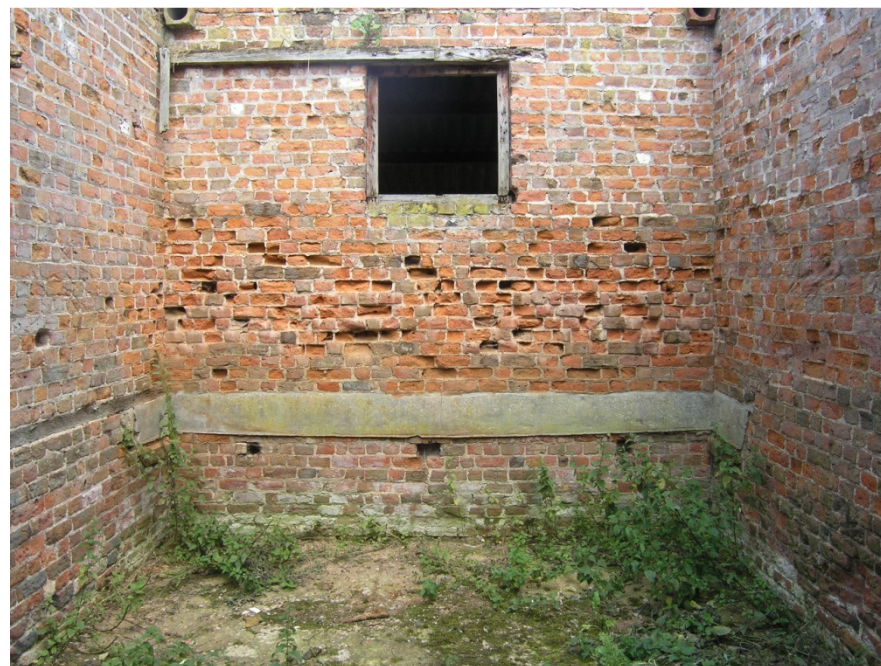
Plate 20: Building 2, rear of Unit B

Unit B has a similar arrangement for a manger, differing only in the number of upright supports (two in Unit B, see *Plate 20*) and the survival in Unit B of timbers components let into the walls at the side (also *Plate 21*).

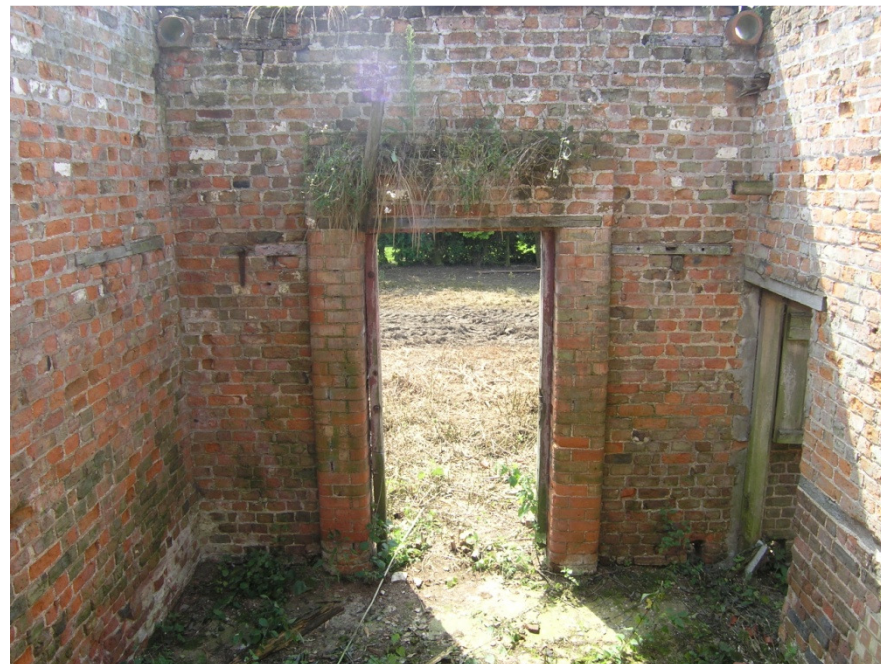
Plate 22 Building 2, Unit B – southwest side

The door in Unit B (Plate 22) is identical to Unit A and there are similar arrangements of timbers let into the walls (Plate 23). There is, however, an iron peg projecting from the timber southeast of the door and a spanner looped over the peg (Plate 24). The timber in the end wall had two sockets below - presumably for supports to a timber structure - and a hinge on its face.

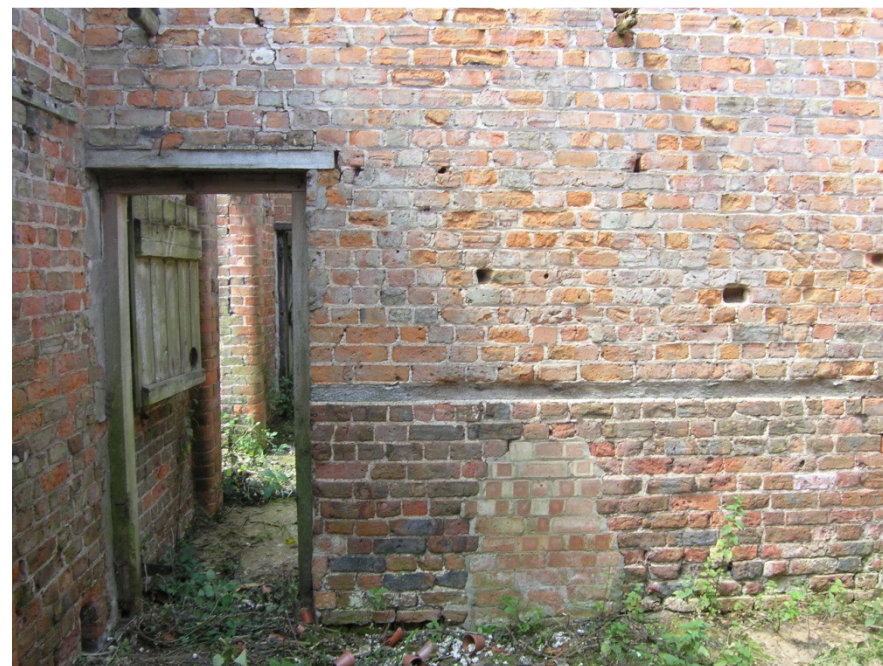
Plate 24: Building 2, Unit B – door to Unit A and repair in the internal wall

A timber is let into the internal wall in Unit B, at a level immediately above the manger (Plate 24). Above the level of the door in the internal wall are two projecting timbers set at a common level (see also Plate 24). The latter may be interpreted as supports for a shelf.

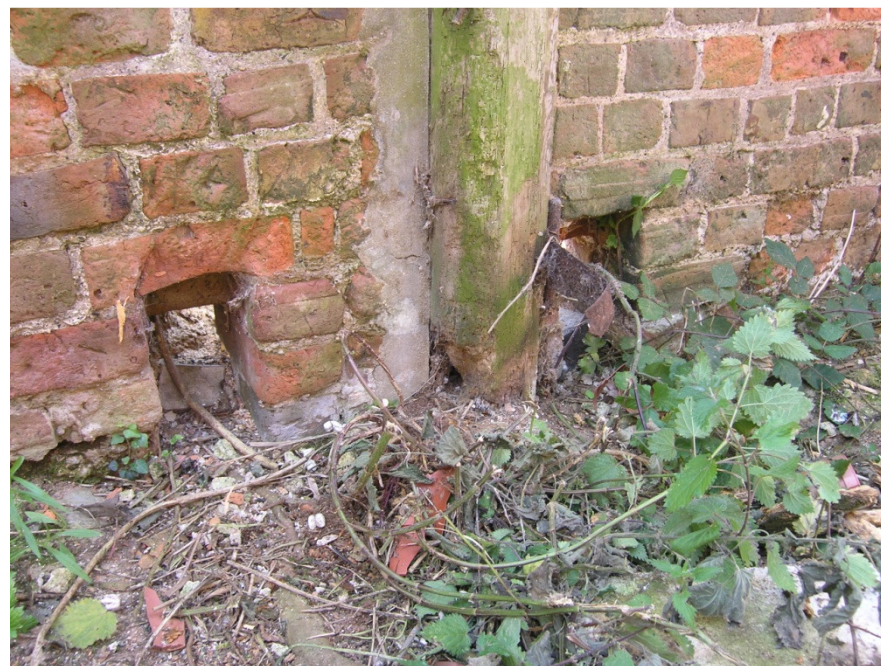
Plate 26: Building 2, Units A & B – floor level openings

Two small openings in the brickwork were present at ground level in Building 2, located in external wall, either side of the connecting door (*Plate 26*).

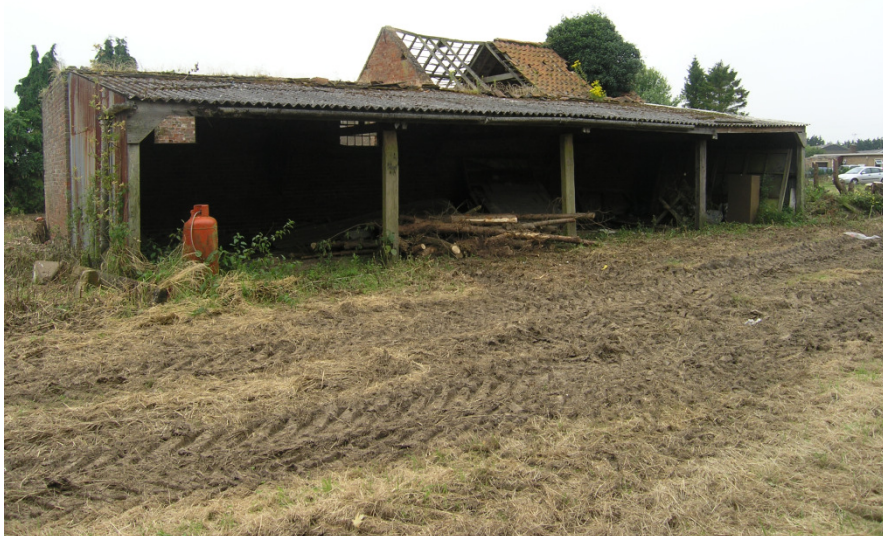
Plate 27: Building 3 – view from the east, looking west

Building 3 is an open sided shed or lean-to constructed against the rear walls of Buildings 1 and 2 (*Plate 27*). The roof covering of corrugated asbestos sheets rests upon three trusses attached to rear wall of brick structure at one end and carried by timber post at the other (*Plate 28*). Sheets of corrugated iron enclose the ends of the structure.
