A report to Hereward Homes Ltd.

September 2014

## **MANOR FARM, MANOR FARM LANE, ESSENDINE, RUTLAND**

### **Historic Building Recording**

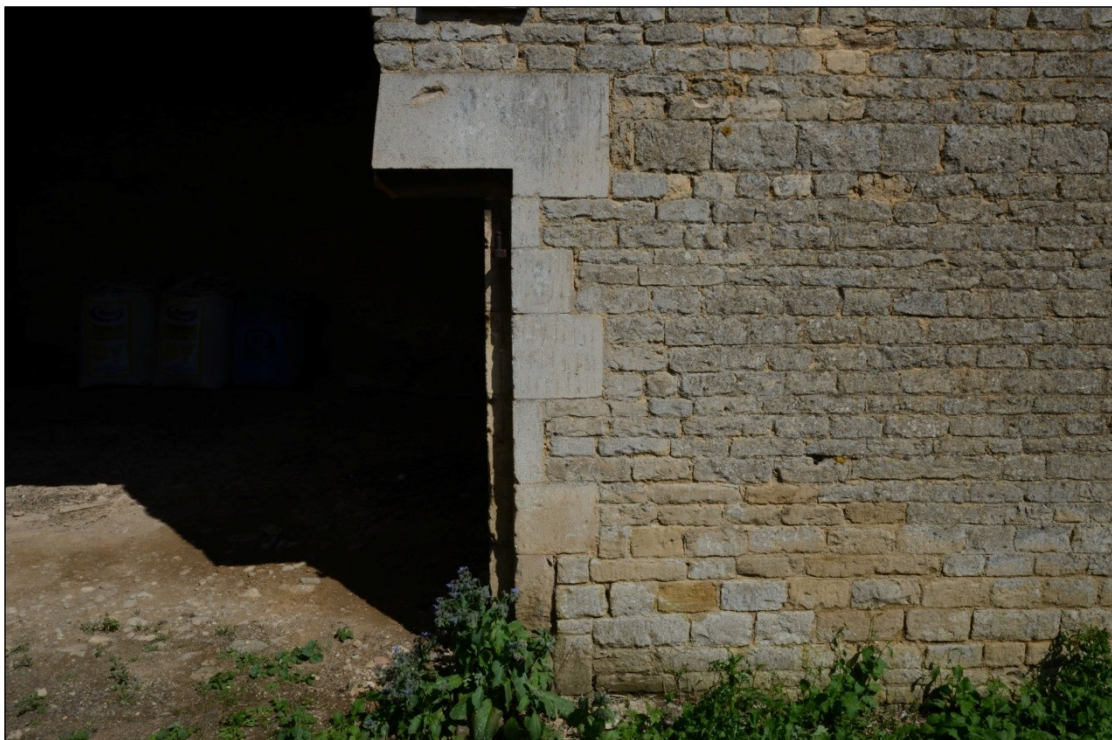
Commencing at the northern end of the west elevation, the gable of the two-storey structure (*Plates 2 and 57*) features a large opening inserted for access by modern farm machinery. The gable above is supported by a steel girder. Part of an original doorway survives at ground floor on the south side of the opening, defined by detailing in dressed stone and a stone lintel (*Plate 3*). The treatment is identical to that seen around the openings elsewhere in Unit 5.

*Plate 2: Buildings east of the access track; west facing elevations, looking north*

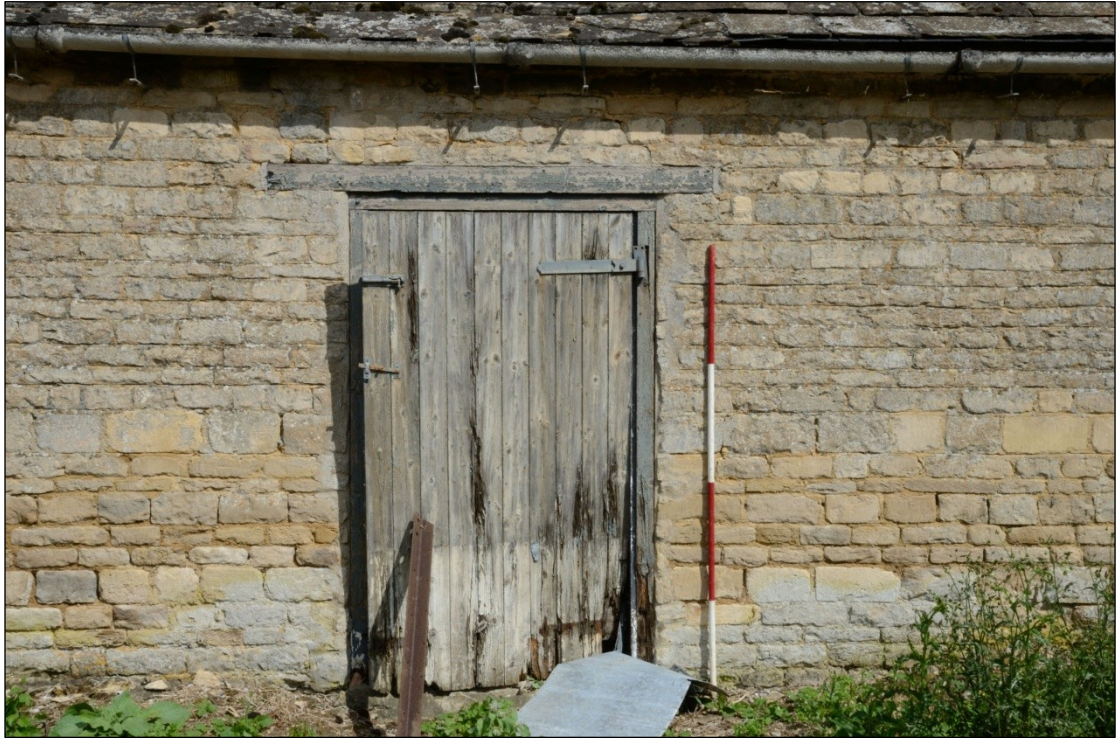
The adjacent chaff house (5B) features a door at its southern end (*Plate 5*) and a pitching door at high level to the north (*Plate 4*). The pitching door retains a wooden plank shutter. The stables (5C) have a single door (*Plate 6*) in the west elevation with a timber lintel and frame. The fact that the door is not in keeping with other openings in Building 5 suggests that it is a later insertion.

*Plate 5: Door in the west wall of Building 5B, looking east-northeast*

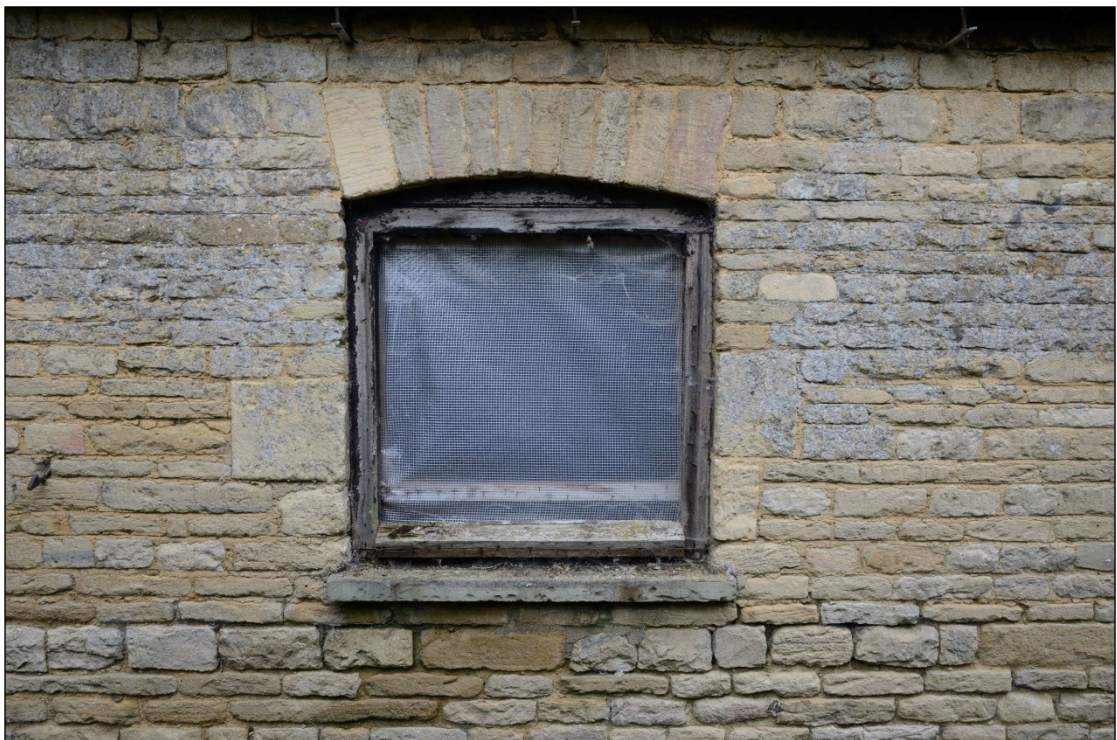
The door to the stable is positioned centrally in the wall to the area (*Plate 10*) with windows/vents placed symmetrically to either side (*Plates 9 and 11*). Although the door has been bricked up and a window inserted, the hooks for split stable doors are intact.

*Plate 10: Former door in the east wall of Building 5C, looking west-southwest (2m scale)*

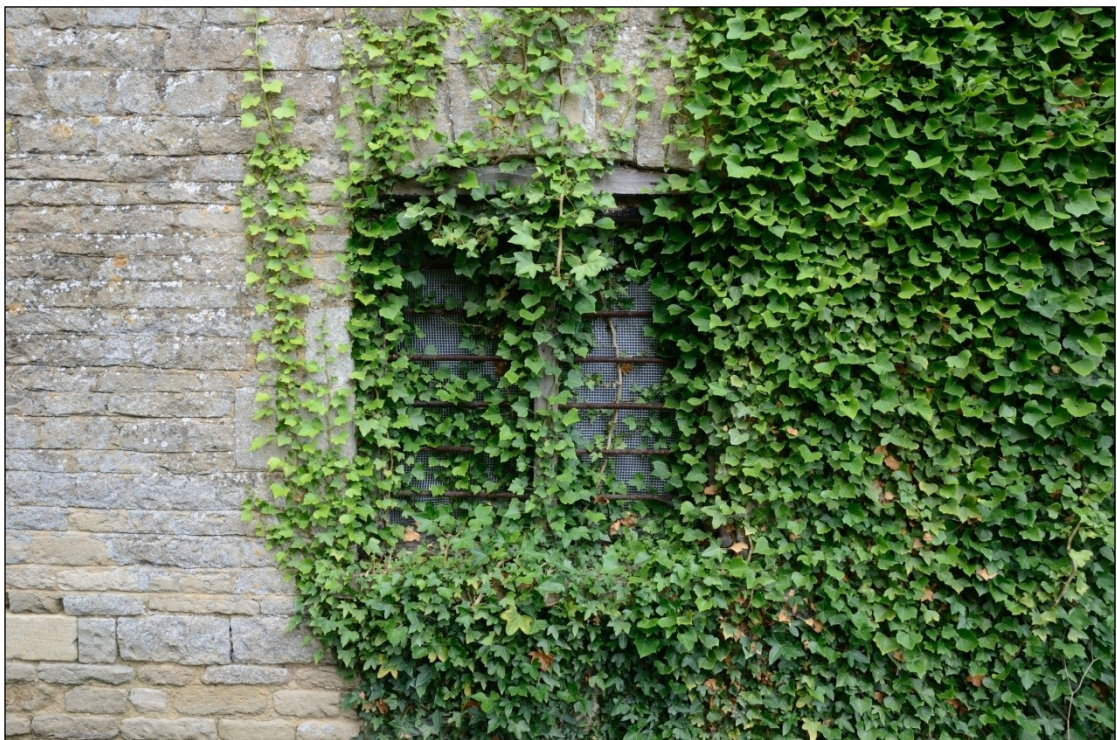
The east elevation of 5B (the chaff house) is heavily obscured by vegetation (*Plate 12*) but appears to be plain except for two windows/vents at ground floor. The southernmost vent (*Plate 13*) contains horizontal iron bars while the northernmost retains a wooden plank shutter (*Plate 14*).

*Plate 12: East side of Building 5B, looking southwest (2m scale)*

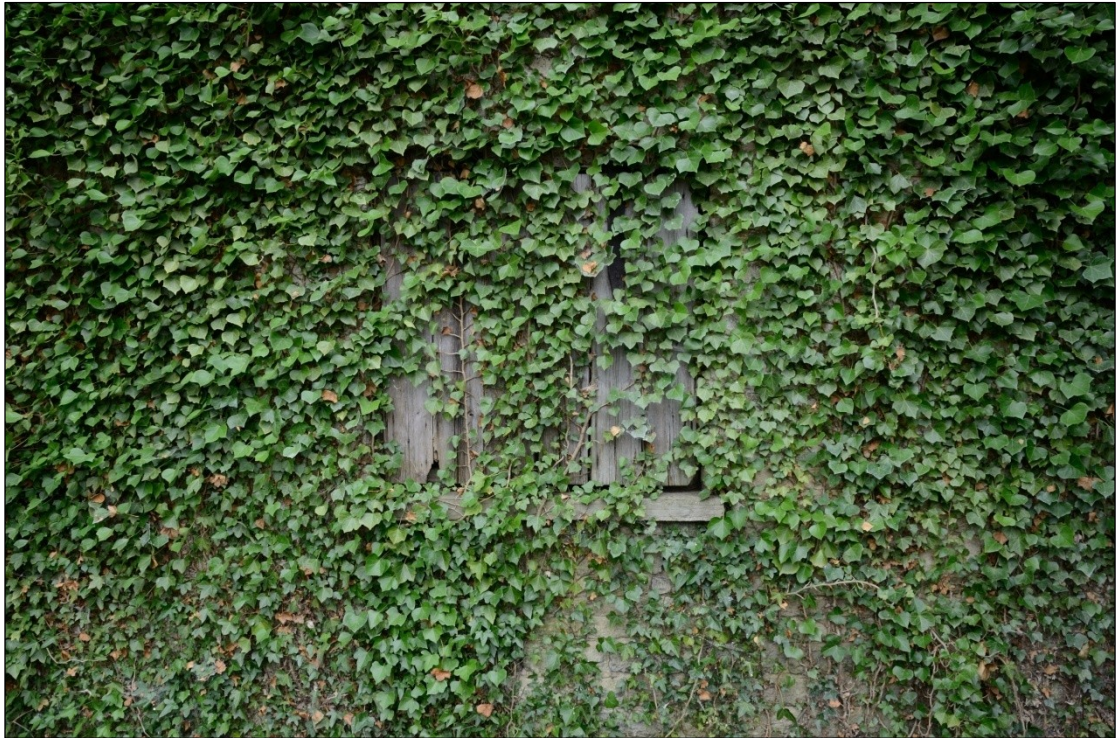
*Plate 13: Window in the east wall of Building 5B, looking west-southwest*

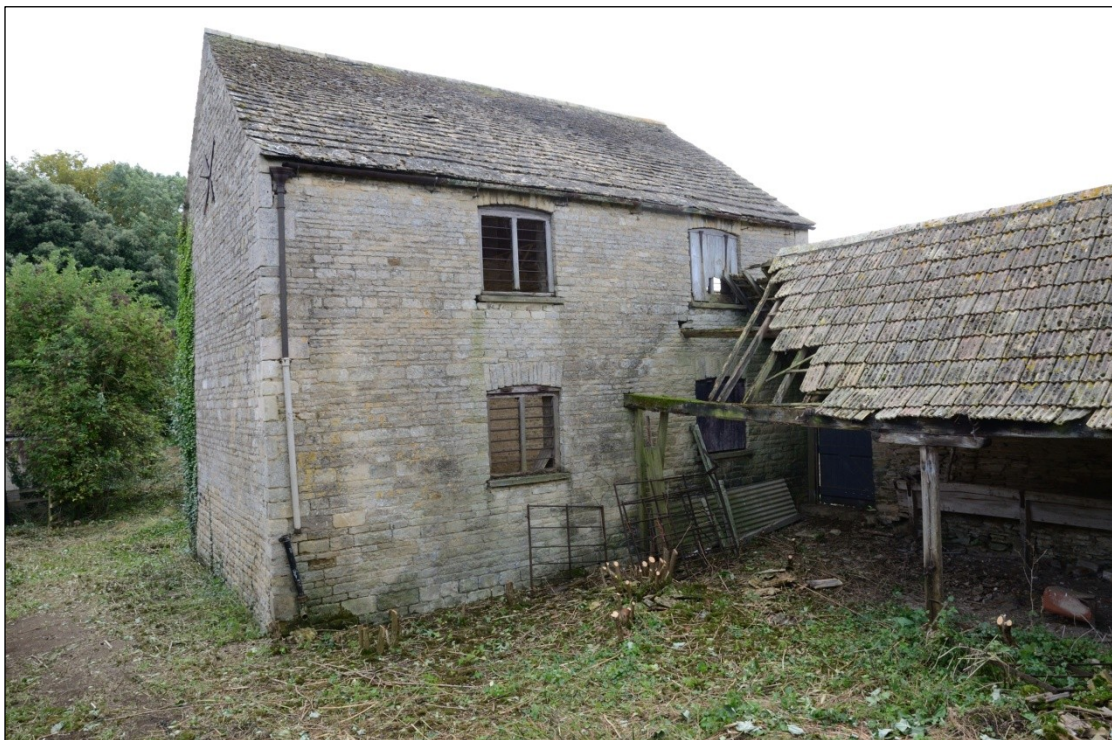
The east gable is plain, except for a tie-plate at approximately eaves level (*Plate 16*). The north elevation (*Plate 17*) contains four openings for windows/vents arranged symmetrically on ground and first floors. The windows are barred in similar fashion to those in 5B (*Plate 18*) and a wooden plank shutter survives in the westernmost ground floor example (*Plate 19*).

*Plate 16: East facing elevation of Building 5A, looking northwest*

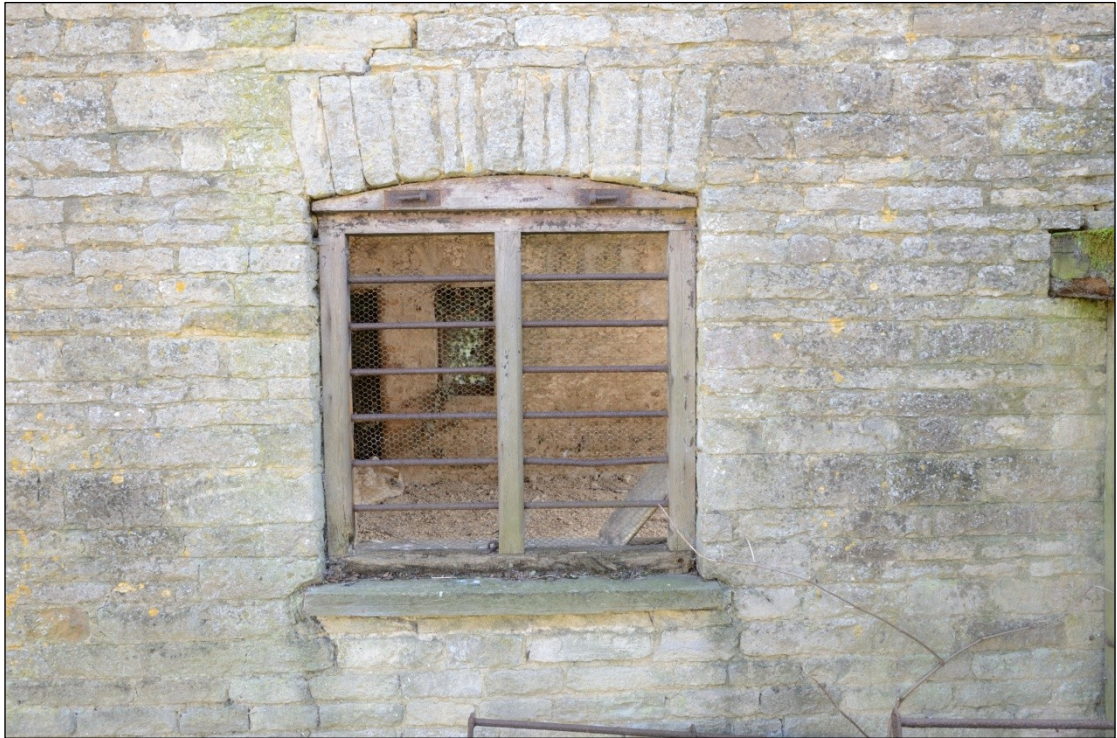
*Plate 17: North facing elevation of Building 5A, looking south*

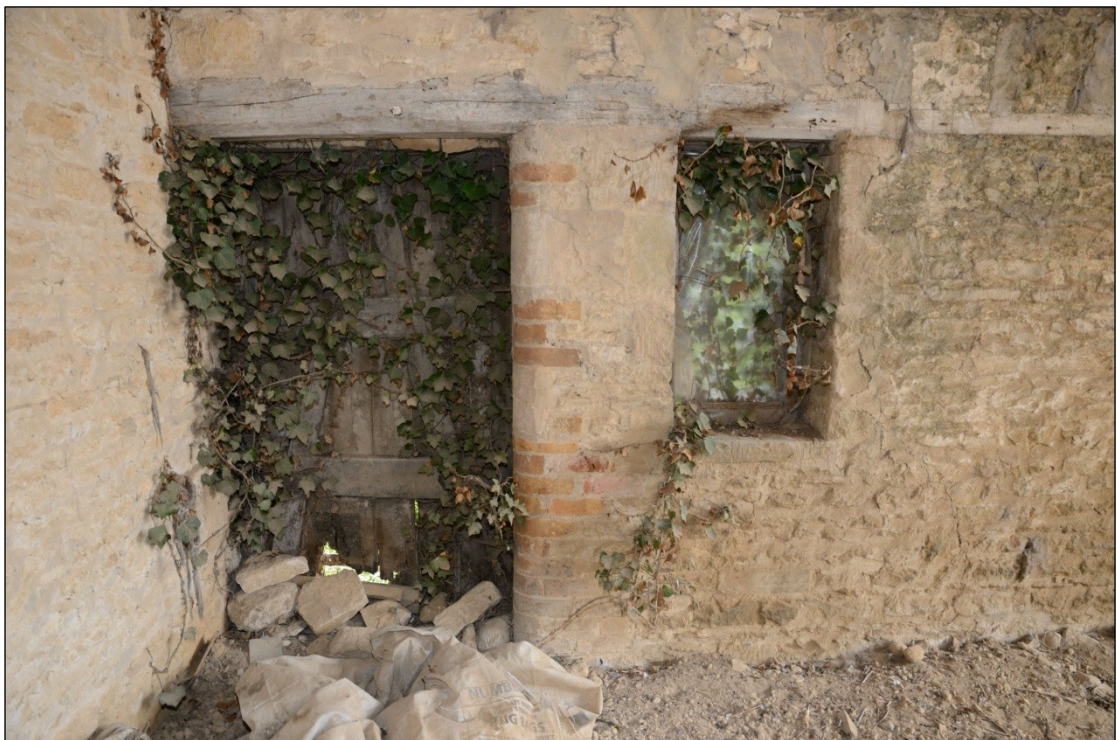
The south wall of building 5A is also heavily obscured by vegetation (*Plate 15*) and little can be seen of the openings for a door and windows which are visible in the interior of the building (see *Plates 24 and 25* as well as descriptive text below).

*Plate 24: Interior of the south wall in Building 5A, looking south-southwest*

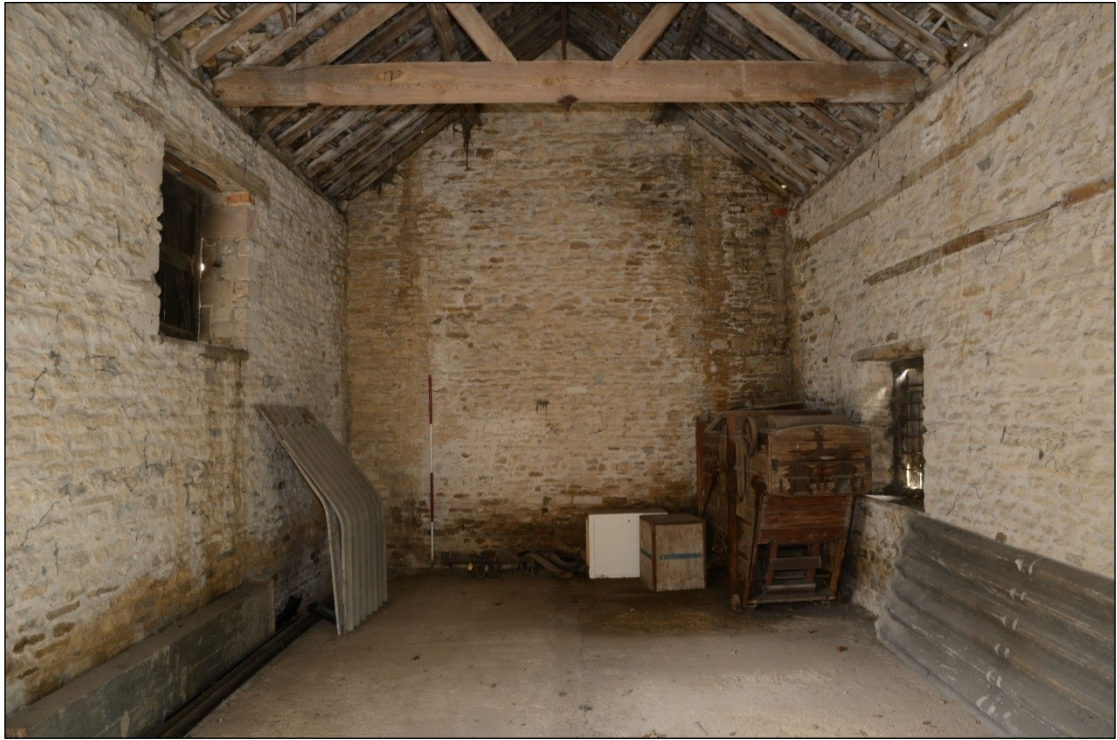
*Plate 25: Ground floor door and window on the south side of Building 5A, looking south-southwest*

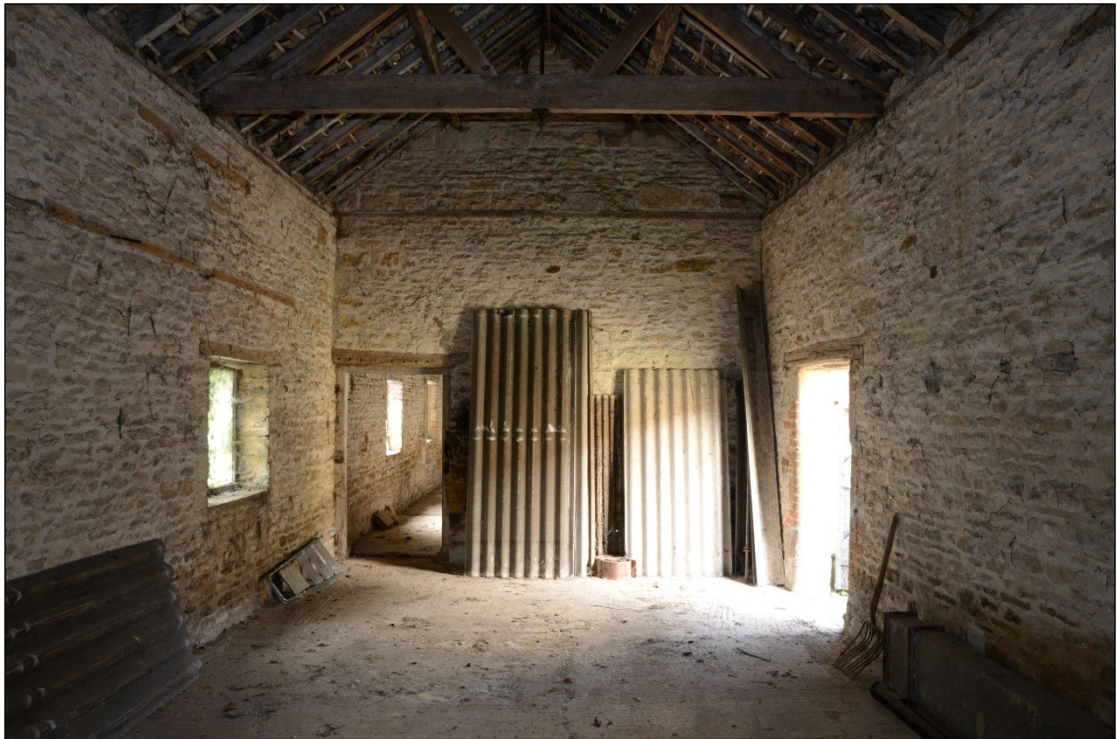
Building 5B – presumably a chaff house – features high walls and is open to the roof (*Plate 26*). At the southern end there is a doorway providing access to and from the stable (5C). The doorway features a timber lintel above and has a wooden frame (*Plate 28*) but the door is missing. The door in the west wall (*Plate 29*) has rounded edges formed by dressed limestone and bull-nosed bricks, similar to the door in 5A. There is graffiti on both inside faces of the doorway including the date ‘1915’ on the south side (*Plates 30 and 31*). There is a pitching door high in the west wall (*Plate 32*) and two windows/vents in the east wall (*Plate 33*). The roof is identical in construction to 5B, having two trusses (*Plate 34*). A modern concrete floor extends throughout the unit.

*Plate 26: Northern end of Building 5A, looking north-northwest (2m scale)*

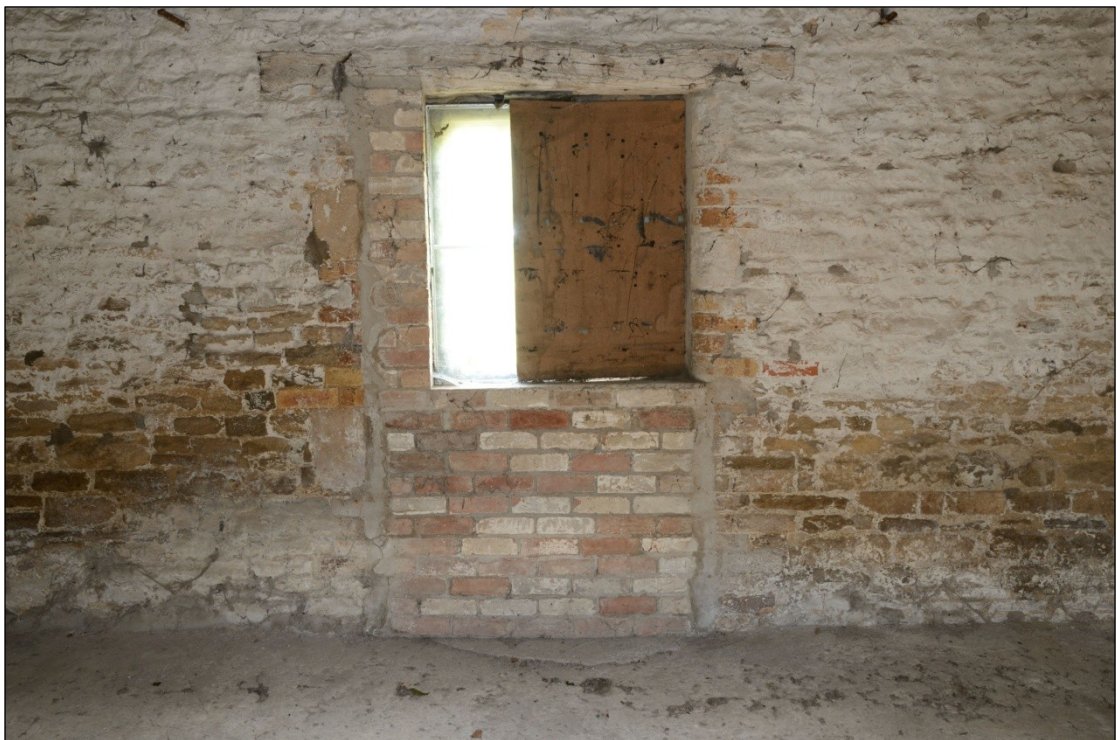
*Plate 36: North end of Building 5C, looking north-northwest*

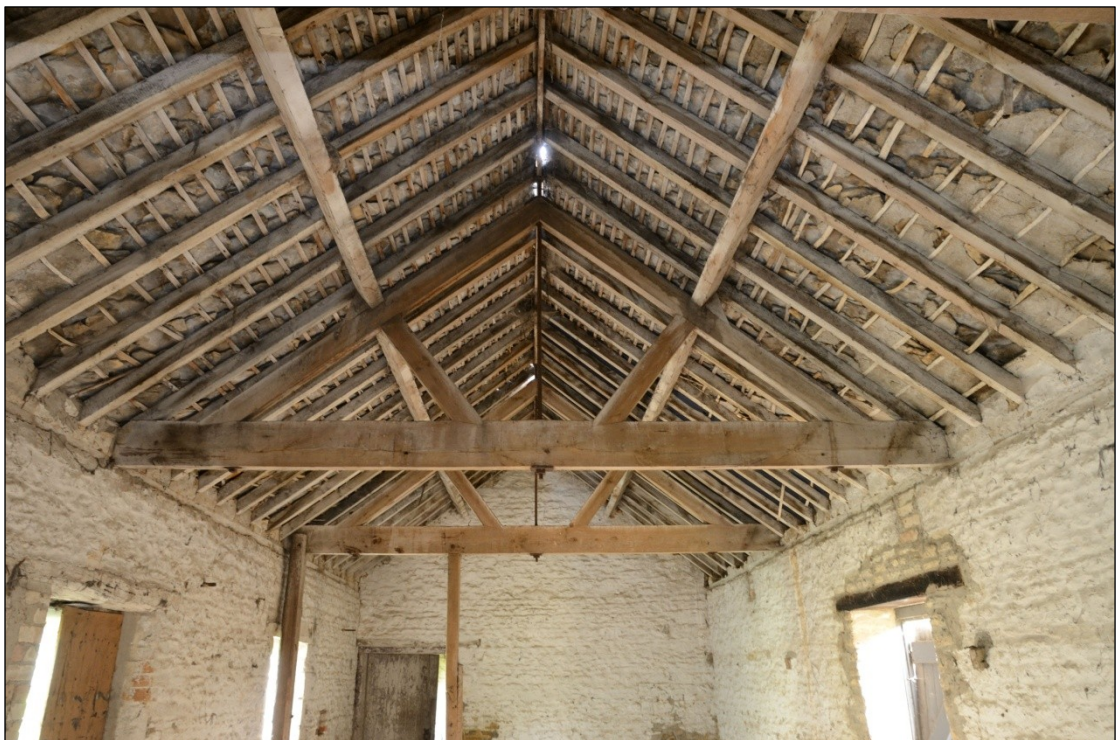
Mangers originally extended along the entire length of the west side of the building. Their top levels can be determined from the extent of limewash (absent in the areas covered by the mangers) and crude repairs to the masonry below the level of the limewash (see *Plates 35, 37 and 39*). There are square vents/windows either side of the east door (*Plate 38*) and recesses near each end of the passage where curry combs and brushes might have been kept (*Plates 40, 41 and 42*). The northernmost recess has been infilled with brick (*Plate 42*). The roof comprises three trusses, which are identical in construction to those in 5A and 5B (*Plate 43*).

*Plate 42: Recess in the east wall of Building 5C, looking east-northeast*

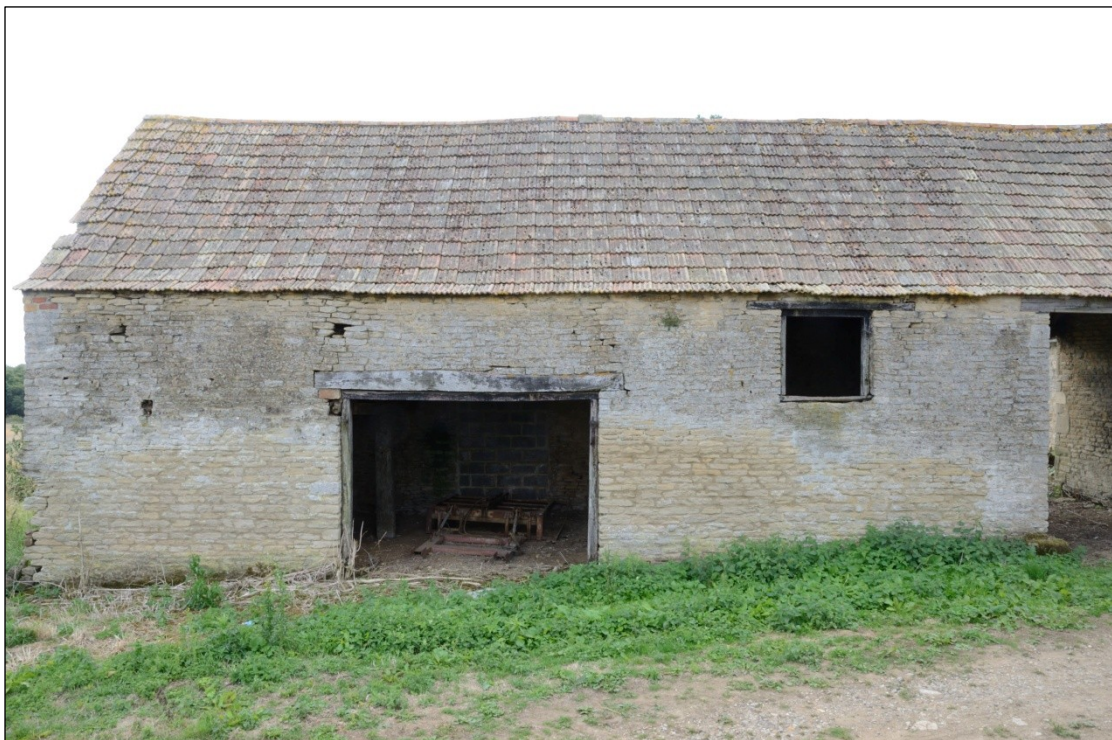
Building 1 features a large ‘barn’ type doorway in the north elevation flanked by a pitching door to the west (*Plate 51*). Both openings have timber lintels and frames but the doors are missing from both (*Plates 51 and 53*). There is a gap between Buildings 1 and 2 bridged by wooden beams to support a continuous roof across (*Plate 54*). The buildings are gabled to either side of the opening (*Plates 55 and 56*) and an offset stone at the northwest corner of Building 1 incorporates a lead setting for the pin of a door or gate. There is also a groove in the side of the stone, which may have received a wooden shutter used to close the opening.

*Plate 50: Buildings 1, 2 and 4, north and west facing elevations; looking southeast*

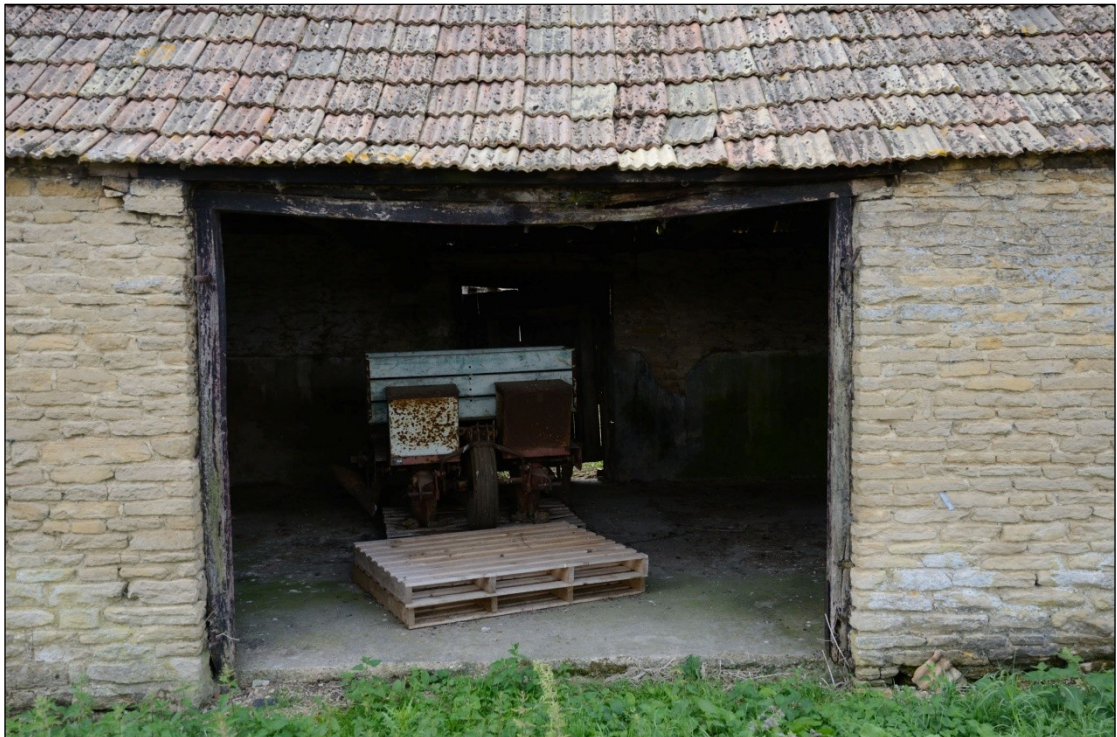
Building 2 features a large, barn-type door in the north elevation, extending the full height of the wall (*Plate 57*). It is spanned by a timber lintel and there are wooden uprights to either side. The door is missing.

*Plate 56: East elevation of Building 2, looking southwest*

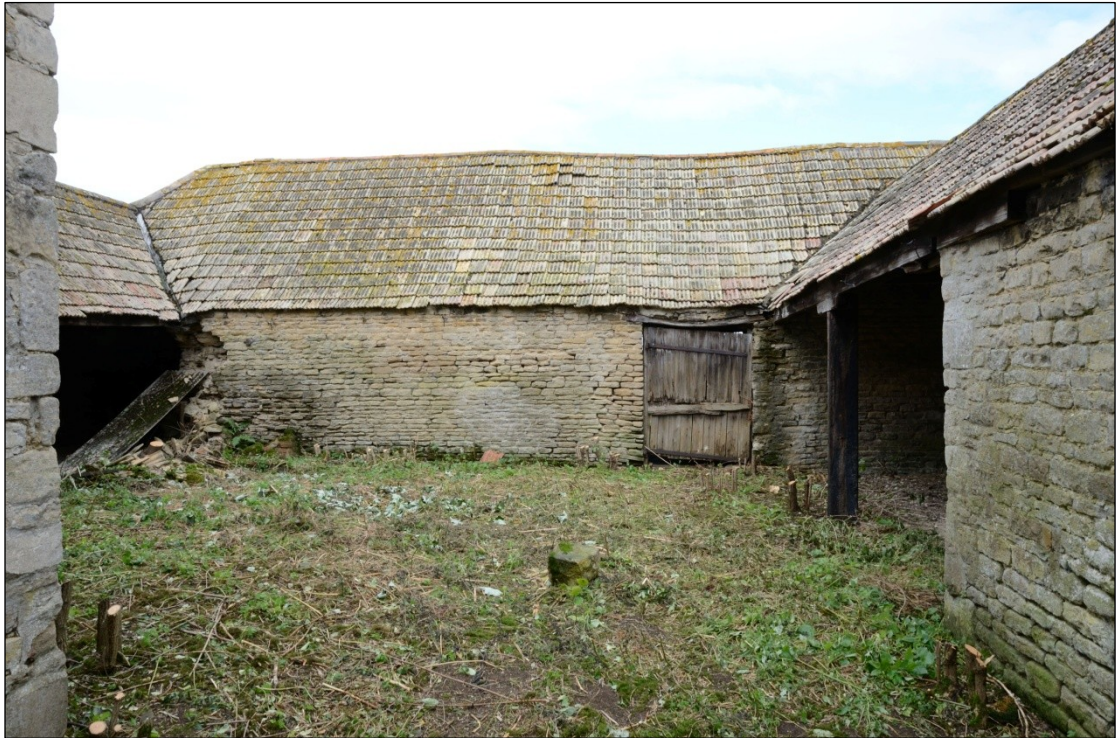
Building 4 is open fronted on the east side (see *Plate 17*), where it faces into a small yard bounded by Building 2 to the north and another shelter shed (Building 3) to the east (*Plate 60*). Building 4 abuts Building 5, partially obscuring the first floor window on the west side of the latter, and enclosing the window/vent beneath (see also *Plate 17*). The southern elevation of Building 2 includes a door (*Plate 61*) situated immediately west of the shelter shed (Building 3). The plank door is in poor condition and the wooden lintel is severely bowed. There has been some collapse of masonry at the southwest corner of Building 2.

*Plate 59: Door in the west wall of Building 4, looking east-northeast*

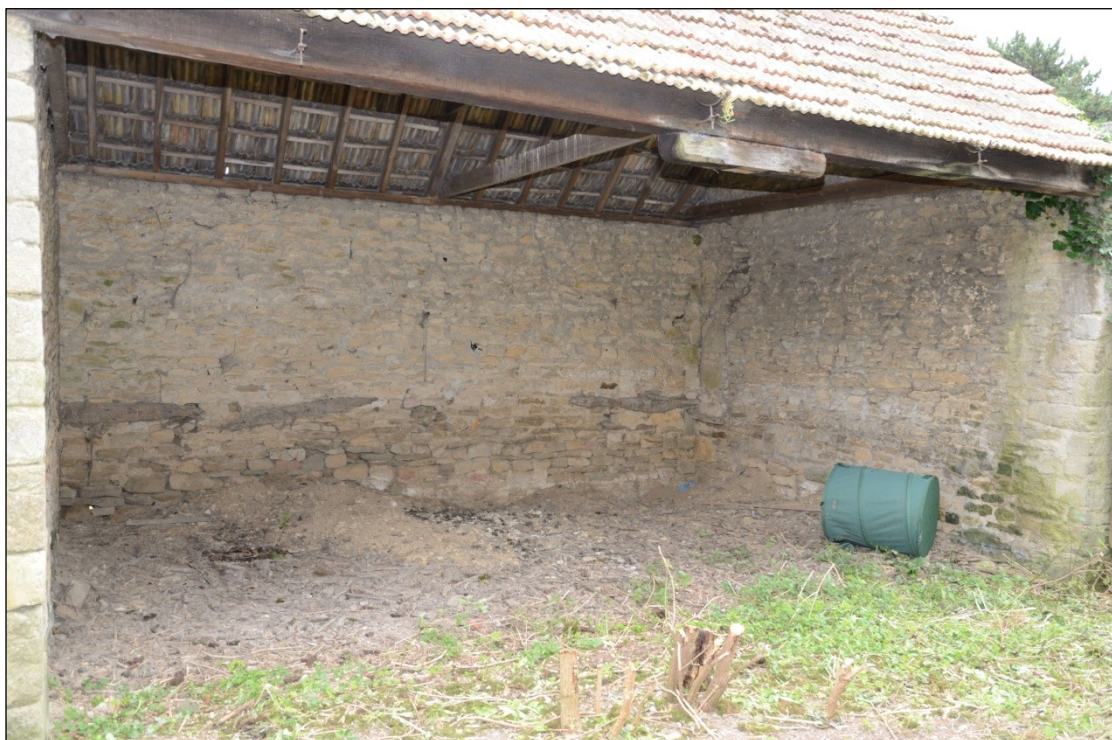
Unit 3B opens to the yard on its west side (*Plates 86 and 87*). Discolouration and irregularities in the lower extents of the walls hint at the former presence of mangers.

*Plate 86: Interior of Building 3B, looking north-northeast*

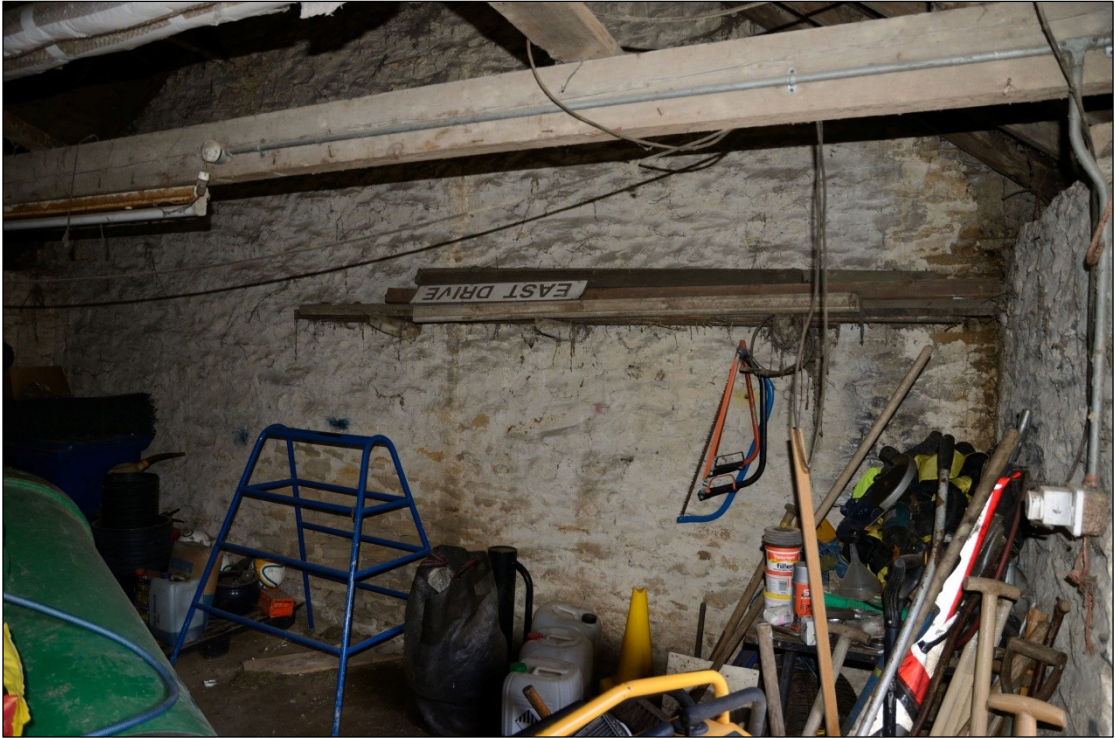
The lock-up garage 6C is limewashed and there are few indicators of original use, but the building could have functioned as a loose box or storage area (*Plates 107, 108 and 109*). The unit has a brick floor (*Plate 110*).

*Plate 107: Interior of Building 6C, looking north-northwest*

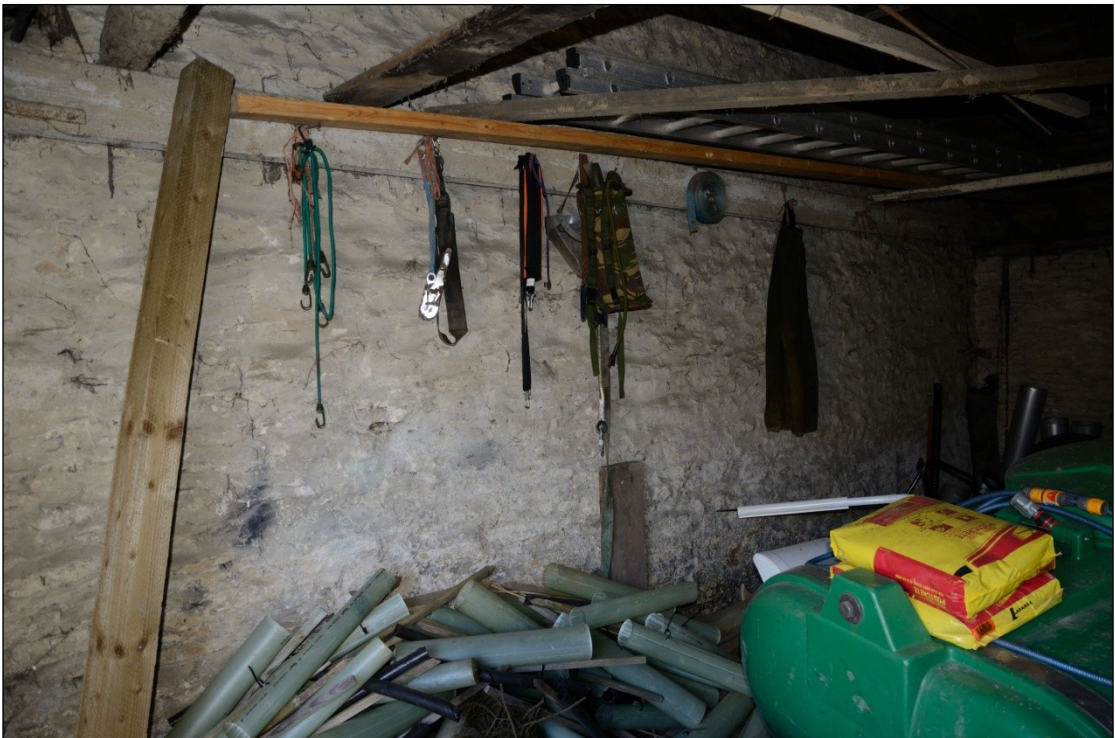
*Plate 108: Interior of Building 6C, looking west-northwest*

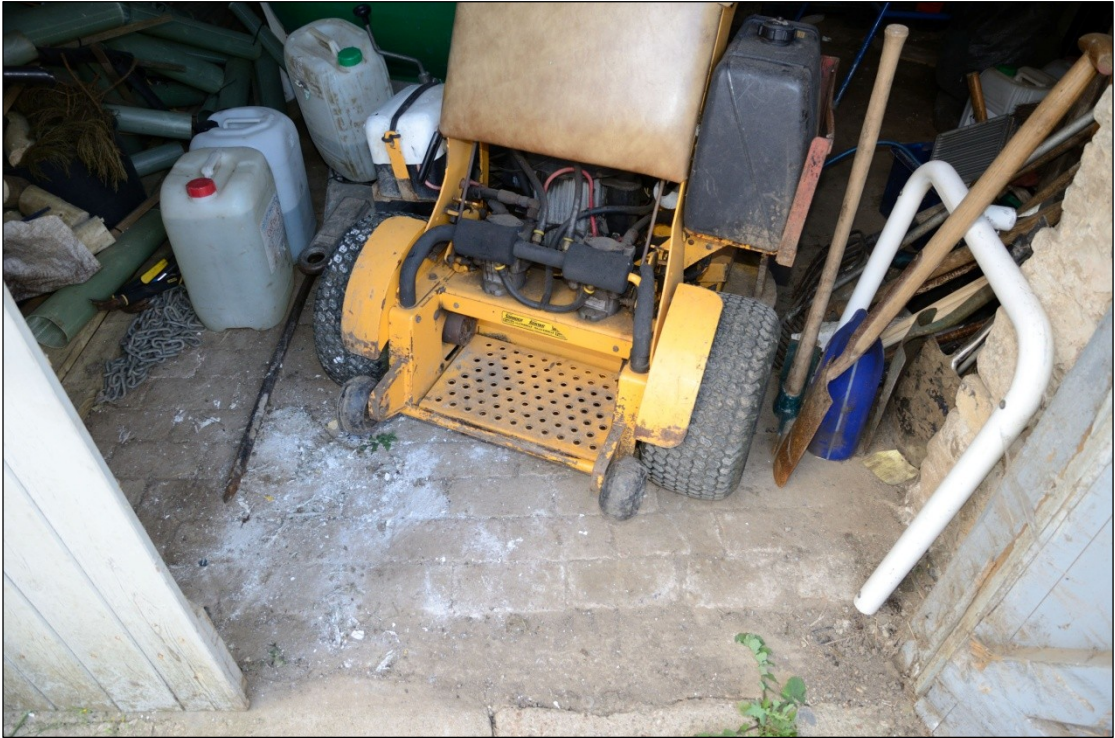
*Plate 109: Interior of Building 6C, looking southwest*
