BARNS AT PARK HOUSE, GOREFIELD ROAD LEVERINGTON, CAMBRIDGESHIRE

Historic Building Recording

BARNS AT PARK HOUSE, GOREFIELD ROAD, LEVERINGTON, CAMBRIDGESHIRE

CHER Event No. ECB3841
Museum Accession No.: TBC
OASIS ID.: withamar1-189800
Planning Application Nos.: F/YR11/0259/LB & F/YR110258/F
NGR: TF 4352 1199

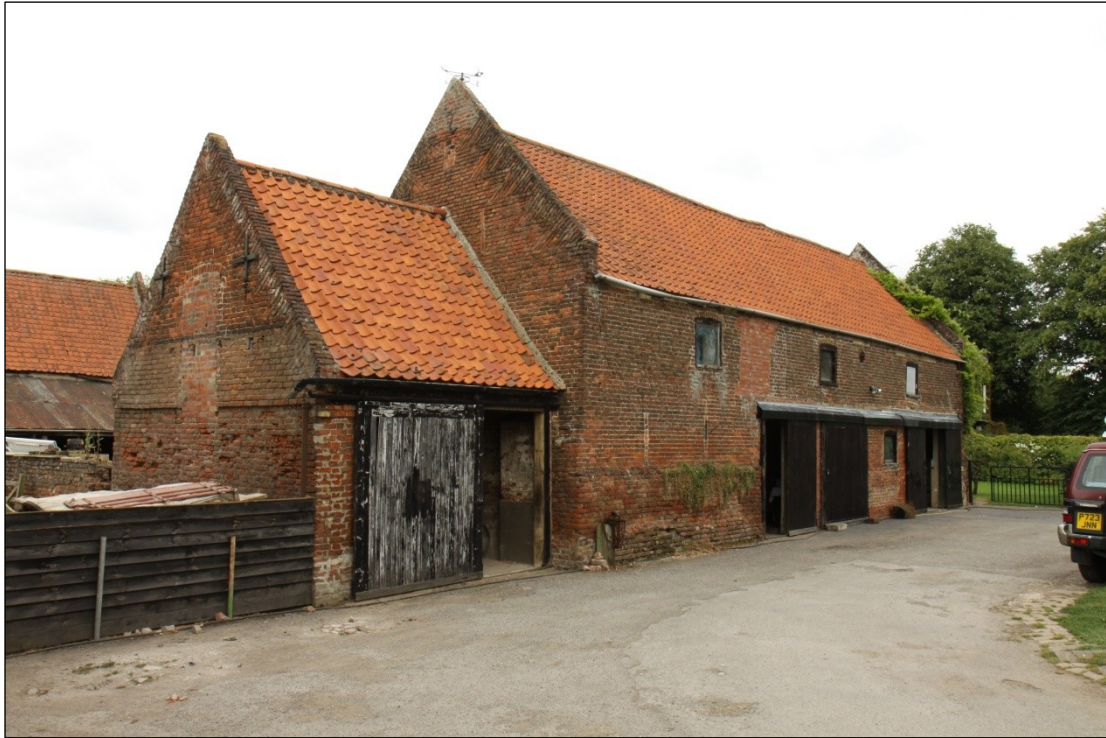
Plate 1: General view of Barn 1, looking northeast

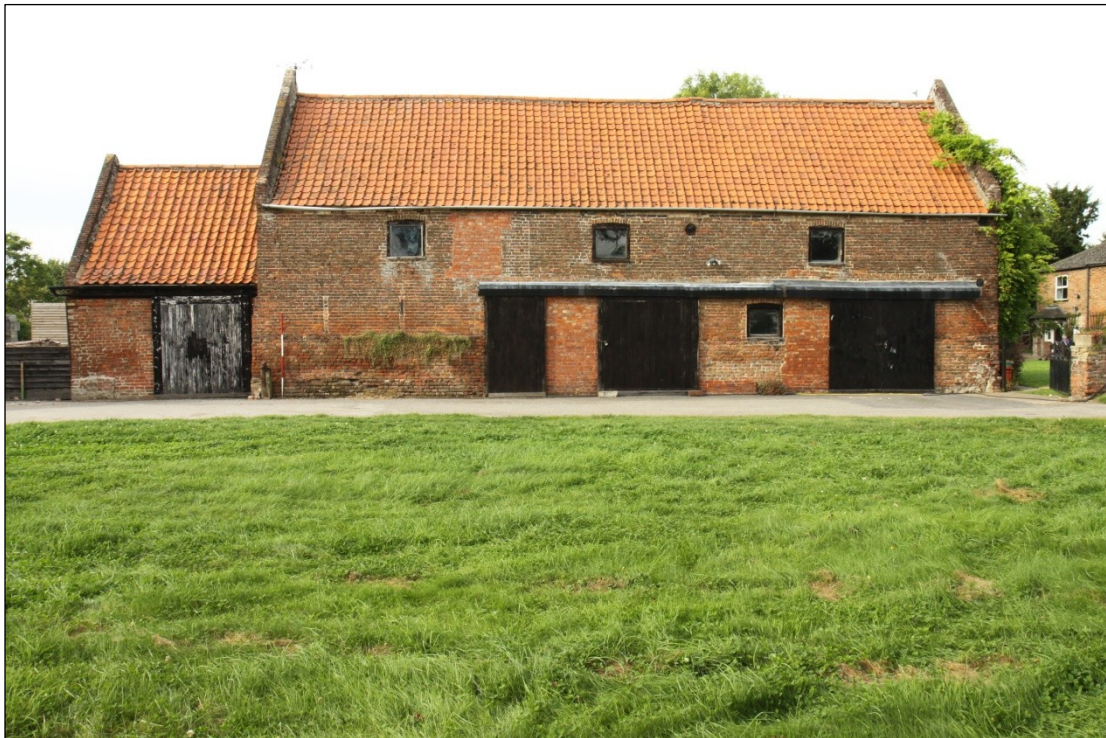
Two bricked up ventilation slots (*Plate 6*) relating to original use as a threshing barn are visible in the south facing elevation (*Plate 4*) of the building, while a wide opening in the centre of the elevation marks the position of the original south door. The west side of the door has been substantially rebuilt (probably as part of alterations to form the stables) and may have resulted in an alteration to the original width.

Plate 4: South facing elevation of Barn 1 with 2m scale, looking north

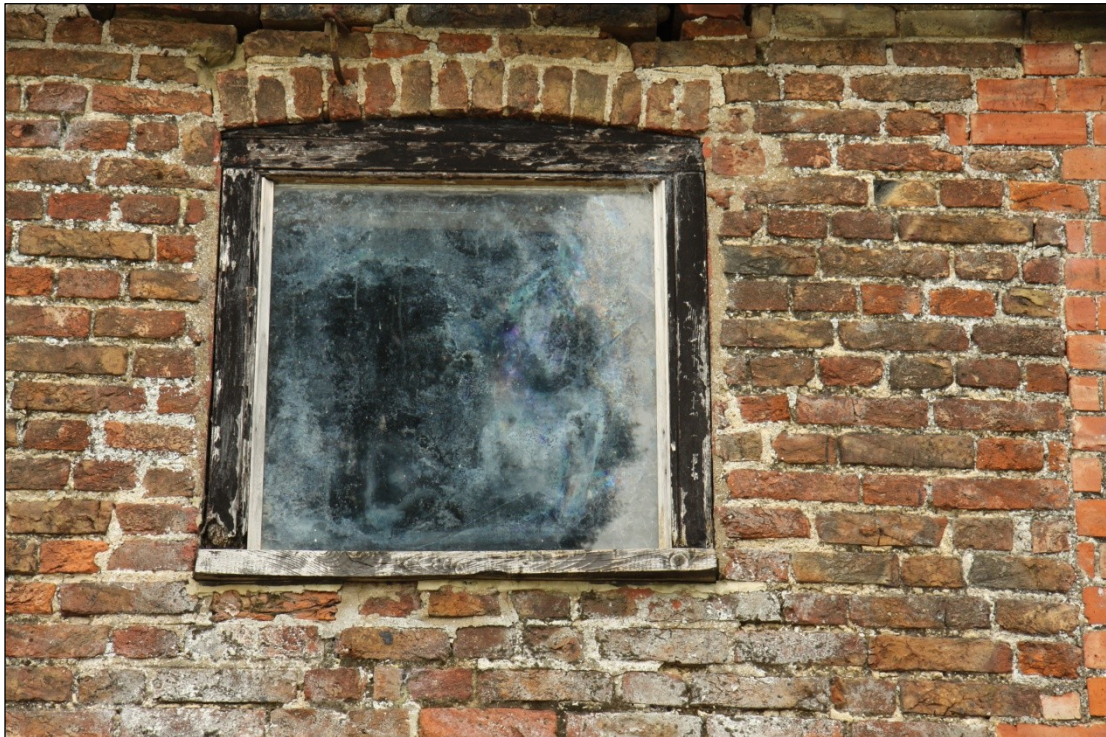
Plate 7: Second floor window located over ventilation slots in the south facing elevation of Barn 1

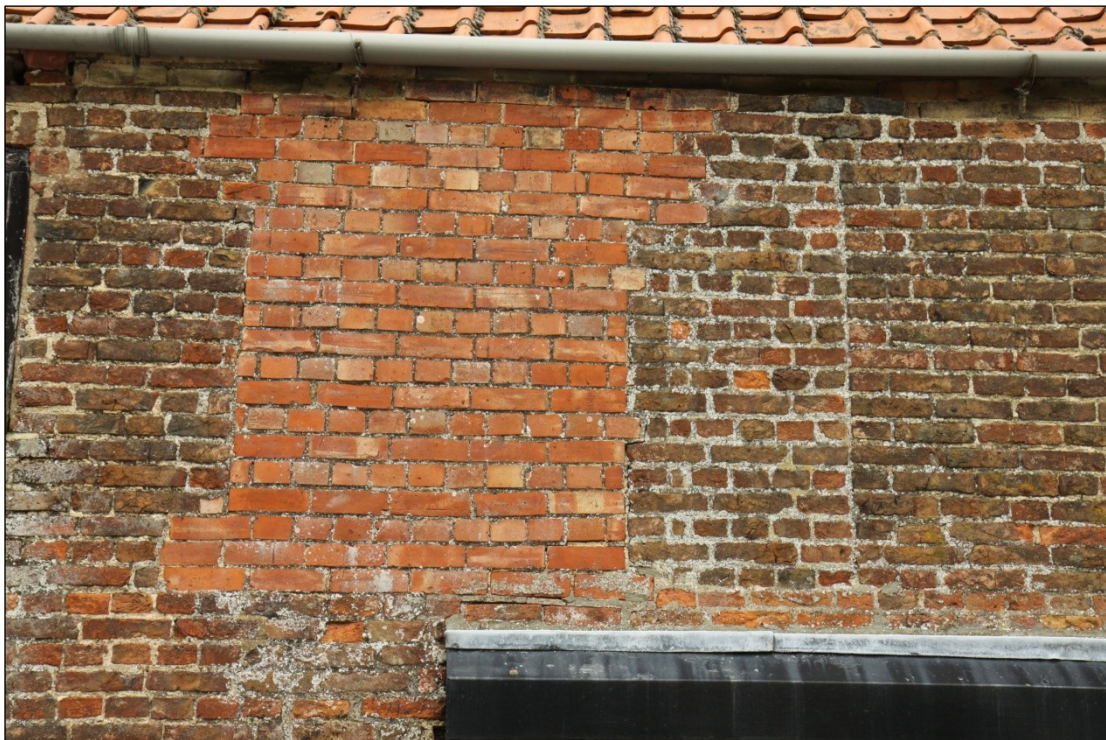
A bricked up opening located above the existing single width door to the stable probably defines the position of a pitching door (*Plate 8*), where the unthreshed crop would have been loaded into the storage area west of the opposing doors. Two phases of infill are evident in the brickwork, indicating initial alteration to form a doorway (possibly for access to an extended first floor- see below) and complete infilling at a later date (represented by red brick).

Plate 8: Position of probable pitching door in the south facing elevation of Barn 1

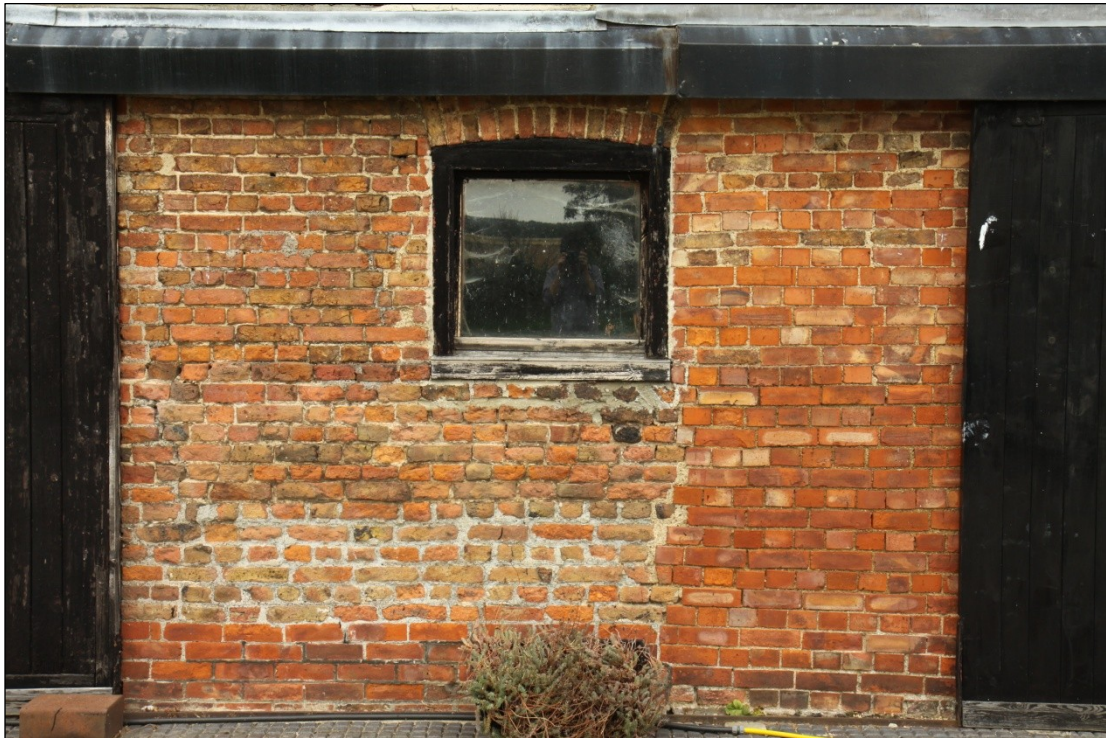
Plate 9: Ground floor window and modified doorway in the south facing elevation of Barn 1

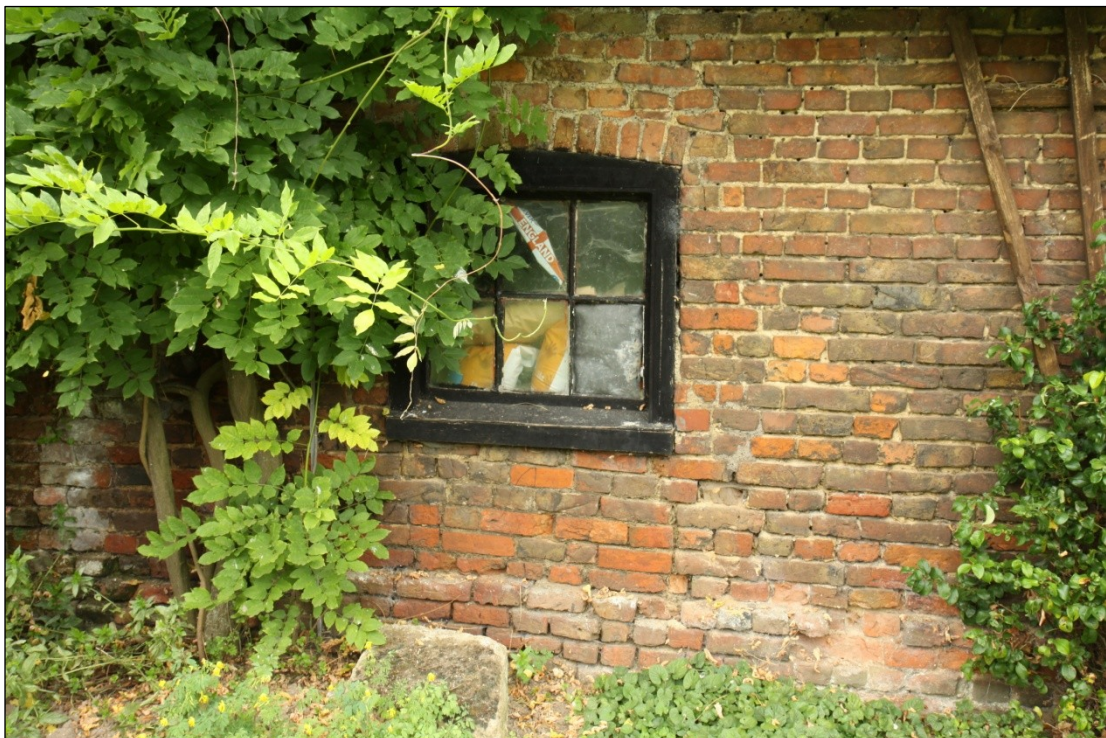
The east facing gable (*Plate 11*) is heavily obscured by foliage. However, a small window (*Plate 12*), similar in style to those in the south elevation is visible at ground floor.

Plate 12: Ground floor window in the east facing elevation of Barn 1, looking west

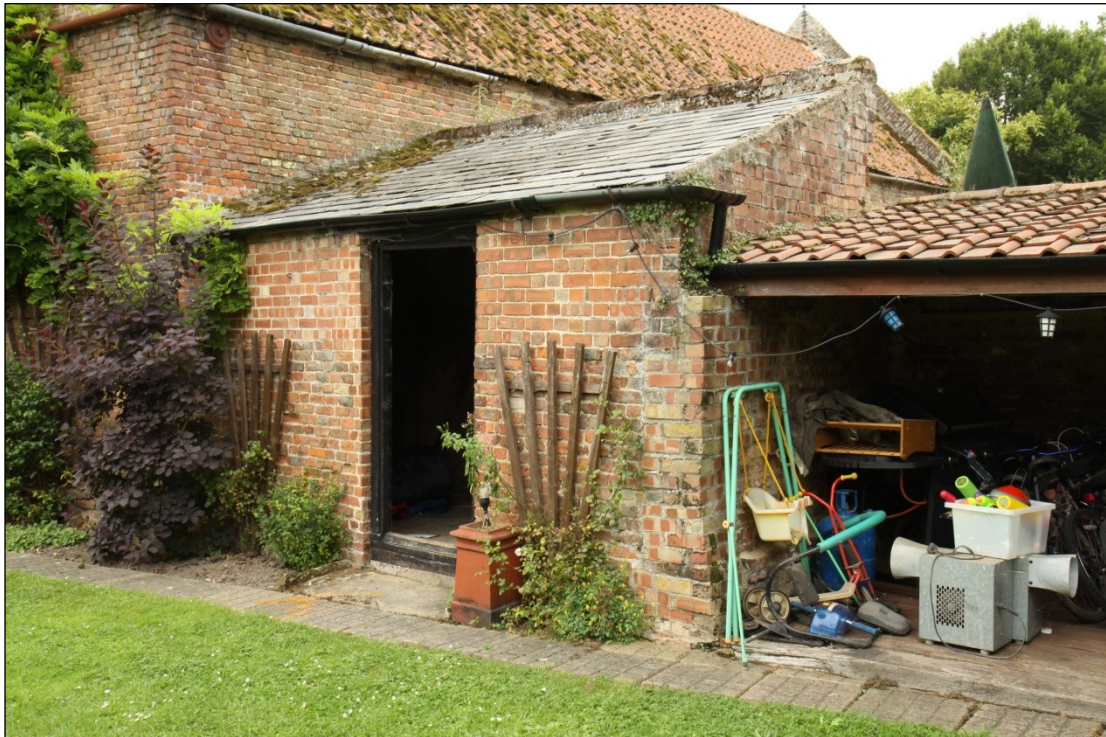
An outbuilding (*Plate 13*), built in brick with a central door (slightly offset to the north) and slate pitched roof facing east, extends north from Barn 1. The east facing elevation has been heightened in brick and even more recent rebuilding is evident in the north wall. The structure is currently used as a store but was probably built as a pigsty (see below).

Plate 13: Outhouse (originally a pigsty?) north of Barn 1, looking southwest

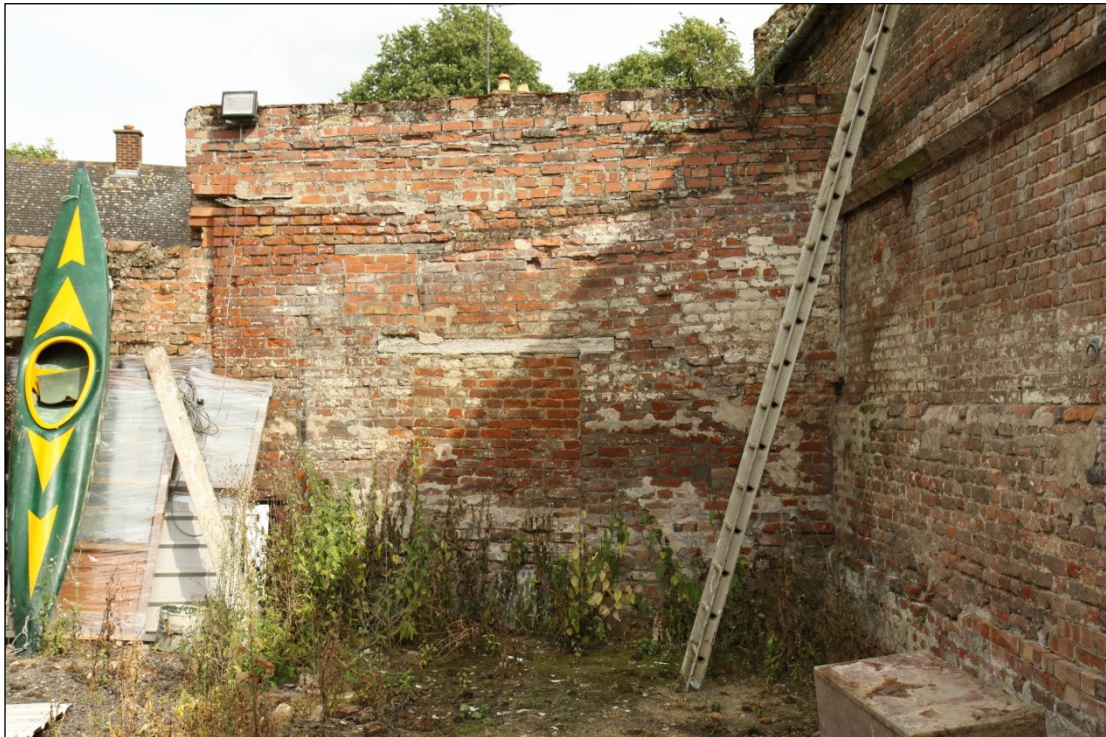
The west facing elevation of the outbuilding (*Plate 15*) is built in red brick heightened by nine courses of more recent construction. There is a bricked up doorway with timber lintel positioned centrally in the elevation and a smaller, square opening (also bricked up and with a timber lintel) immediately north of and slightly above the door. Marks on the wall indicate the former positions of structural components of the lean-to structure (see above) demolished as part of the current works, while whitewash adhering to the wall defined the limits of the interior. The small opening in the wall is

partially covered by the roof of the lean-to and would, therefore, probably have been blocked prior to construction.

Plate 15: Rear wall of the outhouse north of Barn 1, looking east

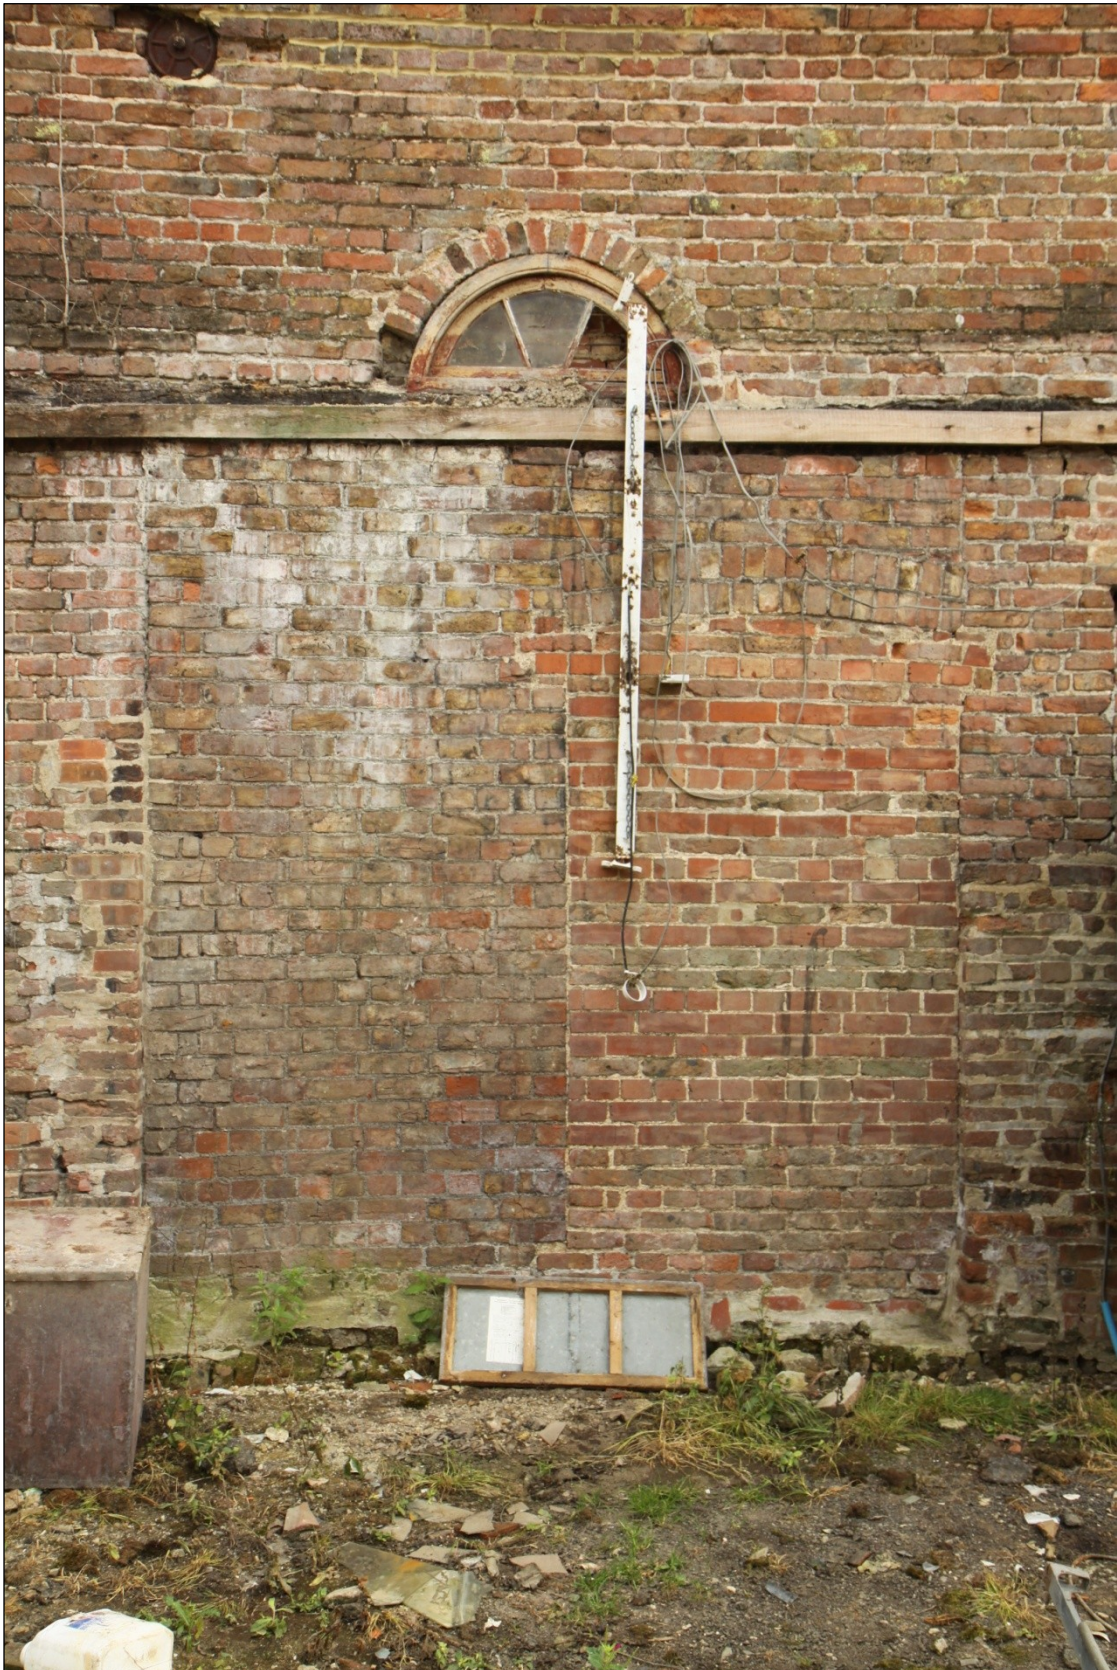
A large bricked up area in the north facing elevation of the threshing barn defines the position of the original north door (*Plate 17*), which was bricked up in two phases - originally to allow the formation of a single width doorway with a segmental arch constructed in two courses of headers. Six ventilation slots (all filled in) arranged in corresponding pairs at ground and first floor levels (*Plate 18* and *Plate 19*) derive from the original phase of use as a threshing barn.

Plate 17: Bricked up doorways in the north elevation of Barn 1, looking south

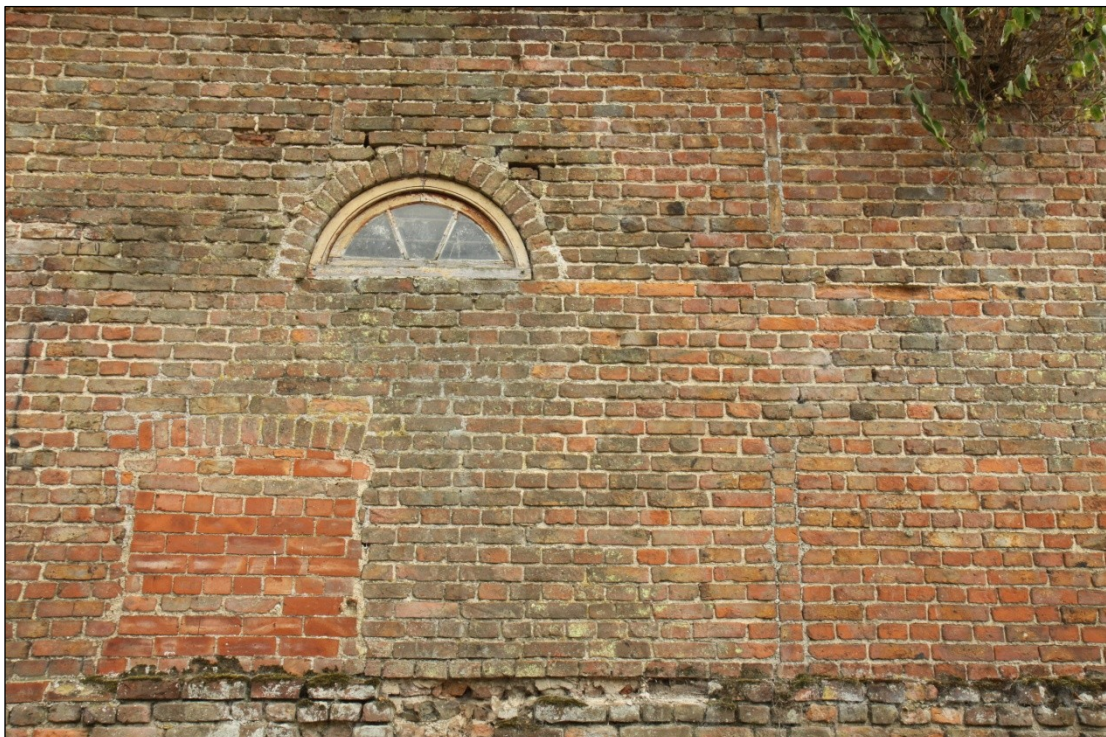
A bricked up opening (*Plate 19*) west of the existing stable door is identical in size and style to openings on the south side and was probably inserted as part of the same phase of alteration. Alternatively, the feature may have originated as a vent for the stables.

Plate 19: Ventilation slots, bricked up window, and fanlight in the north facing elevation of Barn 1

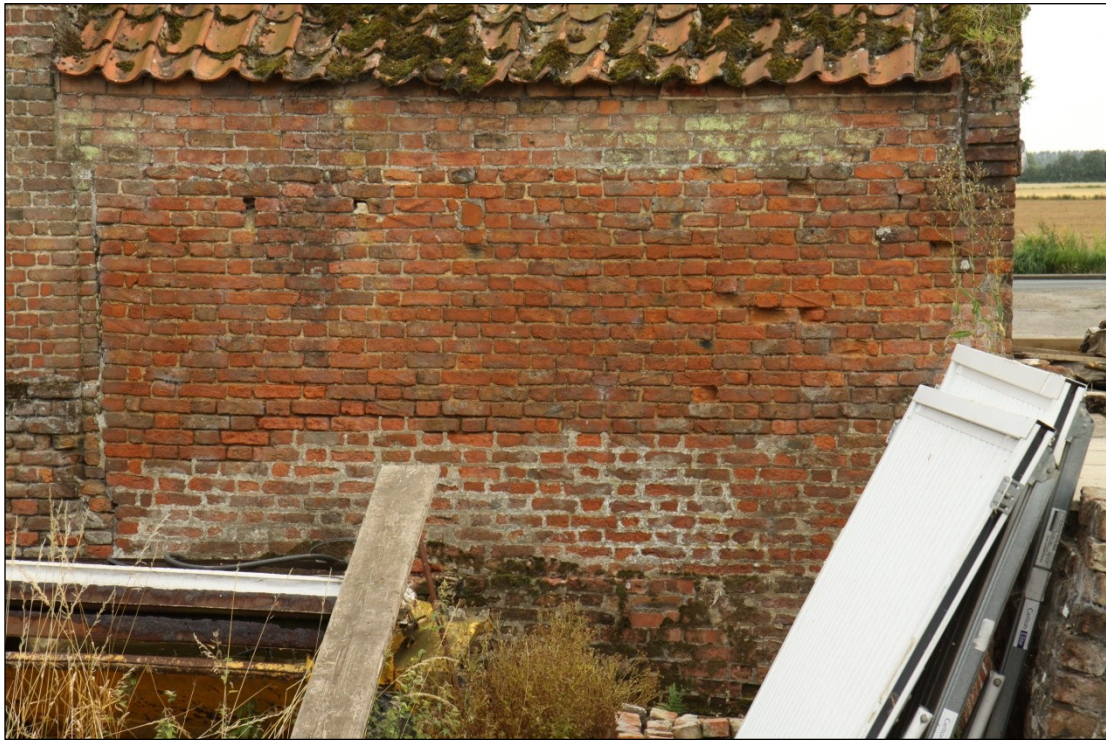
There is a straight join between the main structure and the extension (*Plate 20*).

Plate 20: North facing elevation of the extension at the west end of Barn 1

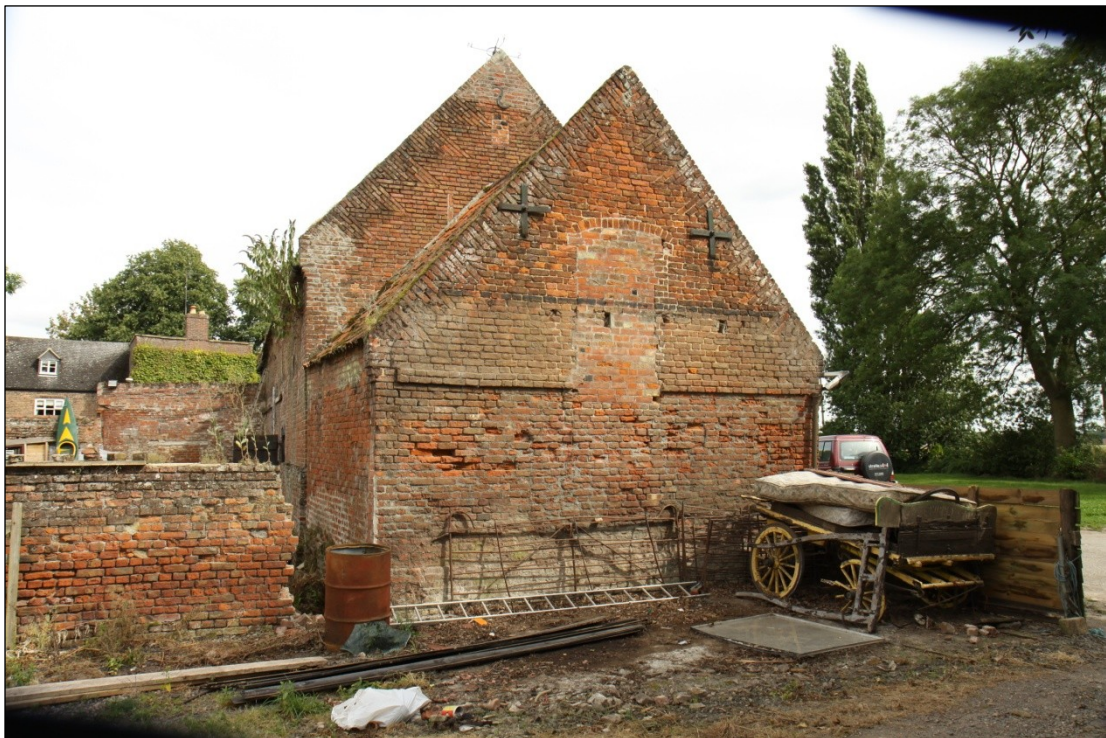
There is a bricked up opening high in the west gable end of Barn 1 (*Plate 21*), possibly representing an owl hole, and a pair of ventilation slots below (*Plate 1*). The gable end of the extension has a bricked up doorway at first floor level and a brick string course between floors (*Plate 22*). Differential weathering on the face of the wall indicates the extent of a lean-to structure demolished in advance of the current conversions, while holes in the brickwork show the positions of the roof timbers. A traditional wooden cart was noted in the area immediately east of the wall (*Plate 23*).

Plate 21: West facing elevation of the extension at the west end of Barn 1, looking ESE

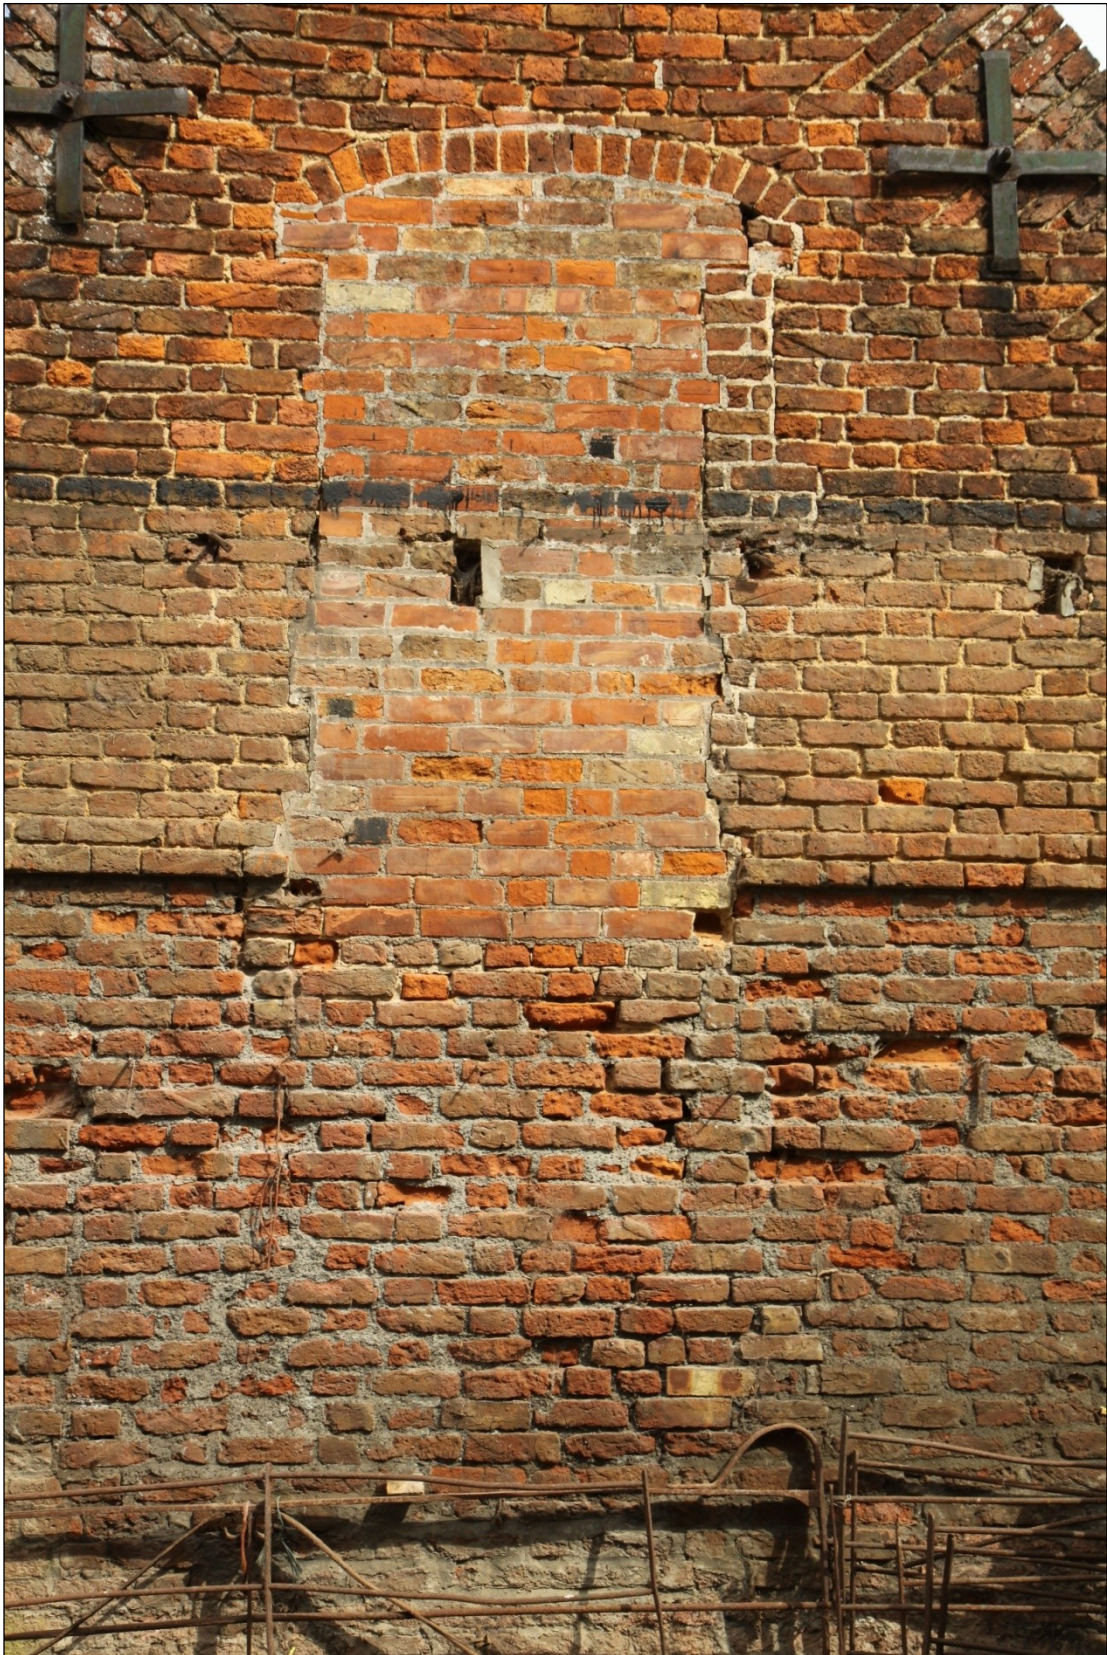
Plate 22: Blocked in doorway in the west facing elevation of the extension to Barn 1

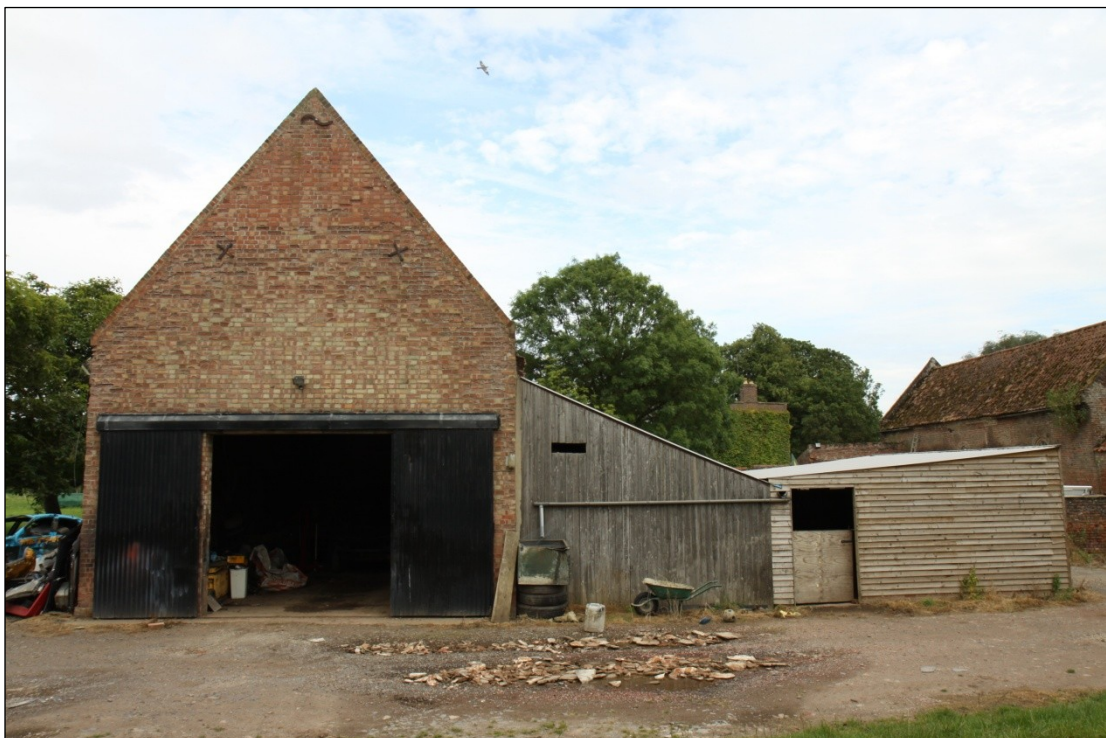
The west gable end is completely rebuilt (*Plate 66*) in modern brick to include a full width opening with sliding doors. The modification indicates a change in use to a vehicle and equipment store.

Plate 66: West facing elevation of Barn 2, looking east

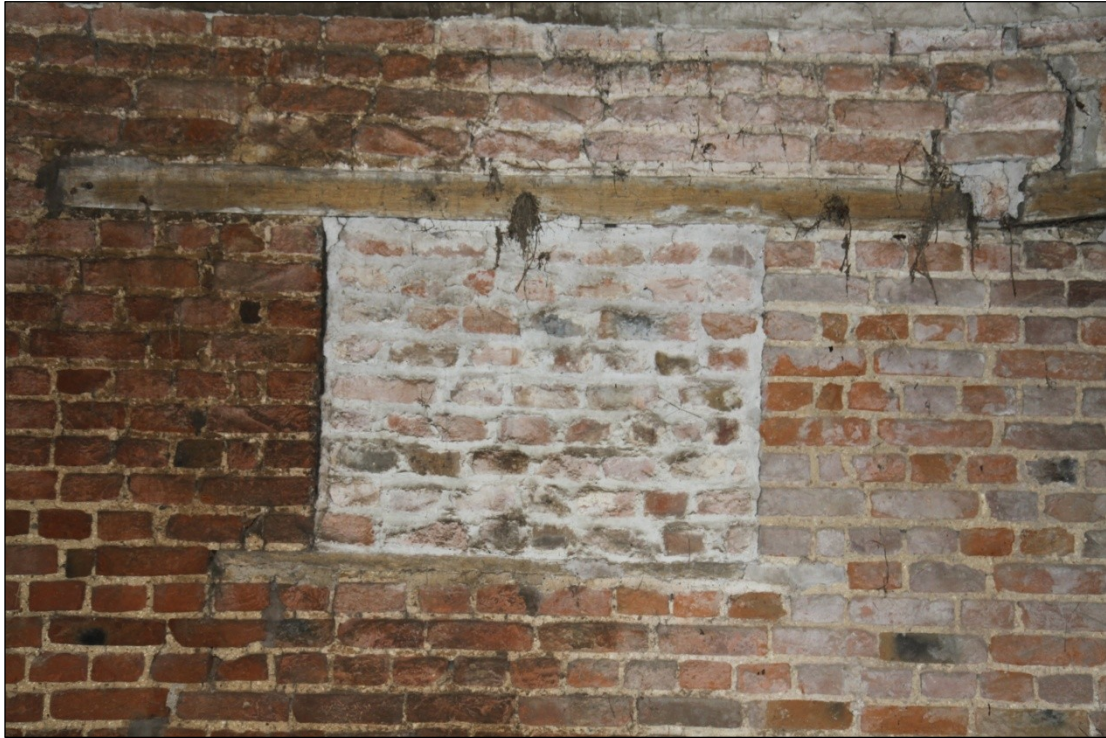
Plate 81: Bricked up vent or window in the east wall of Barn 2, looking east

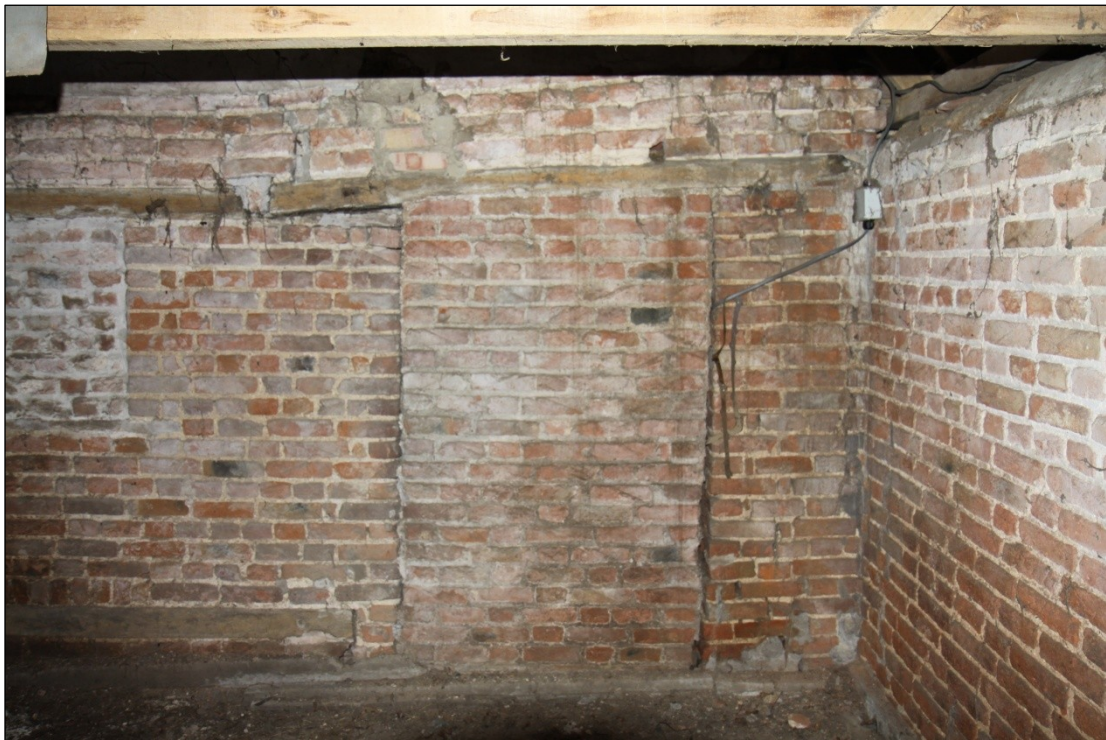
Plate 82: Bricked up door in the east wall of Barn 2, looking east
