*A Survey at
The Wrekin Hillfort,
Shropshire, 2011*

Archaeology Service Report Number 299
© Shropshire Council
September 2011

A report for
Raby Estate (Shropshire)
and
The Shropshire Wildlife Trust

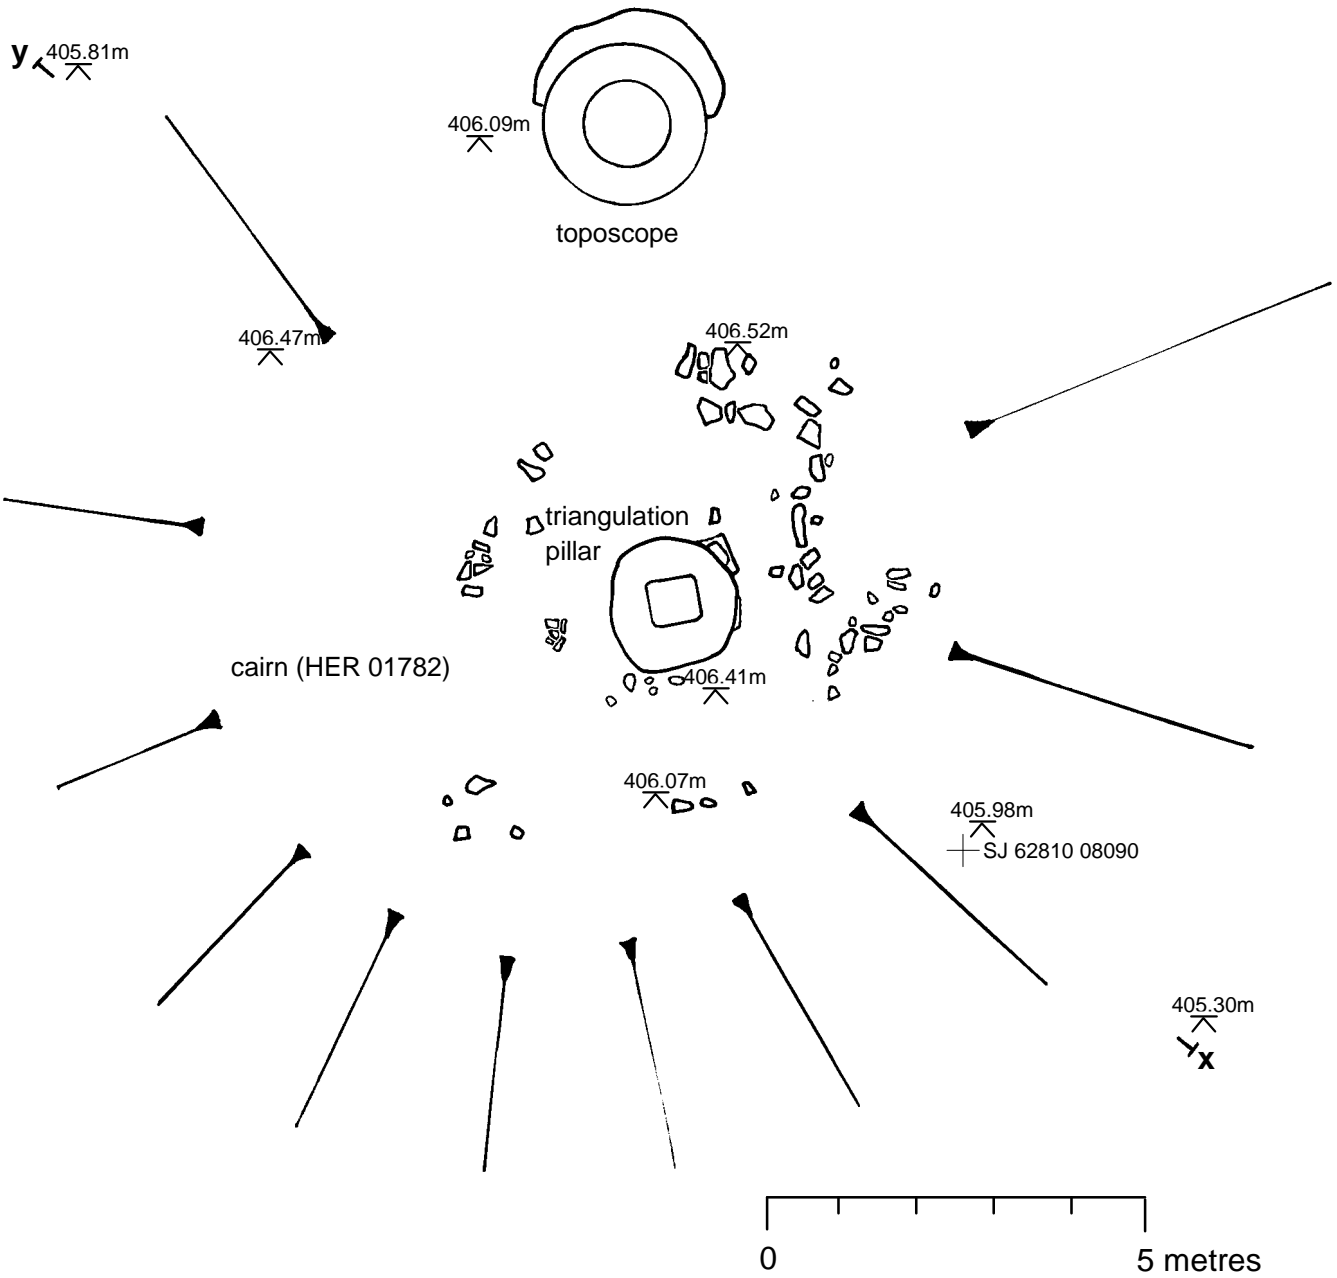
Figure 2: The cairn (HER 01782), triangulation pillar and toposcope; plan view, showing location of profile x-y (Figure 3); 1:100 scale

3.1 The cairn comprises a subcircular mound at the southern end of the summit of the hill, with the natural ground surface sloping down to the south and east. The mound is discernible by more steeply sloping ground on the eastern and southern sides of the hillside, and by a slight mound on the western side. On the south side the mound rises by about 1.2m. The northern side of the cairn is poorly defined and is marked by an even and gentle downward slope (0.5m in height) but there is no discernible earthwork on this side.

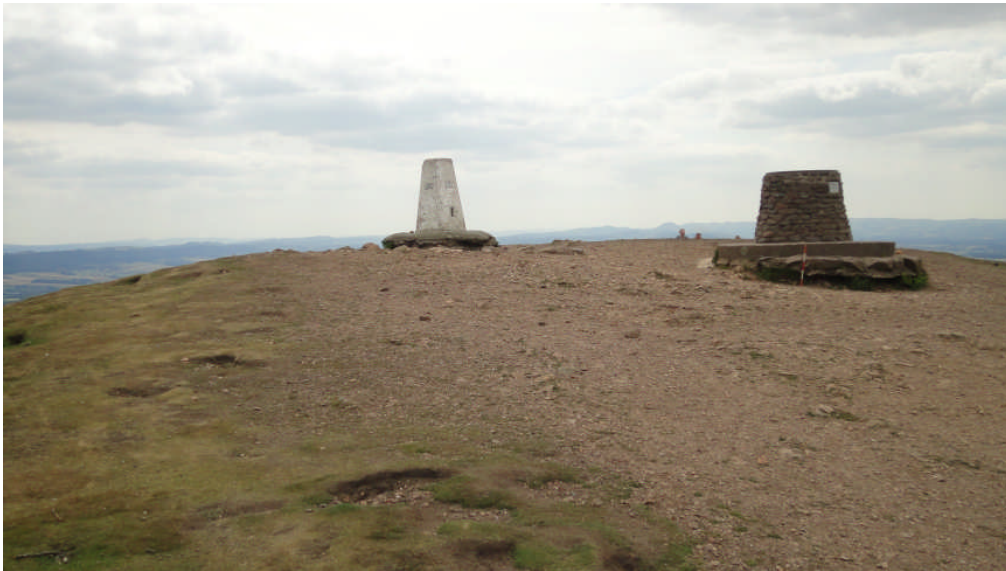
Photo 1: The cairn, triangulation point and toposcope, looking southwest

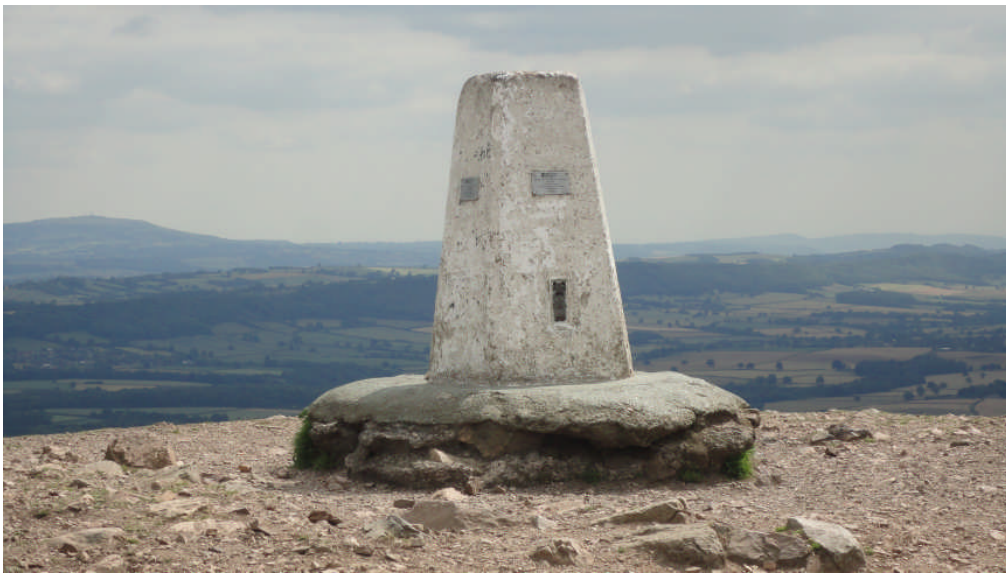
1.3 The deposits around the base of the triangulation pillar have eroded revealing part of what may be the structure of the cairn. It is intended to carry out earthwork repairs to protect the cairn and the base of the pillar by laying membrane, importing material, and securing with geotextile matting.

3.2 The toposcope has been sited on the northern edge of the cairn, though no earthwork remains survive on this side. There has been substantial erosion around the base of the toposcope, particularly on its northern side, exposing its stone and concrete foundations (Photo 3). The triangulation pillar is located just to the east of the centre of the mound. The present ground surface around the triangulation pillar forms a depression about 0.2m deep by about 4m in diameter. That this is due to erosion is evident from the exposure of the foundation concrete of the trig point (Photo 2). Away from the base of the triangulation pillar, the erosion has revealed the top of a number of larger stones in the ground surface. It is possible that these stones may comprise part of the fabric of the cairn. These appear to form a roughly circular pattern, though this is likely to be caused by the nature of the pedestrian traffic around the trig point rather than reflecting the construction of the cairn itself.

Photo 2: The triangulation point, showing the erosion at its base; looking southeast

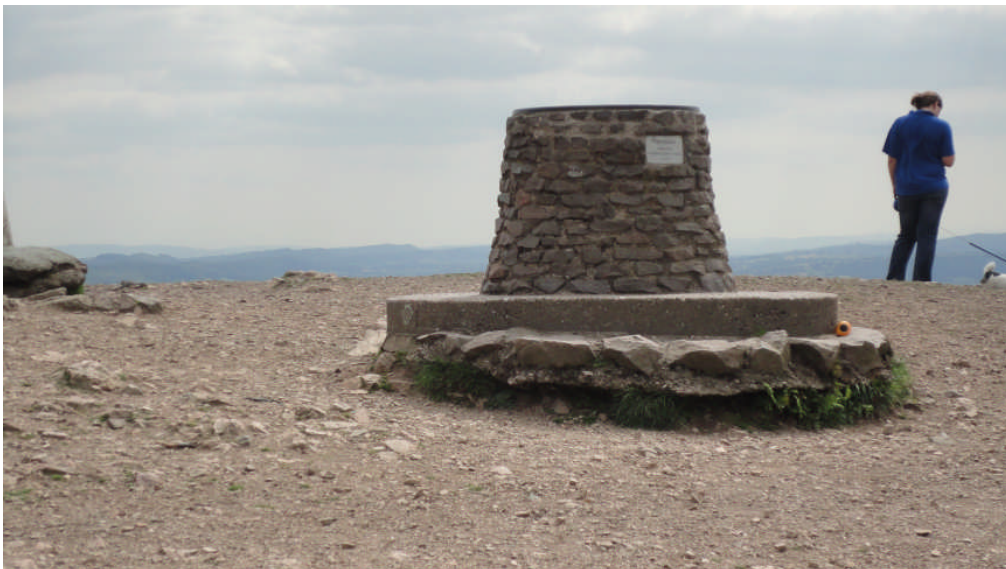
Photo 3: The toposcope, showing the erosion at its base; looking southwest

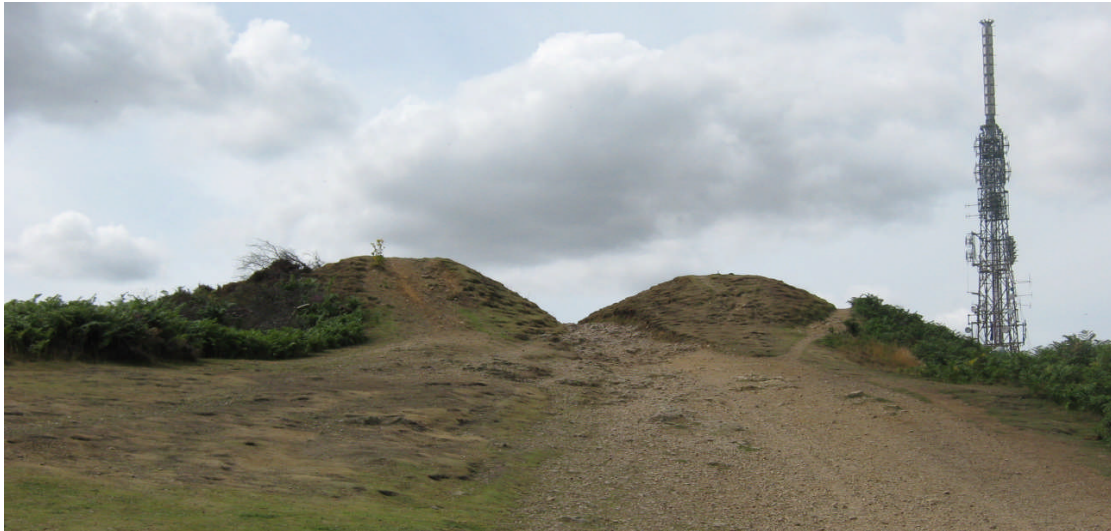
Photo 4: Heaven's Gate (the inner northeast entrance) looking west

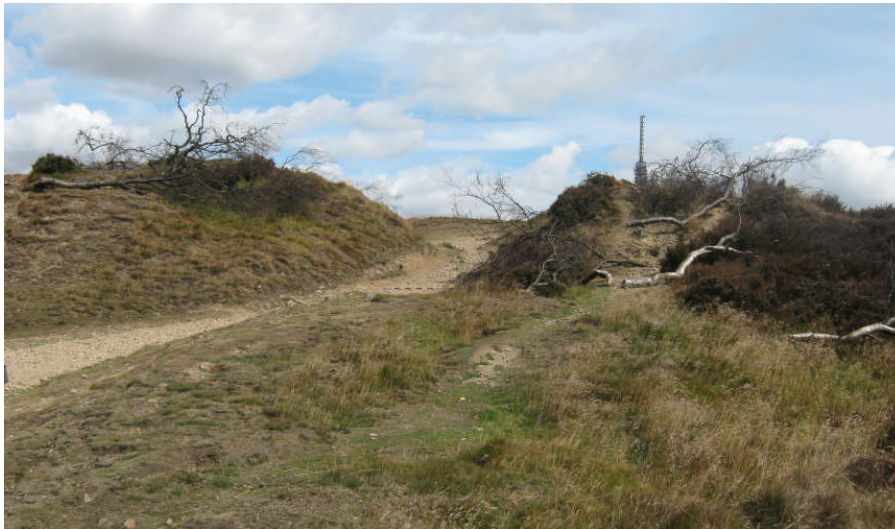
3.4 The opportunity was also taken to capture low-level aerial photographs of the adjacent southwest entrance to the hillfort and the inner and outer northeast entrances (Heaven Gate and Hell Gate) to record the current erosion here, and to record some elements of the WWII military remains.

Photo 6: The southwest entrance, showing erosion, looking north

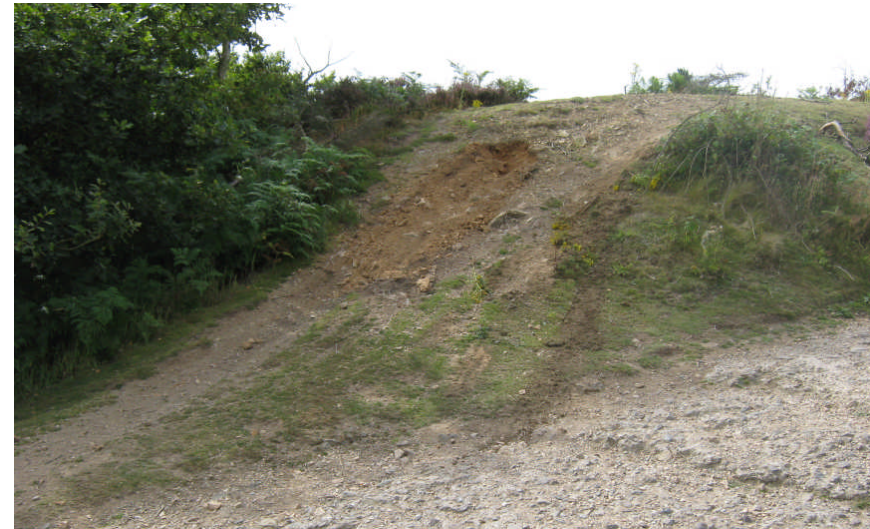
Photo 7: Recent damage to the Hell's Gate (outer northeast) entrance, probably caused by a 4x4 off-road vehicle
