ARCHAEOLOGICAL RECORDING AT STARK'S BRIDGE, WHIXALL, SHROPSHIRE 2017

BRIDGES AND STRUCTURES TEAM SHROPSHIRE COUNCIL

Archaeology Service Report Number 391 © Shropshire Council July 2017

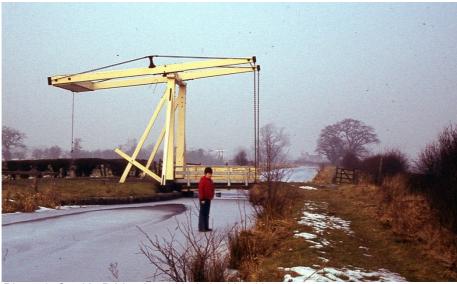
4.1 In c. 1979/80 hydraulic lifting gear was added to the bridge. The HER has a photograph taken in 1979 prior to this addition being made (see Photo 1), showing the rope attached to the ballast box by which the bridge deck was originally raised.

Photo 1: Stark's Bridge in c. 1979, looking N

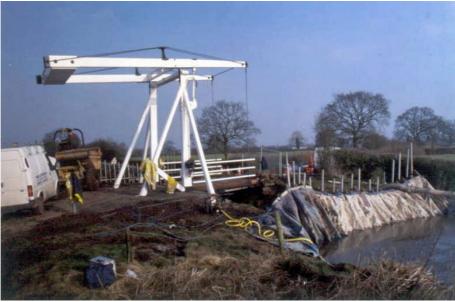
Photo 2: Stark's Bridge during repairs to the canal walls in 2003, looking NE

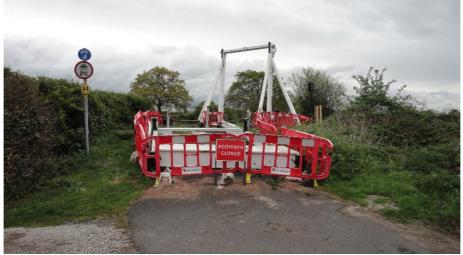
Photo 3: The bridge prior to repairs in 2017, looking E

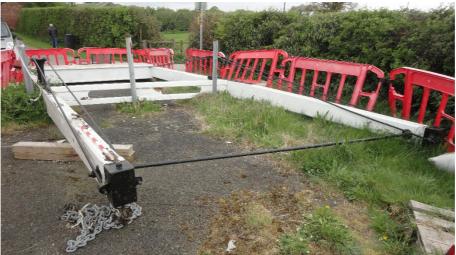
Photo 4: The lifting frame, looking NW, scale bar 1m

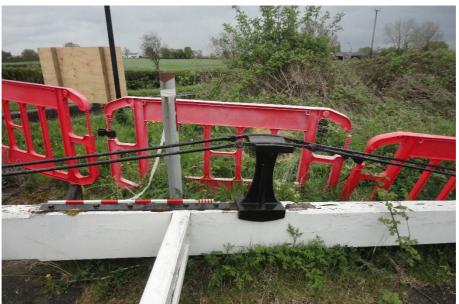
6.1 The timber structure of the bridge has needed replacing on a regular basis as a result of rot and boat strikes, and it is likely that all or most of the timber components have been replaced at one time or another. Equally, much of the ironwork appeared on inspection to be modern – for example, the saddles and end plates on the lifting frame are of welded steel. The tie bars and top brace bars on the lifting frame may be older, though again it is possible (probable even) that they are not the original fittings. The hinges between the base and bridge deck and the portal shoes may be original, although the thickness of the paint on the latter makes this difficult to confirm.

Photo 5: Tie rods and saddle on the lifting frame; scale bar 1m

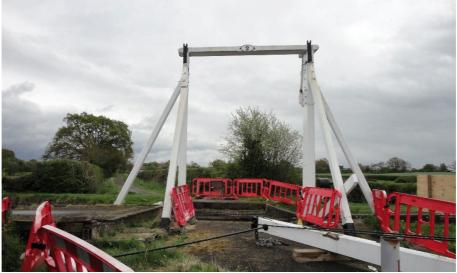
Photo 6: The portal frame, looking E

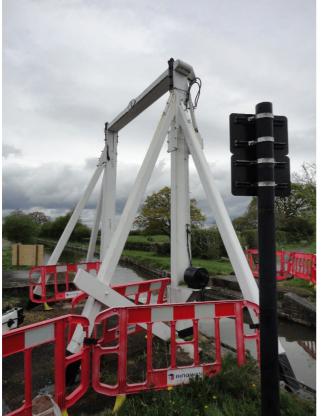
Photo 7: Portal frame, showing lifting gear, looking NE

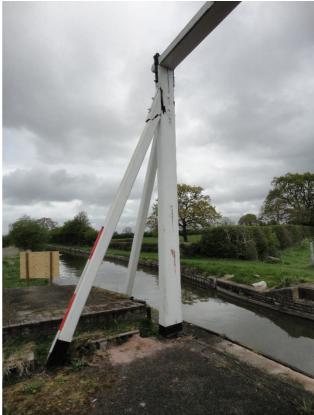
Photo 8: Portal frame, showing crack on N frame looking NE, scale bar 2m

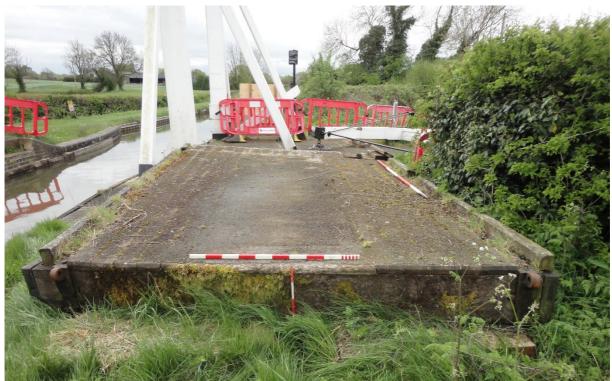
Photo 9: The bridge deck on the towpath N of the bridge, looking S, scale bars 2m, 1m & 0.5m

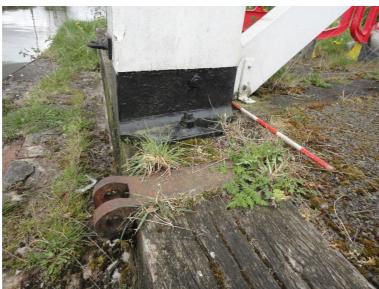
Photo 10: The portal frame base plate (S) and deck hinge, looking S, scale bar 0.5m

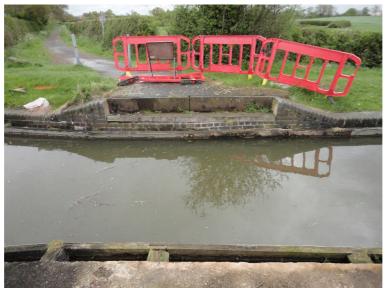
Photo 11: The east abutment, looking E

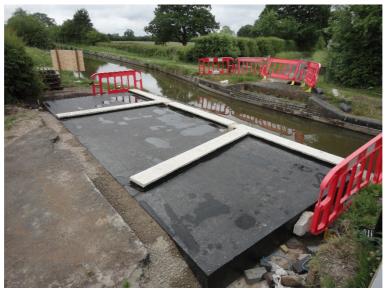
Photo 12: The new portal frame base, looking NE

5.3 The base timbers were removed at the beginning of May 2017 and the new concrete base poured shortly thereafter (Photo 12).
