***An Archaeological Watching Brief at
Stokesay Castle Pool,
Shropshire, 2010***

Archaeology Service Report Number 278
© Shropshire Council
May 2010

A Report for
Highways and Transportation,
Development Services, Shropshire Council

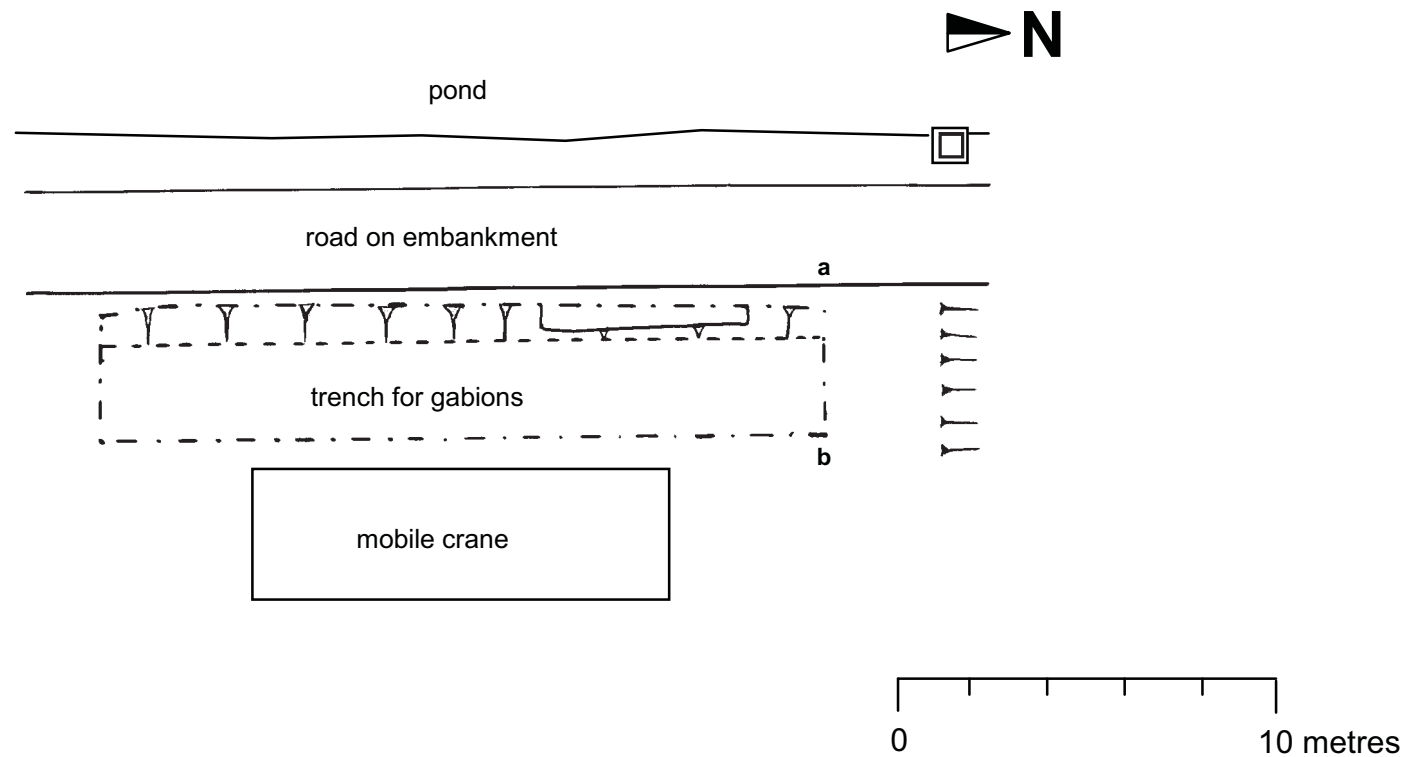
STOKESAY CASTLE POOL 2010

2.1 The emergency repair works entailed the erection of stone-filled steel mesh gabions on the east side of the dam, between the dam and the overturned mobile crane (Fig. 2). The base of the gabions were to be set in a trench c. 2.15m wide by 19m long. The north end of the trench would cut into the toe of the dam by up to 1m depth, the south end by about 0.25m.

Figure 2: Plan view of the pond embankment, showing the location of the mobile crane and the trench for the gabions; scale 1:200

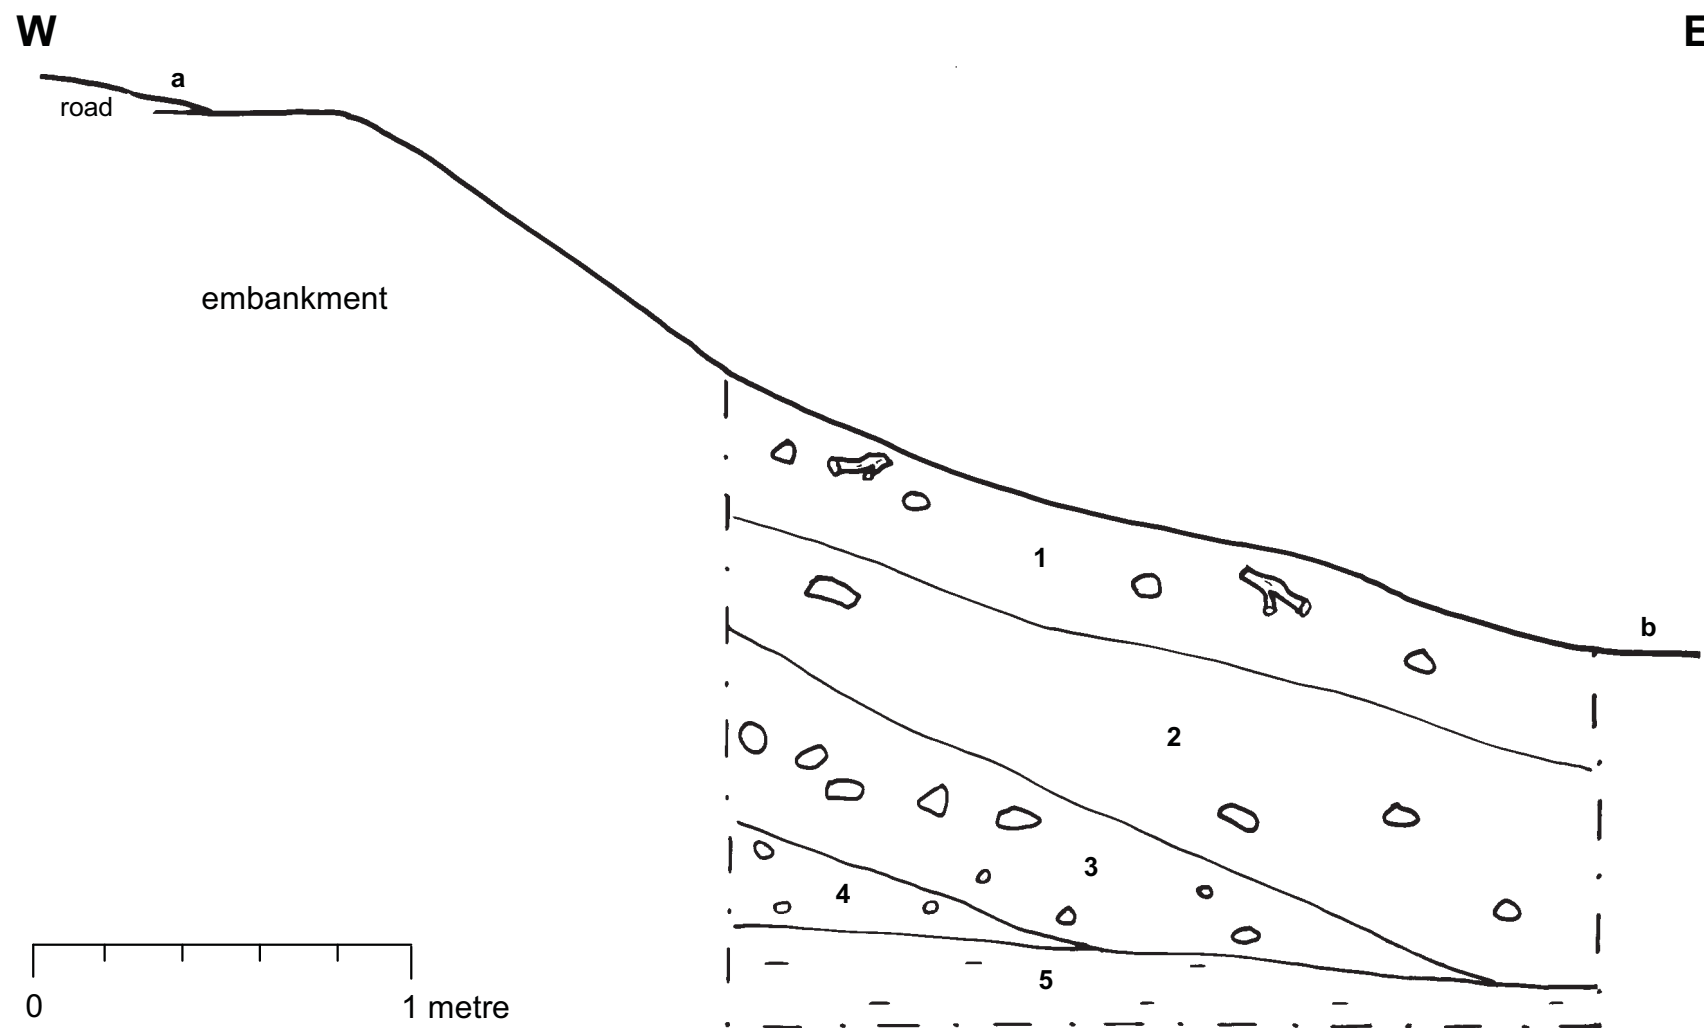
STOKESAY CASTLE POOL 2010

At the bottom of the trench, the excavations revealed a smooth dark grey silt (Fig. 3; 5). Along the western edge of the trench this was overlain by a deposit of dark brown silty loam mottled with buff clay (4) which may have represented eroded material from the dam core. This in turn lay beneath a deposit of dark greyish brown loam with stones (3) up to 0.4m thick. Above this was a soil layer, again of dark greyish brown humic loam (2) up to 0.6m thick, and a similar topsoil (1) 0.3m thick with stones and tree roots.

Figure 3: South-facing section through the gabion trench; scale 1:20

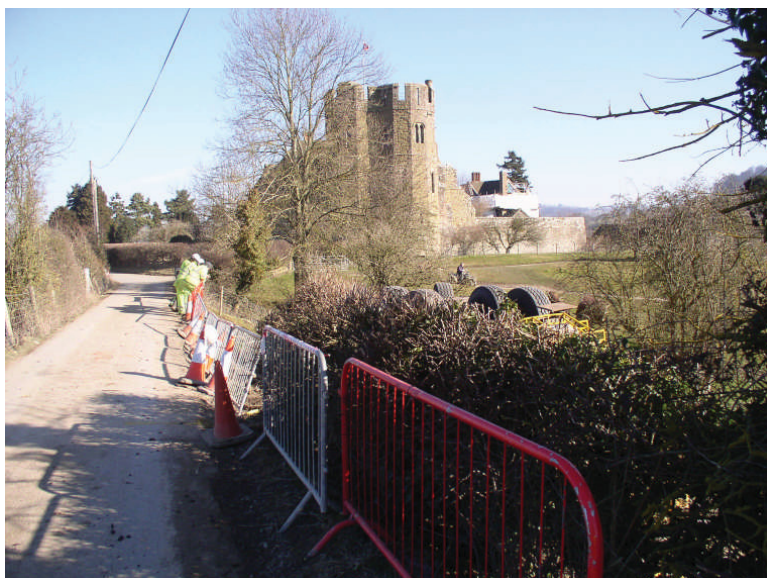
Photo 1: The study area, looking north

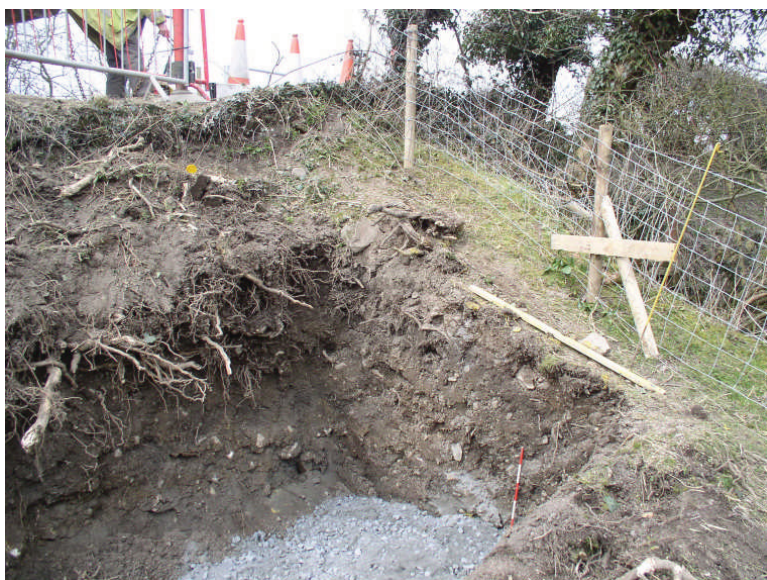
Photo 2: The trench for the gabions, looking northwest

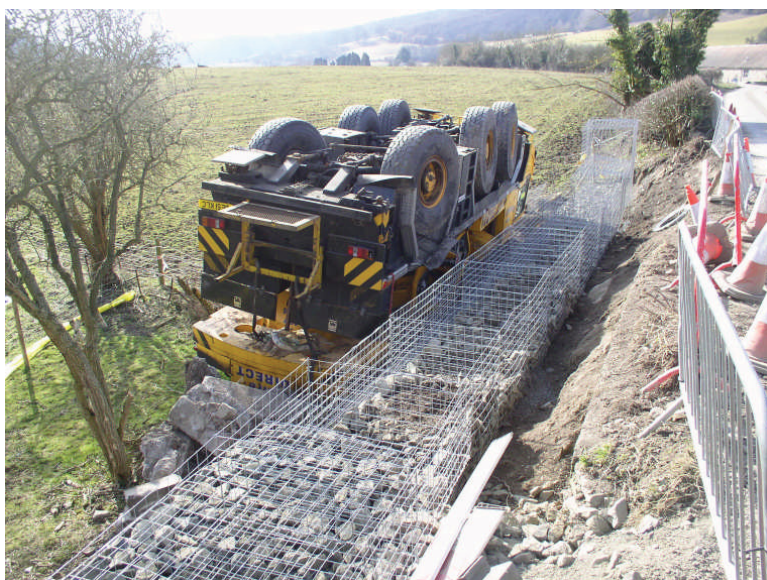
Photo 3: The lower gabions in place
