# A watching brief at the Castle Street car park, Ludlow Shropshire, 2010

by H R Hannaford

### **Archaeology Service**

Highways and Transportation, Development Services, Shropshire Council

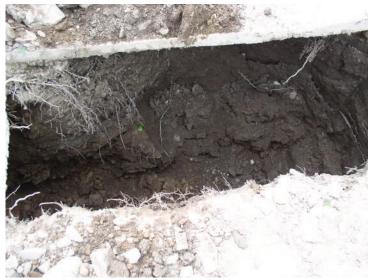
Again in trench B (Figure 3) the earliest deposit recorded comprised a greenish grey silty sand mottled with reddish brown clay and angular stone fragments (13) (similar to trench A, 7); again, this deposit is likely to have been rampart material or a dumped deposit behind the town wall. It was also sealed by a buried garden soil of very dark grey brown loam (12), and a similar deposit containing charcoal and mortar fragments (11). The stub wall separating the car park from the walkway was cut into this deposit, and as in trench A it was cut to the south by a large feature up to 0.7m deep and filled with dark greyish brown sandy loam with pebbles (15) and brick rubble (16).

Photo 3: The north end of Trench B, looking west

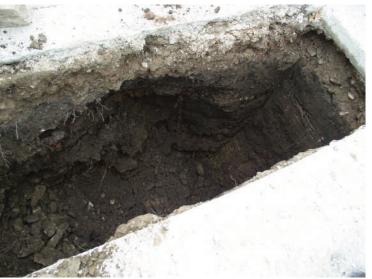
This trench was excavated to a depth of 2m below the ground surface. The lowest deposit recorded by the excavation (see Figure 2) comprised a greenish grey silty sand mottled with reddish brown clay with a high content of angular stone fragments (7). This deposit possibly represented rampart material or a dump of redeposited natural bedrock and subsoil behind the town wall. The top of this deposit lay at a depth of 1.1m below the ground surface. The deposit was cut by a feature containing a dark reddish brown clay (6) immediately behind the wall. It was sealed by a very dark grey brown loam (3 & 5) typical of a buried garden soil, with a lens containing brick fragments and mortar (4). The stub wall separating the car park from the walkway had been cut into this deposit, and it was also cut to the south by a large feature up to 1m deep filled with deposits of dark greyish brown sandy loam with pebbles (9) and brick rubble (10).

Photo 2: The north end of Trench A, looking northwest

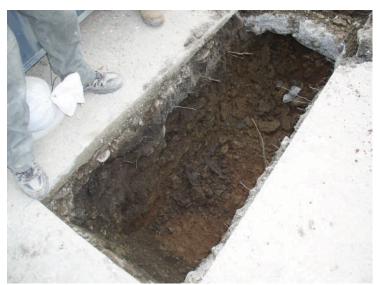
The lowest deposit in trench C (Figure 4) was a greenish grey silty sand mottled with reddish brown clay and angular stone fragments (20). This was similar to the lower deposits seen in the other 2 trenches, though it contained more stone, and these stones were horizontally aligned. It was not clear whether this represented the fragmented surface of the natural bedrock or dumped material behind the town wall. It was covered by a layer of clean, dark reddish brown silt sand (19). This in turn lay beneath a deposit of buff silty sand mottled with reddish brown clay and angular stone fragments (18); again this was possibly rampart material or a dumped deposit behind the town wall, though it was seen to lie at a higher level than similar deposits (7 & 13) in the other trenches. Again it was sealed by a very dark grey brown loam (17). The remains of the stub wall separating the car park from the walkway were again cut into this deposit, and it was also cut to the south by the same large feature as in the western two trenches;

here this cut was up to 0.8m deep and filled with dark greyish brown sandy loam with pebbles (21) and brick rubble (22).

Photo 4: The north end of Trench C, looking southeast
