**ARCHAEOLOGICAL INVESTIGATIONS AT  
FARNLEY MILL, FARNLEY TYAS,  
WEST YORKSHIRE**

***SURVEY REPORT***

Report Number 2012/9.2     June 2012

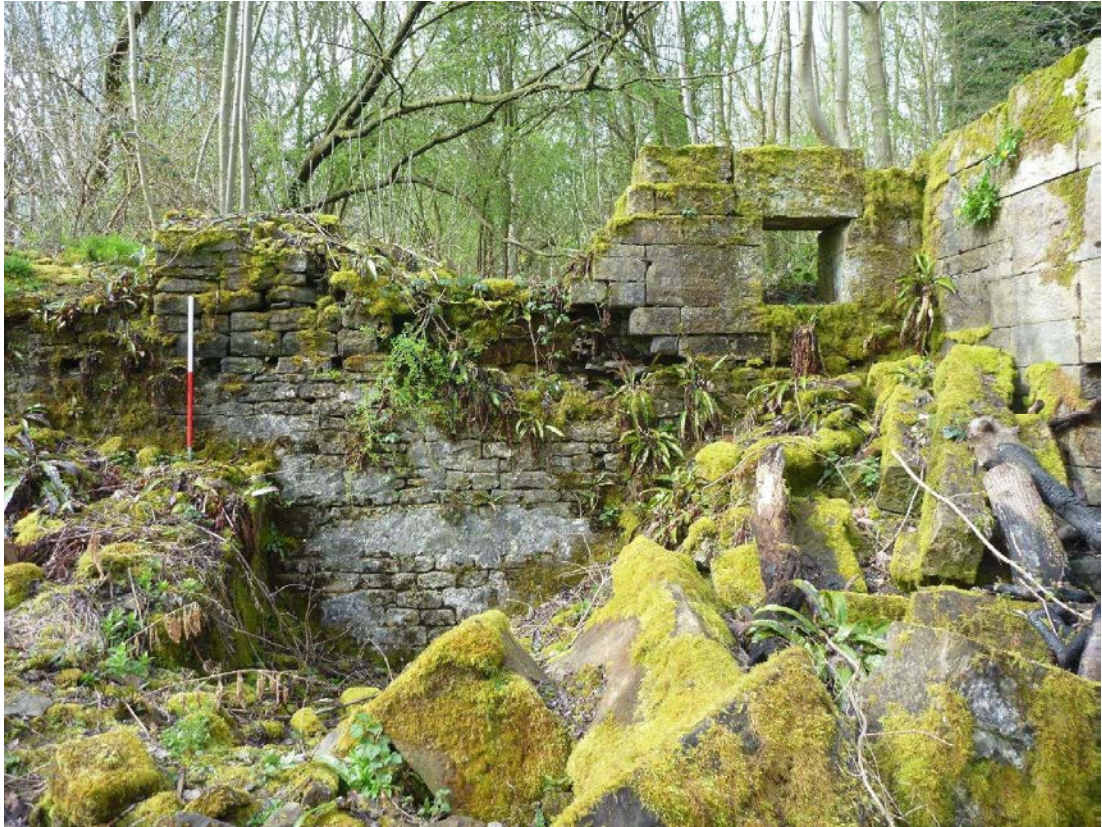
**Plate 3: North end of wall 2, east-facing elevation (viewpoint 3)**

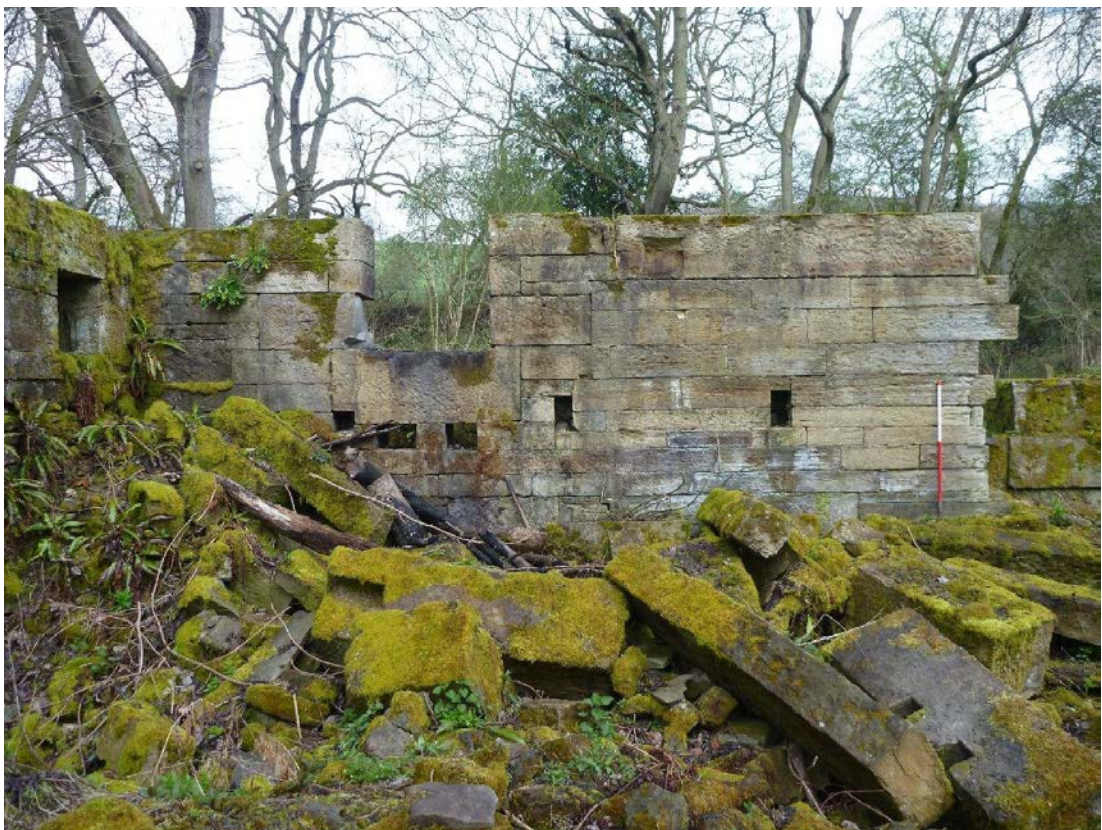
Wall 1 forms the northernmost standing wall of the mill, but appears to have been an internal wall. It is constructed of much larger and more well-dressed stone blocks than wall 2 (Plate 4). There are several square and rectangular holes in the wall, some of which go all the way through the wall. This includes a large square opening which is likely to be related to power transmission from the steam engine. The stonework around the gap has been burnt and in places cracked by a fire set within it fairly recently (Plate 5). Graffiti has also been carved into the stonework.

**Plate 4: South-facing elevation of wall 1 (viewpoint 1)**

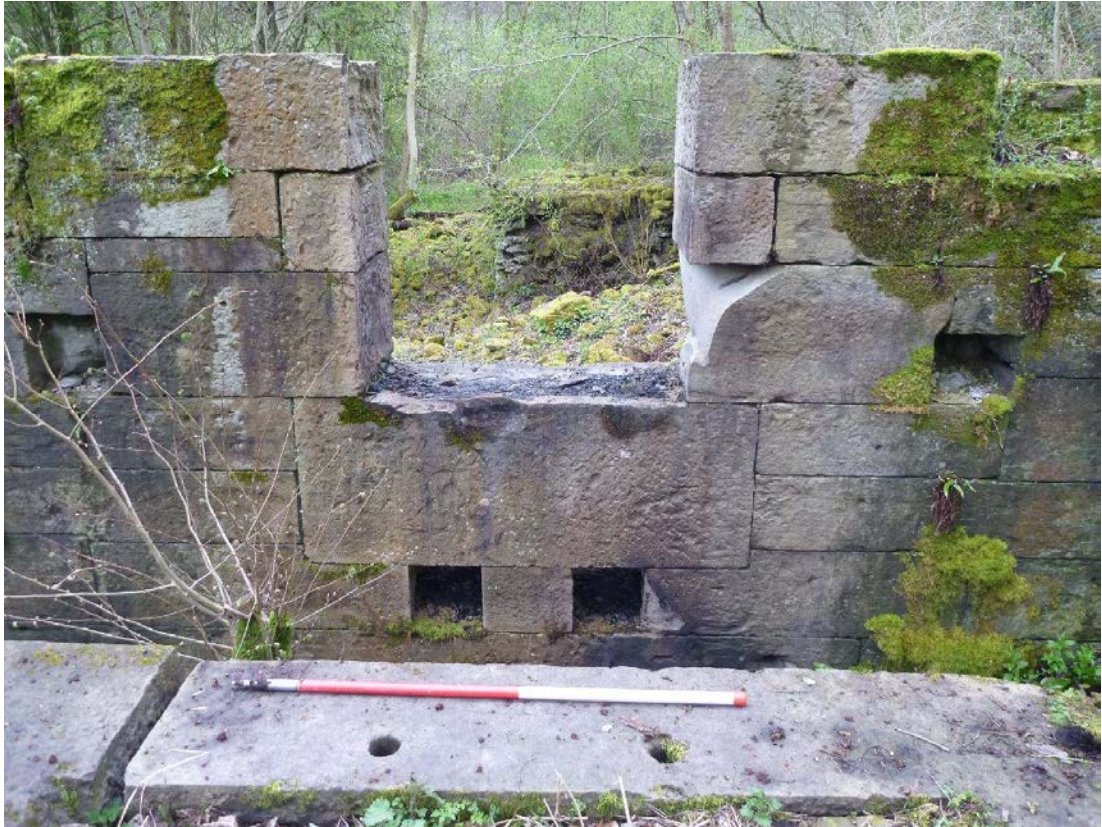
**Plate 5: Power transmission hole in wall 1, showing fire damage (viewpoint 10)**

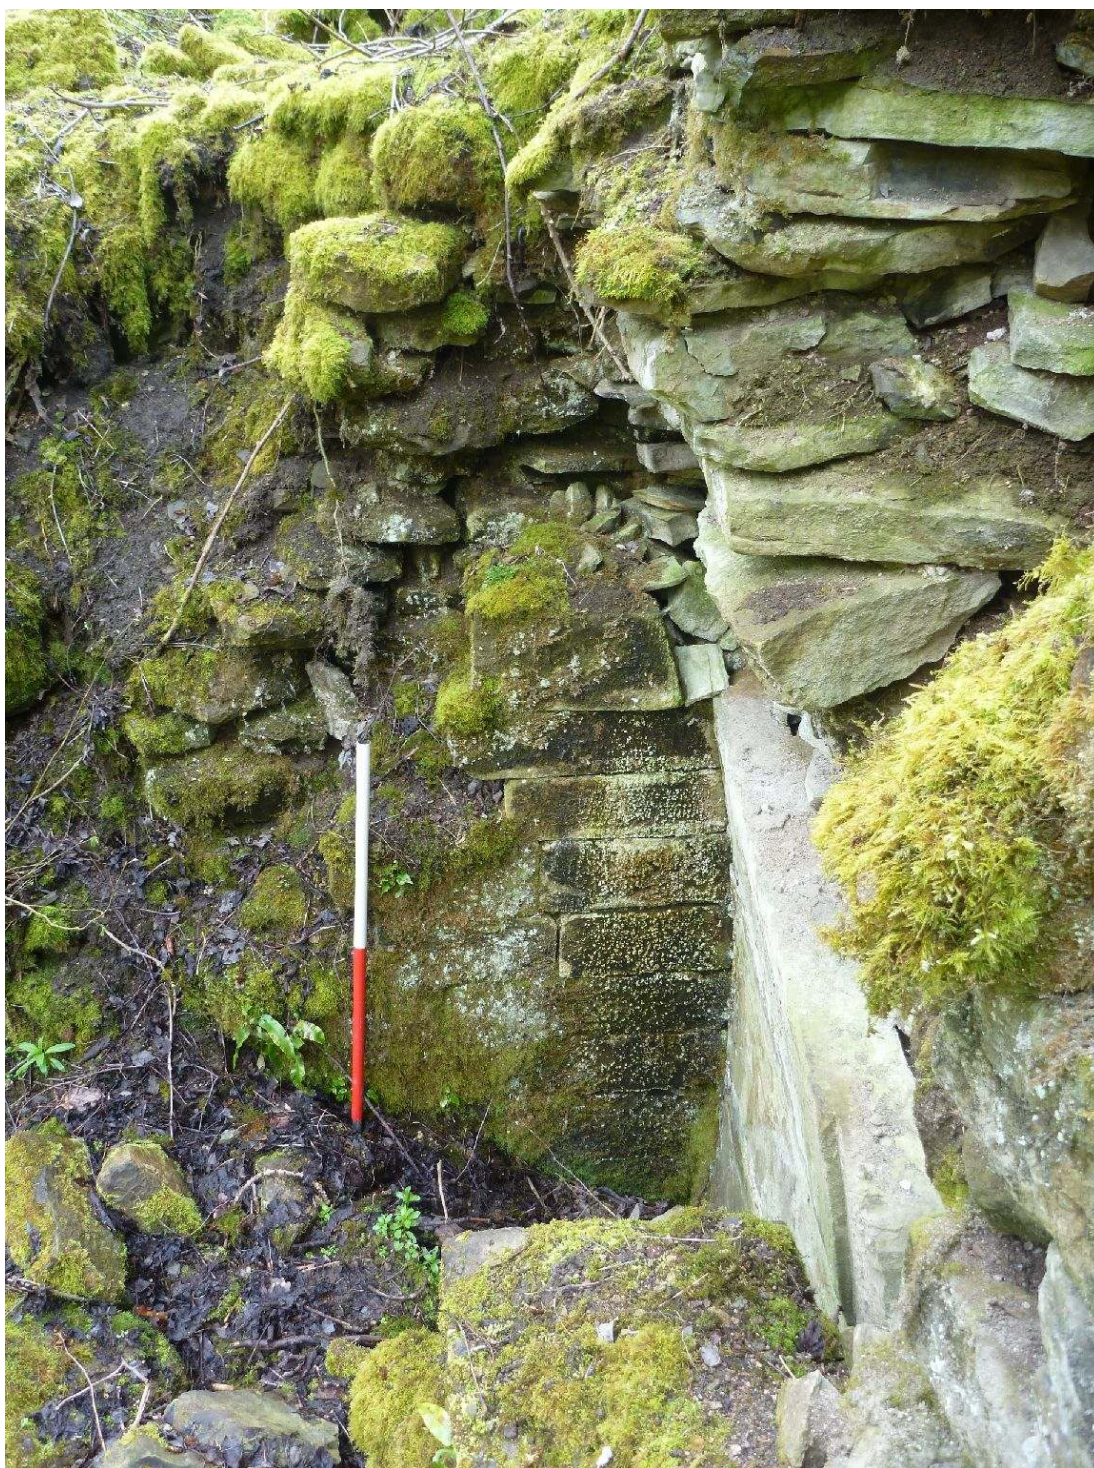
**Plate 9: Detail of west end of wheel pit showing curved back wall, viewed facing south (viewpoint 5)**

3	Rectangular hollow at south end of standing mill structure. Base and sides obscured by rubble and tree roots. Masonry visible at east and west ends. At the west end are thin, wide stone slabs set in a slight curve, possibly indicating the location of a wheel pit. Wall above this is missing facing slabs, and very uneven, but a straight joint in wall 2 to the north suggests this may be later infill. East end is formed of neatly dressed slabs, with a square hole partway down.	Wheel pit	1: Regional	Poor	Threat of wall collapse at west end; trees growing in wheelpit hollow.	5, 6, 82, 84	1828 sketch
4	Structure formed of large stone slabs to the north of wall 1, separated from the wall by a gap. Remains of a wall run along the north side of the slabs, obscured by rubble. There are incised grooves and bolt holes in some of the slabs indicating the presence of machinery. A gap is located between two groups of slabs which appears to be deliberate. A massive displaced slab to the north has grooves matching those in one of the slabs adjacent to the gap, and appears to have overlain this.	Machine bases (engine house?)	1: Regional	Average	Vandalism; vegetation.	7, 8, 9, 10, 11, 83

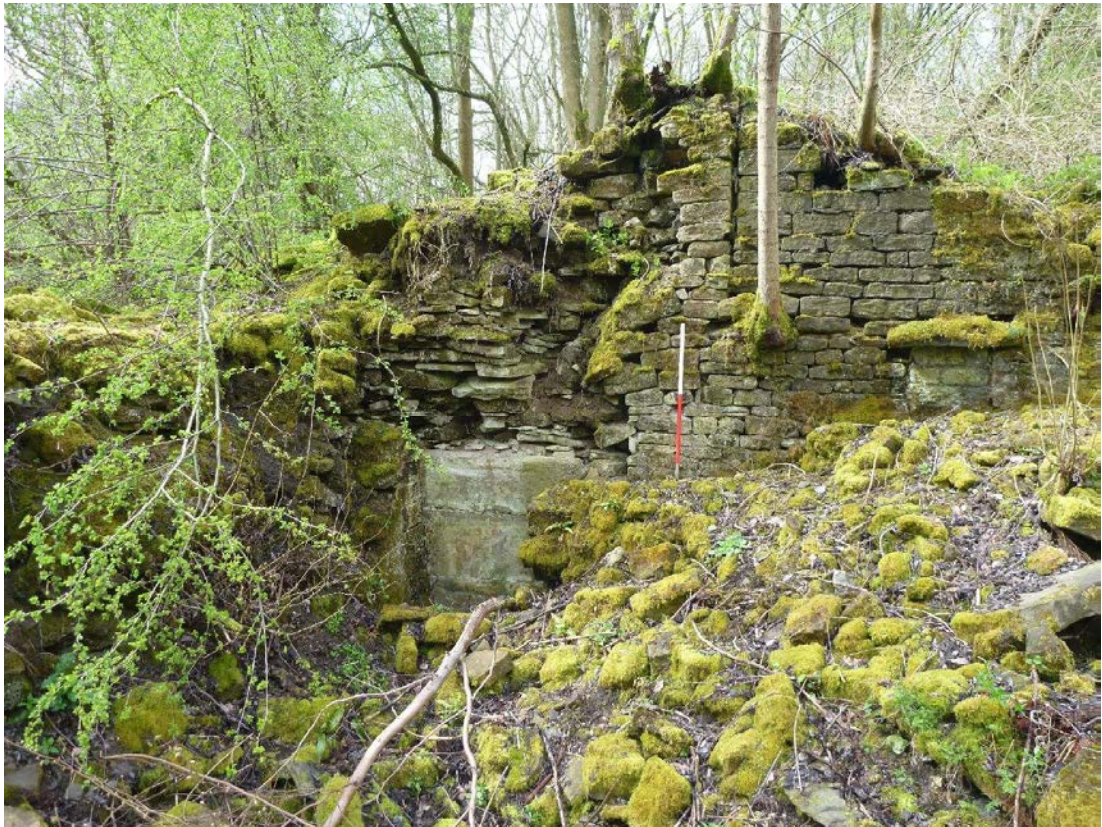
**Plate 10: Wheel pit, showing differences in construction of western wall (viewpoint 4)**

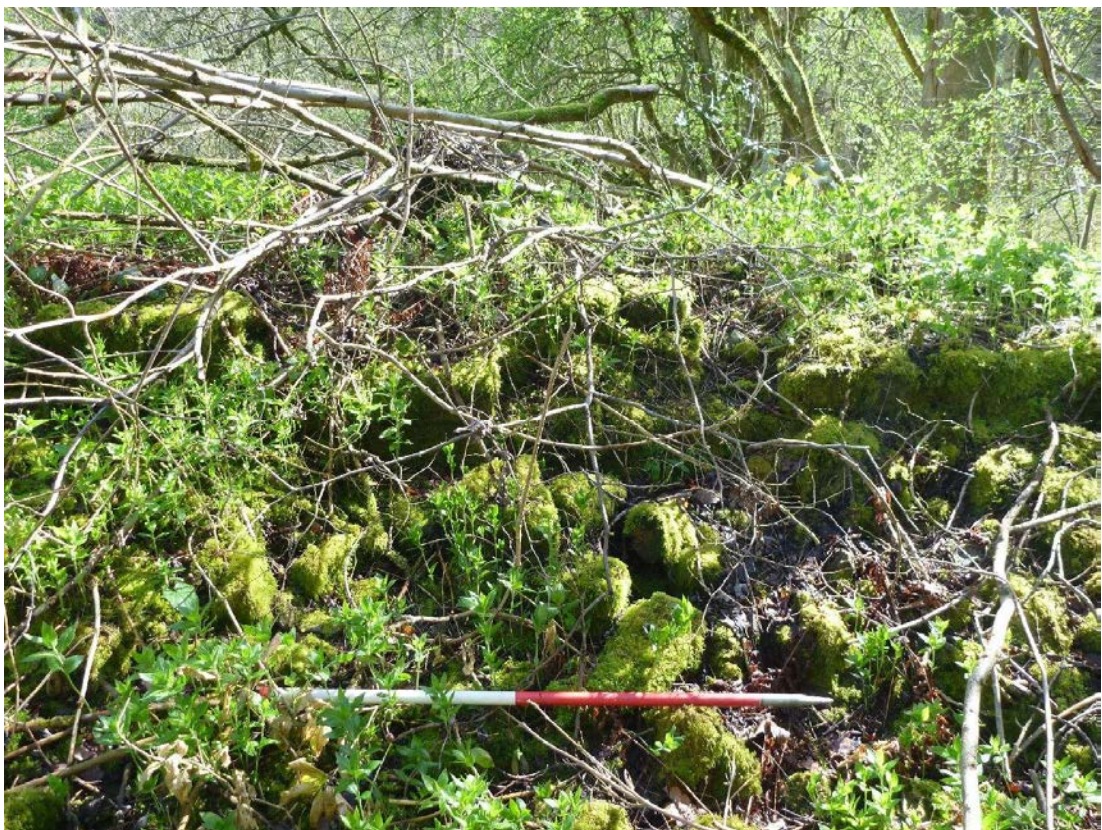
**Plate 11: Bank 32 at south side of north platform of mill, possible remains of wall (viewpoint 25)**

31	Linear hollow within western mill extension, south half.	Hollow	2b: Local	Poor	Tree root and vegetation damage.	26	
32	Banked rubble from building in vicinity of former wall.	Earthwork - woollen mill wall	2b: Local	Poor	Tree root and vegetation damage.	25

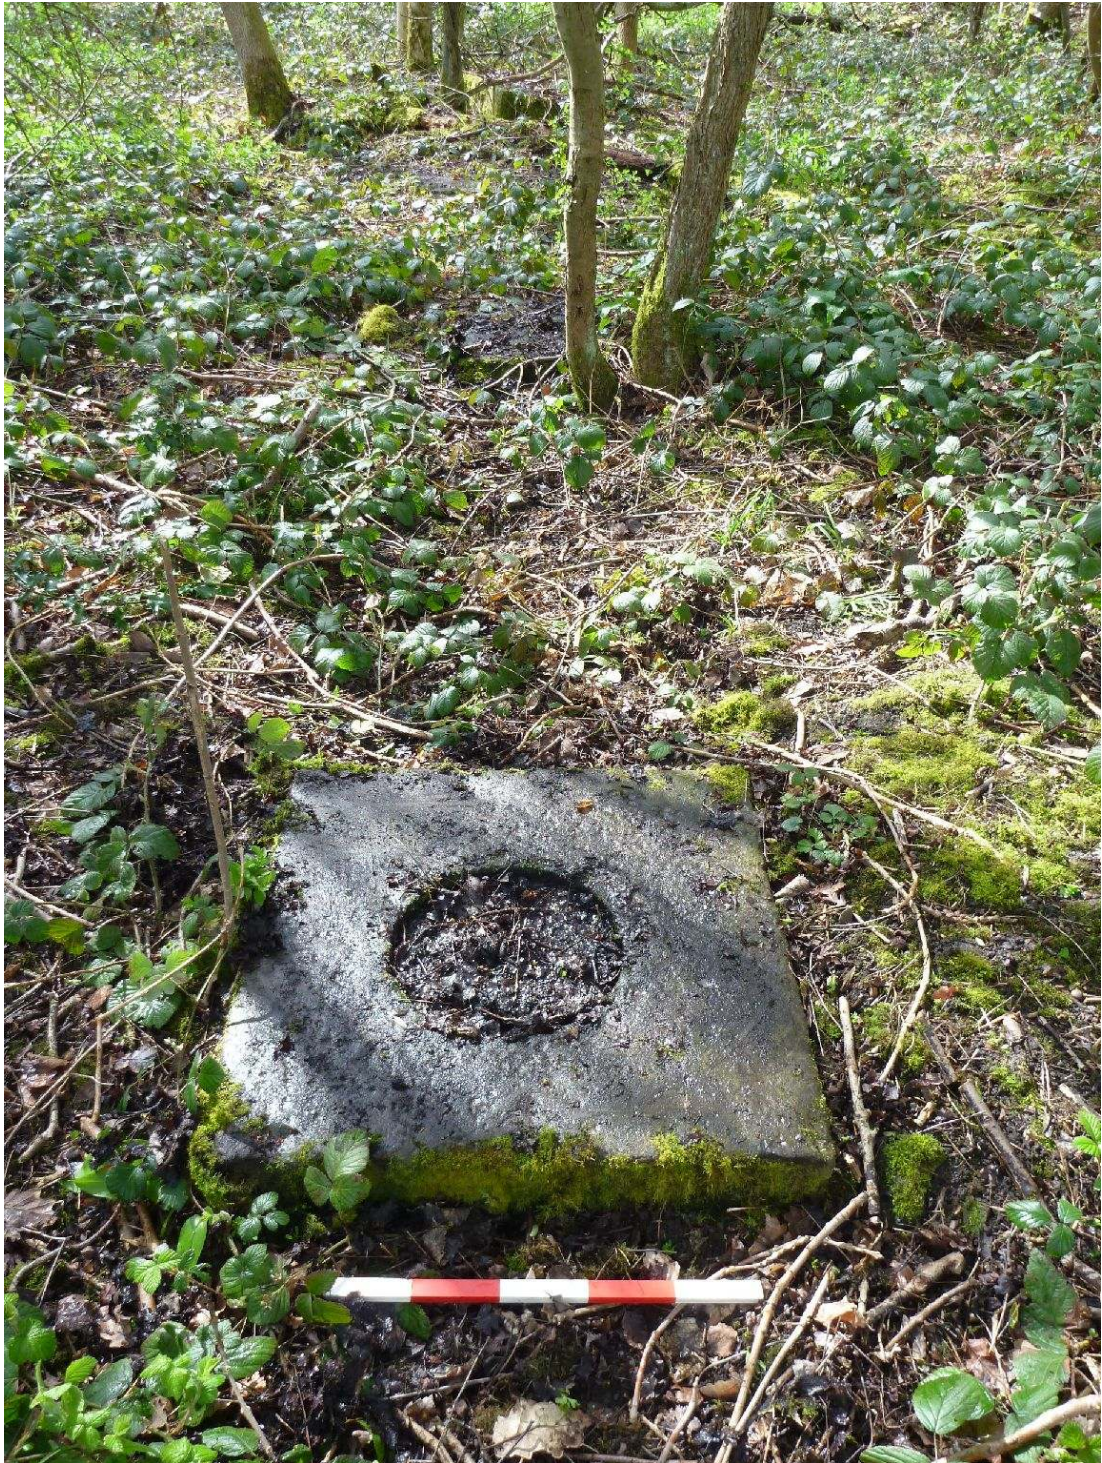
**Plate 12: Detail of stone column base 30 in western mill extension, (viewpoint 22)**

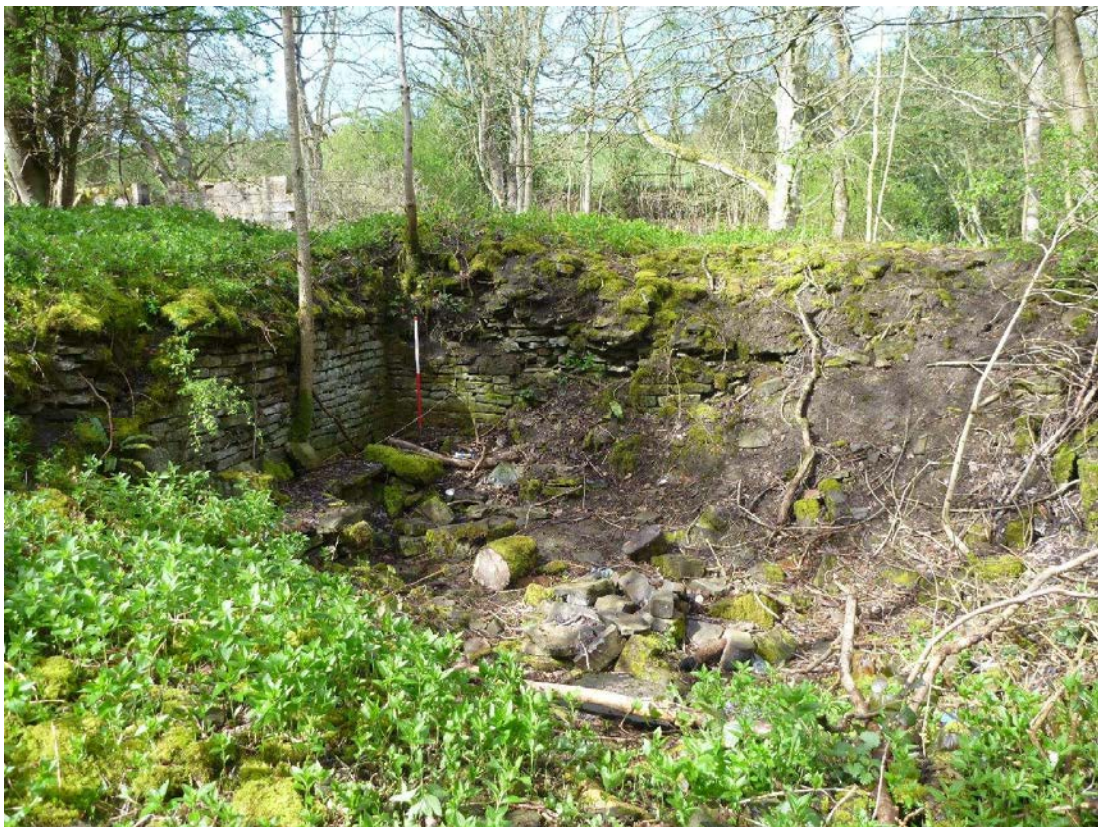
The only structural remains of the long rectangular building to the east of the mill comprise walls on the north and west sides of a possible cellar at the south end (feature 21). The walls survive below the current ground level, but the upper part of the wall is in a poor condition and is at risk of collapse (Plate 16). The room has clearly been used for outdoor gatherings, with benches constructed from the rubble and numerous alcohol cans and bottles in the area.

**Plate 16: Room 21 at south end of former woollen mill, viewed facing northwest (viewpoint 19)**

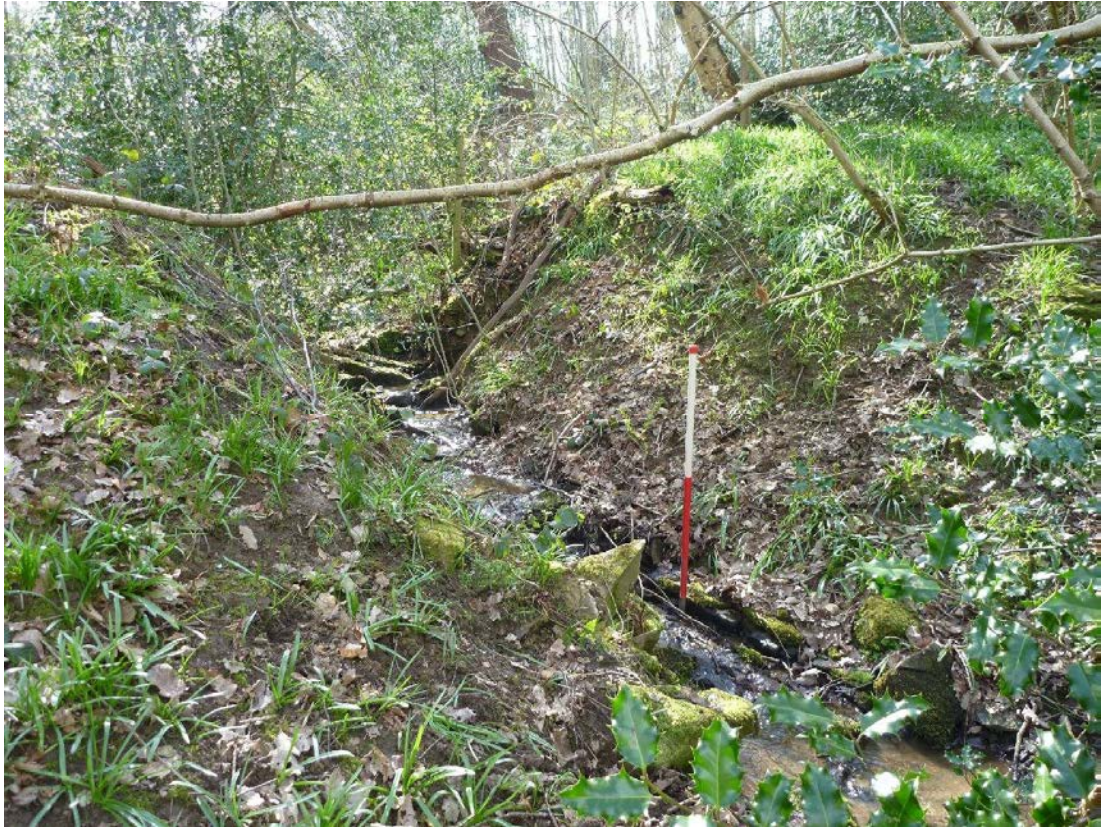
**Plate 21: Gap 45 through banks between reservoirs 48 and 76 with metal pipe in base, viewed facing west (viewpoint 57)**

ID no	Description	Interpretation	Significance	Condition	Threats	Viewpoints	Historic maps
45	Channel, possibly remnant of culvert, between reservoirs 48 and 76. Heavily eroded masonry at either end, possibly the location of sluice gates. Cast iron pipe runs along base of channel.	Culvert	1b: Regional	Average	Tree roots.	57	1854 OS
46	Sandstone drystone wall/revetment.	Boundary wall	2b: Local	Poor		None	
47	Earthen bank on southeast side of reservoirs 48 and 78.	Earthwork - dam embankment	1b: Regional	Good	Tree roots.	60	1893 OS
48	Reservoir, cut into natural slope on northwest side and embanked on southeast side. Small area of masonry revetment visible at southwest end. Silted, but a narrow channel runs through.	Mill pond	1b: Regional	Good	Trees growing within.	61	1854 OS
49	Channel through earth banks between reservoirs 48 and 78. No visibly masonry at either end, so may not be original. Heavy erosion.	Culvert?	1b: Regional	Average	Trees growing within.	63

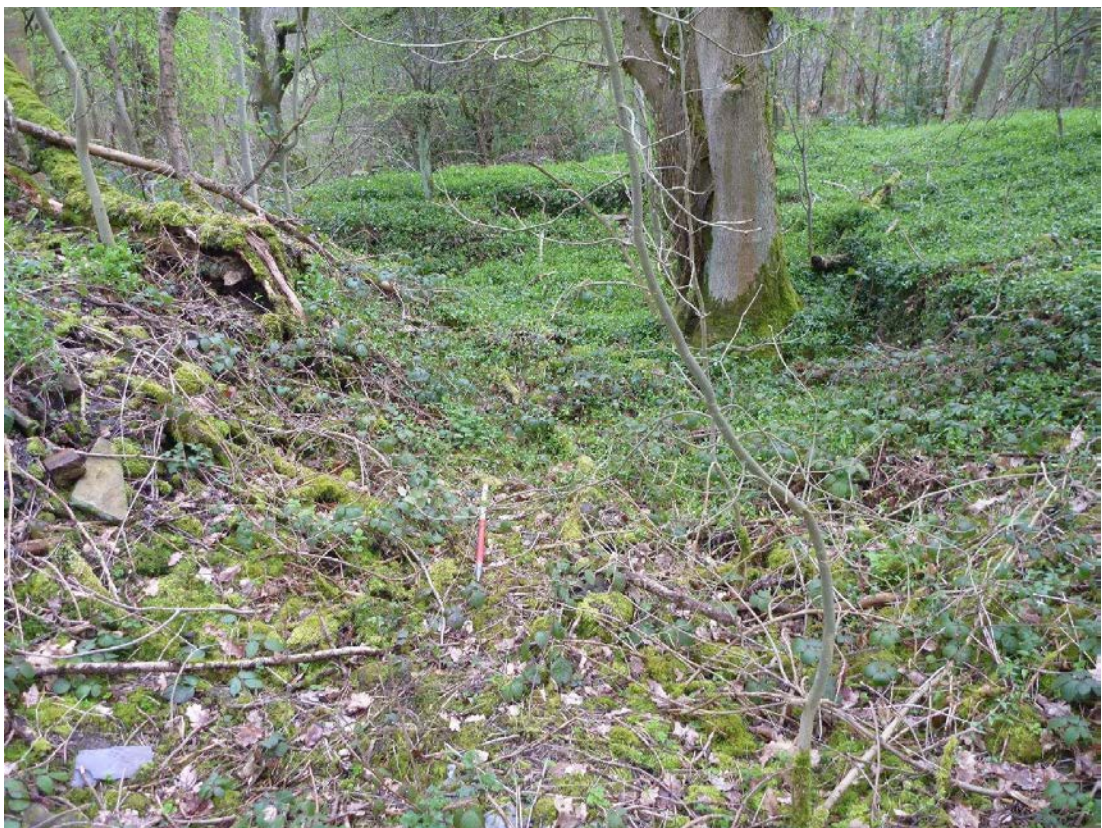
The remains of the cottages occupied by the mill managers survive to the north of the trackway (Figure 13). Oral history suggests that these cottages were standing until the 1940s, though the remains are in a poor condition and little of the fabric survives. The outline of the cottages is visible on most sides (feature 6), either as the remains of stone walls or as rubble banks. The western side of the range is cut into the current ground surface, and walls are visible as low stone revetments against the ground surface (Plate 24). The steps to a cellar are visible at the southern end of this range, and the cellar survives below the ground floor surface, which is solid. The cellar appears to run below the whole of the western side of the building. It survives intact (Plate 25), though it was not entered for the survey due to health and safety considerations. The base appears to be flooded, and it contains dumped asbestos roofing material. Two niches within the western wall of the cellar may relate to coal chutes.

**Plate 24: West side of cottages, cut into ground surface, viewed facing south (viewpoint 34)**

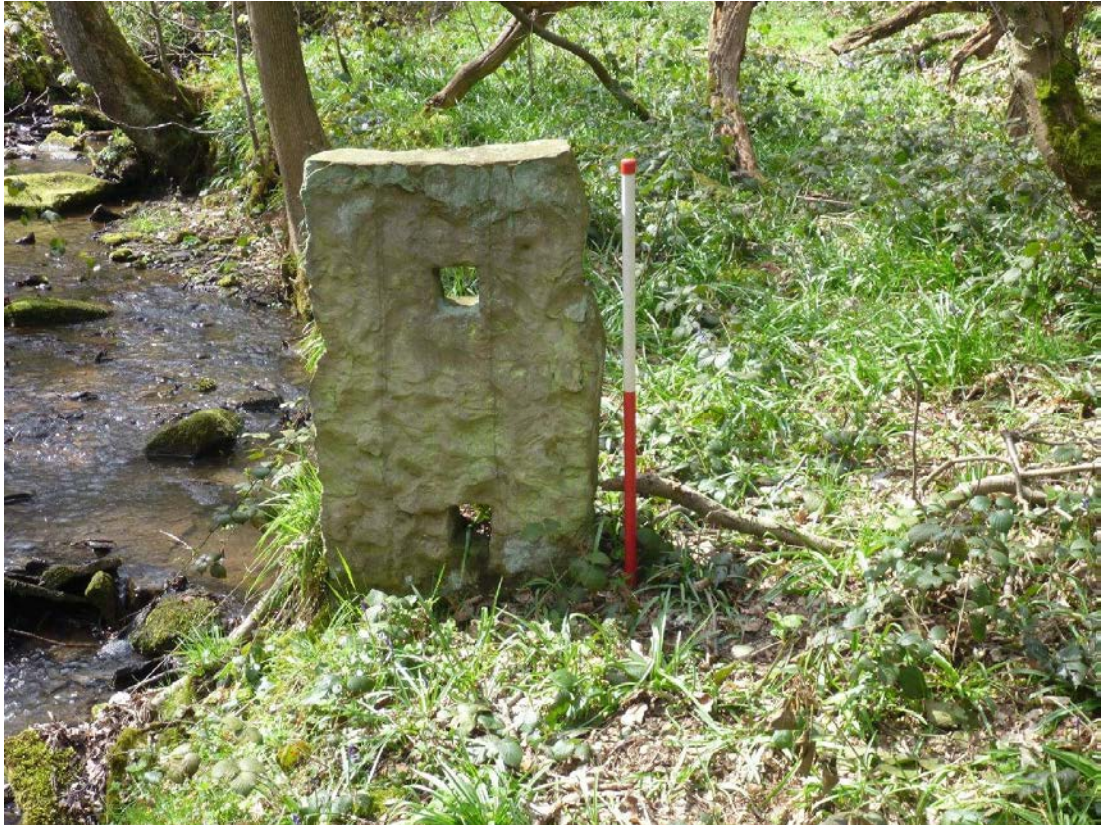
**Plate 29: Upright slab 71 with holes, possibly part of a sluice gate associated with channel 72, viewed facing west (viewpoint 46)**
