Elland Canal Bridge, West Yorkshire

Watching brief report

ArcHeritage 2016

**Elland Canal Bridge, West Yorkshire:
Archaeological Watching Brief**

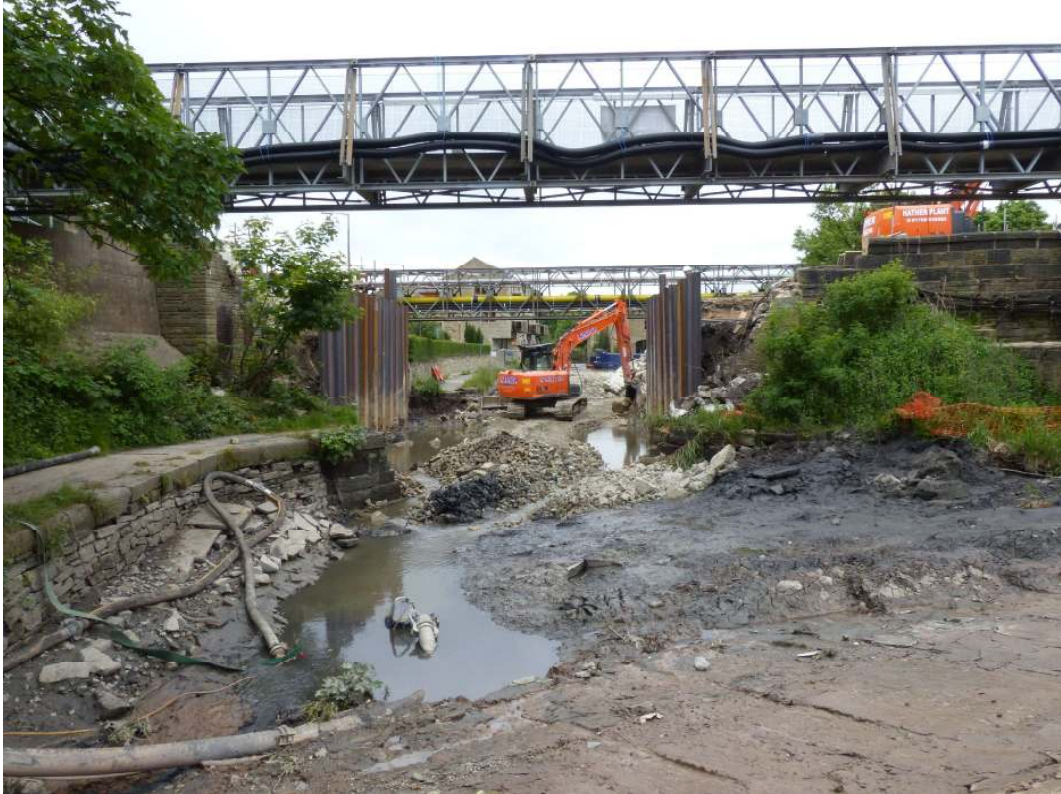
Due to the contractors' construction schedule, archaeological monitoring was only possible after the bulk of the bridge had been demolished. This meant that only limited observation of the core of the bridge was possible, in the edges of the roadway. The area below the surfacing appeared to be constituted of stone rubble and soil (Plate 1).

Plate 1: View of the demolished bridge, showing rubble core behind shuttering, viewed facing east

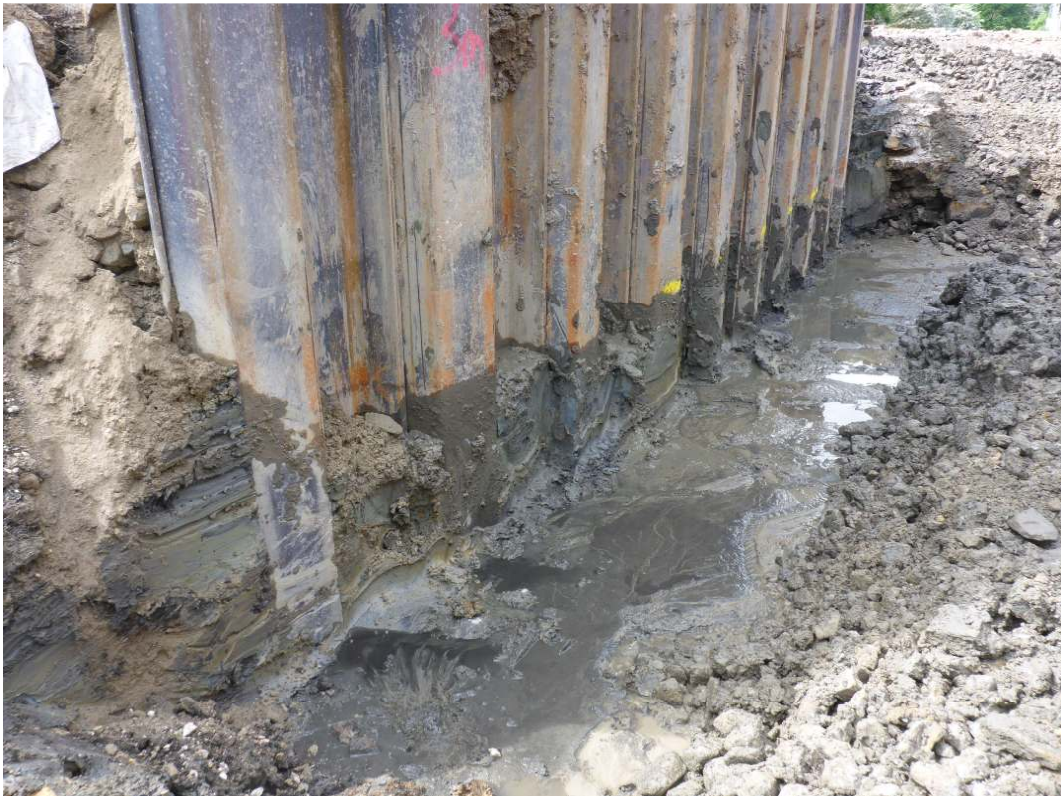
Following the draining of the canal, the buttresses of the bridge were removed and the area below excavated to expose the foundation deposits. No evidence of any wooden foundation piles, or earlier wooden bridge footings was observed. There was also no visible evidence for widening of the bridge. The bridge appeared to have been built directly onto a deposit of grey clay, which also underlay the yellow-brown clay of the canal lining (Plates 2 and 3).

Plate 2: Grey clay underlying the southern bridge foundations, viewed facing southwest

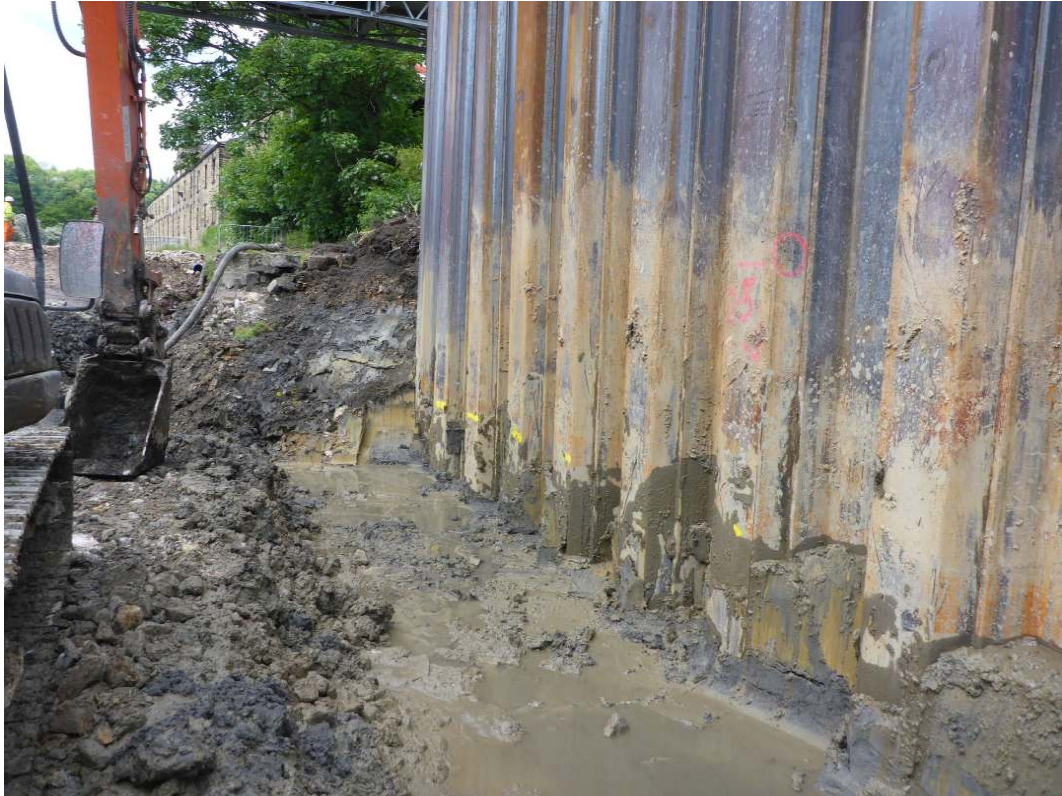
Plate 3: Grey clay under the northern bridge footings, with brown clay canal lining in section, viewed facing northwest

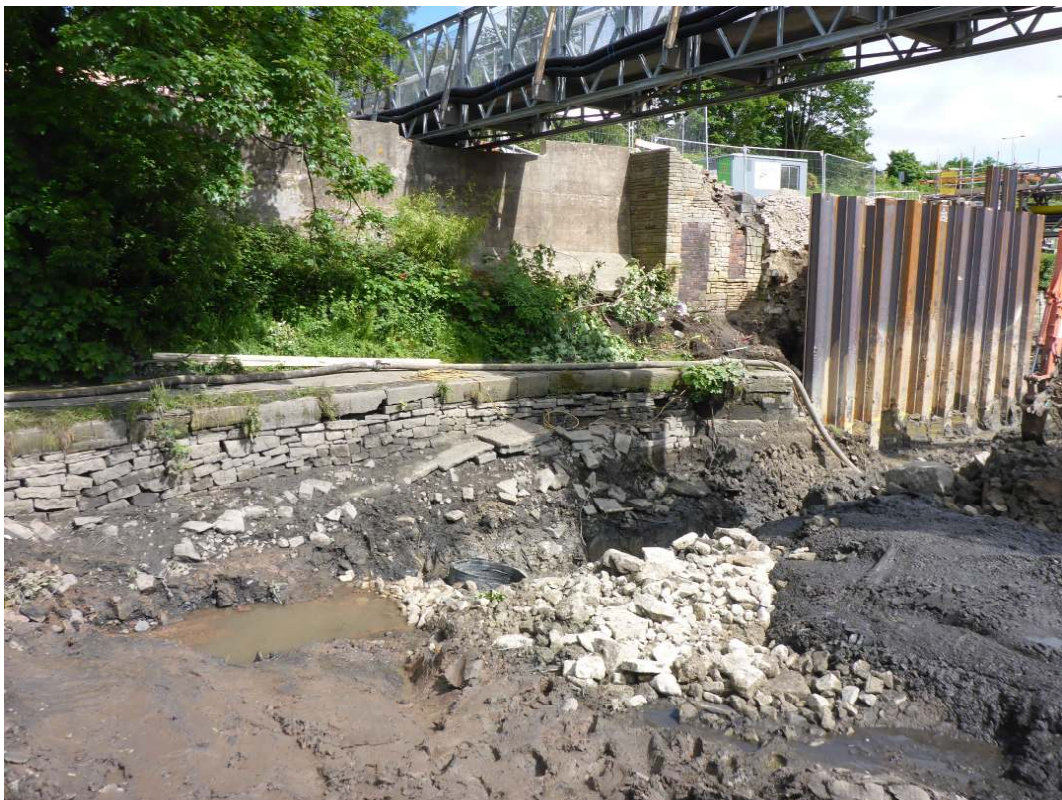
Modifications to one of the buttresses at the base of the northwest side of the bridge were noted, comprising an area of brick infill (Plates 4 and 5). This may have been a repair necessitated by heavy wear or water damage at a point where water pressure against the bridge was high. An earlier phase of walling along the northern canal edge to the west of the bridge was also noted, lower than the current wall. It was of similar stone construction to the existing wall, and surfaced with a layer of flat stone flags.

Plate 4: Northern canal wall west of the bridge, with repairs to bridge buttress and possible earlier canal wall, viewed facing north

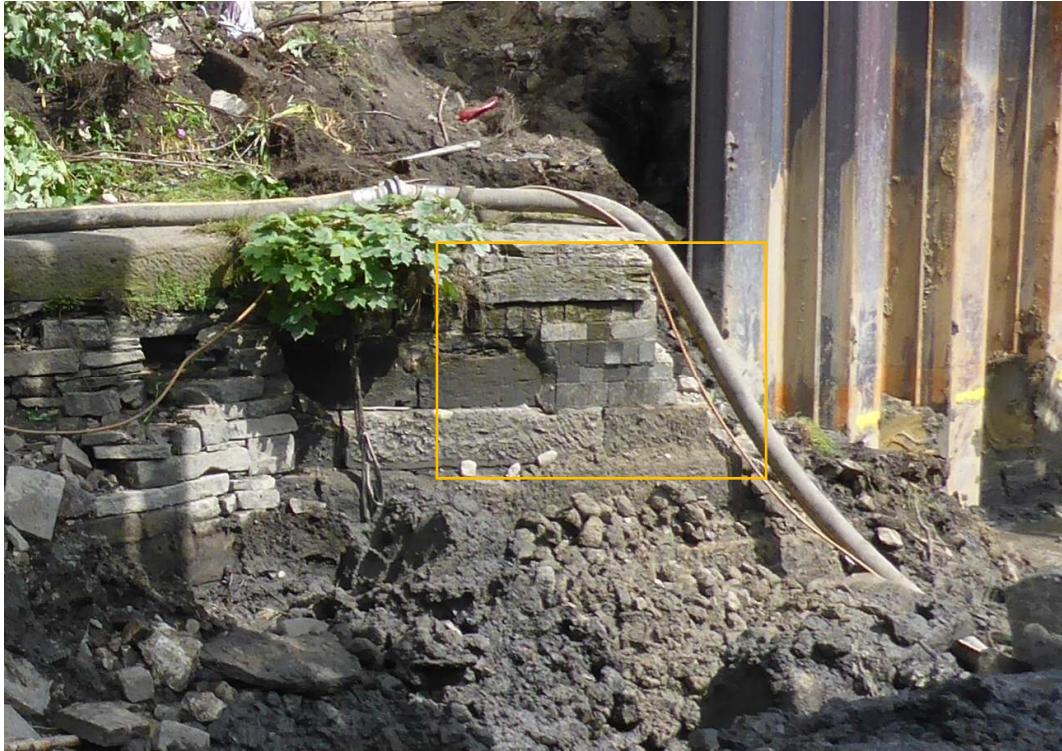
Plate 5: Detail of area of repair to bridge buttress, viewed facing north
