The Workhouse, Southwell:  
Archaeological Survey  
Survey and assessment for the National Trust  
ArcHeritage 2017

**The Workhouse, Southwell, Nottinghamshire:  
Archaeological Survey**

## Key Project Information

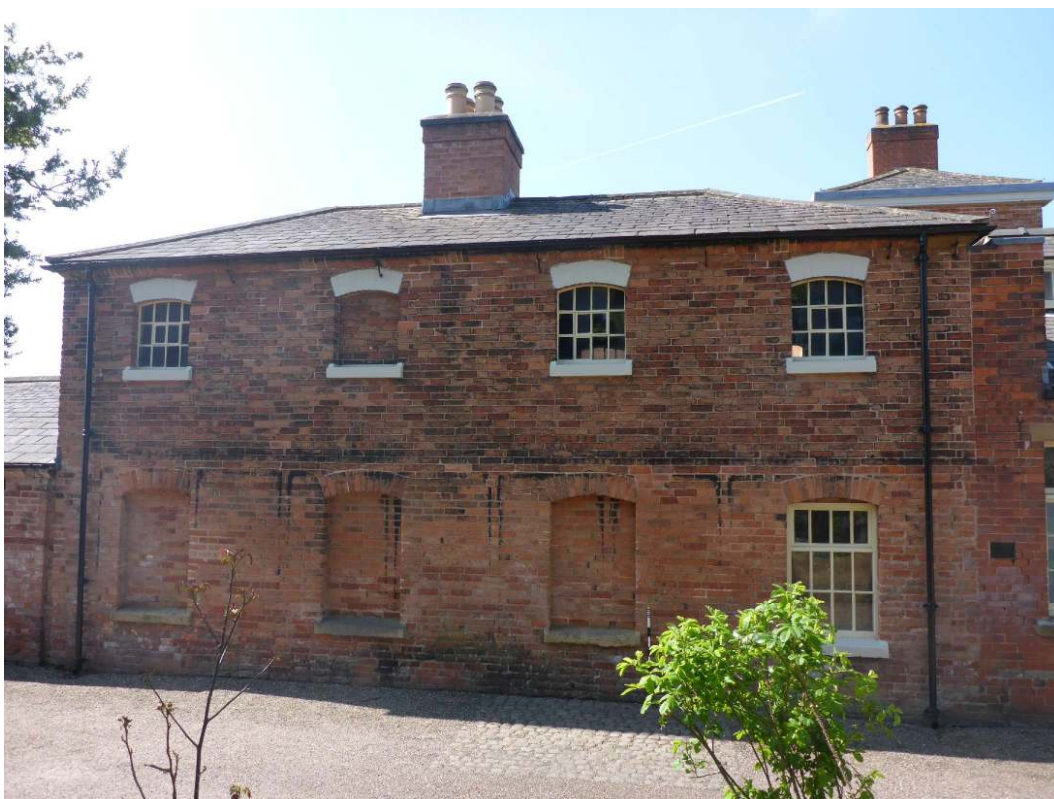
stack. Staining on the north elevation suggests that there has been a canopy and subdivided structure built against it, possibly wooden, in the past (Plate 15). This corresponds with the location of coal storage bins shown on the 1900 to 1930s maps and plans. A squarish patch of stone setts is set into the ground surface adjacent to the north face of the building (asset 117), and may also be associated with the former coal bins.

Plate 15: North face of laundry/infirmary (asset 102), showing staining possibly from former coal bins, and stone setts (asset 117)

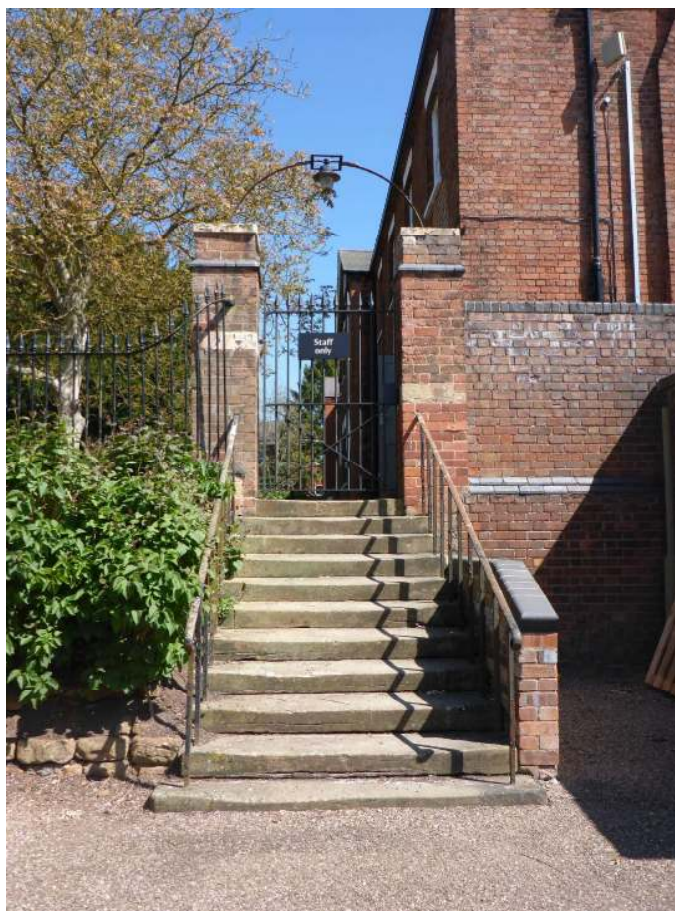
Plate 22: Steps and railings to Firbeck House (asset 114)

ID	NTSMR	Name	Description	Asset type	NGR	Condition	Photos
114		Wall around infirmary	Firbeck House is set within a garden/enclosure largely surrounded by a low wall . It is uncertain whether the wall has been reduced in height, or was perhaps formerly topped by railings, as the southern wall still is; this has a decorative iron gate at the top of a flight of steps leading up from the trackway to the north of the workhouse. The garden area was formerly divided into two, conforming to the division between male and female wards.	Structure	SK 71183 54331	Fair	050-051 facing NE; 052 facing N
115		Modern outbuilding	Square, single-storey brick outbuilding with two plain doors in the south face, with concrete windows and sills; one vented. There are also louvered vents in the east and west walls, and no windows, though there is a low-level blocked opening or hatch in the west elevation. Flat concrete roof.	Building	SK 71187 54298	Fair	048-49 facing NW; 050-51 facing NE

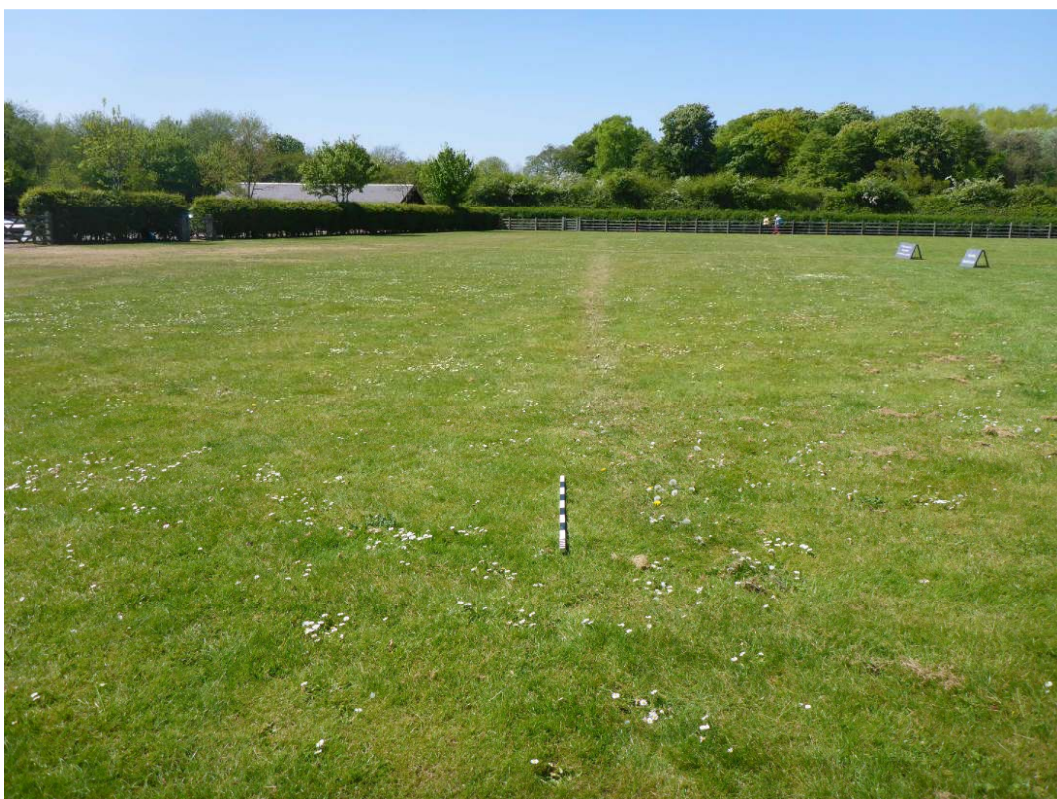
Plate 28: Linear parch mark (asset 121), viewed facing west

ID	NTSMR	Name	Description	Asset type	NGR	Condition	Photos
122		Parch mark in field south of workhouse	Narrow linear parch mark running east-west across the field to the south of the workhouse. Uncertain origin, may be fairly recent, possibly associated with drainage or services. The alignment does not correspond with the overall axis of the workhouse complex.	Cropmark	SK 71086 54187	Unknown	
123		Wall to east of workhouse	Tall brick wall along the eastern boundary of the workhouse grounds. The northeast corner appears oldest, with the area to the south appearing to be recently rebuilt.	Structure	SK 71189 54281	Fair	053-4 facing N
