Barn at Marston Lodge, Marston Montgomery, Derbyshire  
Historic Building Record  
ArcHeritage 2018

Barn at Marston Lodge, Marston Montgomery, Derbyshire  
Level 2-3 Historic Building Recording

Project Name	Barn at Marston Lodge, Marston Montgomery, Derbyshire
ArcHeritage Project no.	1840
Report status	Final
Type of Project	Historic Building Recording
Client	Mr Robert & Mrs Olivia Fernihough
OASIS ID	archerit1-336956
Planning Application ref.	18/00795/LBALT
NGR	SK 13515 39159
Authors	Christopher Curtis
Illustrations	Christopher Curtis
Editor	Glyn Davies
Report Number and Date	2018/78 17/12/2018
Version and Filename	Version 1: 1840 Marston Lodge Barn V1.docx

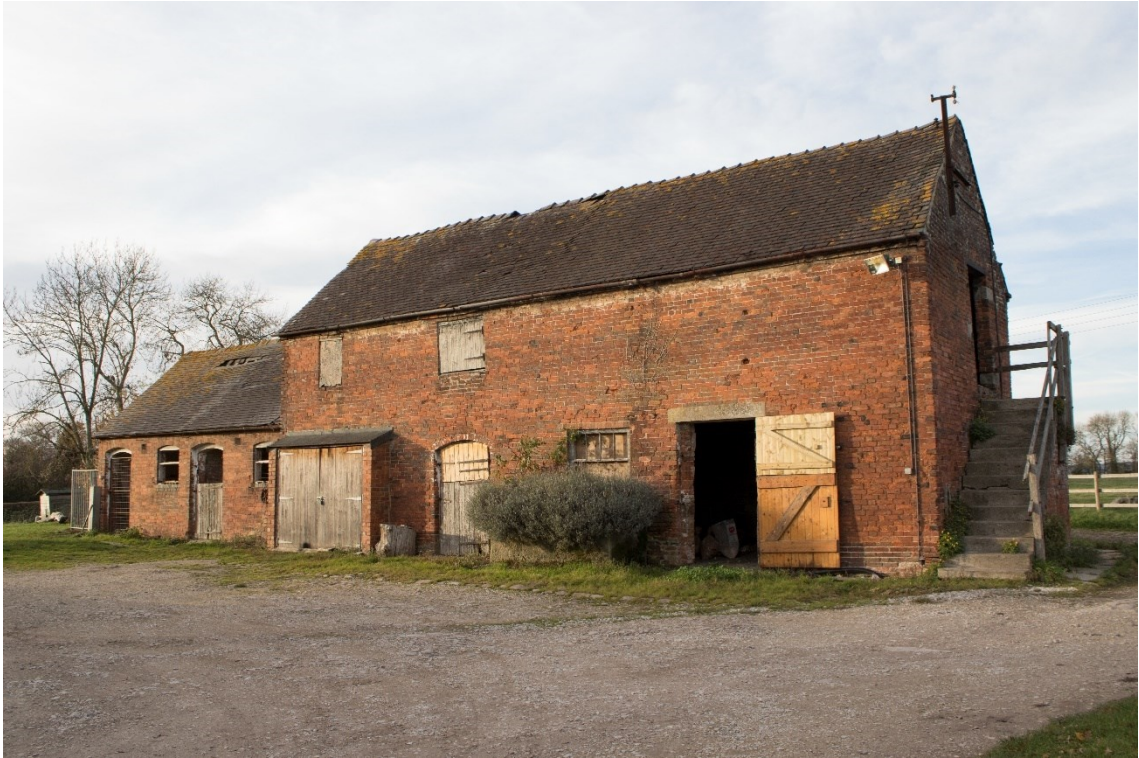
The building consists of two adjacent ranges aligned east-west; a two-storey red brick cow house of four bays and a later single storey cow house of two bays (Plate 1). The principal elevation, containing almost all of the openings faces south towards the farmyard. The main range has gabled ends and a slate roof, and is constructed with red bricks in an irregular bond. The adjoining range to the west is also gabled, has a slate roof and is constructed of a paler red brick in Flemish stretcher bond. The building has an area of cobbled paving in front of it and is set within a similarly paved yard.

Plate 1: South elevation of the barn (1840\_061.TIF)

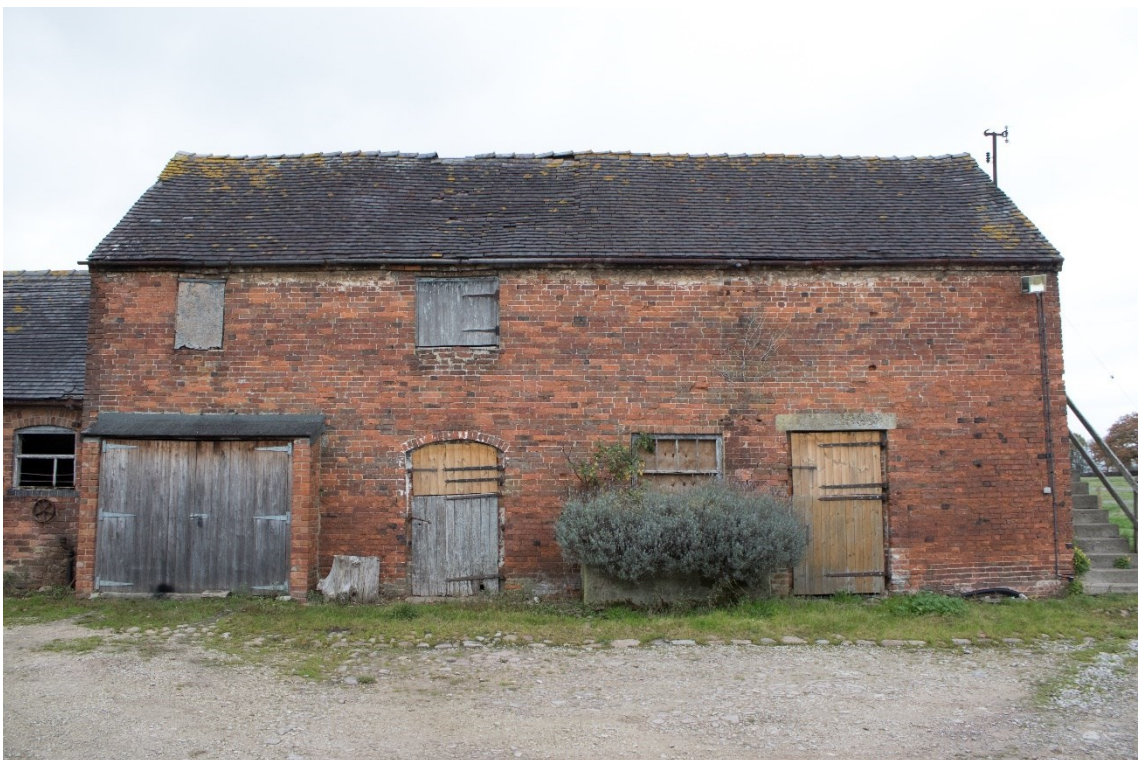
The principal elevation, facing south comprises two parts, the main range and the west range. The main range has two doorways giving access to the two parts of the cow house (Plate 2). The east doorway has recessed jambs and a concrete lintel (Plate 3). Although the lintel is an insertion the doorway appears to be original. The door itself is of modern plank and batten construction, although it is made with strap hinges from an earlier door, possibly the one it replaced.

Plate 2: South elevation of the main range (1840\_006.TIF)

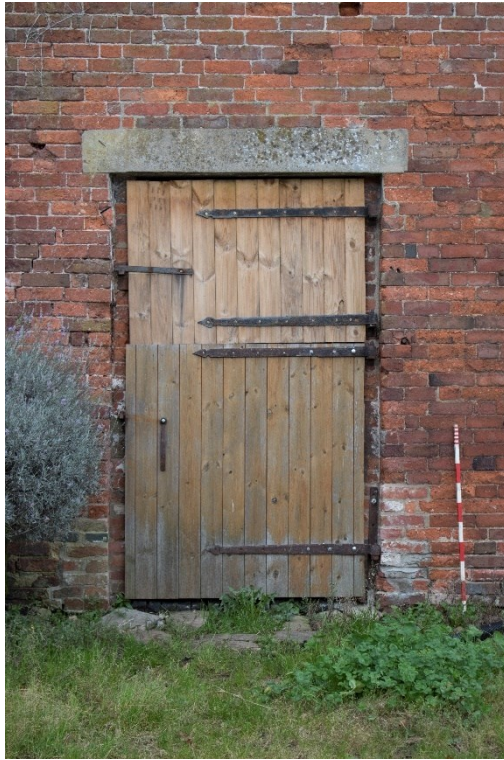
Plate 3: East door to main range, facing north (1840\_008.TIF)

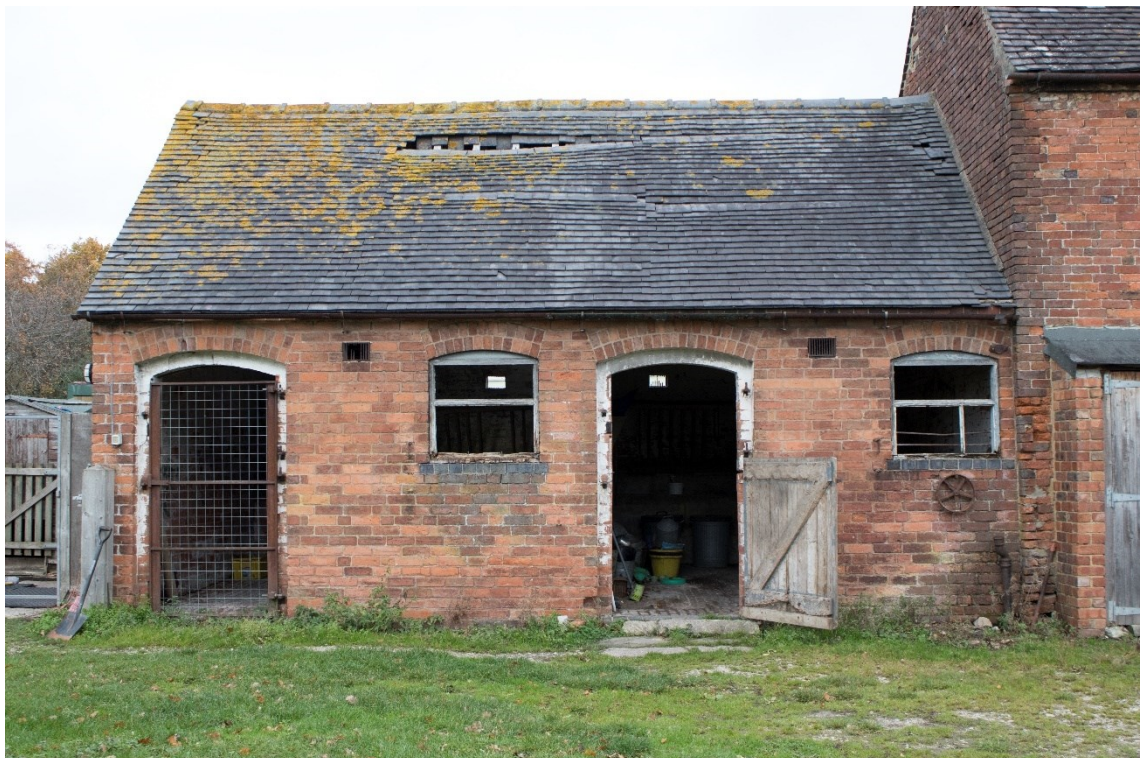
The west range has two almost identical bays (Plate 4). Each has a doorway with recessed jambs and segmental brick arched heads, as well as a small window to the east with similar heads and Staffordshire blue brick sills. Both bays also feature ventilation grates between the windows and doorways. Only the bottom leaf of the east door survives, it is of machine sawn plank and batten construction. The windows appear to have had fixed timber lights with glazing bars (now missing).

Plate 4: South elevation of the west range (1840\_007.TIF)

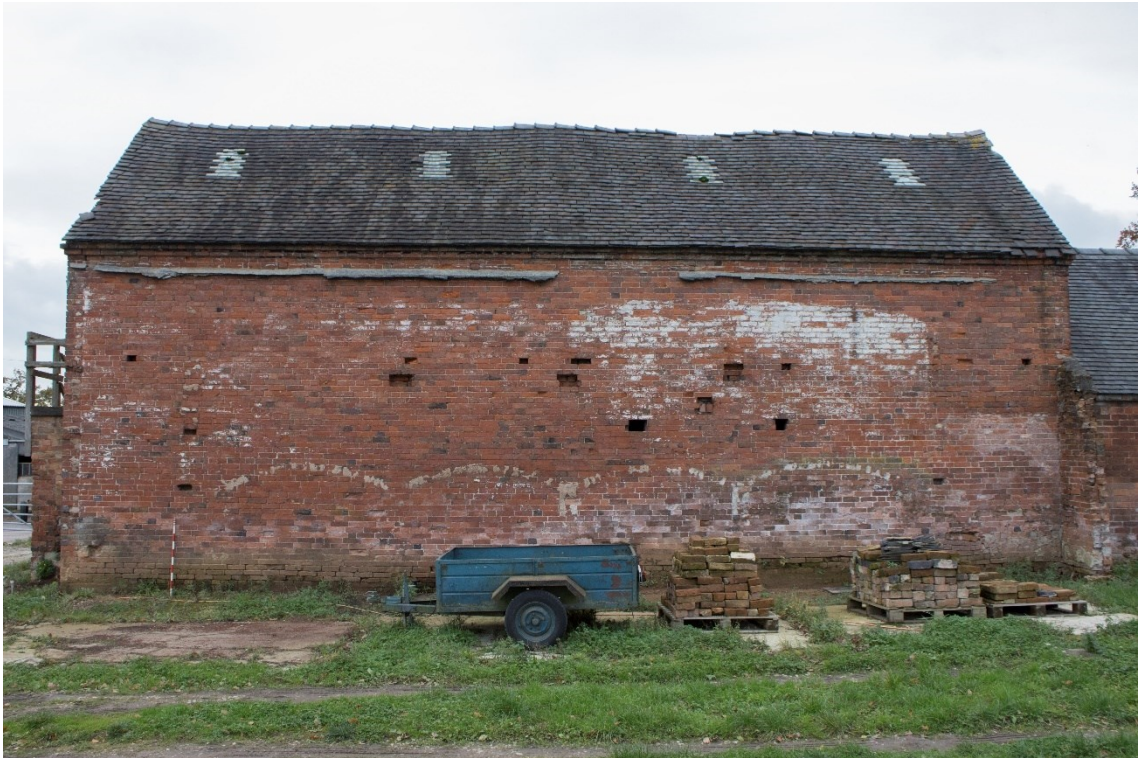
The north elevation is largely blank, apart from the main range which retains fragments of flashing and roof tiles from the former lean-to pigsty (Plate 5). The wall also bears the scars of from the former structure and the stub of a brick wall between the main and west ranges. The quality of the brickwork on the rear of the main range is similar to that of the front and it appears to have been built as an external wall, indicating the pigsties were a later addition. The rear of the west range is blank, apart from four evenly spaced ventilation grills at the top of the wall (Plate 6).

Plate 5: North elevation of the main range (1840\_023.TIF)

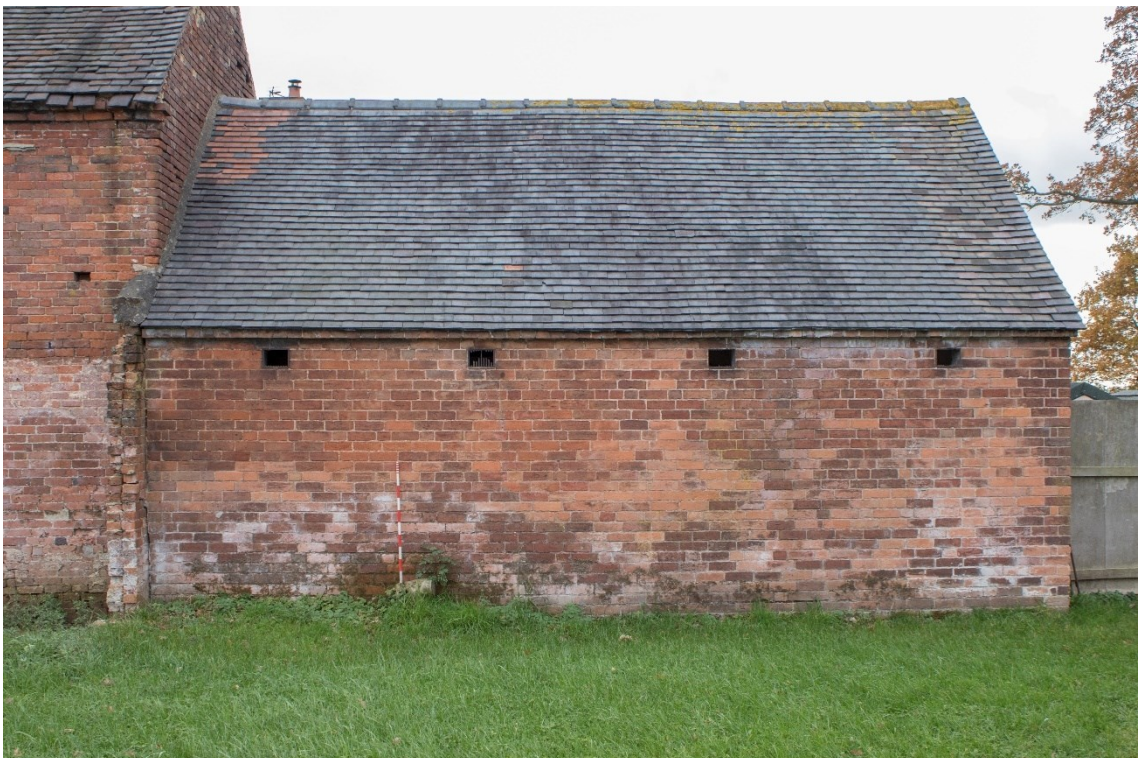
Plate 6: North elevation of the west range (1840\_032.TIF)

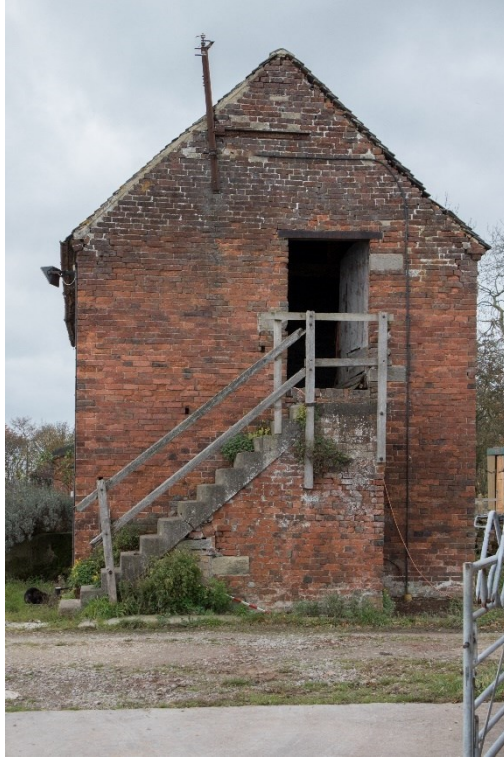
The east elevation is punctuated only by a first-floor doorway, gained via external concrete steps on a brick platform (Plate 7). The opening appears to be original, although the steel lintel over the doorway is probably a replacement. The doorway features random dressed stone blocks in its jambs but is predominantly of brick. The staircase is built from similar brick to the main range and is either contemporary with it or was built soon after, although the steps are cast concrete and are probably a 20<sup>th</sup> century repair.

Plate 7: East elevation of the barn (1840\_020.TIF)

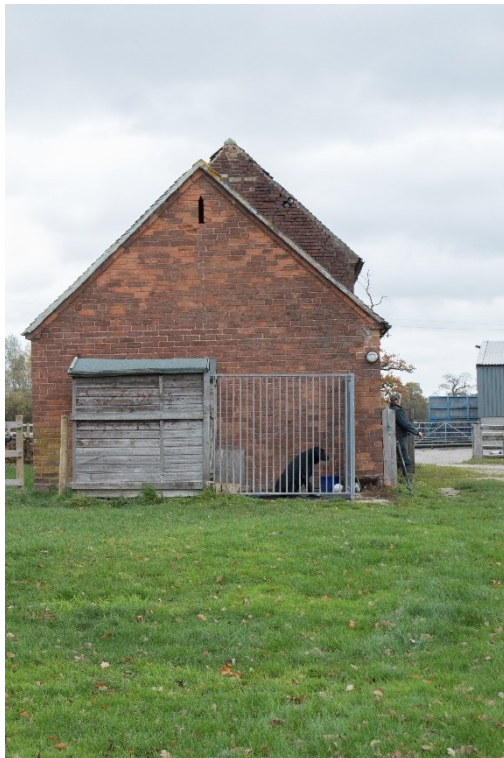
The west elevations of both the west range and what can be seen of the main range are blank, save for a ventilation slit in the west range gable (Plate 8).

Plate 8: West elevation of the barn (1840\_017.TIF)

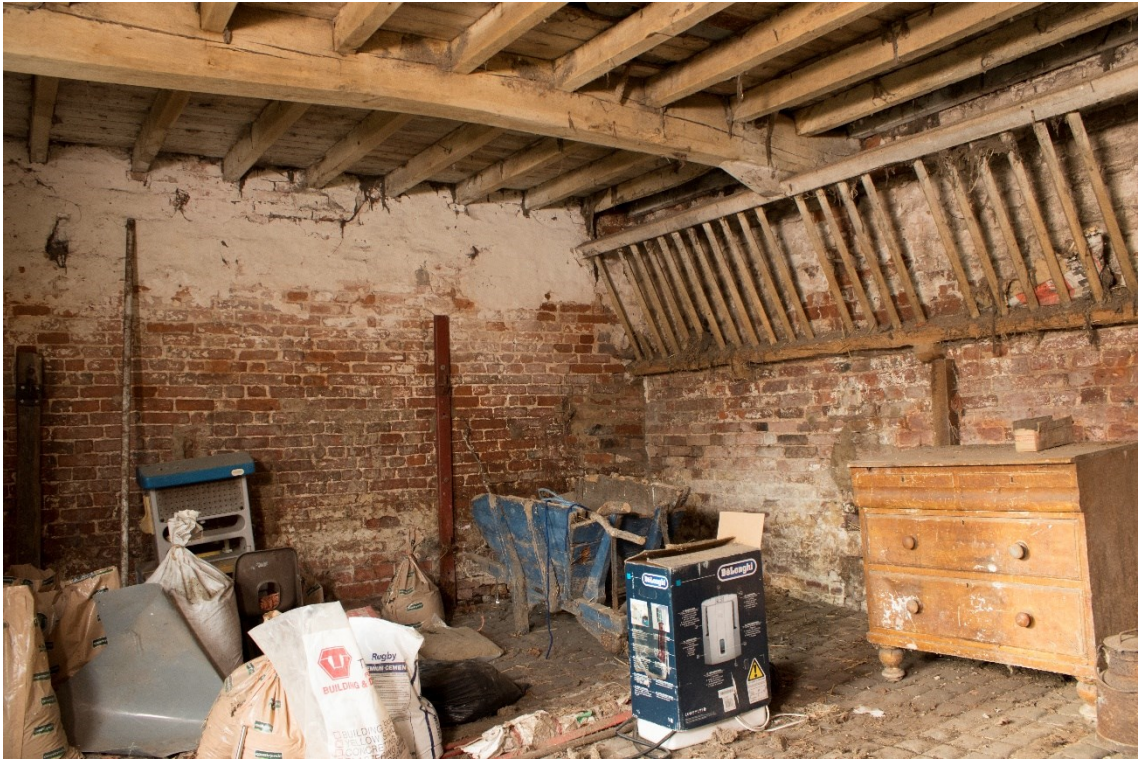
Internally the ground floor of the main range is divided into three separate rooms. The eastern room, formerly a cow house has plain brick walls which were formerly whitewashed (Plate 9). The ceiling comprises two north-south oak bridging beams supporting smaller section oak floor joists. The joists are deep in section, measuring approximately 28 x 19 cm and 12.5 x 7cm respectively. The bridging beams rest in thicker sections of brickwork either side of the door (Plate 10). The room is floored with square stone pavers which drain into an east-west gutter towards the south of the room. The room is missing its stall dividers and mangers; however, it retains a hayrack on its north wall and has makeshift hitching posts at regular intervals along its walls.

Plate 9: Ground floor east room in main range, facing north-west (1840\_027.TIF)

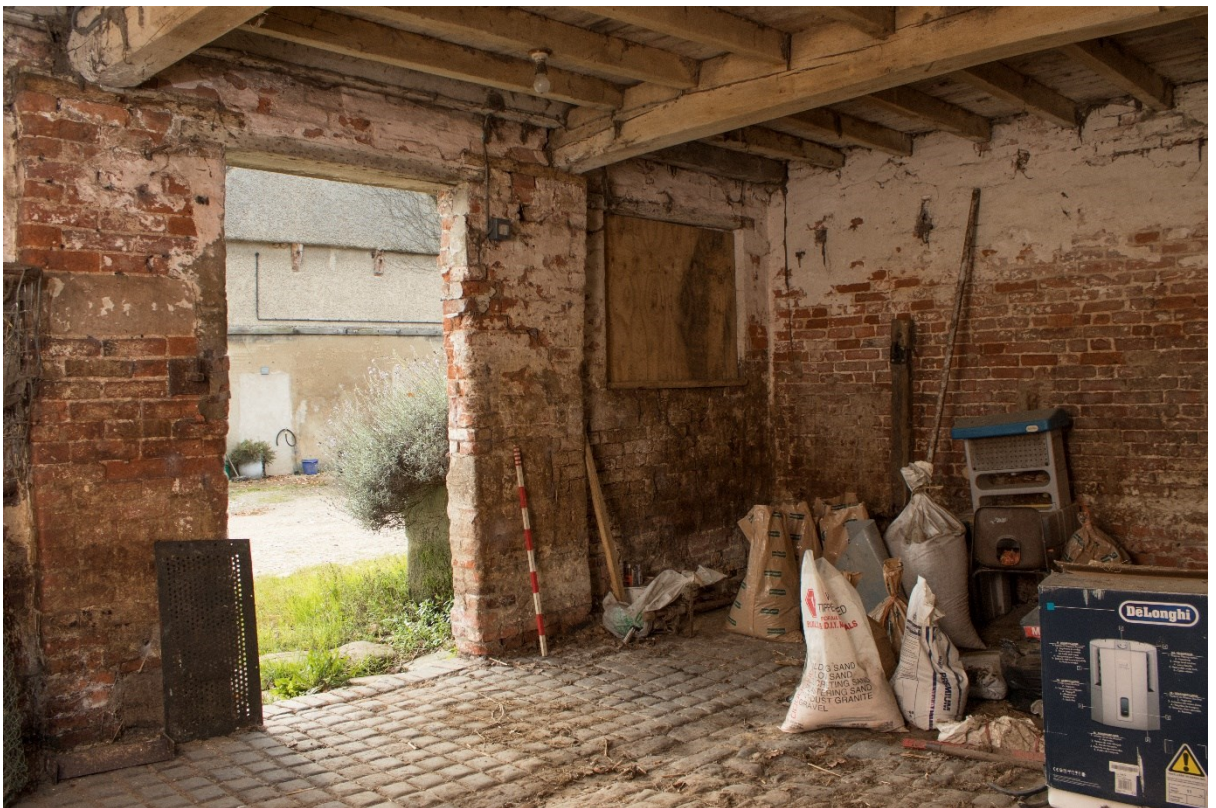
Plate 10: Ground floor east room in main range, facing south-west (1840\_027.TIF)

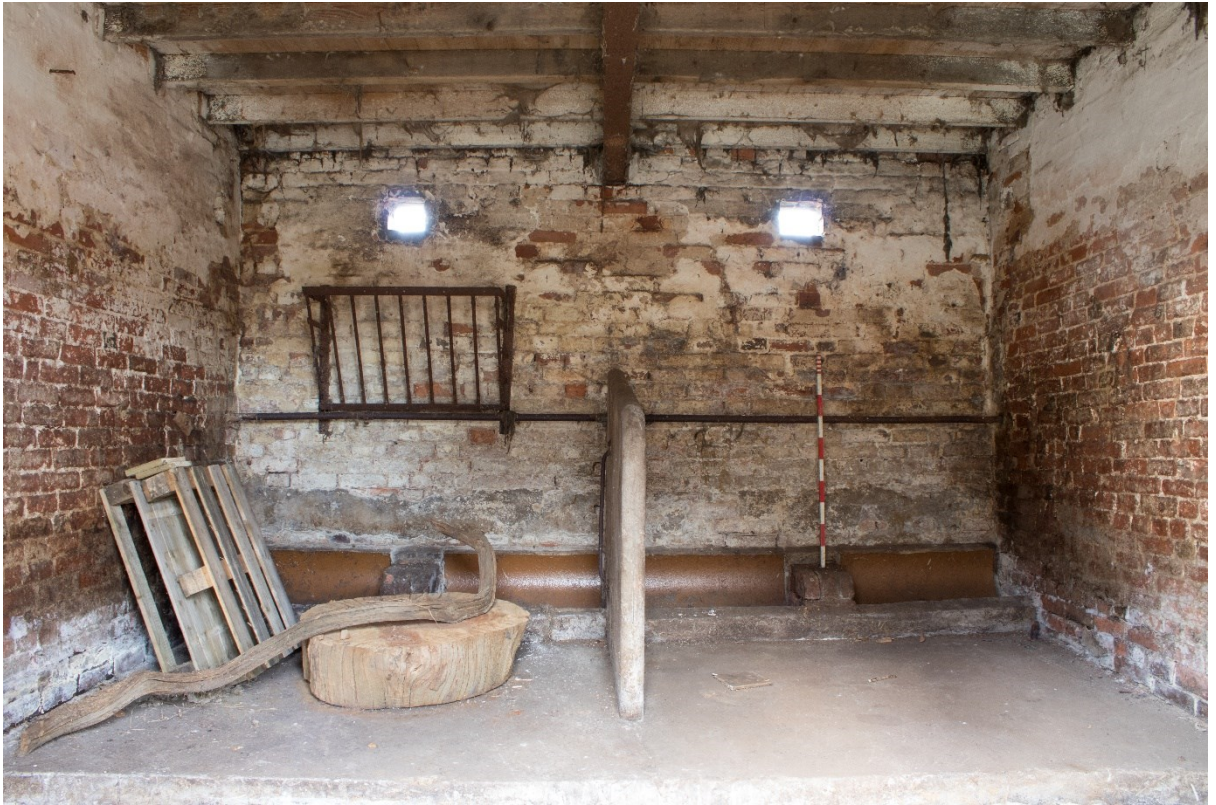
The central room is similar in function but has a somewhat different character to the east. The room is narrower and has whitewashed brick walls (Plate 11). The ceiling consists of a steel bridging beam supporting deep-section machine-sawn softwood floor joists. The room is

Plate 11: Ground floor central room in main range, facing north (1840\_034.TIF)

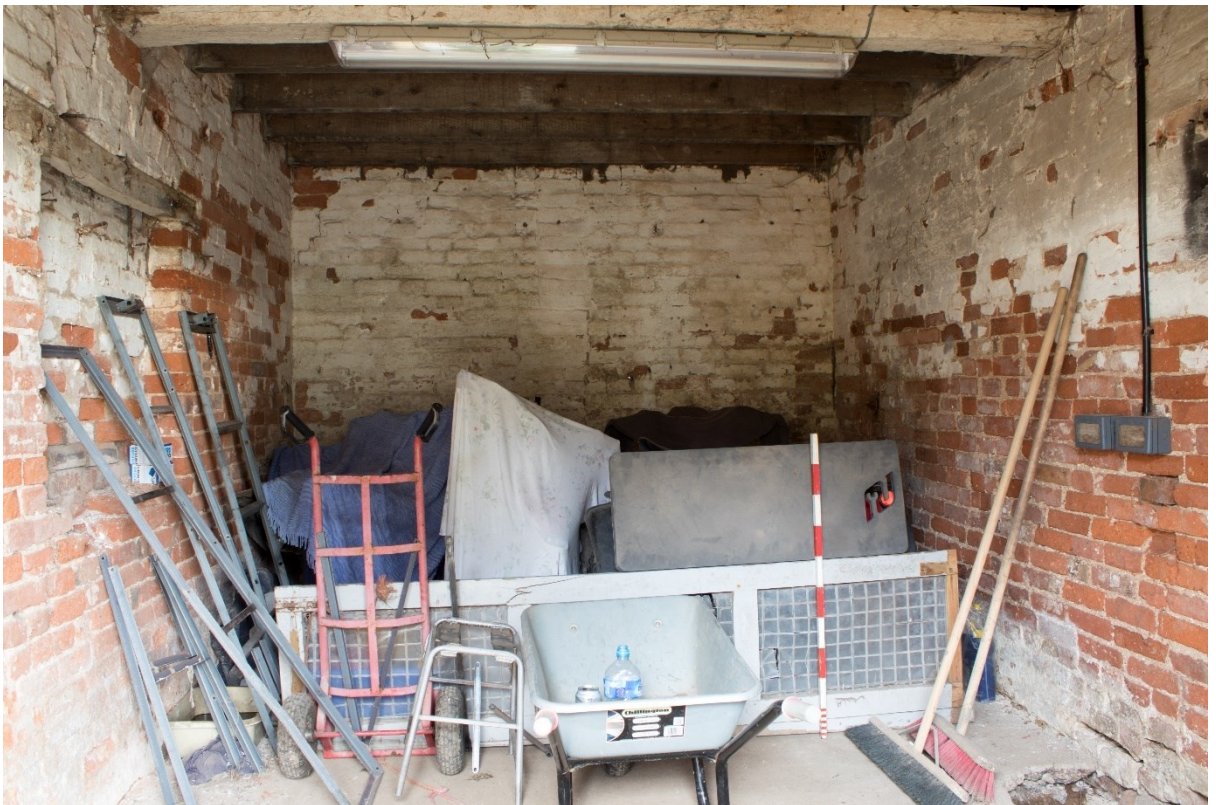
The westernmost room is accessed via modern double doors and consists of a plain room now used for storage (Plate 12). The room has whitewashed brick walls and a plain concrete floor. A blocked window opening occupies the west wall. The ceiling consists of deep section machine sawn joists aligned east-west, supported by the partition walls. A larger bridging beam also runs east-west across the centre of the room, although it supports nothing, and is probably a remnant of an earlier ceiling (Plate 13). That the joists supporting the current ceiling are later additions is confirmed by the scars visible on the internal east wall of the east room of the west range (Plate 19). Here alterations to the brickwork show the line of the inserted joists. In addition, the arch for the blocked former window can also be seen in wall below the scars of the brickwork from the joist insertion.

Plate 12: Ground floor west room in main range, facing north (1840\_001.TIF)

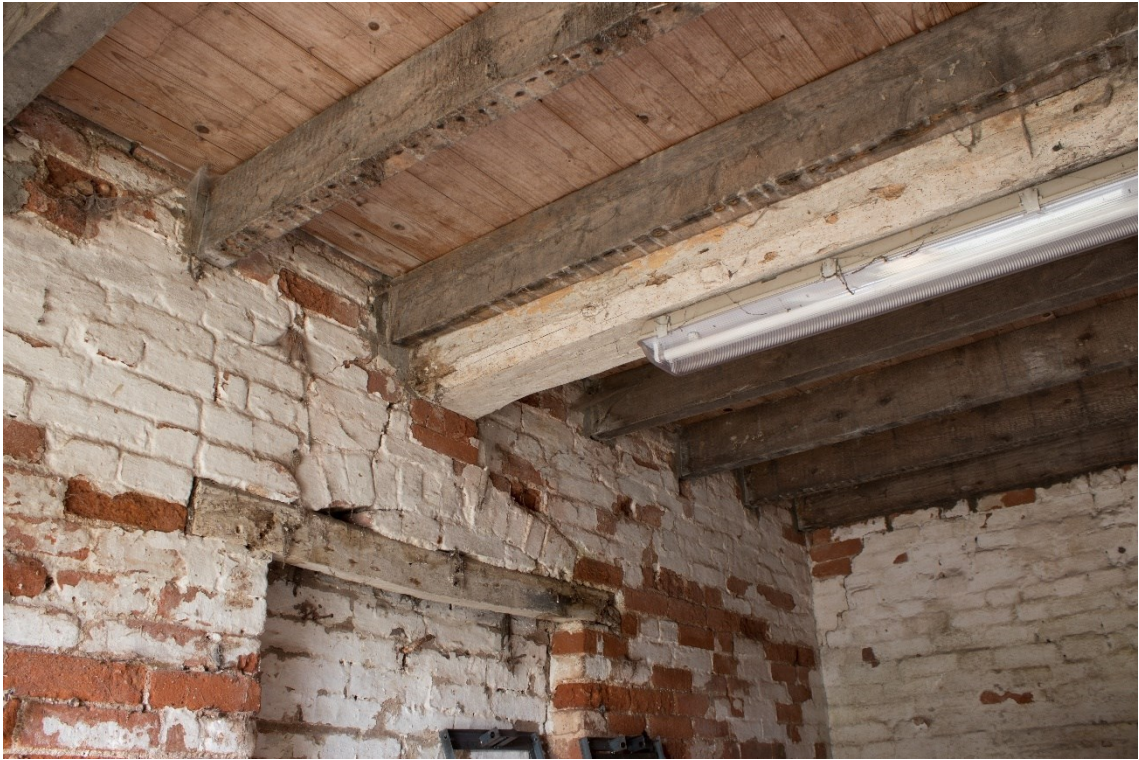
Plate 13: Ground floor west room in main range, bridging beam, facing north-west  
(1840\_003.TIF)

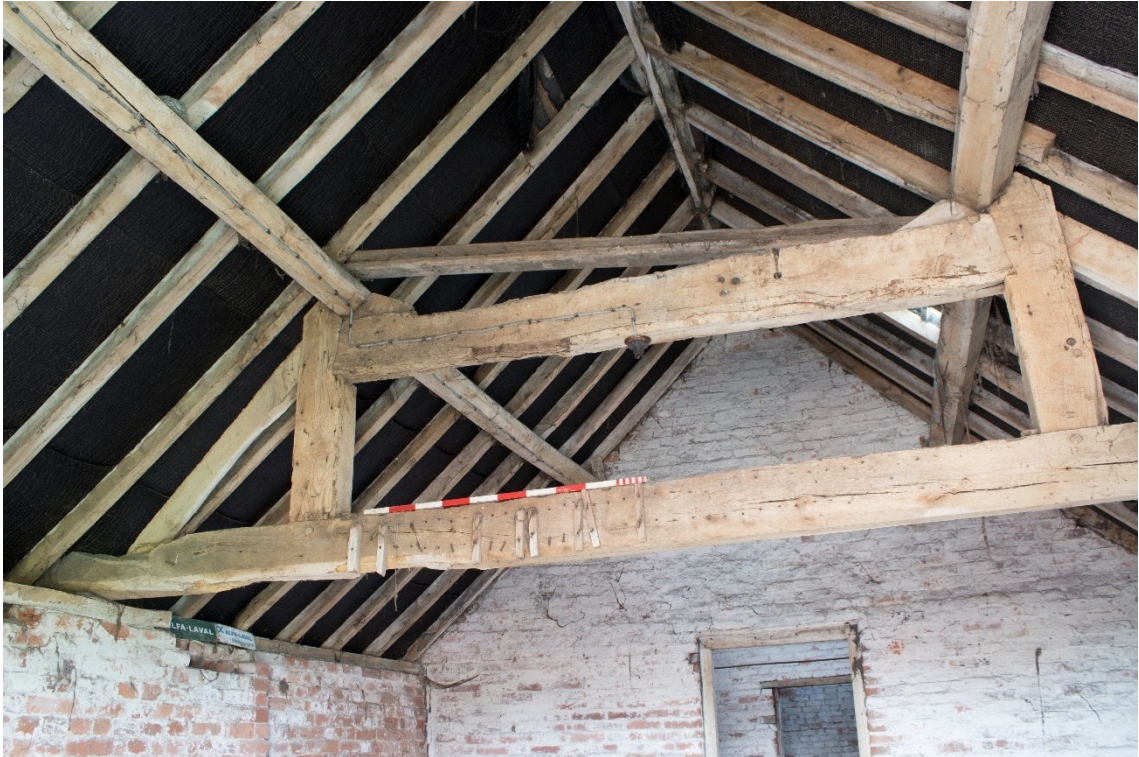
The first floor consists of three rooms that mirror the layout of the ground floor. The floor is accessed from an external doorway at the east end of the building. All of the rooms are open to the roof and separated by brick partitions. The roof construction is fairly consistent throughout, consisting principally of oak common rafters meeting at a ridge-piece. The rafters are supported by purlins which are in turn supported by the internal brick walls which rise to the full height of the roof (Plate 14). The roof timber mainly appears to be hand-sawn oak, although the purlins in the west room show signs of reuse. As the west room is twice as wide as the others and lacks a wall to support the purlins, it features a truss-like structure with a tie-beam, collar and two posts to support purlins. It lacks rafters however, and may be a reused truss from an earlier building, such as part of the farmhouse.

Plate 14: Main range roof structure in first floor east room, facing west (1840\_047.TIF)

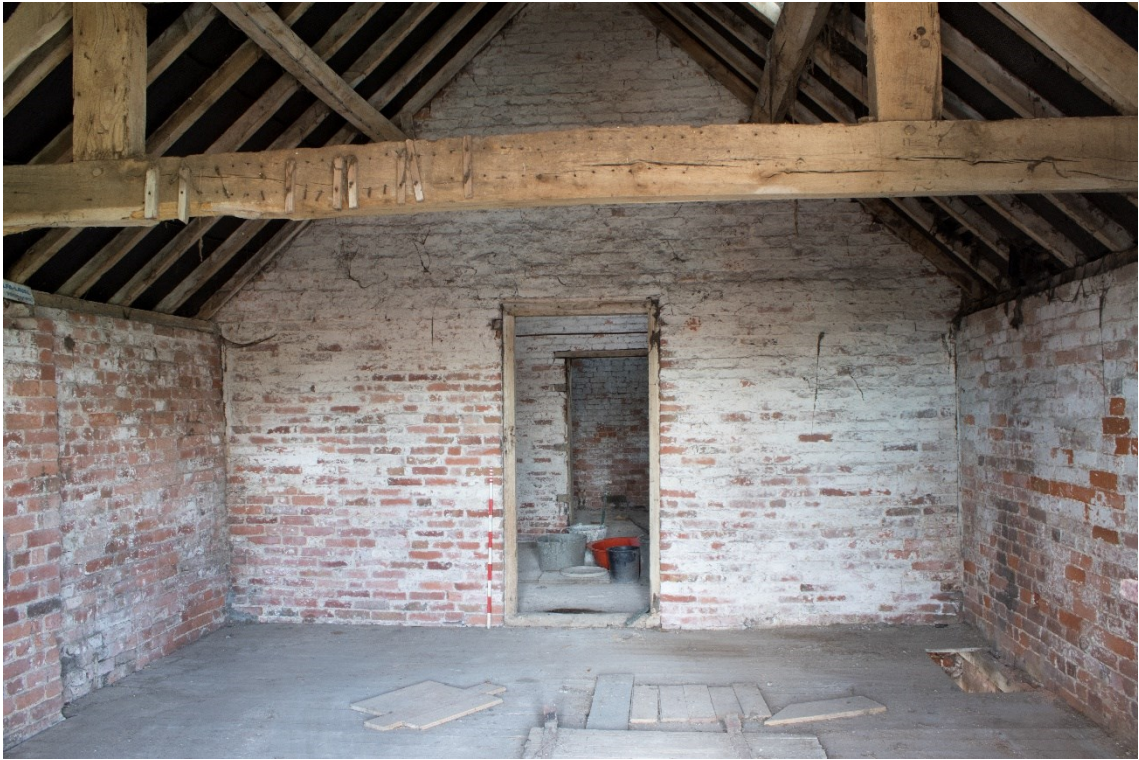
The west room has few noticeable features, and consists of an open space with plain brick walls and a doorway leading to the next room in the centre of the internal wall (Plate 15). The floor of the room is constructed of tongue and groove boards, suggesting the room may have been used for storage of grain. Holes have been cut in the floor at the north end to drop fodder into the hayrack on the ground floor. This suggests that at least in later years the room was used as a hayloft.

Plate 15: First floor east room, facing west (1840\_046.TIF)

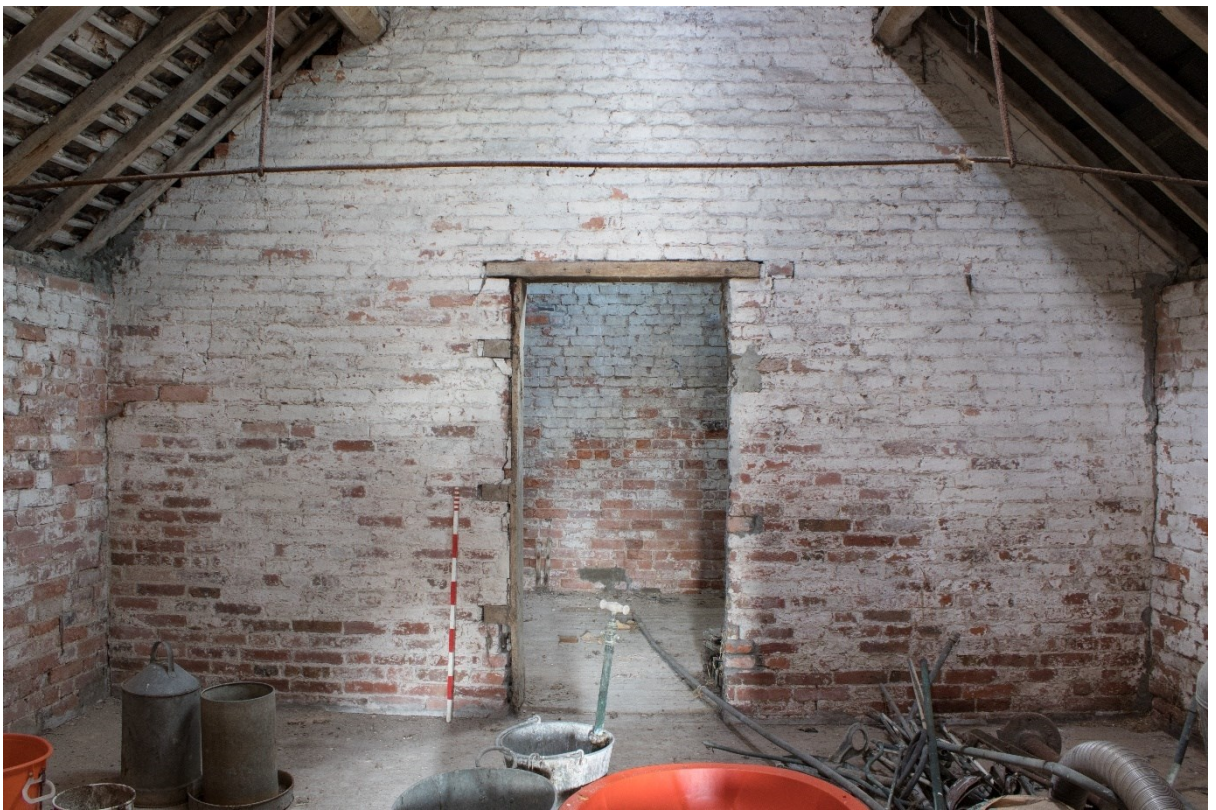
Plate 16: First floor central room, facing west (1840\_051.TIF)

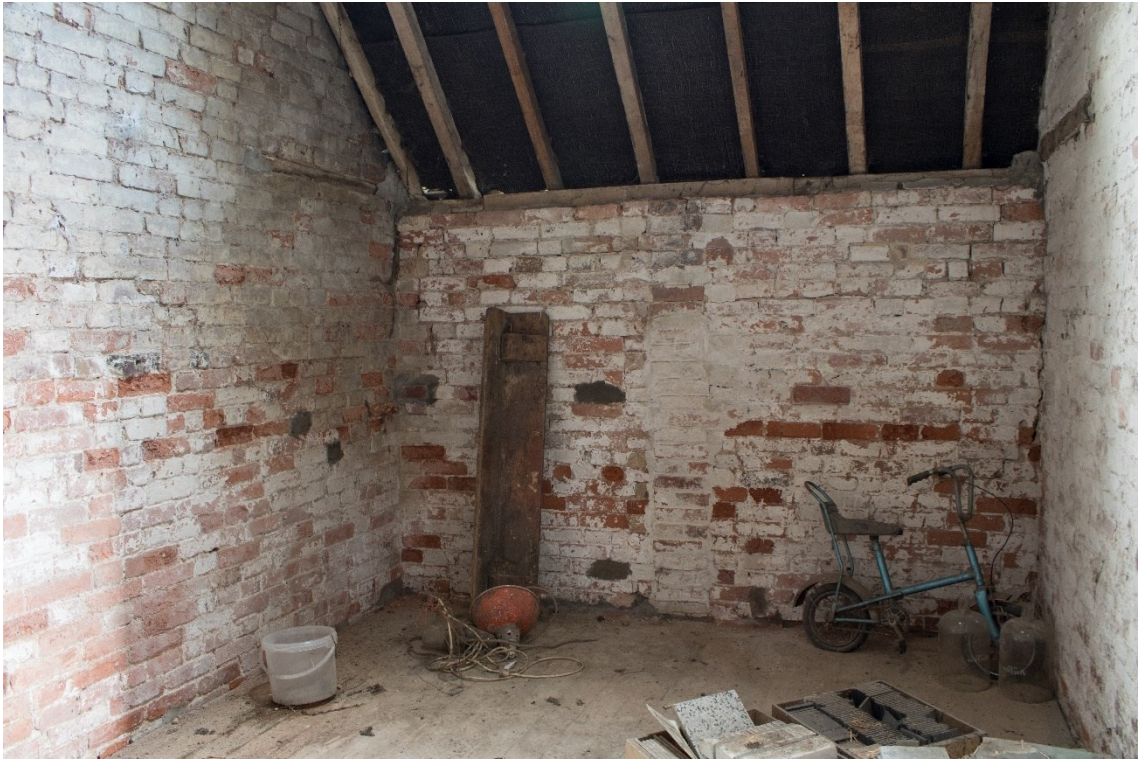
The walls in the central and west rooms show evidence of having been whitewashed but otherwise have no features of note and are similarly floored with tight-fitting floorboards (Plate 16). The north wall of the west room has a straight joint in the brickwork forming a strip of separate brickwork, however the reason for this is unclear (Plate 17).

Plate 17: Straight joint in first floor west room, facing north (1840\_055.TIF)

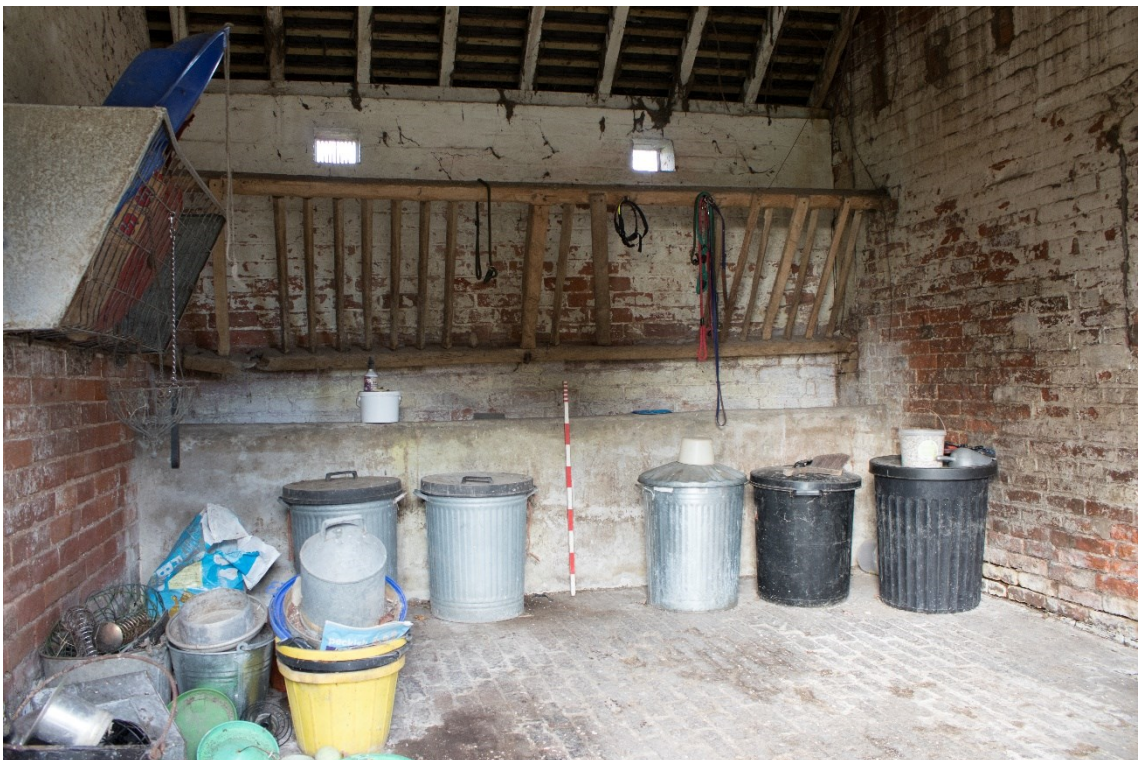
The two parts of the west range are almost identical in form and layout. Both rooms have whitewashed brick walls and are open to the roof (Plate 18). The roof is constructed of machine sawn softwood, with common rafters supported by purlins resting in the brickwork (Plate 19). Both rooms have brick floors and feature timber hayracks and feeding troughs on the north walls. The west room's feeding trough is made from red brick and is likely to be original (Plate 20), whilst the east room's appears to be a concrete replacement (Plate 18).

Plate 18: West range east room, facing north (1840\_039.TIF)

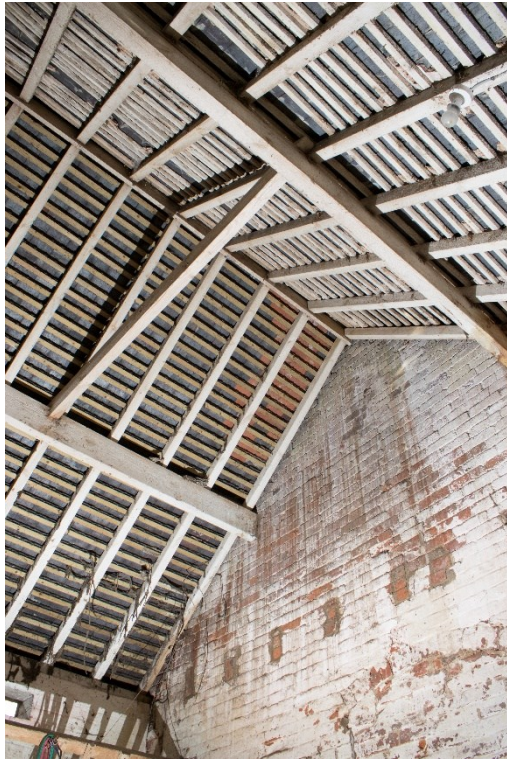
Plate 19: Roof in west range east room, facing north-east (1840\_040.TIF)

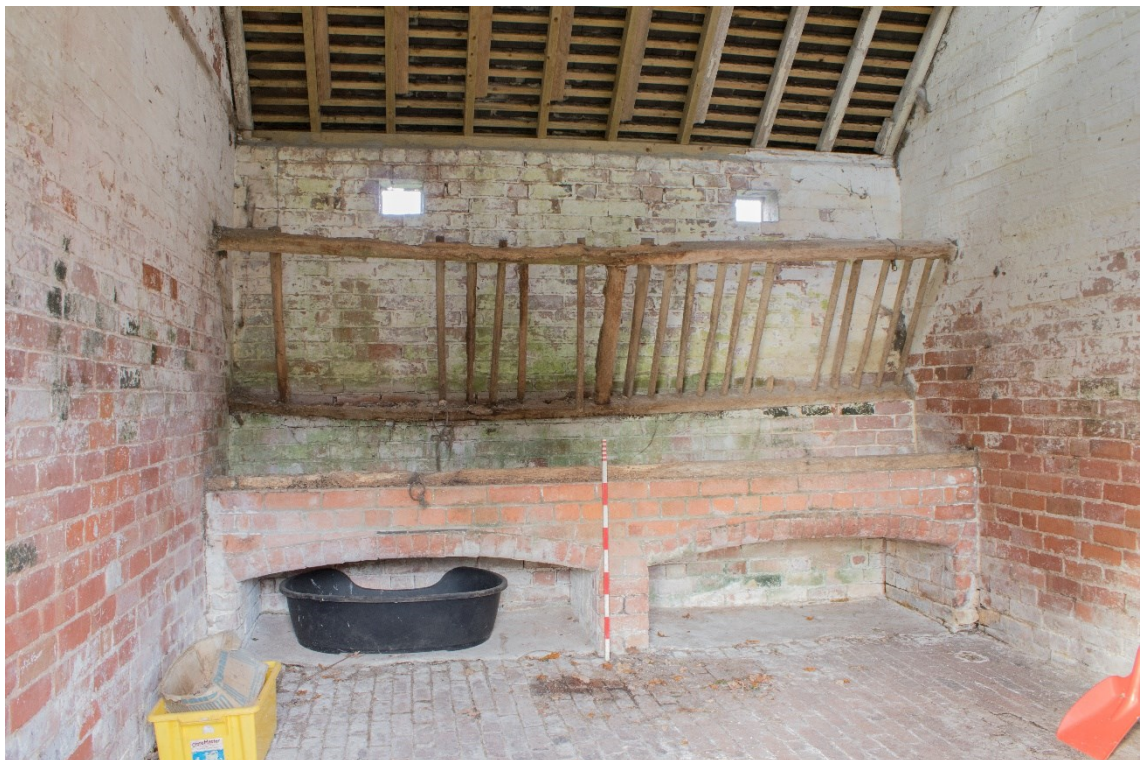
Plate 20: West range west room, facing north (1840\_043.TIF)
