**A DETAILED BUILDING SURVEY OF
THE ROOF AND THE ATTIC OF THE
EAST RANGE, APETHORPE HALL,
NORTHAMPTONSHIRE**

A Report for English Heritage

OS Grid Ref. SK 022 952
TPA Project Code: AHN.1
File Name: AHN1-Rept.doc
July 2007
Amended October 2007

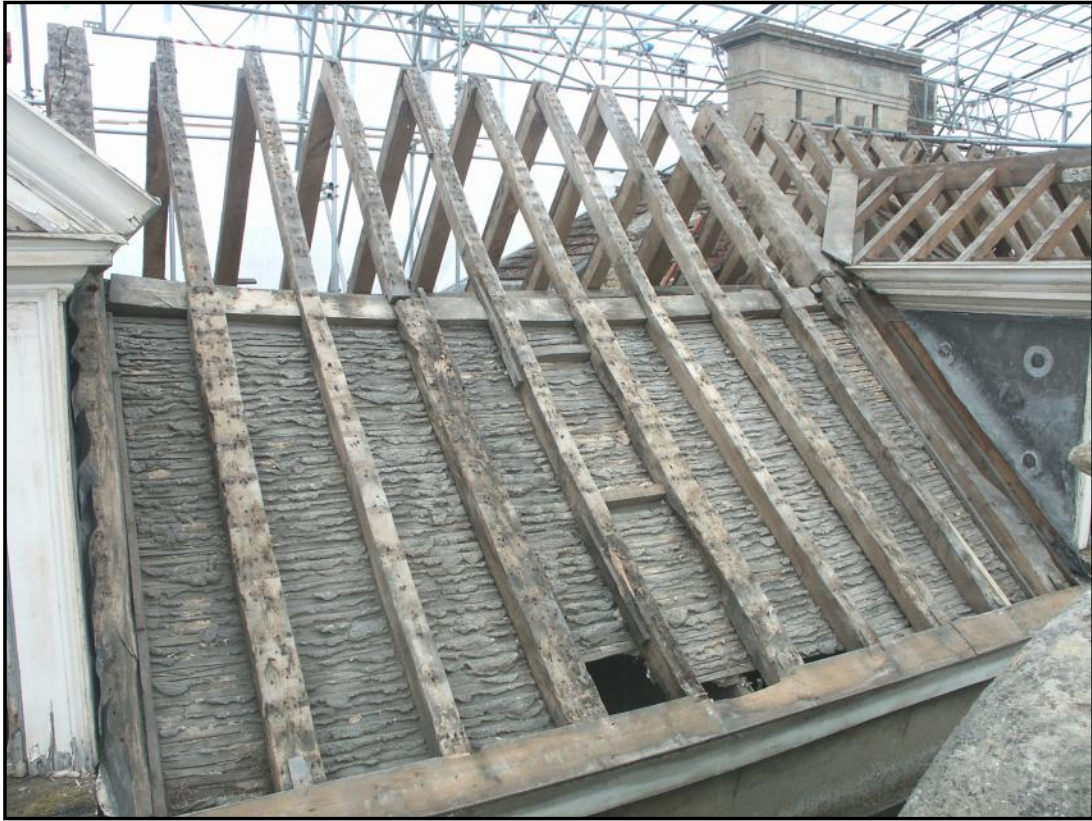
7

Plates of the East Range of Apethorpe Hall. 7: variations apparent in upper and lower common rafters in bay 3 on the east side of the roof, with both wider Type A rafters and narrower Type B ones (photo 121); **8:** a replacement purlin with a dealer's mark showing in bay 13 (east side), along with the broad Type A rafters similar to those found on the west side of the roof. These were probably long rafters cut to fit into the new raised purlin (photo 666).

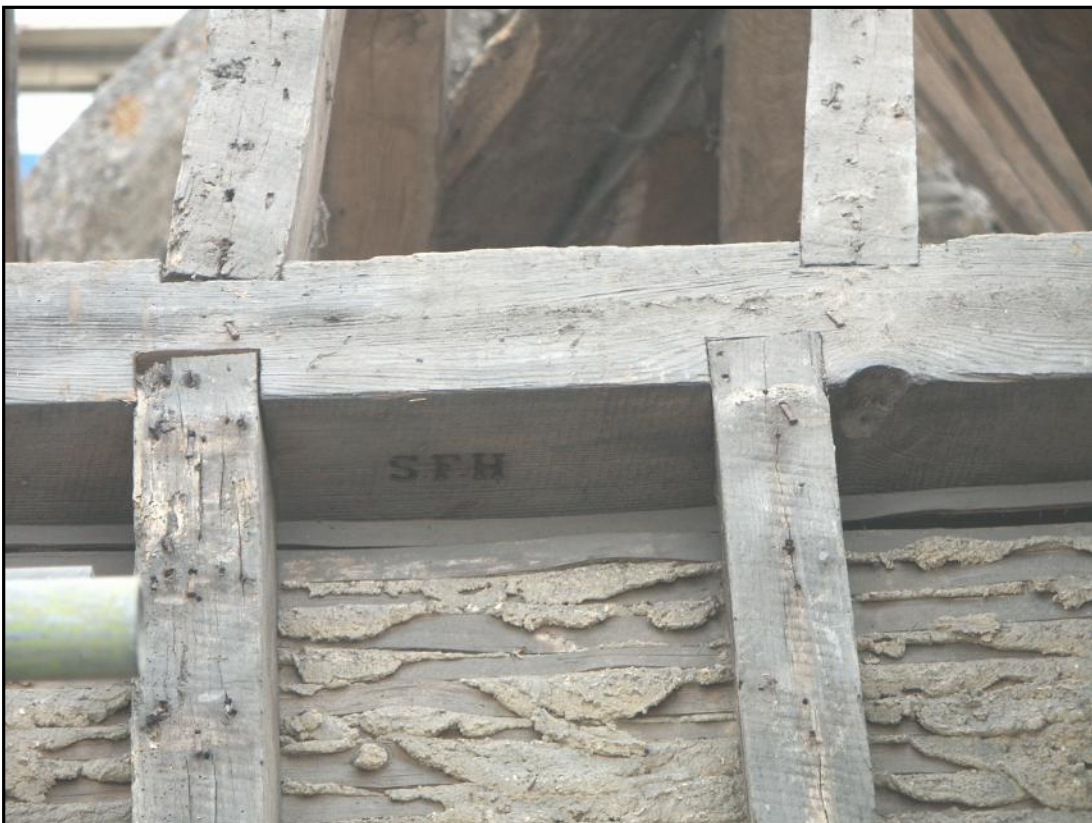
8

the rafters were probably long ones that rested on the original purlin. They were subsequently cut and seated into the top and bottom of the purlin (Plate 8). This may have coincided with the insertion of a dormer window in this bay to help light the south staircase (the Spencer Staircase), added in c.1740. Other paired carpenters' marks were found in the east side-roofs, perhaps indicating that these had not been subject to alterations (Plate 10).

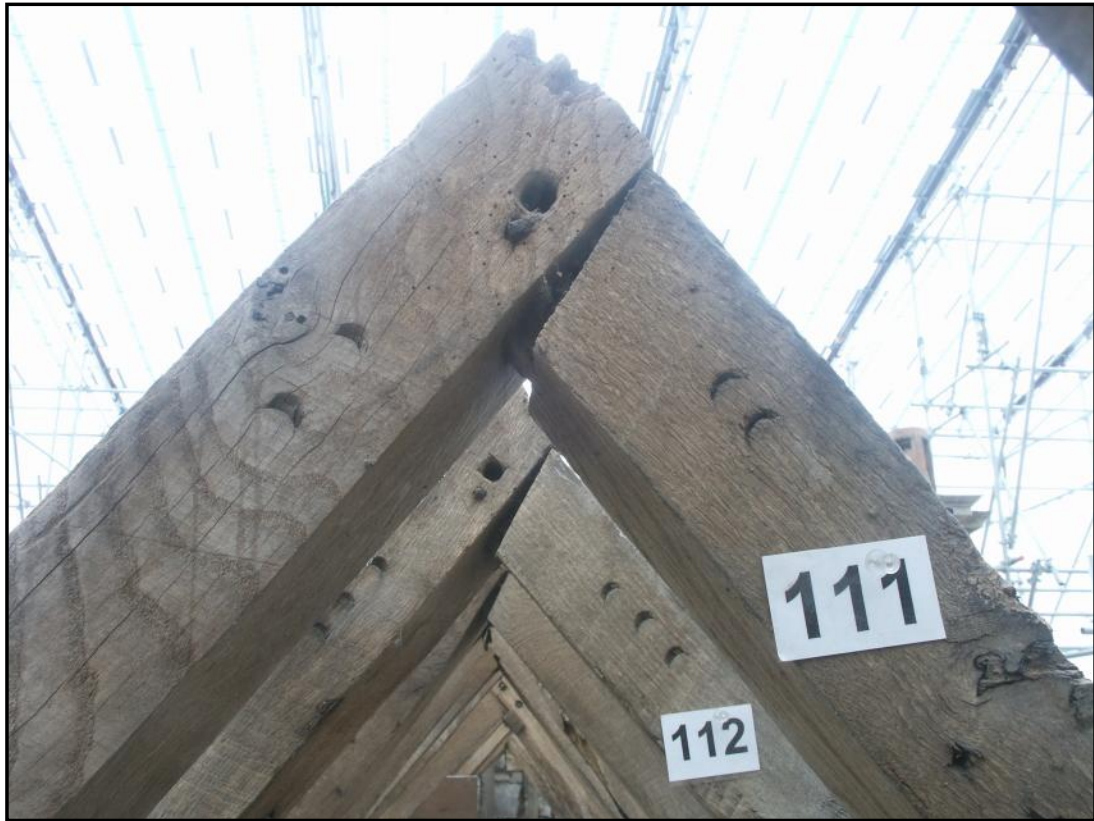
9

Bay 13 is instructive as it also shows that the common rafters were meant to be held together by a single peg through the tenon (Plate 9), whilst the principal rafters had two. The latter were also the reverse of the common rafters, with the east side tenoned into the west. No intact pegs were found along the main body of the roof, and the change of the original design meant that the principals were held together by a single peg in actuality; the builders could perhaps have drilled through another hole but failed to do so. Most of the side roofs still retain their pegs though, the exception being the south-west roof. The presence of clamps in the walling here (which continue through the east wall and under the timberwork) points to a rebuild of this particular roof at some stage.

Plates of the East Range of Apethorpe Hall. 9: paired carpenters' marks at the roof apex in bay 13 (photo 479), the only place on the main north-south roof where this occurs; **10:** paired carpenters' marks and similar-sized and jointed rafters in one of the side-roofs (west roof, bay 15, south end of building - photo 511).

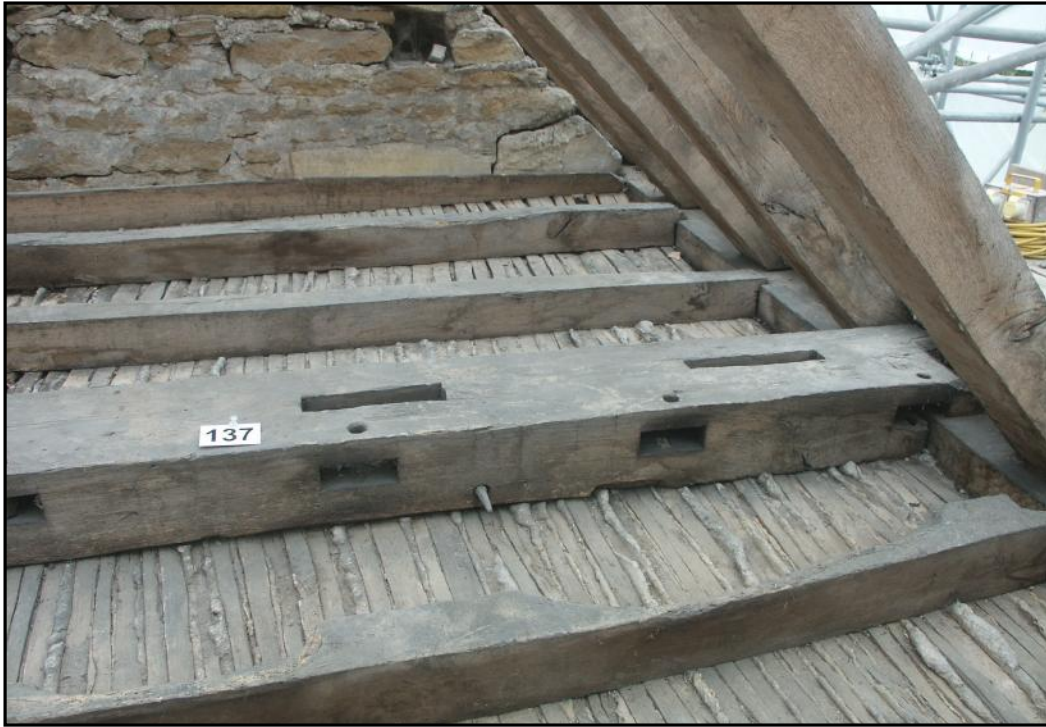
29

reused as collars, are bigger and may have been intended for main walling (Plate 29). Other small timbers, with angled cuts about 1 inch (25mm) deep, used to replace worn common collars, may be rafter-braces (Plate 31). One other timber, used as a rafter, has a shallow double-ogee moulding running the length of one corner. This may have been used as a door jamb and is probably of 17th century date (Fig. 12).

Plates of the East Range of Apethorpe Hall. 29: a large wall-plate with mortices showing in three planes, reused as a collar (photo 646); **30:** a smaller wall-plate reused as a rafter on the east side of the roof (Photo 485); **31:** possible rafter-braces reused as replacement collars towards the south end of the main roof (photo 634).

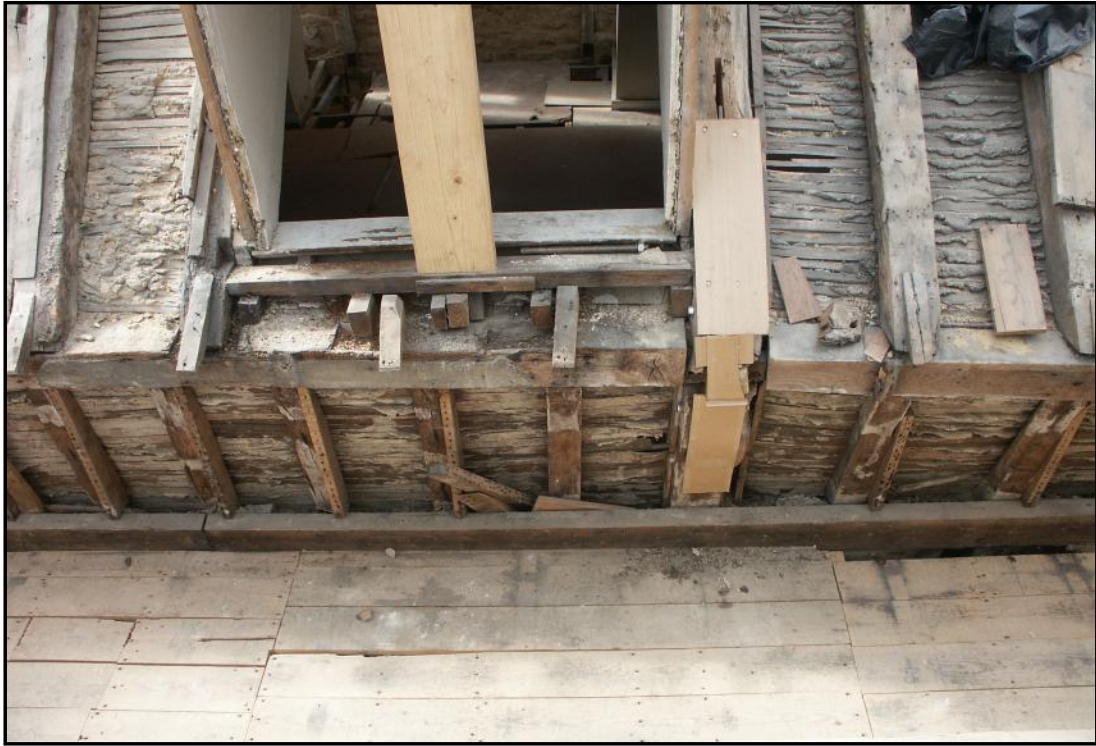
32

On the east side of the roof a line of upper sill beams were jointed into the angle of the principal rafters to form the top of a low wall (Plate 32). Eight of the 13 beams present have cut-out seatings to hold the base of the common rafters and these include beams that run beneath the dormer windows (both those in possible original and later positions), where they are redundant. These sills are chamfered on the underside and feature peg holes that line up with the tenoned ends of the vertical studs that form the wall below. However, none of these holes were found to hold pegs and of the tenons of the studs seen, none had been correspondingly drilled. Plate 33 shows an infilled peg-hole. Either the wall has been re-set or, more likely, the original carpenters had failed to prepare the studs as intended. The other five sill-beams are of slightly bigger dimension, lack the chamfer and peg-holes, and also the seatings, with rafters nailed on instead.

Plates of the East Range of Apethorpe Hall. 32: the low wall on the east side of the roof with upper sill beams showing. Seatings for the rafters show in the sill beneath the dormer window in bay 4, whilst the sill to the right in bay 3 lacks them and the rafters are nailed on instead (photo 186); **33:** one of the empty or infilled peg-holes showing on the underside of those sills with rafter seatings (photo 214).

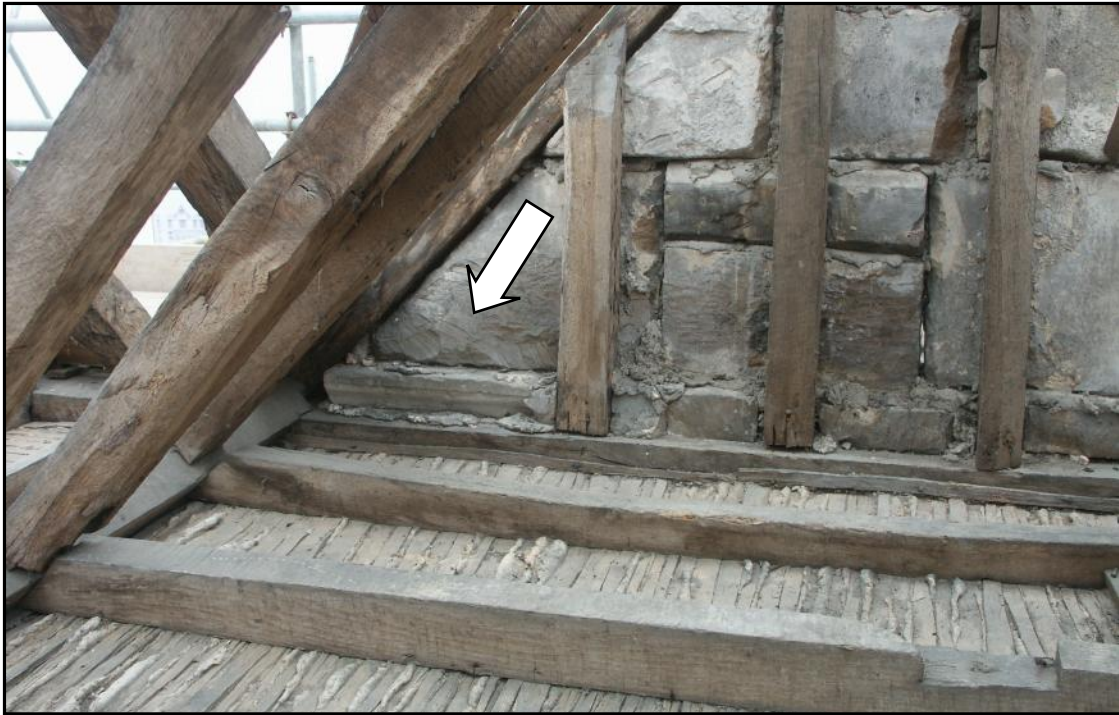
36

Plates of the East Range of Apethorpe Hall.
36: stone with moulded face showing in the south end wall in the roof, indicated by the arrow (photo 661); 37: the end of one of four iron clamps showing on the outside of the walling to the south-east side roof (photo 305); 38: detail of the other end of one of the clamps (with inserted wedge to prevent movement) behind the stonework (photo 313).

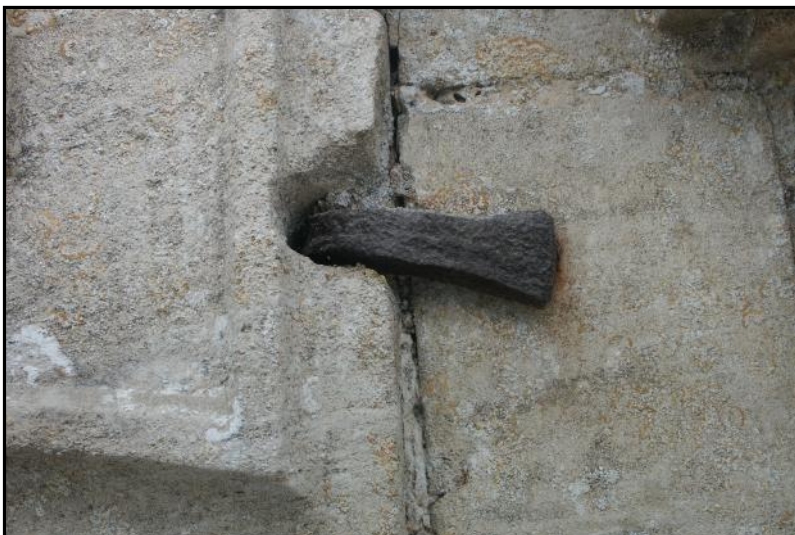
37

been added to hold the walling together. The outer ends had been turned through 90 degrees and extended for a length of about 10cm (Plate 37). The bars were at least 50cm long and on the inside were constructed so as to retain a metal wedge, thereby securing the clamp to the back of the masonry (Plate 38). The date of this repair is not known.

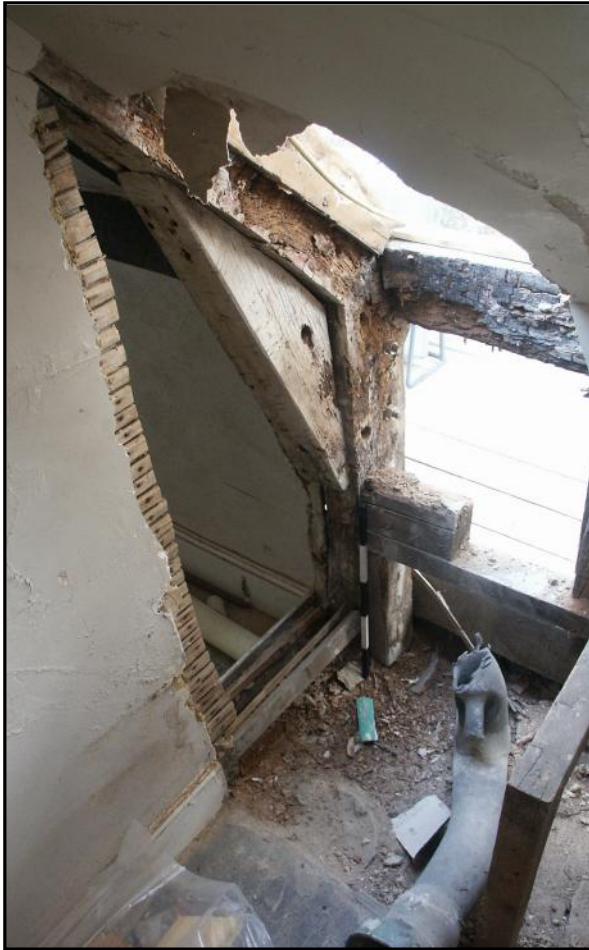
43

Plates of the East Range of Apethorpe Hall. 43: repair work by one of the knee-angled principal rafters, showing that the knee-brace was nailed on (photo 686); **44:** construction details of the partition on the west side of the attic (photo 670); **45:** dismantling in progress of the inserted fireplace in the west side of bay 2, showing the flue above it (photo 333).

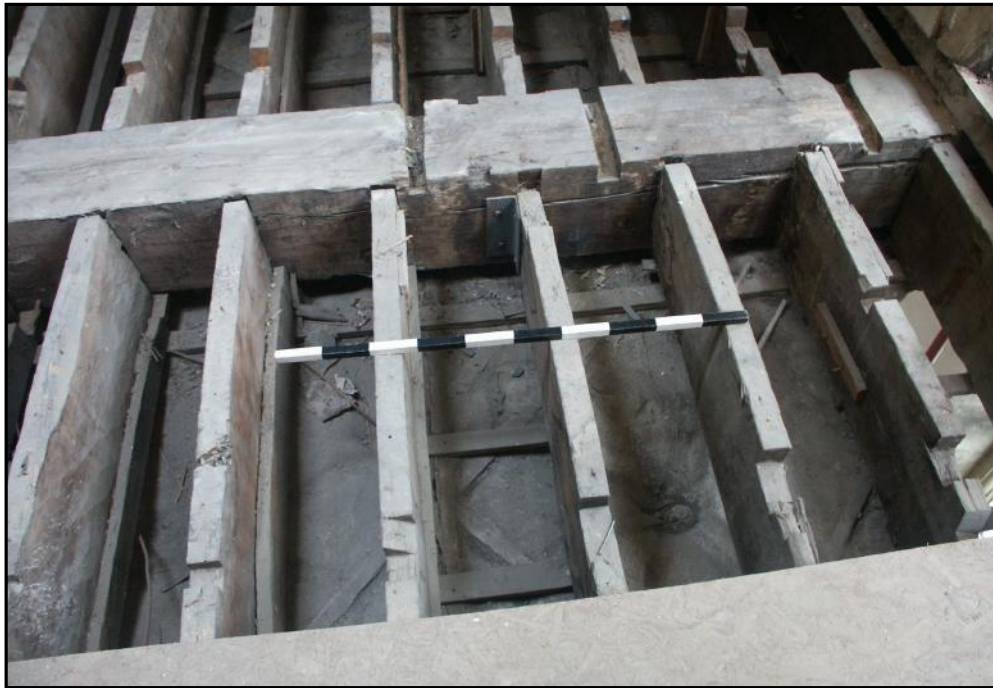
46

The attic was floored with mainly softwood boards and a few oak ones. Most of these were removed early on for safety reasons and replaced with large boards. With the bridging beams and floor-joists exposed (Fig. 15) the opportunity was taken to look for evidence of former partitioning. Many long and short lines of notches cut into the tops of the joists and some in the bridging beams were recorded. These were mostly straight cuts of differing widths, but some were angled cuts (Plate 46).

Plates of the East Range of Apethorpe Hall. 46: bridging beam 13 under the floor of the attic, showing the nature of and extent of notching and cuts to the beams and joists for service pipes etc (photo 707); 47: looking west along the line of bridging beam 3 (north end of attic) with mortices for a partition wall and possible doorway (photo 700); 48: looking west along the line of bridging beam 16 (south end of attic) with the damaged surface of the beam and two added sleepers (indicated by arrows - photo 712).

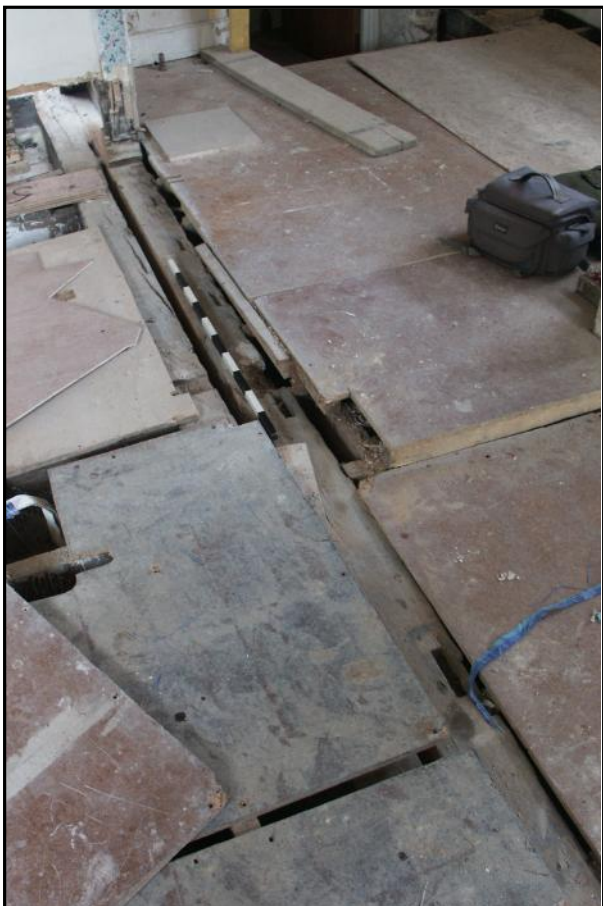
47

(120mm x 50mm), set 0.85m apart, a distance sufficient for a doorway (Plate 47). At the other end of the attic, in a comparable position on beam 16, the upper part of the timber had been damaged, possibly by bricks having been laid on it (Plate 48). This extended for a similar distance as the features on beam 3.

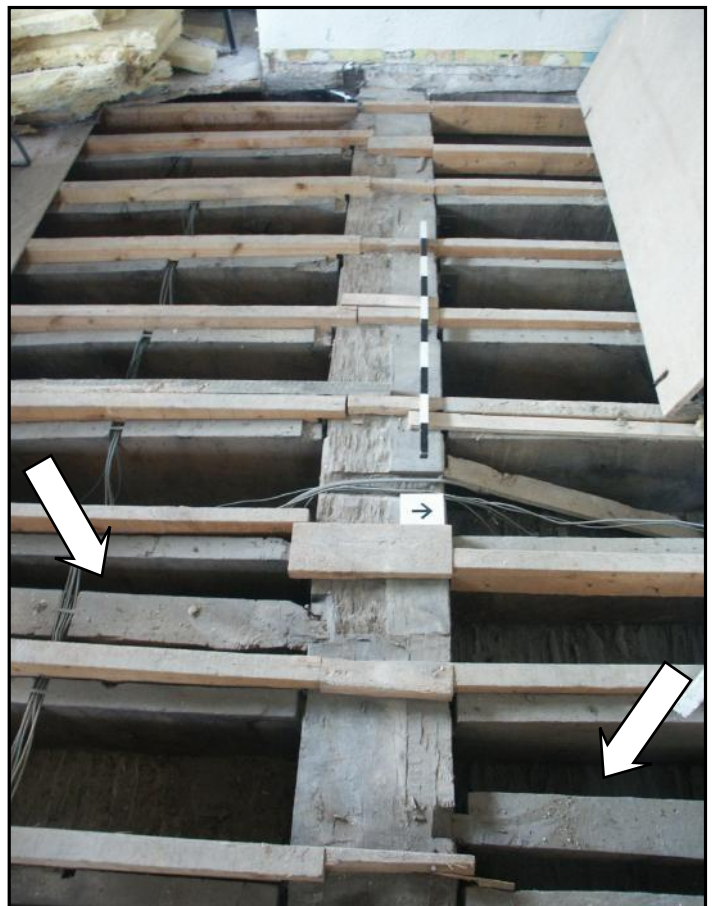
48

Two lengths of additional timber or sleeper beam were found attached to bridging beam 16, highlighted by arrows in Plate 48. The north one continued across to the next beam (15), and a line of other surviving timbers and, where the timbers were missing, notches cut into the beams, continued as far as beam 3 (but not on to beam 2). This line was about 1.2m (4ft) from the east wall of the attic, a sufficient distance for marking a corridor or a partition wall. A small projection at the end of each sleeper had fitted into a short angled notch, but one that could not have withstood much pressure (Plate 49).

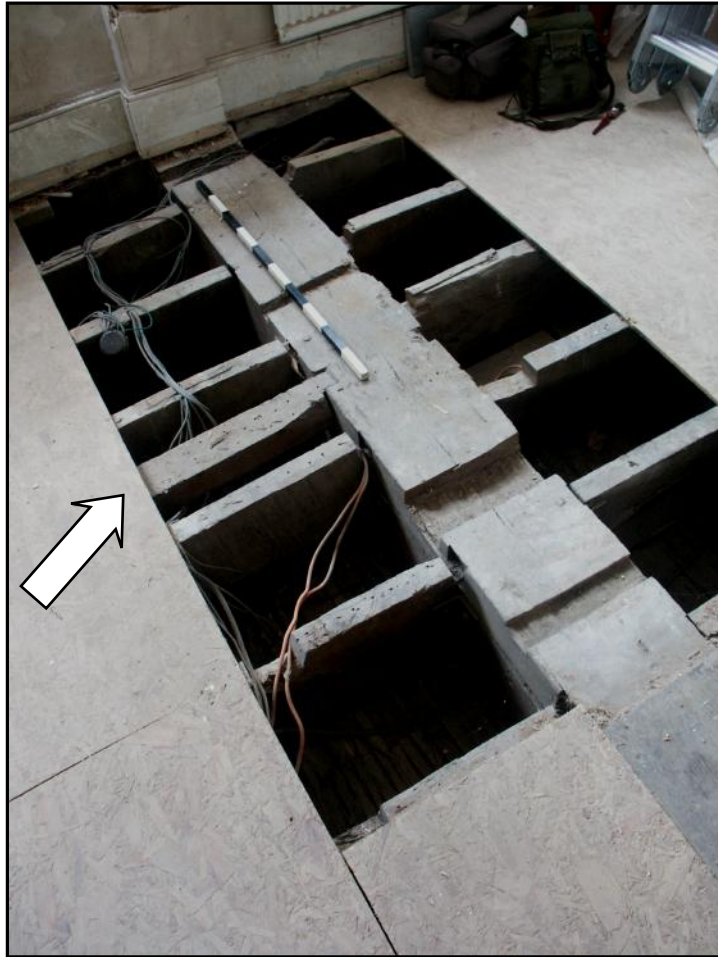
49

Plates of the East Range of Apethorpe Hall. 49: one of the surviving pieces of sleeper beam under the floor of the attic that may have supported a corridor partition wall, here indicated by the arrow (photo 718); **50:** one of several short cross-pieces along the line of the supposed corridor where the sleeper beams were absent (photo 720).

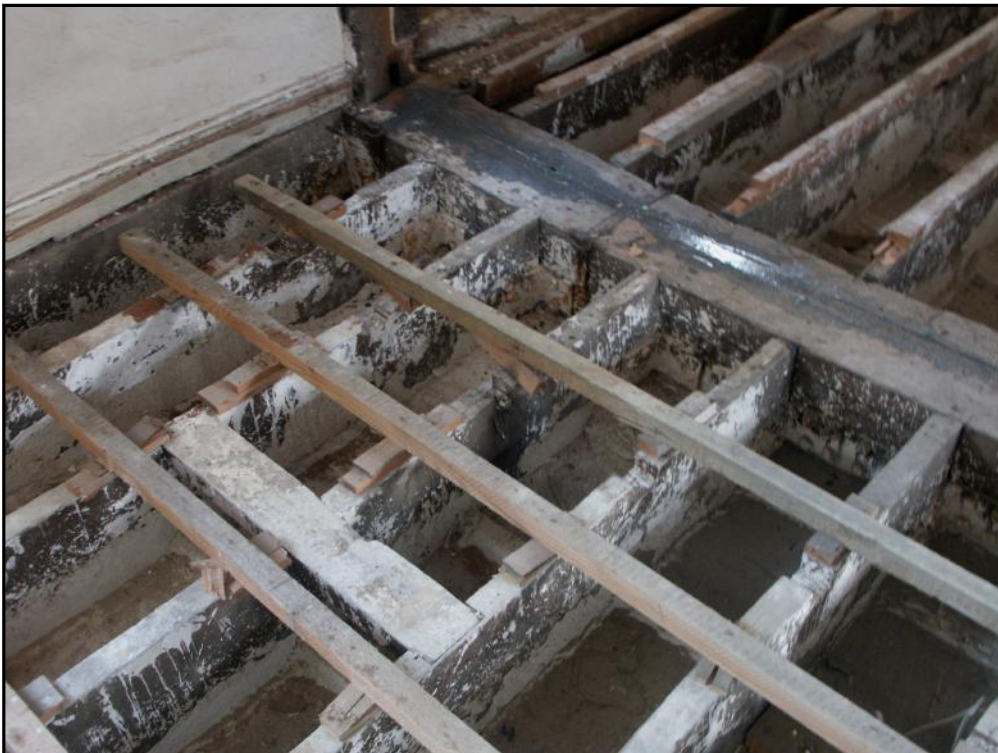
50

Along the north end of the projected line of these sleeper beams, where only two short lengths survived, some short cross-pieces were found (Plate 50). Two of these had been spaced at equal distances between every bridging beam. Again, where now missing, holding notches were found cut into adjacent floor-joists, cut in a similar fashion to those on the bridging beams. The fact that most of these timbers were missing but had evidently once been in place, indicates that the floor had been raised at some point and they had been removed.
