# Wollaton Park Walled Garden

## Structural Recording and Condition Survey

For Nottingham City Council Museums & Galleries

TPA Report code: 144/2014

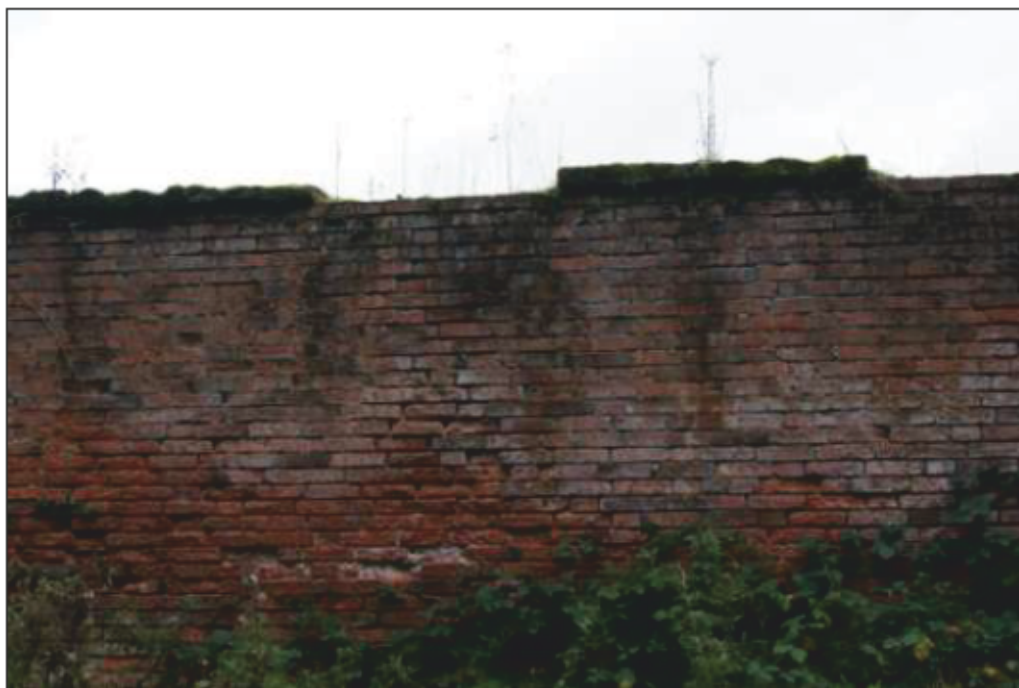
Plate 1: Wall face 1, showing remains of demolished exterior glasshouse or possible infilled entrance. Looking west.

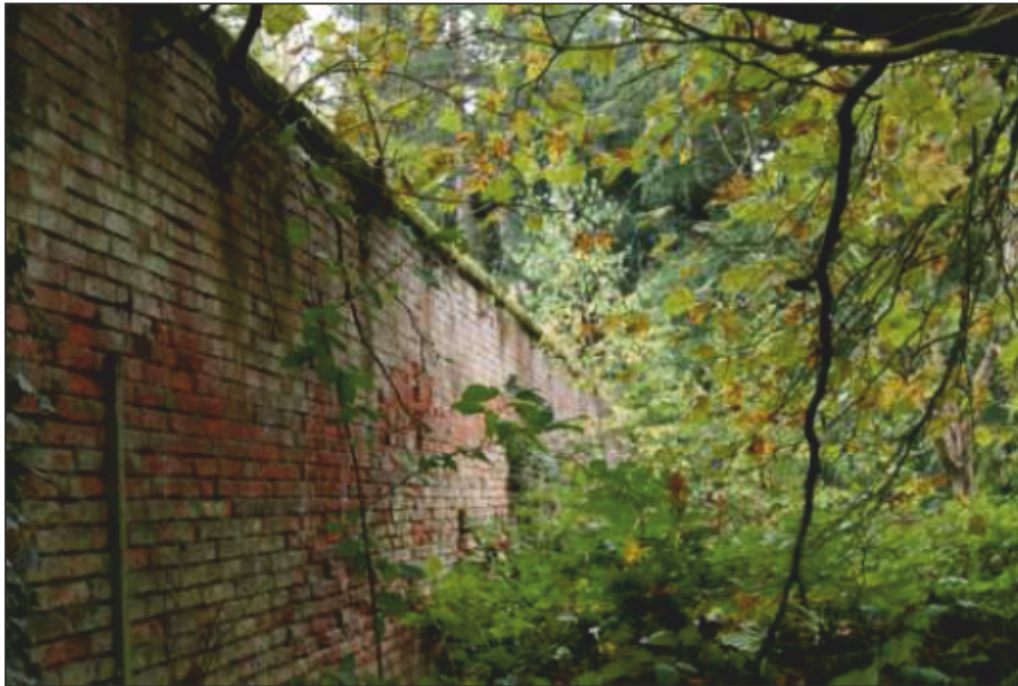
4.3.1 **Wall face 2** is aligned north to south and located in the southern half of the garden, to the west. It forms part of the external walling. The wall was inaccessible to survey due to overgrown vegetation (Plate 3). The brickwork was in a good condition, but some spalling and loss of stone cappings have been observed. Lichen and efflorescence has bloomed on the brickwork (Plate 2) and this may indicate water retention.

Plate 2: Wall face 2 showing efflorescence and spalled brickwork, looking east.

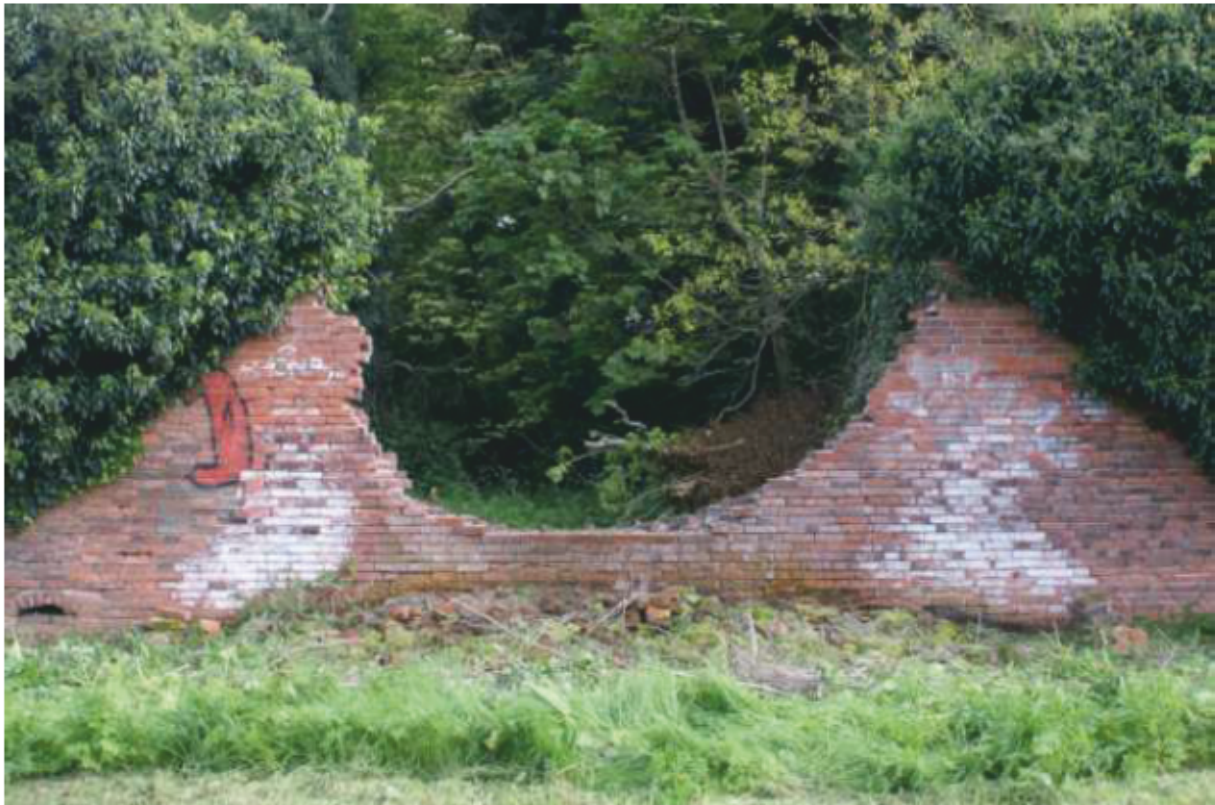
Plate 4: Wall face 2, looking west.

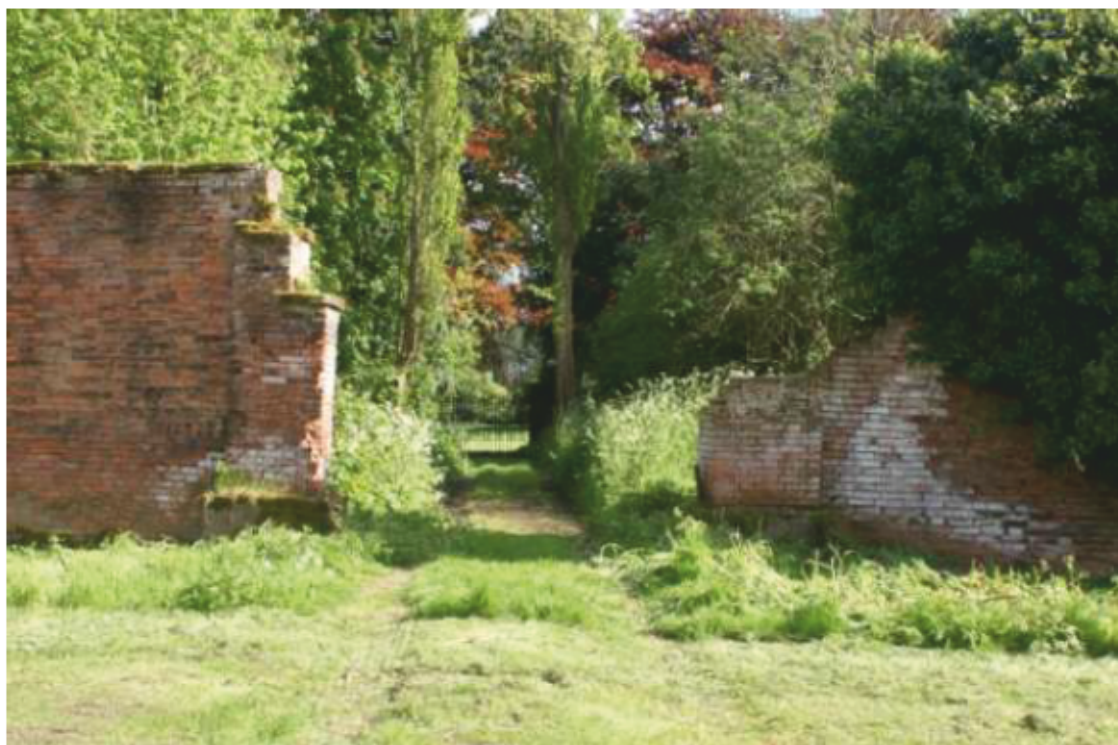
Plate 5: Wall face 3, showing damage caused by fallen tree. Looking north

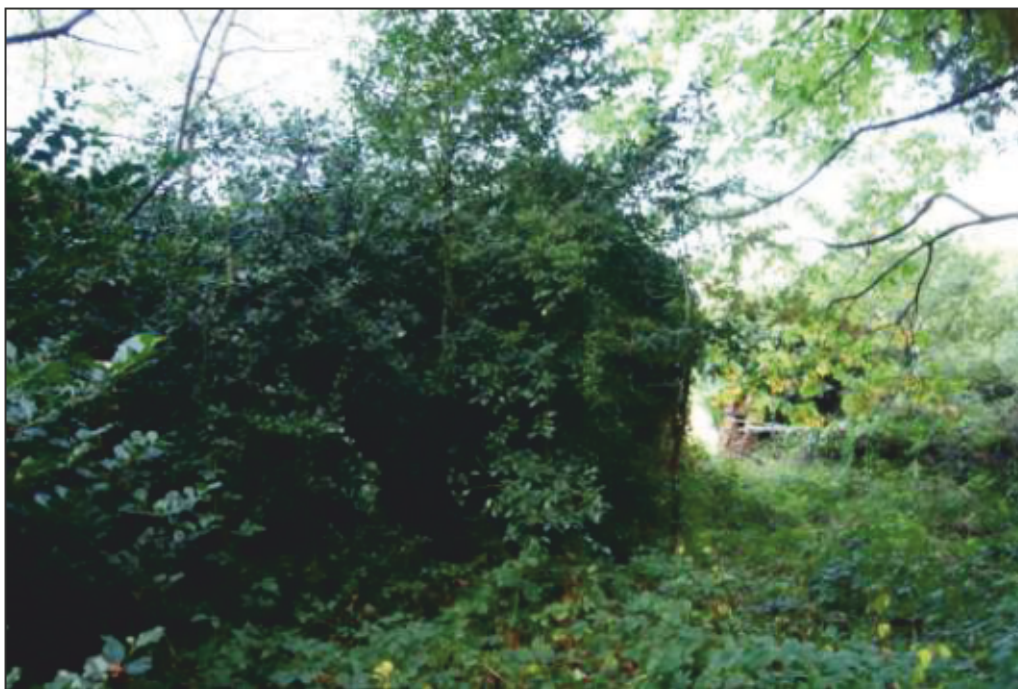
Plate 7: Wall face 4 showing damage to the wall face, looking west.

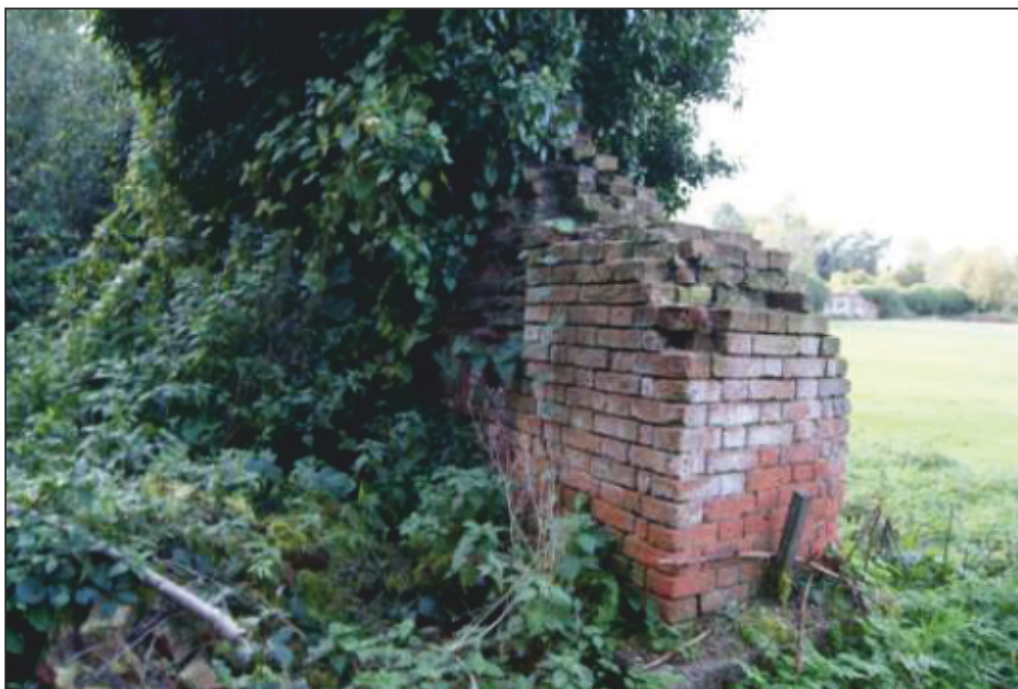
Plate 9: Wall face 4 showing soiled brickwork, looking north-west.

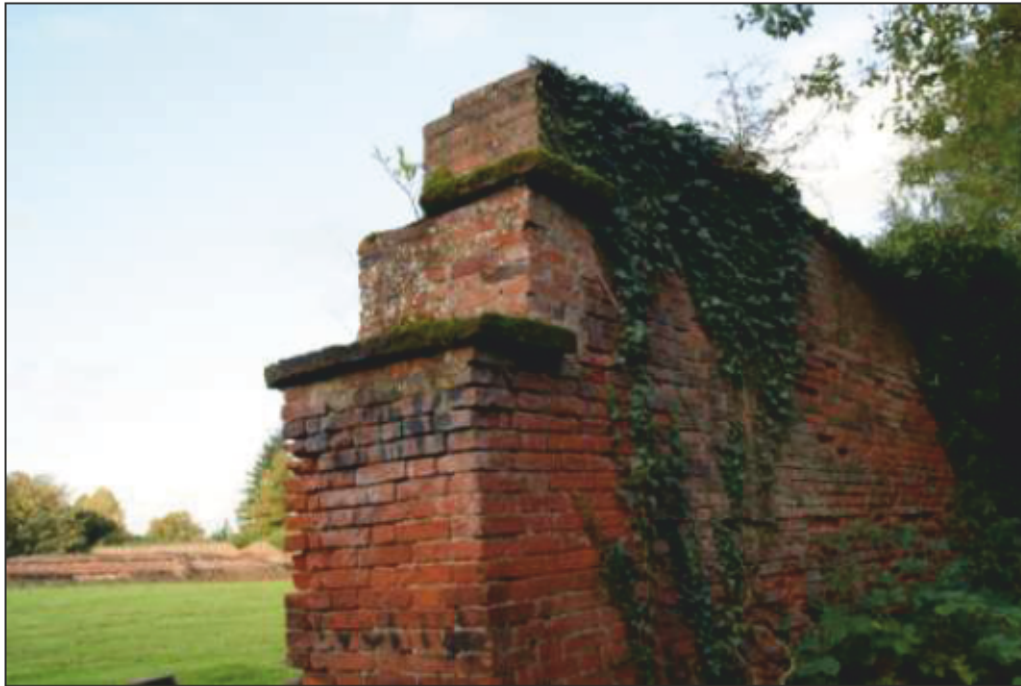
Plate 10: Wall face 4 showing damaged pillar, looking north-west.

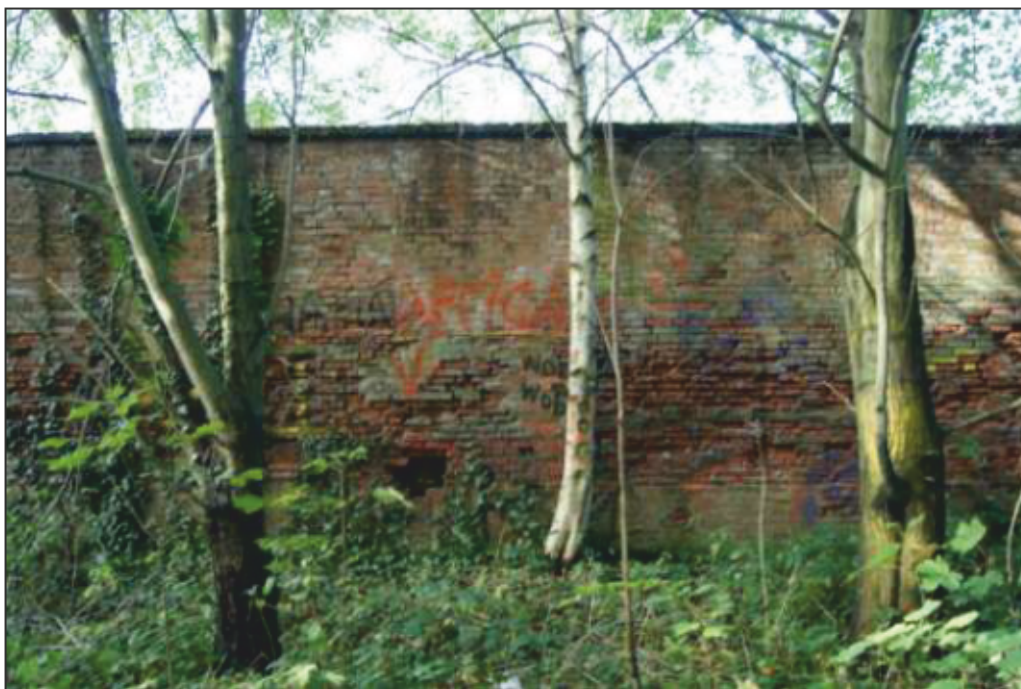
Plate 11: Wall face 6 showing condition of pillar, looking north-east.

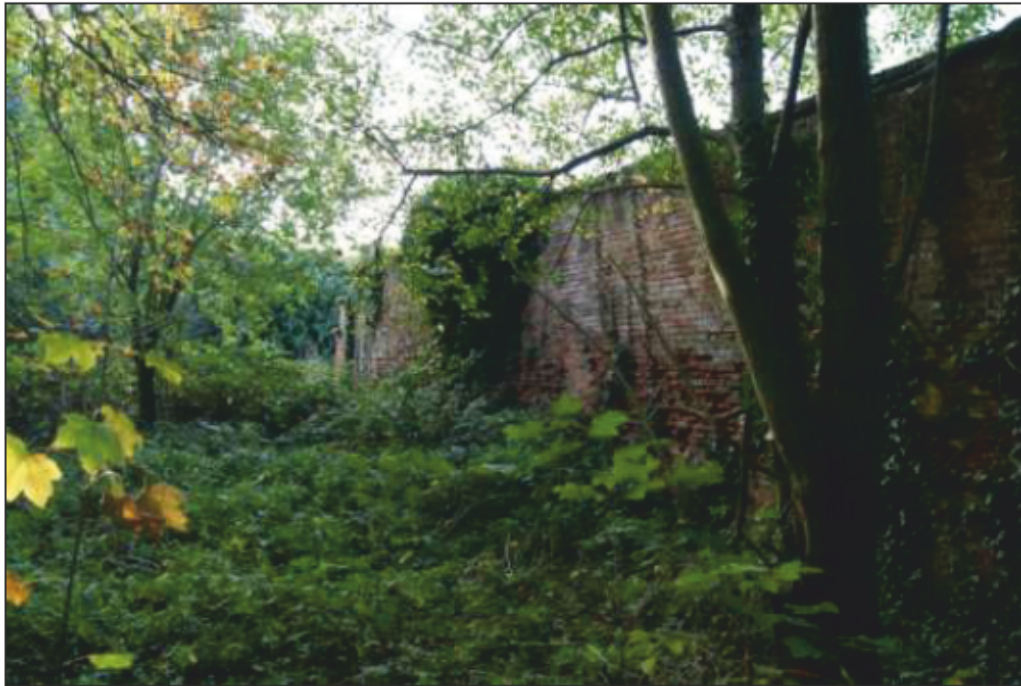
Plate 12: Wall face 6 showing condition of brickwork, looking north.

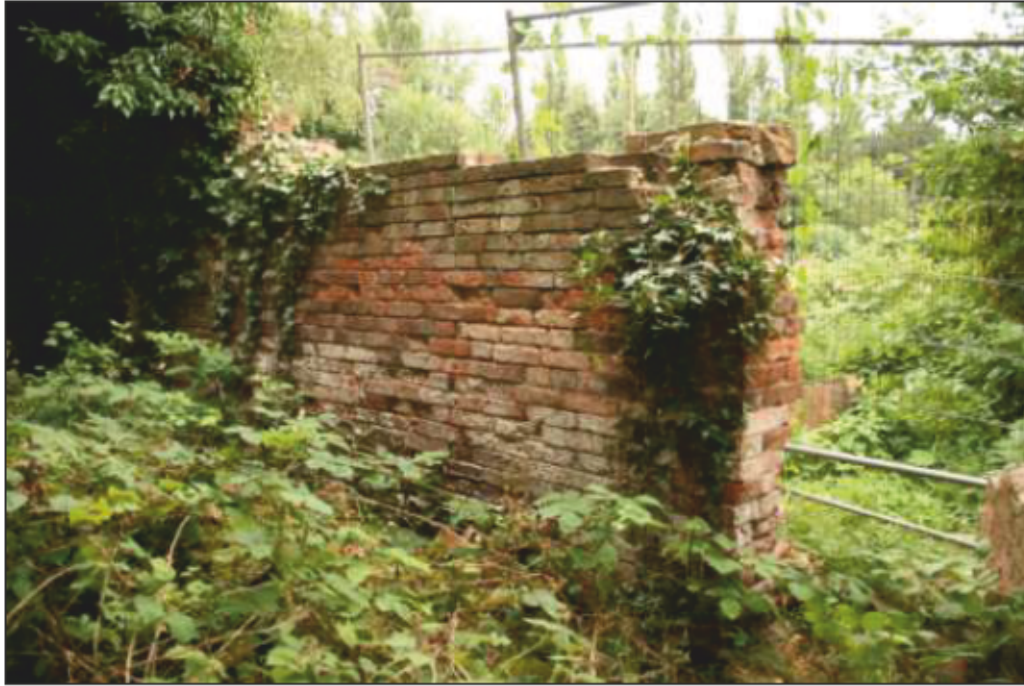
Plate 18: Wall face 8 showing ivy, looking north-west

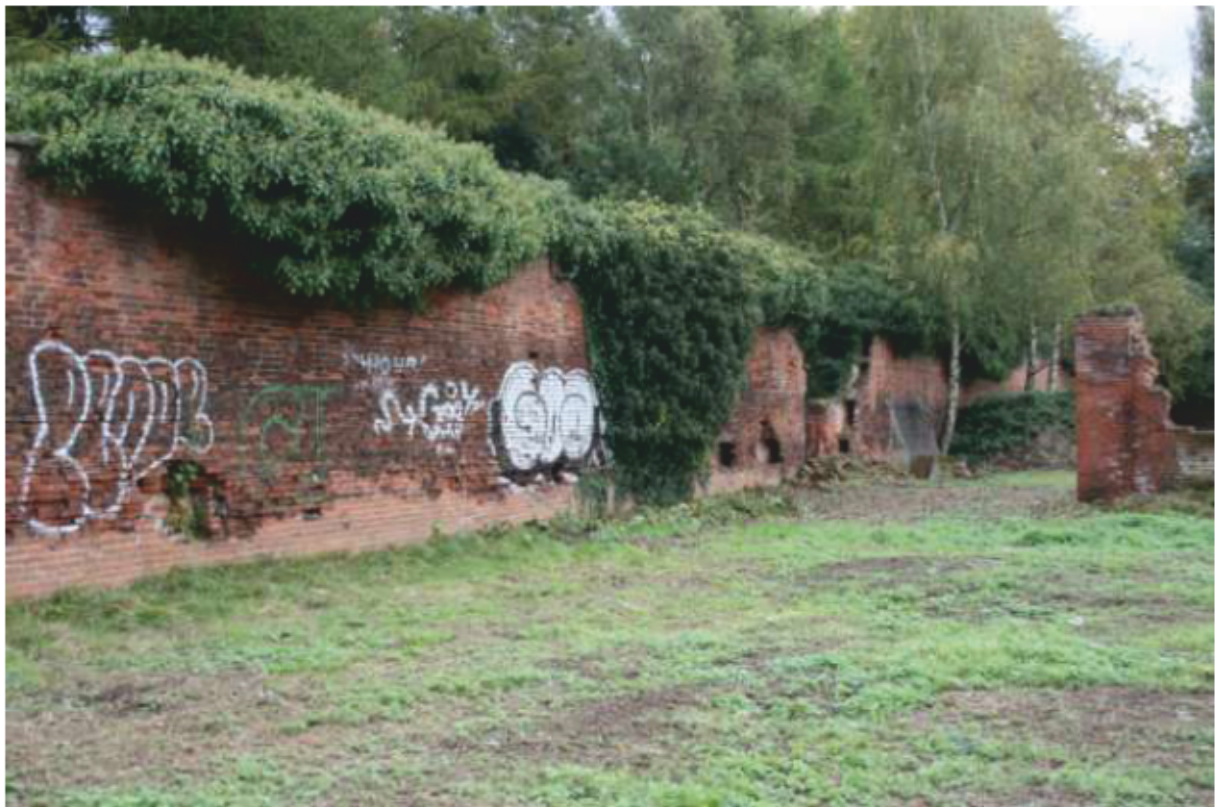
Plate 19: Wall face 8 showing damaged entrance, looking south-west.

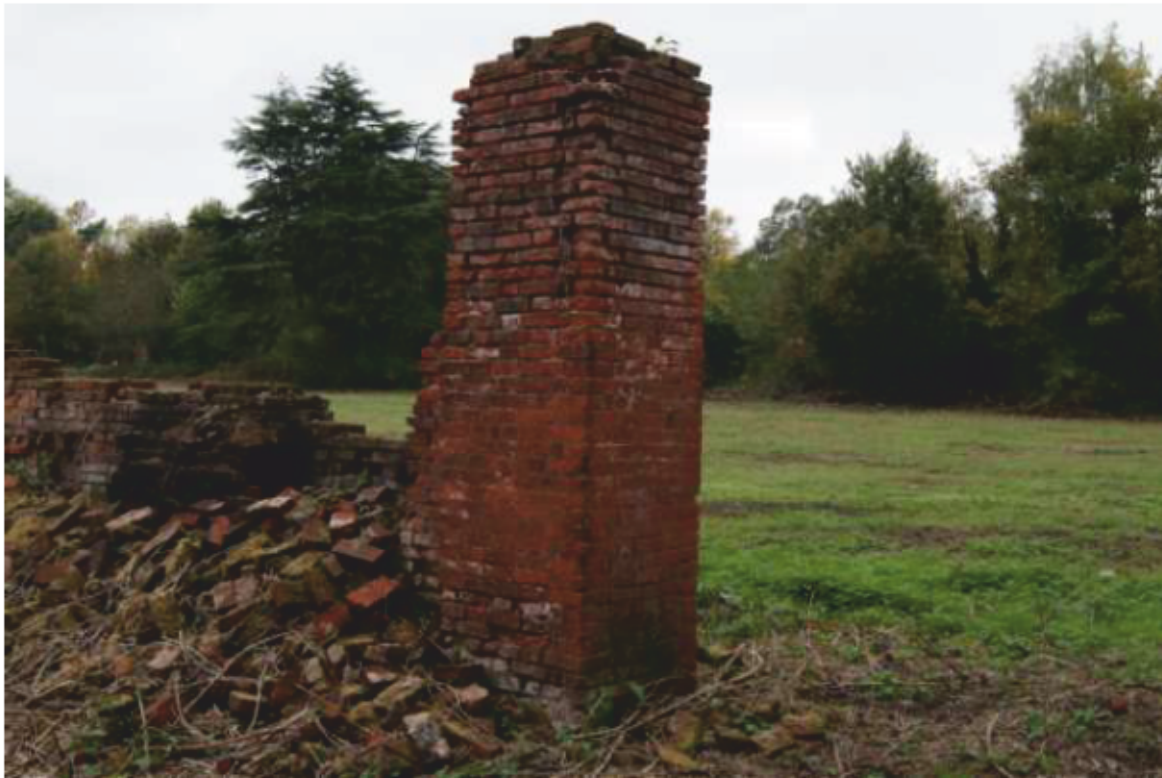
Plate 26: Wall face 15, showing exposed core of double-skinned wall. Looking north-east.

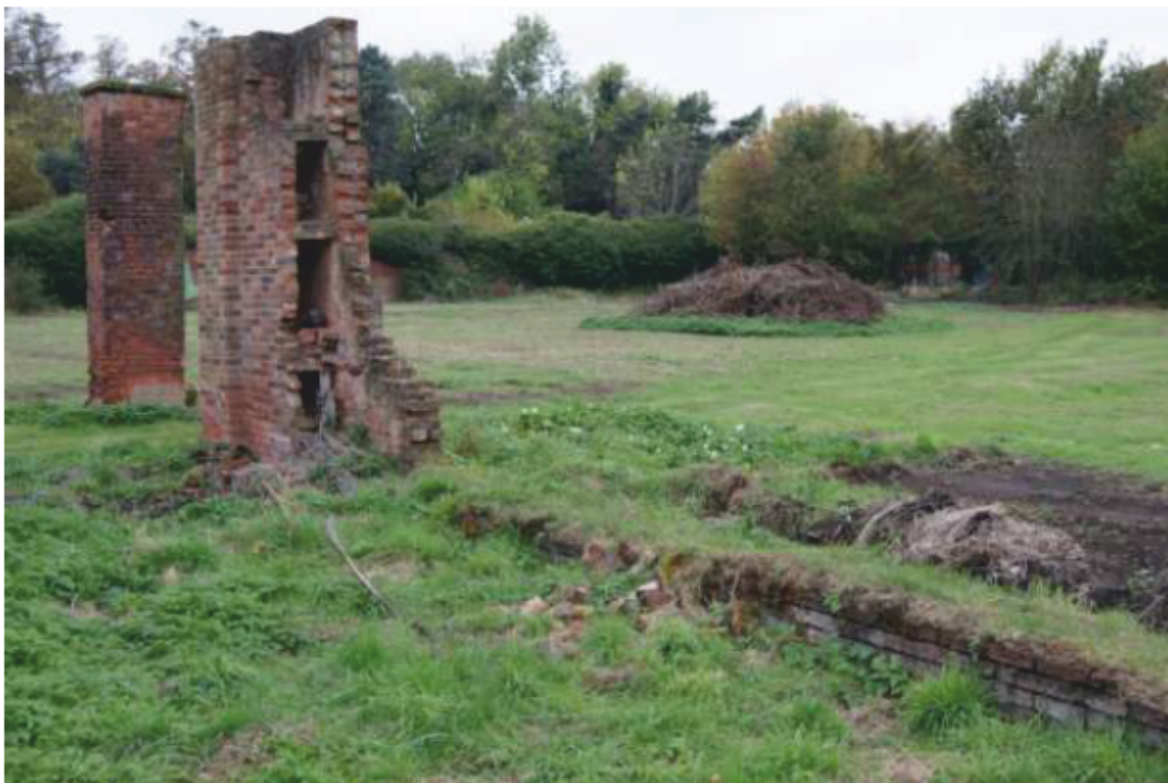
Plate 27: Wall face 15, damaged standing pillar at east end of wall. Looking north-west.

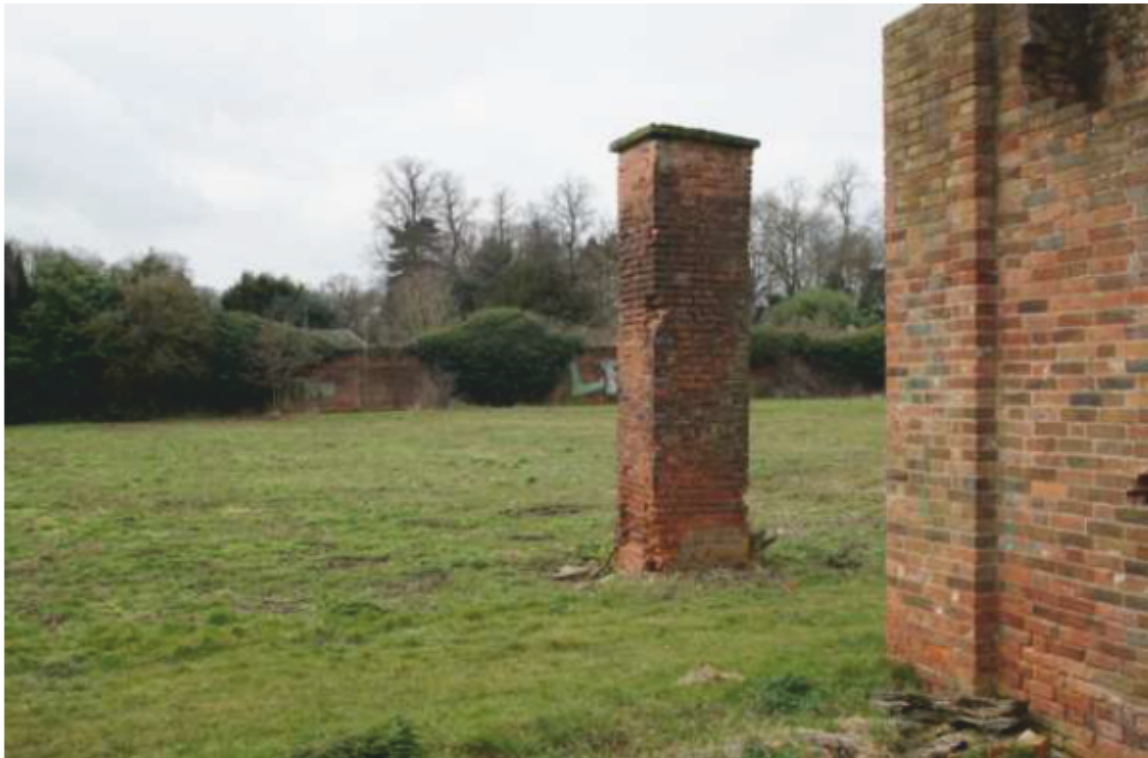
4.16.1 **Wall faces 21 and 22** were aligned east to west and mirrored Wall faces 15 and 16. Wall faces 21 & 22 have been completely destroyed and razed to ground level, with the exception of the pillar standing at its eastern end (Plate 31). Moss and lichen cover a large proportion of this pillar and the brickwork is rough on its western side, but the capping survives and the pillar is in reasonable condition (Plate 28, Plate 30).

Plate 30: Wall face 21, surviving pillar. Looking south-east.

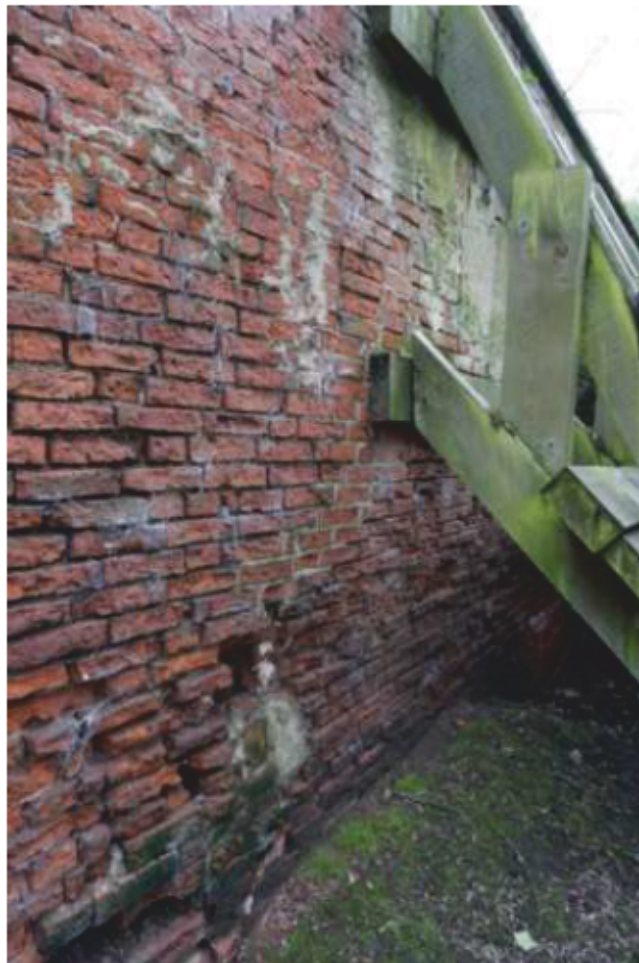
Plate 35: Wall face 11 showing window opening. looking north-west.

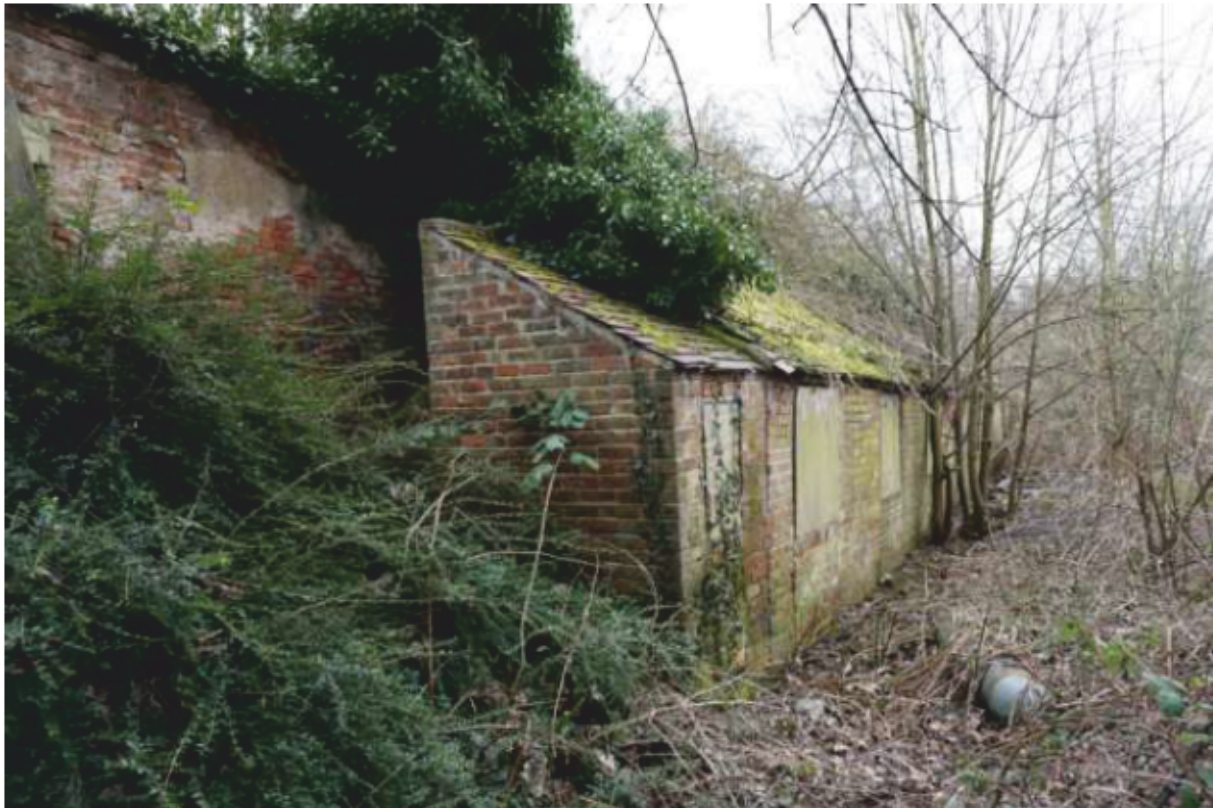
4.18.1 **Wall face 12** is aligned east to west and located within the northern half of the garden. It forms part of the external walling. The wall face was inaccessible for detailed survey but a measured sketch and photographs were taken (Figures 33 and 34). At the eastern end of the wall, directly opposite the modern infilled brickwork on wall face 11, timber supporting buttresses have been built. This section of the wall has clearly been deemed unsafe in the recent past and secured with brickwork and supporting woodwork (Plate 36).

Plate 36: Wall face 12, showing degraded (double-skinned) brickwork and wooden buttress supports. Looking south-west.
