**HISTORIC BUILDING APPRAISAL
OF THE FORMER CHAPEL AT
STANCLIFFE HALL, DARLEY DALE,
NEAR MATLOCK, DERBYSHIRE**

*by
Richard Sheppard*

OS Grid Ref. SK 2677 6400
TPA Project Code: SHA.2
February 2013
TPA Report No. 023/2013

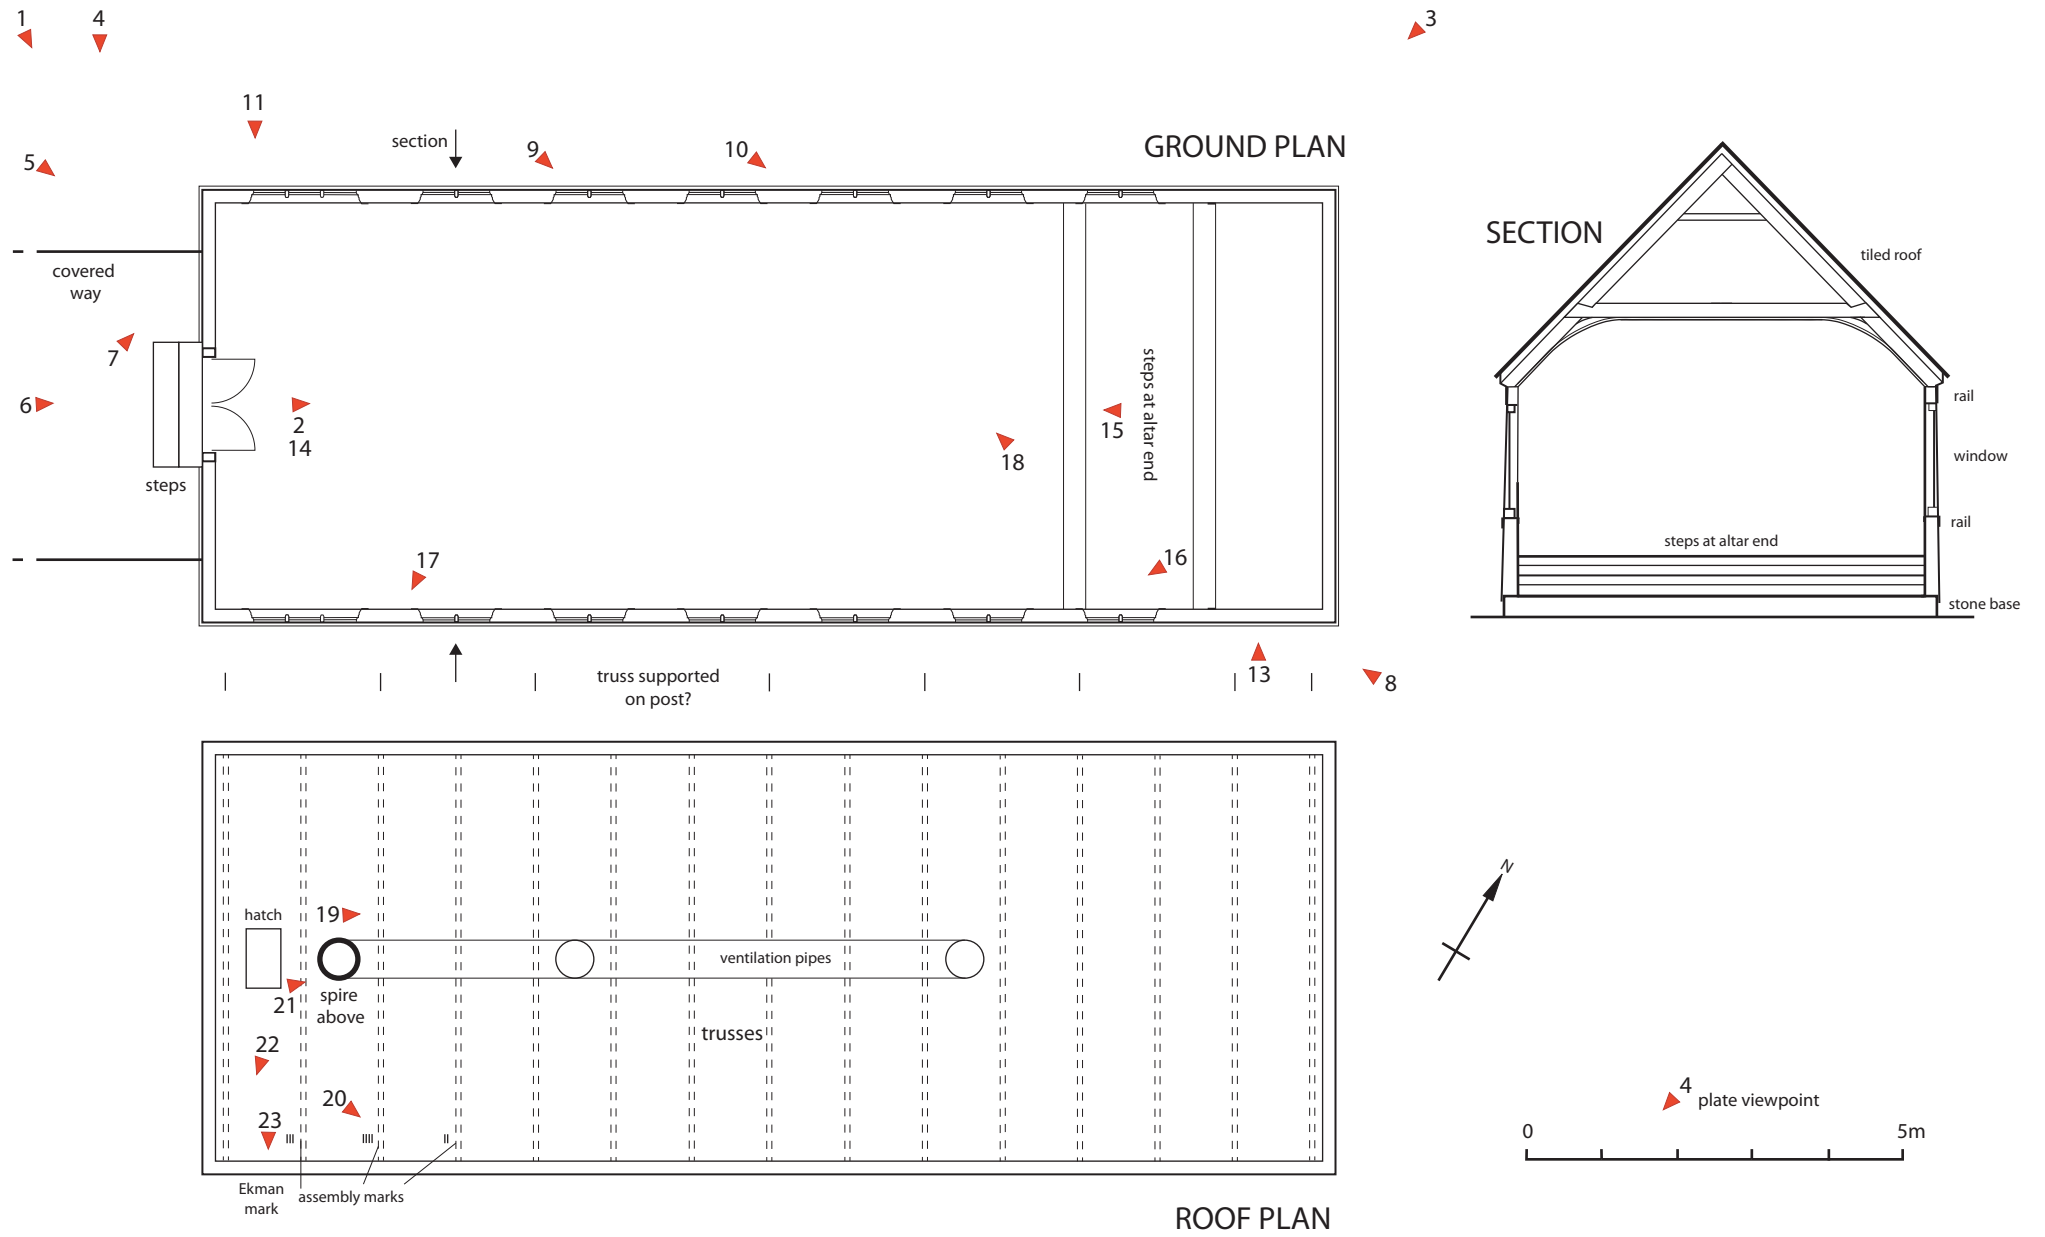
Figure 3: Plans of and a section through the former chapel at Stancliffe Hall, Darley Dale, Derbyshire. Scale 1:100.

The roof plan included in Figure 3 shows the presumed truss spacing and, between this plan and the ground plan above it, where the building's side walling may include vertical posts. Although there is a line of closely set windows on either side of the building, the truss arrangement allows for 8 out of the 15 positions to have the support of a wall post. The structure may also include wall plates at the bottom of the rafters and on the stone base but, if so, these are masked by the outer timberwork.

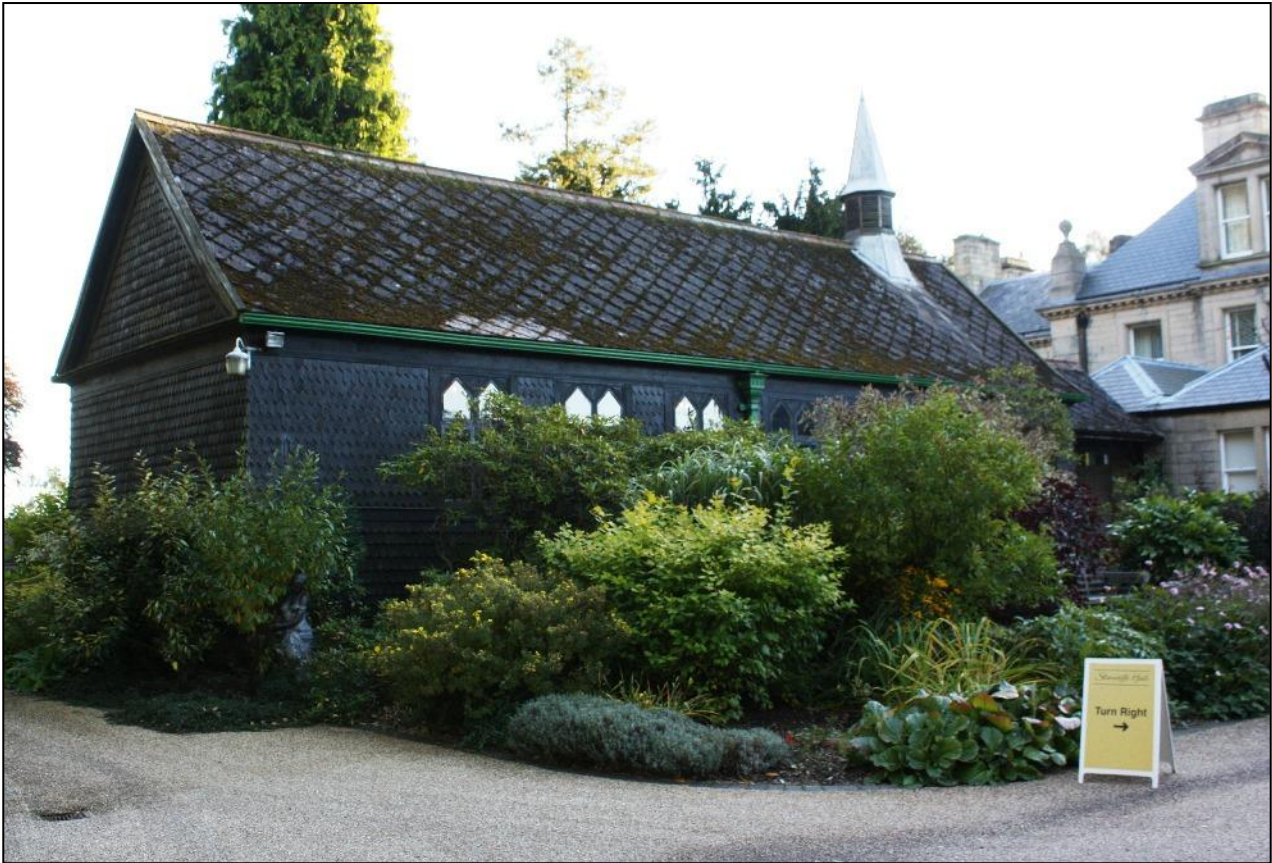
The roofing is composed of a chequer-board pattern of reddish asbestos tiles (Plate 3) although early views of the building show it originally had horizontal bands of small reddish tiles on the roof (Plate 1). The roofline is broken by a single spire with a lower grill, its function having been to act as a ventilation outlet for the by-products of combustion for internal gas lighting. Water was removed along cast-iron gutters feeding into a centrally-placed down-pipe on either side of the building (Plate 10).

Plate 3: View showing relationship of the chapel to the main building complex at Stancliffe Hall.

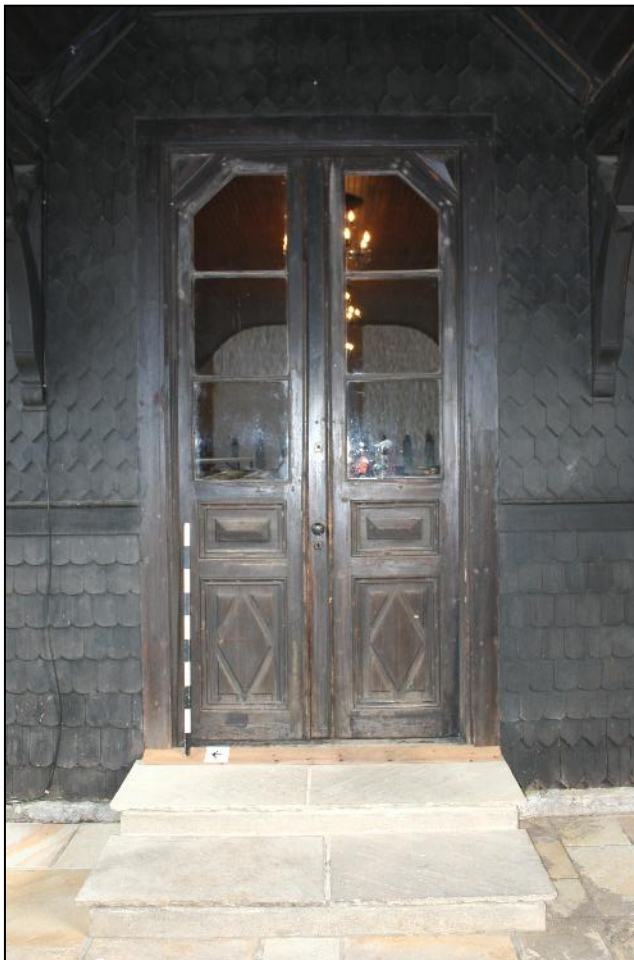
The south-west end has a decorative partly paneled double-door entry beneath a covered way that served as a sort of porch (Plate 6). The latter is held in place by some decorative brackets (Plate 7). There are seven windows with pointed tops along each of the long sides (Plate 9) but no openings in the north-east end of the building.

Plate 6: Double-door entrance with decorative panelling

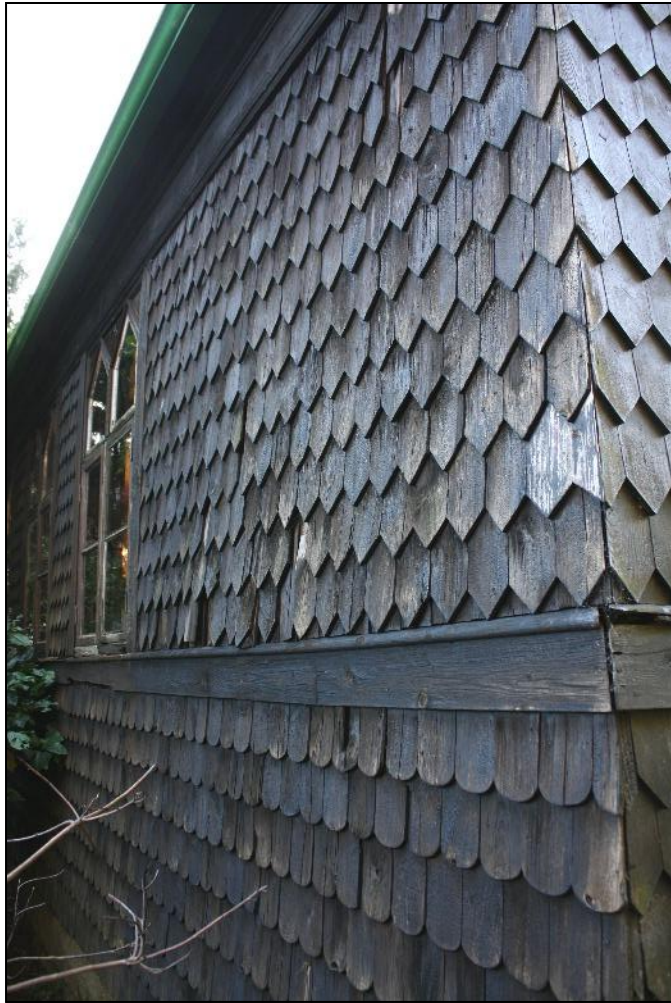
Plate 8: Shingles of differing shape.

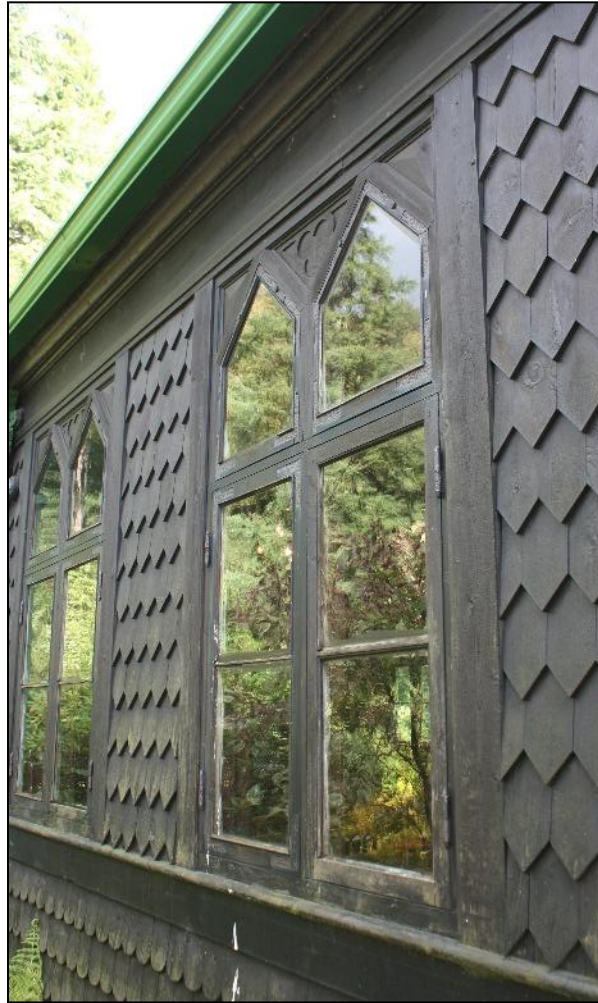
Plate 9: Pointed windows.

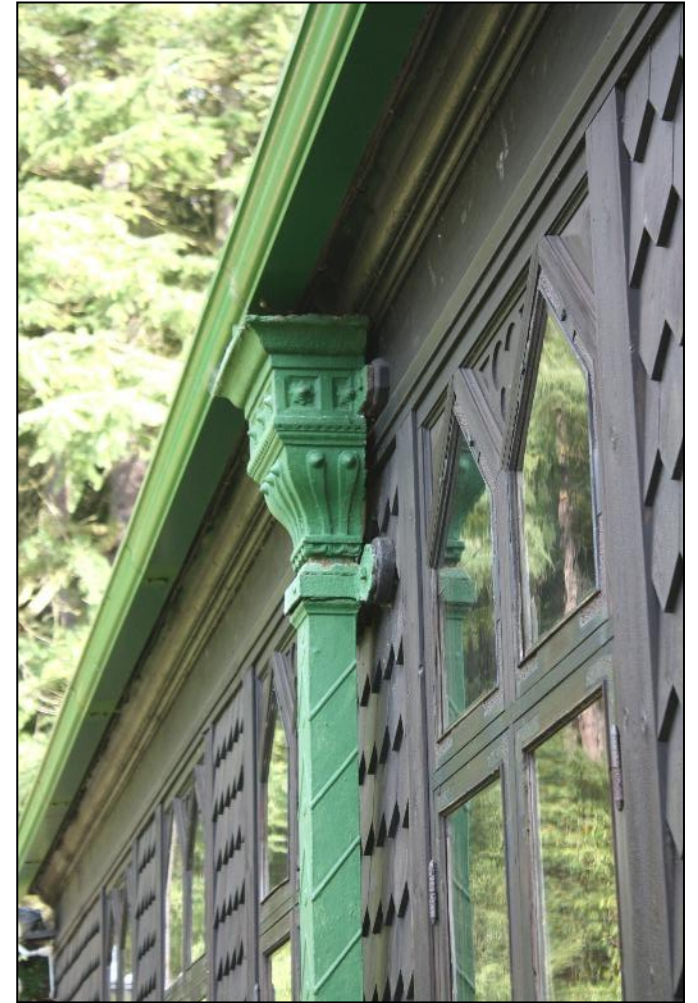
Plate 10: One of two cast-iron down-pipes with decorative rain-heads.

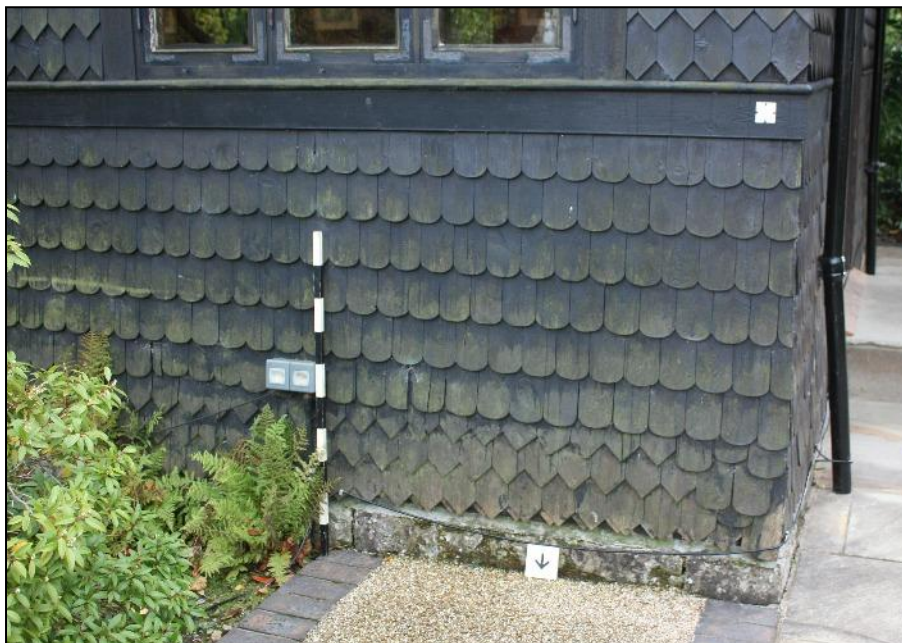
Plate 11: Stone and concrete base and closer-set shingles towards the bottom of the side walling.

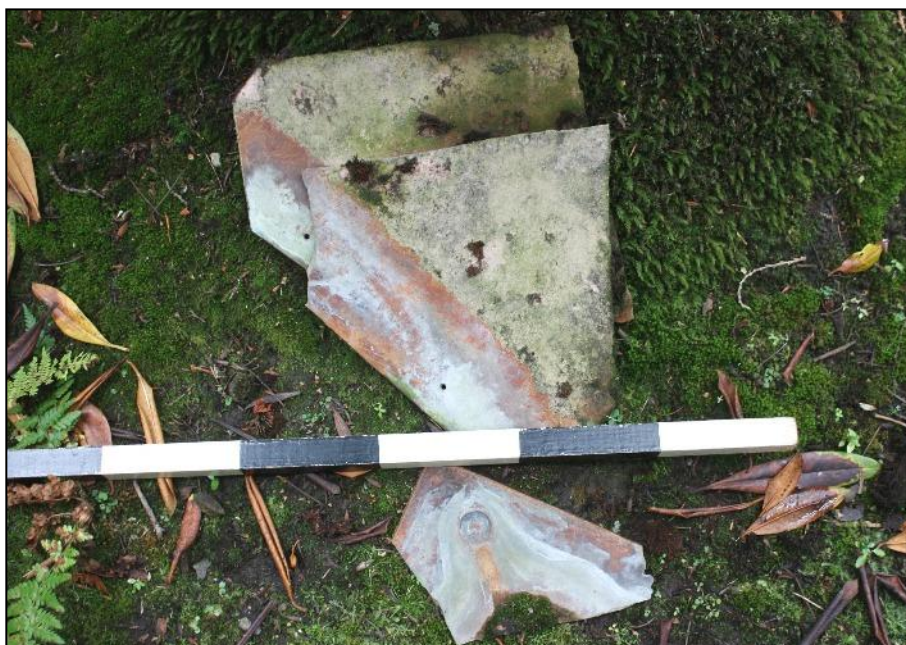
Plate 12: Fragments of asbestos tiles from the roof.

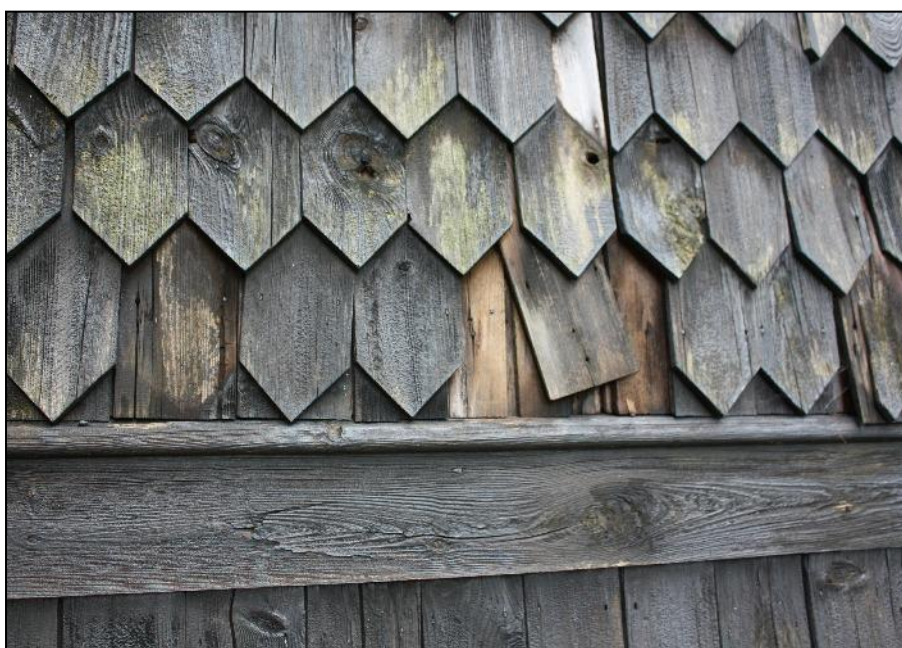
The building's side walling is relatively thin, probably being no more than 20cm (8 inches) thick in total, although the side walls do appear to taper outwards and downwards on the outside faces. Towards the north-east end some shingles have deteriorated and become displaced (Plate 13). At least three layers of thin timbers were counted here.

Plate 13: Area of lost and damaged shingles and exposure of timber layering.

The building's design of no division between nave and aisles, and a small spire is similar to many rural churches found in Norway. The chapel was designed to be light and airy and had gas lights for increased lighting when required. It was modestly decorated with panels and moulded woodwork. Although the close-set roof structure was probably meant to take the weight of locally sourced tiles, at some stage these were replaced by lighter asbestos tiles, although this is unlikely to have reduced the effects of any fire below. The building remains in relatively good condition for its age, although the roof cover probably now needs replacing again and some repairs are needed to parts of the external walling.

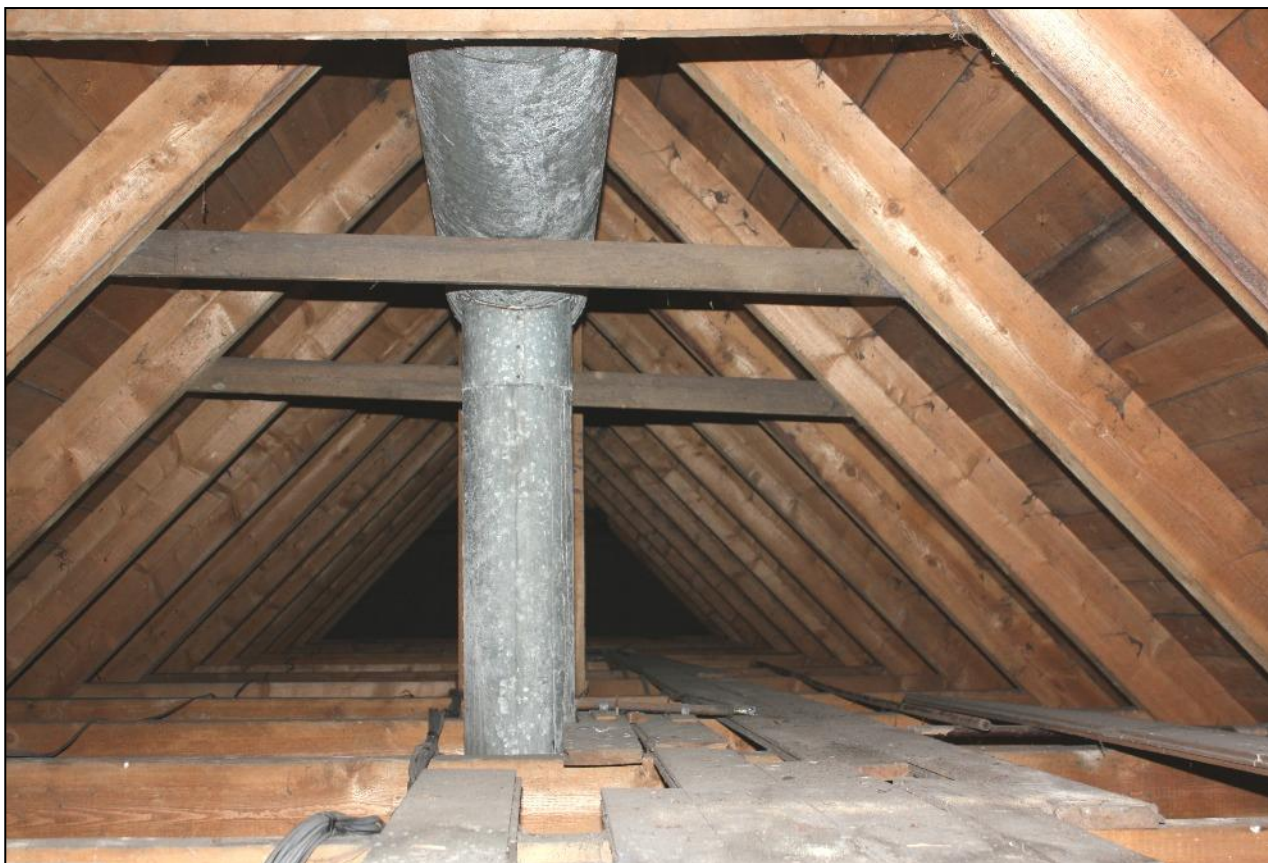
The roof is held up by a series of simple principal rafter trusses, each rafter being jointed into and extending down below a tie-beam (Plates 19, 20). Some trusses have added collars nailed on. From the vantage point of a hatch entry at the south-west end the author counted 15 regularly set trusses, each just under 1m apart. Assembly marks II, III and IIII showed on several trusses close to the hatch, but not in sequence (Plate 20). A maker's mark bearing the name in English *The New Ekman Co., Stockholm, Sweden* showed on a roof timber close to the hatch (Plate 23). Also showing in the attic were two vertical metal pipes, a connecting horizontal one and a rising pipe below the roof spire (Plate 21). Modern batons beneath the replacement roof tiles showed in one area (Plate 22).

Plate 19: View looking towards the south-west end of the chapel's attic showing closely spaced trusses with simple collars and pipe-work for the ventilation system.

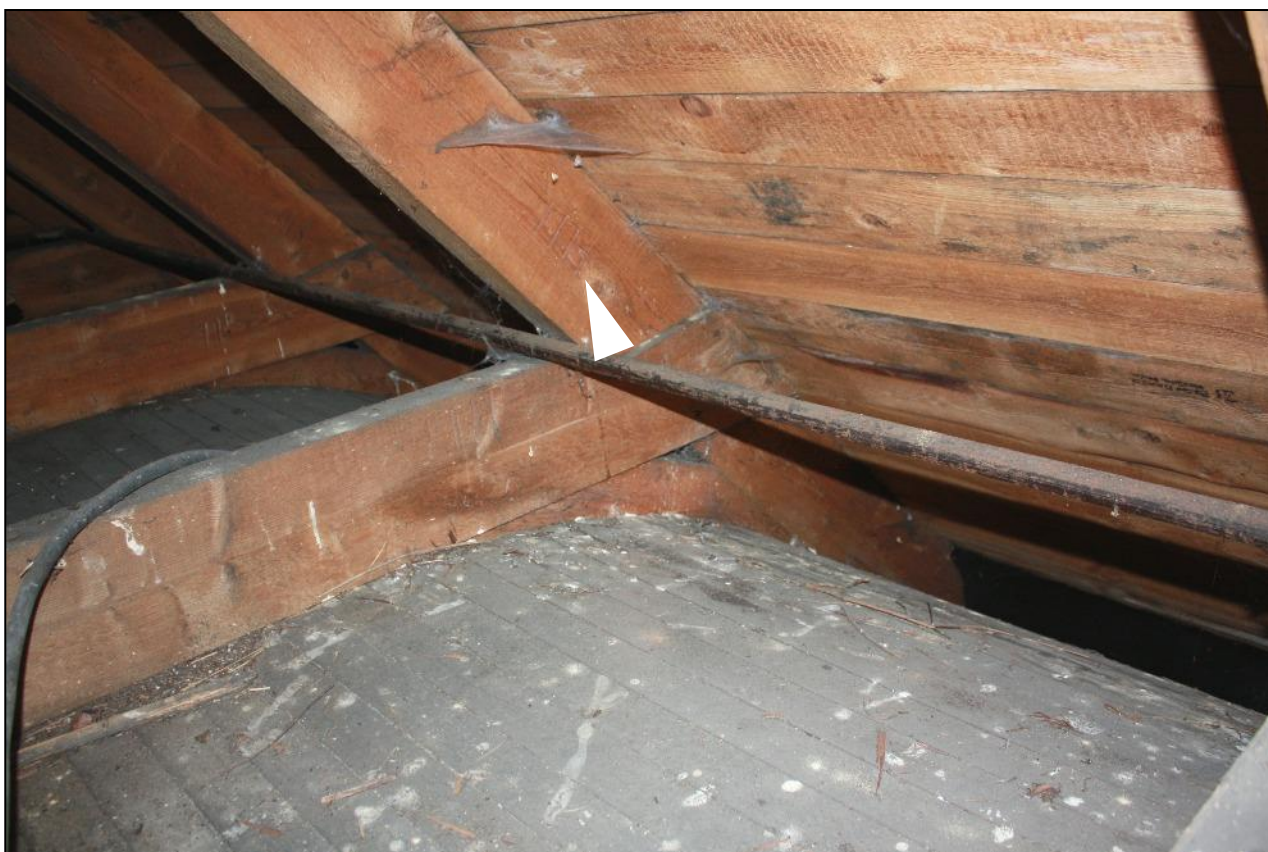
Plate 20: Junction of a tie-beam, principal rafter, connecting brace and curving ceiling timbers. The arrow points at an assembly mark.

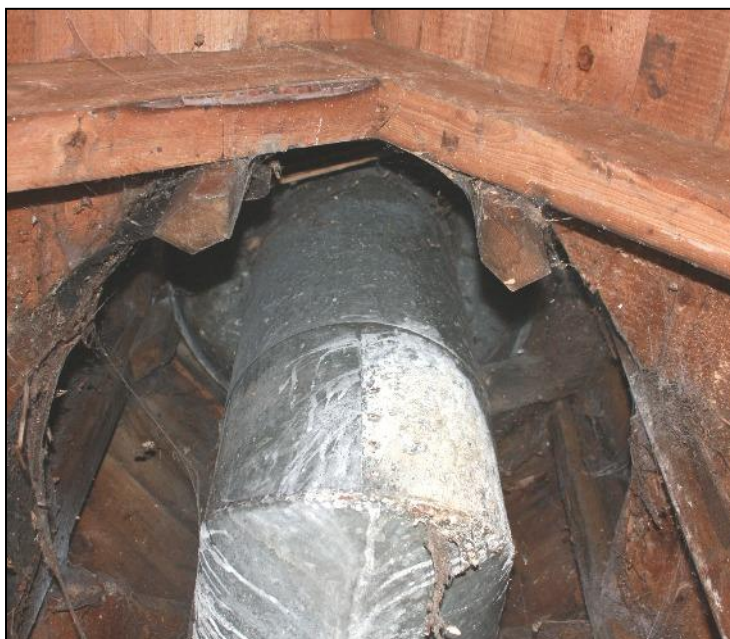
Plate 21: Where the ventilation pipe-work connects to the external spire.

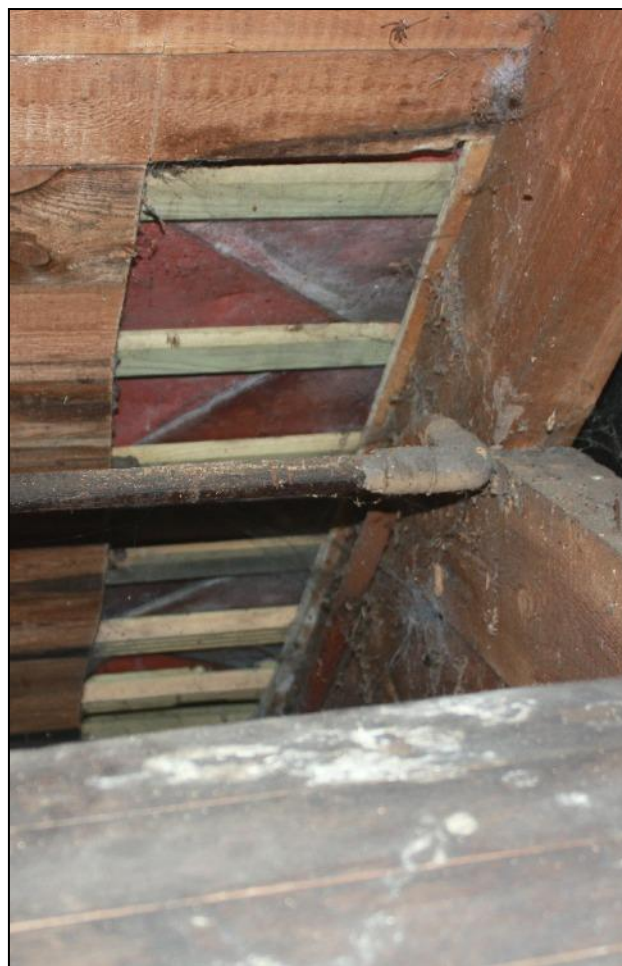
Plate 22: Timber framework showing in the attic beneath asbestos roof-tiles.

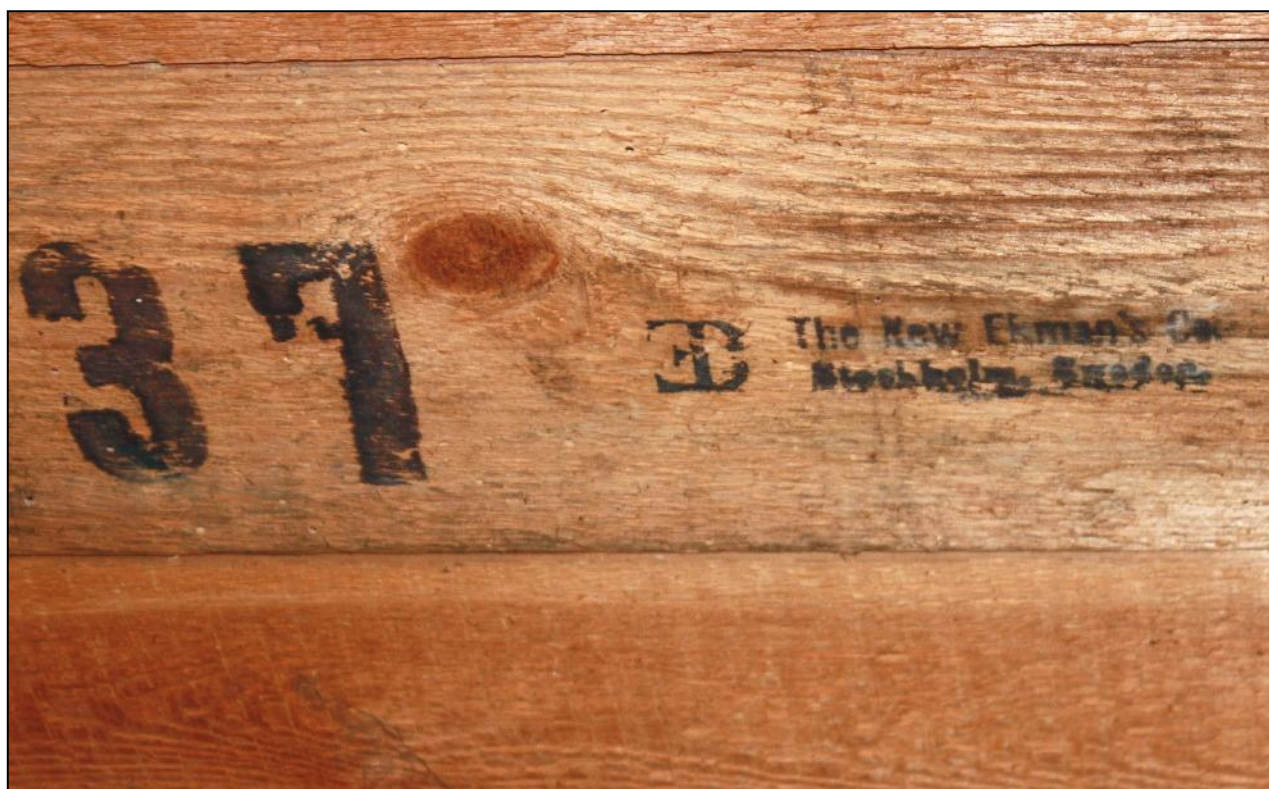
Plate 23: A maker's mark that reads in English *The New Ekman Co., Stockholm, Sweden.*
