DAWLEY BROOK CULVERT, KINGSWINFORD, STAFFORDSHIRE.

Report on an Archaeological Watching Brief

TPA Report No.050/2013

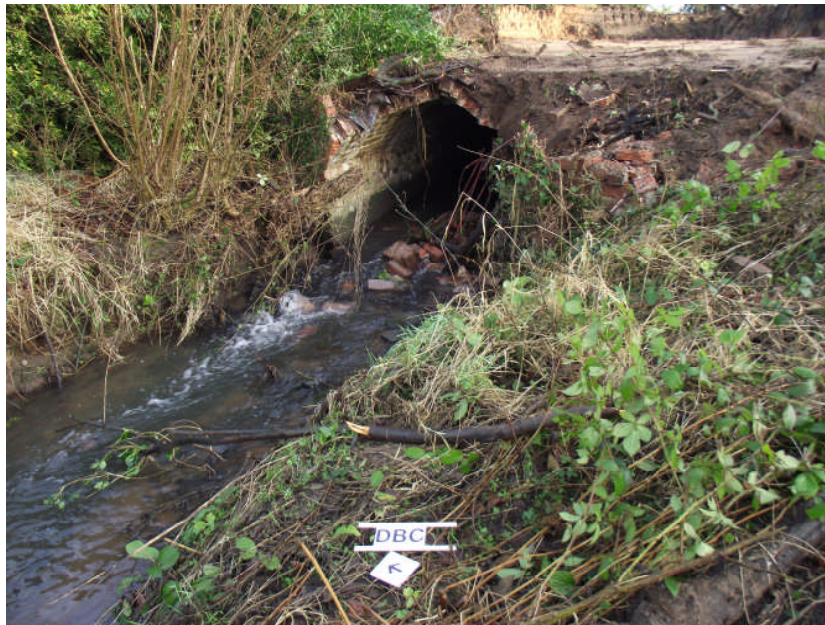
South west end of Dawley Brook Culvert emerging from the embankment.

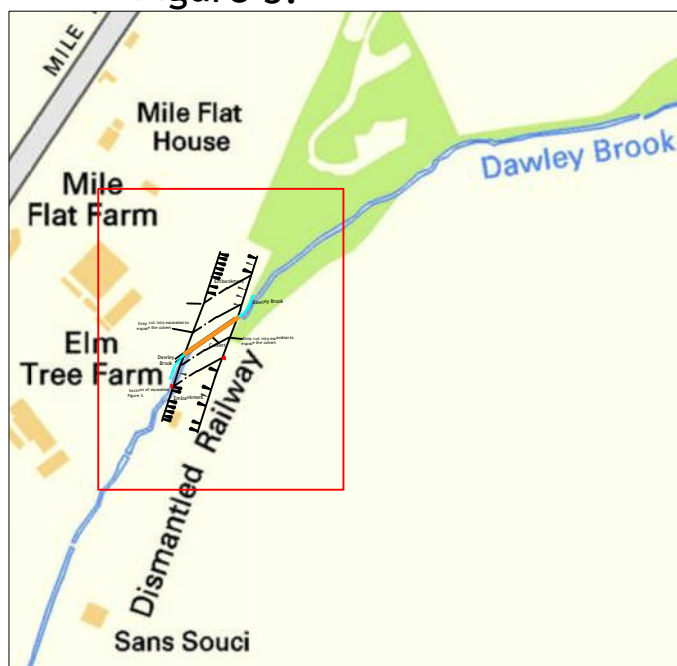
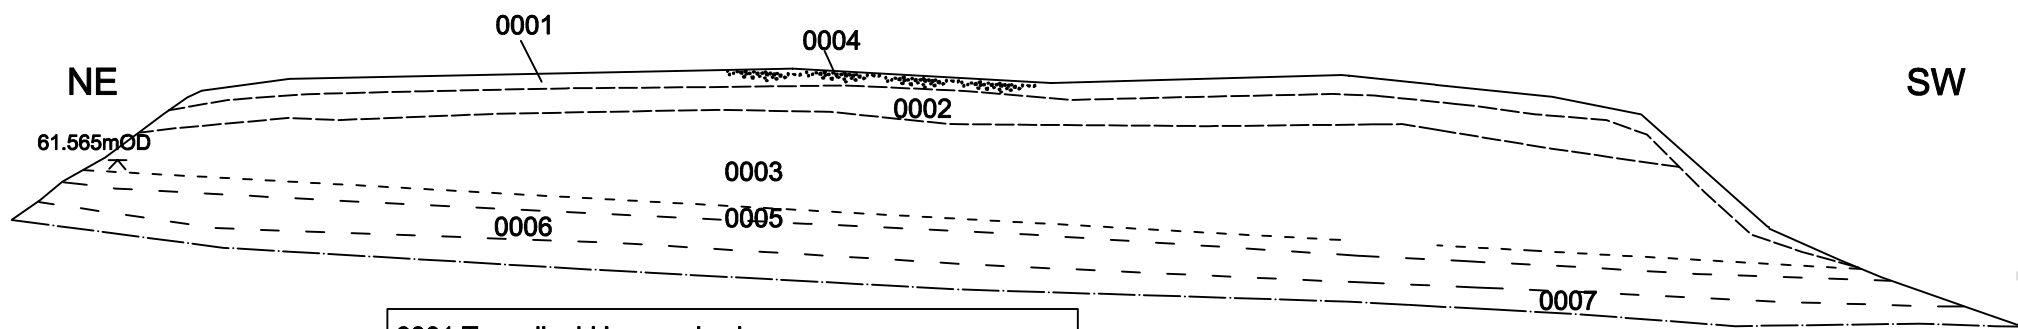
Section of excavation Figure 3.

2.4.2 The ground slopes down to the east forming a shallow but wide valley through which the Dawley Brook flows. The railway embankment was constructed against this slope being steeper along its north western side in order to create a level surface for the track at its summit (Figure 3).

- 0001 Topsoil mid brown clay loam.
- 0002 Dark grey/black ash, clinker with elements of 0001.
- 0003 Yellow/orange fine grained sand.
- 0004 Angular stones white/light grey.
- 0005 Brown clay loam subsoil
- 0006 Light to mid brown clay
- 0007 Grey clay

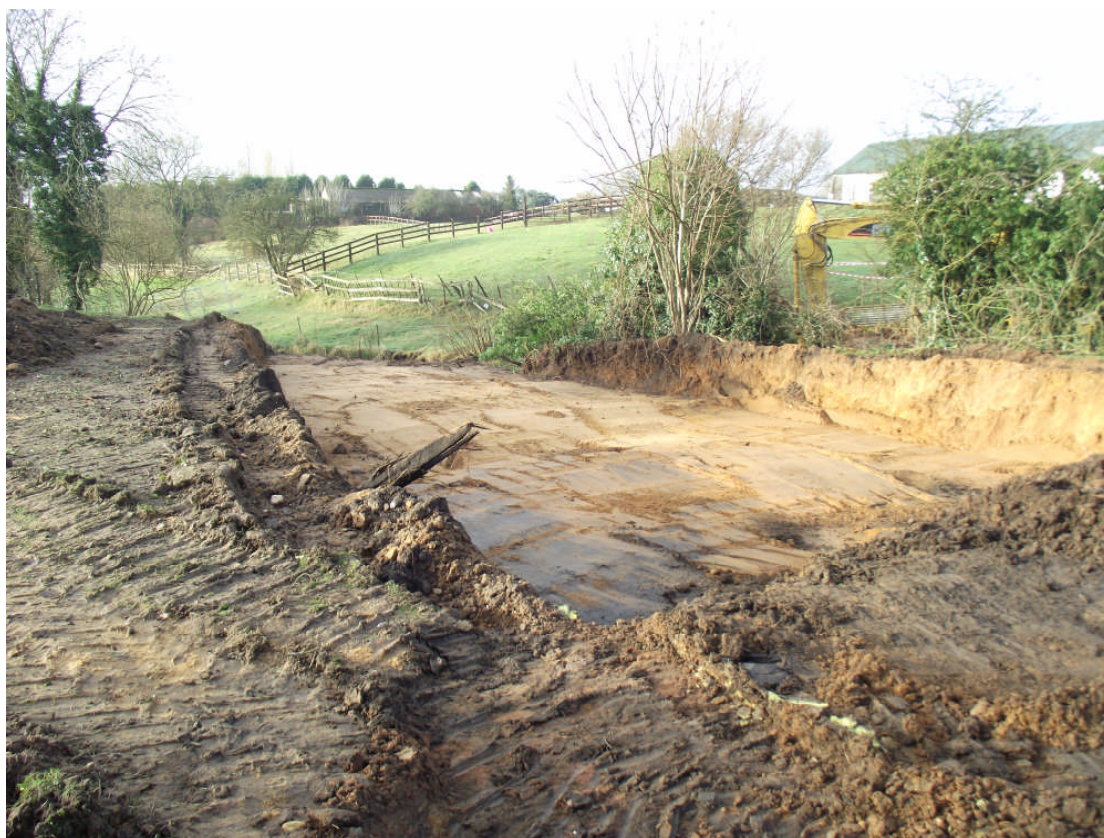
3.1 All intrusive groundwork and the demolition of the culvert were carried out by a tracked 360° excavator using a smooth-edged ditching bucket. The sides were battered during the course of the excavation due to the unstable nature of the deposits making up the embankment (Plate 2).

Plate 2. The section the embankment during excavation. Looking north.

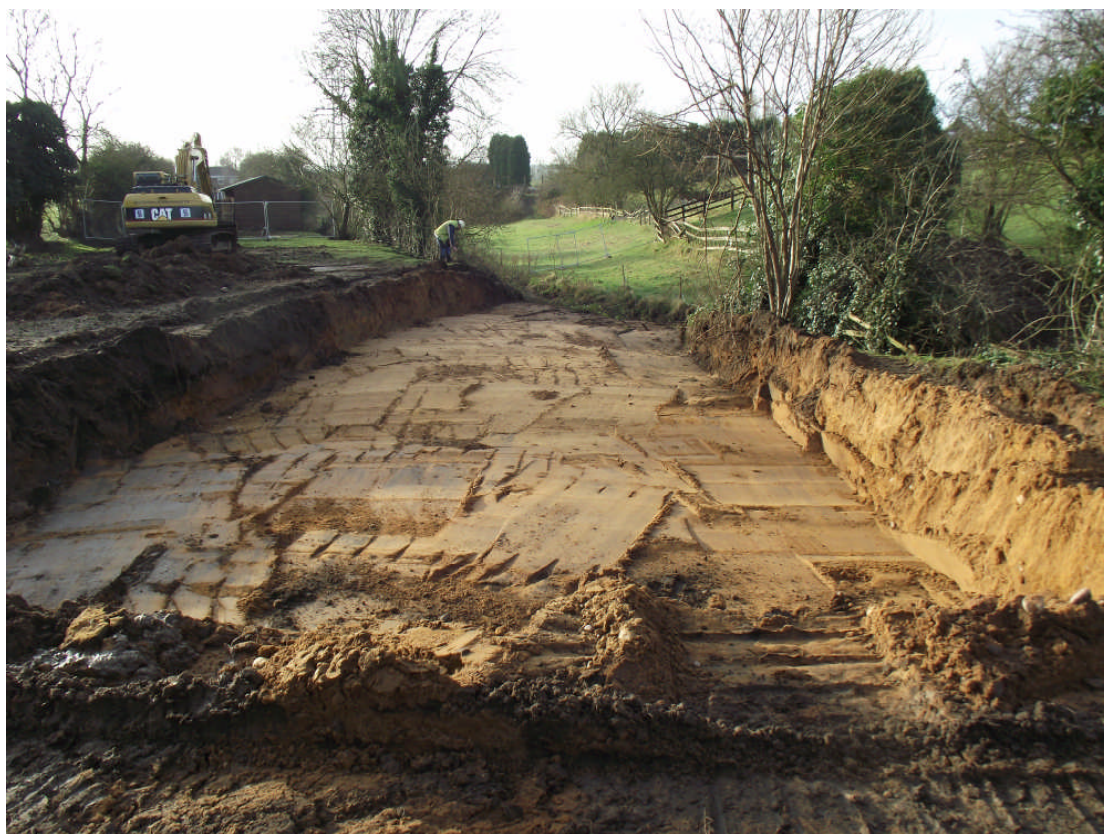
4.2.1 A consistent stratigraphic sequence was observed in the north-east facing section. The topsoil (0001) has probably developed after the railway was decommissioned, overlaying the deposits used to form the railway bank (Plate 3). These deposits consist of mainly sand and clinker (0002-0004). Below these layers were lenses of grey sand and clay, which have been initially been interpreted as being part of the original ground surface.

4.3.1 The sequence observed in the south-east facing section mirrored that of the opposing section. The topsoil (0001) overlay the sand and clinker deposits used to form the embankment (0002). Below these deposits a brown clay loam subsoil, (0005), was observed. This subsoil is sat above mid-light brown clay, (0006), which merges into, a grey clay (0007). Together these layers probably form part of the original ground prior to the construction of the embankment but are redeposited having been used to infill the cut in which the culvert sits (Figure 3 and Plate 3).

Plate 3. Excavated section through the embankment showing the sand which comprises the main element of the structure. Looking south west.

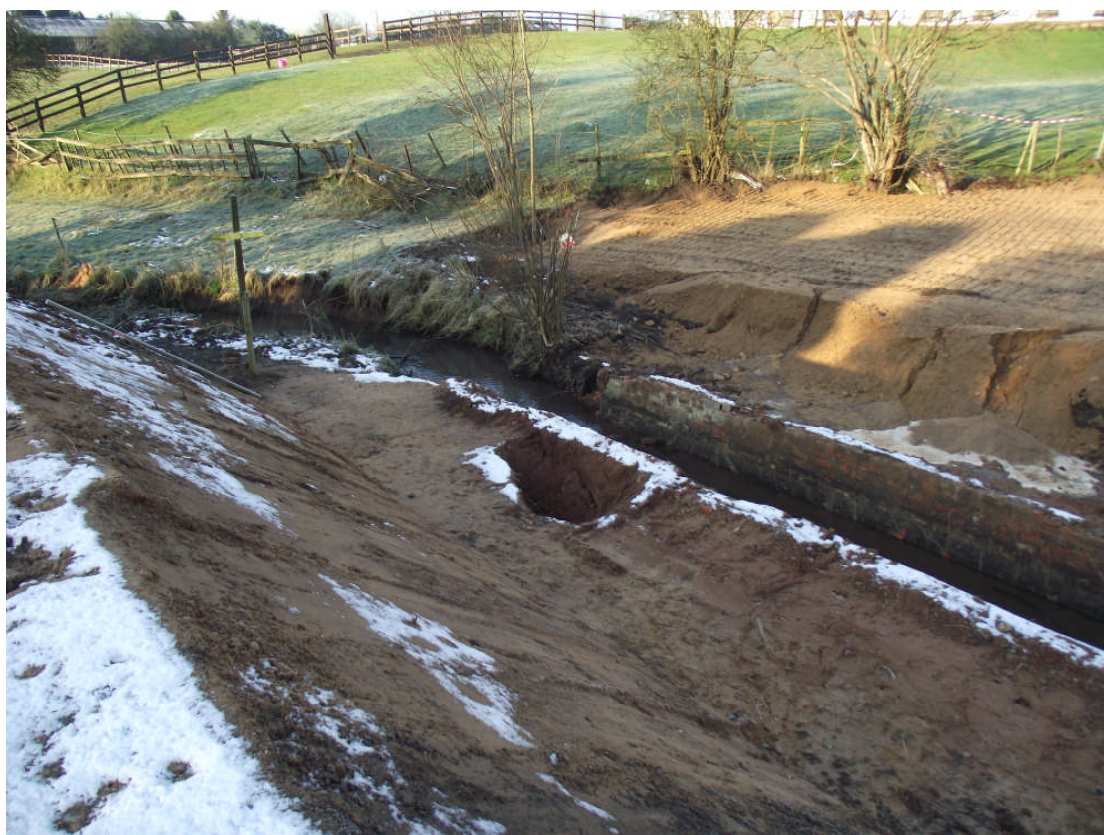
Plate 4. The partially demolished culvert with exposed sections of the embankment to either side after the sections had been battered and stabilised. looking north east.

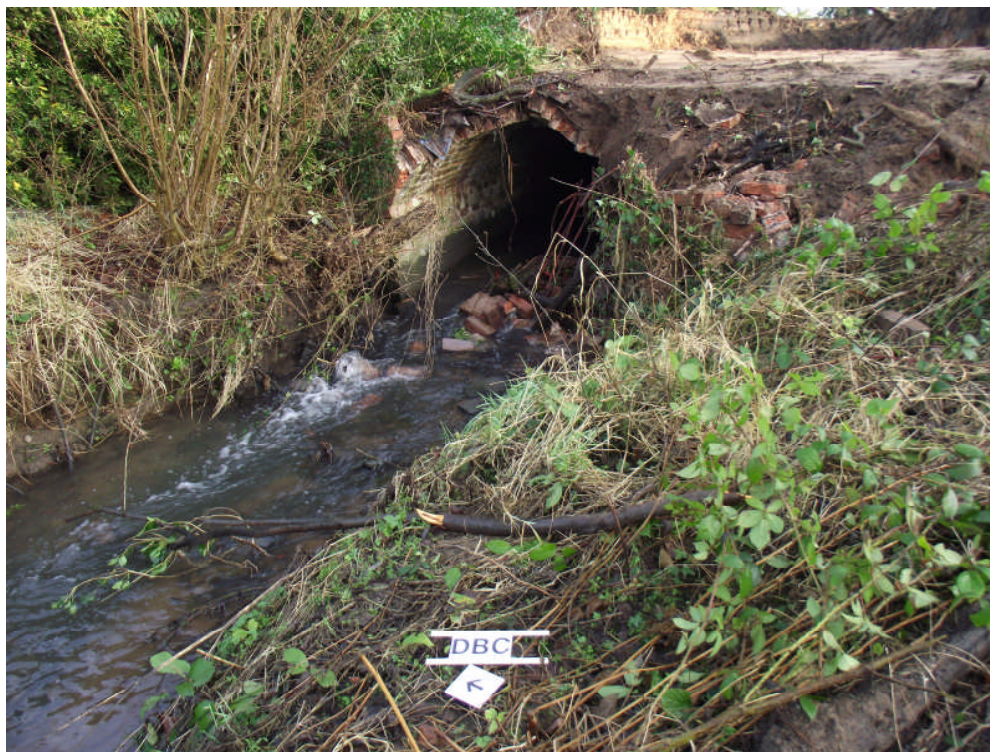
4.4.3 The sides of the culvert appeared to be distorted and this was probably caused by the weight of material above it. The arched roof at the south western extent of the culvert appeared to be compressed with the arch becoming pointed in contrast to the even curve of the arch as demonstrated by the central section of the culvert (Plates 10 to 12 and Plates 13 to 17). The height of the arch varies from 60cm from the top of the upright courses at the south west extent, to 80cm at the north east end (Plates 5 and 6).

Plate 5. South West facing end of the culvert prior to the start of the demolition. Looking north east.

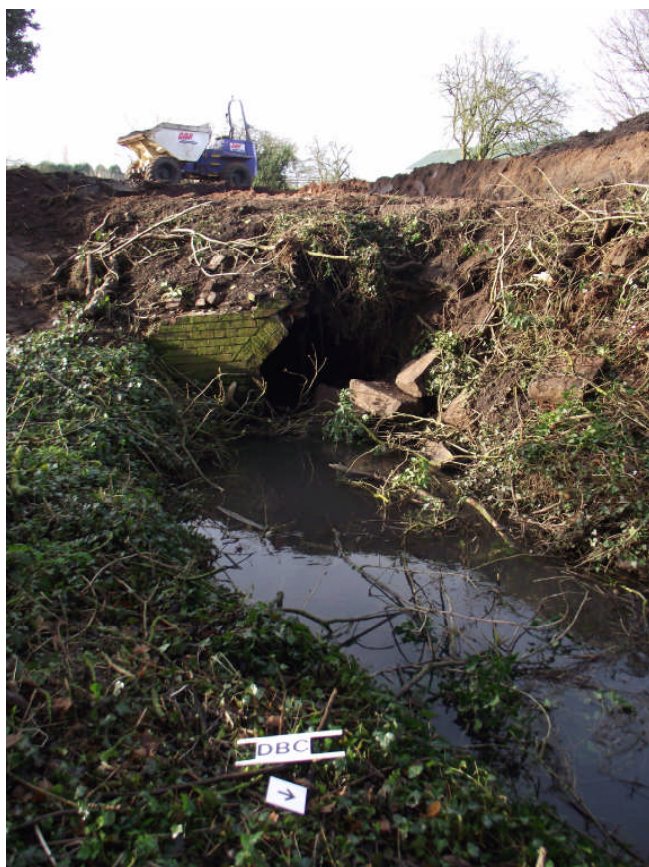
Plate 6. North East facing end of the culvert with part of the retaining wall intact. Looking south west

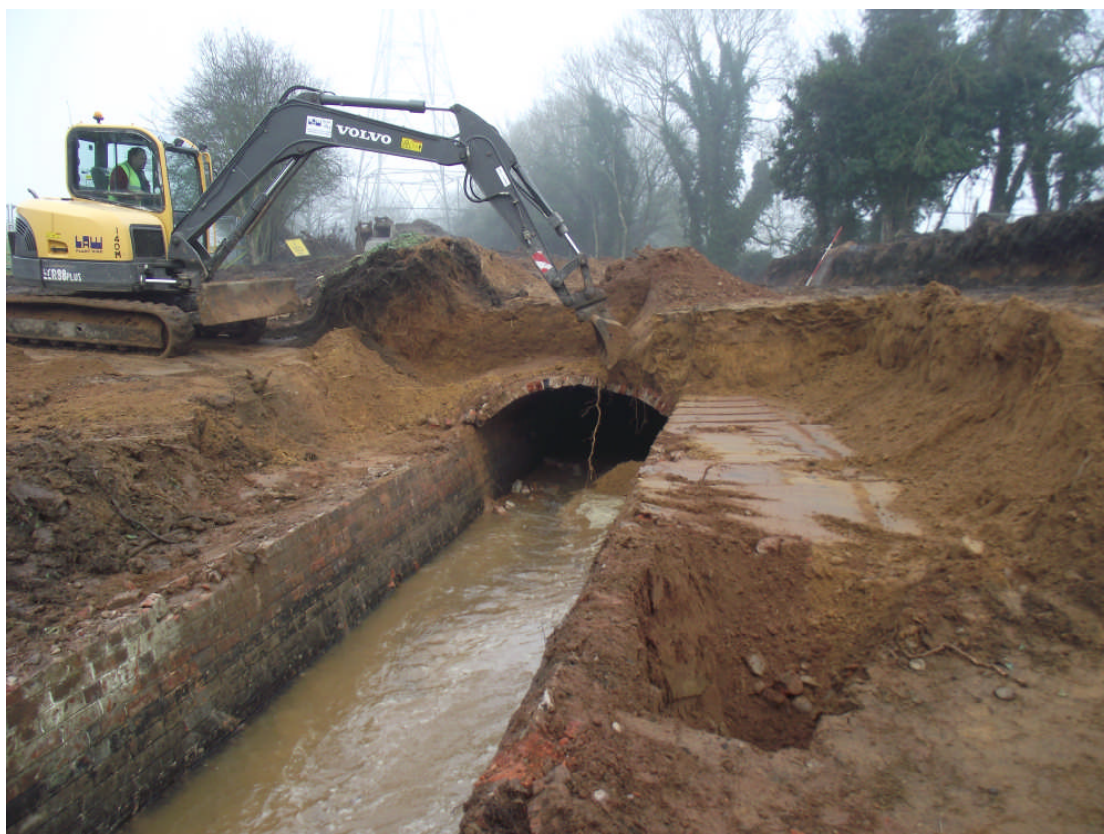
4.4.4 With the brick work of the culvert removed the existing channel was dredged to ensure improved flow. Much of the material removed from above and to the sides of the culvert comprised re-deposited sands and clays that had been used to cover the structure at the time of the original build. No cut for the culvert was discerned. Access to the newly cut channel was restricted due to the unstable nature of the resulting sections and detailed recording was not possible in these circumstances (Plates 7 and 8).

Plate 7. The culvert during demolition. Looking north east.

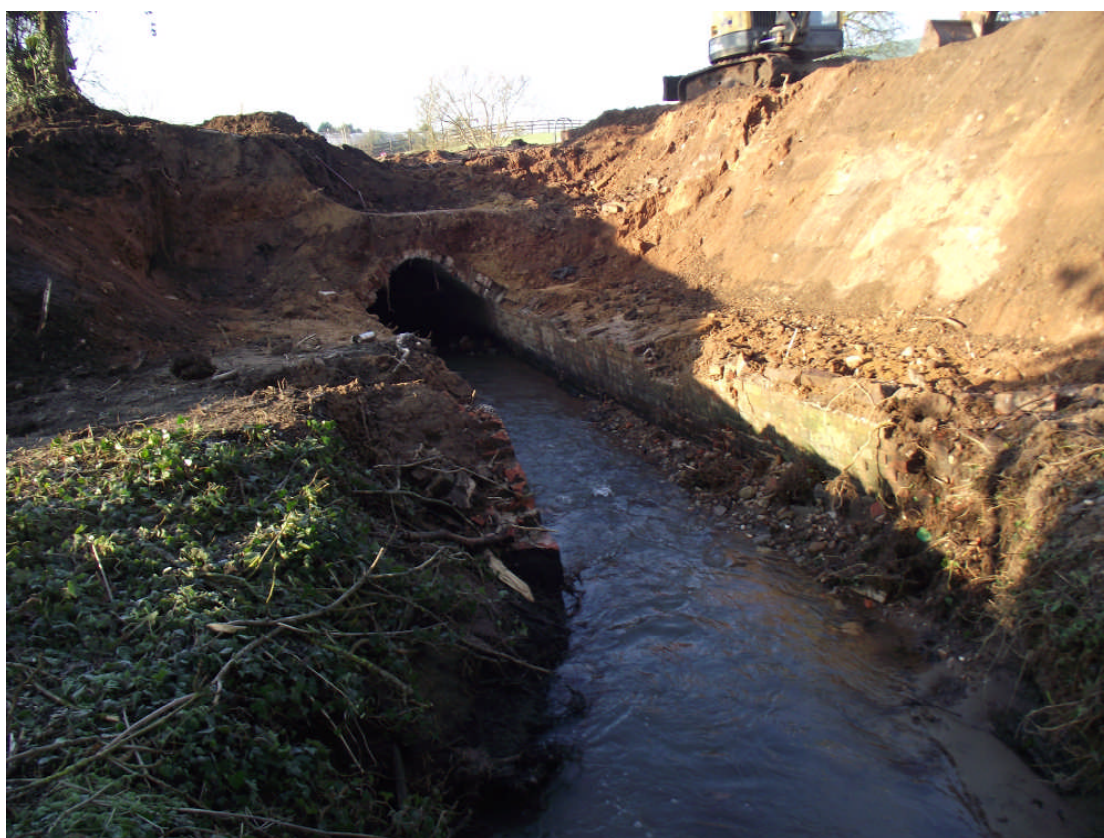
Plate 8. The culvert during demolition showing the removed overburden and stabilised bank. Looking north

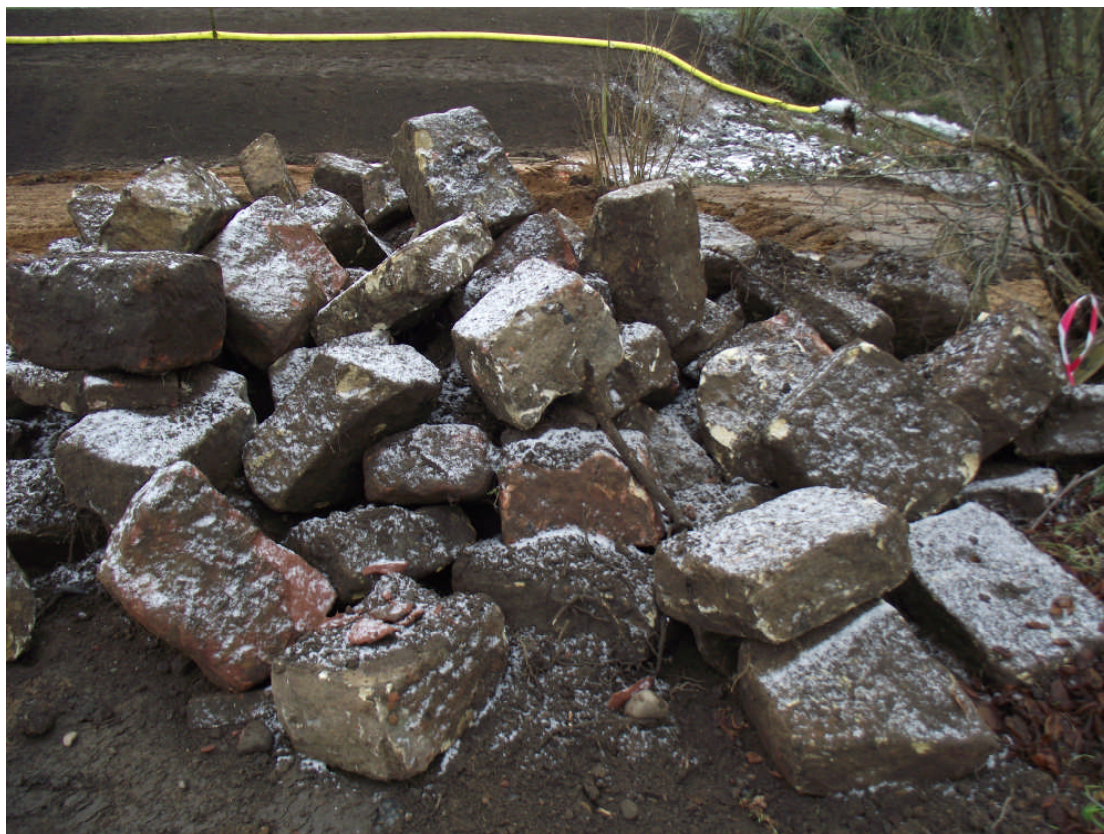
4.5.1 Large pieces of masonry were lifted out of the lower levels of the sand and clinker deposits (0002, 0003). Although not a distinct layer the masonry was given the number 0009 for discussion purposes. Some of these had clearly been worked, and may have been a part of a previous bridge structure that had spanned the brook although no verification of this is currently available. (Plate 9).

4.5.2 The masonry (0009), was at the interface of the material used to construct the embankment and what has been interpreted as a subsoil layer (0007), at the base of the excavation. It is not clear whether the masonry had been reused as an element of the embankment construction or having been removed from its original location it was simply left in the base of the excavation.

Plate 9. Blocks of masonry following their extraction. These were subsequently used to reinforce the newly created bank of the Dawley Brook. Looking south west.
