Report on an Archaeological Watching Brief at the Church of St. Mary the Virgin, Nether Broughton, Leicestershire.

Report Number: 022/2018

Client Name: CEL
Document Title: Report on an Archaeological Watching Brief at the Church of St. Mary the Virgin, Nether Broughton, Leicestershire.
Document Type: Final Report
Issue/Version Number: V1
Grid Reference: NGR SK 6958426212
Report No. 022/2018

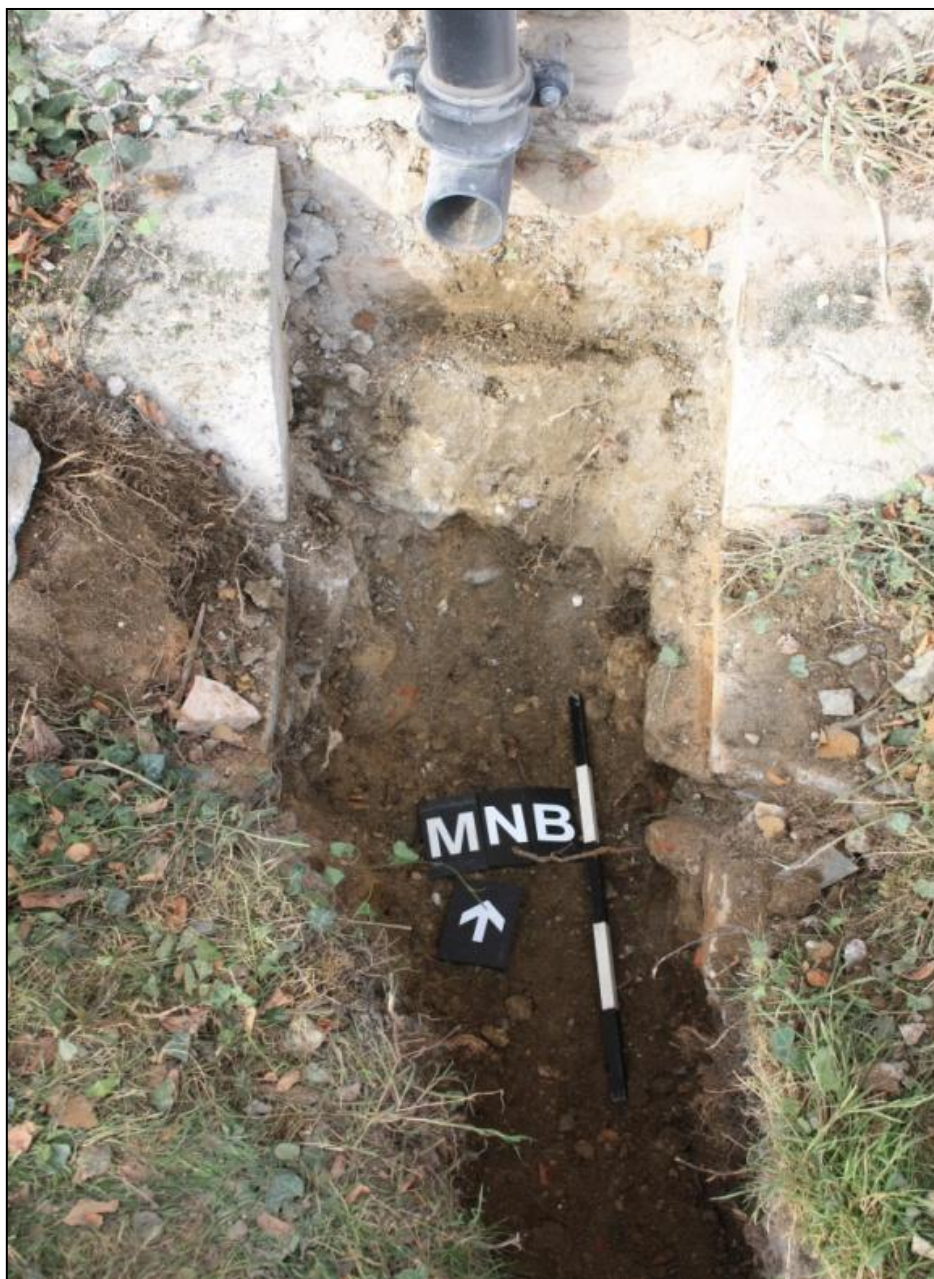
- 6.2.3 Where Area 01 abutted the south wall of the nave a sump was excavated. The below ground foundation was obscured by the residual concrete from a c.19th or early c.20th century drain trough which had been installed along the length of the South wall.

Plate 13: Area 01. Foundations obscured by residual concrete from a modern drain trough. Looking North.

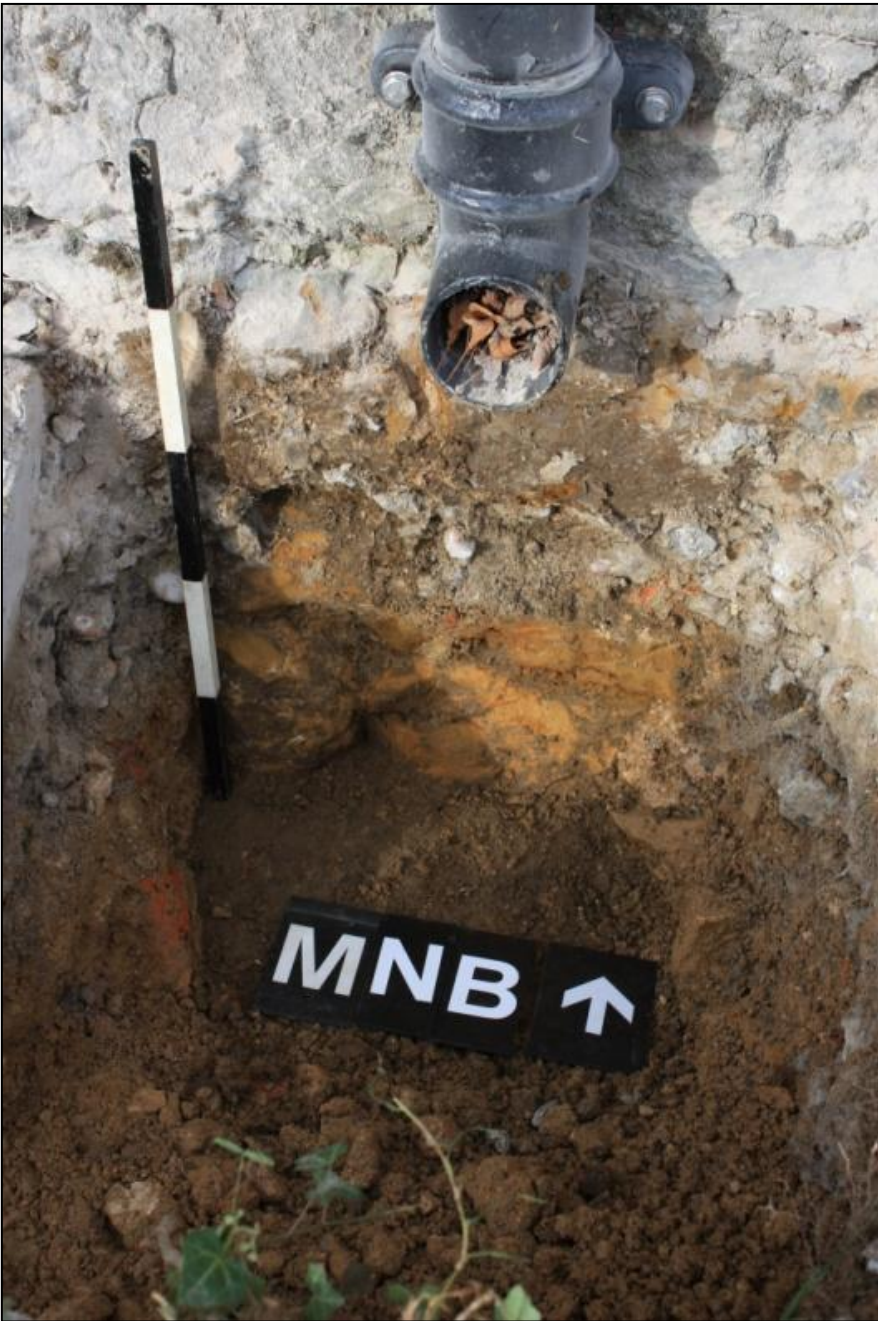
6.4.4 A portion of the foundation of the current South wall of the nave was exposed within this trench, [0304], which was formed of undressed ironstone blocks, with surrounding fragments used as packing. Above [0304], [0303] was recorded as the extant above ground dressed blocks, forming the South wall of the nave.

Plate 14: Area 03. Original foundations of the South aisle wall. Looking South.

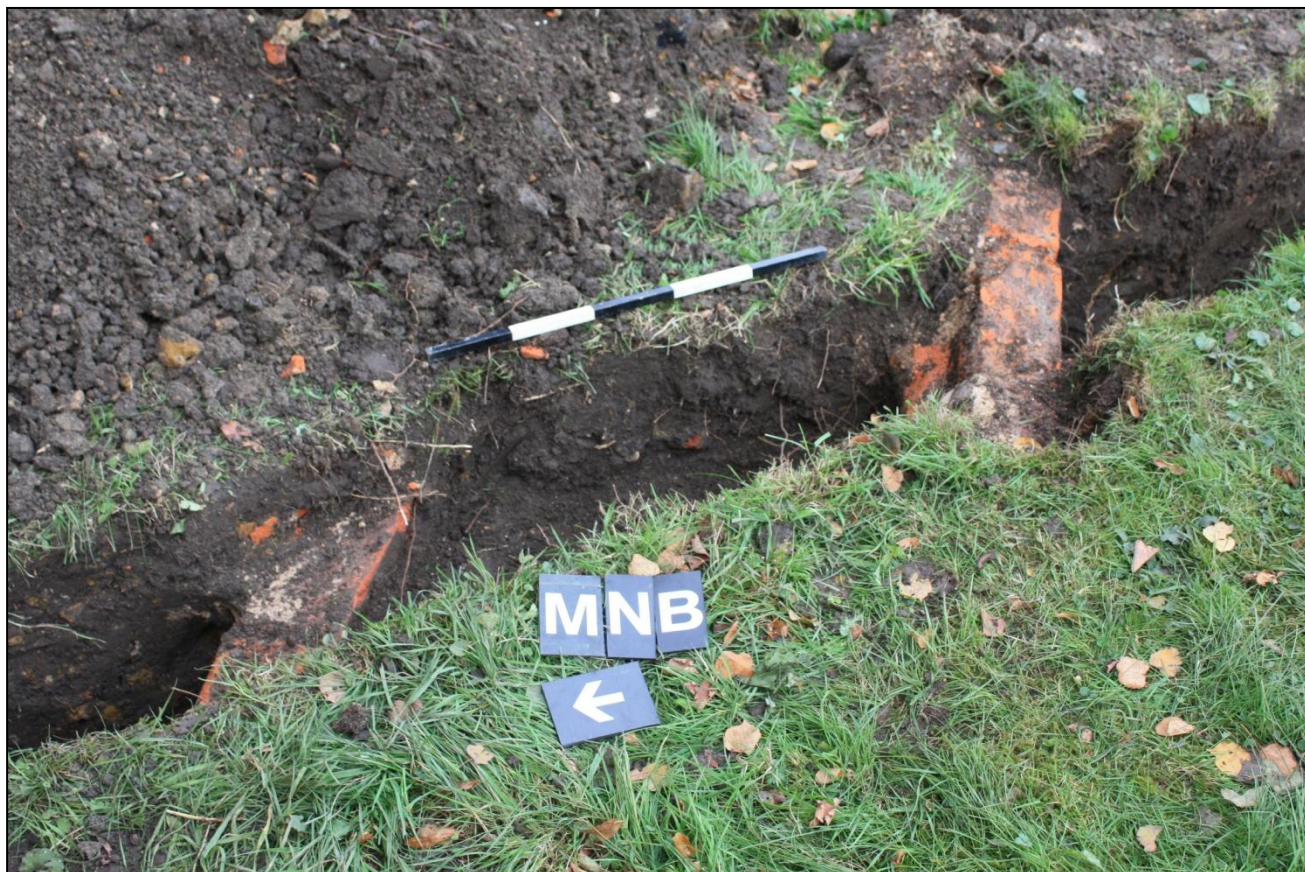
6.5.2 Approximately 1.4m south of the chancel wall, the top of a brick burial vault [0404] was uncovered. This comprised two single skin brick walls with dark brown/black 'grave earth' (0406) infill. The vault [0404] was oriented East-West alongside the orientation of the current church. [0404] was of narrow construction, measuring 0.67m in width. No above ground memorial was found associated with vault [0404], and excavation did not extend to the depth at which *in-situ* coffins may have been located. No dating evidence was found associated with [0404], although the fabric of the brick work suggests c.19th or later.

6.5.3 Only a small part of burial vault [0404] was uncovered by excavation, with full measurements unrecorded. It was not considered feasible to divert the drain run in this area for this reason, due to the position of the burial vault [0404] against the chancel wall, which connected the drain run and the extant drain pipe.

- 7.5 A brick grave vault [0404] was also recorded with in Area 04 (drain run). The upper courses of brickwork were exposed but the excavation did not penetrate to the depth of any interment within it. No associated above ground grave marker was present.

Plate 15: Brick grave vault [0404] within Area 04 (drain run). Looking East.

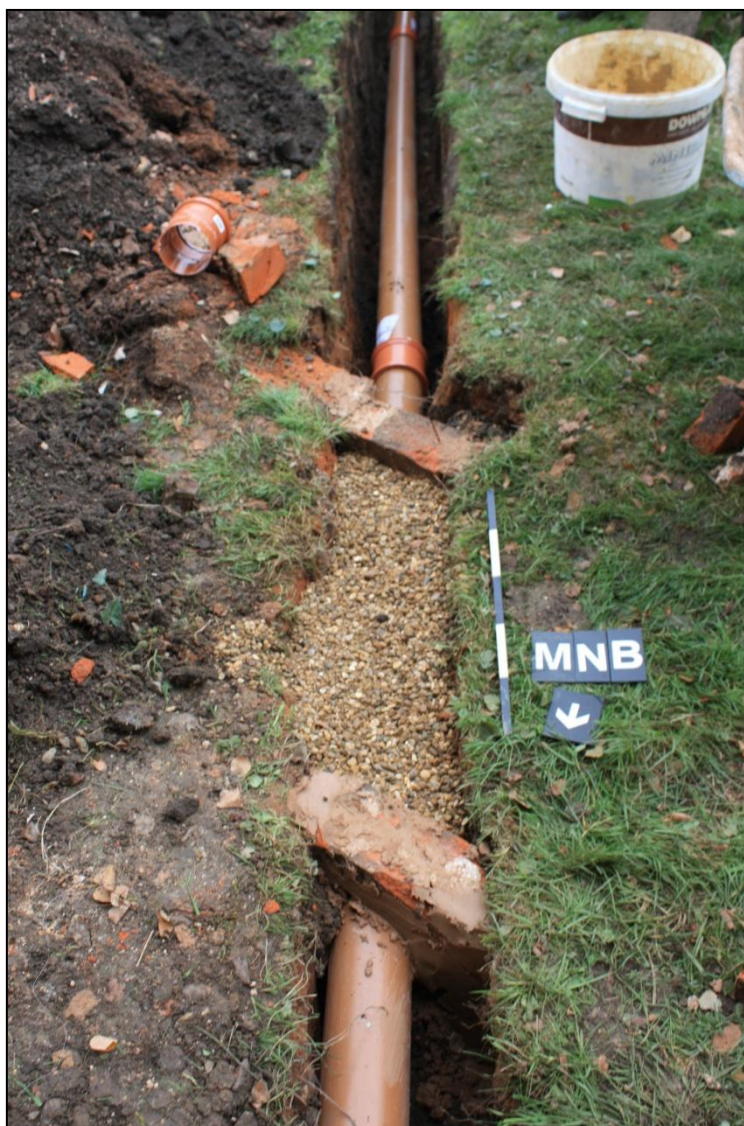
Plate 16: Brick grave vault [0404] (Area 4) after laying new drainage pipe. Looking Southeast.

6.5.4 The top two courses of burial vault [0404] were subsequently removed, which allowed the laying of the new drain through the top of the vault. The top two courses of brick work were then reinstated over the top of this, and the internal space infilled with pea gravel.

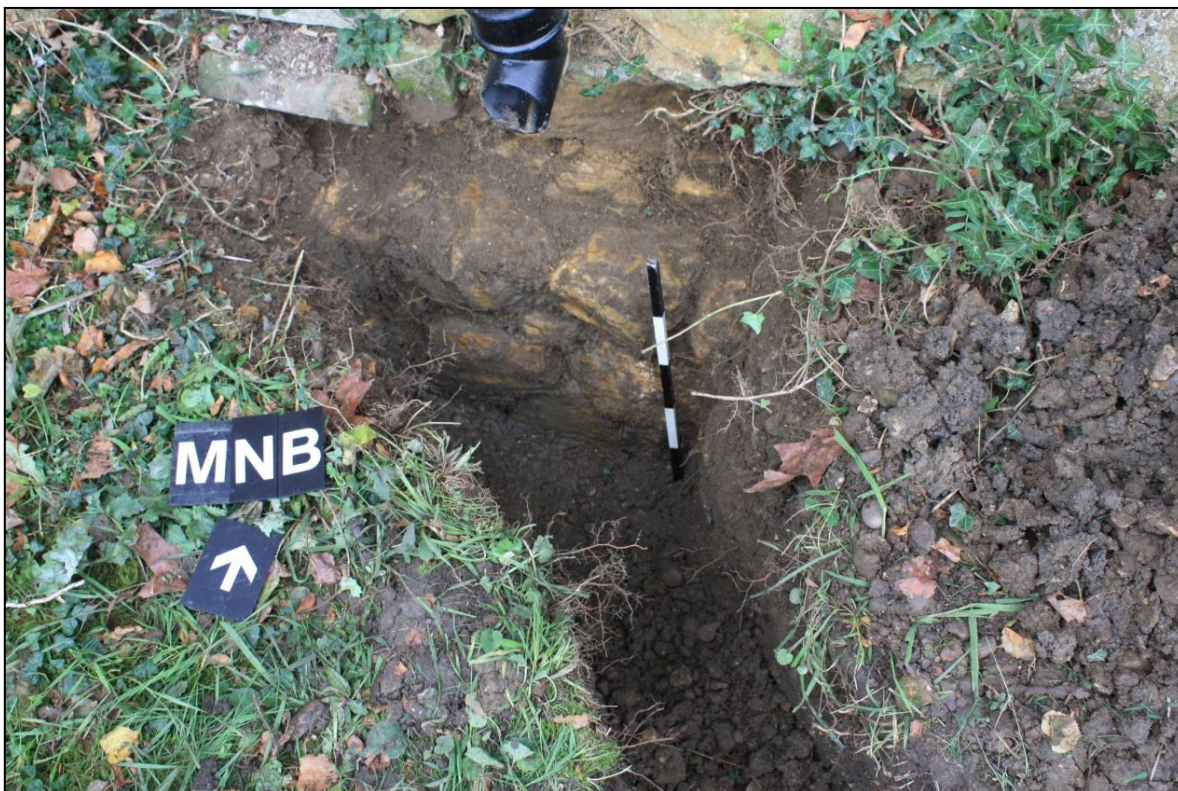
6.5.6 Where Area 04 abutted the South wall of the chancel, a section of the current church foundations were revealed. This comprised roughly dressed ironstone blocks with infilled with ironstone packing fragments. (Plate 9).

Plate17: Area 04. Original foundations for the South wall of the chancel. Looking North.

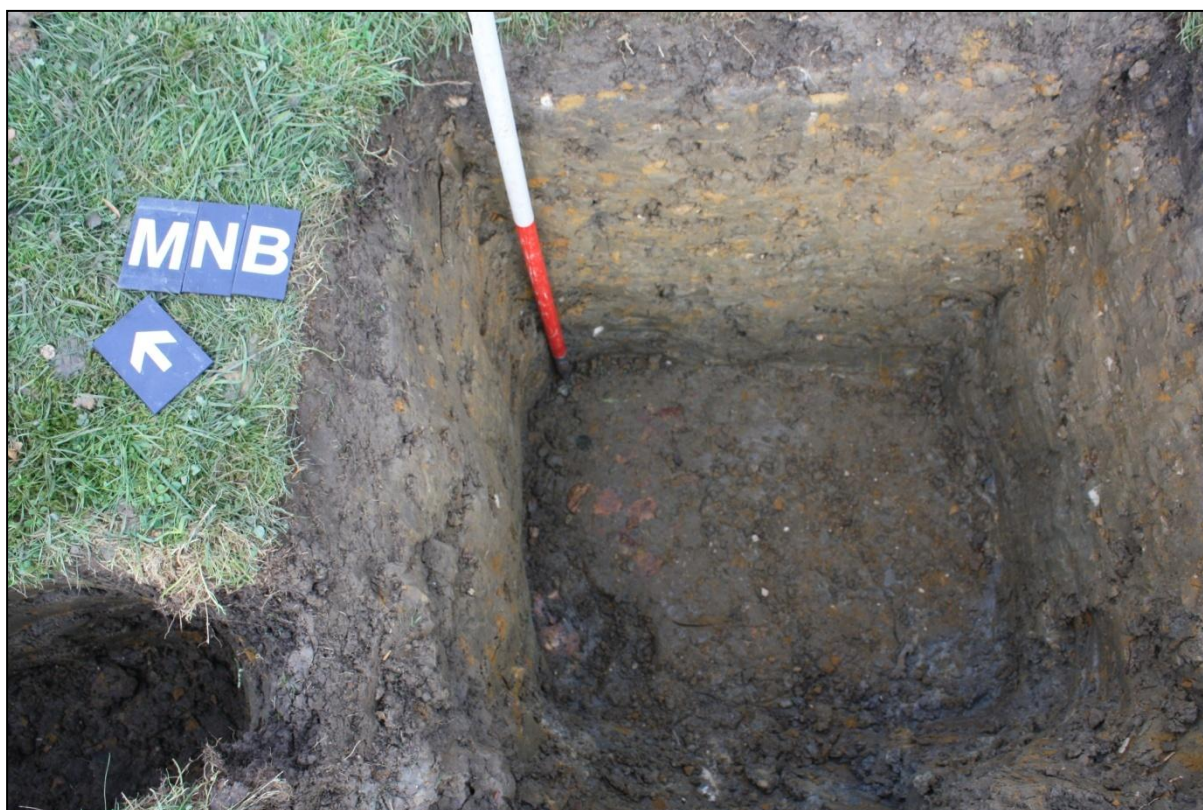
6.6.2 Within (0502), at the point in which Area 04 (drain run) connected with Area 05, a human skull was observed which was likely to be part of an *in situ* burial. This was

located towards the base of the excavation. (Plate 10). Further disturbance of the remains was not necessary, and were left *in situ*.

- 6.6.3 The burial was most likely aligned East-West. There was no evidence of a coffin or coffin furniture, suggesting a shroud burial more common of the medieval or early post-medieval. No above ground marker was present.

- 7.2 Two of the soakaways, Area 05 and Area 10, revealed evidence for *in situ* burials. In Area 05 a human skull was partially exposed. The position and state of preservation of the skull suggest that it formed part of an *in situ* burial. The skull was observed at a depth of 1m, which was the limit of the excavation. Ground works did not necessitate further excavation of the burial, which was left *in-situ*.

Plate10: Area 05 (soakaway) with a partially intact burial to the base. Looking Northeast.

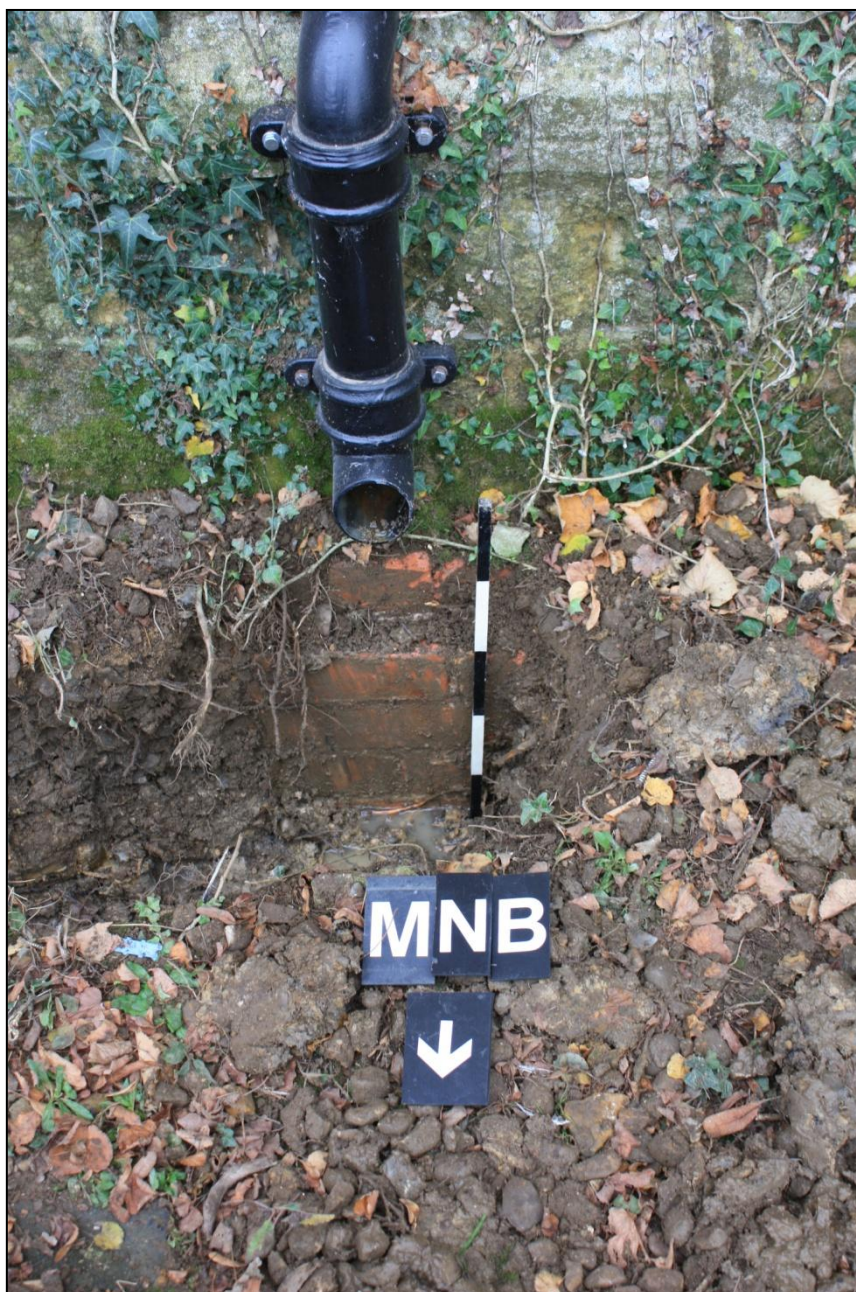
6.7.2 Where Area 06 abutted the North wall of the church, exposed brickwork was observed. This was underpinning the North wall and had either replaced the original foundation or had been inserted beneath the lowest course of stonework in order to stabilise the structure. This likely took place during a phase of church renovations during the 1890's.

Plate 18: Area 06. Brick underpinning of the foundation of the North wall. Looking South.

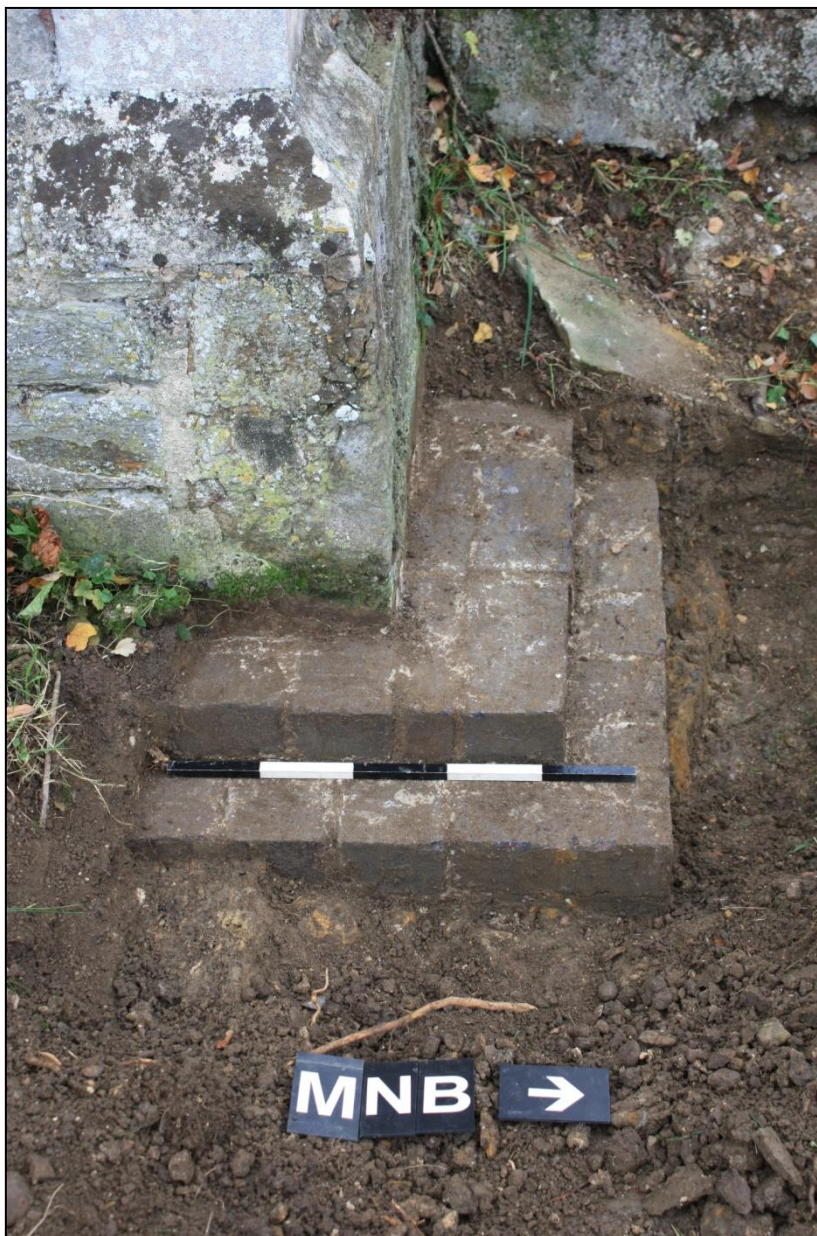
deposit, a c.19th brick underpinning was noted [0903], as part of a phase of works to stabilise the church structure during the earlier renovations. A series of undressed ironstone blocks, (0904) were located around the brick lining [0903], which may represent an earlier foundation wall of the current chancel.

Plate 12: Area 09. Brick underpinning of the Northeast corner of the chancel. Looking West.

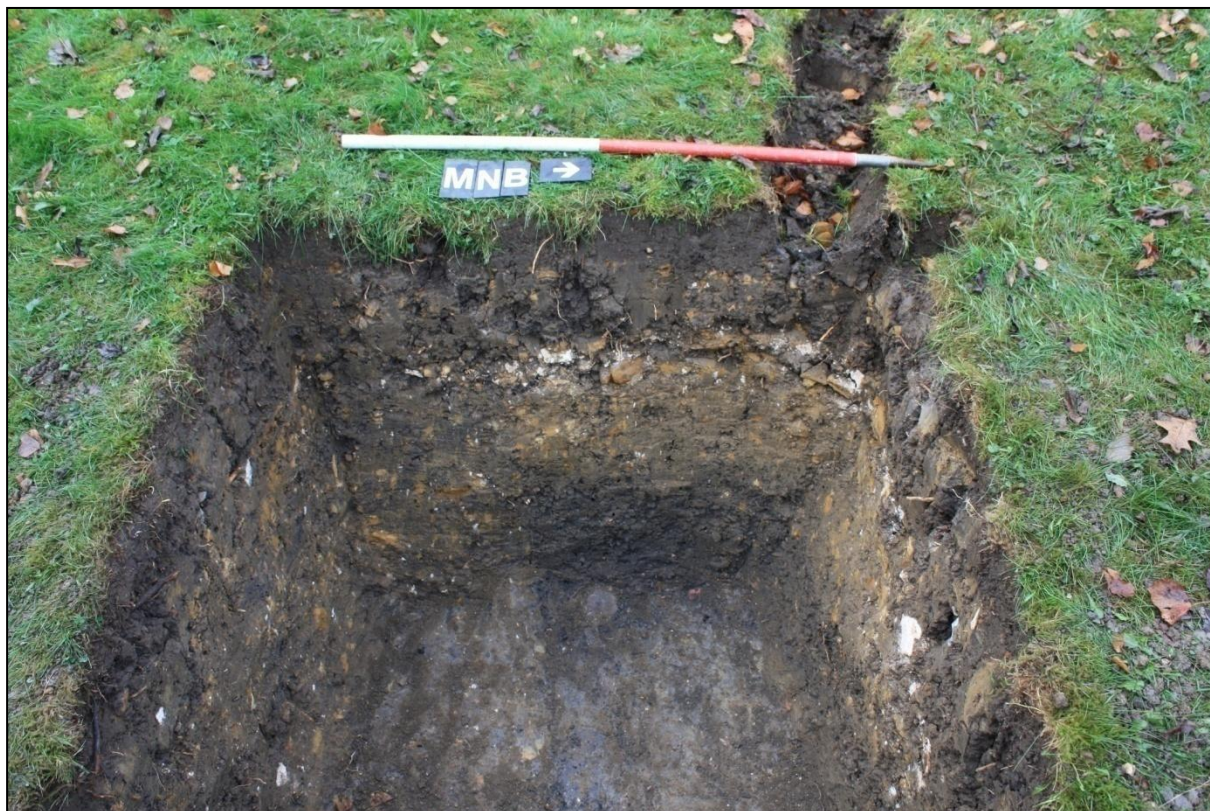
6.11.2 On the Northern side of Area 10 a grave cut [1006] was observed. The excavation of Area 10 did not go deep enough to uncover any human remains. No above ground grave marker was present.

- 7.4 In Area 10 the cut of a grave was observed [1006]. Excavation in this area was not sufficiently deep to uncover any coffin or human remains, or the coffin in which they were placed. The cut of the grave appeared deeper than 1m, which suggests that it belonged to the post-medieval or early modern period.

Plate 13: Area 10 (soakaway) with a grave cut to the left. Looking West.

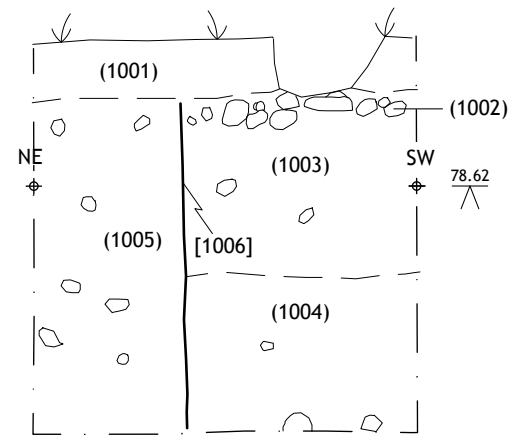
Dr#12
North West Facing Section of Area 10

6.11.1 Area 10 represents the excavation of a soakaway pit measuring approximately 1m x 1m x 1m, which was hand excavated to connect with Area 09 (drain run). This revealed a relatively simple stratigraphic sequence of dark grey clayey loam topsoil (1001) to a depth of 0.15m, which sealed a thin banded deposit of ironstone fragments (1002). This overlay a deposit of yellowish brown clay (1003) to a depth of 0.47m. Beneath this, a deposit of grey brown loam containing several modern brick fragments was observed (1004) to a depth of 0.4m, which sealed (1005), a grey brownish loam to a depth of 0.08m. This comprised the infill of grave cut [1006], which was not excavated.
