**HISTORIC BUILDING
RECORDING AND
ARCHAEOLOGICAL
WATCHING BRIEF AT NO.
31A HITCHIN STREET AND
THE MALTINGS, PARK
STREET, BALDOCK,
HERTFORDSHIRE**

SITE CODE: HMMB11

PCA REPORT NO. R11142

**DECEMBER 2011, REVISED
MARCH 2012**

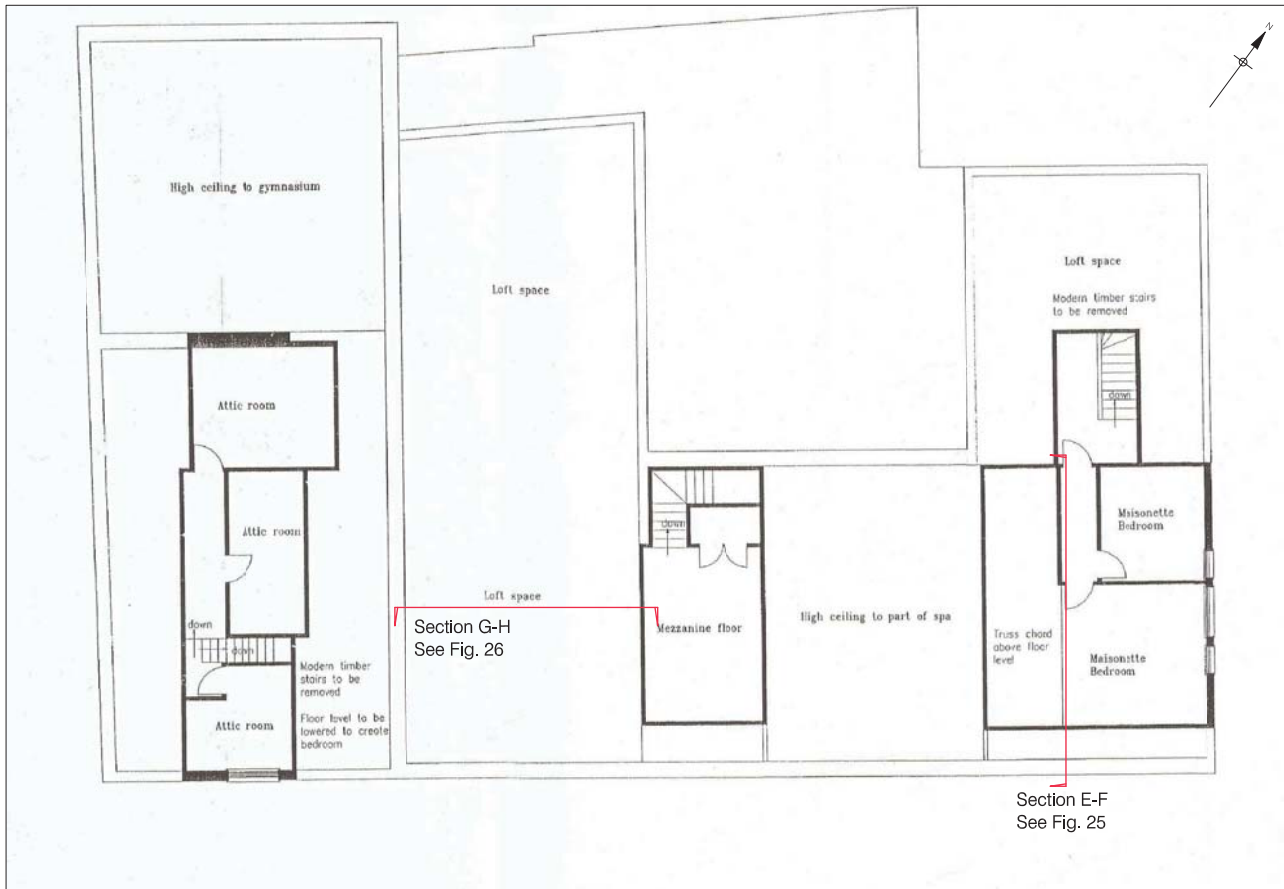
Figure 16
Second floor plan of Maltings
(Buildings 5, 6 and 7)
Musgrove Maltings, Baldock
Not to scale at A4

- 6.6.19 The east-west block of Building 5 had a second floor, but the central section had been removed as shown by the empty secondary joist holes in principal floor joists (see 'High ceiling to part of spa' label on **Figure 16; Plate 31**). This was probably removed at the same time that the square of first floor was removed and the timber steps down to the ground floor inserted, as the two sections of missing floor were directly above each other and created a light well to the ground floor. Removing this large section of second floor meant that the two remaining sections of the second floor at the east and west end were physically unconnected. The area at the east end was enclosed and became the bedrooms for the accommodation of the first floor of the east wing accessed from an inserted staircase. As a result of this new access a purlin and the wall plate of the roof in the east-west block were severed causing the remaining timbers to sag considerably (**Plate 33**).

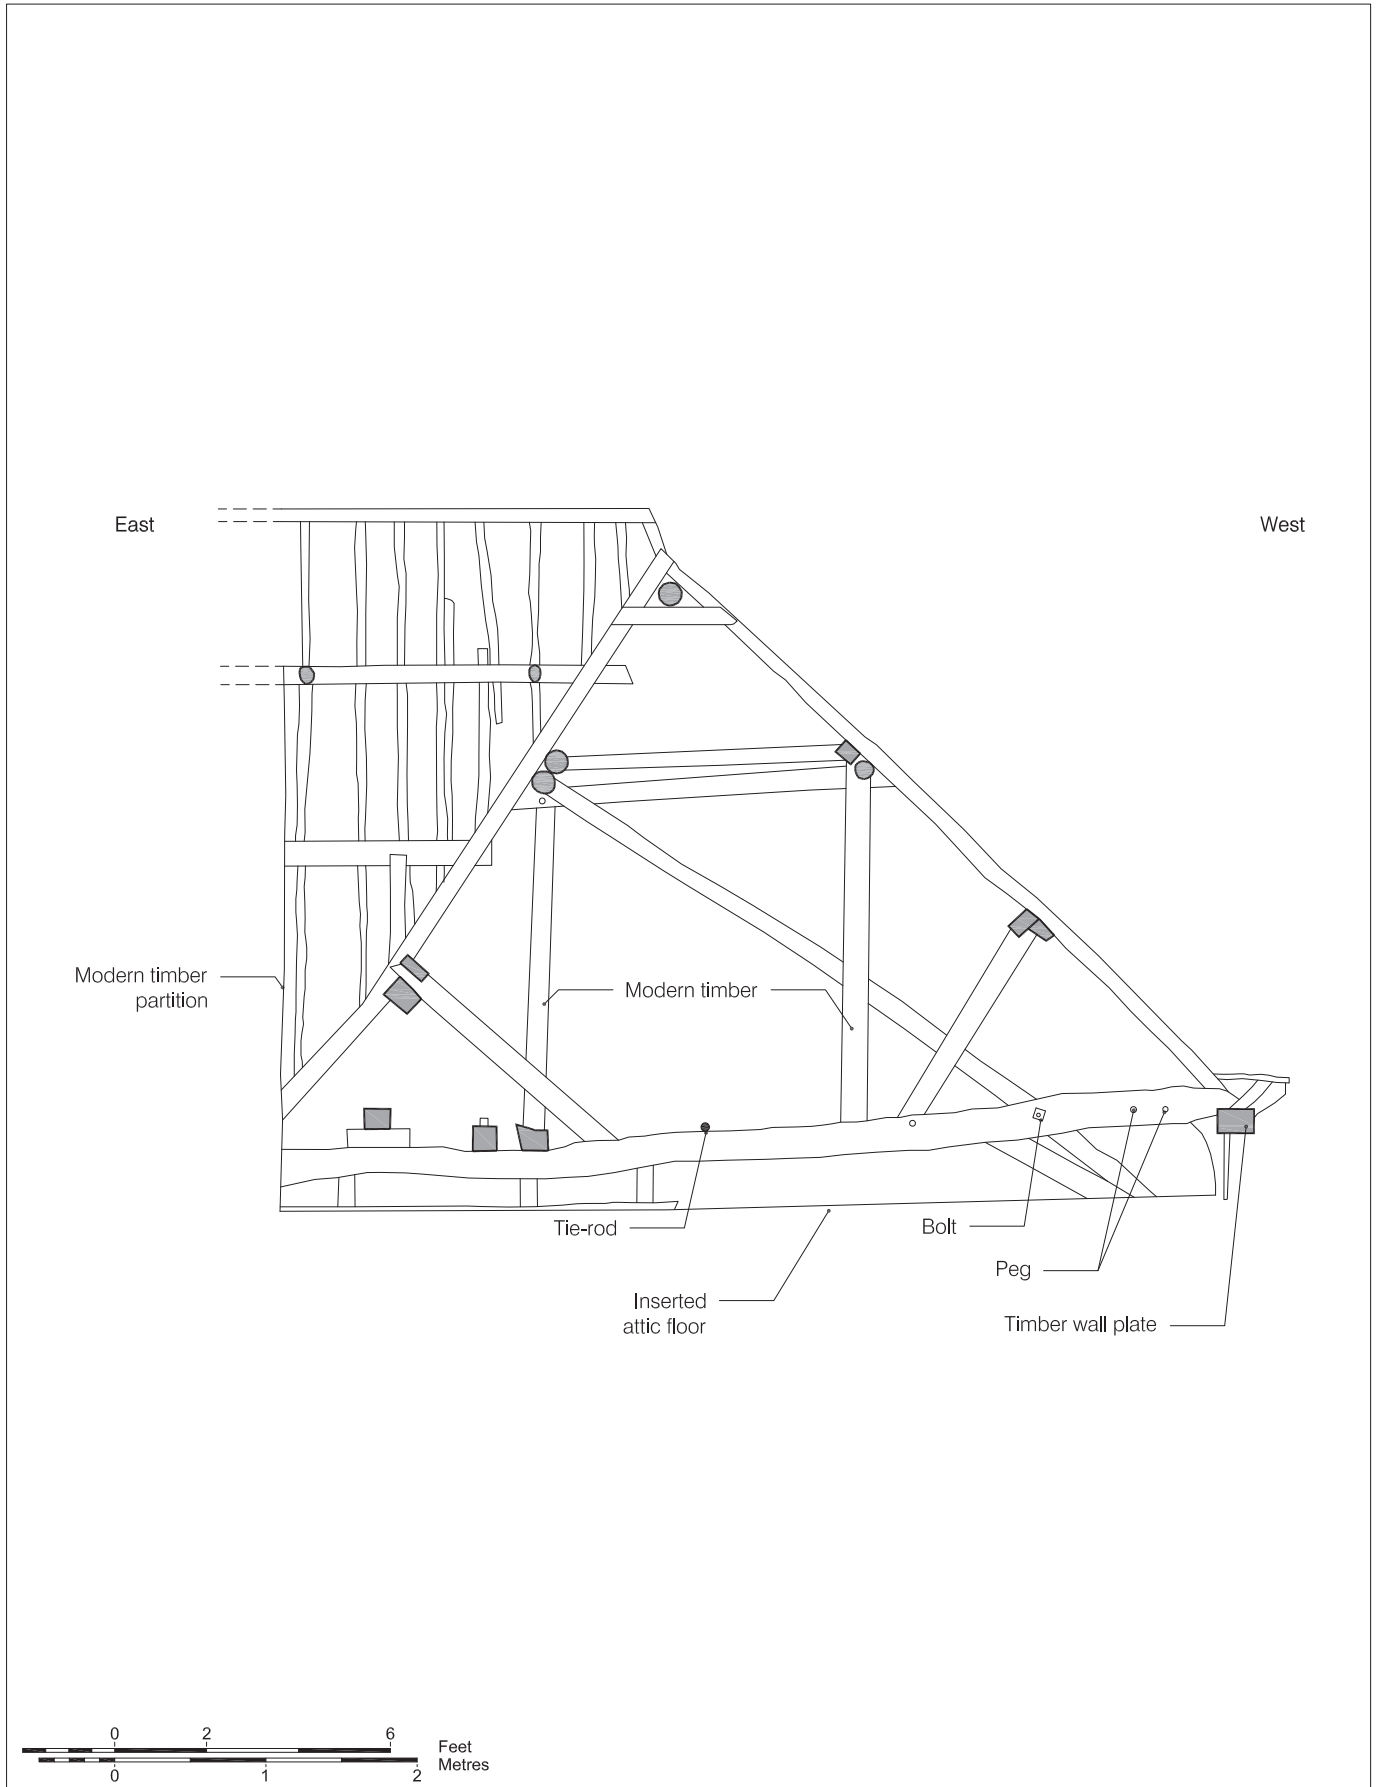
Figure 26
 Section G-H through roof of north-south block of Maltings (Building 5)
 Looking south
 Musgrove Maltings, Baldock
 1:50 at A4

- 6.6.22 The roof structure of the north-south block was similar to that of the east-west block with collar, tie-beam and a single rather than two diagonal braces on each side (**Figure 26; Plate 37**). Including the trusses in the north and south gable ends, the roof consisted of five trusses with the roof of the east-west block abutting the east side of the north-south block. Many new structural timbers had been inserted due to either decay or instability, in at least two episodes of repair. Many of the rafter ends along the west side of the roof had been replaced. In addition, the weight of the adjoining roof of the east-west block seems to have caused this side of the roof to drop, requiring additional supports to the purlins and collar beams on the east side. A metal tie rod also ran the length of the roof space to resist any longitudinal spread. For the most part, the roof of Building 5 was covered with ceramic peg tiles hung on timbers battens. However, the east slope of the roof of the north-south block and the west end of the north slope of the roof of the east-west block were both covered by corrugated asbestos sheets nailed into position with an asbestos ridge flashing.

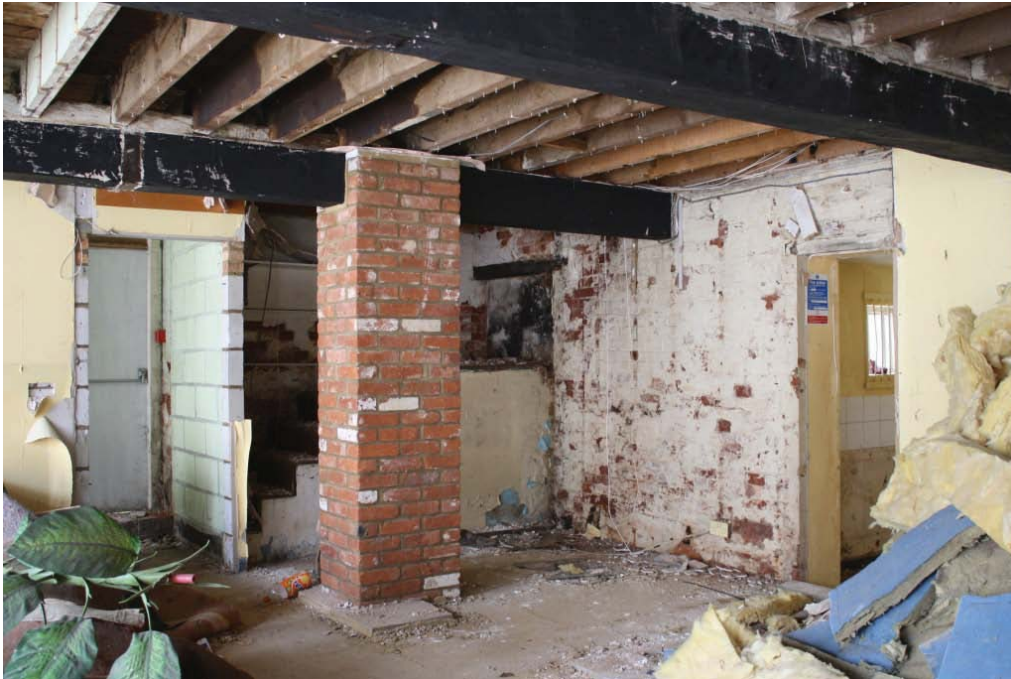
Plate 5. South-east corner of no. 31a Hitchin Street shop (Building 1), showing inserted brick pillar and blockwork partitions, with a blocked door and truncated flight of steps to the first floor in the corner of the room.

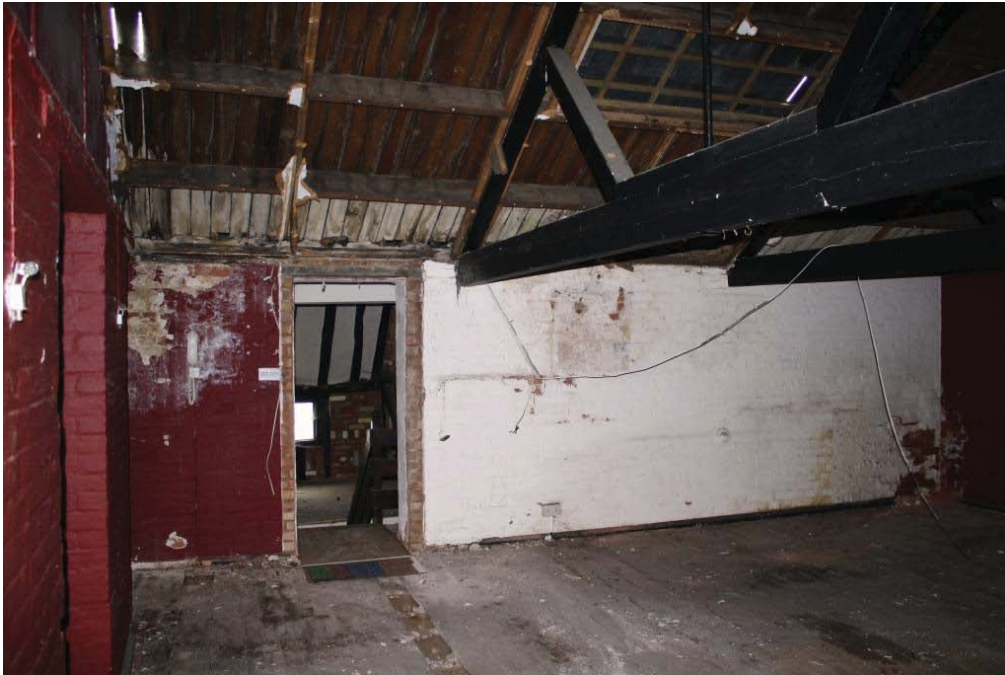
Plate 7. East wall of Building 1 extension at first floor level looking east, showing blocked skylight and doorway to stairs.

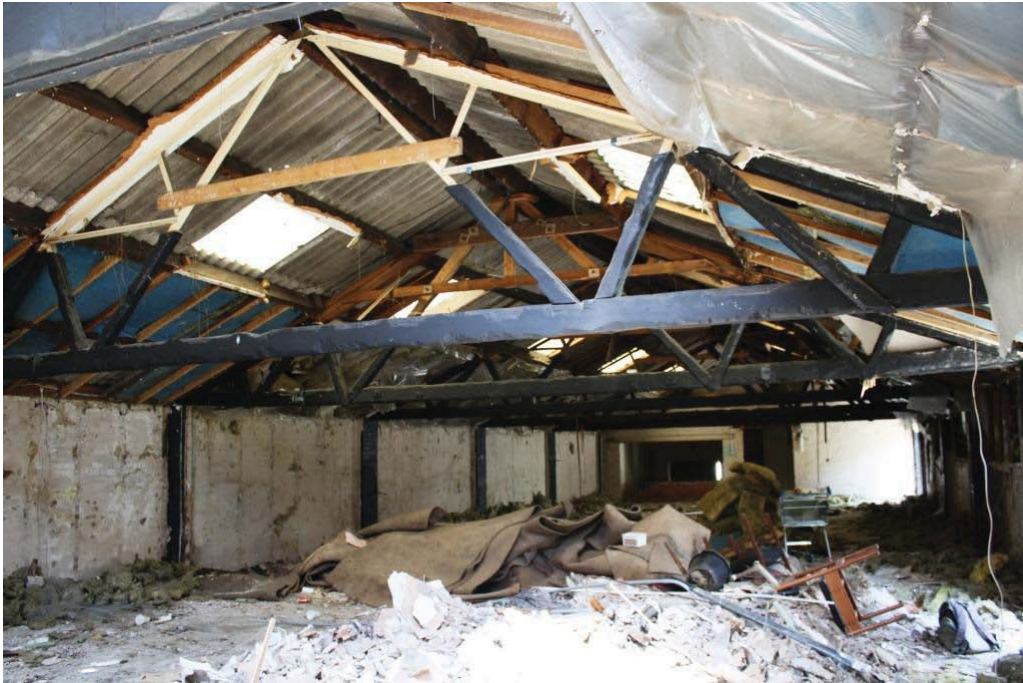
Plate 15. Interior of Link Building (Building 3), looking north-west, showing lower half of steel roof truss clad in timber below a now removed ceiling.

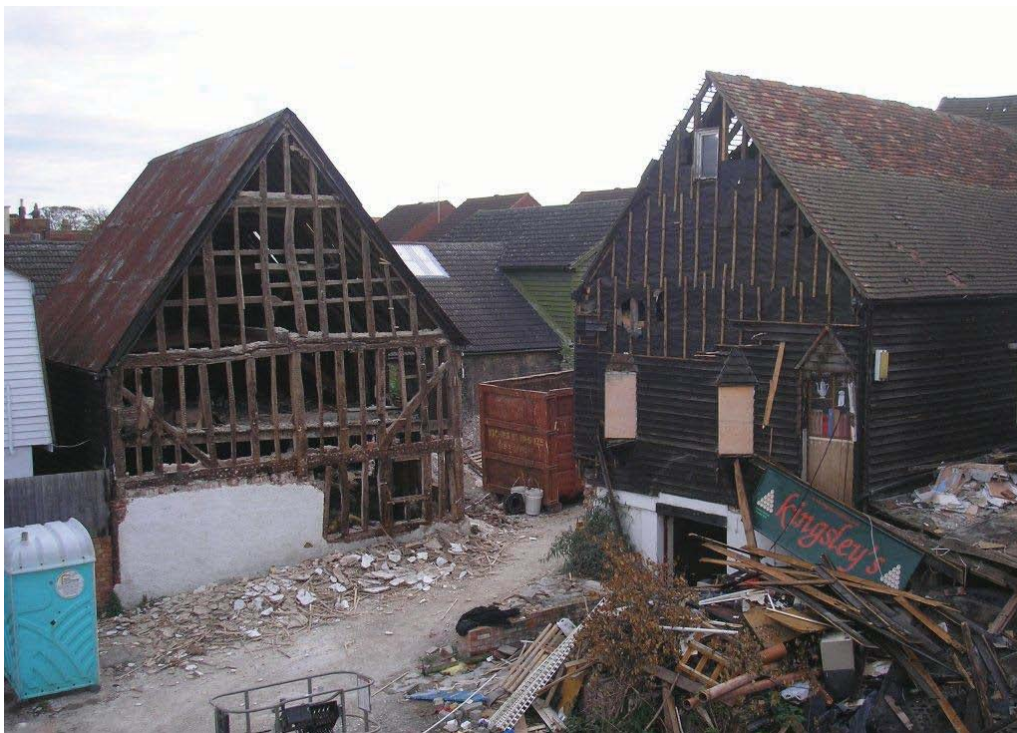
Plate 18. Exposed timber-frame of west elevation of the Cottage (Building 4), looking south-east.

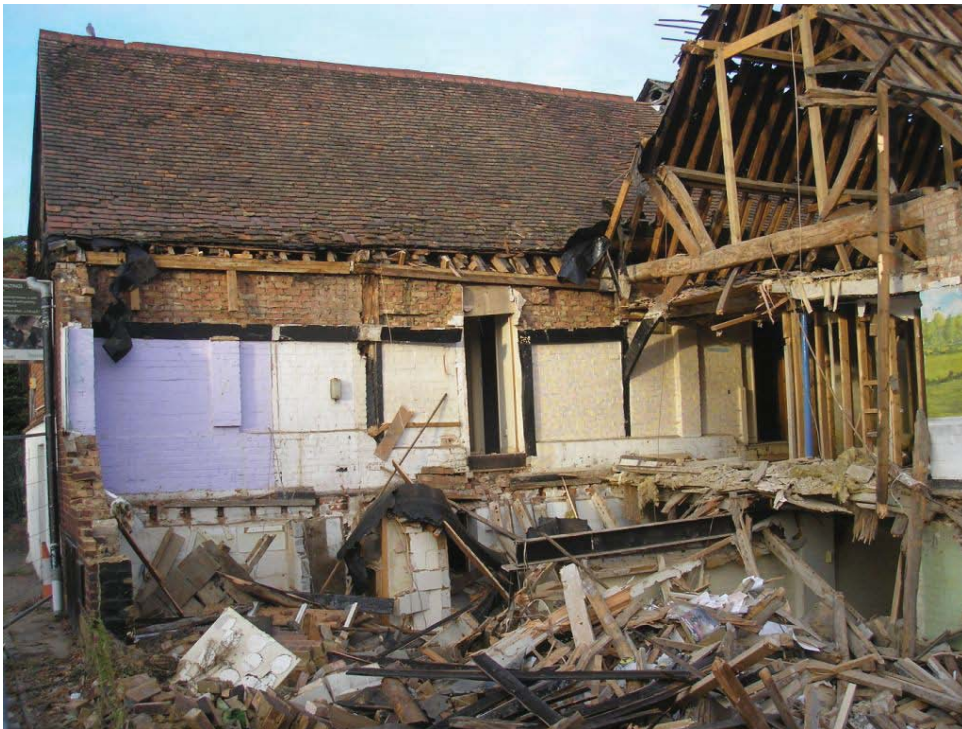
Plate 24. North-south block of Maltings Building 5, largely demolished, showing how the brick walls of the later Building 7 infilled between the timber posts of Building 5, looking north-west with Park Street to the left.

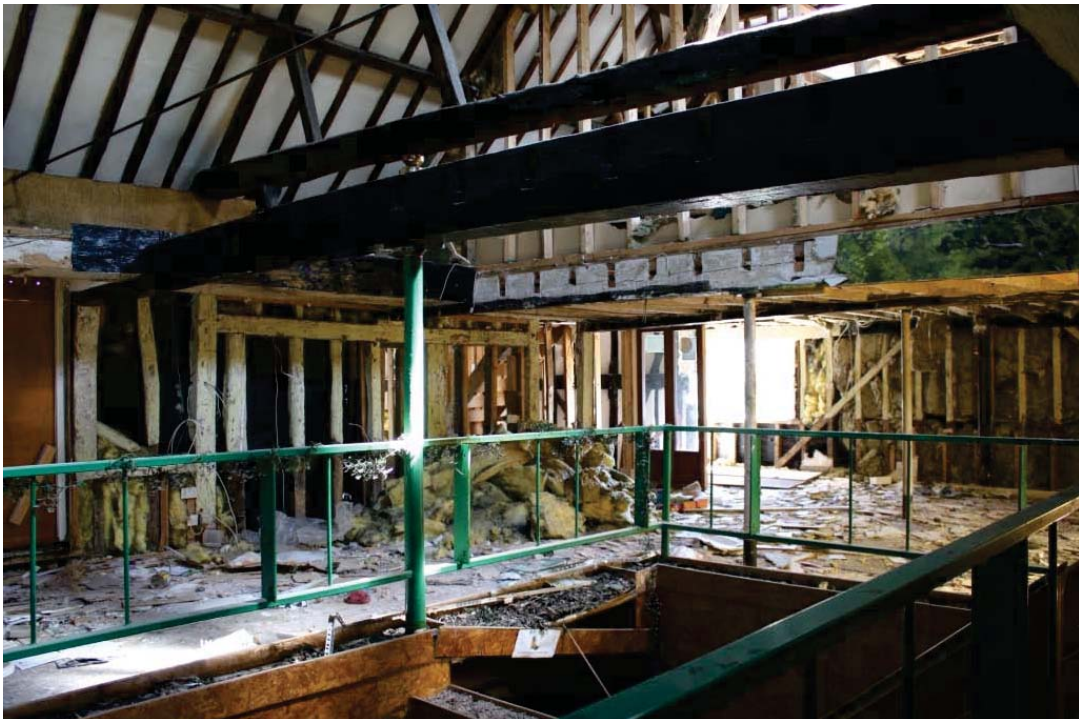
Plate 30. First floor of east-west block of Maltings Building 5, looking north-east, showing timber-framing, inserted stairs down to ground floor in foreground and missing floor joists above.

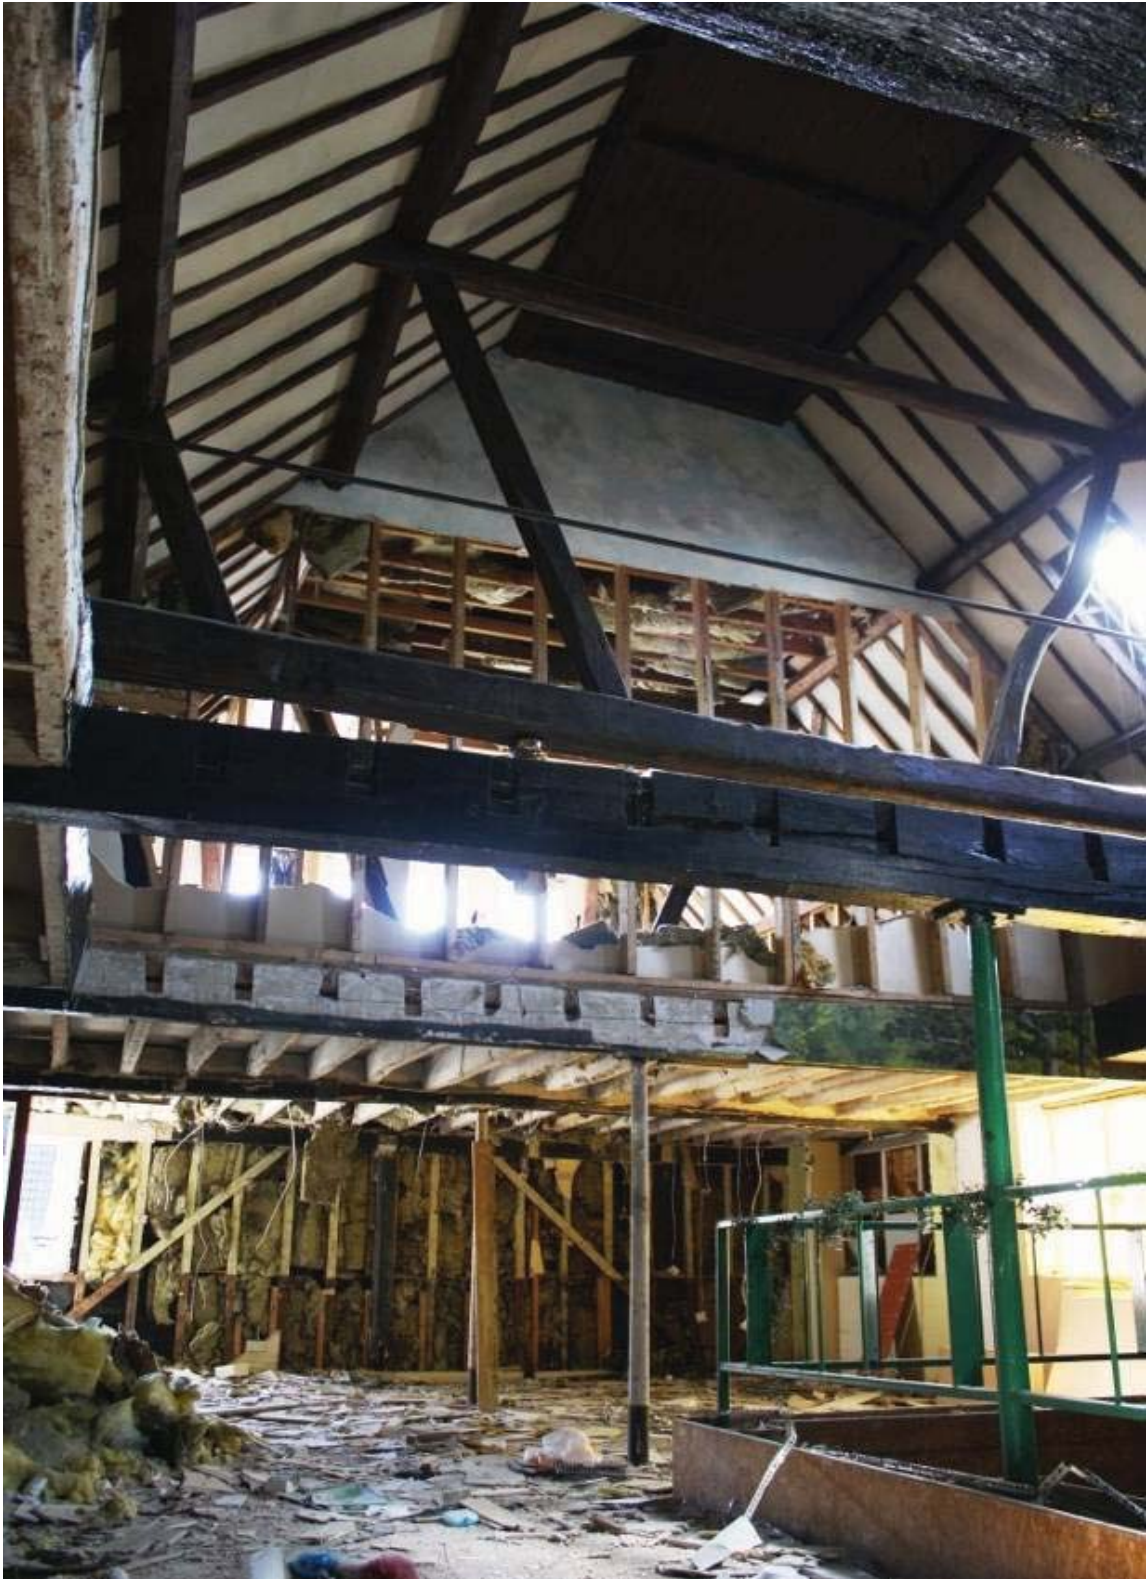
- 6.6.20 The second floor was inserted in the 19th century and the level of this floor was slightly lower than the tie-beams of the roof trusses. In several places there were short, carved timber props between the inserted floor and the tie-beam. The props replaced the downward braces when these were removed for the inserted floor (**Figure 24**). The east-west width of the bedrooms coincided with the position of the principal floor joists, supporting the secondary floor joists and, so was slightly longer than the first of the four bay roof structure. This resulted in the inclusion of a roof truss into the bedroom (**Plate 34**). The four roof trusses of the east-west block were all of the same design, as was a fifth truss forming the east gable end wall, and most had obvious carpenter's marks (**Plate 35**). Each truss was formed of a collar and tie-beam, with two diagonal parallel braces on each side, supporting the principal rafter and a purlin. The uppermost purlins were separated by a short horizontal timber. In the bedroom this latter detail was hidden by an inserted ceiling (**Figure 25**). Beyond the bedroom where the rest of the roof was visible, this short timber had been inserted between the roof trusses so that timber boards could be laid along the length of the roof to enclose the apex (**Plate 31**).

Plate 31. First and second floors of south-east corner of east-west block, Maltings Building 5, looking east.

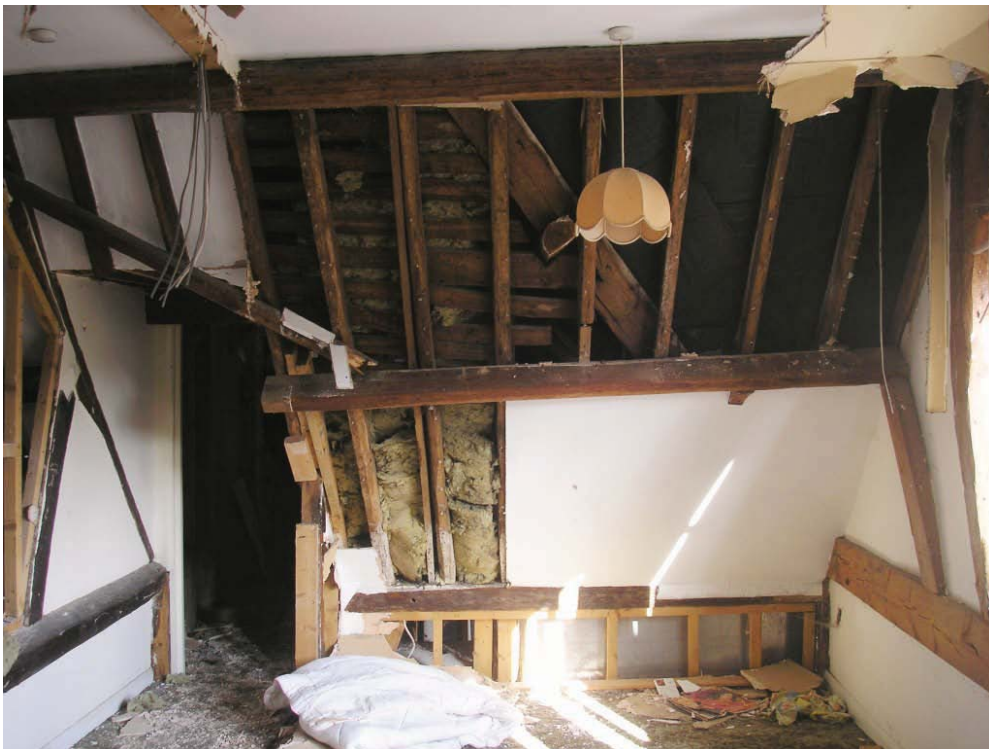
Plate 33. Inserted doorway at second floor level, between east-west block and east wing in Malting Building 5, looking north. The purlin has been severed and the roof line of the added east wing is visible through the rafters.

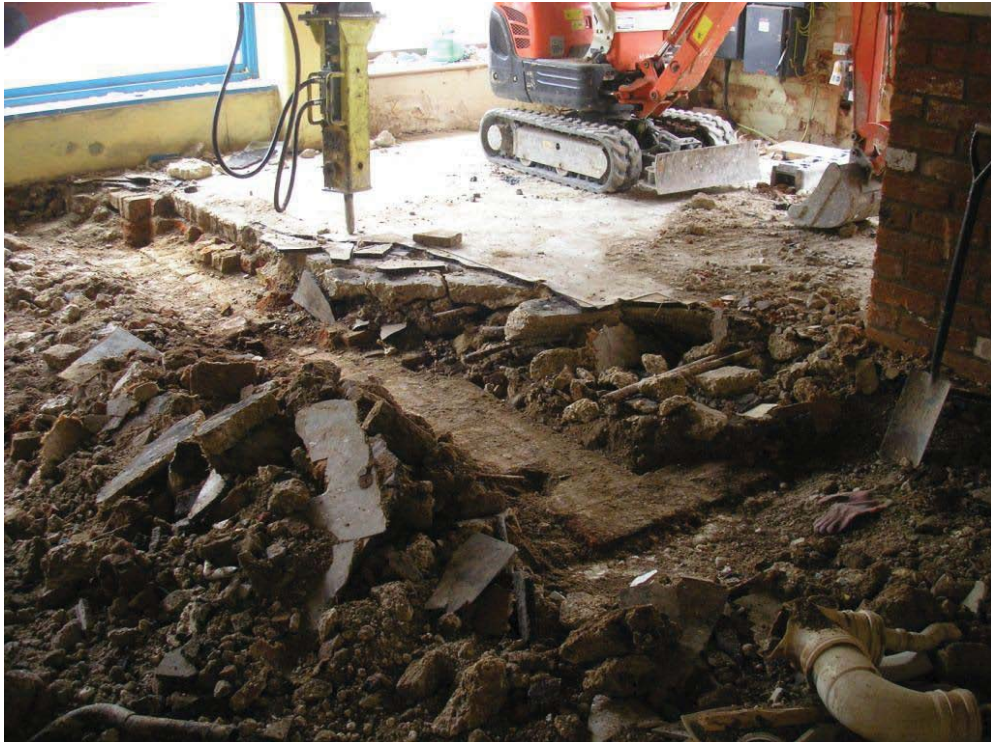
Plate 46. Linear brick feature [21] discovered beneath 20th century concrete floor, north-east corner of Building 1 (Trench 1).

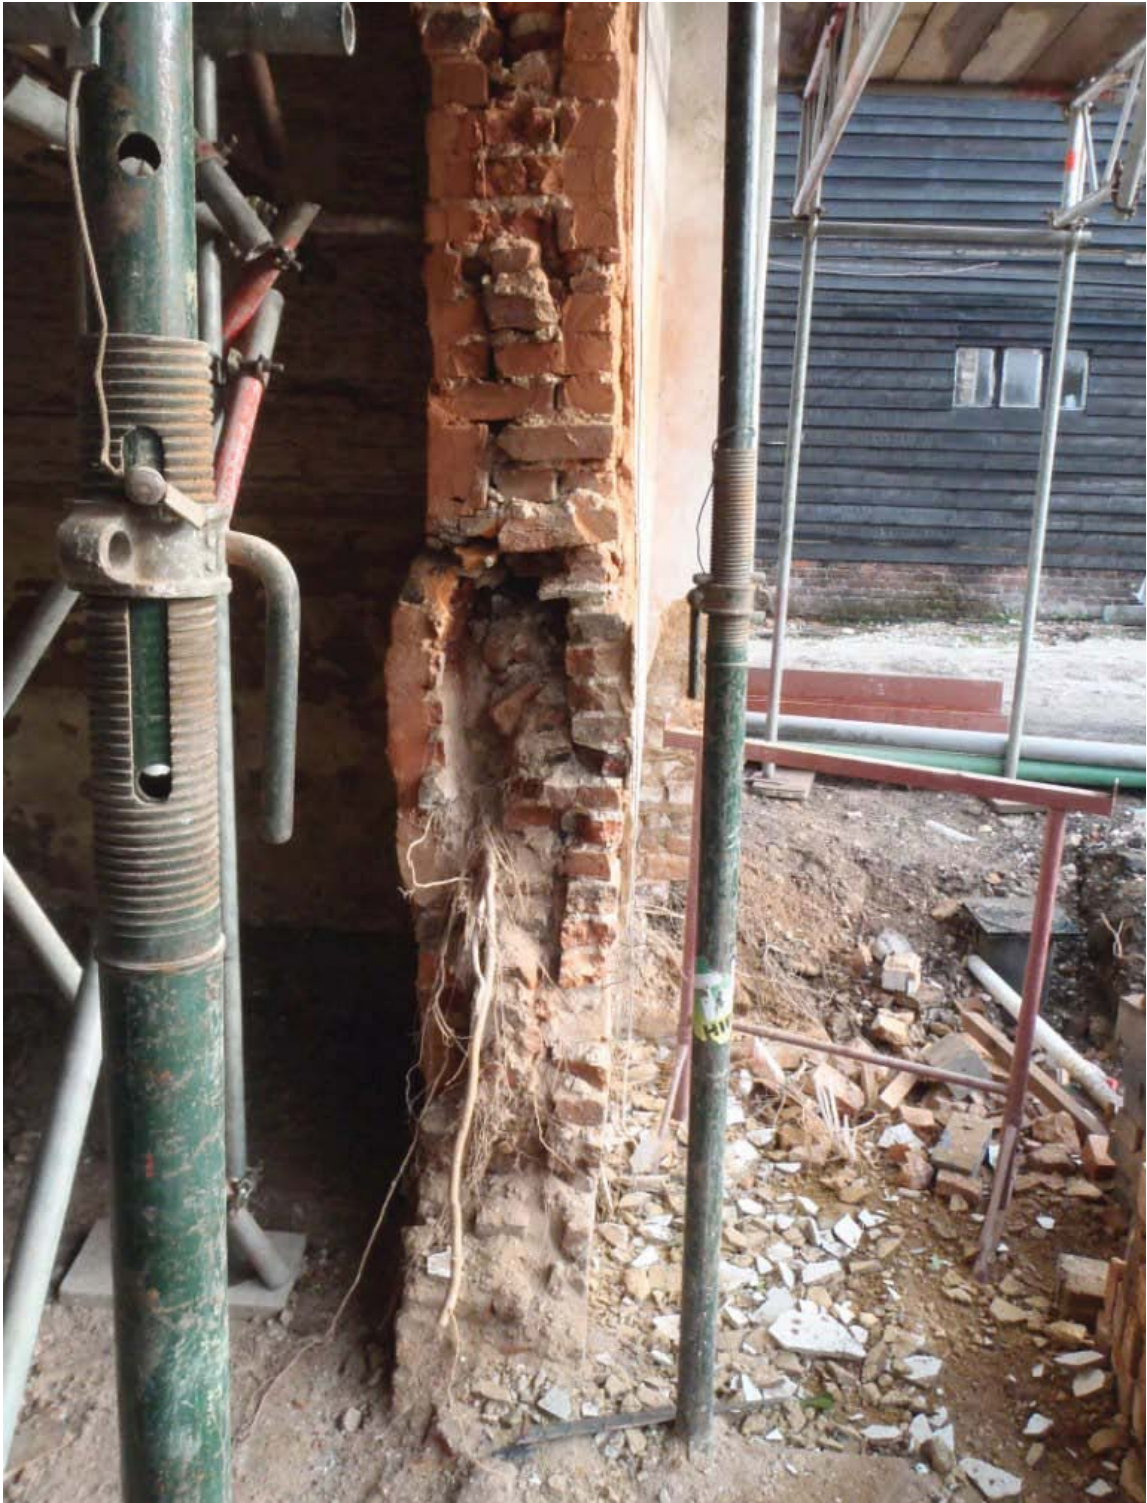
Plate 52. South gable end of Building 2 seen in cross section looking north-east, with a noticeable change in brickwork.
