**MARY ROSE NEW MUSEUM
PORTSMOUTH HISTORIC
DOCKYARD
PORTSMOUTH
HAMPSHIRE**

**ASSESSMENT OF CONSTRUCTION
PHASE ARCHAEOLOGICAL
WATCHING BRIEF**

PCA REPORT NO: 11279

SITE CODE: PMRP08

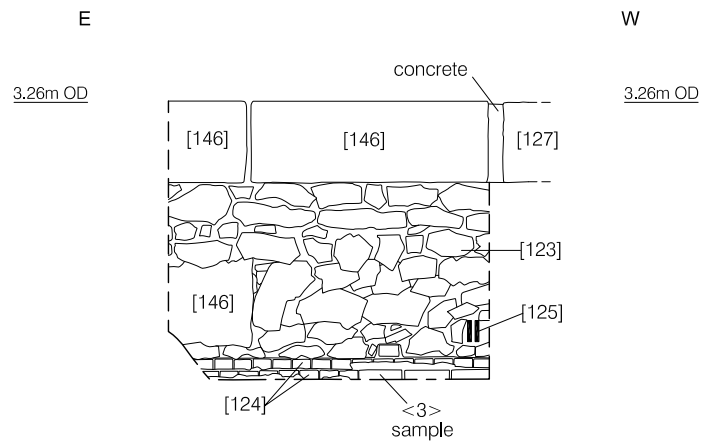
Section 86
Trench 2 West, Penstock [146] and foundations [123]
North Facing

- 7.6.29 Directly below the granite surface stones [146] and [127] was a 0.90m thick layer of limestone [123] composed of irregularly shaped crudely finished limestone blocks averaging 0.60m wide by 0.30m thick roughly laid in courses, giving a rubble-like appearance. The top of [123] was at 0.43m below ground level at 2.83mOD extending down to 1.91mOD. This feature is thought to be a general widespread foundation layer supporting the dock surface stones above (Fig. 19, 20).

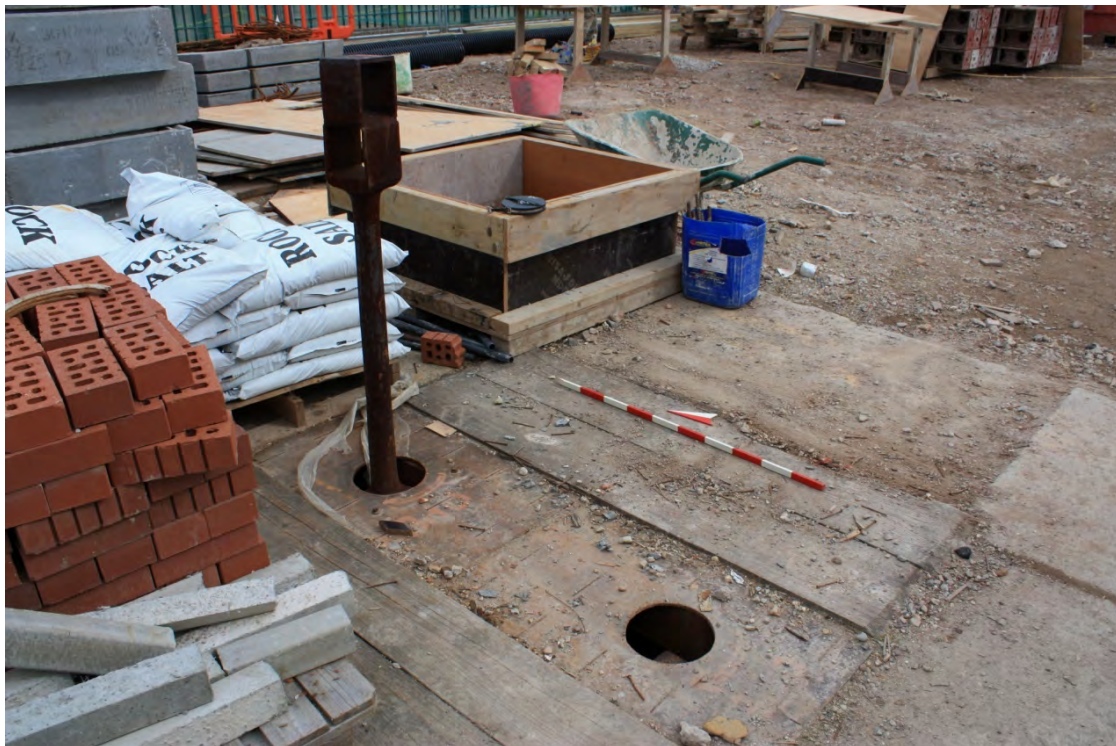
Plate 3. D308/17. Penstock valve P11 opening gear on the surface. NW corner Dry Dock No. 3. Scale 1.0m looking NE.

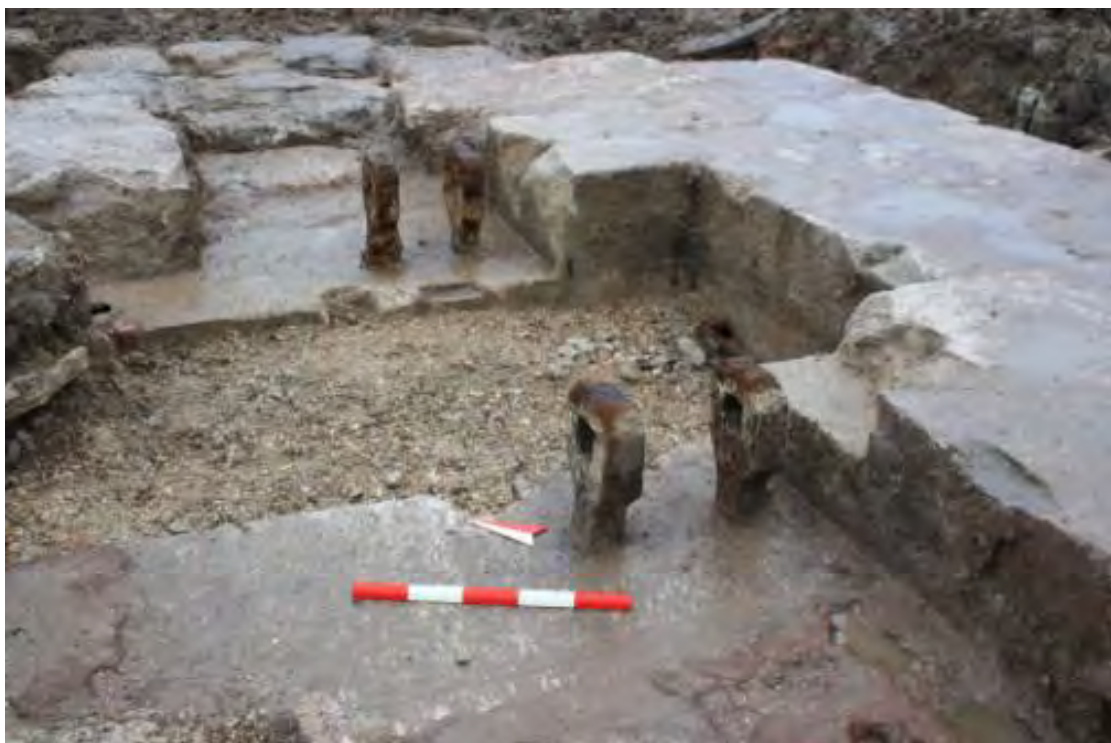
Plate 4. Penstock valve [37], North side Dry Dock No. 3 found in January 2010 (PMRP08 Phase 3). Scale 0.5m looking NE. Compare with Plates 5, 6 & 7 below.

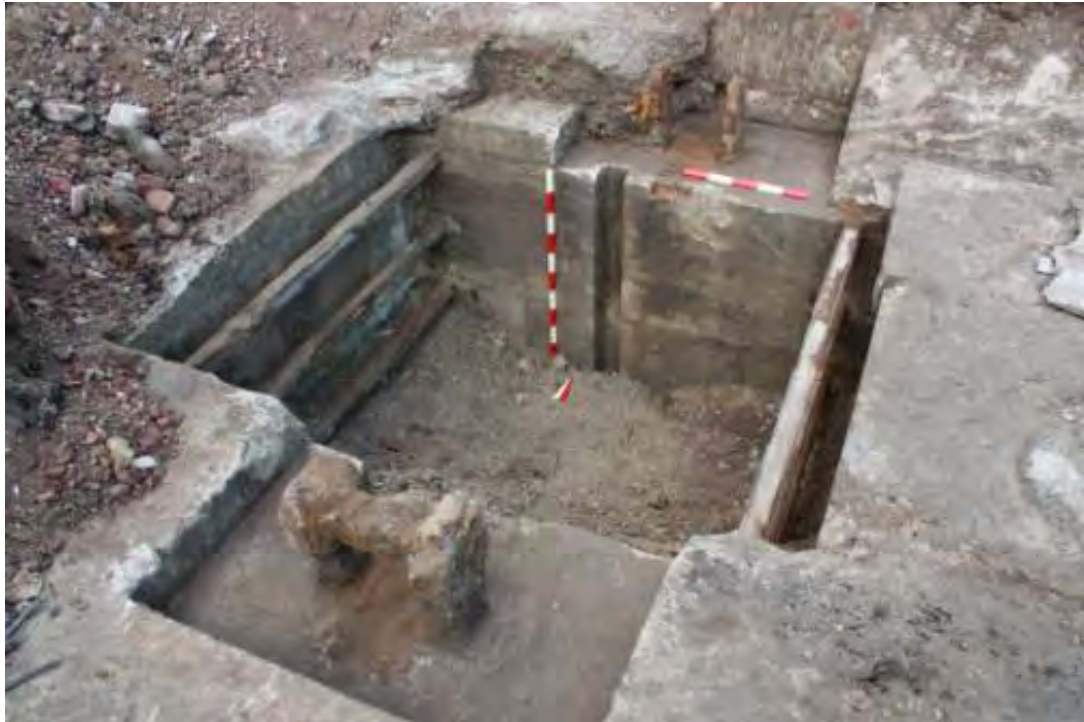
- 7.6.14 The Penstock structure [132] was encountered at 0.40m below ground level, with a highest level recorded at 2.96mOD.
- 7.6.15 The top of the Penstock valve [132] was covered by a modern concrete slab supporting a dockside crane rail that was installed in the 1920s. The shaft had been backfilled with a loose cement and gravel mix topped by a layer of concrete. It is believed that the Penstock valve served Dry Dock No. 4 from the 1770s and became redundant after the construction of Dry Dock No. 3 in 1803 (Fig. 18, Plates 5 & 8).

Plate 5. D.312/23. Penstock valve [132], North side Dry Dock No. 3, adjacent to Dry Dock No. 4. Scales 0.5m & 1.0m looking NNW.

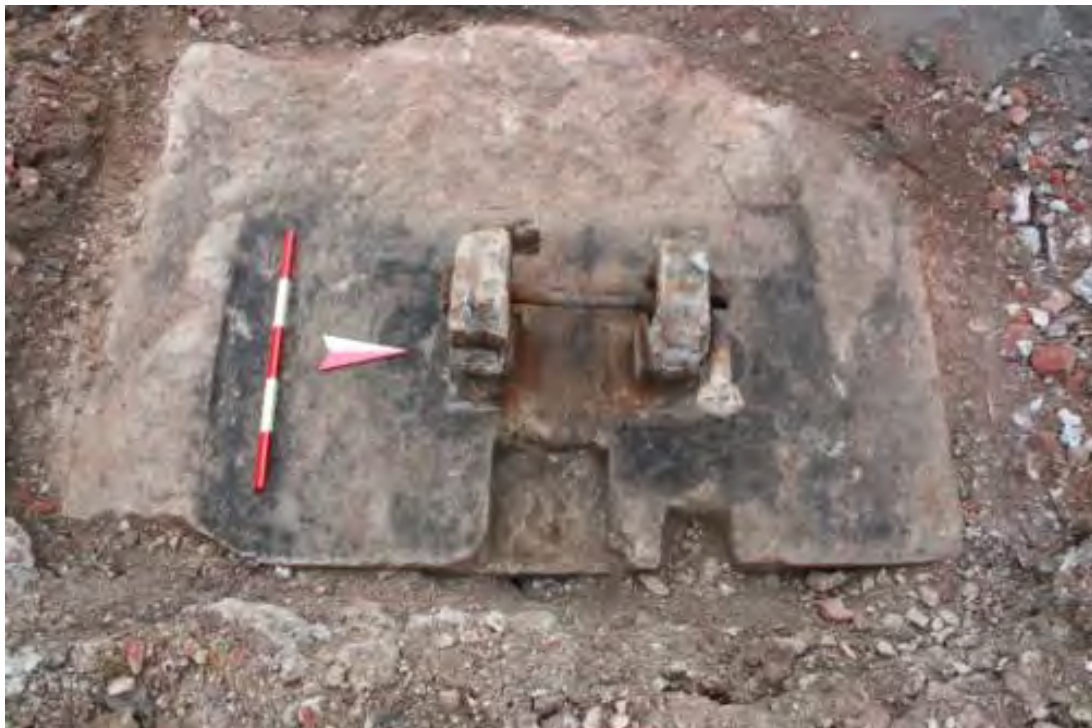
Plate 6. D.313/41. Penstock valve [137], North side Dry Dock No. 3, adjacent to Dry Dock No. 4. Scale 0.5m looking W.

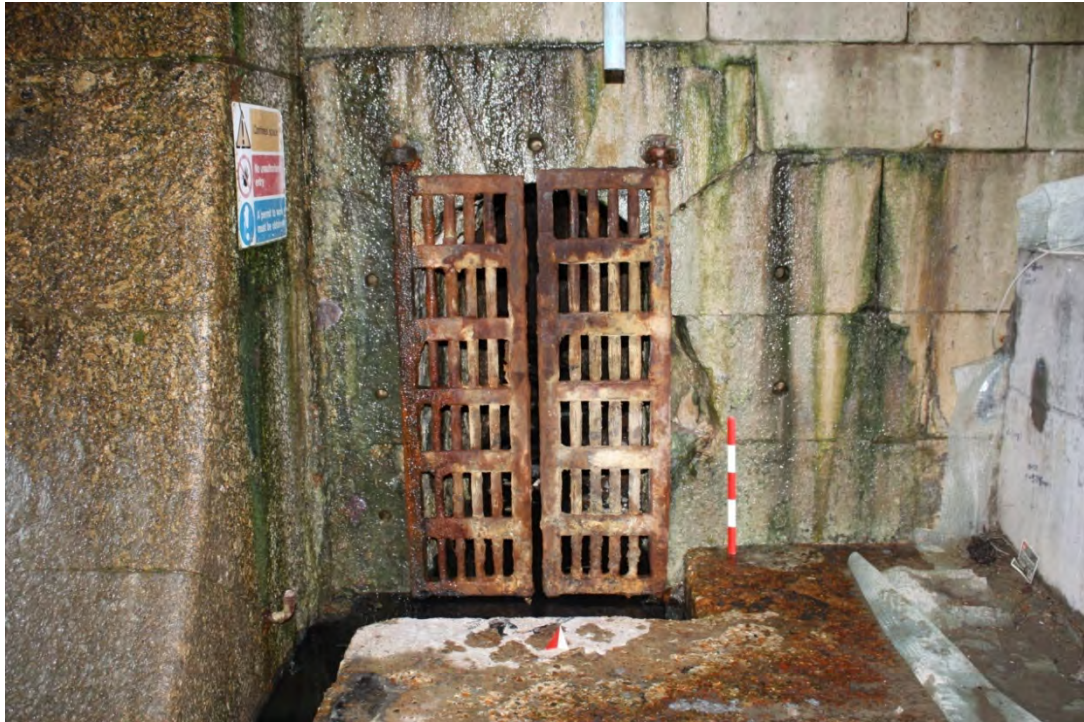
Plate 9. D305/72. Entrance to culvert [108] in the base of the NW corner of Dry Dock No. 3. Cast iron gates closed. Scale is 0.5m looking N.

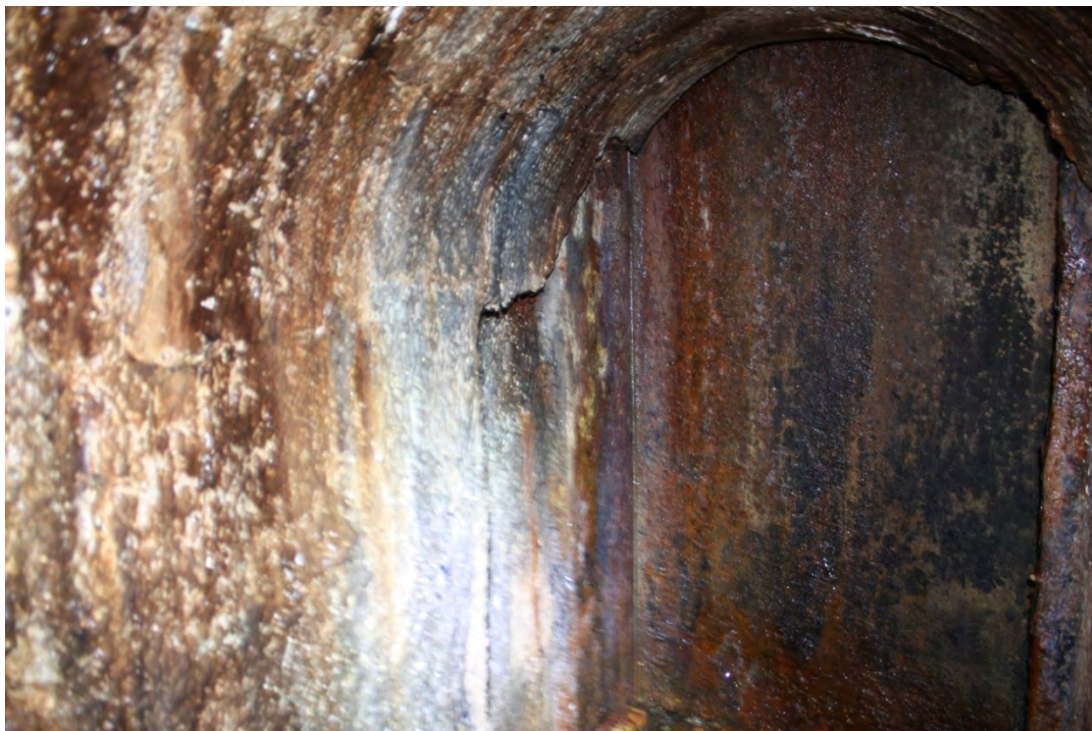
Plate 10. D305/61. 9.0m inside culvert [108]. On the right is the closed metal gate of Penstock valve P11 This isolates this section of the culvert from the rest of the system. Looking N.

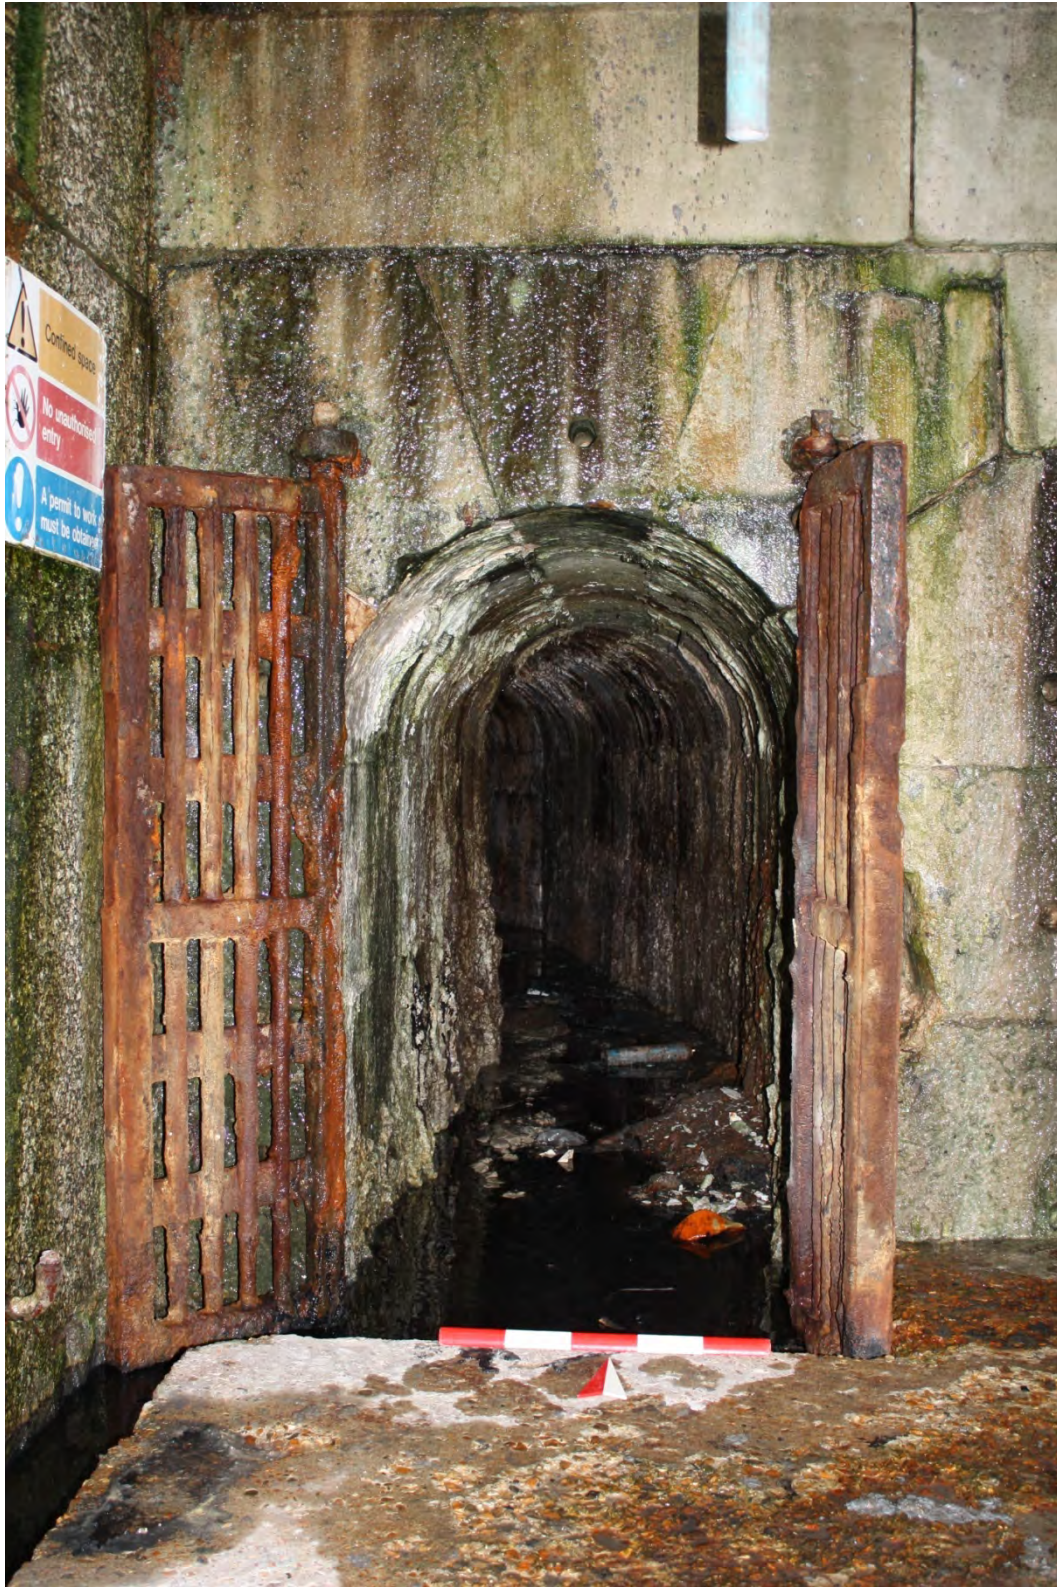
Plate 11. D305/74. Entrance to culvert [108] in the base of the NW corner of Dry Dock No. 3. Cast iron gates open. The standing water is c. 0.20m deep. Scale is 0.5m looking N.

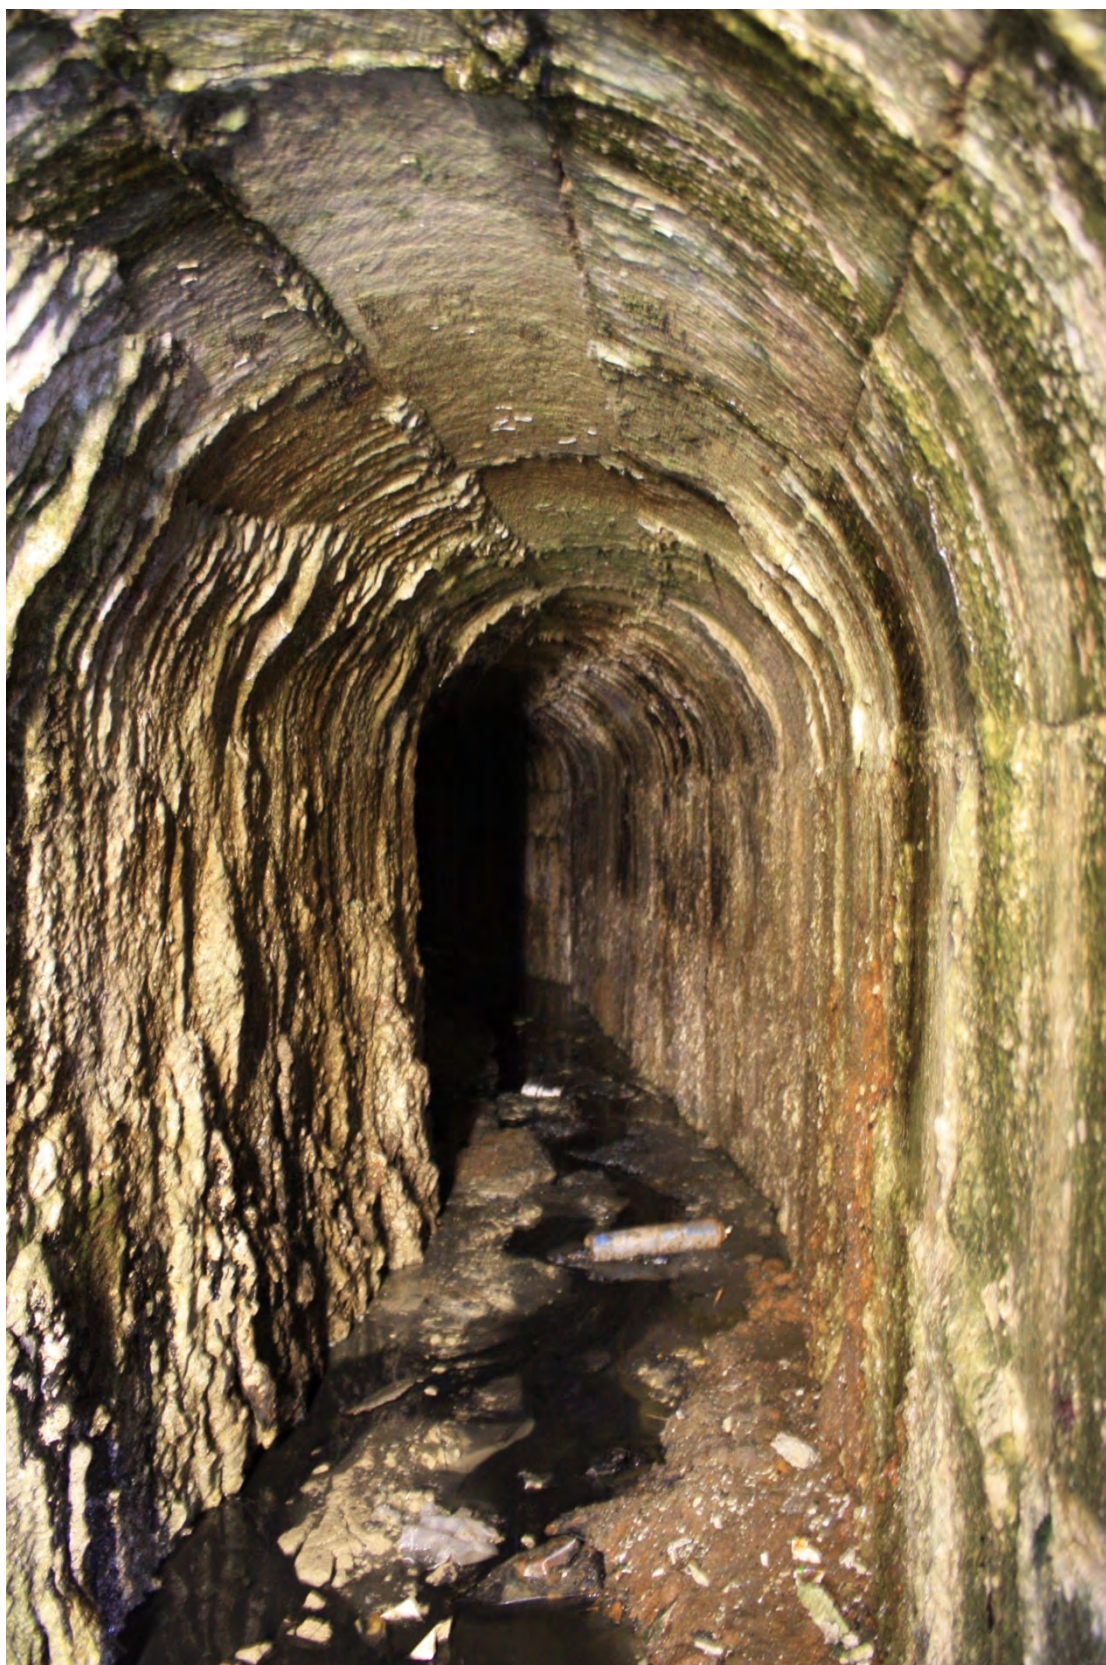
Plate 12. D305/85. Internal view of culvert [108], c. first 5m in. All of the culvert is built from Portland stone blocks as illustrated here. Looking N.

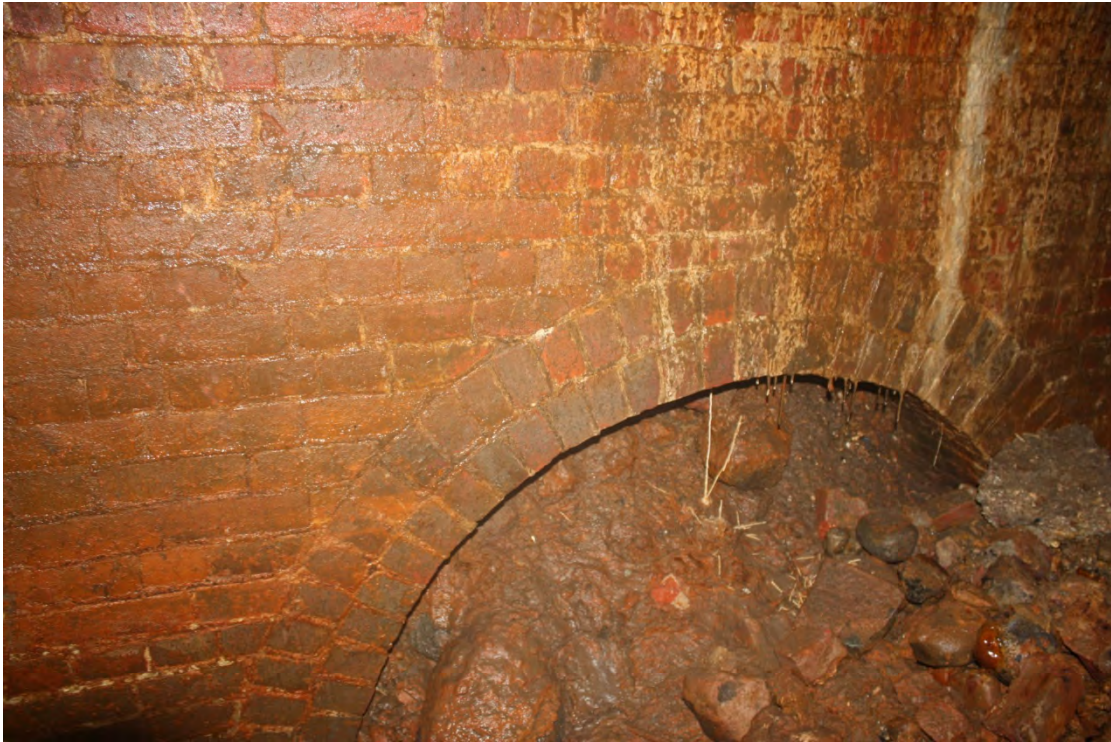
Plate 16. D316/41. [142] Sewer. Backfilled culvert in main southern wall. Looking S.

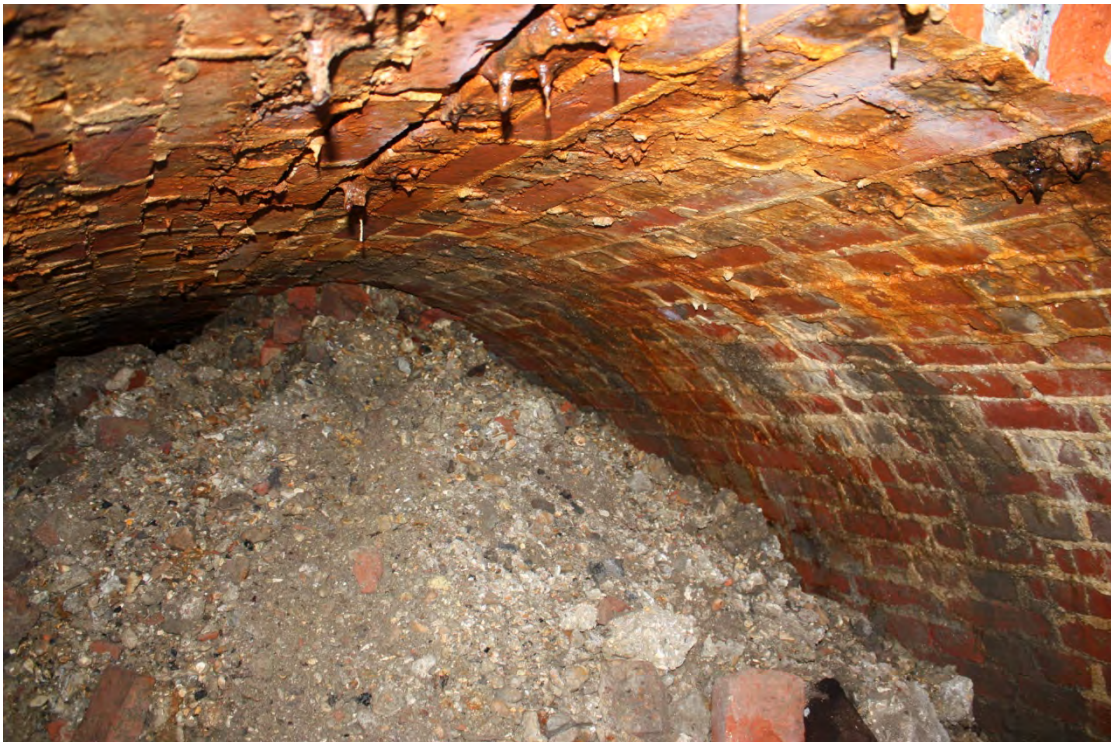
Plate 17. D 316/61. [142] Backfilled sewer at its western end. Note: material entered through hole in roof. Looking W.

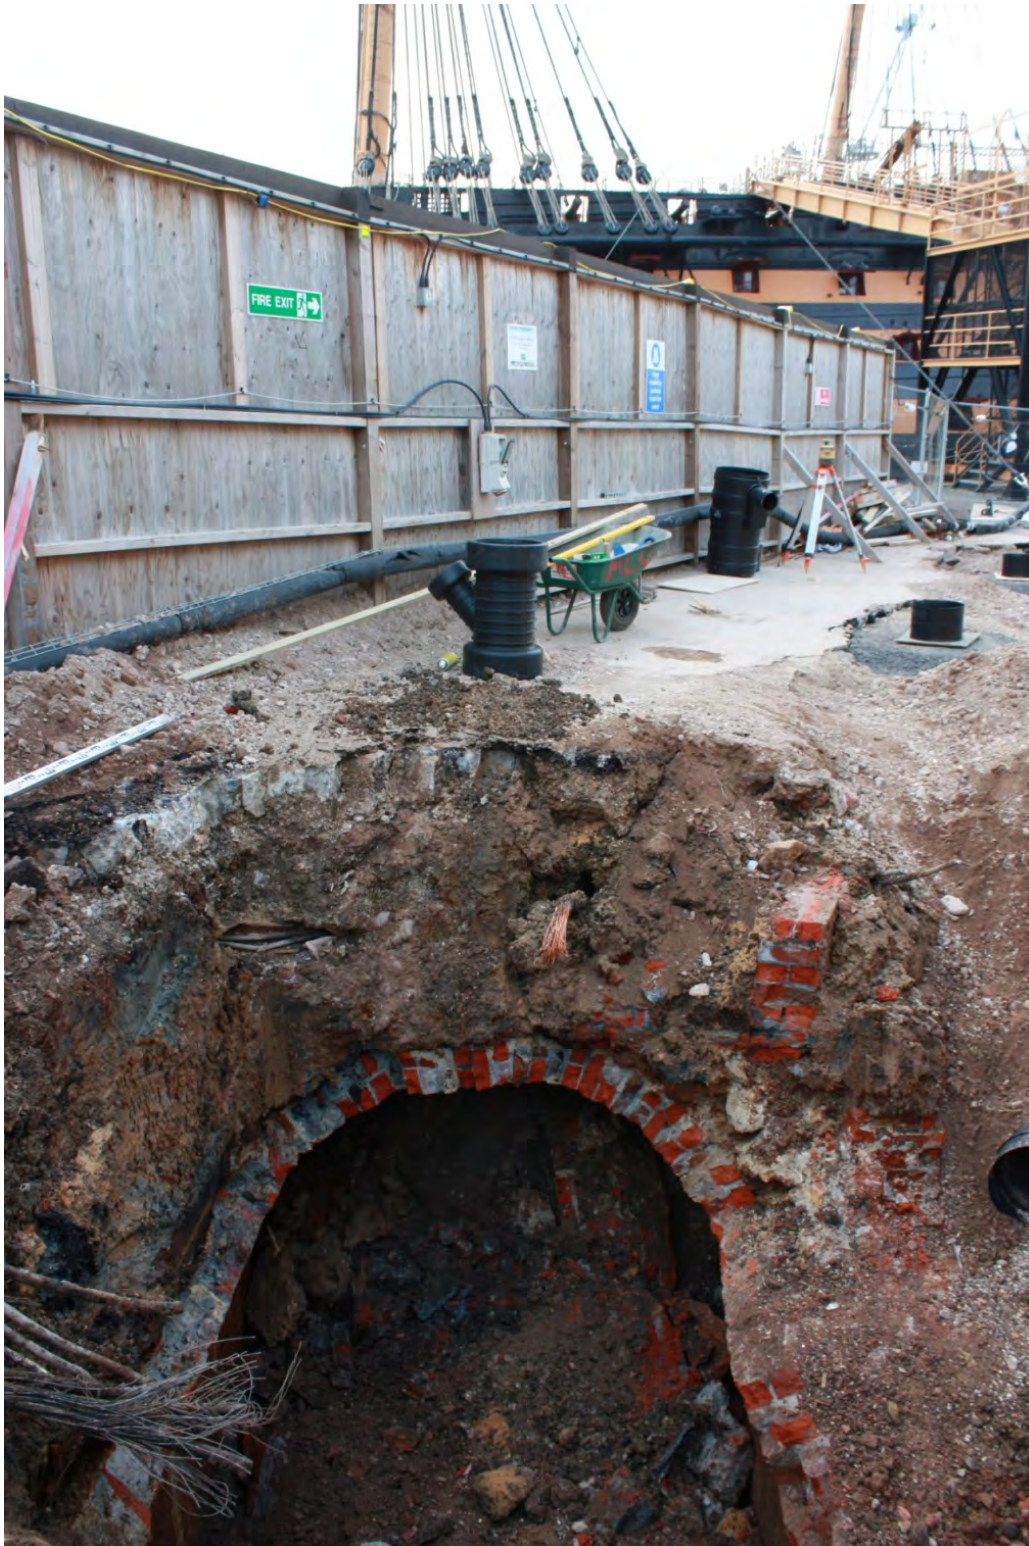
Plate 18. D 316/66. [142] Demolition shows sewer roof in section. Looking W back towards HMS Victory.

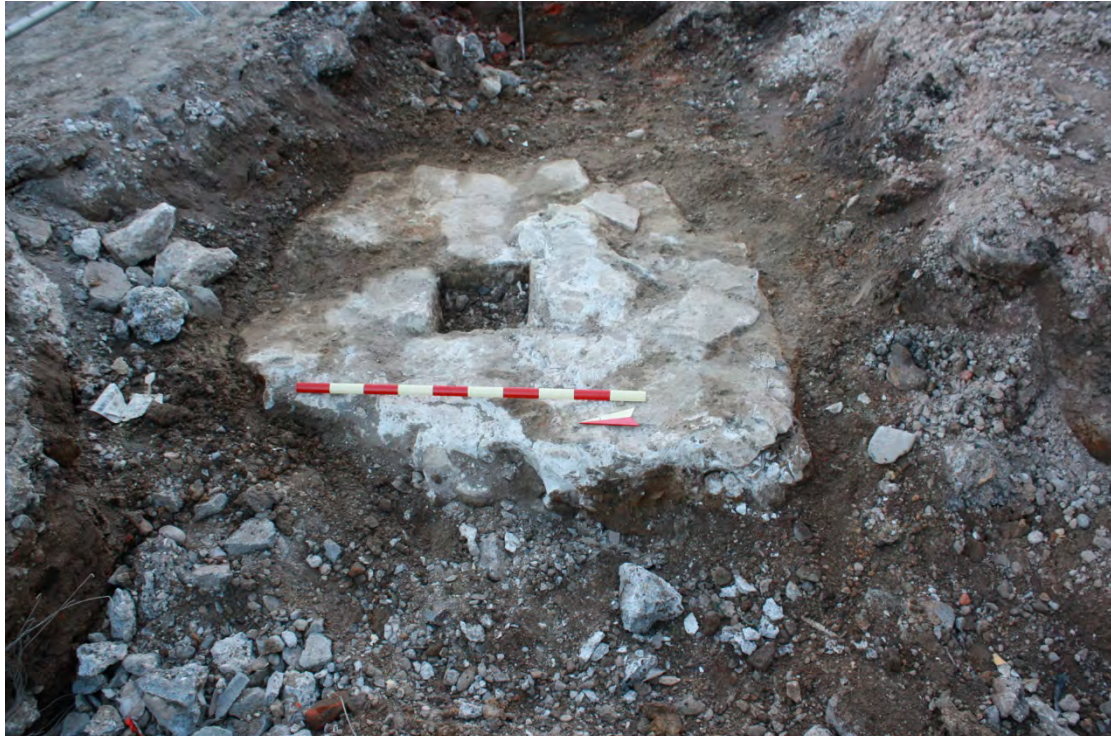
truncated away in the past; the northern edge lay beyond the trench limit of excavation. Placed centrally was a square hole formed by the stonework measuring 0.30m north-south by 0.35m east-west. [141] was encountered 0.70m below the surface at 3.98mOD. After recording the feature was removed by machine. It is believed that this structure was the remains of a stone foundation pad to support timber uprights to a large shed built over Dry Dock Nos. 3 and 4 in the early 19th century, one of a number identified on site (Fig. 24. Plate 20).

Plate 20. D316/22. Stone foundation structure [141]. Scale 1.0m looking E. Compare this with [145] below.

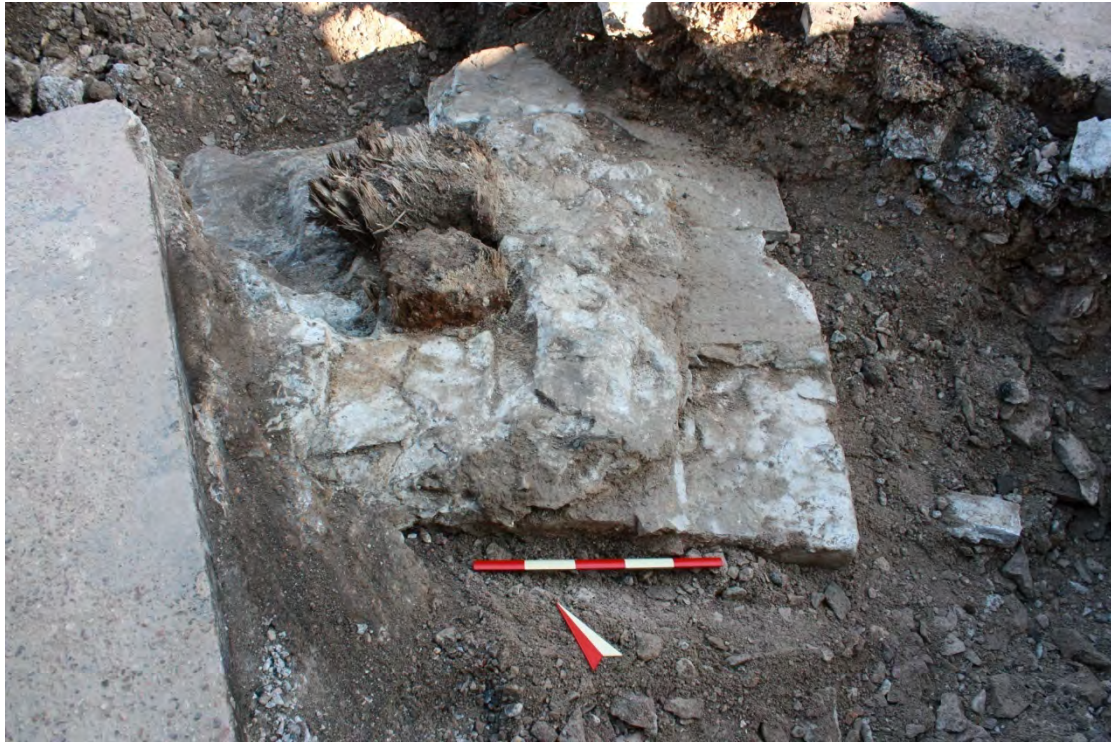
- 7.8.10 It is believed that this structure was the foundation remains of a timber shed that was built over Dry Dock No. 3 in the early 19th century (Plate 22) and removed at the end of that century. The two posts possibly formed one of the main vertical supports at the building's north-east corner. The structure itself lay no more than 0.50m from the north-east dock side. A number of similar structures have been found during this, and previous investigations, and have all been distinguished by a square hole in the centre of the feature, along with [145] these also include [103], [113], [133], [135], [141] and context [80] from the Phase 3 investigation²².

Plate 21. D317/23. Stone foundation [145] with truncated timber posts in-situ. Scale 0.5m looking NE. Believed to be the foundations of a timber framed building constructed over Dry Dock No. 3 in the 1870s. Possible that [141] (above) is a similar feature?
