**HISTORIC BUILDING
RECORDING OF FARM
BUILDINGS AT NEWHOUSE
FARM, WARESIDE, WARE,
HERTFORDSHIRE**

PCA REPORT NO. R11243

JUNE 2012

Historic Building Recording

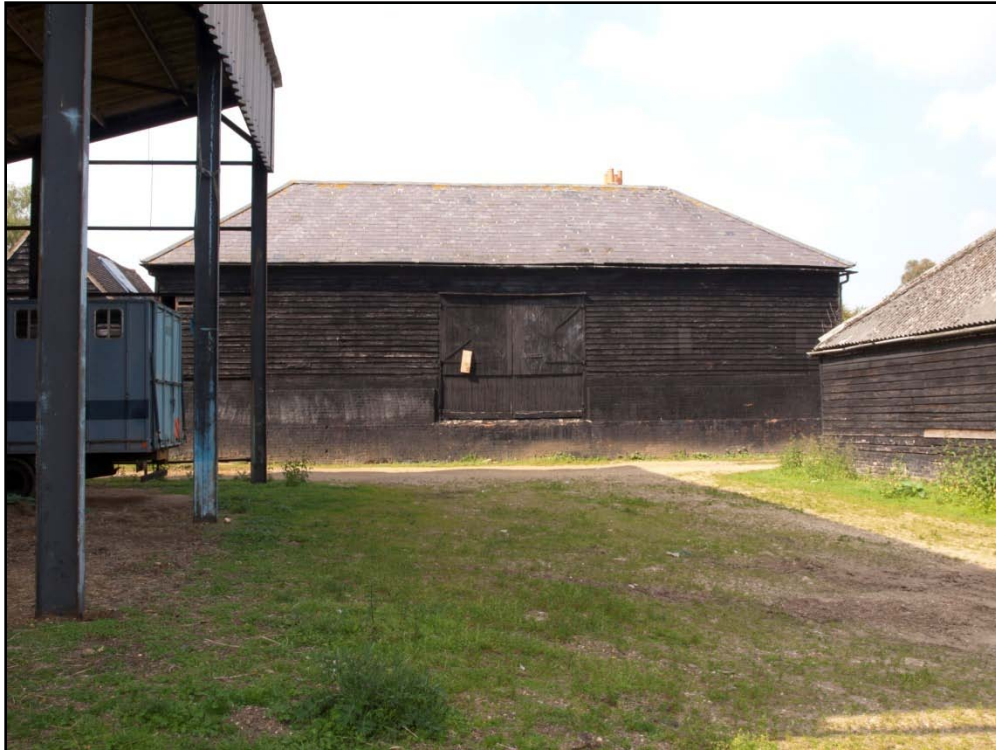
Plate 1: South elevation of Building 1 viewed from the south

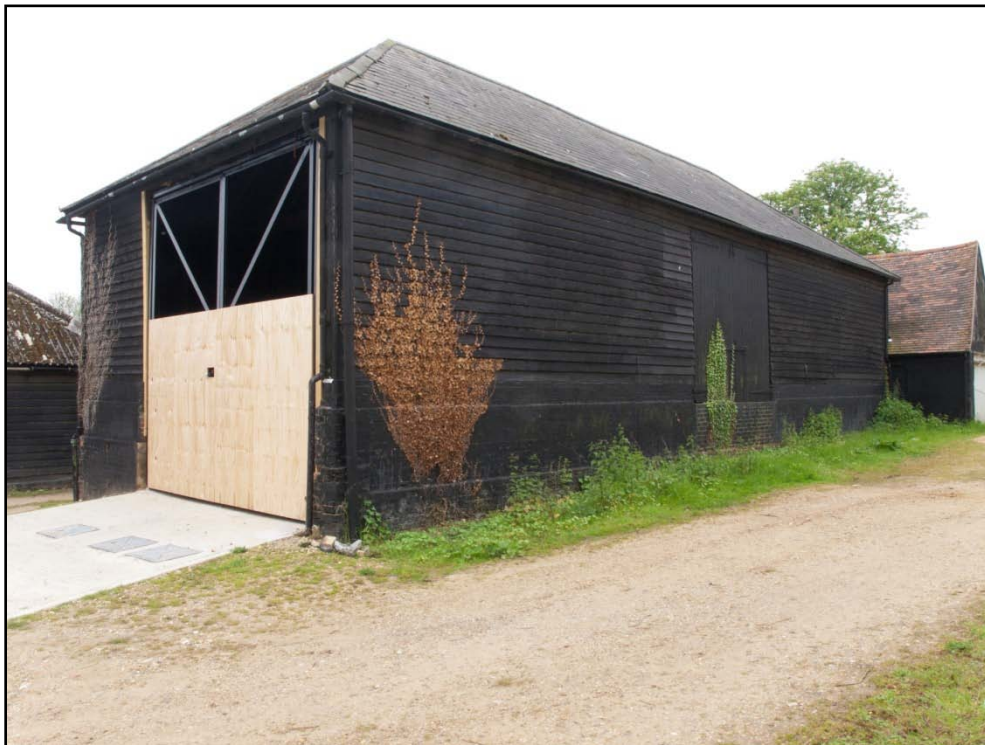
Plate 2: East (left) and north (right) elevations of Building 1 viewed from the north-east

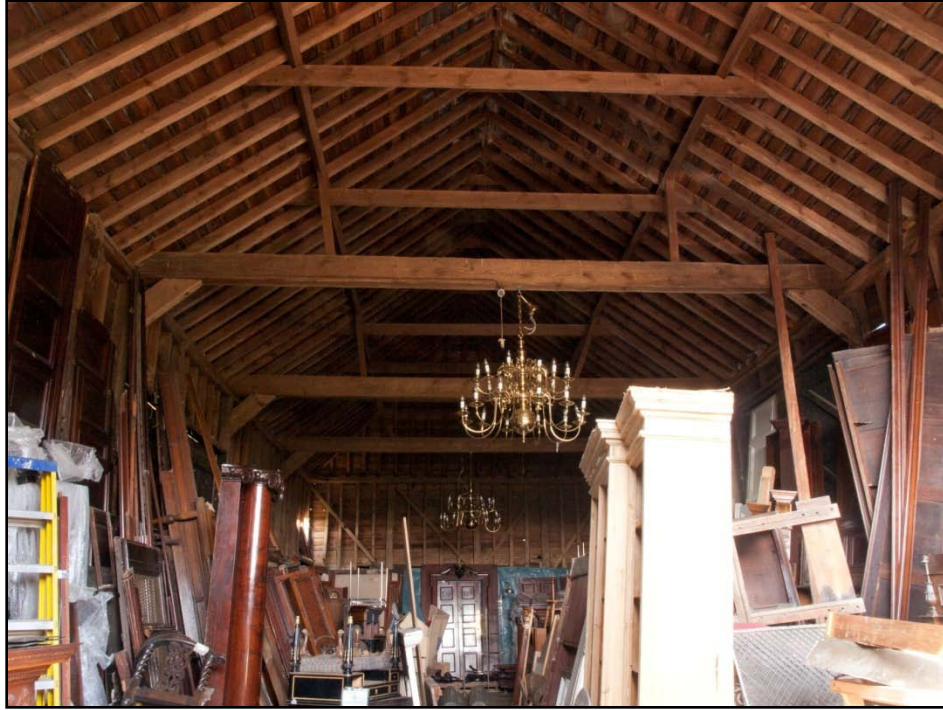
- 6.1.2 The undivided interior remains in good condition and is largely unaltered, with studwork and black painted brickwork below. At the time of the site visit, only the floor at the eastern end of the barn was visible and was covered with modern tarmac which had cracked overtime, presumably through constant use (**Plates 3 and 4**). The roof is constructed from four timber trusses with queen struts supporting a single row of clasped purlins. The latter support numerous slender common rafters, which descend from a thin ridge board. All of the timber used within the barn's construction was machine cut (**Plates 5 and 6**).

Plate 5: Roof structure of Building 1, viewed from the east

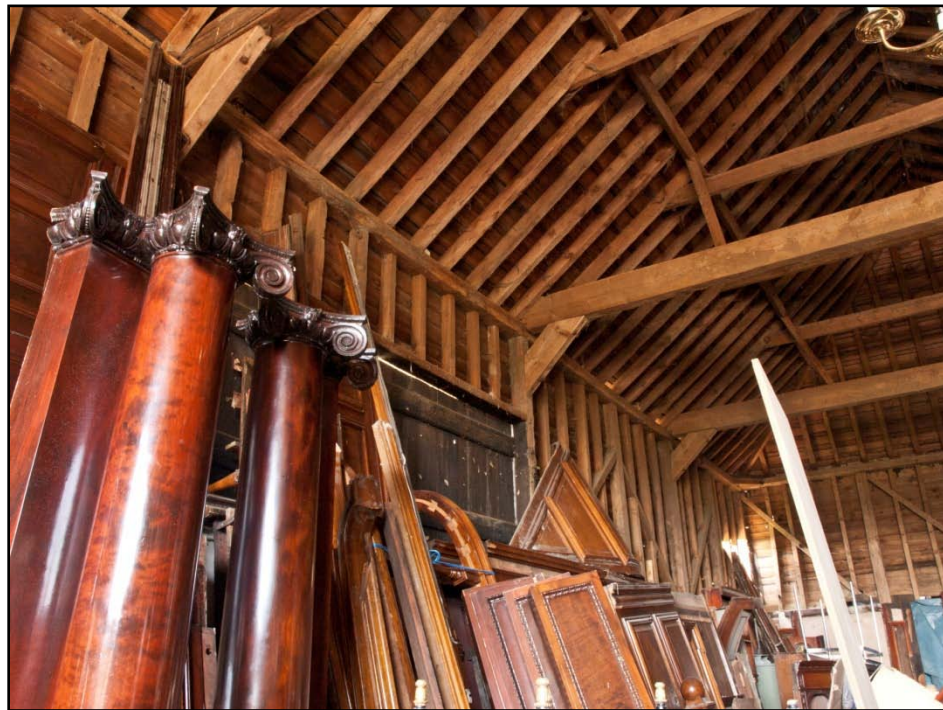
Plate 6: Roof structure of Building 1, viewed from the north-east

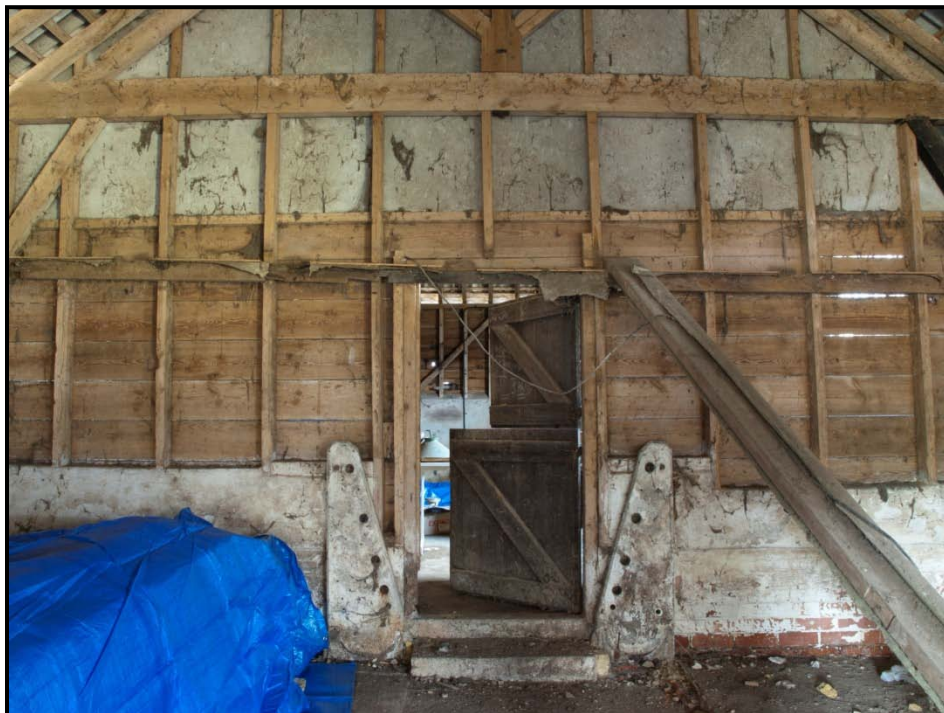
- 6.2.3 The interior of the barn is divided in two by an original timber-framed partition (**Figure 10; Plate 12**). The southern half used to house livestock, while the northern half had been used to repair vehicles and at the time of recording was used for storage. The floor of the building was constructed from poured concrete. The northern end of the barn did not have any fixtures or fittings, simply an open area containing a 0.45m deep inspection pit, which presumably would have been used to repair farm machinery (**Plate 13**). The low brick wall visible on the external elevations was internally cement rendered and supported timber studwork (**Plates 11 and 13**).

Plate 12: Internal partition in Building 2, viewed from the south

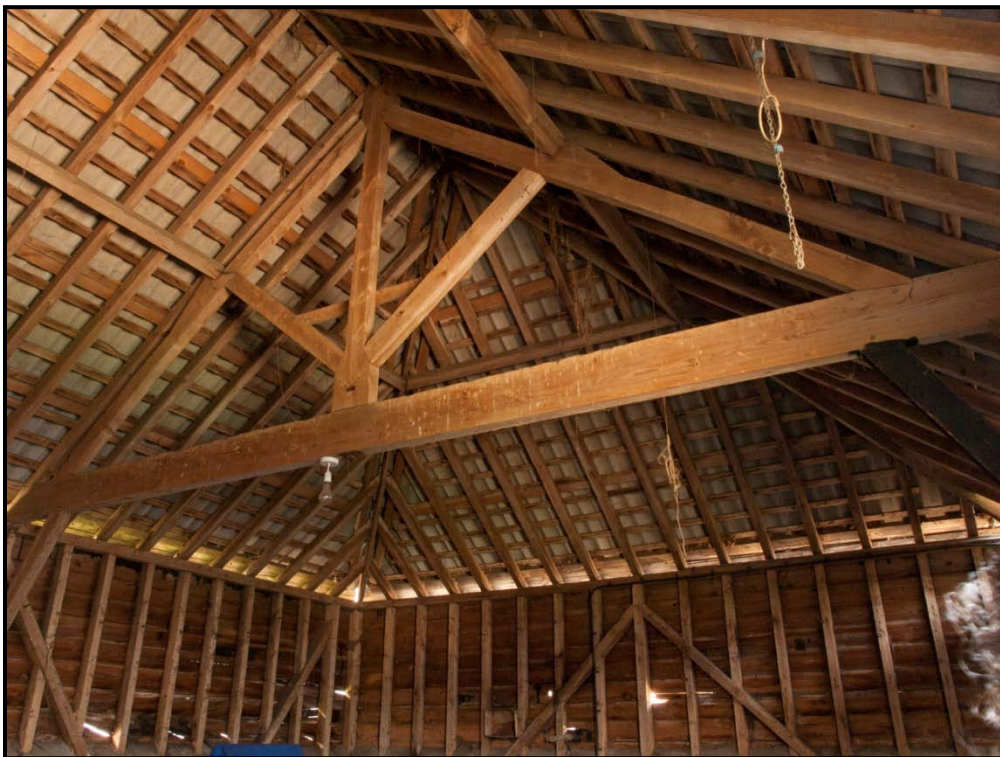
short two diagonal braces attached to the vertical timber posts (**Plates 14 and 15**). The principal rafters in each truss are linked to the wall plate with metal fixing rods, with numerous common rafters between the wall plate and ridge plank. No pegs, mortices or sockets were noted during the recording and rotary marks indicative of machine cut timber was present on many of the timbers.

Plate 14: King post truss in northern part of Building 2, viewed from the south-east

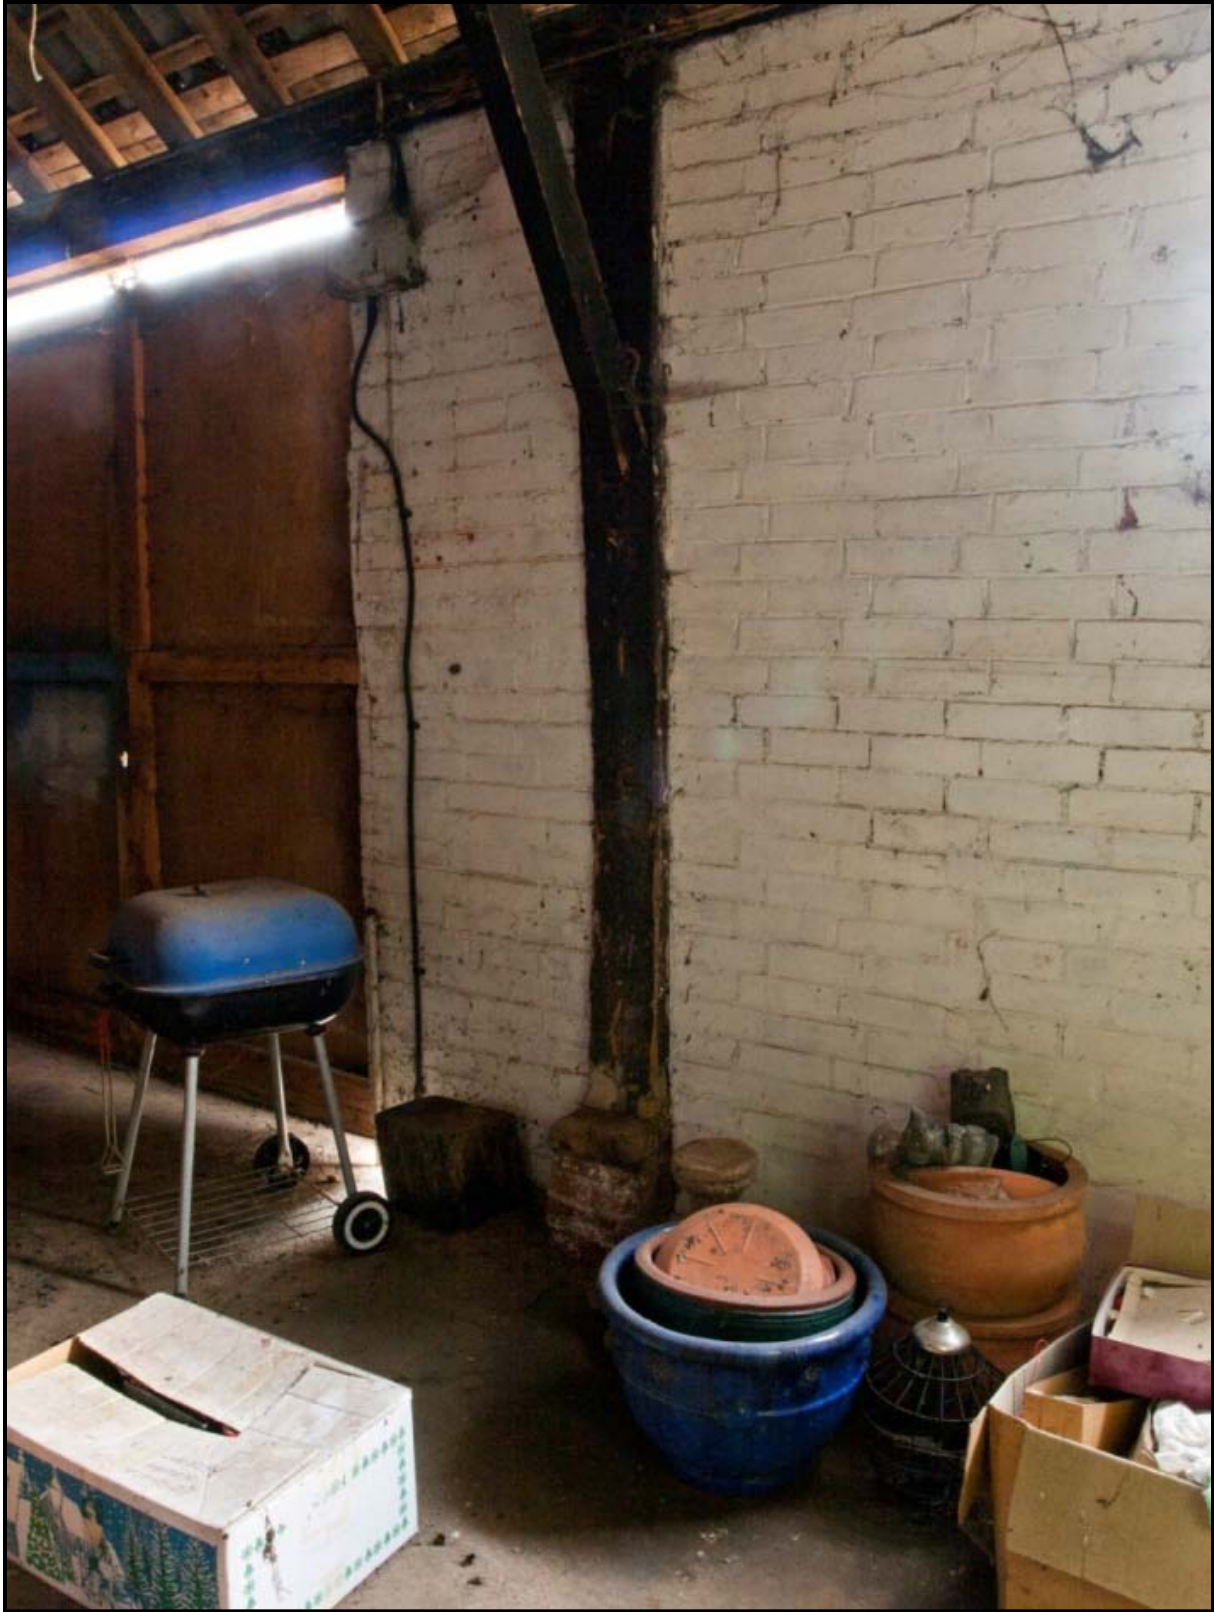
- 6.2.2 The east elevation was originally open sided with three vertical timber posts between the south and north corner (**Plate 15**) and originally faced onto the farm yard to the east (**Figure 2**). The brickwork at low level that wraps around the rest of the building finishes neatly at the north and south ends of the east elevation. The east elevation was later infilled and has two doors, a single heck door (a door divided horizontally into two parts and independently hinged) at the south end and a double door at the north end (**Plate 9**). Between these two doors, the elevation has been infilled with two panels of later brickwork. The panel at the southern end is constructed in modern machine cut yellow bricks laid in stretcher bond, topped with half bats (bricks cut in half) with weatherboarding above, the panel at the northern end is constructed from slightly older red Fletton brickwork in stretcher bond and has a 20th century metal-framed window at high level. The south elevation has an inserted 20th century double, fixed, metal-framed window facing the north elevation of Building 6 (**Plates 10 and 11**).

Plate 15: Vertical timber post in the east elevation in northern part of Building 2, viewed from the south-west

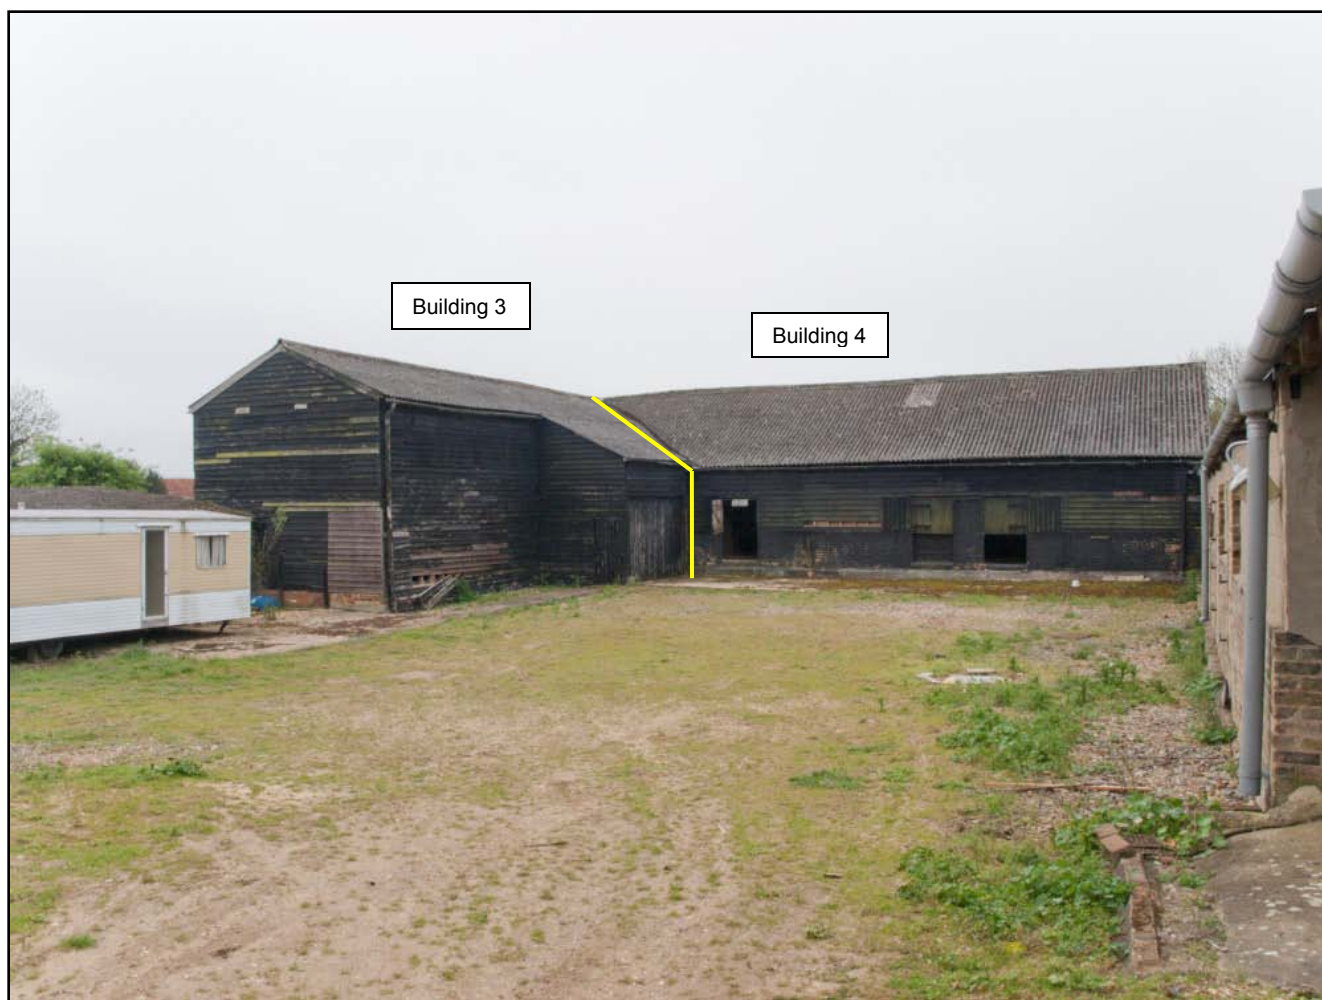
- 6.3.1 Buildings 3 and 4 are two attached barns with an L-shaped plan (**Figures 2 and 11; Plate 16**). They are located towards the south-east corner of the farm complex and are shown on the 1845 Tithe map (**Figure 3**). Building 3 butts the east side of Building 4 and the east elevation of Building 4 forms the south part of the west elevation of Building 3. Building 3 was therefore constructed after Building 4.

Plate 16: Buildings 3 and 4, viewed from the north-west

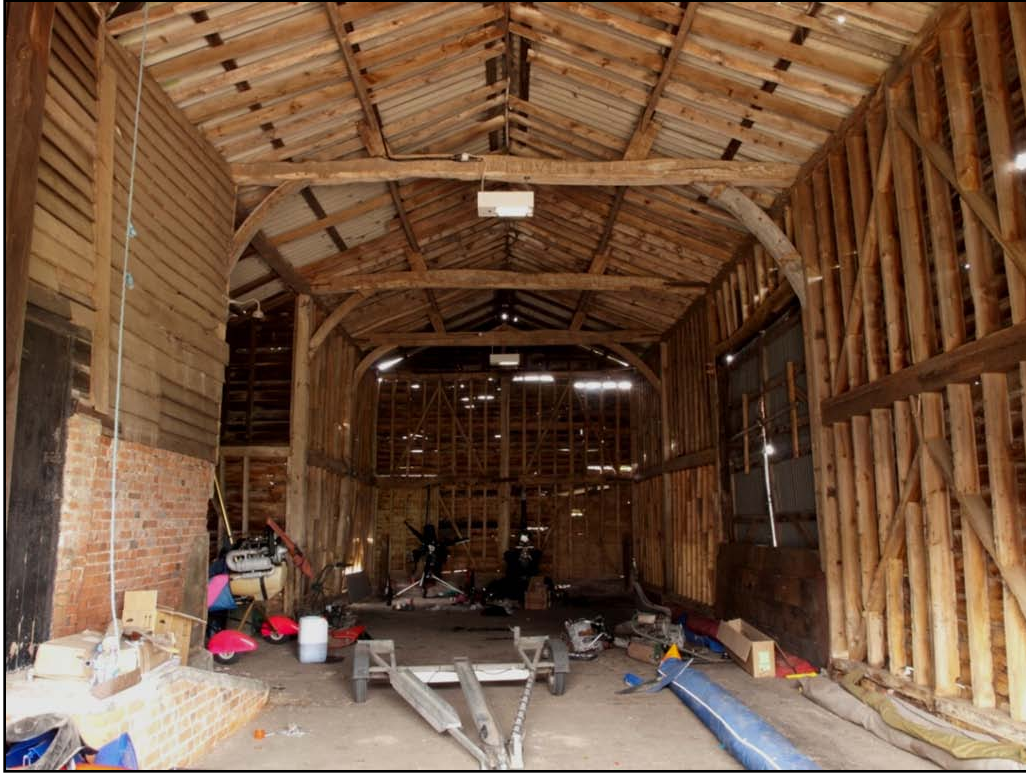
- 6.3.3 The interior is in good condition with some hand hewn timber beams but predominantly machine cut pine studwork and common rafters. The floor is covered with 20th century poured cement. The exterior weather-boarded east elevation of Building 4 is visible within the interior of Building 3 and is weather boarded above a brick wall (**Plate 21**). The roof has four timber trusses with raking queen struts supporting a single row of clasped purlins. The roof has been replaced and lowered, with the raking queen struts shortened and the ridge lowered in the late 20th century. Numerous slender common pine rafters descend from a thin ridge board to the wall plate (**Plates 21**). The roof of the west entrance porch also appears to have been rebuilt.

Plate 21: Interior of Building 3, viewed from the south

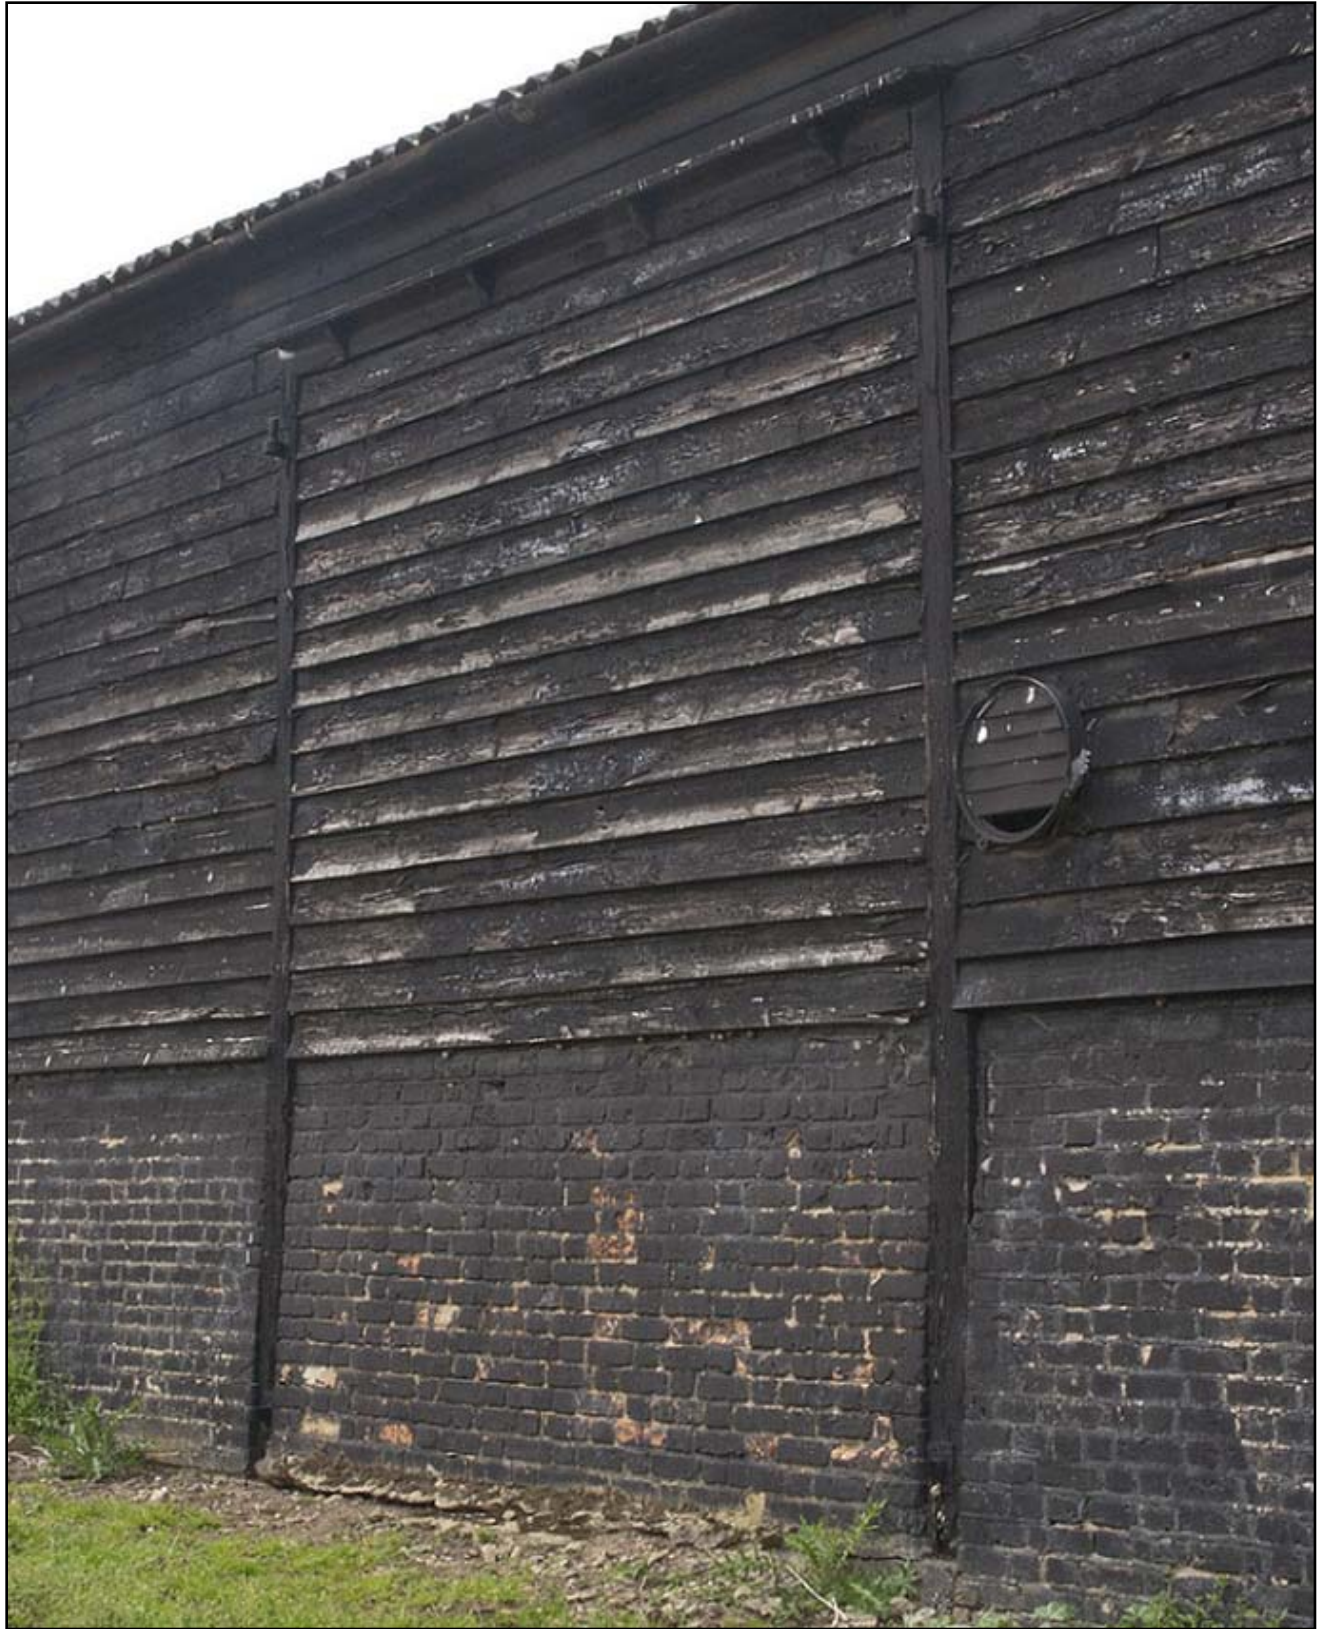
- 6.4.2 The south elevation has a blocked double door opening, which would have originally provided cart access into the barn (**Figures 11; Plates 22 and 23**). Three small windows located at intervals along this elevation are 20th century insertions (**Plate 22**). The north elevation faces the farm yard and has three heck doors. Two vertical timber posts in this elevation align with roof trusses (**Figure 11; Plate 24**).

Plate 23: Infilled double door in the south elevation of Building 4, viewed from the south-east

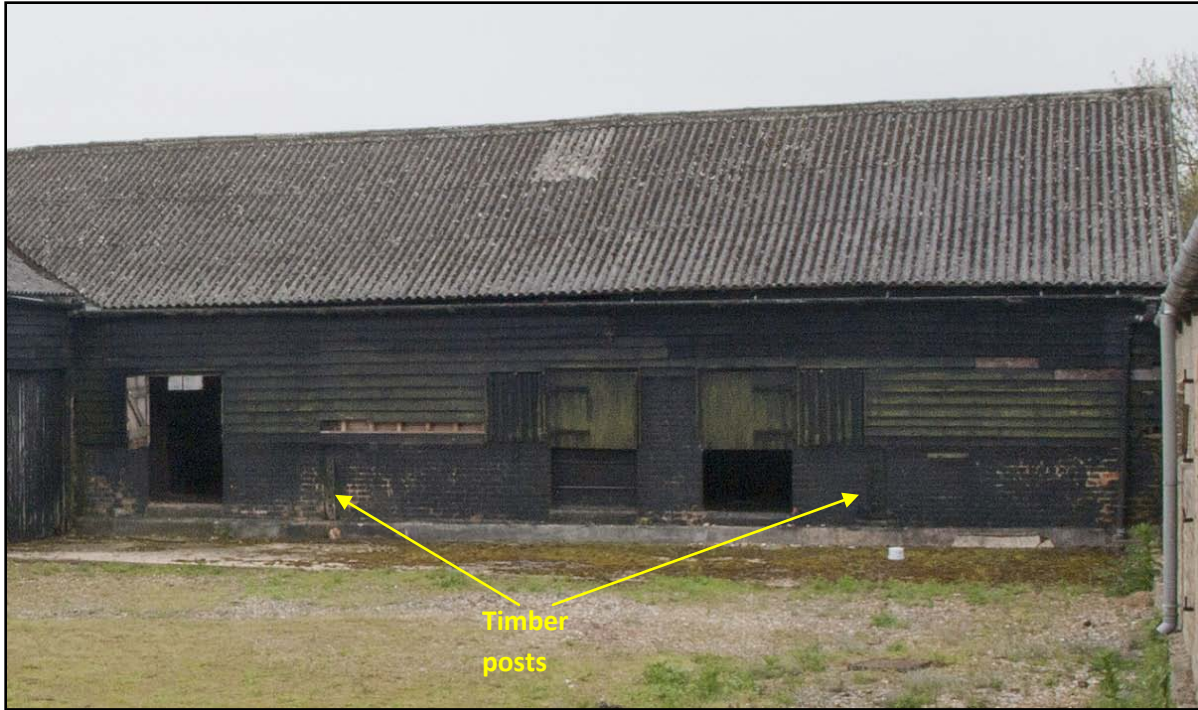
Plate 24: North elevation of Building 4, viewed from the north

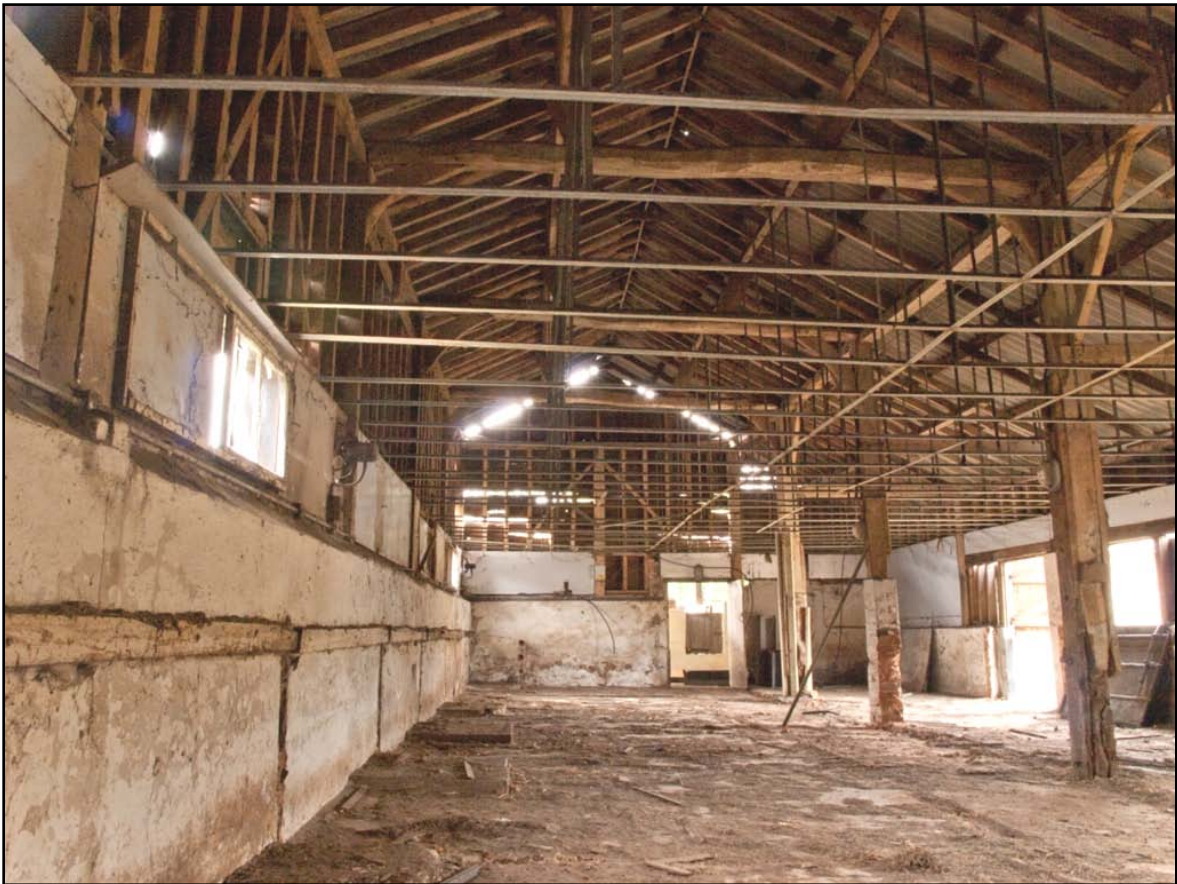
century metal framework suspended below the tie beams is associated with providing heating and light (**Plates 25 and 26**).

Plate 25: Interior of Building 4, viewed from the east

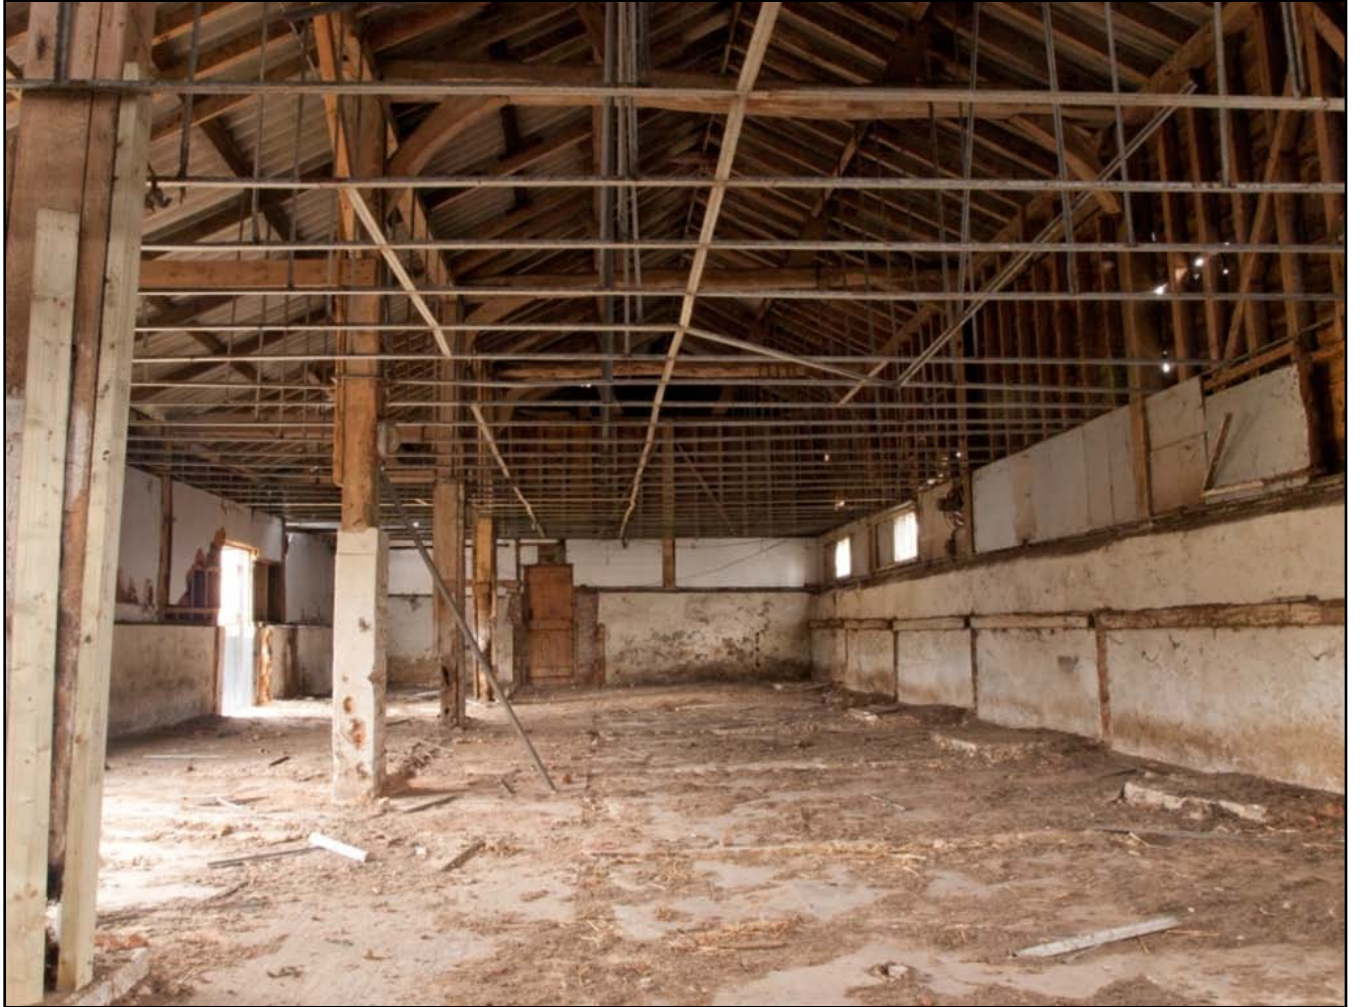
Plate 26: Interior of Building 4, viewed from the west

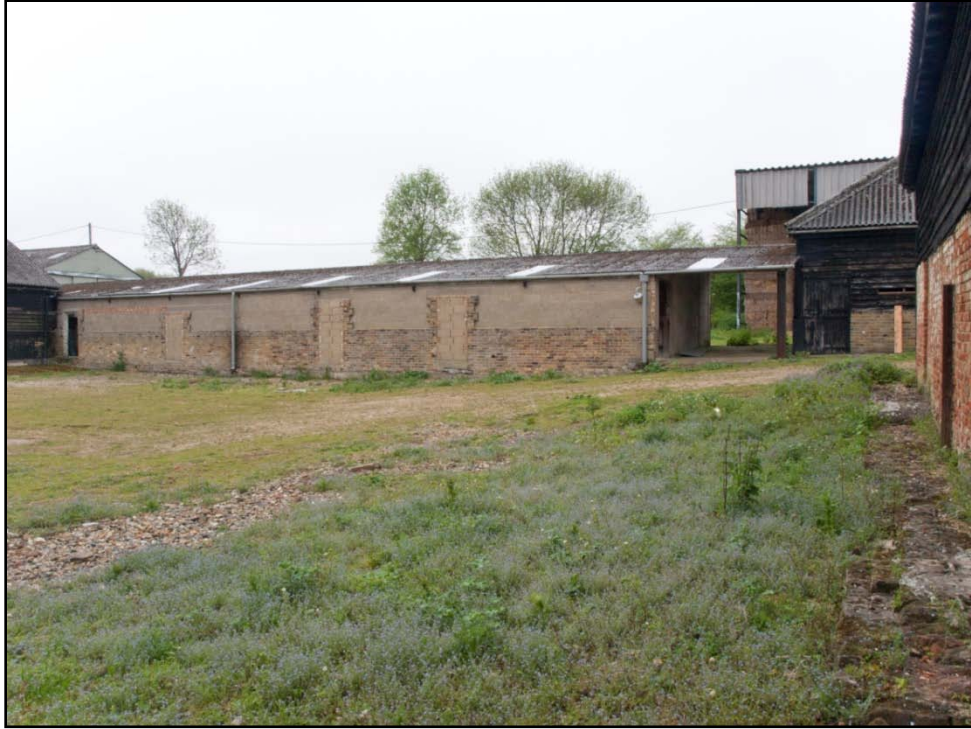
Plate 34: East elevation of Building 6 showing infilled doorways, viewed from north-east

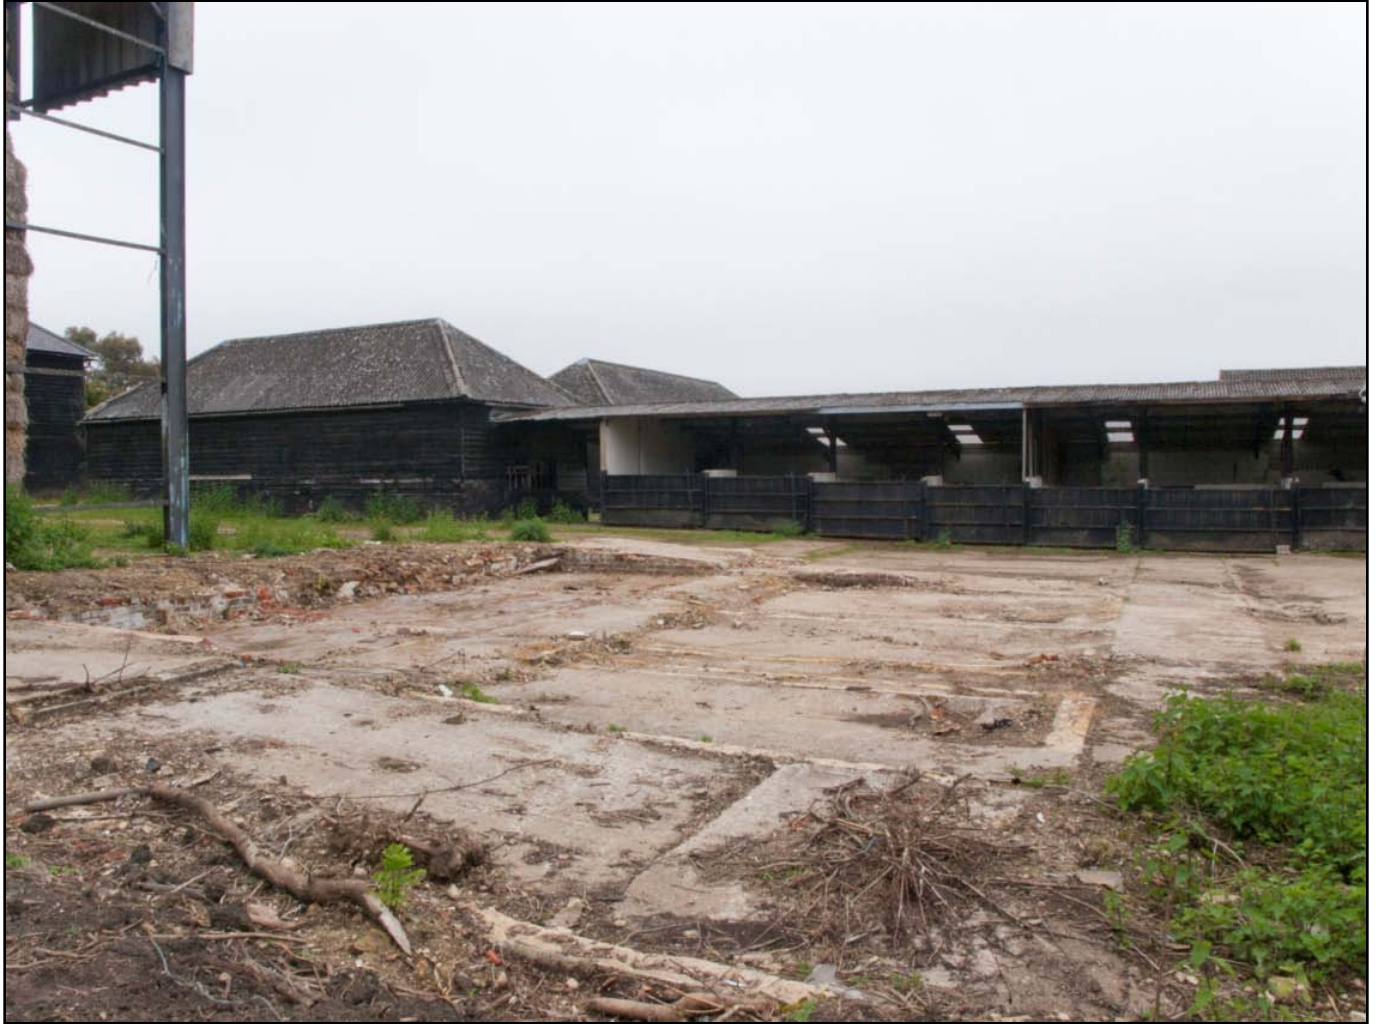
Plate 40: Footprint of Building 7, viewed from the west
