**AN ARCHAEOLOGICAL WATCHING BRIEF AT  
16 SOUTH BAILEY, DURHAM,  
COUNTY DURHAM**

**ASSESSMENT REPORT**

**SEPTEMBER 2013**

Pre-Construct Archaeology Limited Quality Control	
<i>Project Number</i>	K3020
<i>Site Code</i>	SBD 13
<i>Report Number</i>	RN11028

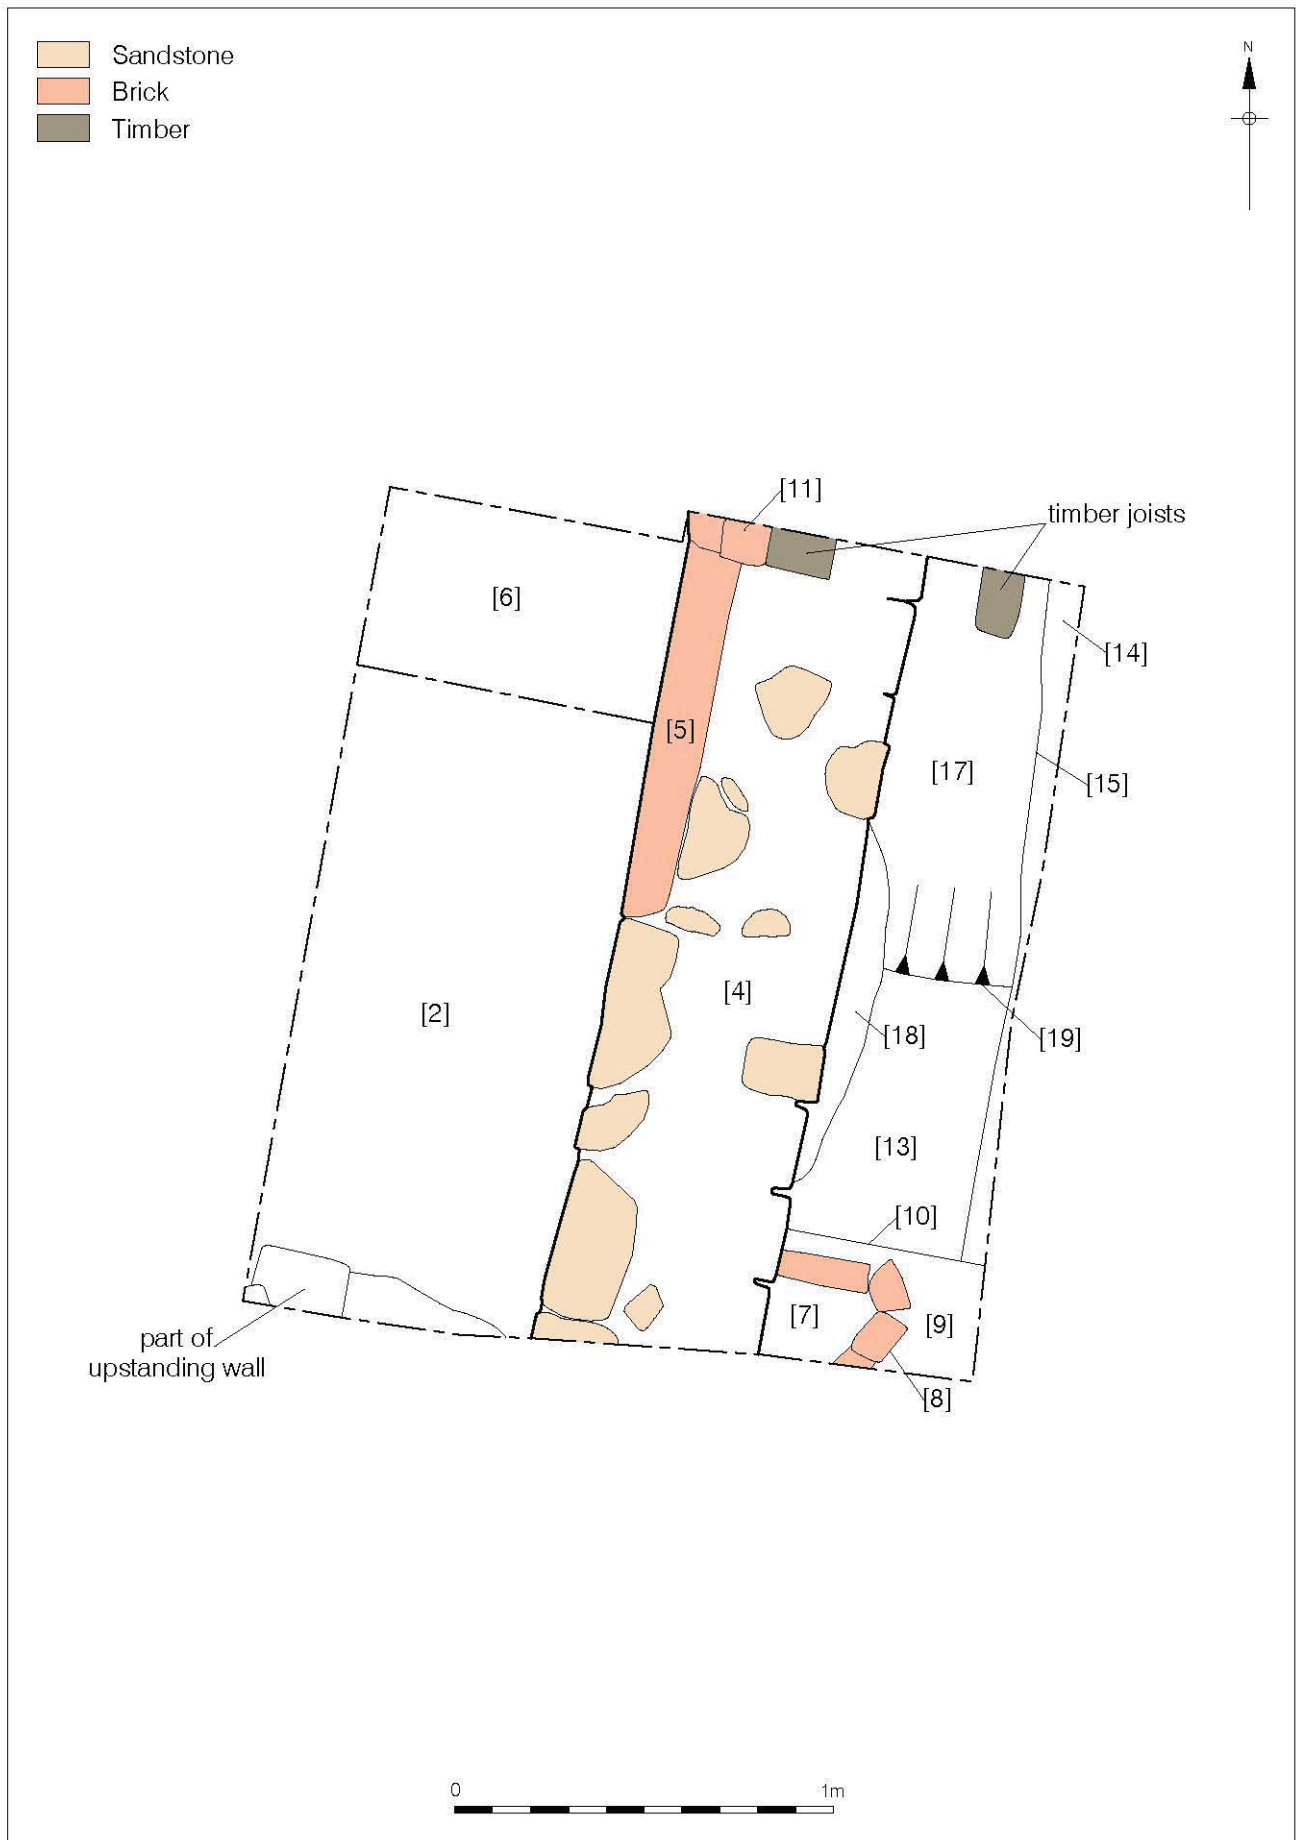
Figure 3  
 Plan of Excavation Area  
 1:20 at A4

- 5.2.3 An area of brick infill, [5], abutting the northern extent of the west side of wall [4] was exposed for a distance of c. 1.0 north-south and was 0.30m high (Figure 3; Plates 1 and 2). It comprised three courses of a single skin of hand-moulded brick fragments (up to 130mm by 120mm by 60mm) laid in stretchers and bonded with lime mortar. Specialist examination of the brick indicates a late 17th- to mid-18th-century date. The structure probably represents a repair to the earlier sandstone wall during this period.

- 5.2.4 A clayey sandy silt deposit, [2], recorded to the west of wall [4] directly overlay brick infill [5]. This measured at least 2.10m north-south by c. 0.75m east-west and was 0.22m thick, recorded at a height of 56.21m OD. Frequent fragments sandstone and lime mortar were observed within the layer, which may represent a levelling layer or an activity horizon associated with the demolition/modification of the wall. The complete base of a 17th-century ceramic vessel and a single fragment of bone were recovered from this deposit.

- 5.2.5 A loose clayey silt deposit, [1], extended across the whole excavation area; it was up to c. 0.15m thick and was recorded at a maximum height of 56.34m OD. The deposit produced small assemblages of pottery, glass, bone and a fragment of 17th-century tobacco clay pipe stem. The main group of pottery recovered from this deposit was of a similar 17th-century fabric to that recovered from deposit [2] and is probably from the same vessel, therefore probably residual in context, with the remainder including a single sherd of medieval pottery, certainly residual in context and a single sherd of 19th-century pottery. Some of the glass fragments are probably from 'onion' type bottles dating to the late 17th to early 18th century (see Section 8). A glass bead (SF4) also recovered from this deposit is similar to early 19th-century beads (see Section 9). Fragments of brick and lime mortar material were also observed. The deposit is interpreted as a 19th-century dumped levelling layer.

- 5.2.6 Two brick structures, [11] and [12], were recorded at the northern and southern extents of the excavation area, respectively. Both were similarly constructed with the northernmost, structure [11], comprising two courses of brick and the southernmost, structure [12], comprising three courses of brick, both bonded with lime mortar. These were brick pads or stacks built to support north-south aligned timber floor joists of a former floor probably during the 19th century. The floor boards, joists and a subsequent concrete surface had been removed prior to the archaeological excavation.

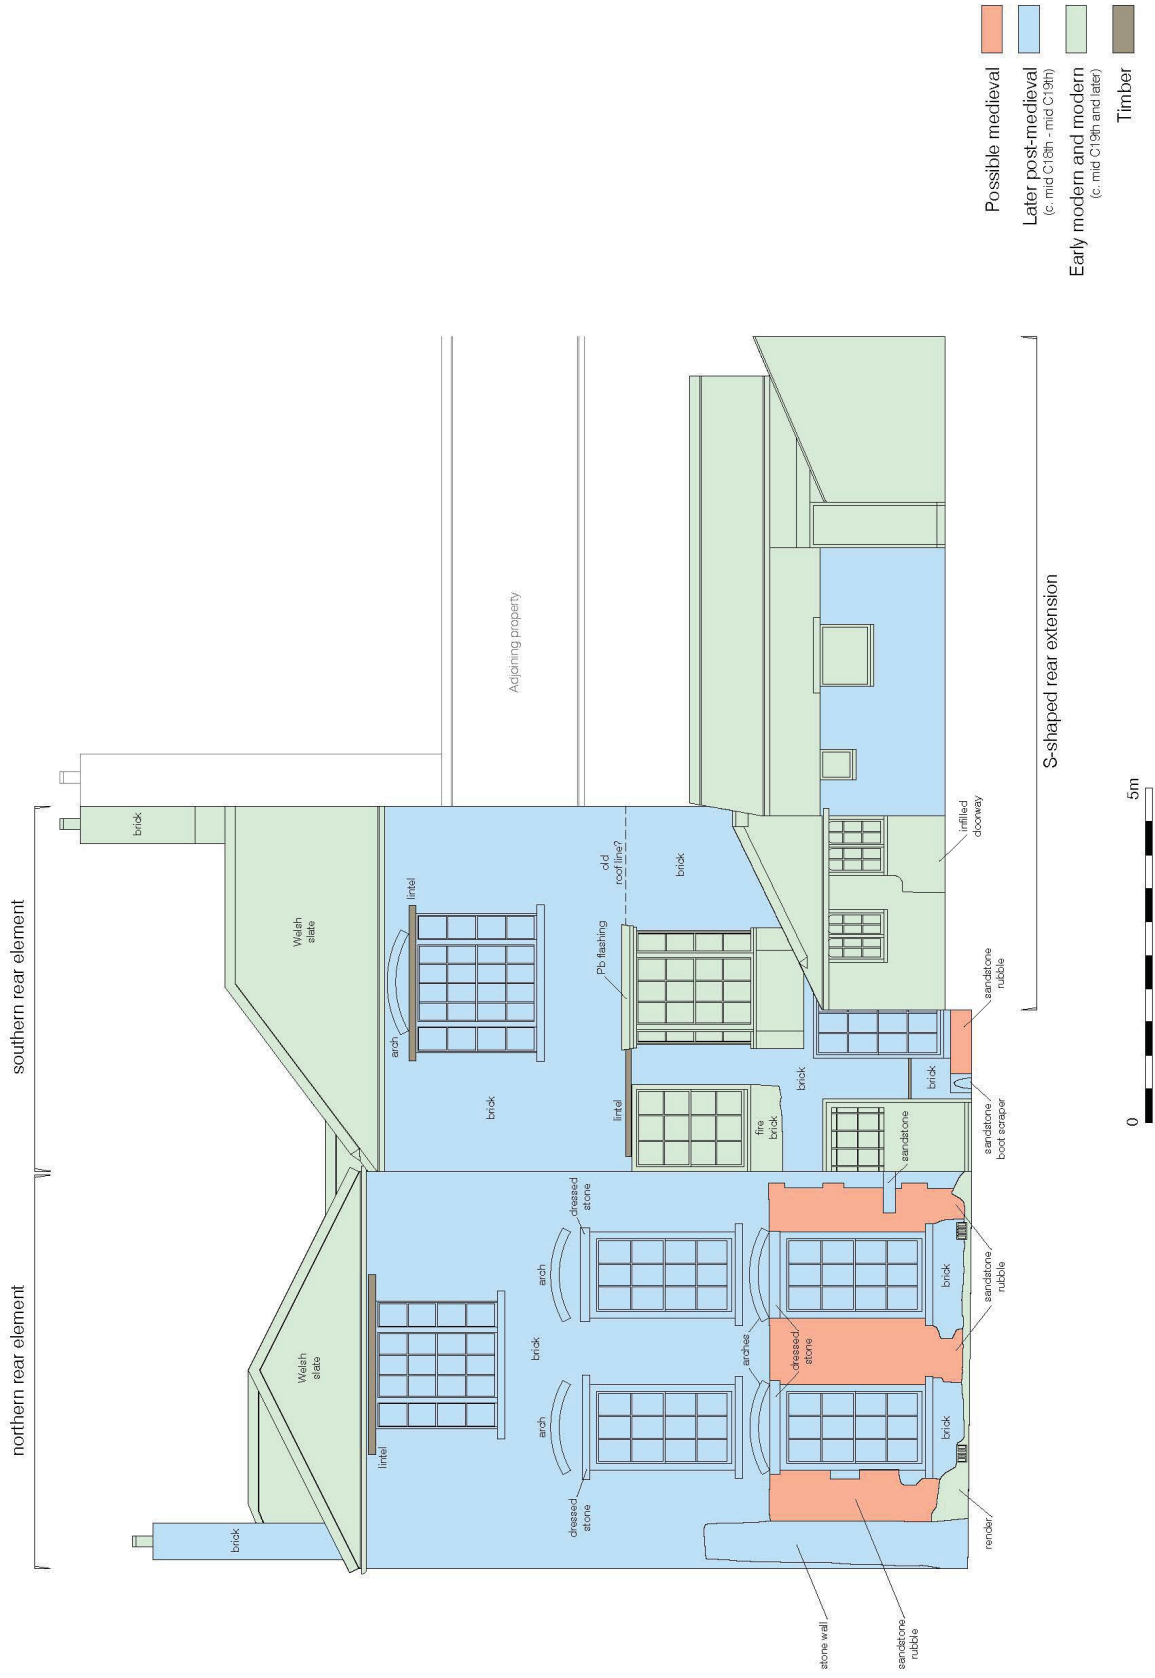
Figure 6  
West-facing (rear) elevation  
1:80 at A3

- 6.2.25 In the rear elevation (Figure 6), the sash window to the left in the first floor of the southern element is known to have been installed during refurbishment work undertaken in 2002 to replace a fire escape door (Plate 29).

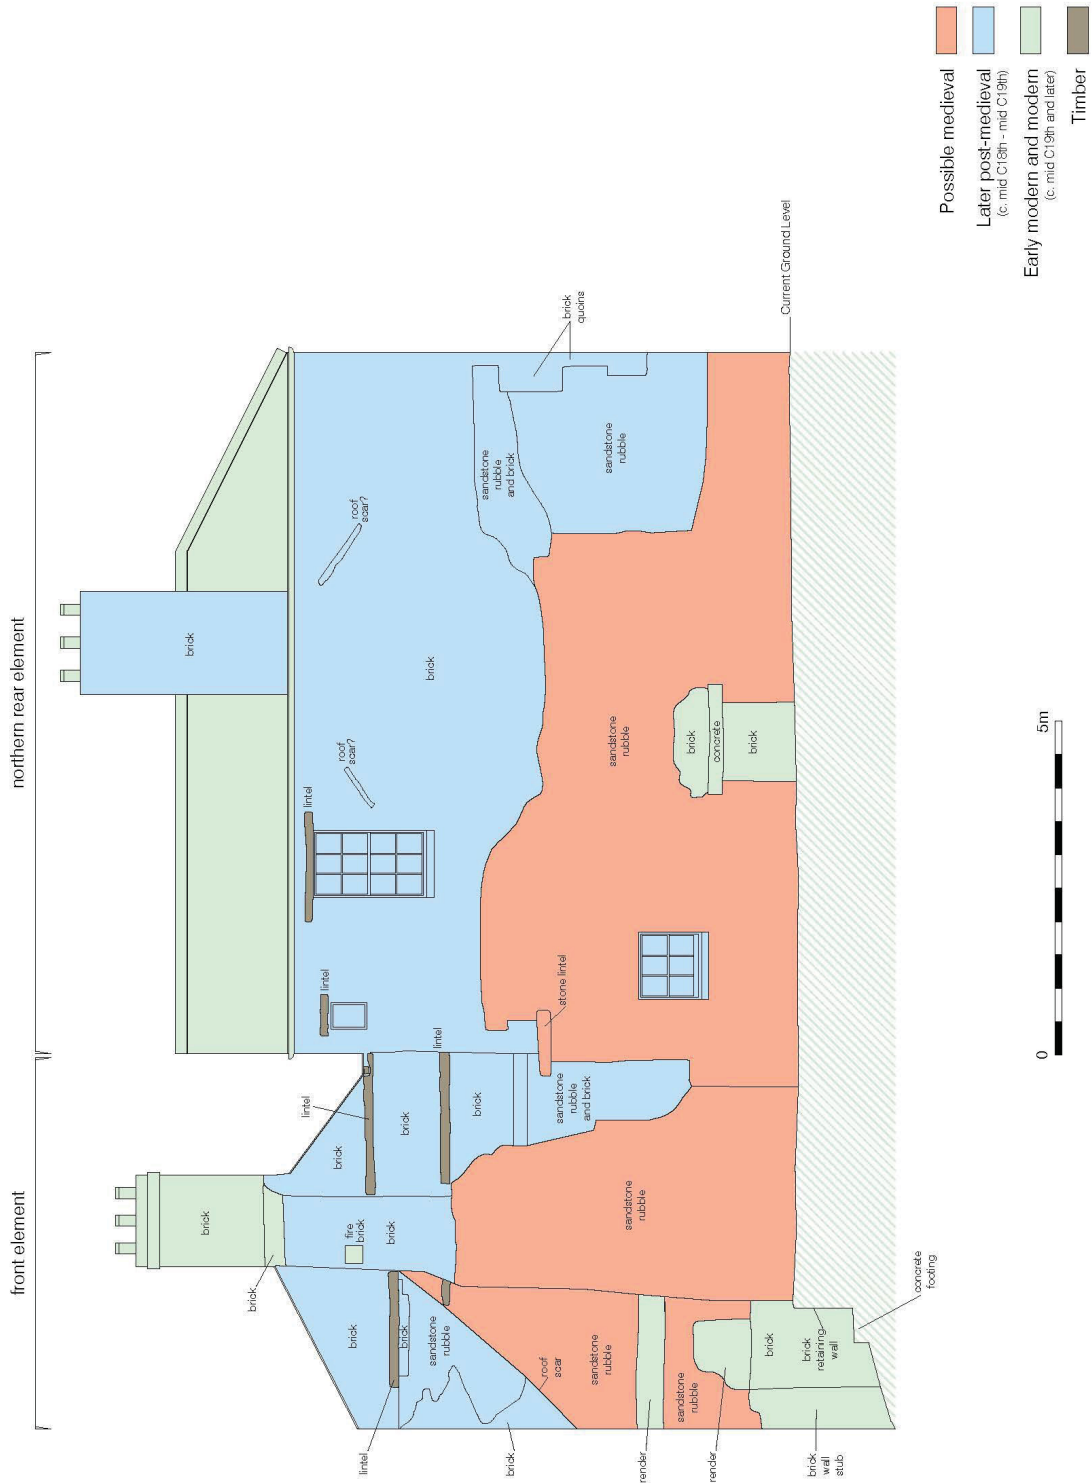
Figure 7  
North-facing (side) elevation  
1:80 at A3

- 6.2.24 Across the side elevation (Figure 7) the main modern insertions recorded were: small area of firebrick infill to the upper portion of the chimney stack in the gable end; the aforementioned infilled central doorway within rear northern element; concrete and brickwork structural elements associated with the former garage/outbuilding demolished as part of the work.

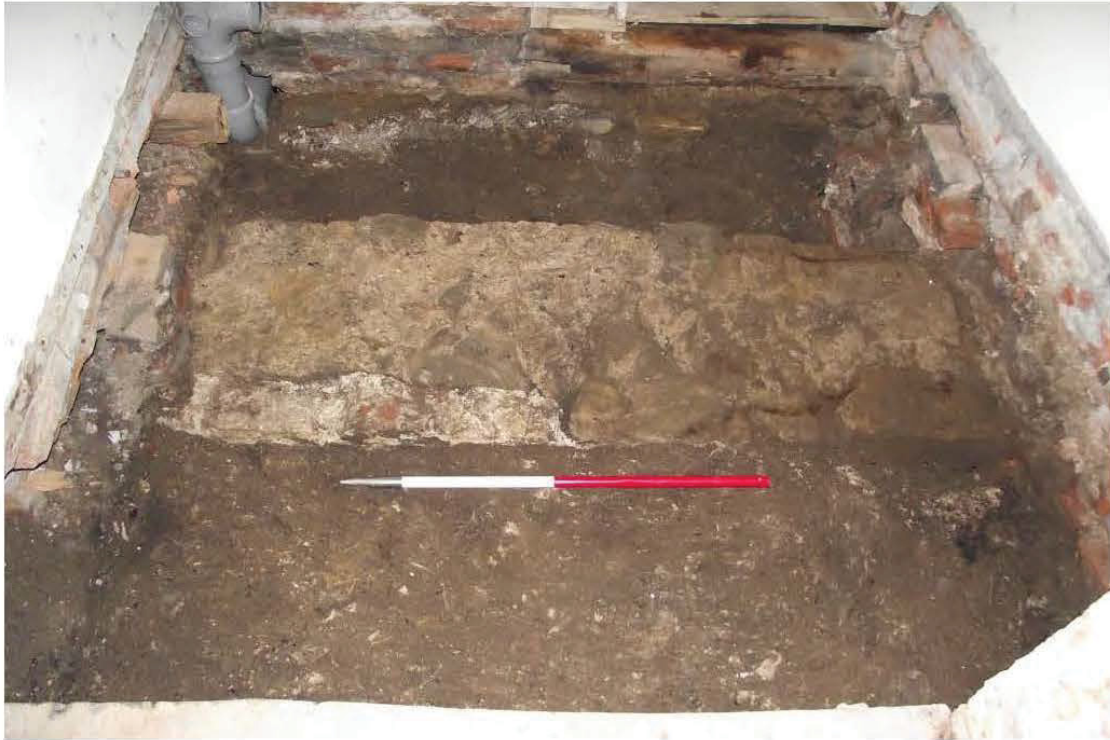
Plate 1: Excavation area; wall [4] and later brick infill [5], looking east (1m scale)

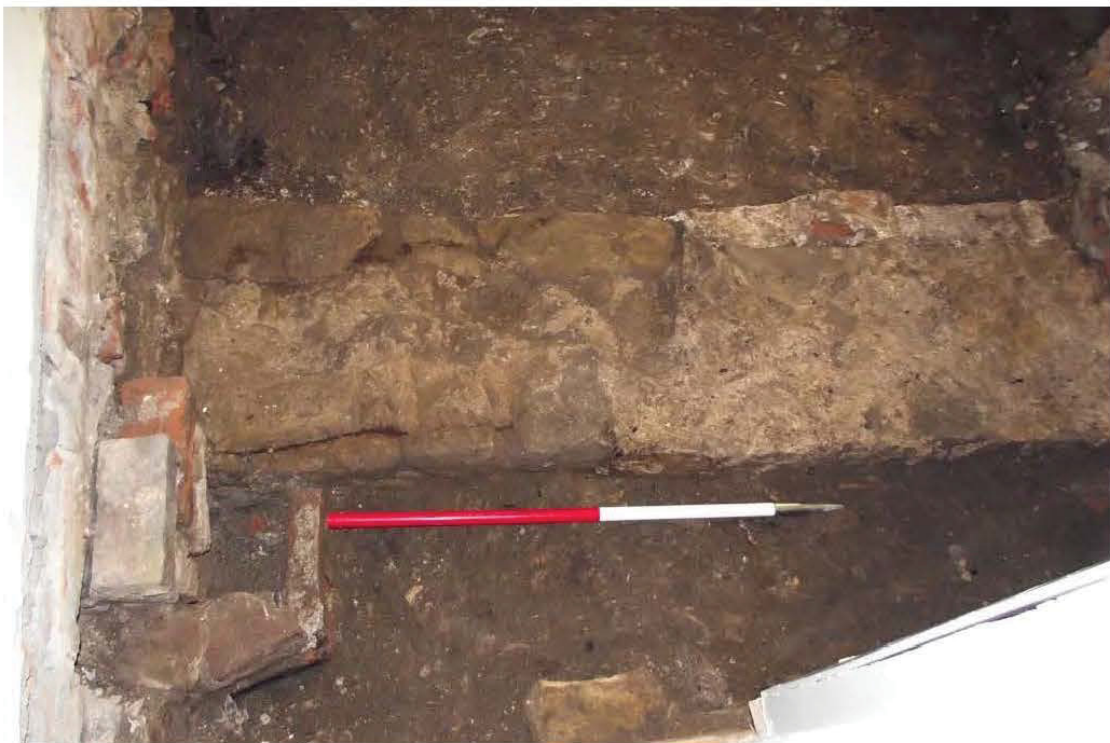
Plate 2: Excavation area; wall [4], later brick infill [5], brick drain [8] and stack [12], looking west (1m scale)

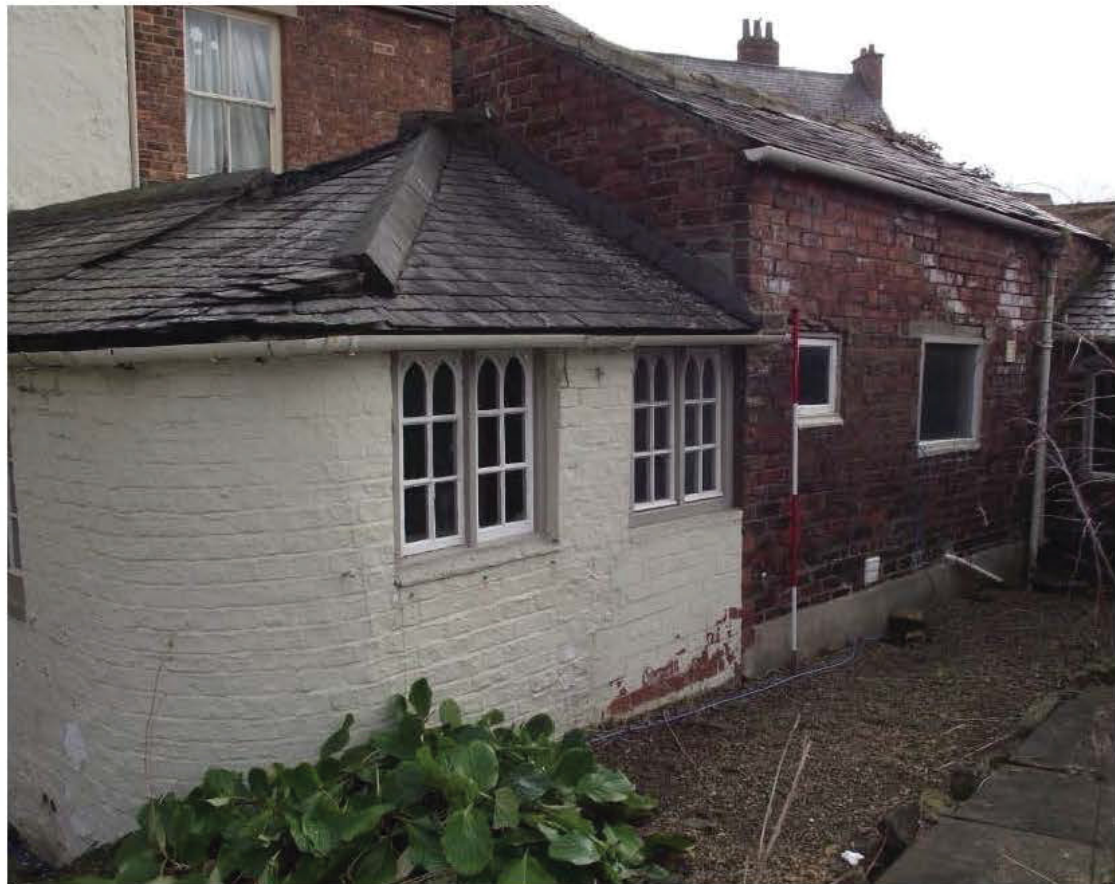
- 6.2.7 The west elevation of the kitchen range has a pair of similar bipartite windows, with that to right a reproduction replacement, this infilling part of a former doorway, with the remainder infilled with brick (Plate 6), these modifications are also known to date to 2002. The double-pitched slate roof extends into the adjacent property. The central range has a single-pitch slate roof, likely added when the building was raised in height, probably in the late 19th or early 20th century. Its west elevation has two simple wood-framed casement windows. The outbuilding has a single-pitch slate roof to the east and a pantile roof to the west; its north elevation has a tripartite replacement window (Plate 8).

Plate 6: S-shaped extension, west-facing elevation, oblique view, prior to works (2m scale)

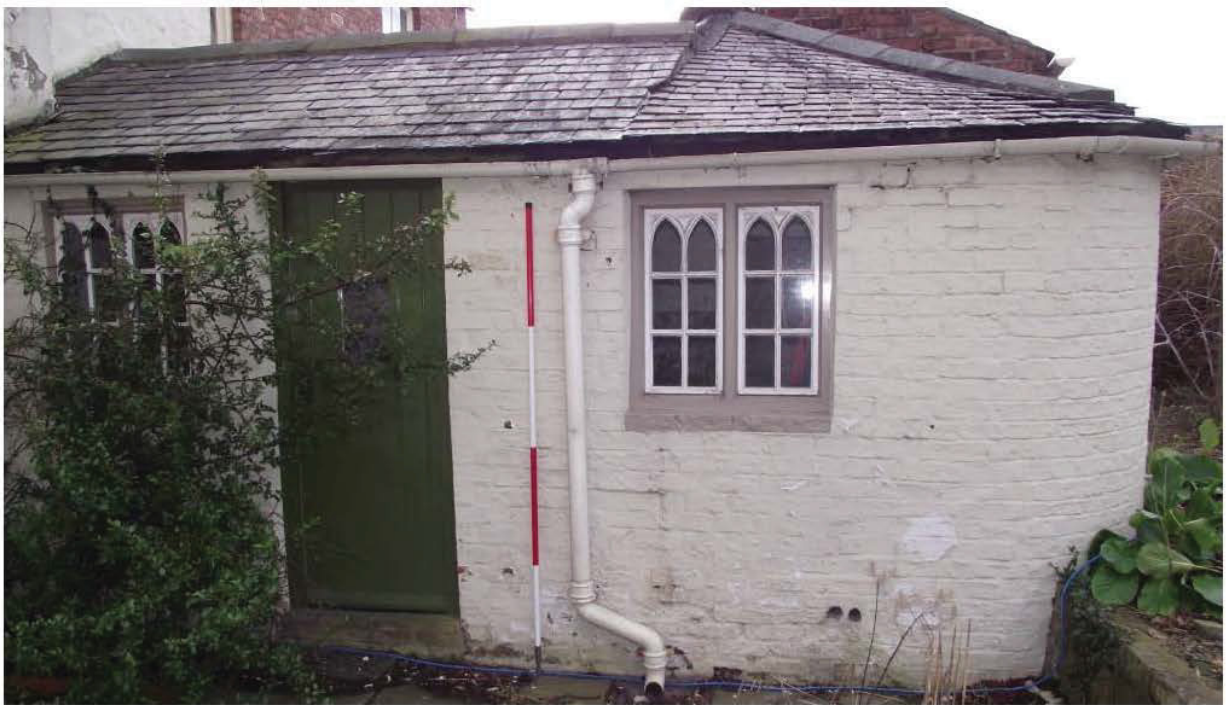
- 6.2.6 The north elevation of the kitchen range has a central door with small glazed panel, flanked by bipartite, six-paned Gothic arched windows (Plate 7). The door and window to the right are known to have been inserted during refurbishment work undertaken in 2002, the window being a reproduction replacement, the door evidently a re-used fixture. The rounded corner of the range was likely built at the same time as a curving garden/yard wall depicted on the 1897 Ordnance Survey 2nd edition map.

Plate 7: S-shaped extension, north-facing elevation (kitchen range), prior to works (2m scale)

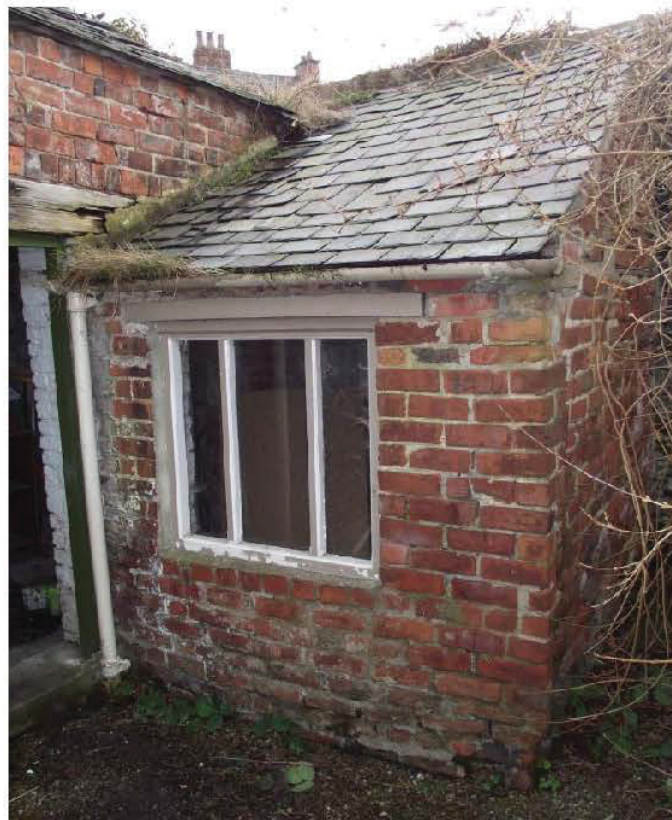
Plate 8: S-shaped extension, north-facing elevation (outbuilding), prior to works (view, no scale)

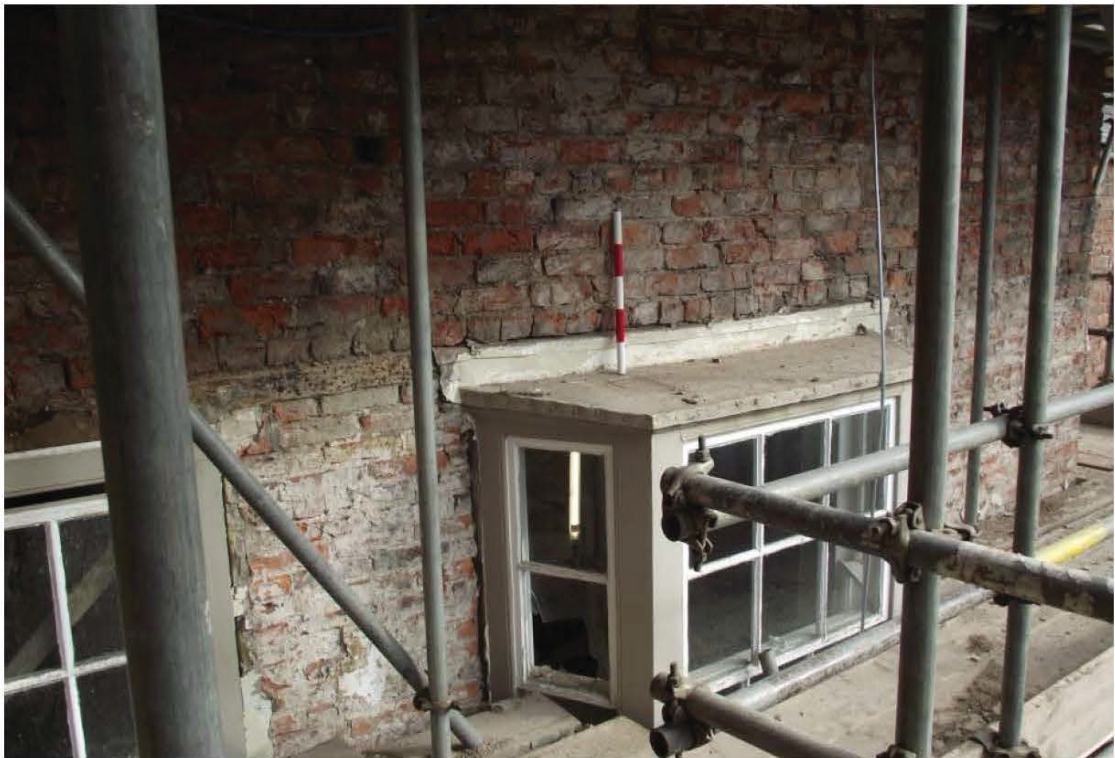
- 6.2.20 The two-storey element was at least 5.10m high from current ground level, with what was evidently the original roof line noted in the brickwork of the rear elevation (Figure 6; Plate 25). The brickwork (average brick dimensions 230mm by 110mm by 60mm) was laid entirely in stretcher bond bonded by lime mortar. The former roof line continues to the left of a later window by a horizontal timber in the brickwork, similar to that seen in the side elevation of the frontage building and probably not an original window lintel. Only the sash window in the ground floor is likely part of the later Georgian development, although the door to the left is possibly a late 19th- to mid 20th-century replacement in an original opening. The central canted bay first floor window is possibly of late 19th- to mid 20th-century date.

Plate 25: West-facing (rear) elevation, southern element, brickwork detail above window (0.5m scale)

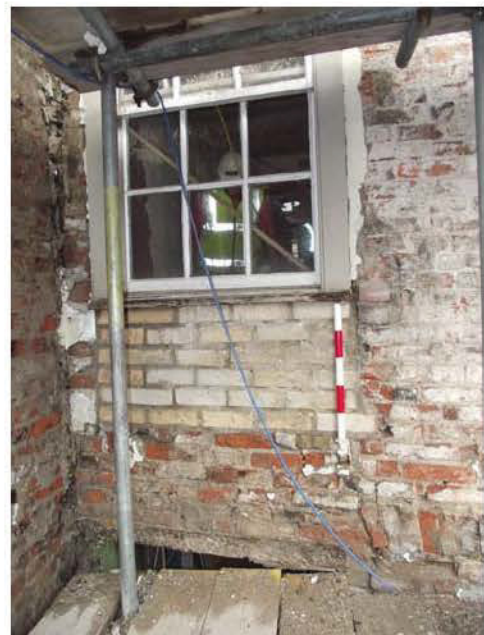
Plate 29: West-facing (rear) elevation, southern element, brick infill below replacement window in first floor (0.5m scale)

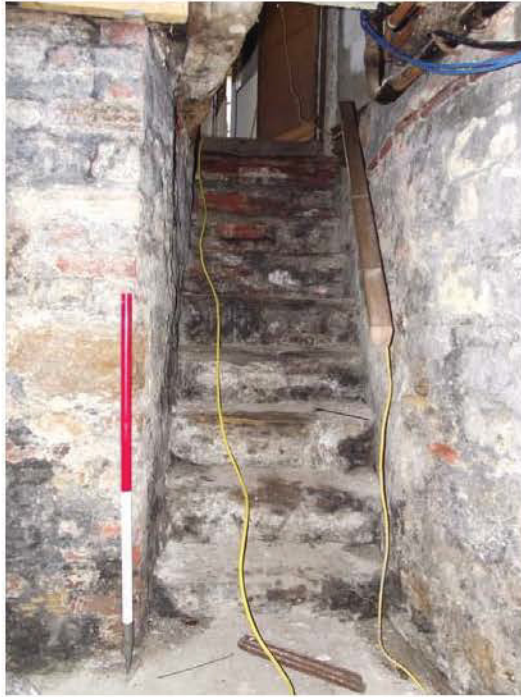
- 6.3.4 The stairs leading to the cellar are narrow and steep (Plate 30), with the lowermost four steps formed by large sandstone slabs, also probably medieval in date, and the uppermost five steps built in brick (average brick dimensions 230mm by 110mm by 60mm), these presumably built to replace original stone steps in the post-medieval period. The current floor surface is concrete. Later additions include areas of modern brick infill associated with the installation of services, as well as brickwork associated with a substantial steel supporting joist inserted in the east and west walls.

Plate 30: Cellar, access steps (1m scale)

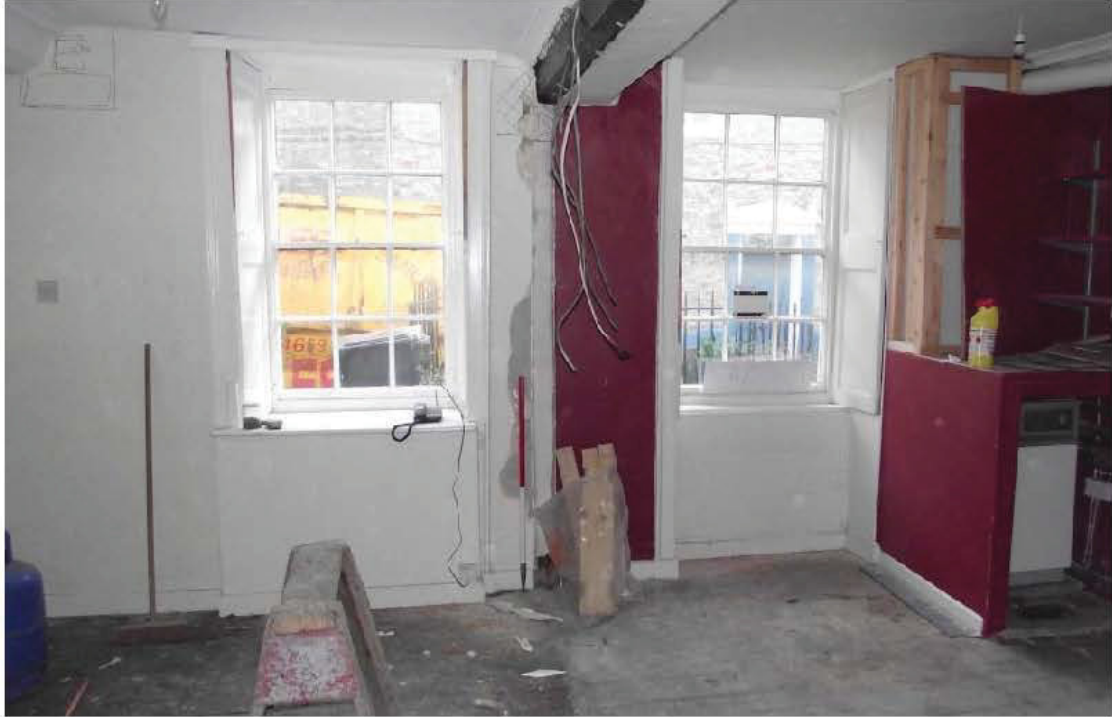
- 6.3.8 Partition walls between the study, flat lobby and WC were removed during the refurbishment works (Plate 36) and a doorway leading to the staircase in the northern rear element was infilled. A partition wall to the south was extended to create a single office space in the northern part of the frontage element. A blocked fireplace in the north wall of the flat lobby was partially exposed and was noted as comprising a dressed sandstone surround infilled with late 19th-century or later brick and covered in bitumen (Plate 37).

Plate 36: Front element, ground floor, study and flat lobby, partition wall removed (1m scale)

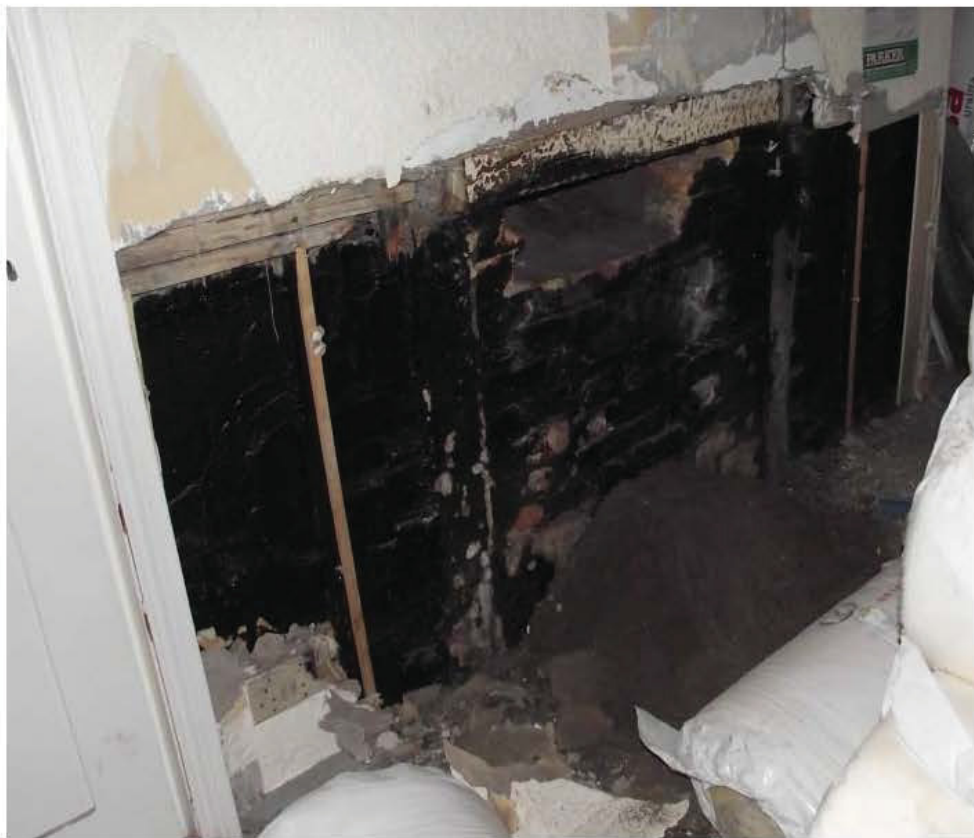
Plate 37: Front element, ground floor, flat lobby, exposed fireplace in north wall (view, no scale)

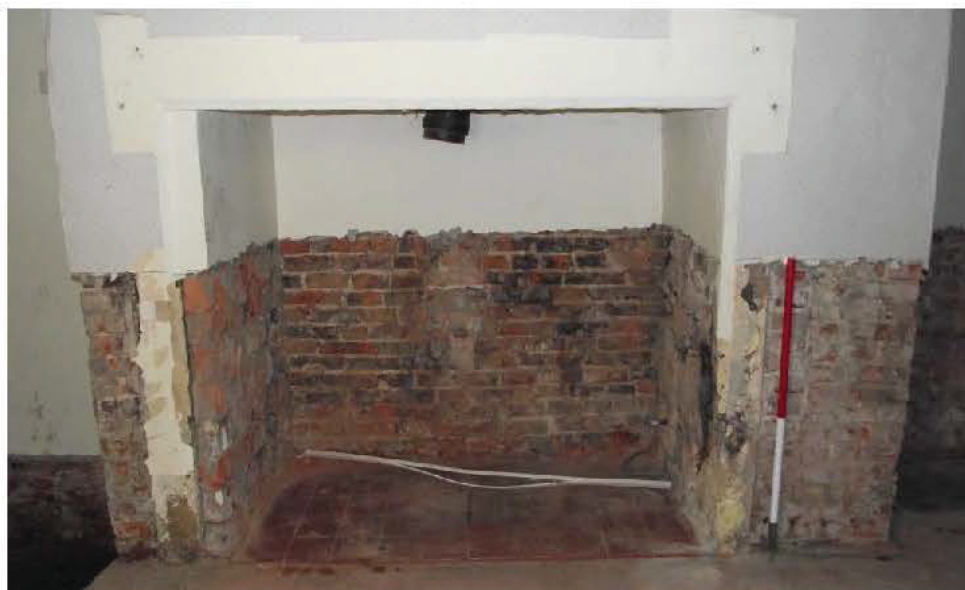
- 6.3.12 The fireplace has a chamfered dressed stone surround with brick back liner and 20th-century tiled surface, brick side liner to the west and brick and concrete repair to the back liner (Plate 42). The enabling hole made in the wall immediately west of the fireplace exposed a small area of sandstone masonry, masked by a single skin of probably 19th-century brickwork. Five courses of sandstone rubble (blocks up to 230mm by 150mm), bonded by lime mortar, were exposed and may represent surviving medieval fabric.

Plate 42: Southern rear element, ground floor, Reception Room 2, exposed masonry in fireplace (1m scale)
