**BUILT HERITAGE  
RECORDING OF A PANEL  
OF THE PARAPET OF  
CHISWICK BRIDGE, GREAT  
CHERTSEY ROAD, LONDON  
BOROUGH OF HOUNSLOW**

**PCA REPORT NO. R11474**

**JULY 2013**

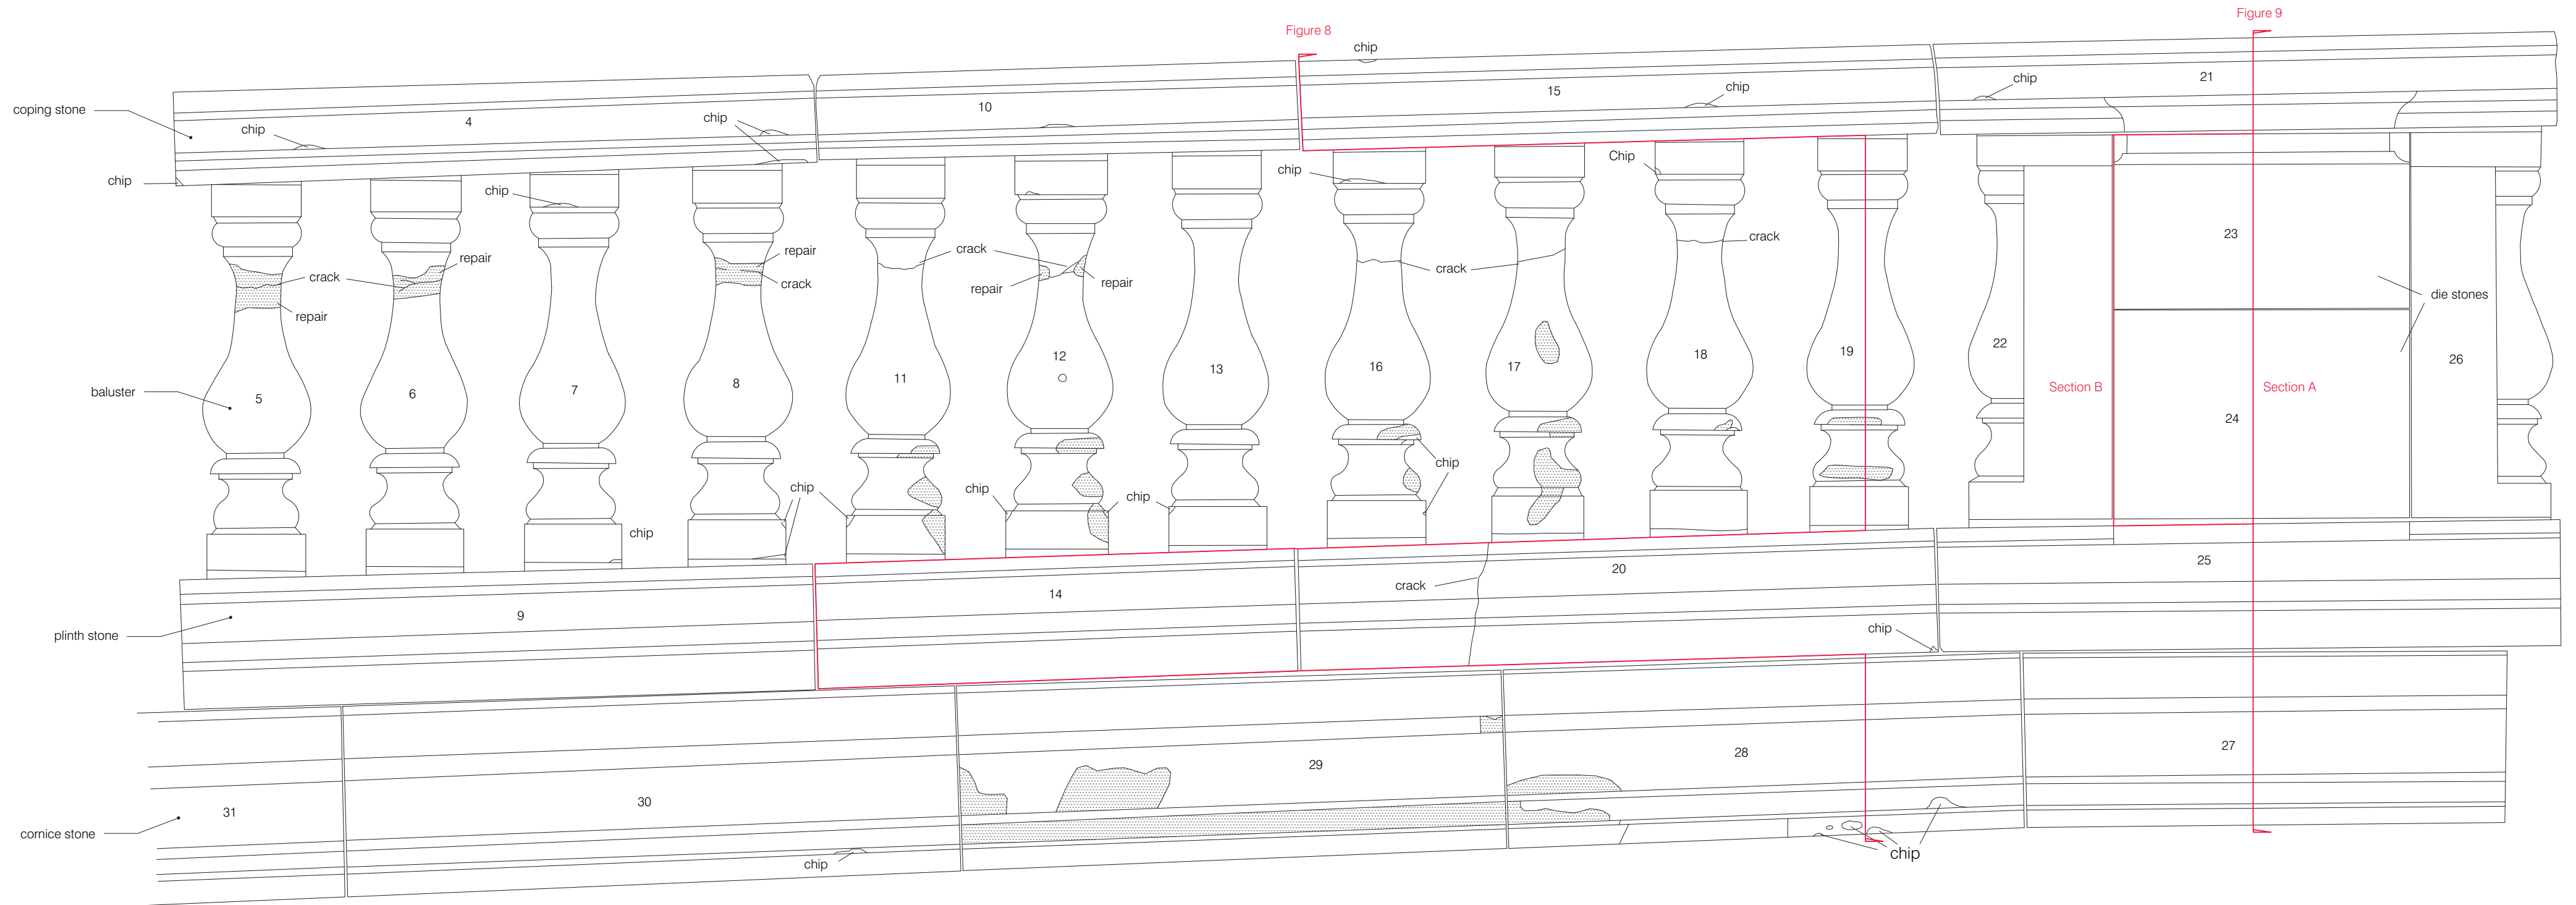
Area of severe weathering

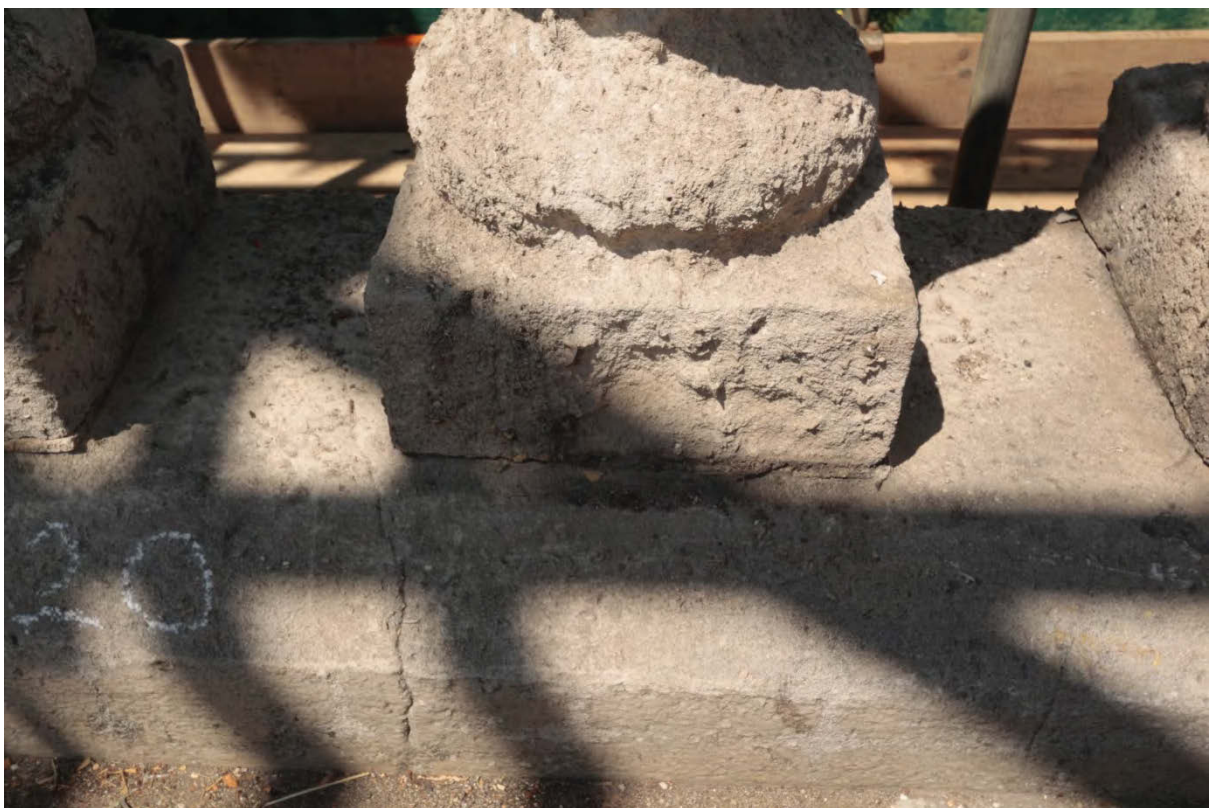
- 6.1.2 All of the stones within the recorded parapet panel exhibited varying levels of weathering. This variety in degradation is due to the composition of the shale bed Portland stone. The large concentration of shell fragments within the stone creates natural weaknesses and voids that breakdown at different rates. An example of this weathering was visible towards the base of baluster 17 (**Figure 5**; **Plate 9**).

- 6.1.4 Most of the joints between the coping stones appeared to be in fairly good condition (**Plate 11**). Each joint had a diamond shaped pouring point which had been filled with cementitious mortar (**Figure 7**; **Plate 11**). The joint between coping stones 4 and 10 (**Plate 12**) had moved slightly due to local settling within the bridge structure. This movement was also possibly the cause of the cracking which was visible in most of the necks of the balusters and in plinth stone 20 (**Figures 4** and **5**; **Plate 9**).

Plate 9 Cracks in plinth stone 20 and weathering on baluster 17, looking west (CIS13 D1 3217)

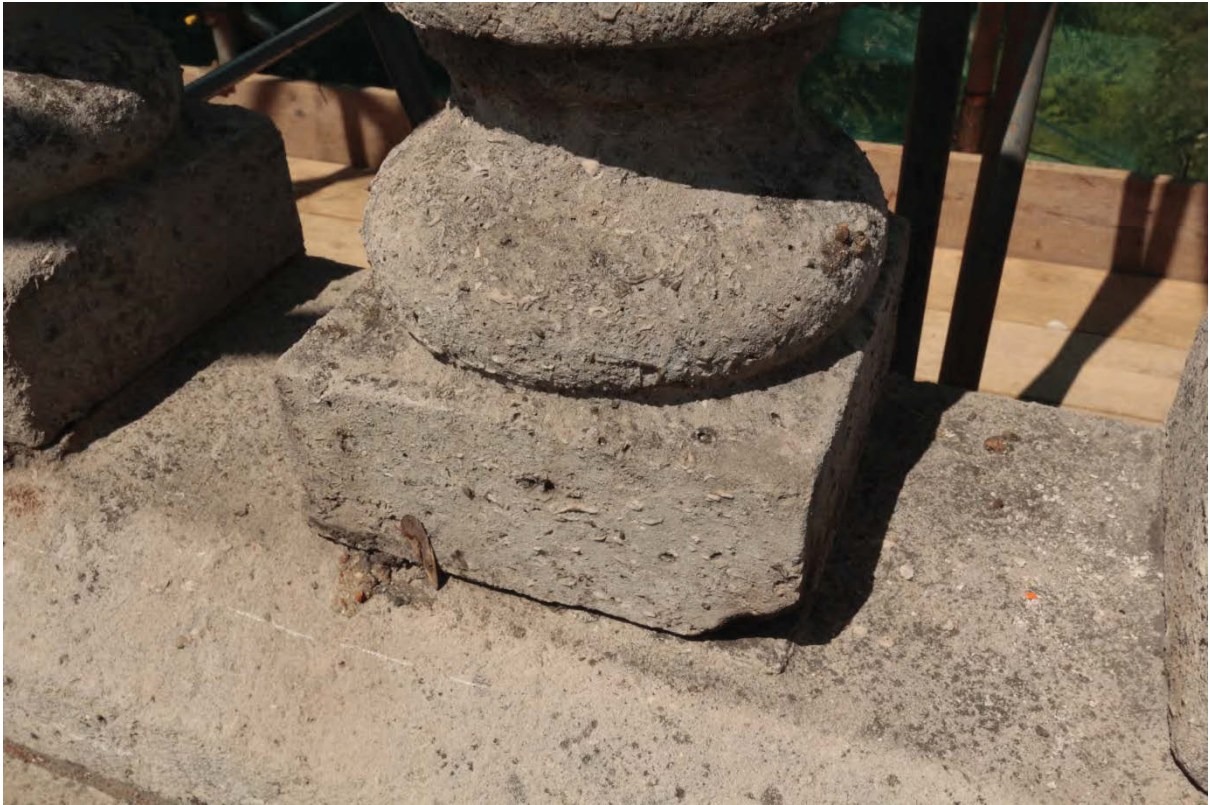
- 6.1.3 Many of the coping stones and balusters have received small chips from accidental impact damage (**Figures 4** and **5**). This type of damage was evident at the base of baluster 7 (**Plate 10**).

Plate 10 Detail of chip at base of baluster 7, interior (east) elevation, looking west (CIS13 D1 3201)

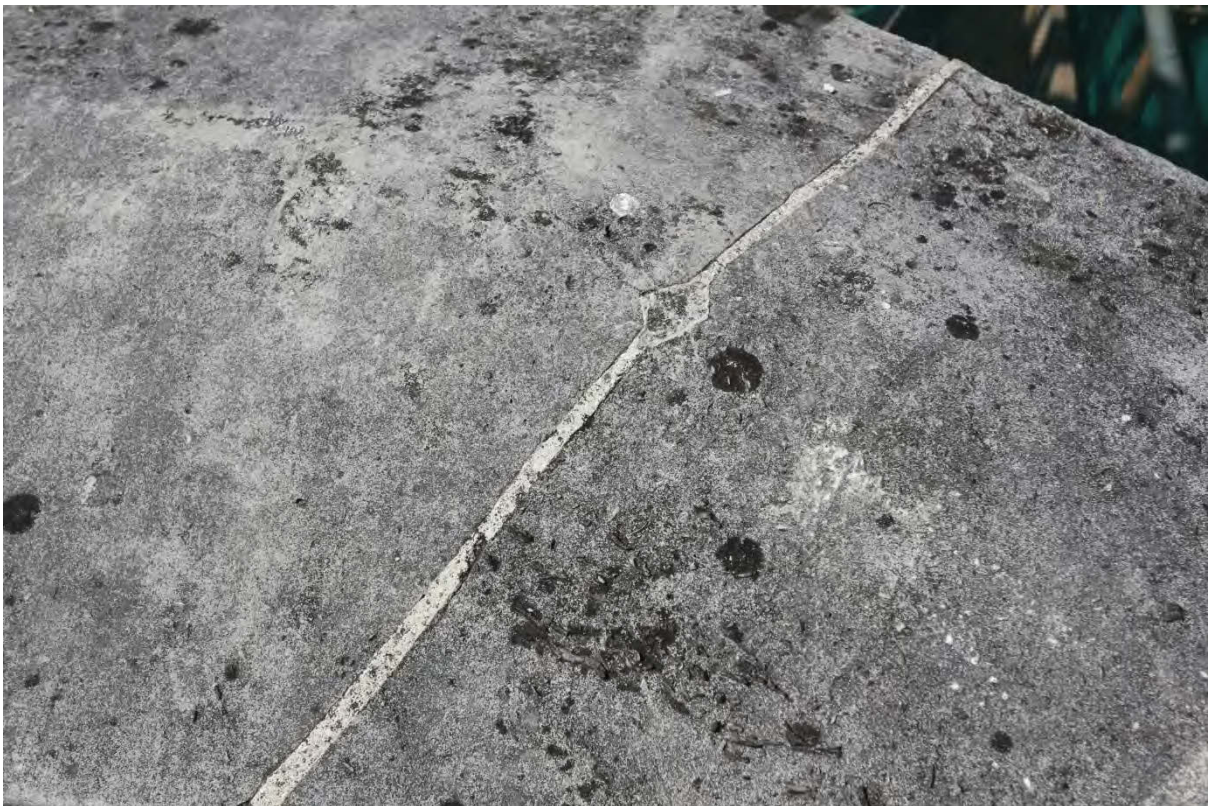
Plate 11 Joint between two coping stones by the staircase near but outside the recorded parapet panel, looking south-west (CIS13 D1 3254)

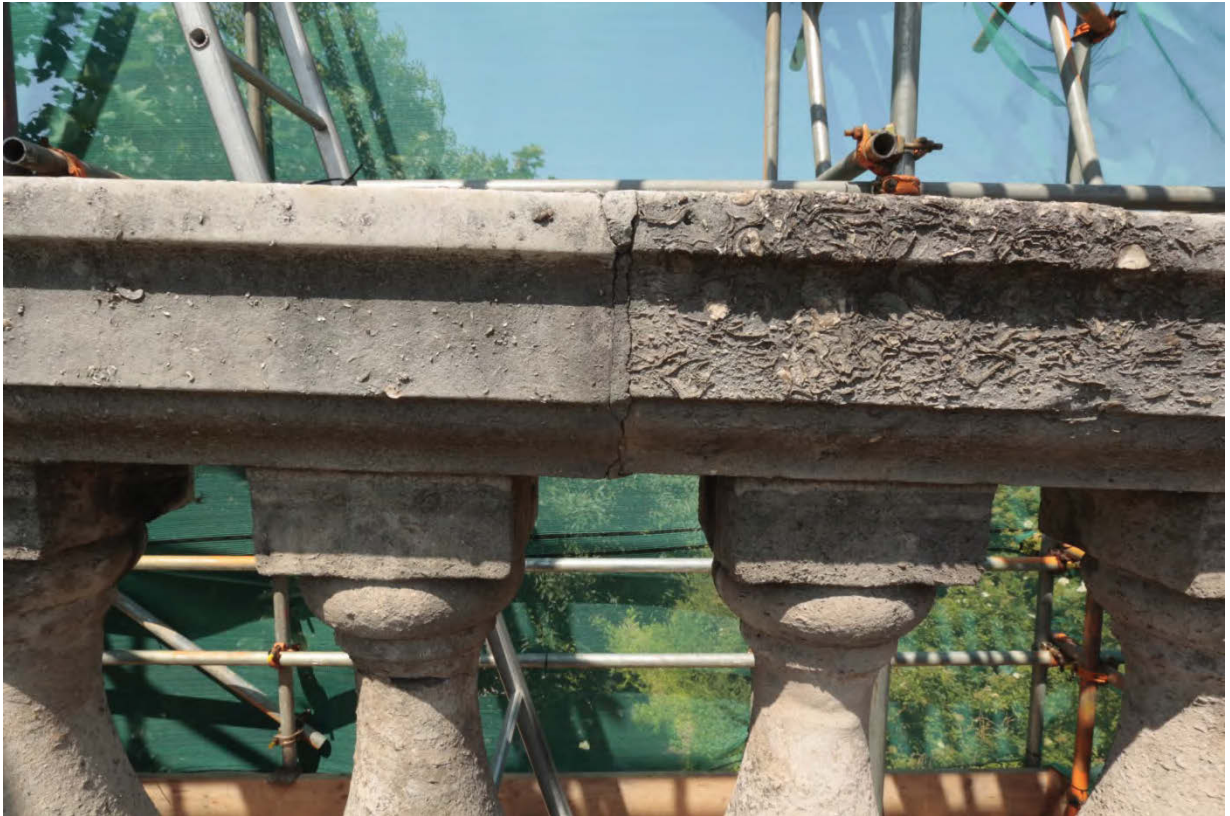
Plate 12 Differential height between coping stones 4 and 10, interior (east) elevation, looking west (CIS13 D1 3205)

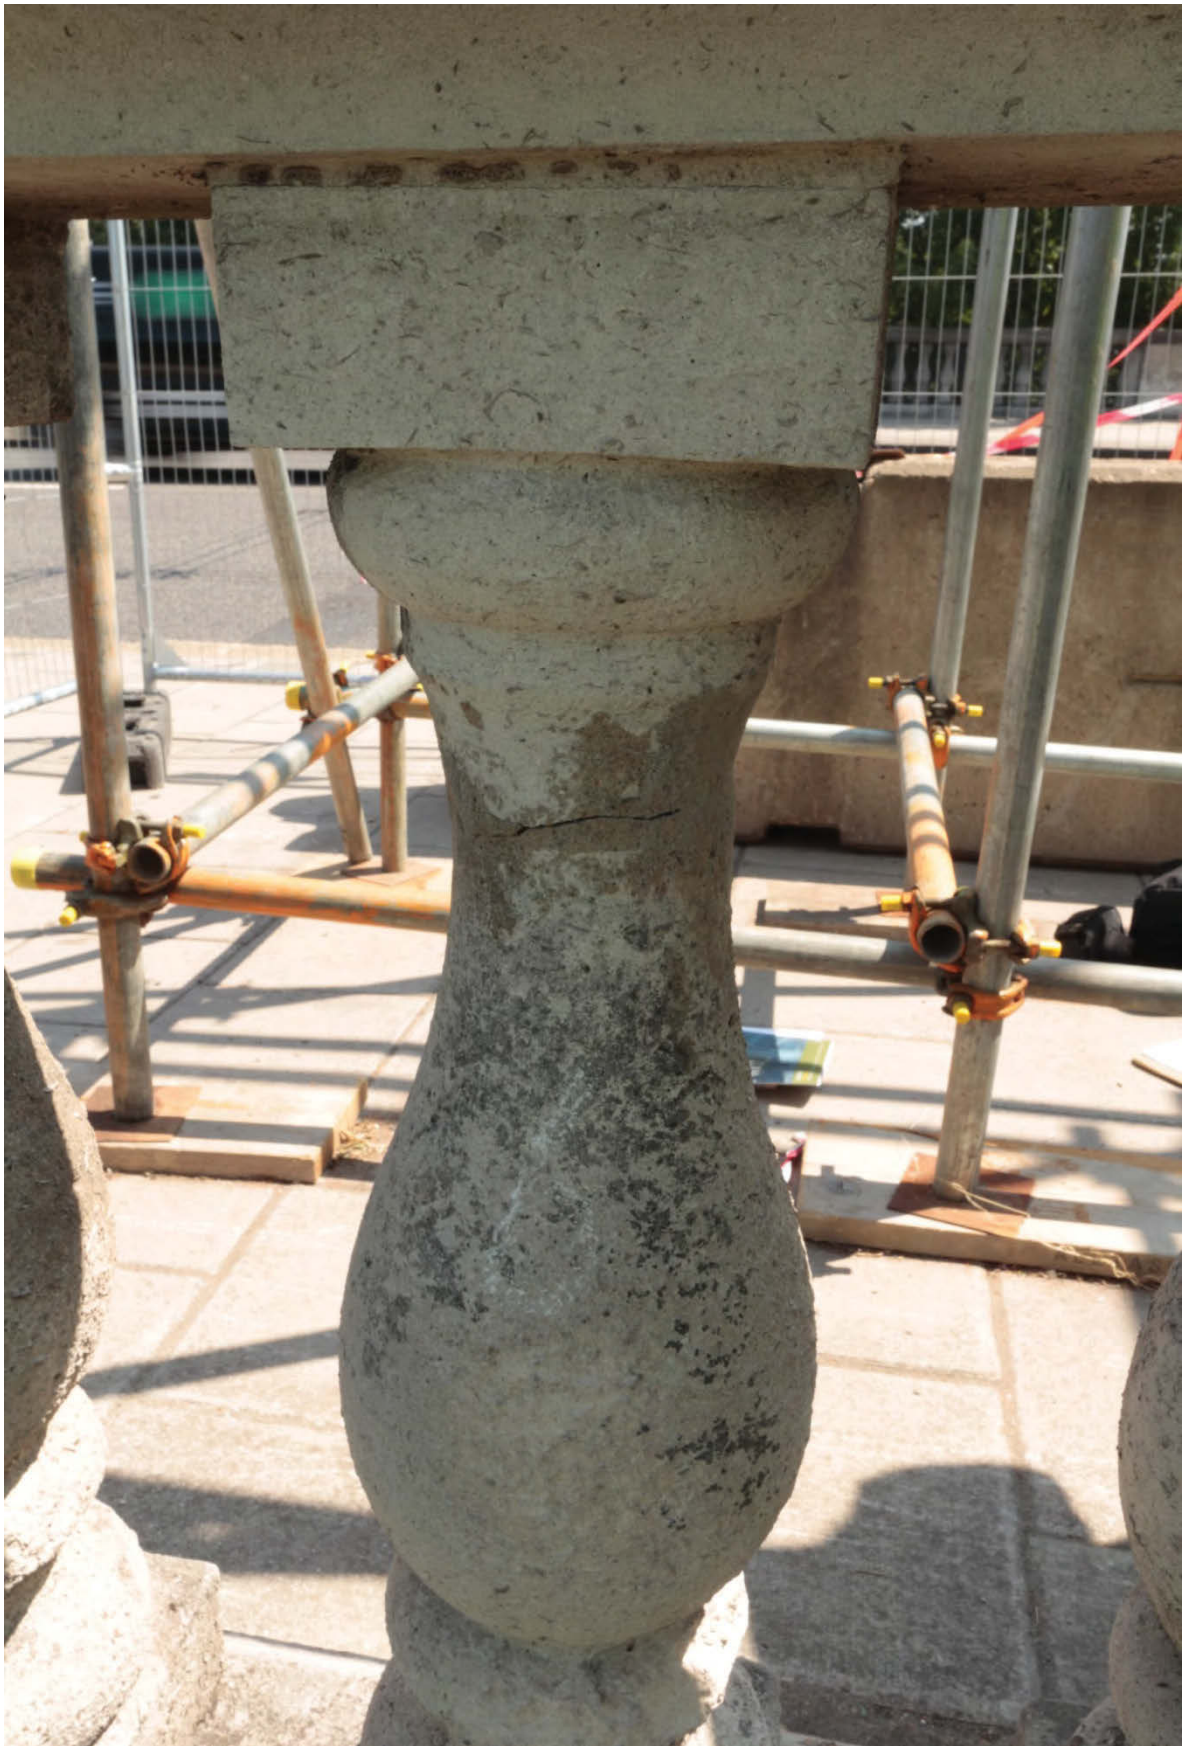
- 6.1.5 Several of the balusters showed signs of repair (**Figures 4** and **5**; **Plate 13**). These repairs, using a yellowish grey sandy cementitious mortar, appeared to be little more than cosmetic with the mortar smeared around the crack. The extent of the damage to the balusters was most clearly demonstrated during the lifting of coping stone 4 (**Plate 14**). Of the 11 balusters recorded in the area of investigation only three (balusters 7, 13 and 19) were not cracked at the neck (**Figures 4** and **5**).

Plate 13 Repair of baluster 6, external (west) elevation, looking east (CIS13 D1 3240)

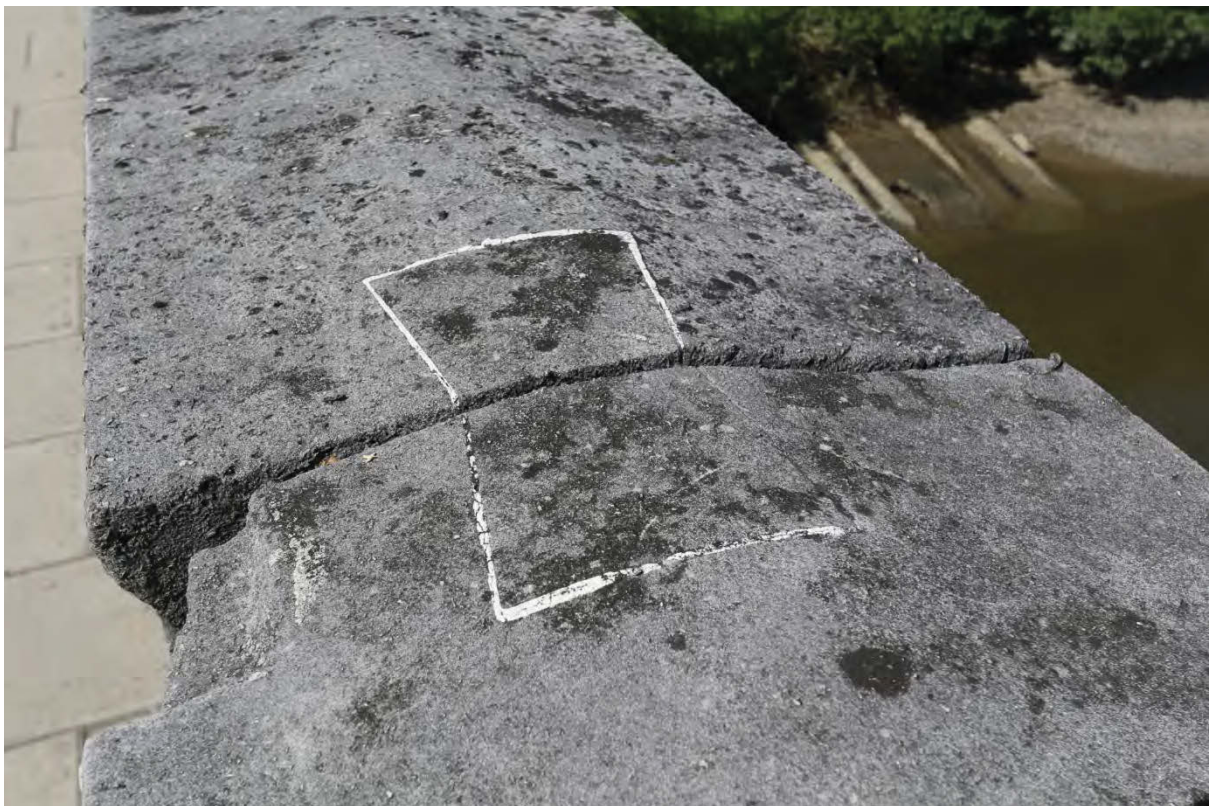
- 6.3.1 Towards the centre of the bridge several coping stones had been altered to include a butterfly joint and a new dowel, which appears to be metal (**Plate 27**). These repairs may have been an attempt to reduce the amount of movement within the bridge structure or simply to reinforce the coping along the parapet.
- 6.3.2 Just below the recorded parapet panel, part of an ashlar block was removed from the external (west) elevation of the bridge by the stone masons at Stonewest (**Plate 28**). This exposed a fixing, possibly bronze, between it and the ashlar block above.

Plate 27 Butterfly repair, near the centre of the west side of the bridge, looking south (CIS13 D1 3257)

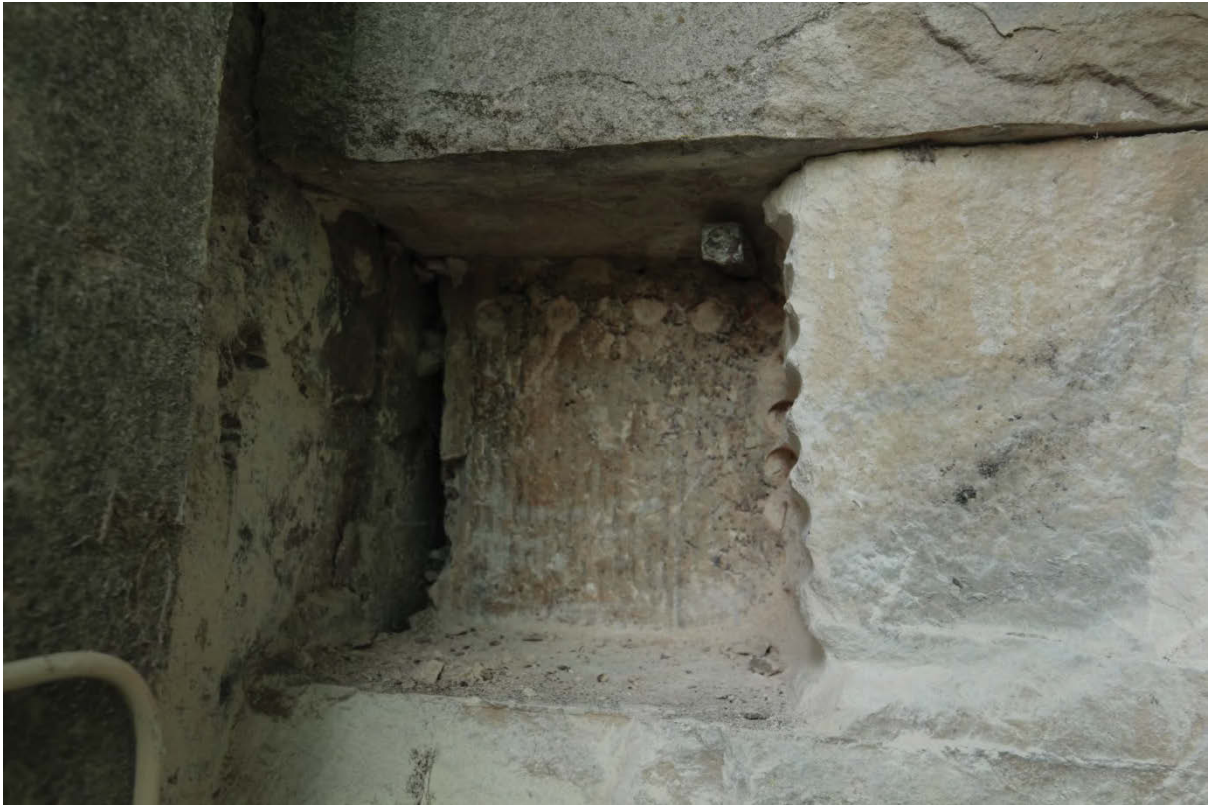
Plate 28 Metal fixing behind ashlar block, looking east (CIS13 D1 3294)
