**HISTORIC BUILDING SURVEY OF
FORMER STABLE BUILDING AT
BREEDON HALL, BREEDON-ON-
THE-HILL, LEICESTERSHIRE**

PCA REPORT NO: 11491

SEPTEMBER 2013

**Historic Building Survey of former Stable Buildings, No. 8 the Delph, Breedon Hall,
Breedon-on-the-Hill, Leicestershire.**

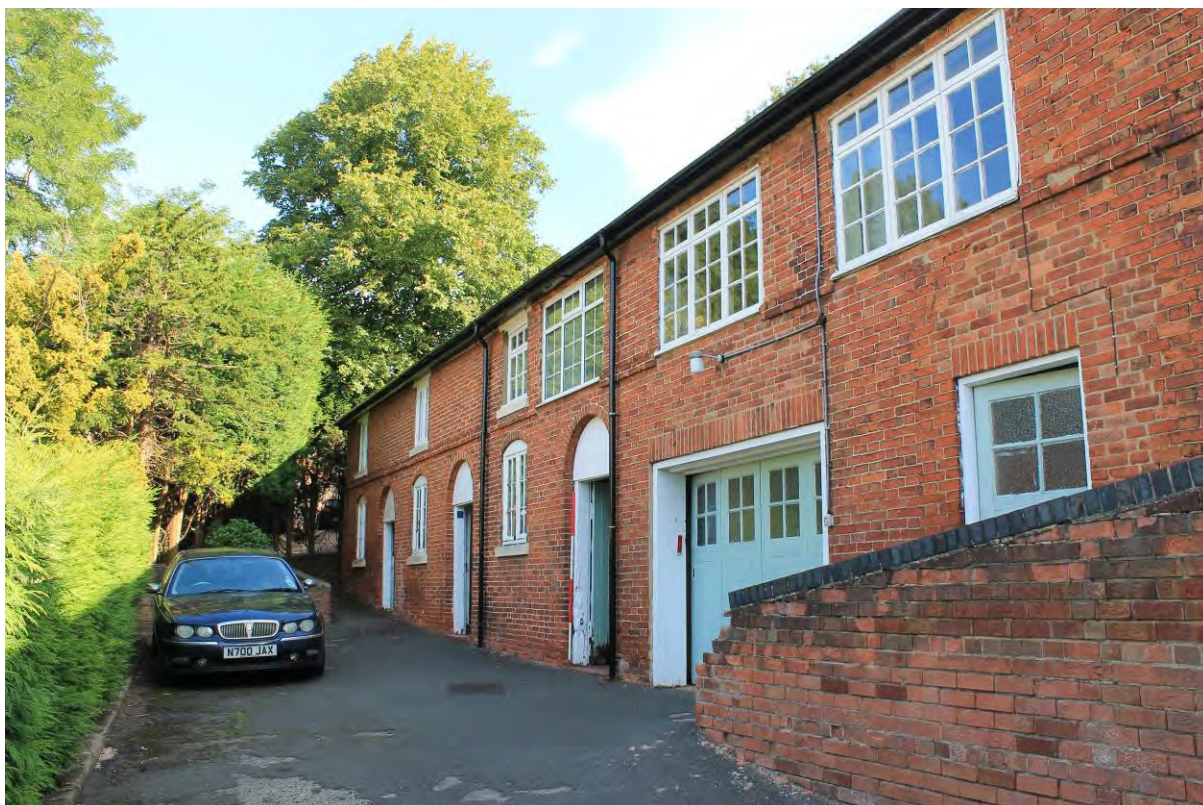
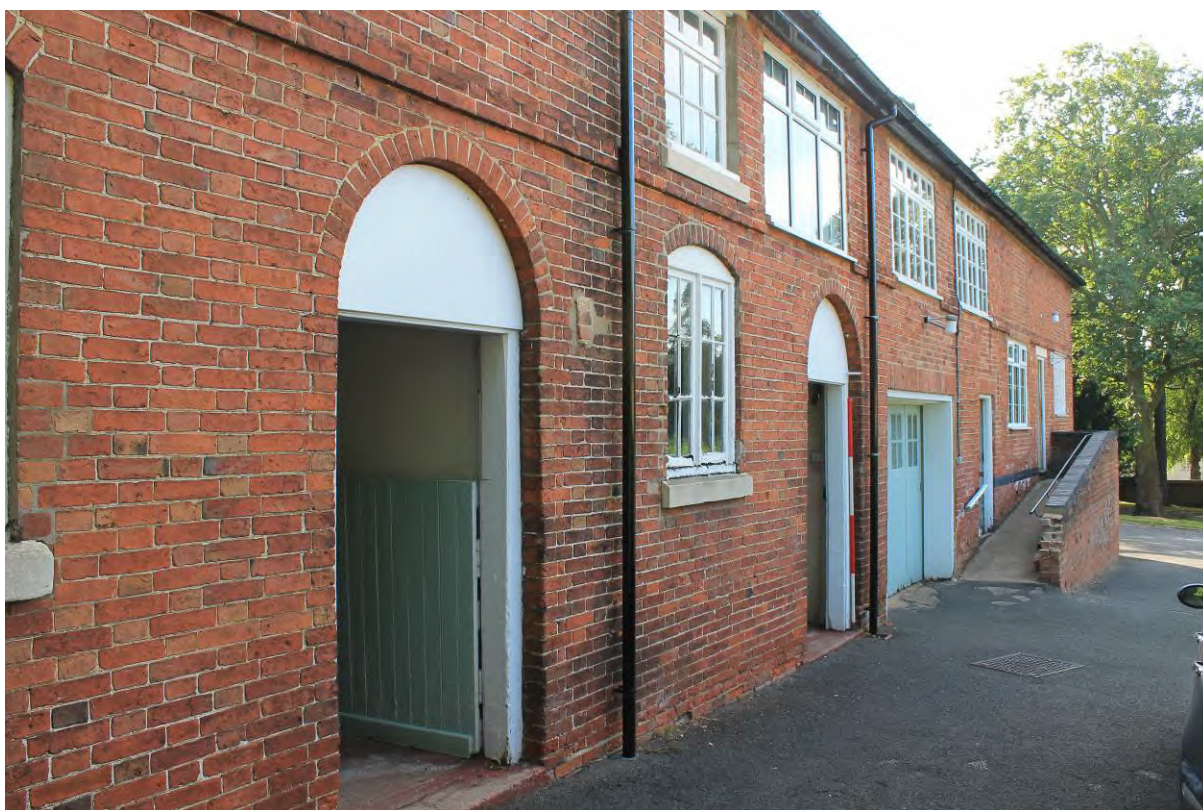
6.3 Principal Western Elevation (Plates 3 & 4)

- 6.3.1 The stable is laid out over twelve bays and two storeys with its principal elevation facing west. This can be divided, by function, into the northern and southern bays with those to the north comprising the former stables and to the south, staff accommodation. The northern bays of the elevation were considerably less altered and included original window and door openings, while those bays to the south included much re-fenestration and re-organisation.

- 6.3.2 The brickwork comprised good quality red bricks with smooth faces and sharp arises. A few burnt headers were present (not as a decorative element) as were examples with kiss marks and others with horizontal squish marks. The bricks measured on average 230-235mm x 55-60mm x 110mm and were laid in Flemish bond. Queen closers were used around the openings and angles (but not seen around the later inserted/rebuilt openings) and the wall measured 14 inches thick, i.e. one and a half bricks. The brickwork was bound by a lime mortar with a high lime content, which was notably finished using penny-struck joints. This decoration was also seen (partly) across the less visible southern and northern elevations.

- 6.3.3 Architectural embellishment of the elevation was restrained. This mainly comprised a protruding two-brick floor band which extended the length of the elevation just below the level of the first floor windows and the use of brick arches to some of the openings. The floor/sill band had however been interrupted and rebuilt as a consequence of later re-fenestration works, particularly that allied with the insertion of the modern first floor windows into

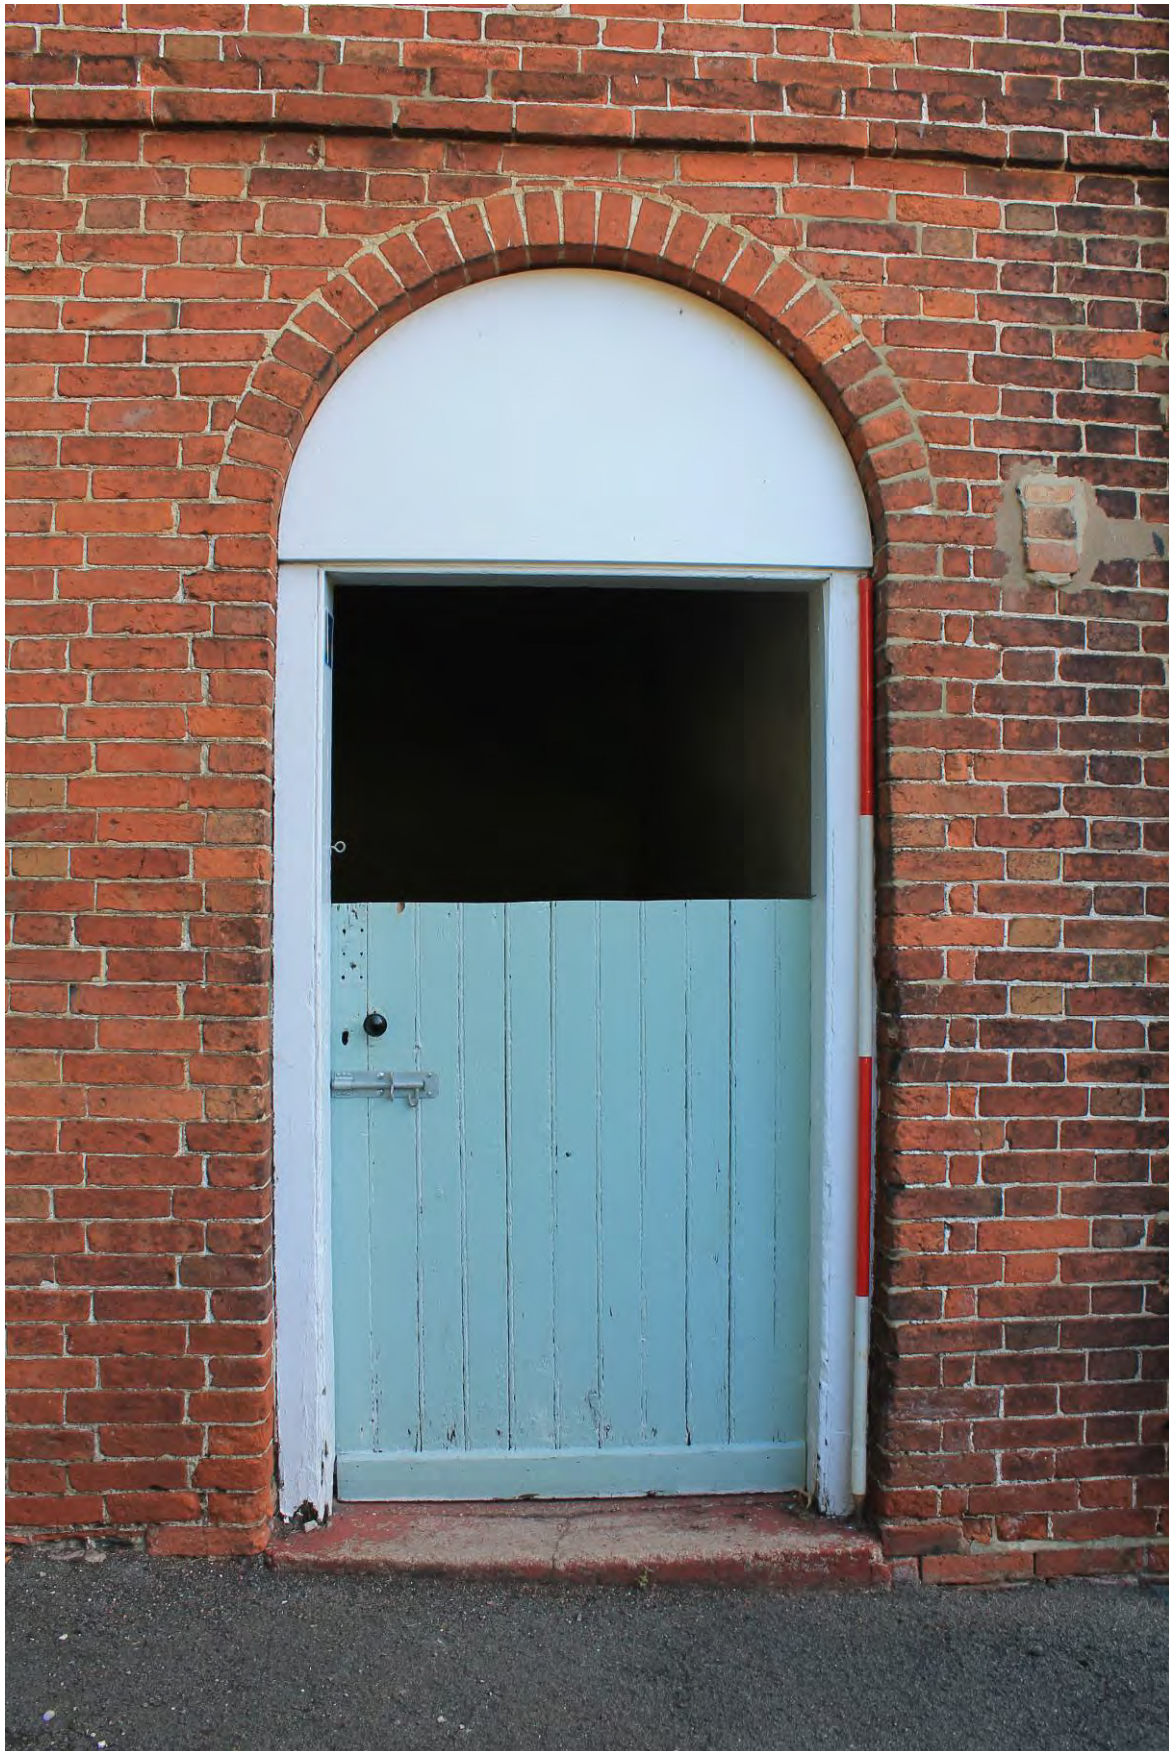
Plate 5 Arch Headed Stable Door Opening and cut-down Door

6.3.5 The northern bays included three, original, half-round arch-headed door openings with rough brick heads of a single on-edge course and three original window openings at ground and first floor. The tympanum of all three door openings into each stable bay were latterly boarded over, but once probably comprised a simple mesh or ventilator to the stable. The timber architraves to the doors were original, with a beaded detail to the inner medial edge and were generally in a fair condition despite some rot at the base. The bead decoration was also a feature of the surviving doors, with each vertical board beaded along one edge both internally and externally. The two northern doors were half doors (lower section of a stable door) while the southernmost (to room 3) retained a full height door. Inspection showed that the two northern half doors were in fact cut down examples of the full height door to room (3). The latter, though rotten along its base, survived intact. It is a ledge and batten door with diagonal set bracing to the rear and was hung on a pair of heavy wrought iron strap hinges.

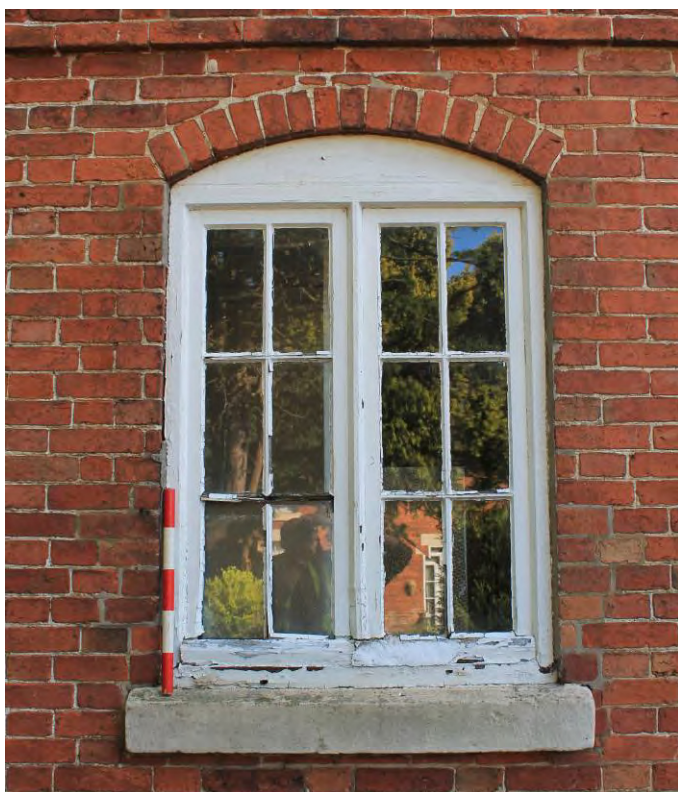
Plate 6 Ground Floor Window

6.3.6 The ground floor window openings were built with rough brick heads (as the door openings) and whilst this plain treatment may suggest that the elevation was originally plastered (as ashlar render), the use of the penny struck detailing argues that if this was the case, its removal was quite early. The windows of the first floor were tucked under the eaves line and accordingly had simple stone lintels built flush with the brickwork. All the openings were built with plain limestone sills (5½ inch deep), those to the first floor resting upon the brick first floor band. The fenestration was generally in a poor condition but comprised two fixed (no sign of hinges) casements of six narrow rectangular lights. The glazing bars had an ovolo detail along the inner side and a plain detail to the exterior. They typically appear to date to the 19th century or later.

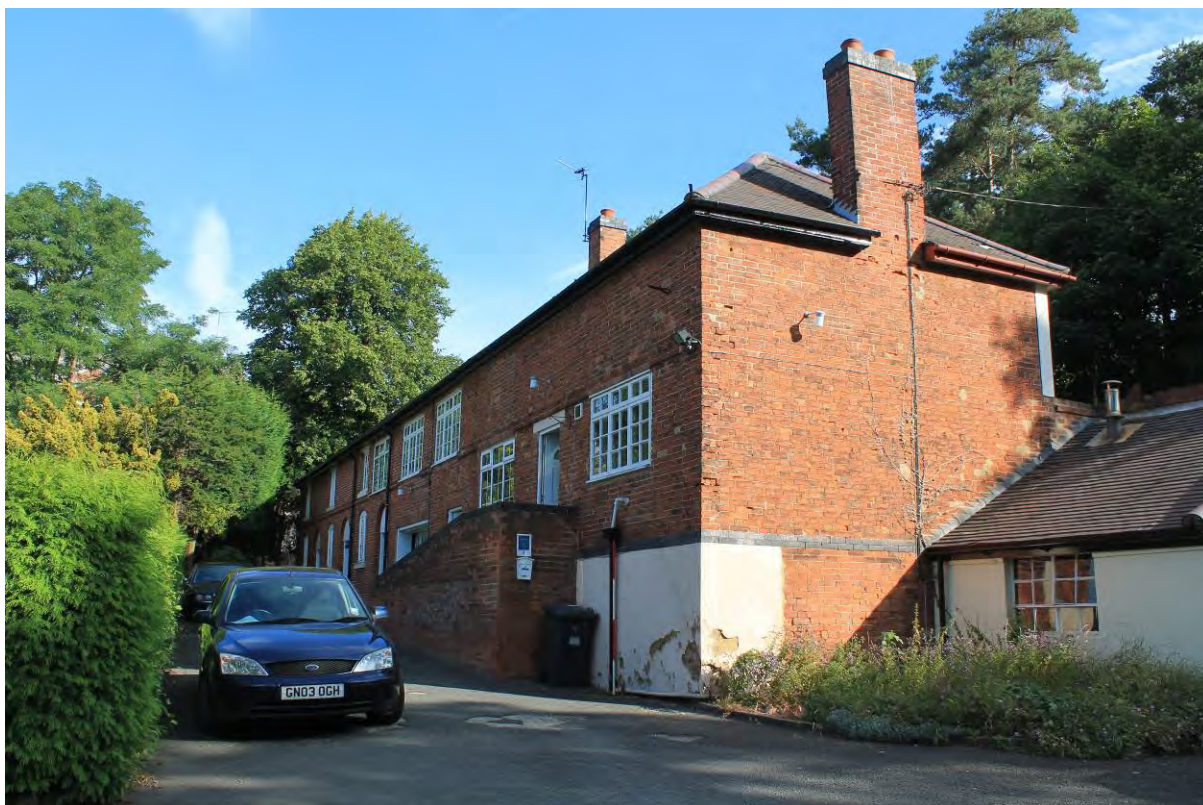
6.3.7 Southern Bays (Plate 9)

6.3.8 The southern bays were considerably more altered than those to the north. These alterations include the insertion of a wide garage door opening into the central bays (Room 4) at ground, the insertion of three large modern windows into the central bays at first floor (Rooms 11, 10 & 9) and corresponding modern windows into the kitchen and sitting room (Rooms 6 & 8). These windows were either timber-built casements with hoppers or replacement UPVC examples of a similar design. These openings all have flat heads with soldier courses and are likely contemporary insertions, carried out when the building was converted to part residential use during the mid 1980s. The location of two former first floor windows was apparent above the two inserted windows to the kitchen and sitting room (Rooms 6 & 8). Both were blocked using brick and were of a similar size as those original openings to the east. They were very likely blocked when the internal floor levels within the southern bays were altered during the conversion works in the 1980s. Another significant alteration to the elevation includes the addition of an unsympathetic brick-built ramped access to the southern rooms.

6.3.9 A two brick wide blue brick band, not present in the northern bays, was present toward the base of the wall from the doorway into room (5) to the south angle, continuing around to the southern elevation. As the band respected both doorways, they are likely to be contemporary and original features.

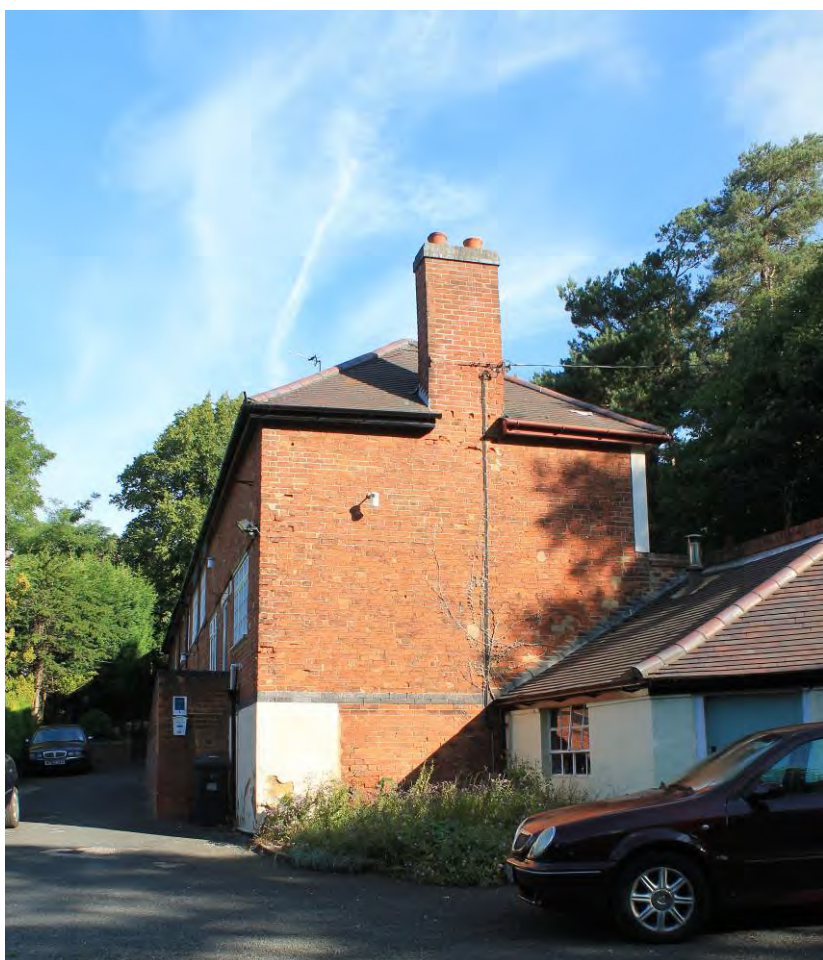
6.4 Southern Elevation (Plate 10)

6.4.1 The southern elevation is constructed using the same brickwork as that used in the principal elevation and includes the blue brick floor band that delineates the height of the floor/undercroft. This band also delineates an area of modern render which wraps around the south western angle. The brickwork bond is

more irregular along the southern elevation, particularly below the floor band, possibly suggesting that this work was not meant to be visible.

6.4.2 The elevation is and was built without openings and includes a centrally positioned end wall chimney stack. This rises through the eaves line and is capped by a blue brick over-sailing course. The brickwork of the stack above the eaves however appears to be different to the main elevation, suggesting that it is either a later addition or a more recent rebuilding.

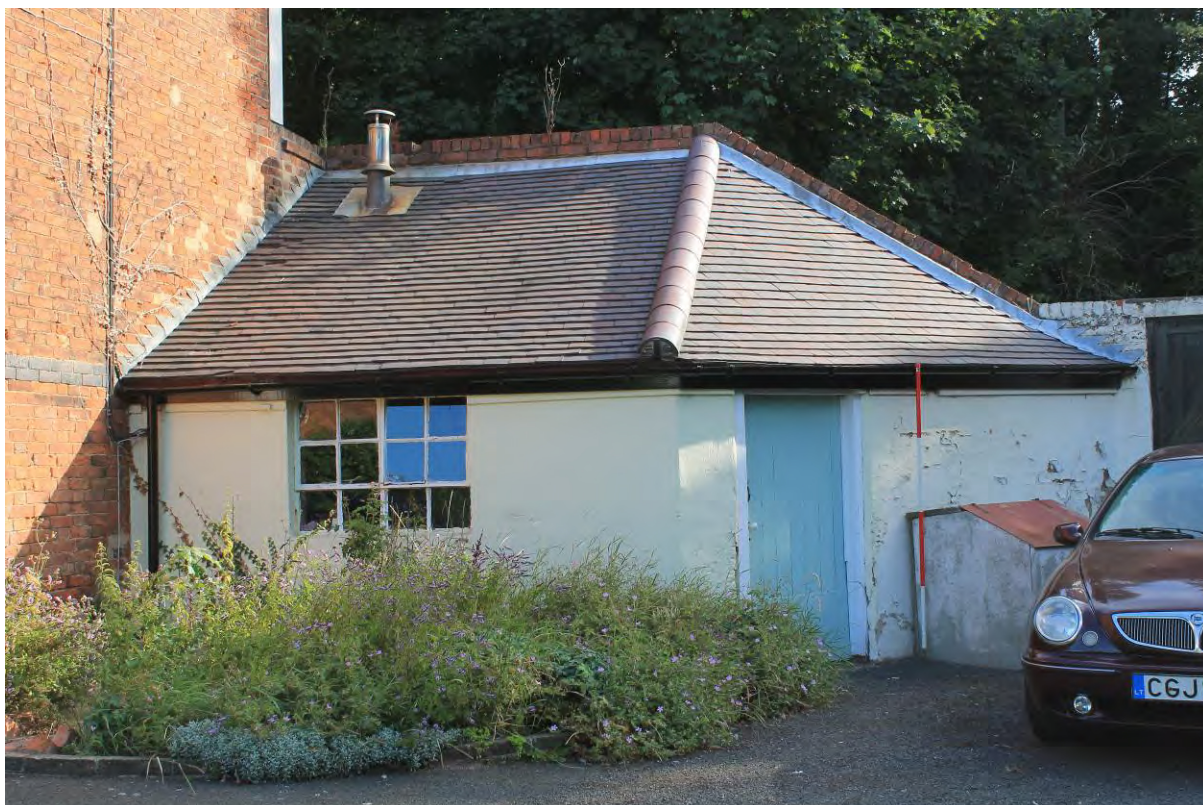
Plate 11 Lean-to looking East

6.4.3 A small lean-to (boiler house) accretion butts up against the southern elevation and backs onto the eastern boundary wall (**Plate 11**). It has a canted end wall to the south and a fully hipped roof covered with modern plain tiles (as stable block) and half round ridge/hip tiles. The lean-to has rendered brick built walls and incorporates a door opening in the canted wall and a 20th century metal framed casement window. Internally the roof of the lean-to is supported by a single truss, constructed from re-used timber from a considerably older building (**Plate 12**). The lean-to includes a boiler serving the adjacent residential accommodation and access to the sub-floor void of the undercroft. Access was not available but it was clear that the floor joists of the southern bays ran east-west across the shortest distance and were supported by dwarf walls of honeycomb brickwork.

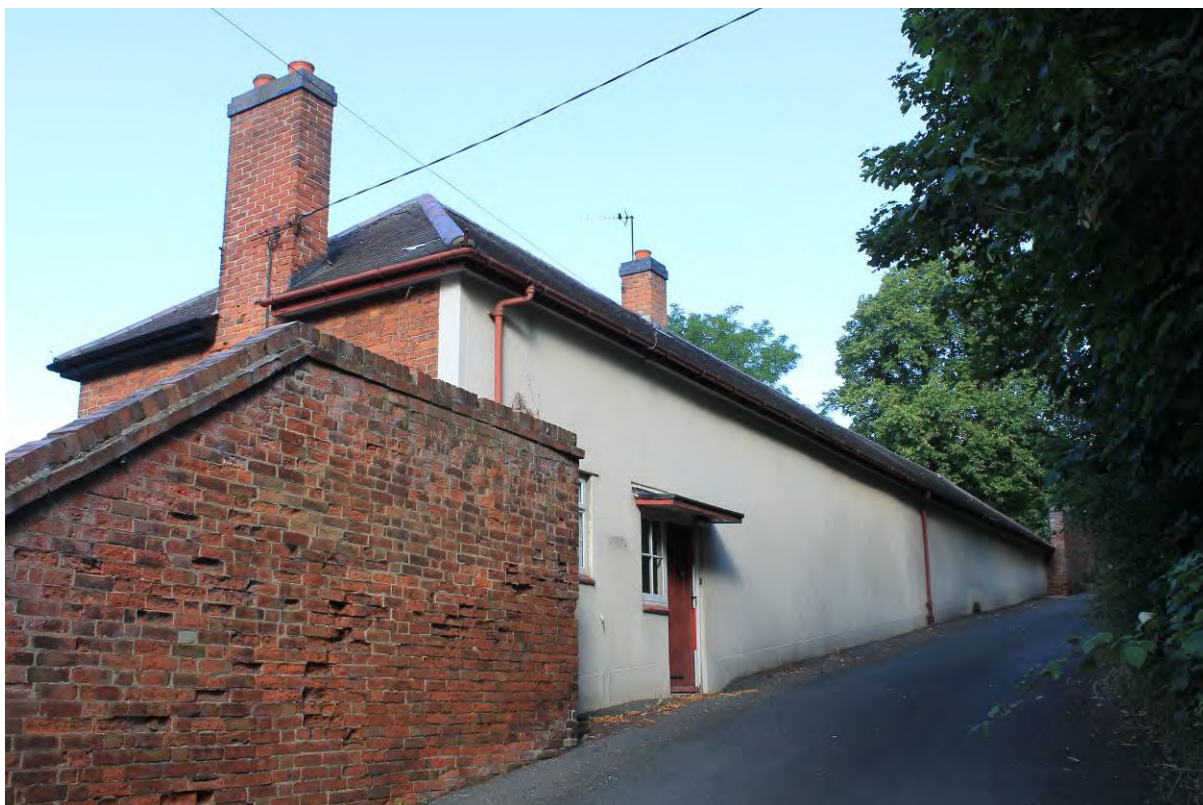
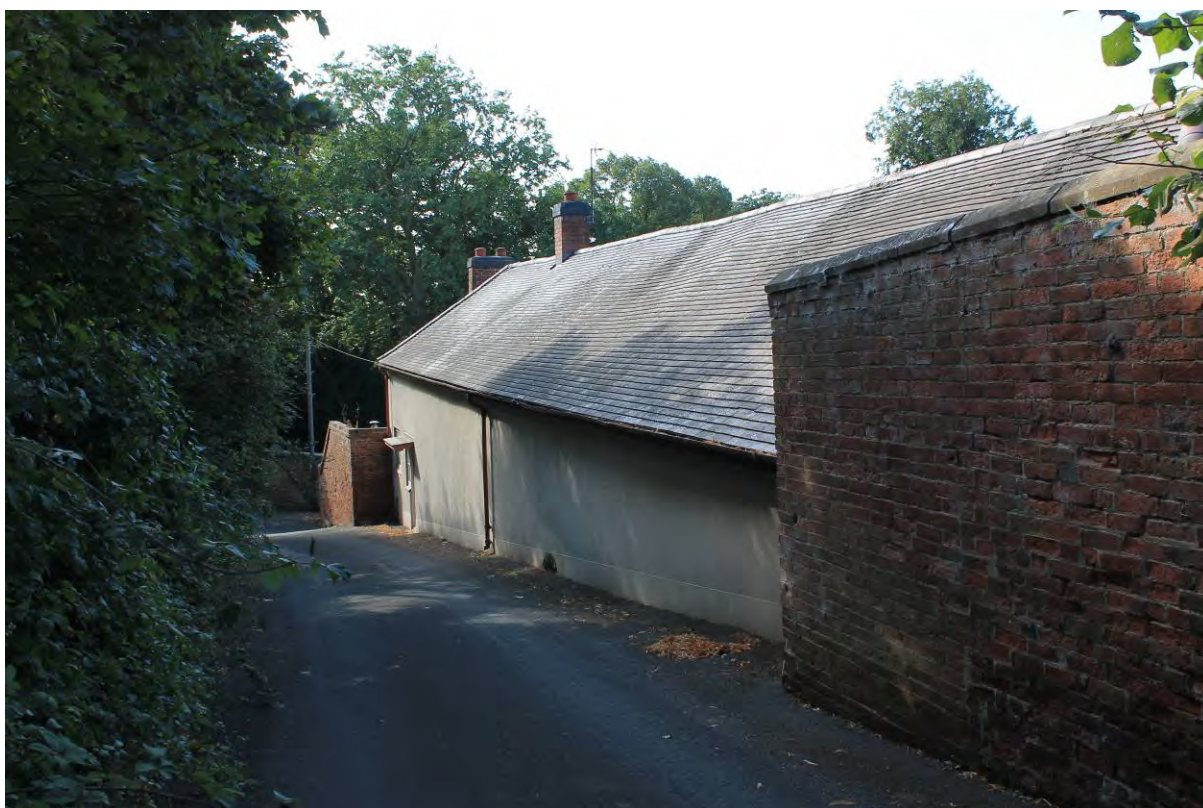
6.6 Western Elevation (Plates 13 & 14)

6.6.1 The western elevation, fronting onto The Delph was part obscured, particularly across the northern bays, by the gradient as the land rises up to the north. The western elevation, unlike those facing into the hall grounds, was covered by a modern rough-cast render. The elevation was devoid of openings along its length apart from an entrance and window in the southernmost bay. The door has a modern flat canopy, a glazed side light and lies to the north of a modern window to a bathroom (Room 7). The rough-cast render obscured all evidence of previous openings, of which there was a blocked door way and a window.

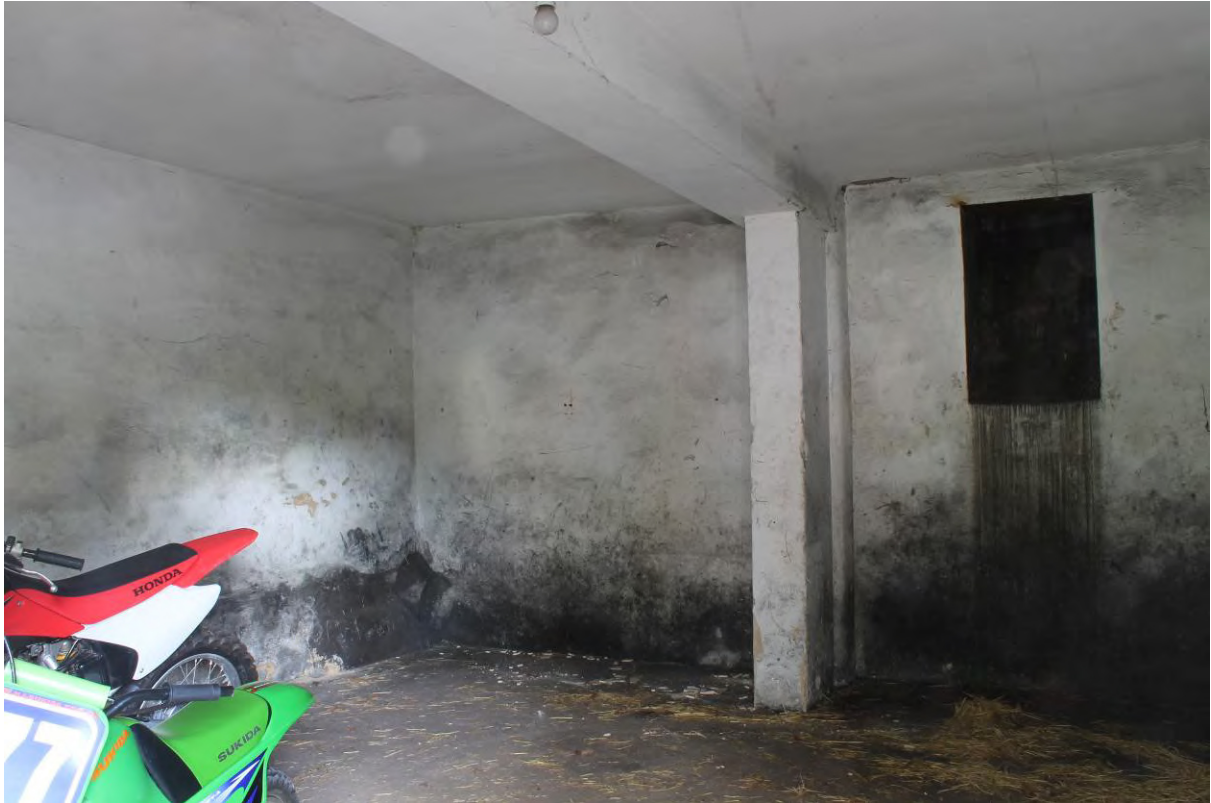
6.7.2 Stable, Room 1 (4.58m x 4.85m) (Plate 15)

6.7.3 The former stable (R1) is a two bay room divided centrally by a boxed-in binding joist (east-west) set into the wall between the door and the window openings. The walls were covered with a hard cement render and the floor resurfaced using a modern concrete screed. No original internal features or fittings associated with an equestrian use survived. This is due to its later re-use as a coal store for the main house. A coal chute, originating from the Delph (roadside), had been inserted along the eastern flank wall and into the southern bay. As this area coincided with where the food troughs and hay racks were likely to have been located, they were probably demolished when the room was converted to a coal store.

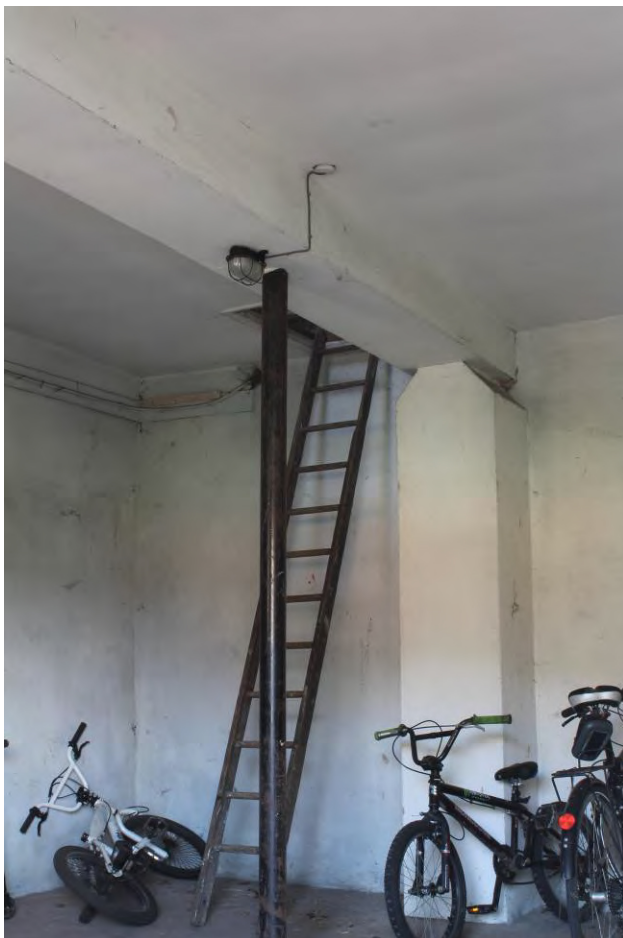
6.7.4 Stable, Room 2 (4.22m x 4.85m) (Plate 16)

6.7.5 In common with stable room (1) stable room (2) retained no original internal features or fittings associated with an equestrian. It is a two bay room divided

centrally by a boxed-in binding joist that was supported along the eastern wall by a pier and central by a iron column. The walls, as (1) were rendered and the floors covered in a modern concrete screed. A WC had been added, built into the north-western corner, while a open hatch in the ceiling, provided access, via a ladder, to the first floor rooms (13 and 14).

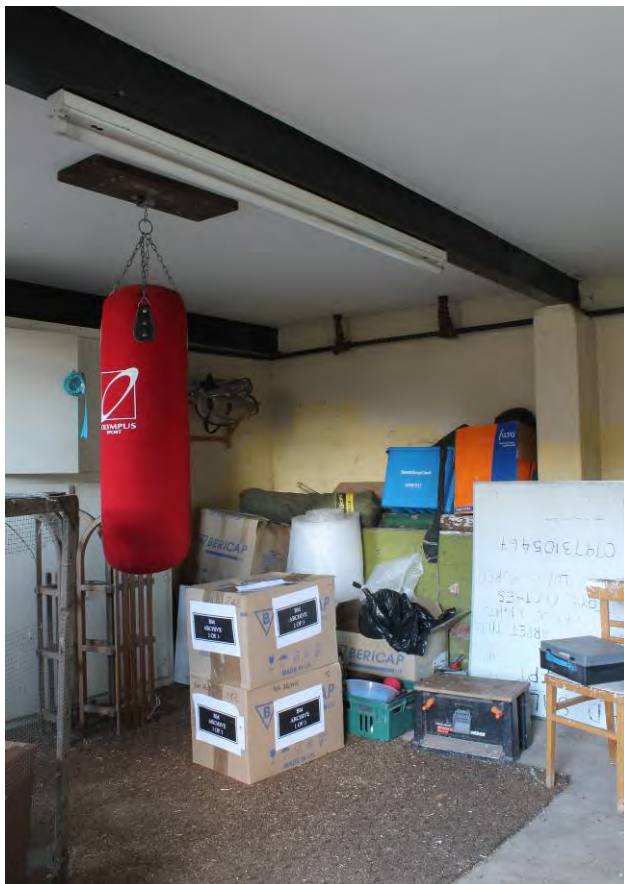
6.7.6 Stable Room 3, (4.50m x 4.86m) (Plate 17)

6.7.7 Stable Room (3) was also laid out over two roughly equal bays divided centrally by a modern inserted 8 x 4 inch H section steel beam supported by a pier along the east wall. Two more steel beams, presumably incorporated to strengthen the floor in association with the residential conversion above, followed the line of the northern and southern party walls. The floor and wall treatments were the same as rooms (1 and 2).

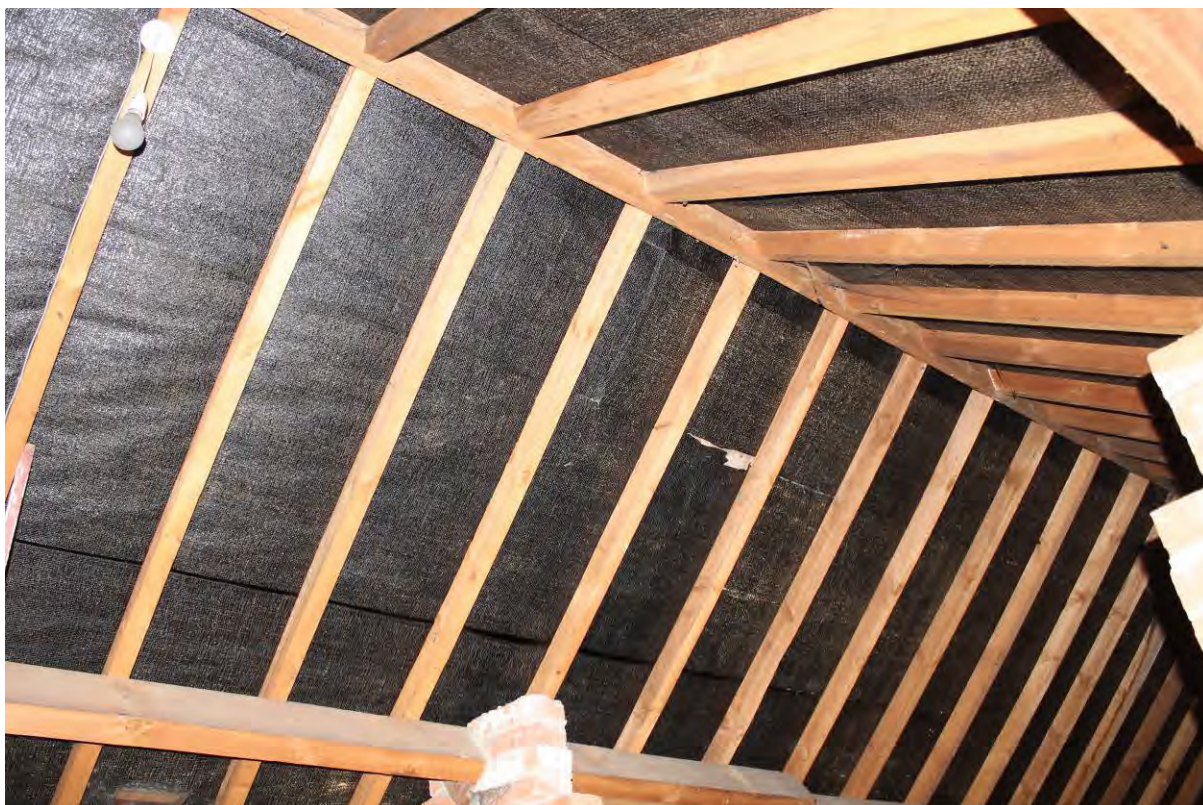
Plate 27 Roof over Southern bays, showing modern roof with ridge plank

6.7.24 The roof structure above these two northern rooms, and from a limited area inspected above the southern bays, was clearly a later, modern replacement. The roof is constructed from machine cut soft wood of very regular section. The rafters (3 x 2 inch) are set at 12 inch intervals and rise up to a thin board like ridge plank. The jack rafters to the hips are all nailed using iron cloat nails. The purlins however appear to be older and may have been re-used. They measured 7½ x 3 inches and were rather crudely joined along their length by simply over-lapping the purlins instead of joining end-on using a scarf joint. This method requires the construction of a supporting wall at the junction to hold the purlin in place. The wall plates, which do join end-on using simple unpegged side halved scarfs, were also modern replacements and were braced to the inner face of the walls using mild steel straps. Evidence of openings

- 7.1.2 Modern alterations to the stable building include some considerable works. The original roof structure to the entire range has been completely replaced with a modern machine cut soft wood roof structure, while the southern bays have, in recent years, been considerably re-modelled to form a residential annexe to the hall. The re-use of the stables for general storage and a coal store has removed most of the internal structural evidence relating to its former use, though a brick-built feed trough and the base of a similar structure, had survived within two of the former stables.
