**HISTORIC BUILDING
RECORDING AND
ARCHAEOLOGICAL
MONITORING AT PLESHEY
LODGE FARM BARN, THE
STREET, PLESHEY, ESSEX,
CM3 1HF**

PCA REPORT NO. R11608

JANUARY 2014

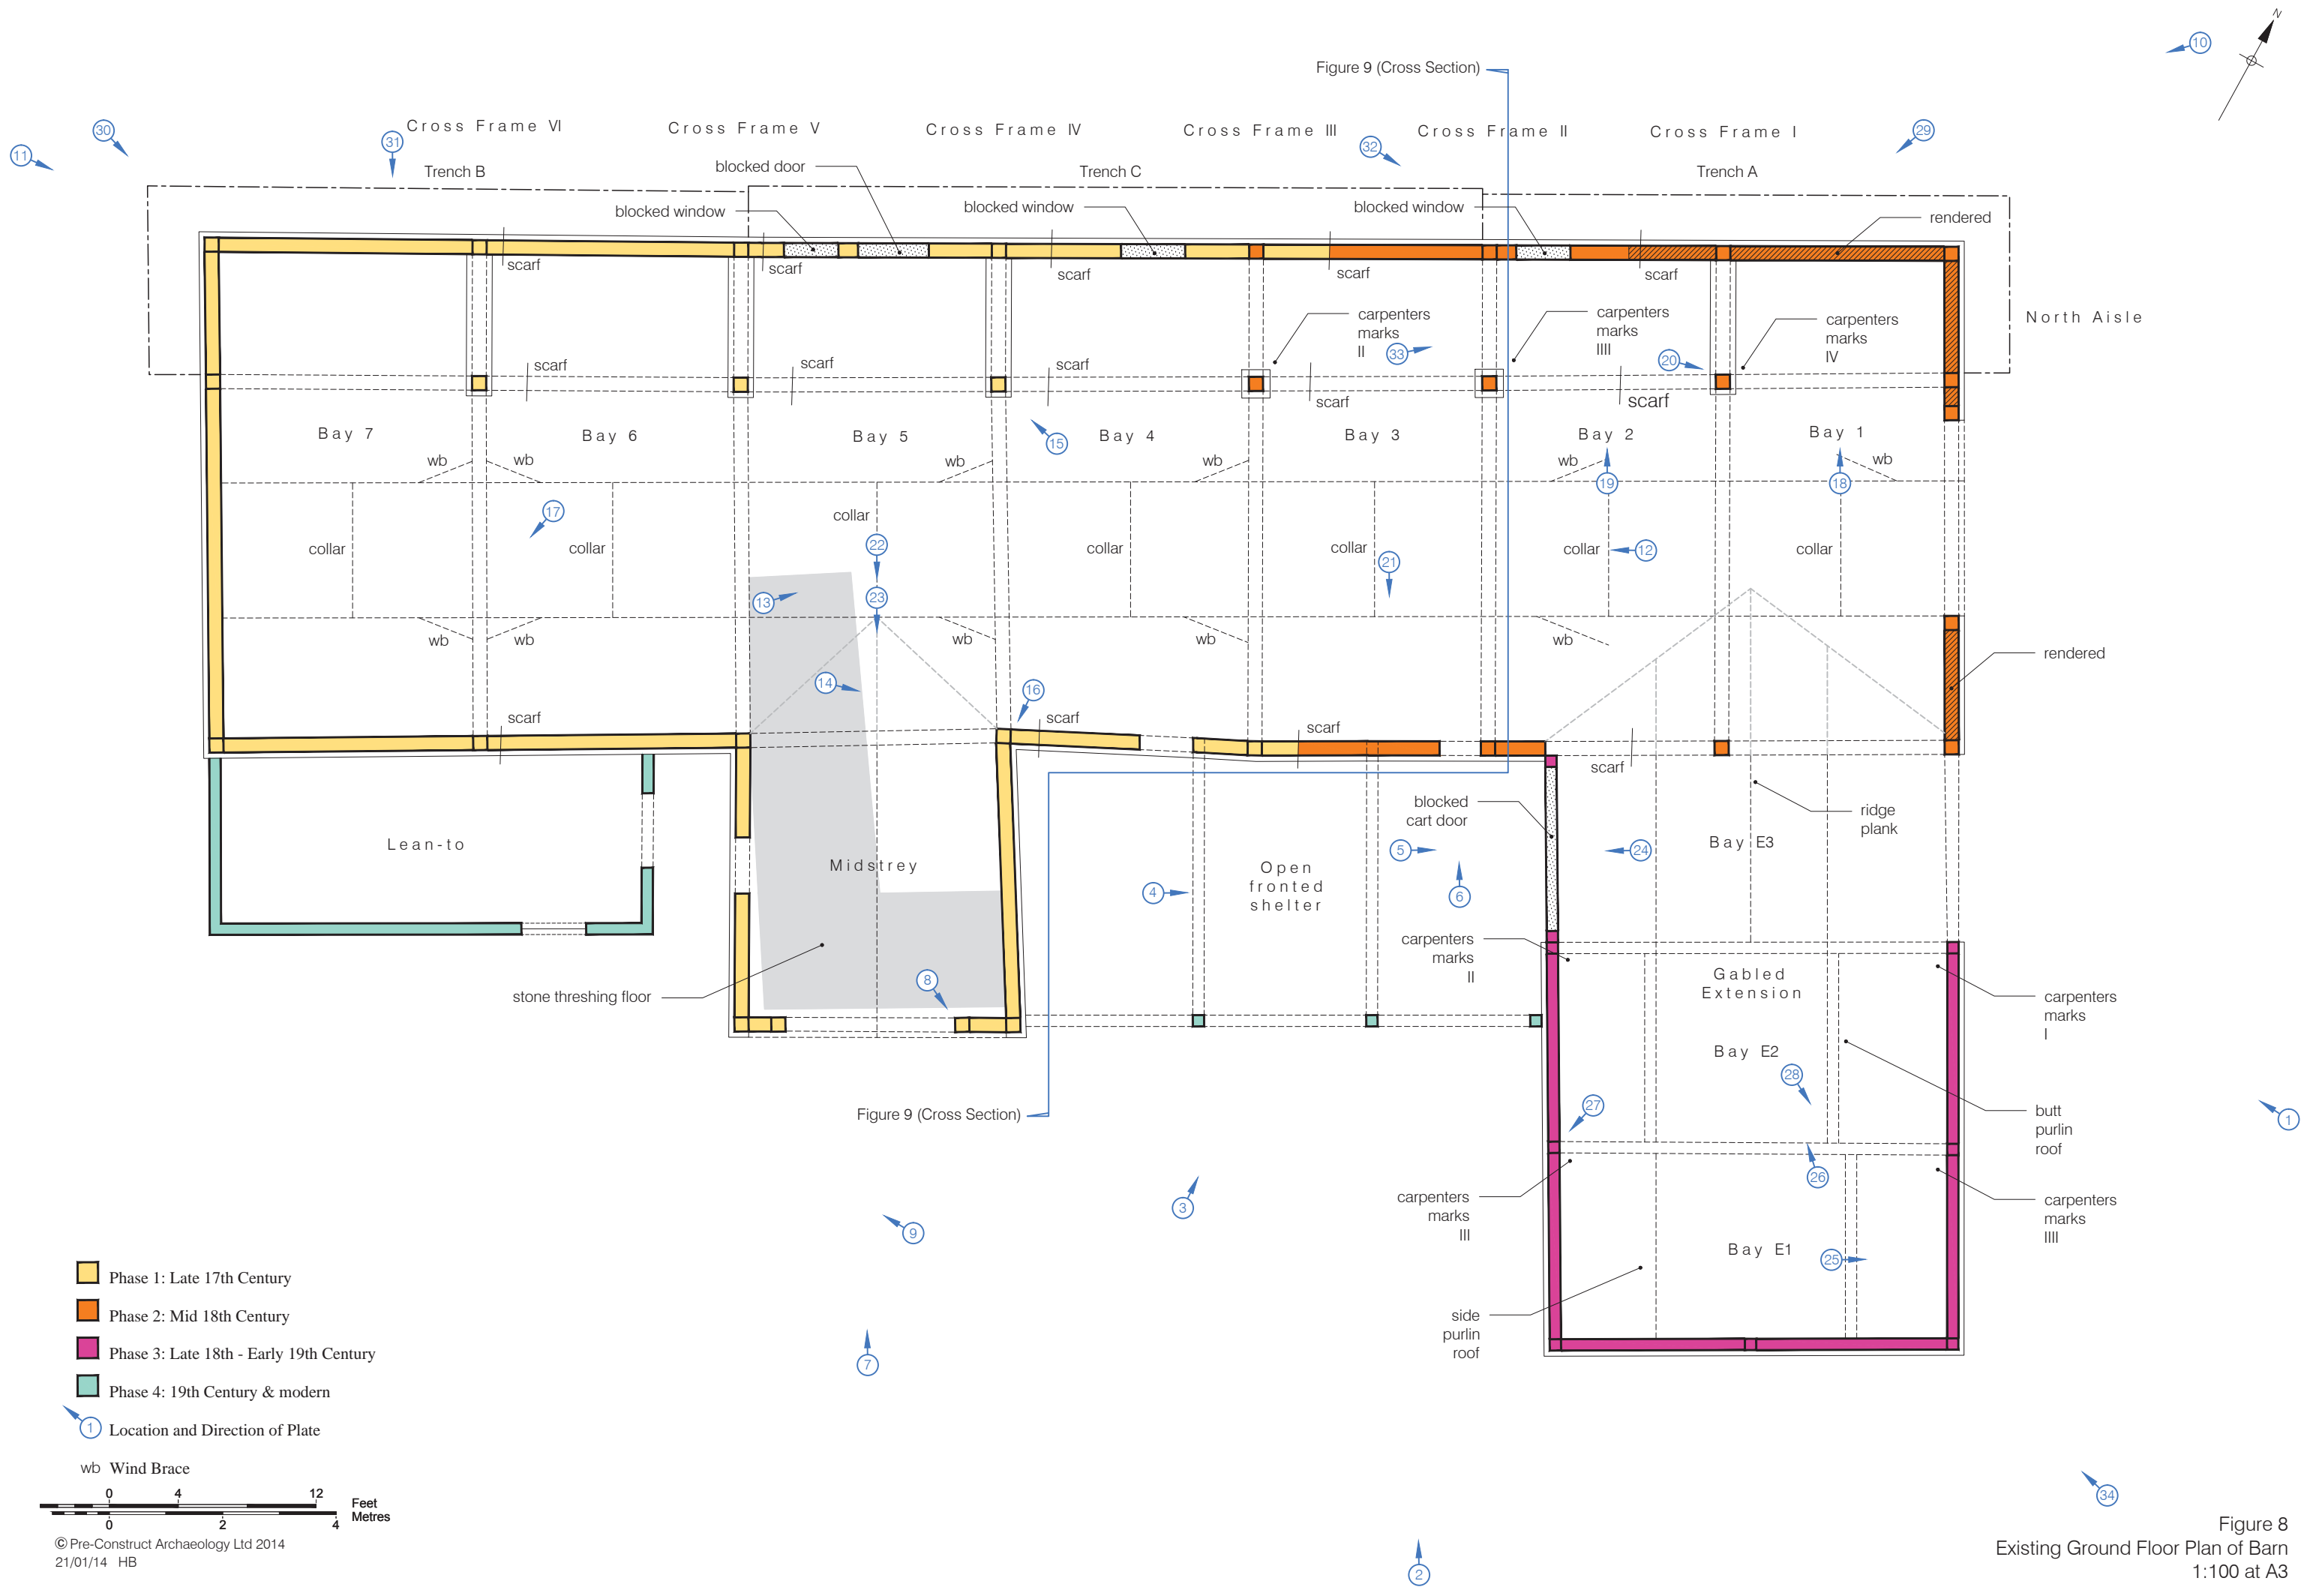
Figure 8
Existing Ground Floor Plan of Barn
1:100 at A3

- 6.5.2 The timber-framing is covered using hot tarred weatherboard which extends to the brick plinth walls. The latter have been the subject of numerous rebuilds and patch repairs and are in a very poor condition. Areas of walling are breaking away at the base and rotating over to the north due to the pressure imposed upon them by the considerable raking of the timber-frame to the south. The western end of the wall plinth has been considerably rebuilt and strengthened, stepping in by six courses, while localised areas of patch repair using brick, stone and tile occur mainly towards the western end. Given the number of, and diversity of, brickwork and other repairs it is apparent that this barn has historically had long term structural problems which have impacted upon the brickwork of the northern elevation. The northern wall is interrupted by three blocked (weatherboard) windows and a single blocked door opening, the latter to the rear of the midstrey bay (**Figure 8**).

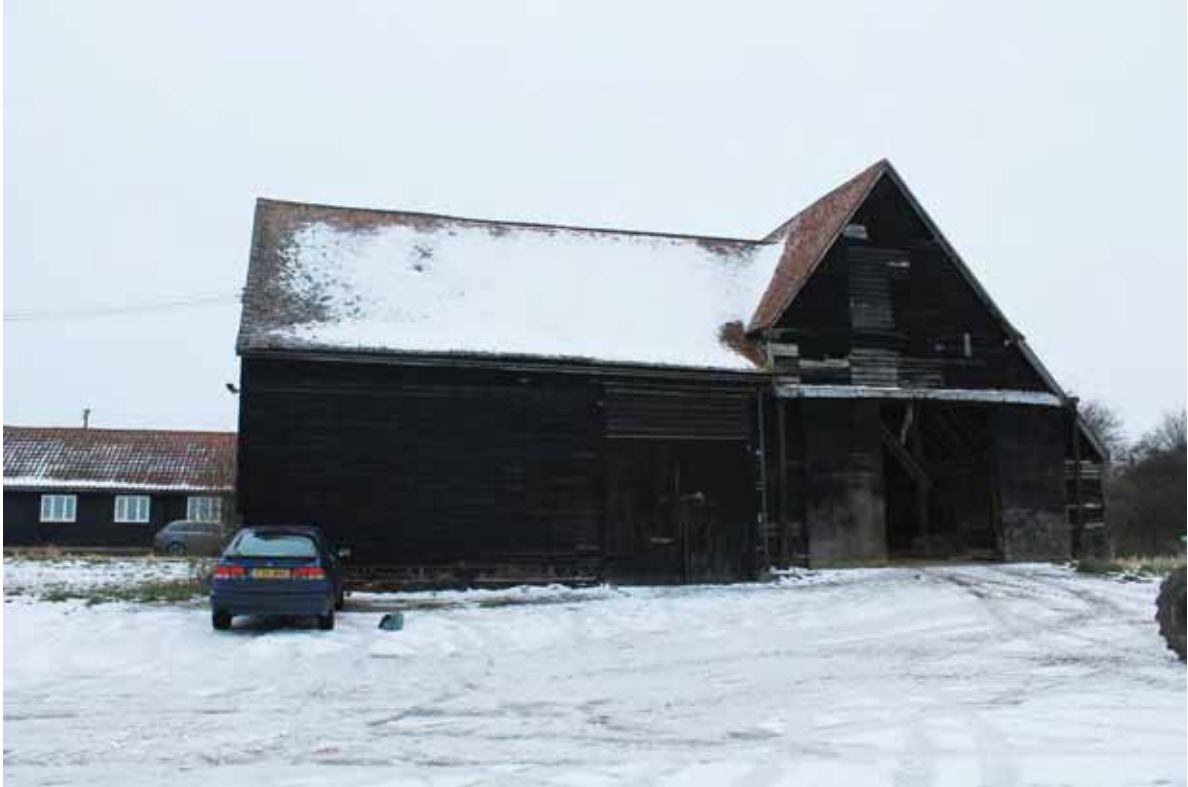
6.3.1 The eastern elevation comprises the eastern gable wall of the main aisled barn and the eastern flank wall of the south-eastern extension (**Plate 1**). Both are clad in weatherboard and have pitched roofs covered in modern plain tiles. A large sliding full height door (over mid rail level) has been inserted into the eastern gable wall to enable access into the barn for modern agricultural machinery. It has two doors supported on an external steel framework of I section joists. Above the door and off-centre to the south is a blocked door opening, formerly used as a pitching door. The brick plinth is of eight courses and is a later wall, keyed into the plinths of the north and south walls, but re-built using Fletton brickwork.

Plate 1 Eastern Elevation, looking west

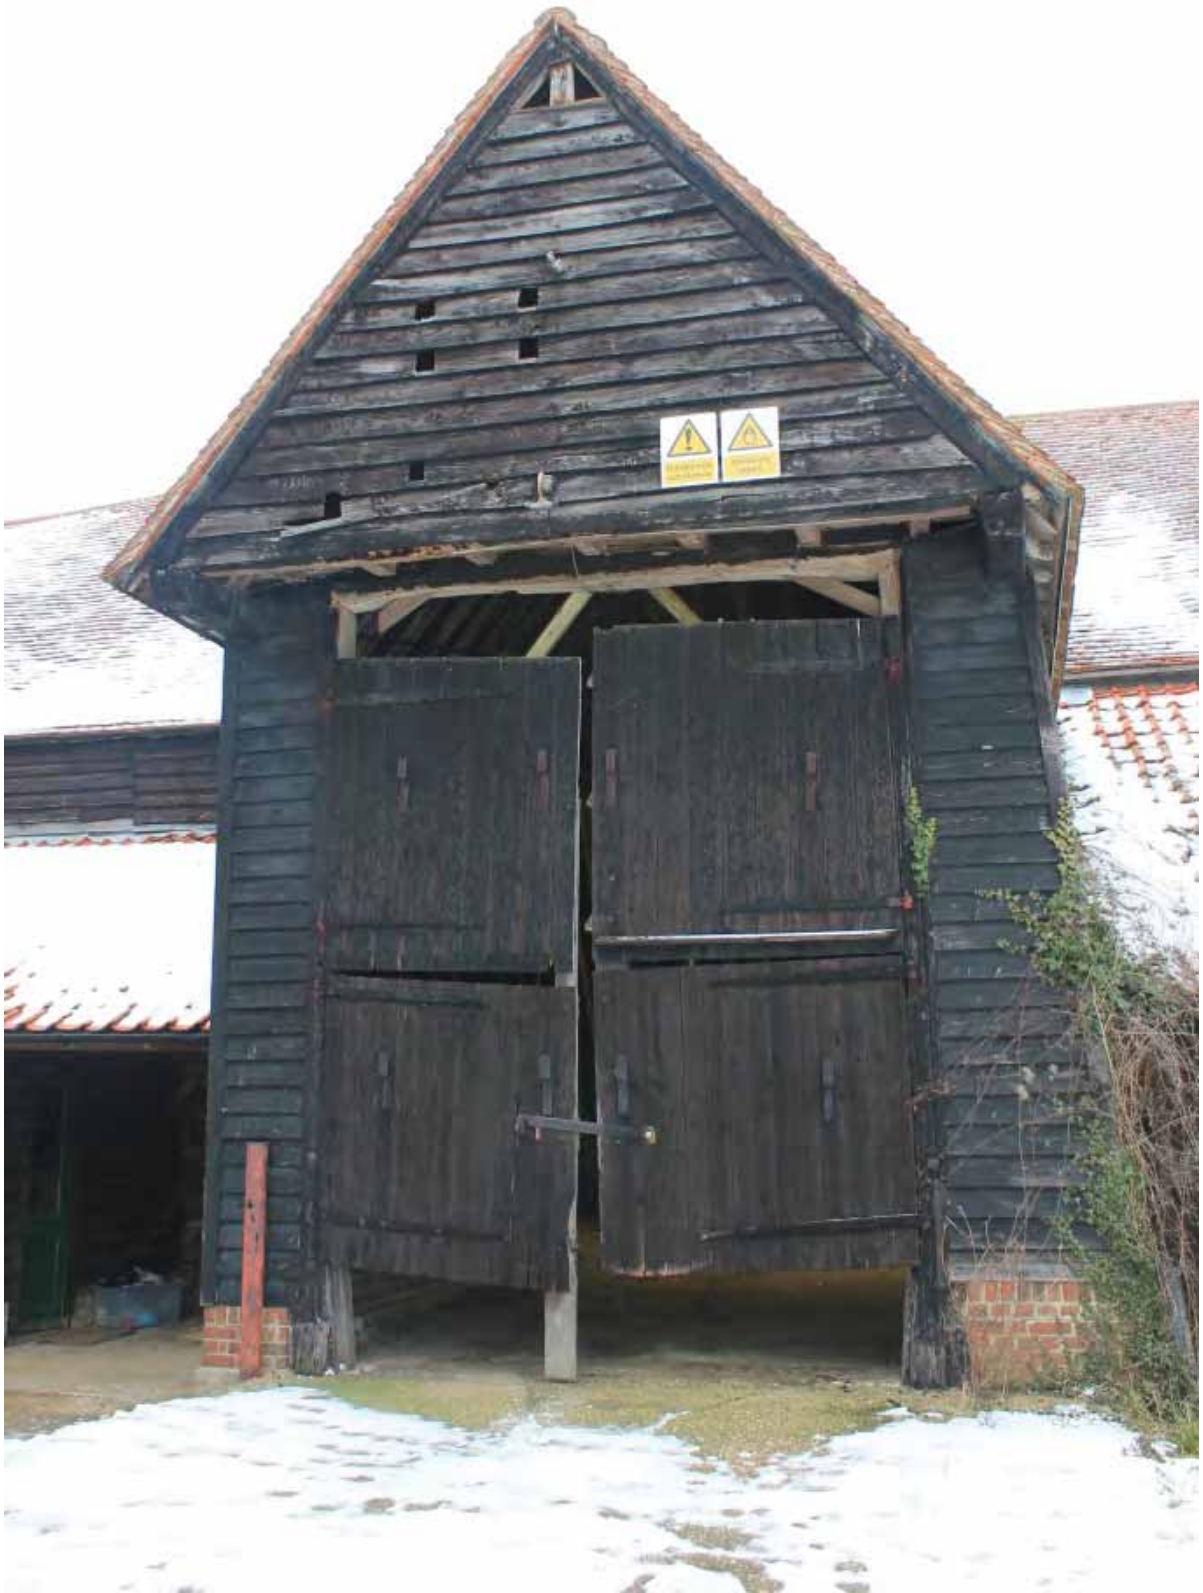
divided into upper and lower sections and each hung on two wrought iron strap hinges with round end detail and iron pintles (**Plate 7**). Despite the missing leap boards, the doors do not properly fit the door opening and are likely to be later additions. A single doorway into the midstrey is located in its western flank wall (**Figure 8**).

Plate 7 Midstrey with over-sailing gable dove-cote, looking north

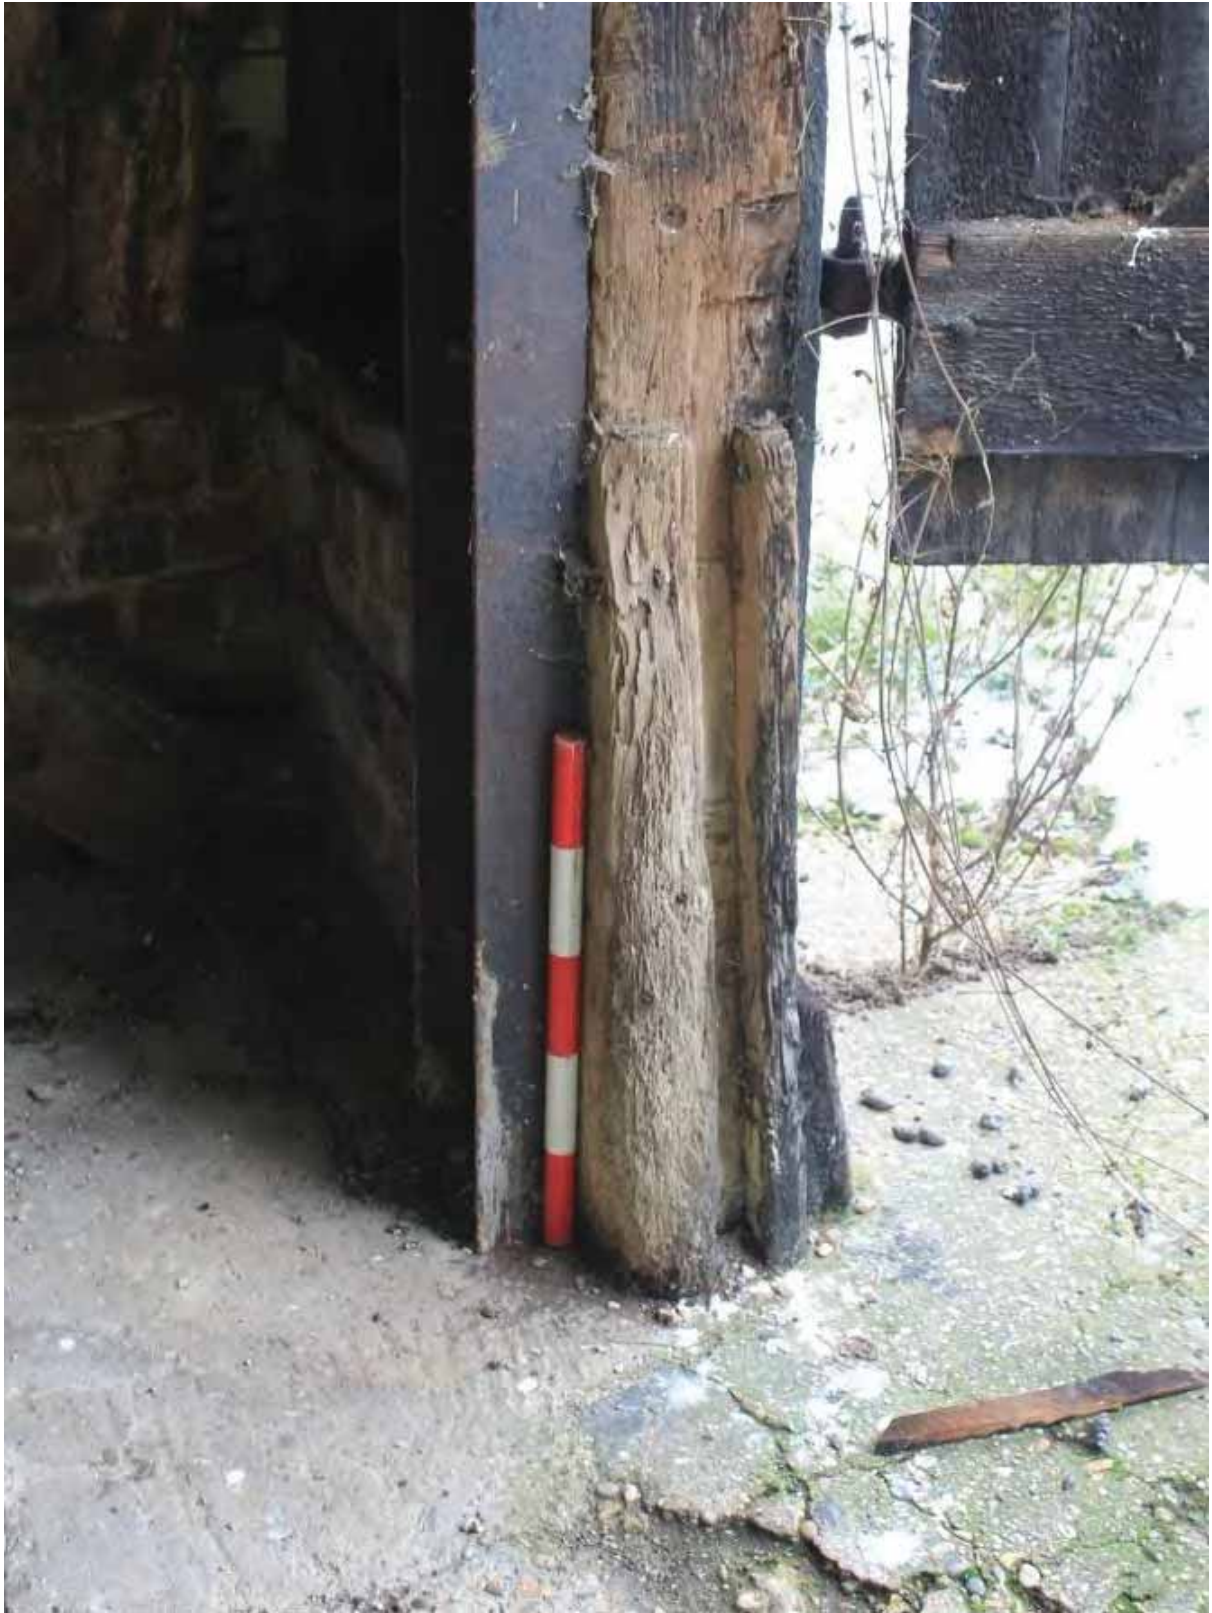
- 6.4.8 The midstrey has an elevated position when compared to the yard to the south and is reached via a gradually sloping concrete ramp. The midstrey's south and western plinth walls have both been rebuilt using modern red brick with a damp proof course, that now rest upon concrete foundations. The midstrey opening has rebates in both posts for leap boards (**Plate 8**) and has a pair of ledge and batten plank doors, both

Plate 8 Rebates for leap boards in the east post to the entrance of the midstrey, looking south-east

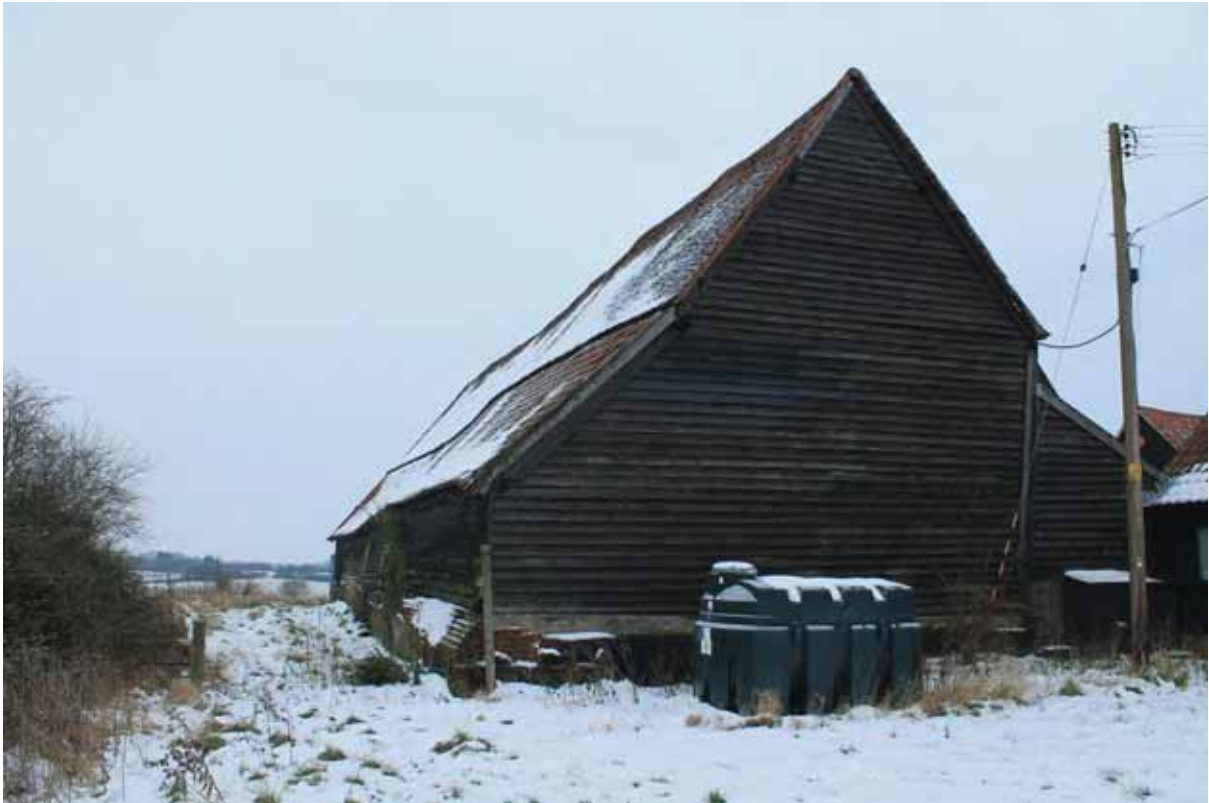
- 6.6.1 The entire western elevation was clad using modern weatherboard (**Plate 11**) and was built onto a modern brick wall underpinning a concrete beam foundation. The wall has no openings and has clearly been recently rebuilt.

Plate 11 Western Elevation, looking east

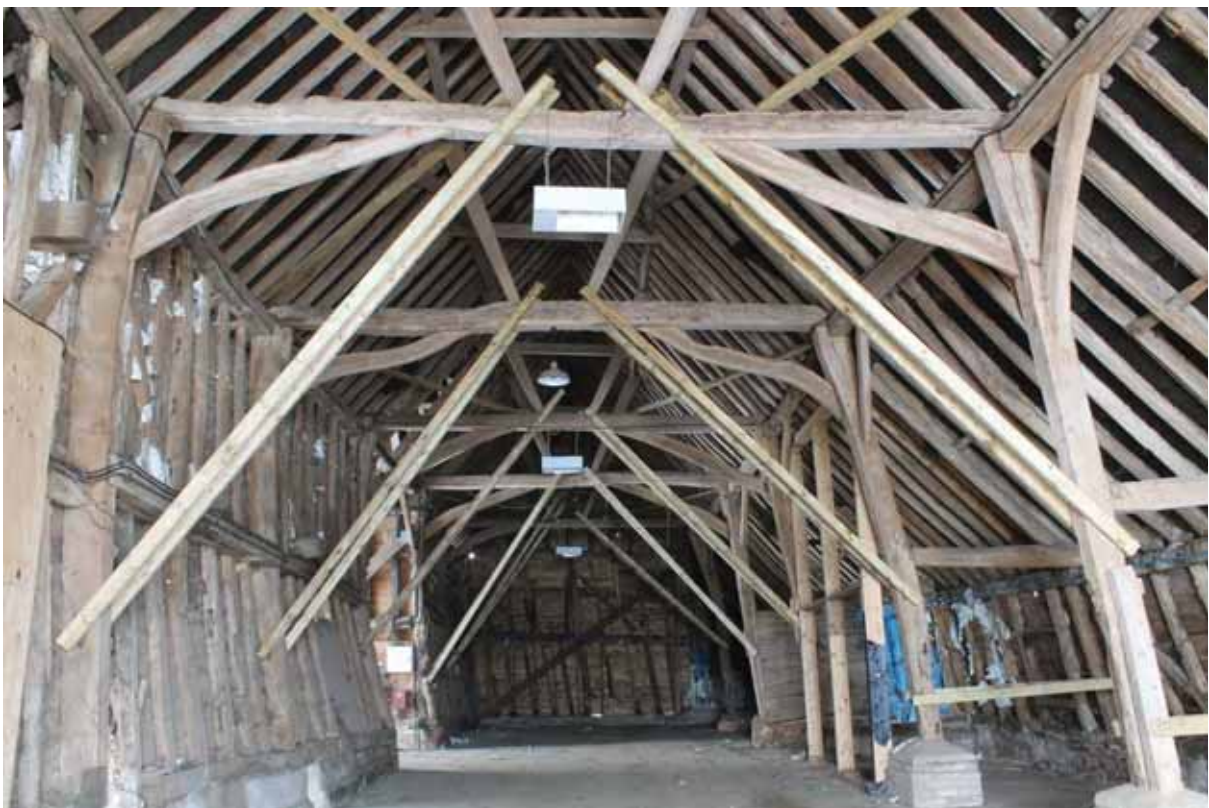
- 6.7.2 The most noticeable characteristic of the barn is its deformation. The frame has raked considerably to the south, particularly within the central and western bays (**Plates 12 and 14**). This has caused many of the aisle posts to rake over to the south (**Plate 13**), in turn distorting the aisle walls and transferring compression onto the opposite principal posts. This considerable loading is all too apparent in the posts and wall frames of the southern wall, which are no longer in the vertical plane and now show a distinct concavity and structural failure (**Plate 14**). If the barn had been built without a mid-rail, it is likely that the southern wall frames would have failed completely. These structural problems have clearly been a chronic long term problem, with both historic, using heavy wrought iron braces, and modern attempts at arresting the movement and repairing the outcome.

Plate 12 Interior of aisled barn, looking west

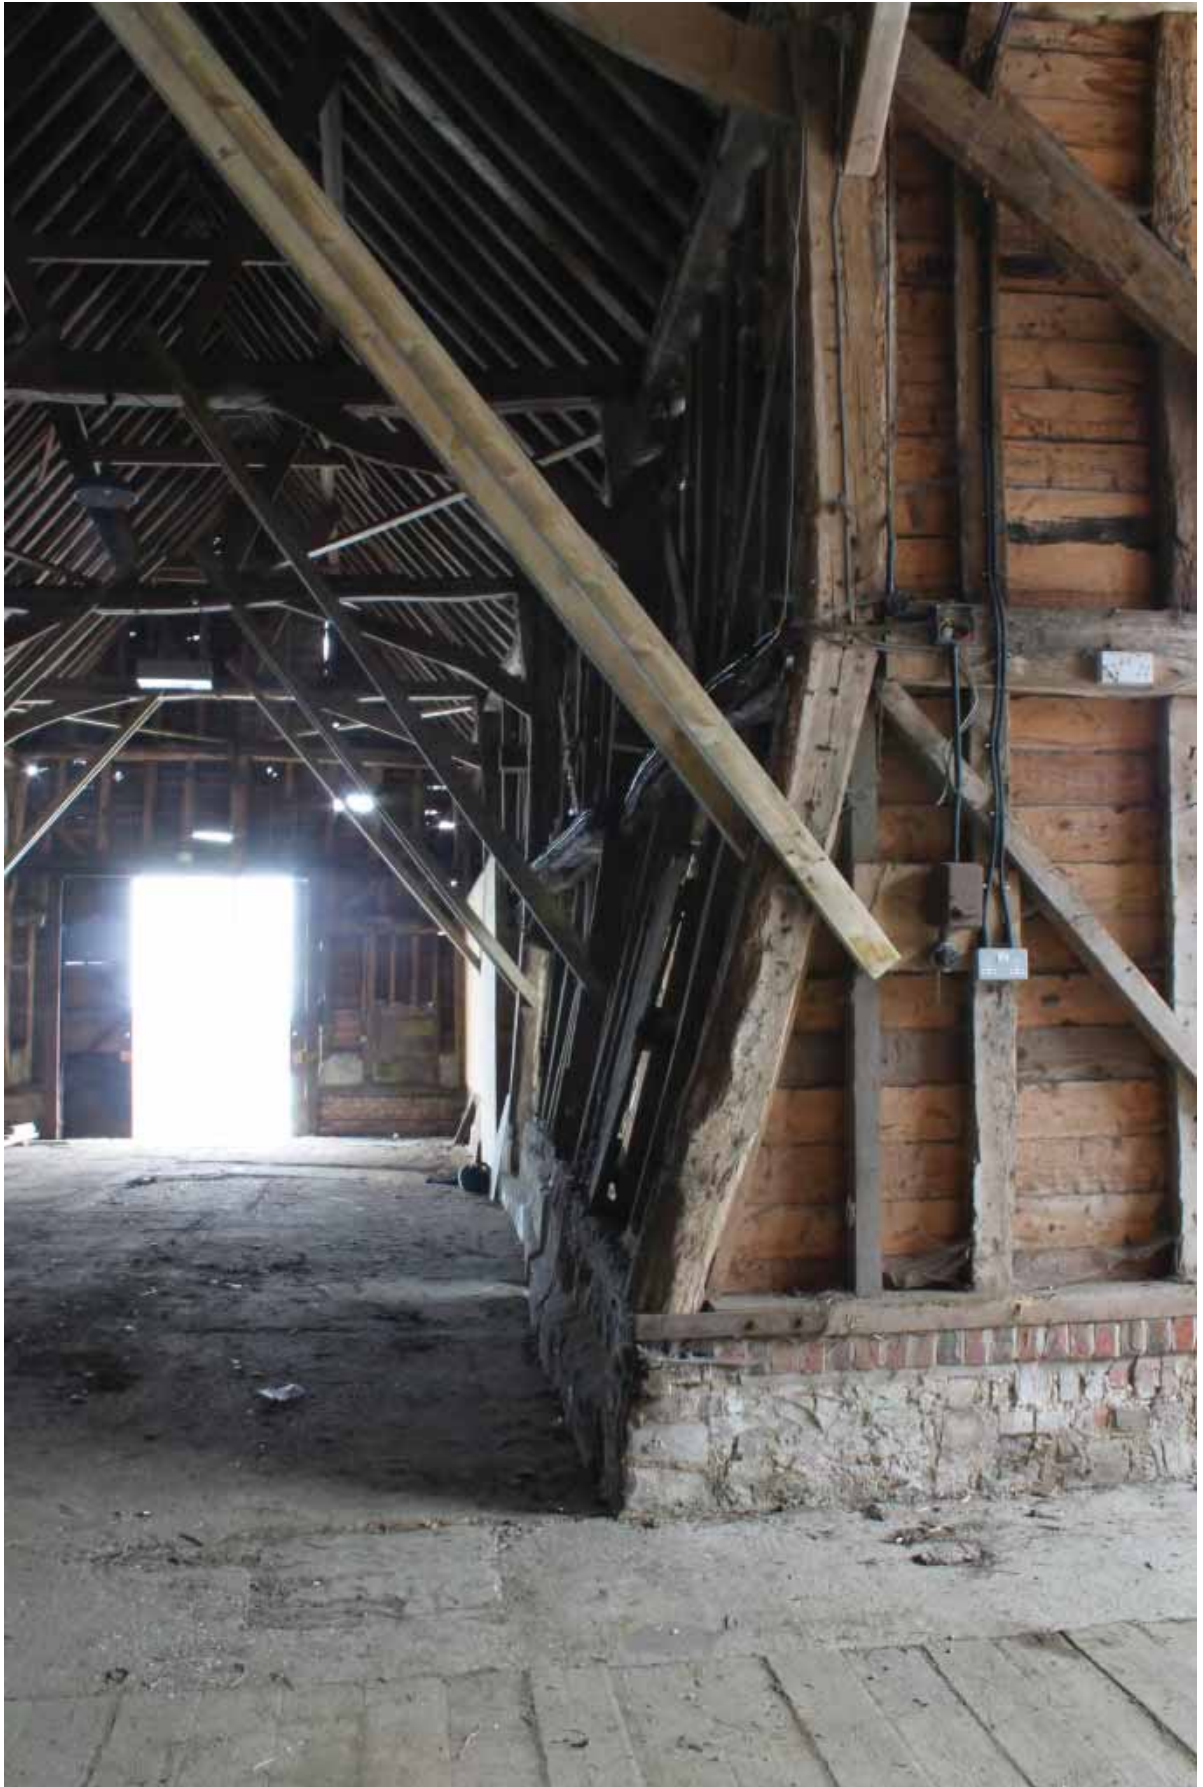
Plate 14 Deformation of wall post (Bay 4/5) and wall frame, looking east

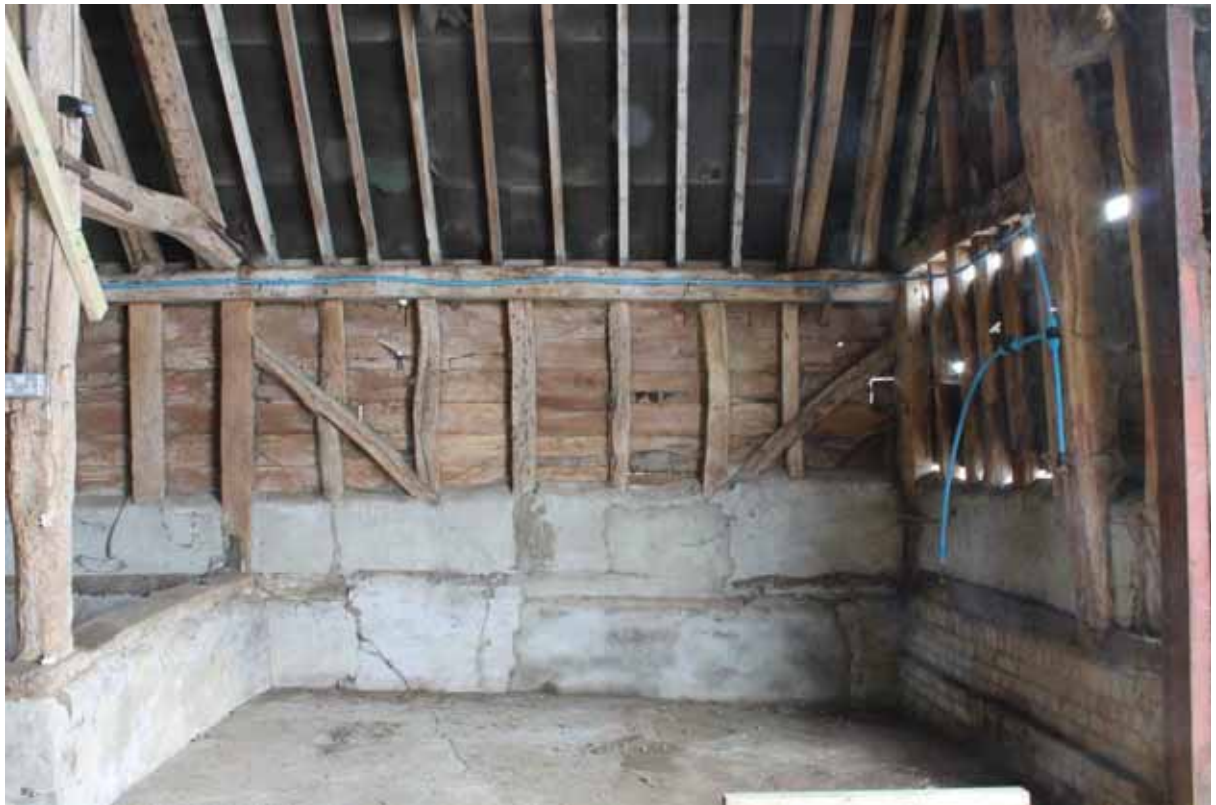
- 6.7.9 The roof over Bay 1 has seen much reworking with many of the common rafters replaced with modern softwood rafters (**Plate 18**). There are 11 rafters over the aisle, of which only two are heavier scantling and historic. The upper roof has 7 rafters per bay and incorporates four extra rafters to double up and strengthen the roof and a wind brace on the northern pitch only. The wind braces in Bays 1 and 2 are narrower and straighter than those used in the rest of the roof structure and are nailed to the rafters.

Plate 18 North aisle Bay 1, looking north

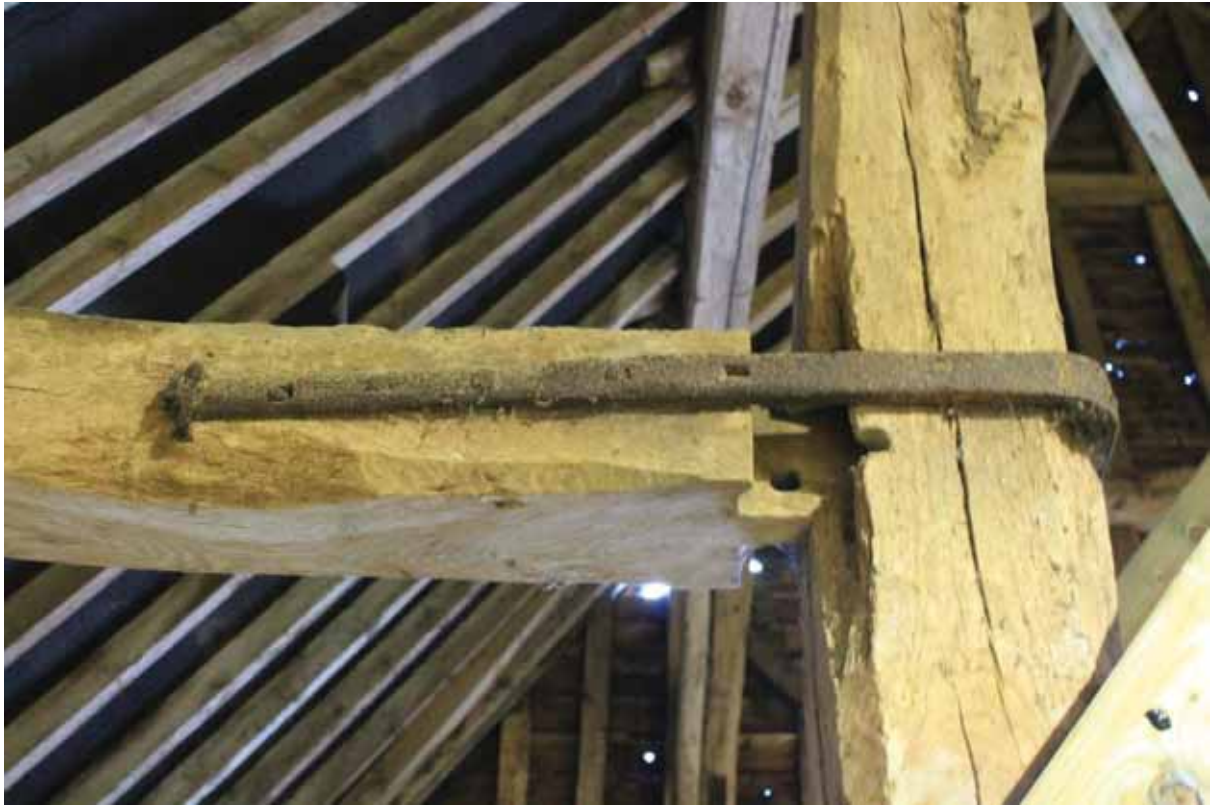
Plate 20 Historic repair using wrought iron strap (Bay 1/2), looking east

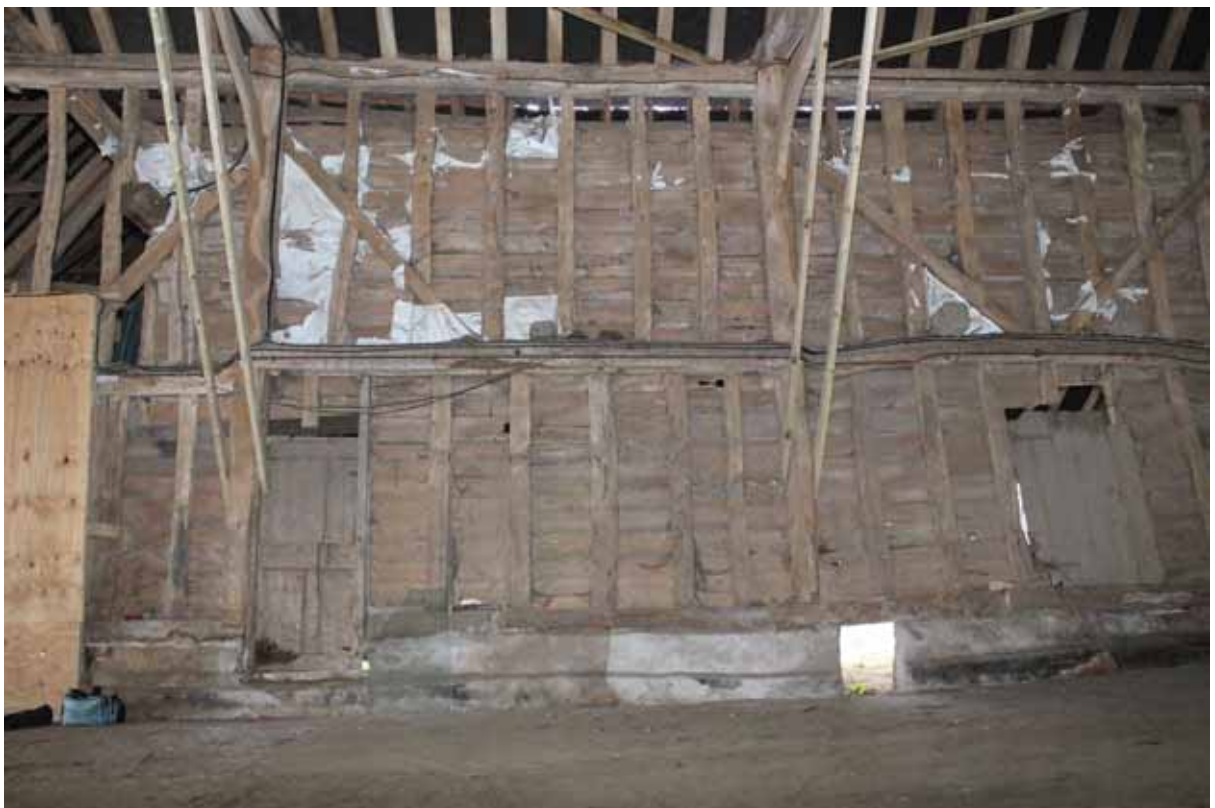
Plate 21 Southern wall frame at Bays 2 (left), 3 (centre) and 4 (right) showing misaligned studding, looking south

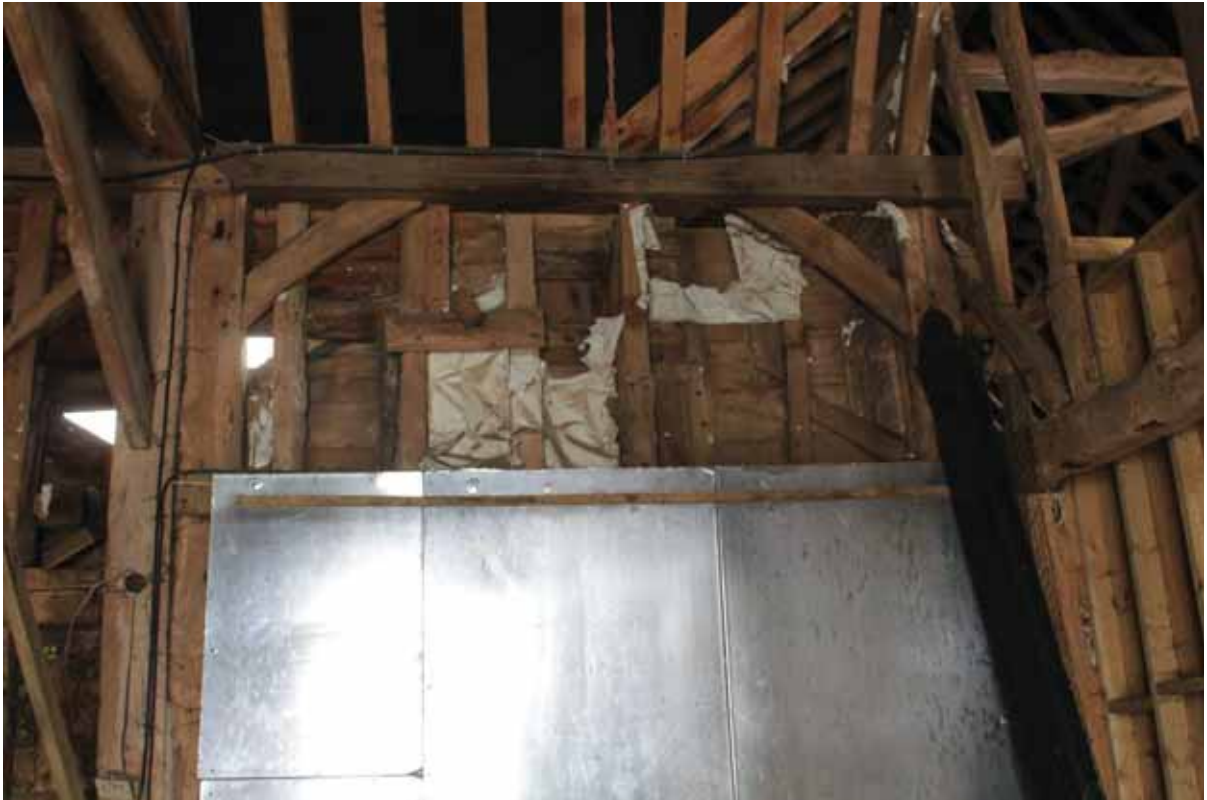
Plate 24 Blocked cart door in western wall of Bay E3 in the south-eastern extension, looking west

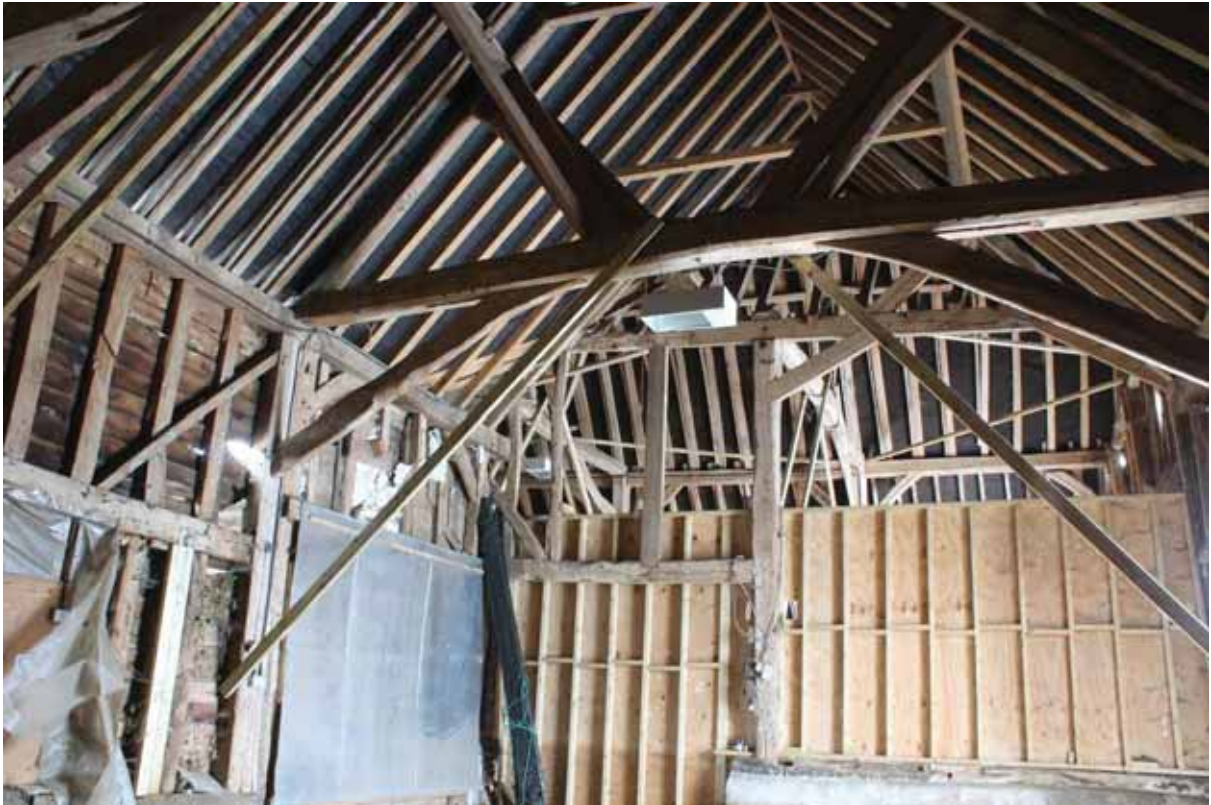
- 6.7.10 The southern wall frame of Bay 1 is open sided without studding (**Plate 26**). This is a later reworking of the wall frame following the insertion of a new south wall plate. The south wall plinth survives across this bay but has been broken through in Bay 2 to enable access between the barn and south-eastern extension.

Plate 26 South-eastern extension, showing deep arch braces, looking north-west
