**HISTORIC BUILDING  
RECORDING AND  
ARCHAEOLOGICAL  
MONITORING AT POND  
HOUSE, NO. 162 LOWER  
CLAPTON ROAD, LONDON  
BOROUGH OF HACKNEY**

**PCA REPORT NO. R11599**

**JANUARY 2014**

**Site Code: POH12**

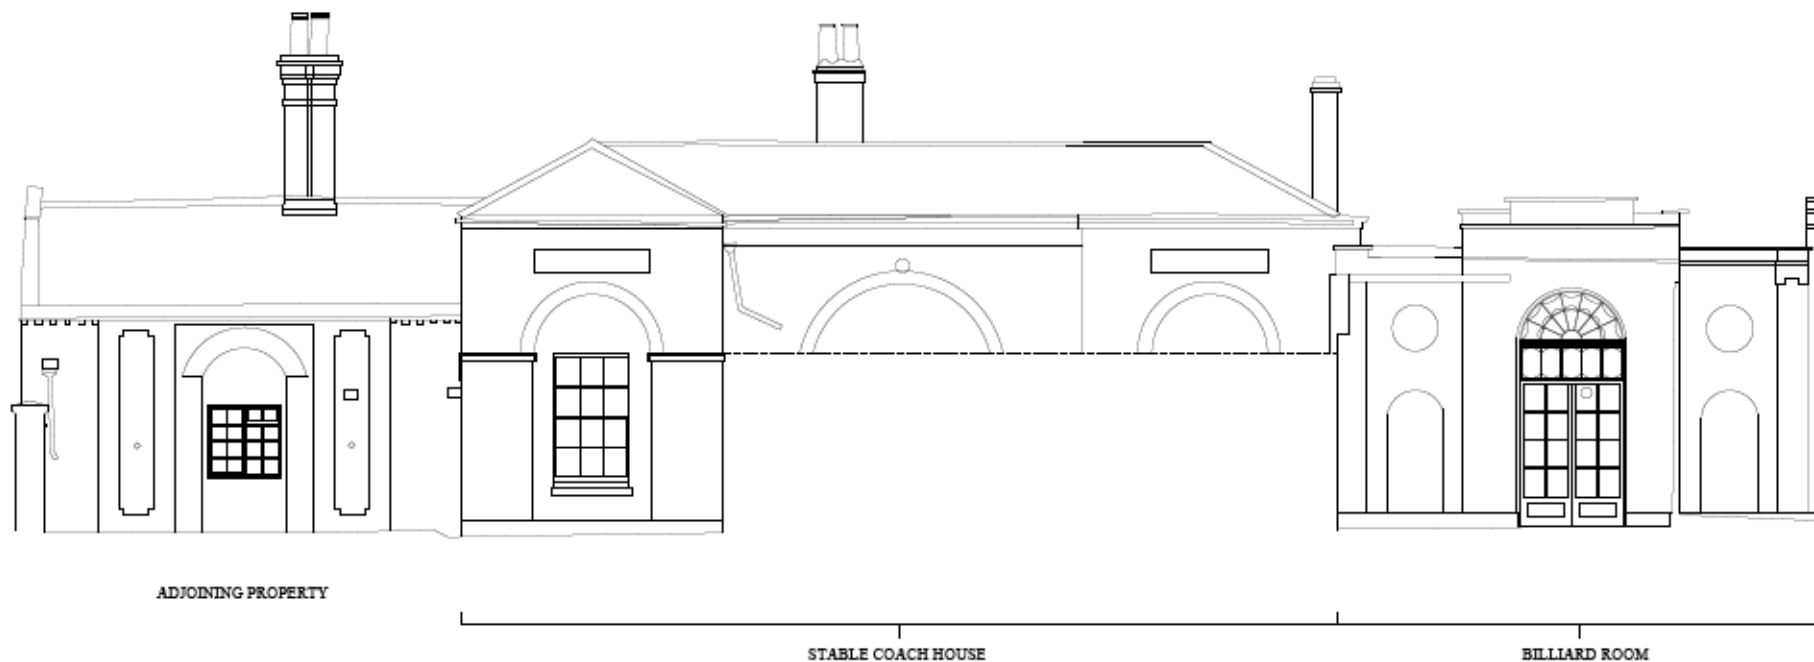
Figure 8  
Coach House Stable & Billiard Room Side Elevation  
1:125 at A4

- 6.10.6 The southern wall of the stable block is divided into three bays and is arcaded with a stuccoed impost band which continues from the quadrant wall (**Figure 8**). At the time of the initial recording it was generally in a poor condition and had been subjected to localised fire damage. The elevation comprises two arched recesses with gauged brick arches (outer bays) set either side of a similarly arched window, central to the elevation and towards the eaves. The western arch springs from the stucco impost band and includes a window opening with segmental gauged brick head and stone sill. This detail was repeated in the corresponding recess to the east, but later adaptation to a doorway into the stable has seen the loss of the lower window and sill and its partial blocking. Both arched niches sit below a rectangular recess below the eaves. The central bay (as the house) is slightly recessed and includes a central doorway with bull nose jambs below a Diocletian style window with external bars. A plain brick eaves band extends the width of the central bay (only).

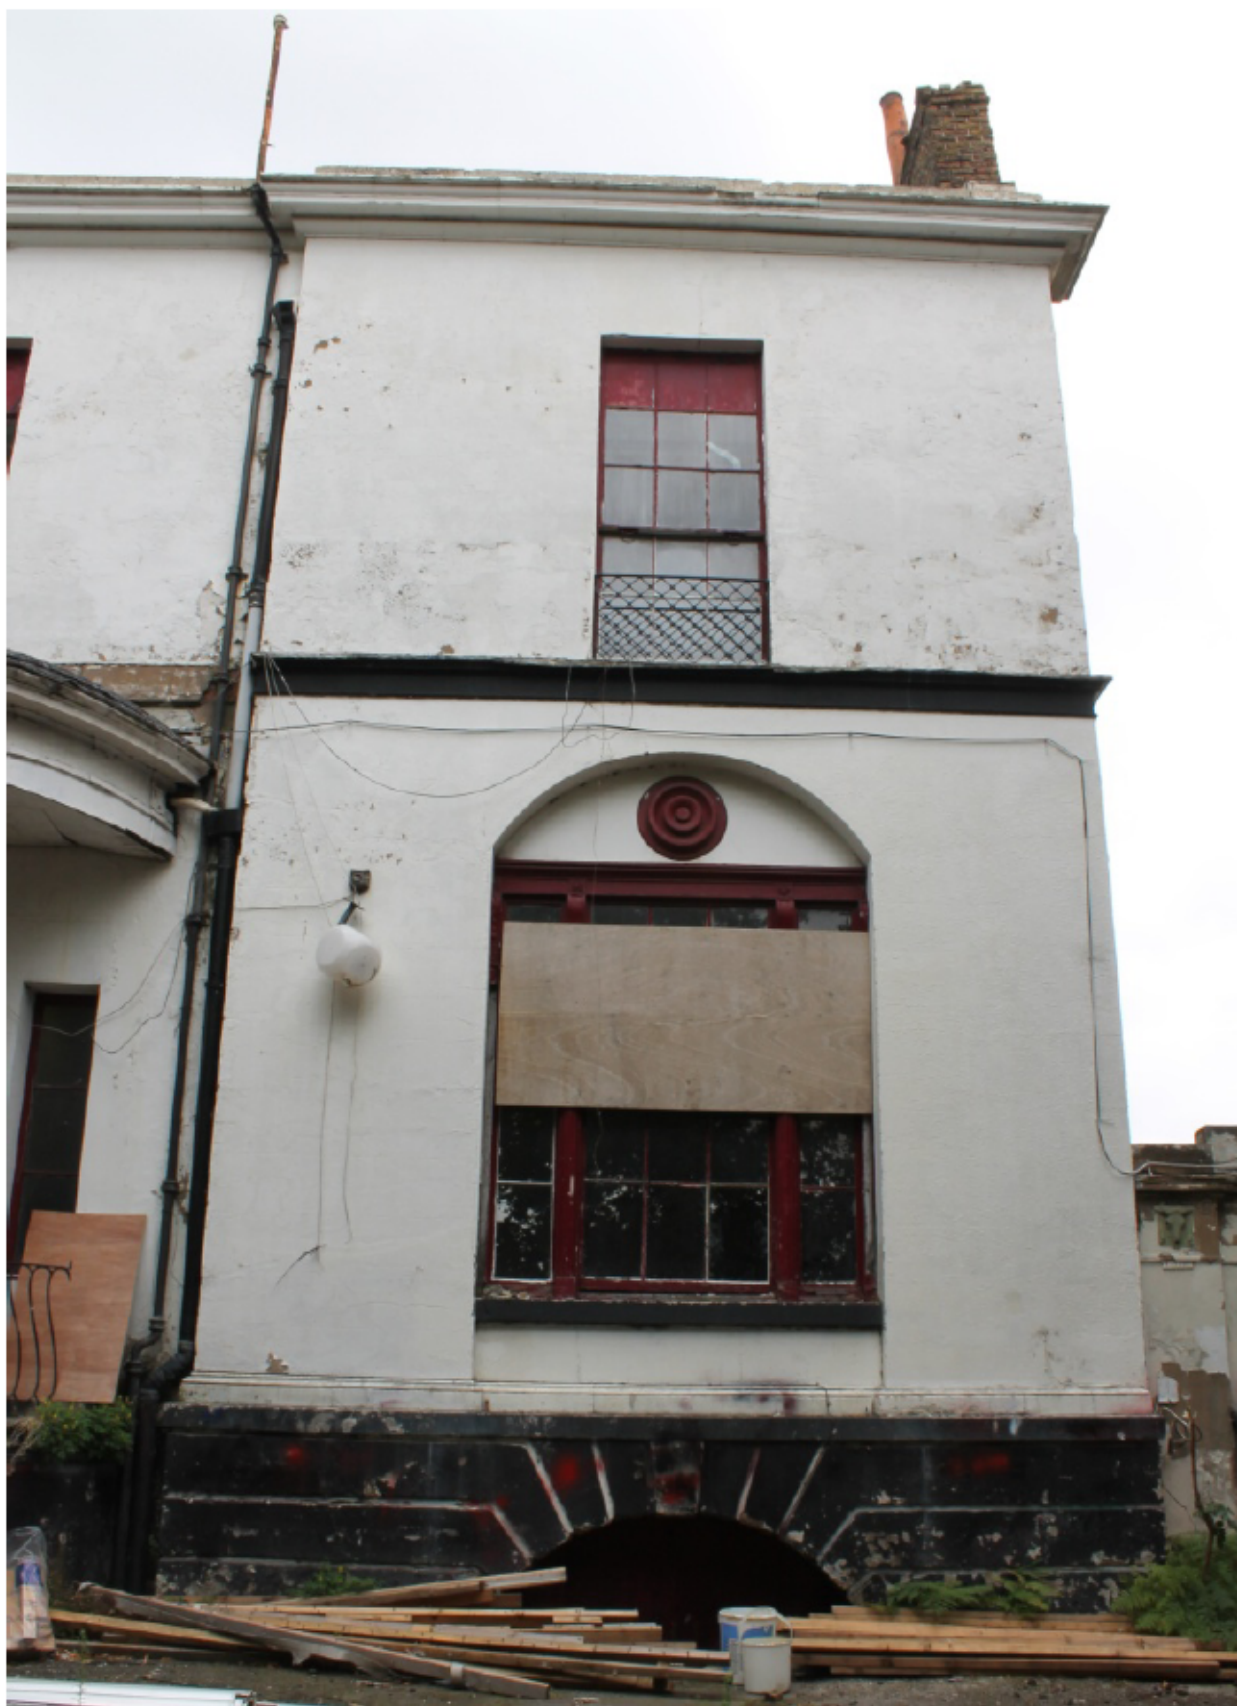
- 6.3.2 The principal ground floor windows are set back from the wall plane and within tall arch headed recesses with a single patera feature over the window head and within the tympanum (**Plate 3**). The windows are tripartite sashes, with narrower side lights, decorative fluted mullions rising to modillions with fleuron decoration, below a flat window head. The central sashes are 6 over 6 with narrow glazing bars, the outer narrower side sashes, 2 over 2, both top hung and vertical. Along the base of the northern window is low open wire-work balconette (a feature now missing from the southern window) and above both, a first floor band. The three windows of the first floor are identical tall elegant 9 over 6 sash windows with fine glazing bars. Each retain an openwork balconette and the windows are set back from the wall plane. Notably the upper light of all three windows are 'blind' due to lower internal ceiling heights. Above the first floor windows is a simple cornice and a parapet wall with stone copings. The attic storey is concealed by the parapet wall although the dormer windows in the attic rooms are symmetrically aligned with the first floor windows below.

**Plate 3** Ground and first floor windows at the south side of the principal (west) elevation, looking east

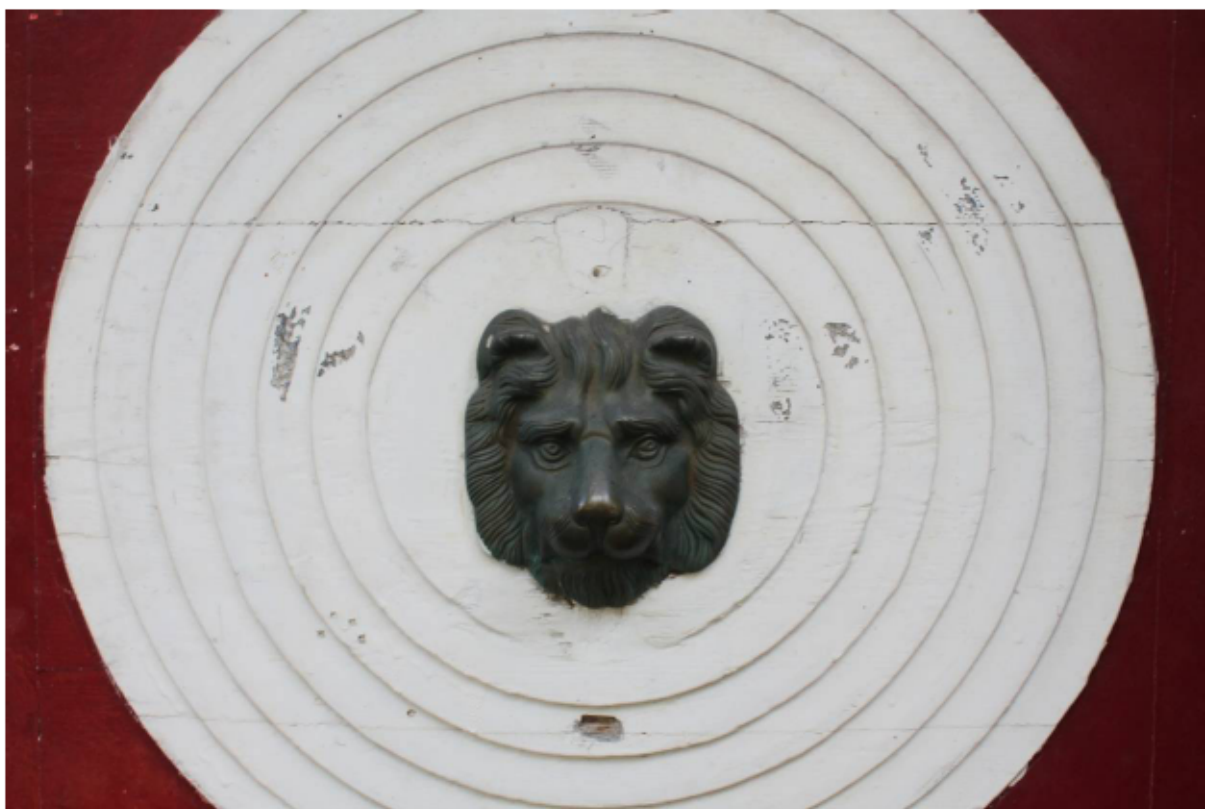
construction. It has however lost the southernmost column of the circuit, but all four square Portland stone plinths on which the columns rest, remain. The floor of the portico is stone flagged, with rounded, over-sailing edges. The entablature has Bucranium (ox-head) motifs set above each pillar and an over-sailing flat canopy above. The principal entrance doorway is flanked by a pair of narrow sidelights (with replacement obscure glazing) and is surrounded by an ornate moulded architrave with raised lion head decoration on each of the upper angles (**Plate 45i**). The main door has two leafs with recessed shaped panels with lunette designs. Each leaf has a central moulded patera with a brass lion head door knocker (**Plate 5**); both are now missing their striking rings.

**Plate 5** Patera and lion head knocker at the centre of the south leaf of the front double door in the principal (west) elevation, looking east

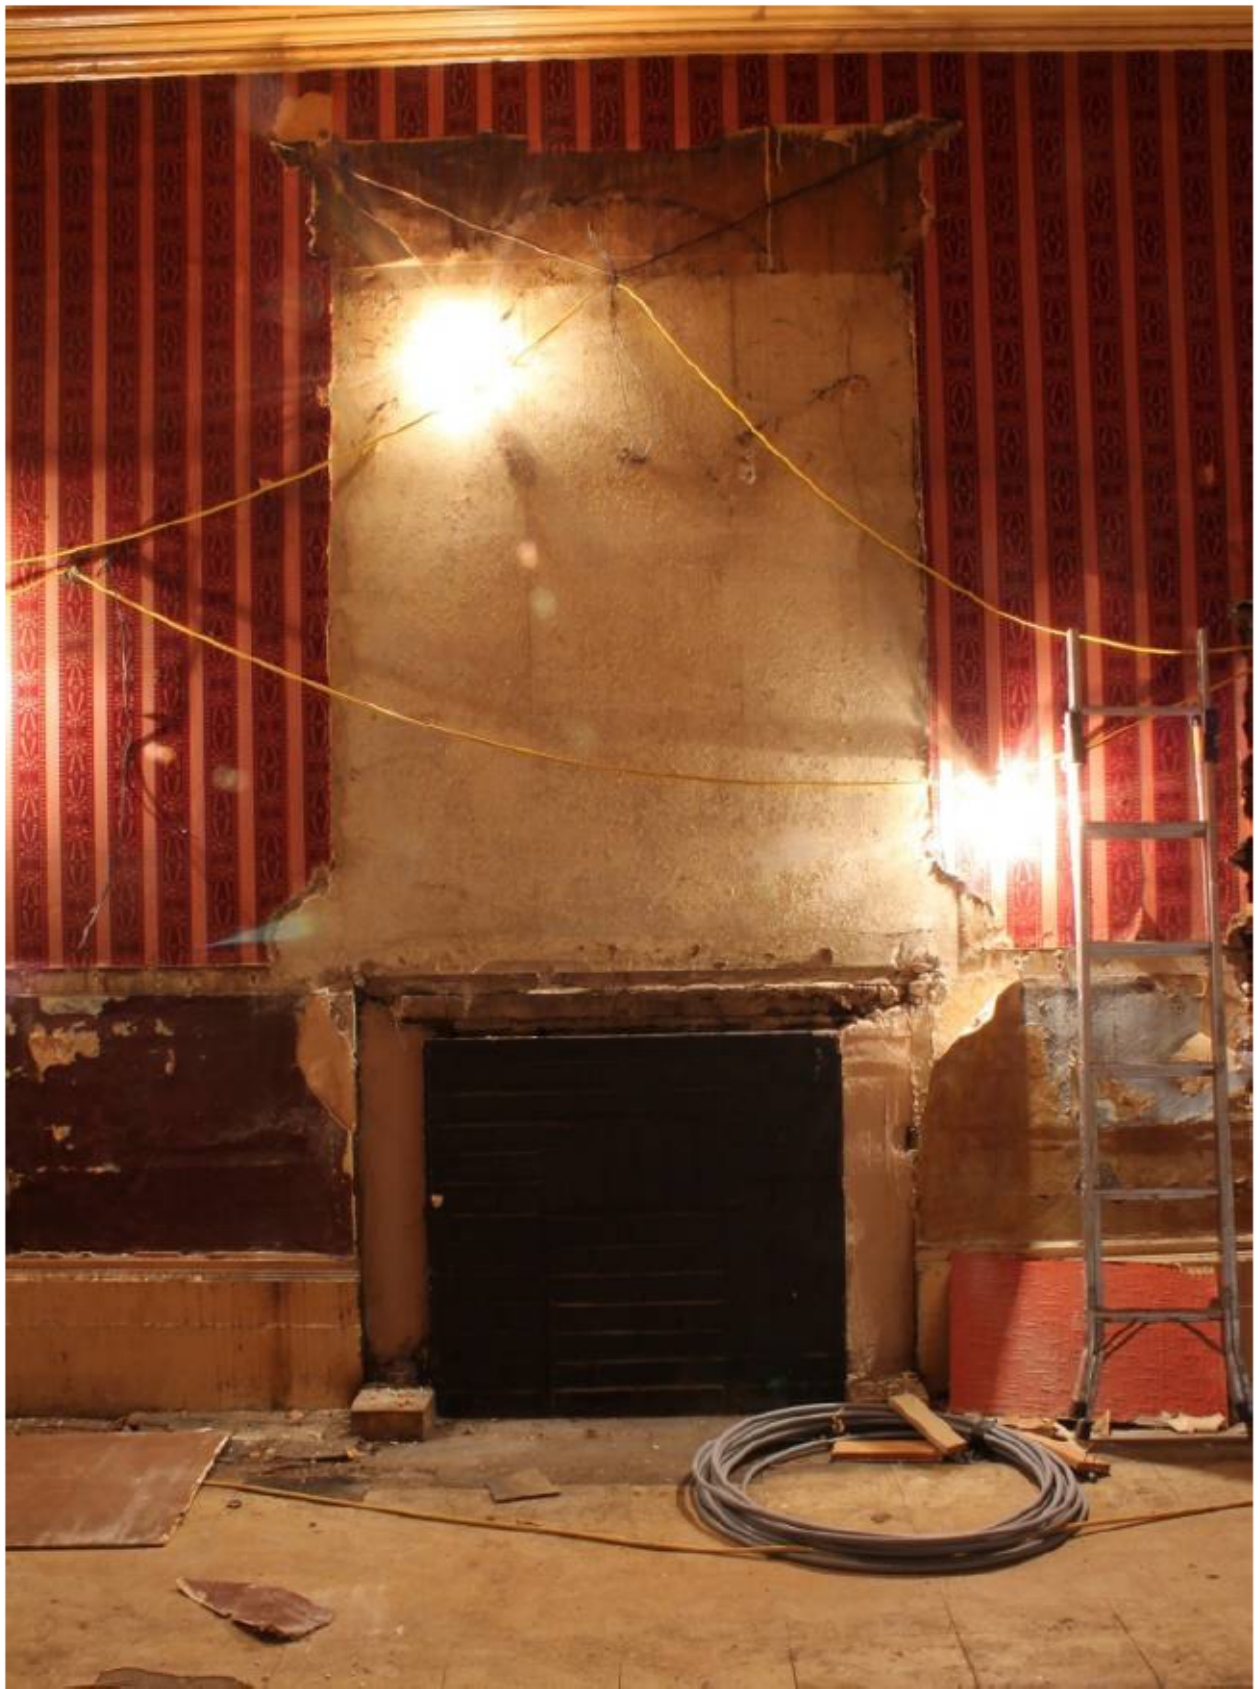
**Plate 16** Scar of fireplace and overmantle in Withdrawing Room (G4), looking south

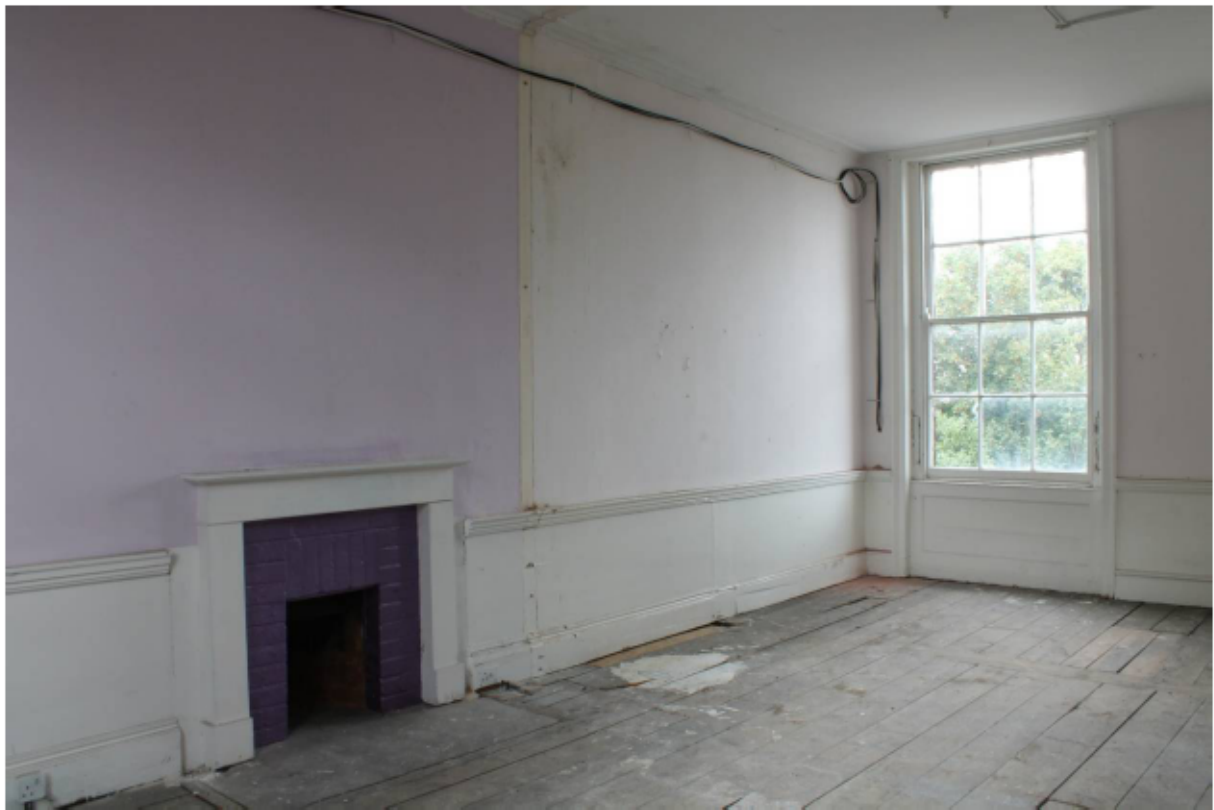
- 6.7.8 Bedroom (F7) had until recently been divided using lightweight partitioning into two flats (**Plate 23**). This involved the creation of a pair of separate doorways into the flats and the subsequent loss of the original architrave, although the door case remains. The bedroom retains the same lower wall detailing: skirting board, panelling and dado rail as present in the adjacent room (F6). It has also suffered the same replacement brick fireplace and loss of its original surround, though the stone hearth still remains intact. The present fire surround is crude and 'homemade'. The sash window to the western frontage has been reworked with replacement ovolo glazing bars and a horned lower sash. The reveals are splayed and panelled but do not show evidence of shutters.

**Plate 23** Bedroom (F 7), looking north-east

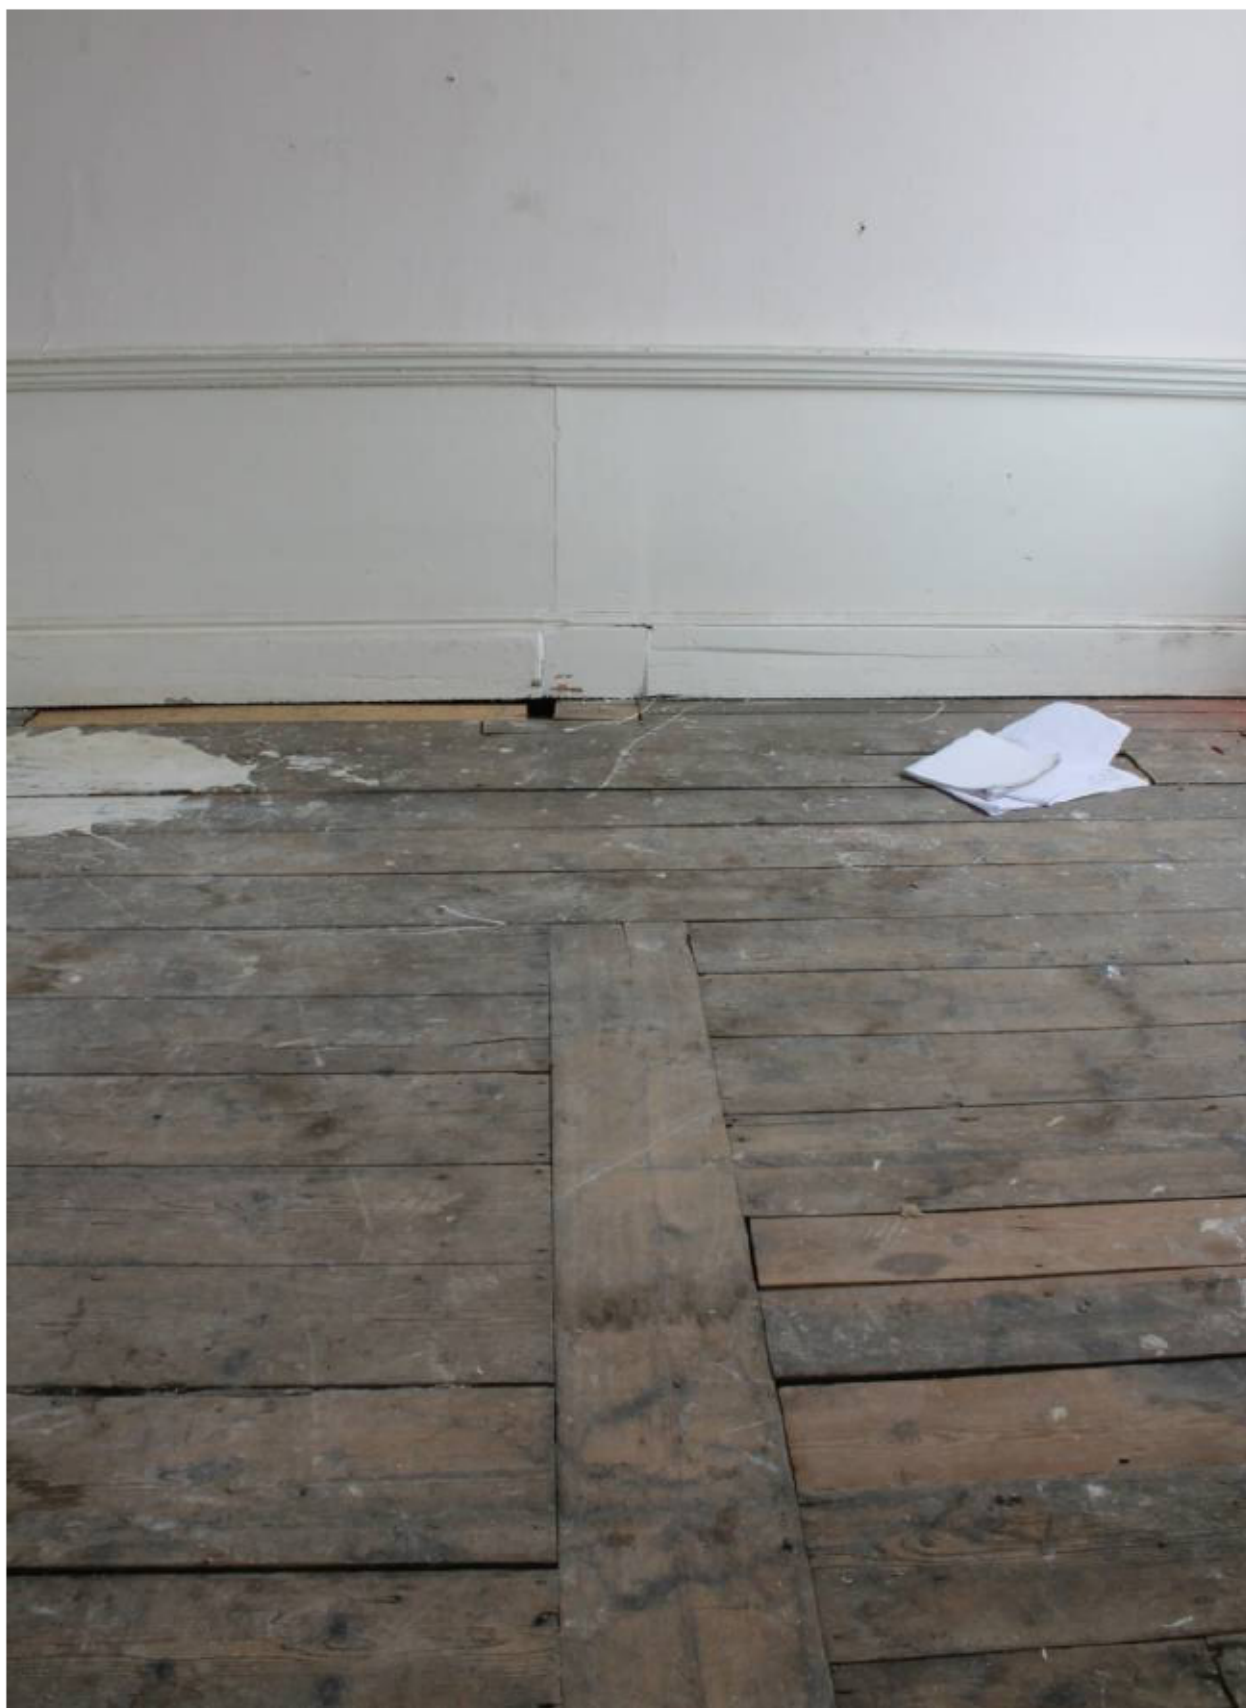
**Plate 24** Scar of removed wall (F7/7a), looking north

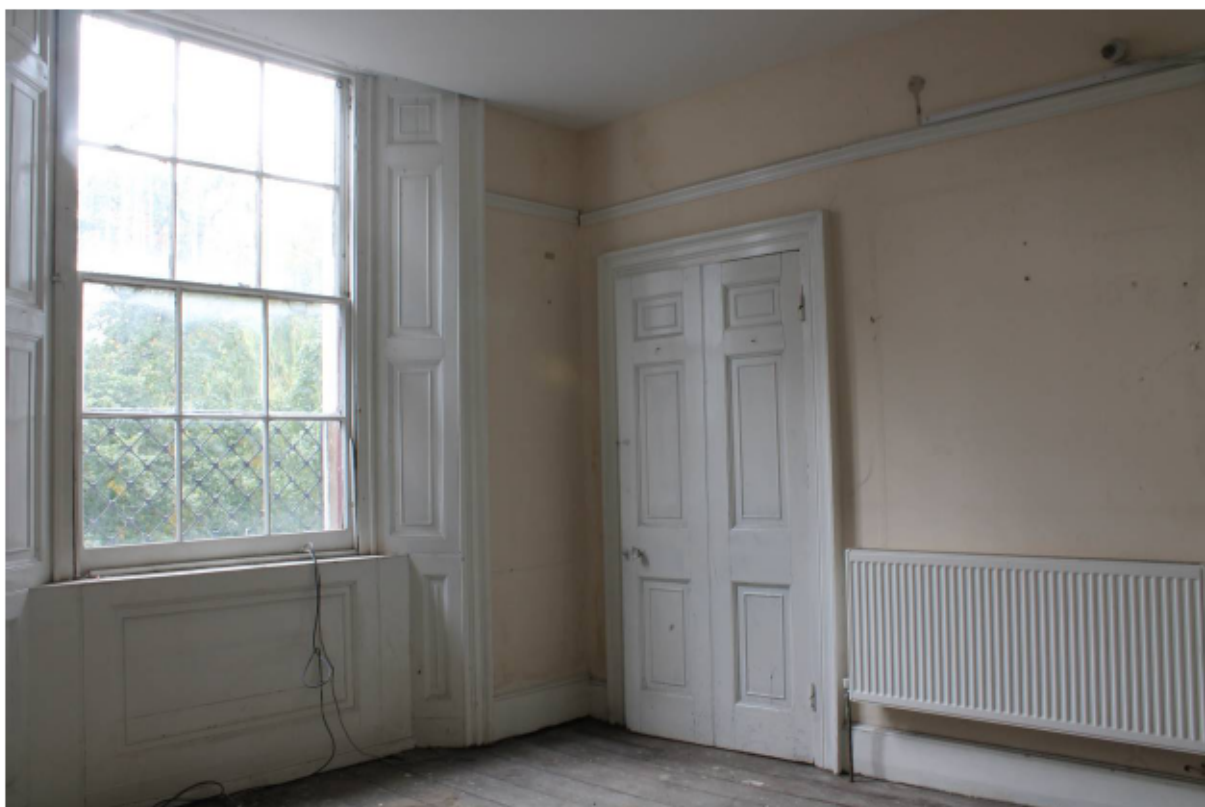
- 6.7.11 Bedroom (F8) (**Plate 25**) lies to the south of the landing and in common with the other bedrooms on the first floor was originally heated by an open fireplace. Also in common with these rooms, the original fireplace and surround no longer remain, although a decorative tiled hearth (measuring 1.23m x 0.47m) does survive (**Plate 26**). The extent of the original surround measured 1.44m, the distance between the ends of the skirting boards. The skirting boards and picture rail survive intact, though no evidence of a ceiling cornice remains, possibly due to a later replacement of the ceiling. The panelled door with a central vertical bead and the architrave to bedroom (F8) remains, as does an original built-in wardrobe/cupboard with two panelled doors (**Plate 46viii**). The interior is battened out for shelving. The western window is similar to that in bedroom (F7) with panelled splayed reveals, panelled soffit or apron below the window and 6 over 6 sashes (only three lights in the upper sash visible due to the lowered ceiling). The lower sash and the glazing bars are modern.

**Plate 25** Bedroom (F8), looking north-west

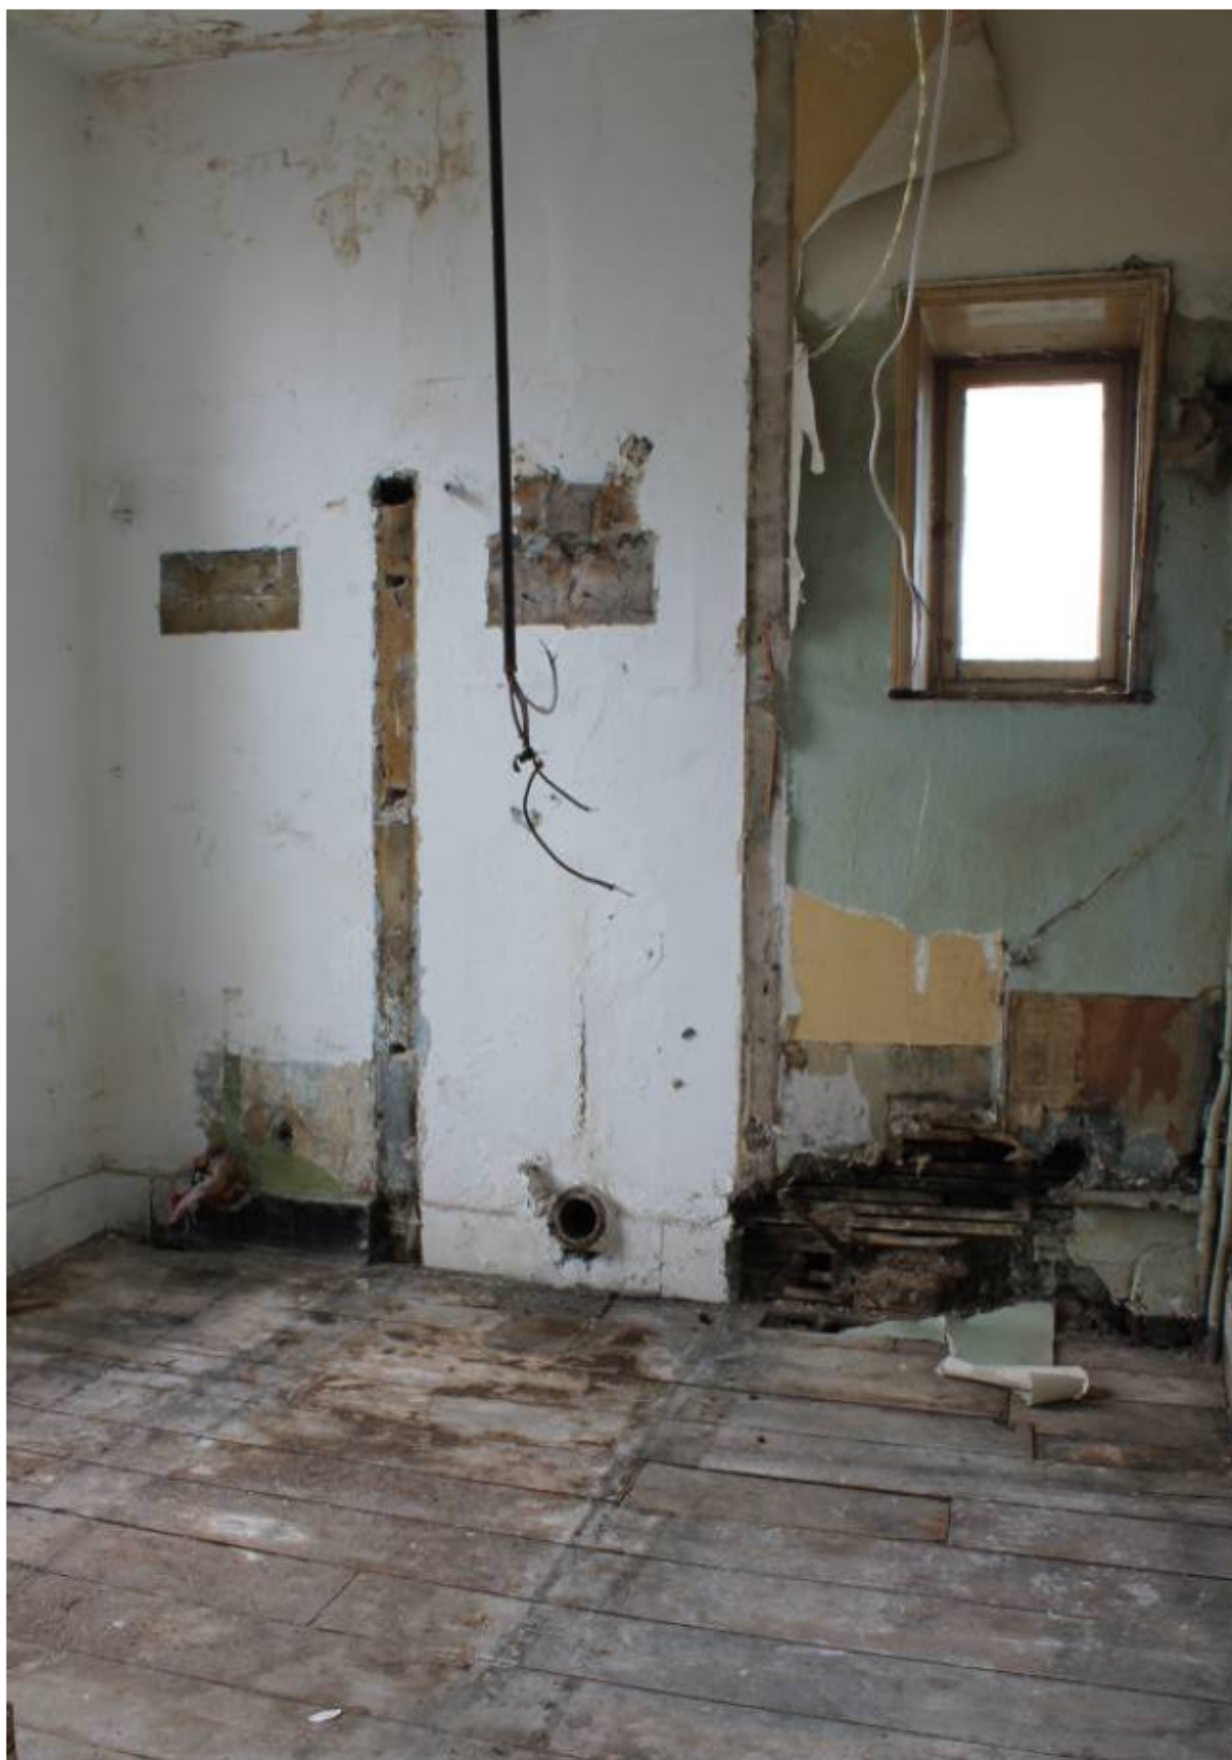
Accordingly it appears to be a less important room, although almost all evidence for treatments and fixtures have been removed following its extensive conversion into a toilet and bathroom (**Plate 27**). Some lengths of plain skirting remain as does the original door and architrave. The window is intact with no replacement bars and has a very plain architrave and apron. No evidence of a fireplace survives, though this may be due to later reworking. The function of the room is unclear, its plainer treatment and location suggest a more subservient role, possibly a bedroom for an older child or higher status servant.

**Plate 27** Bedroom (F9), looking south-east

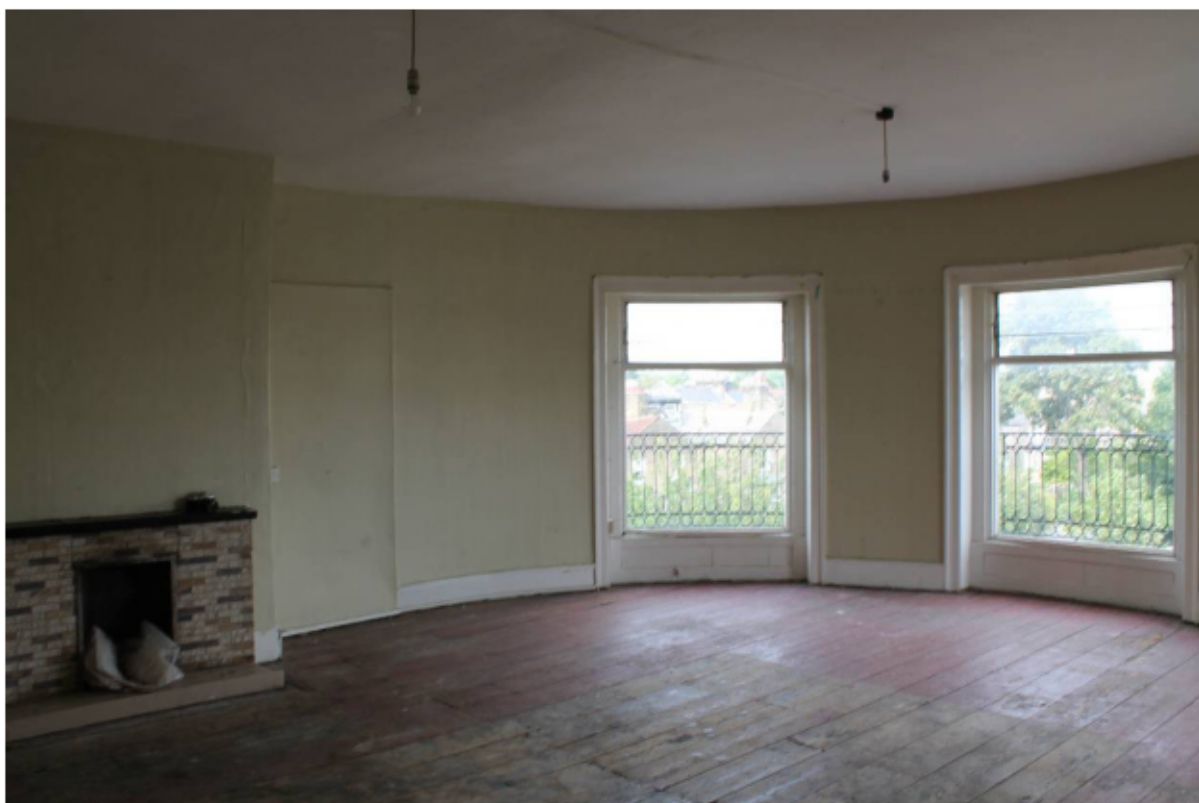
- 6.8.2 Nursery room (S10), as is the case with all the rooms of this floor, is much plainer in treatment than those of the floor below (**Plate 28**). The room had no picture rail, dado or ceiling cornice and a plain skirting with roll moulding. The three original sash windows in the room have all been replaced with fixed glazing, two light windows with louvers, though the window architraves, with a simple ogee moulding, remain. A built-in cupboard/wardrobe with original shelving and peg hangers is built into the south wall. A modern replacement fireplace with a 1950s tile surround and raised hearth is located against the north wall, just to the west of a now blocked doorway into the adjacent room (S11). The party wall with the corridor is lined out using modern plasterboard.

**Plate 28** Nursery Room (S10), looking north-east

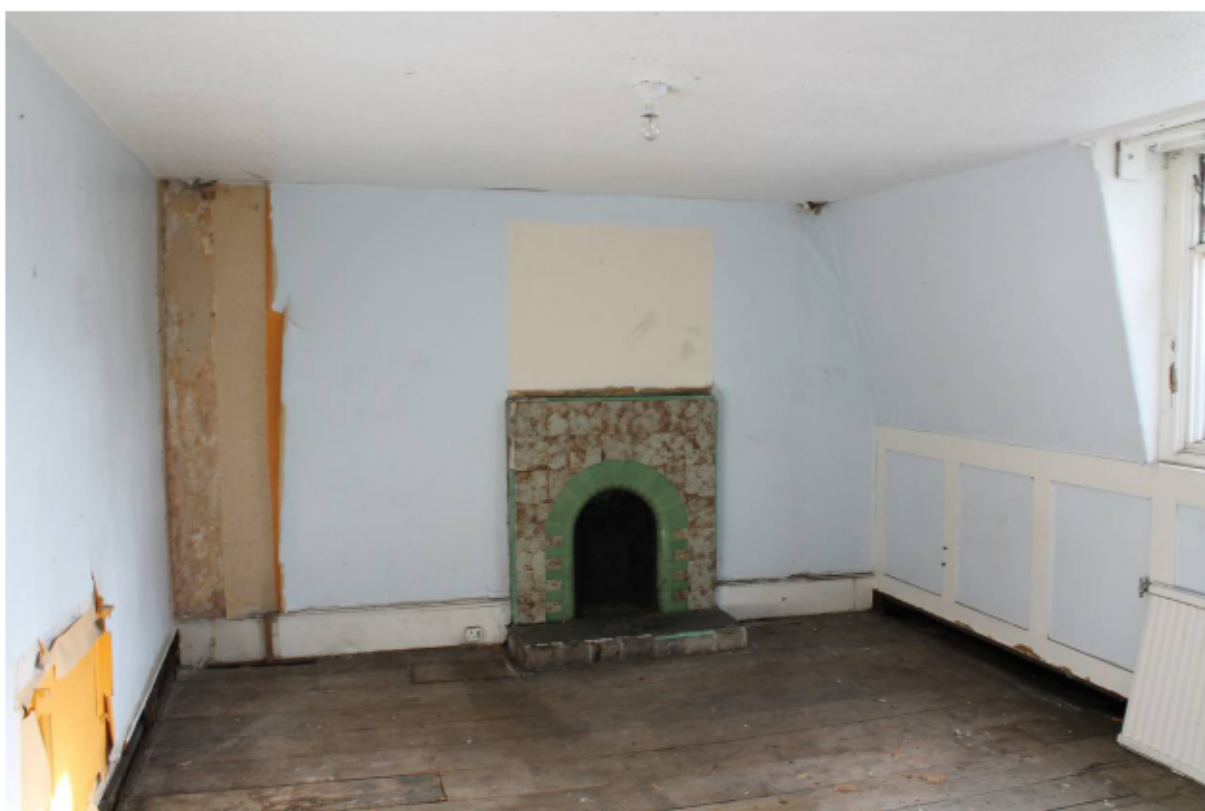
- 6.8.8 Bedroom (S13) is the only bedroom on the western side to retain its original panelling/blocking below the level of the dormer window (**Plate 31**). This comprises seven recessed panels. The skirting boards remain on three walls and the door architrave is original. The dormer has a modern replacement fixed glazed window with louvers and the 1950s replacement fireplace has brown and green ceramic tiles, bullnose to the fire opening. This was built over the original stone hearth, still surviving to the front.

**Plate 31** Bedroom (S13), looking south

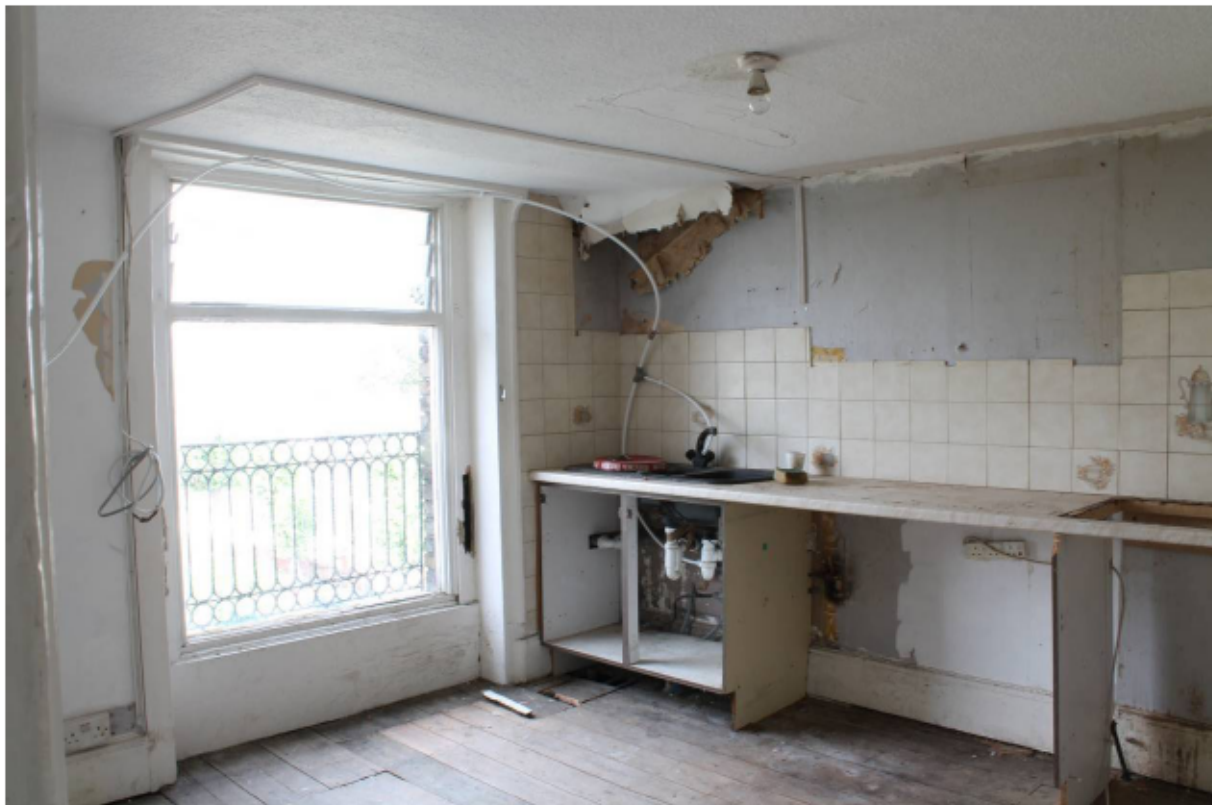
- 6.8.9 Bedroom (S14) was latterly converted into a kitchen (**Plate 32**). This later use has removed many of the original features, although the plain skirting boards and door architrave survive. The window surround also remains despite the replacement of the sash window with fixed glazing. Many of the floor boards are modern and there is no evidence for a fireplace. Plaster missing from the dividing wall with (S13) shows that the internal partitions at this level are timber stud walling comprised of primary bracing. It is likely that this bedroom and (S13) were initially used as servant accommodation.

**Plate 32** Bedroom (S14), looking south-east

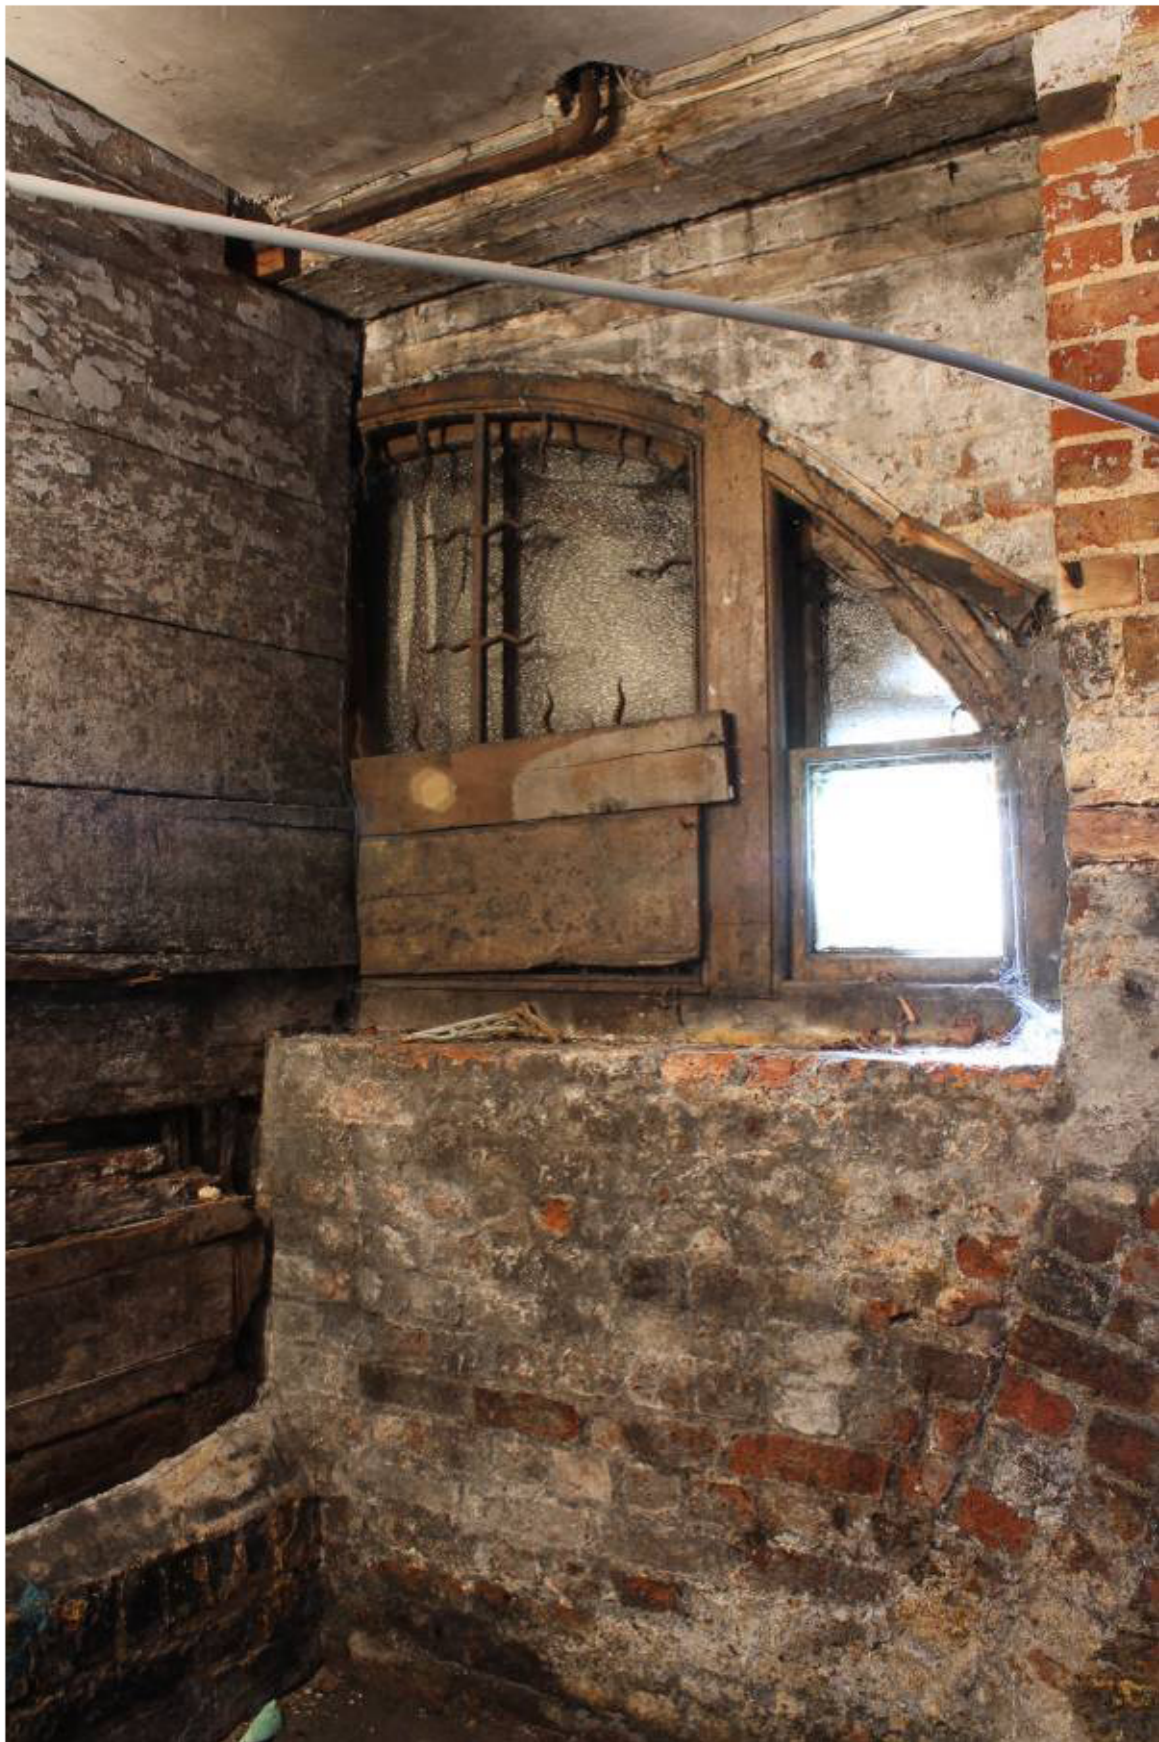
- 6.9.13 Internally the partition walls are part boarded-out, using heavy 11 inch horizontal oak planks, to protect the timber stud internal walls from damage (**Plate 38**). At the time of the initial recording, the brick flank walls were bare of plaster or other treatments. Where exposed the internal primary braced stud partition walling was nailed together using c.60mm x 90mm softwood studs. The southern partition internal wall is set onto a brick out-set plinth, the floor is covered in red brick pammets. Entry to the coal store is through an original door opening with architrave and four panel door. A large mortice lock in a wooden casing is still attached to the door.

**Plate 38** Basement window in Coal Store (B19), looking south-west

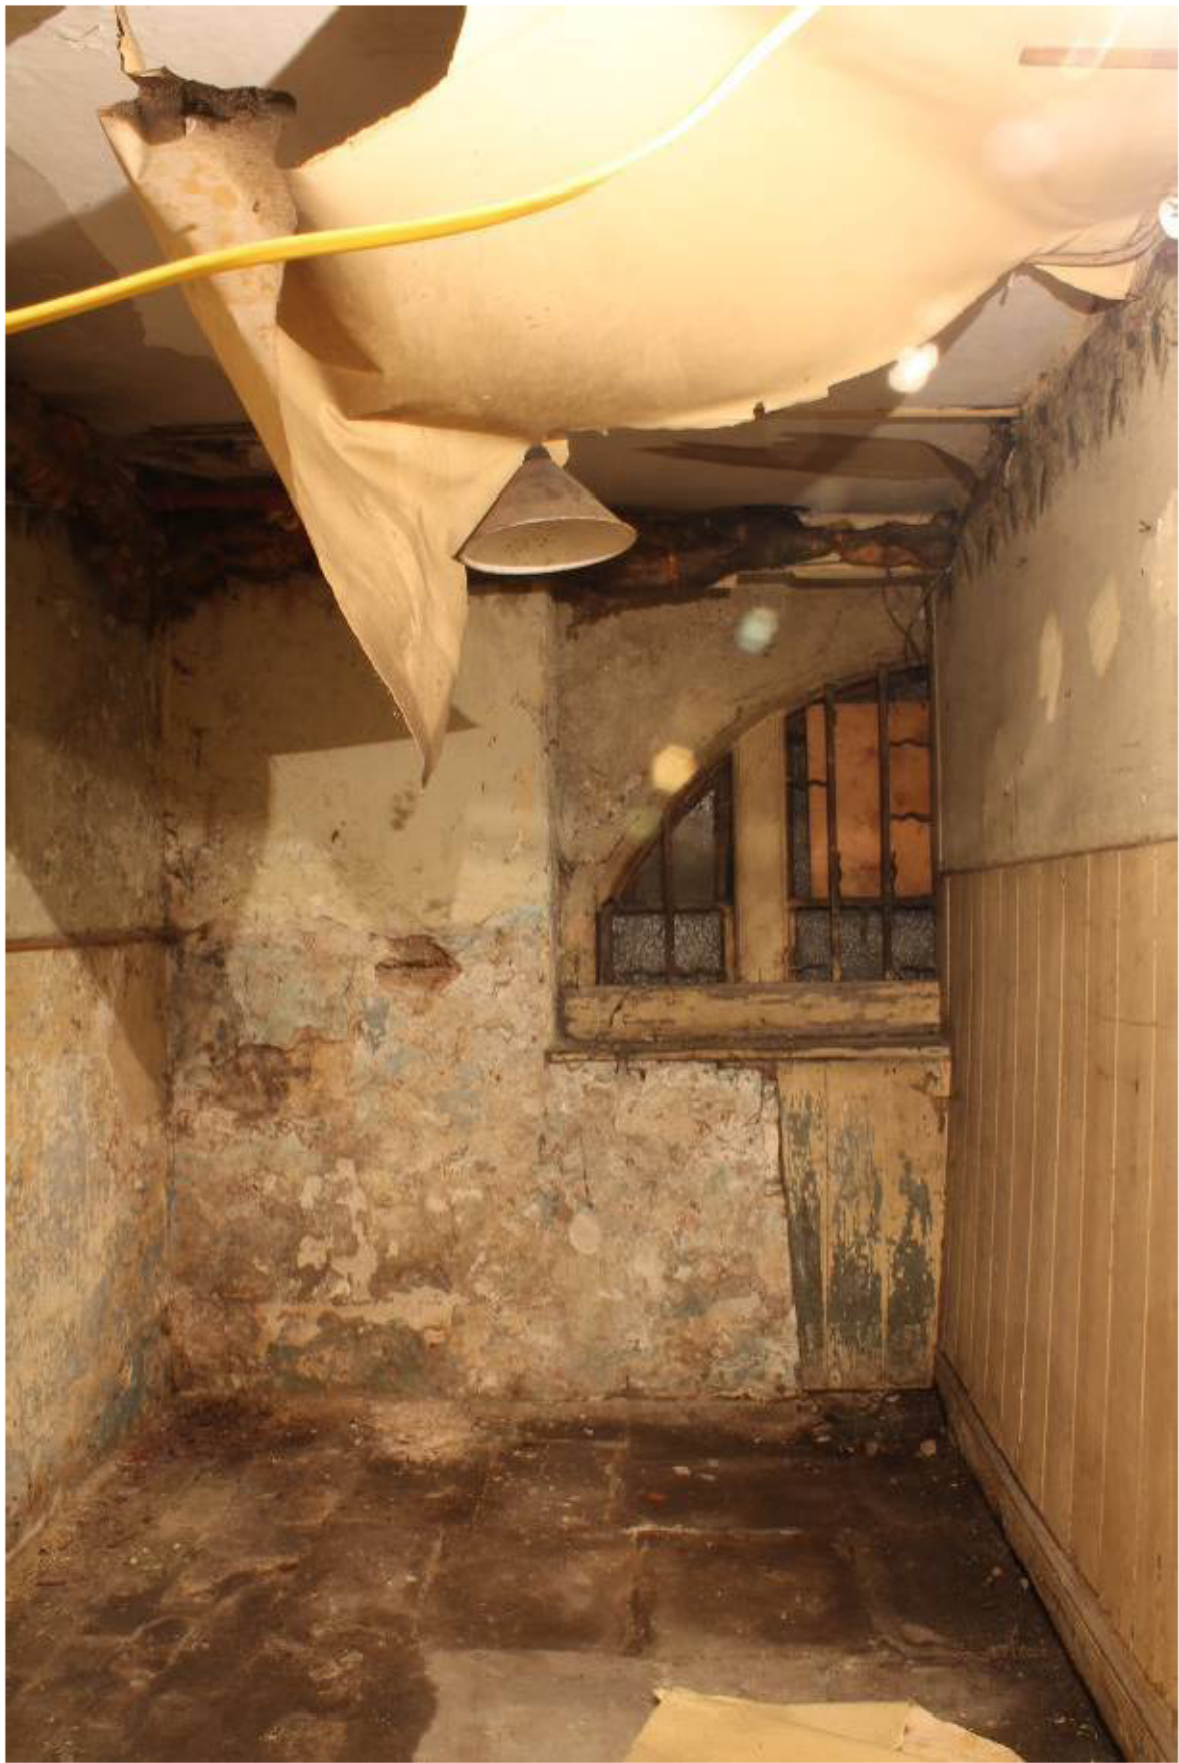
- 6.9.15 Dairy Room (B18) is situated to the south of the coal store (**Plate 39**). As it is the only room within the basement to have a stone flagged floor (with later brick patch repairs) and is located within the darker western side of the building, it seems likely that this room was originally in use as a small dairy/cold food store. It has a simple three plank ledged and battened door from which the lock mechanism has been removed. Internally it had been boarded out using vertical match-boarding with bead detail on all four walls, though only the match boarding on the north wall and part of the west wall survives. The room shares a basement window, a Diocletian style window with a beaded detail, with the adjacent coal store (see above) and retains the same glazing and bespoke security bars. The presence of a floral frieze (**Plate 40**) around the top

**Plate 39** Former Dairy/Pantry (B18), looking west
