**HISTORIC BUILDING  
RECORDING AND  
ARCHAEOLOGICAL  
MONITORING AT POND  
HOUSE, NO. 162 LOWER  
CLAPTON ROAD, LONDON  
BOROUGH OF HACKNEY**

**PCA REPORT NO. R11599**

**JANUARY 2014**

**Site Code: POH12**

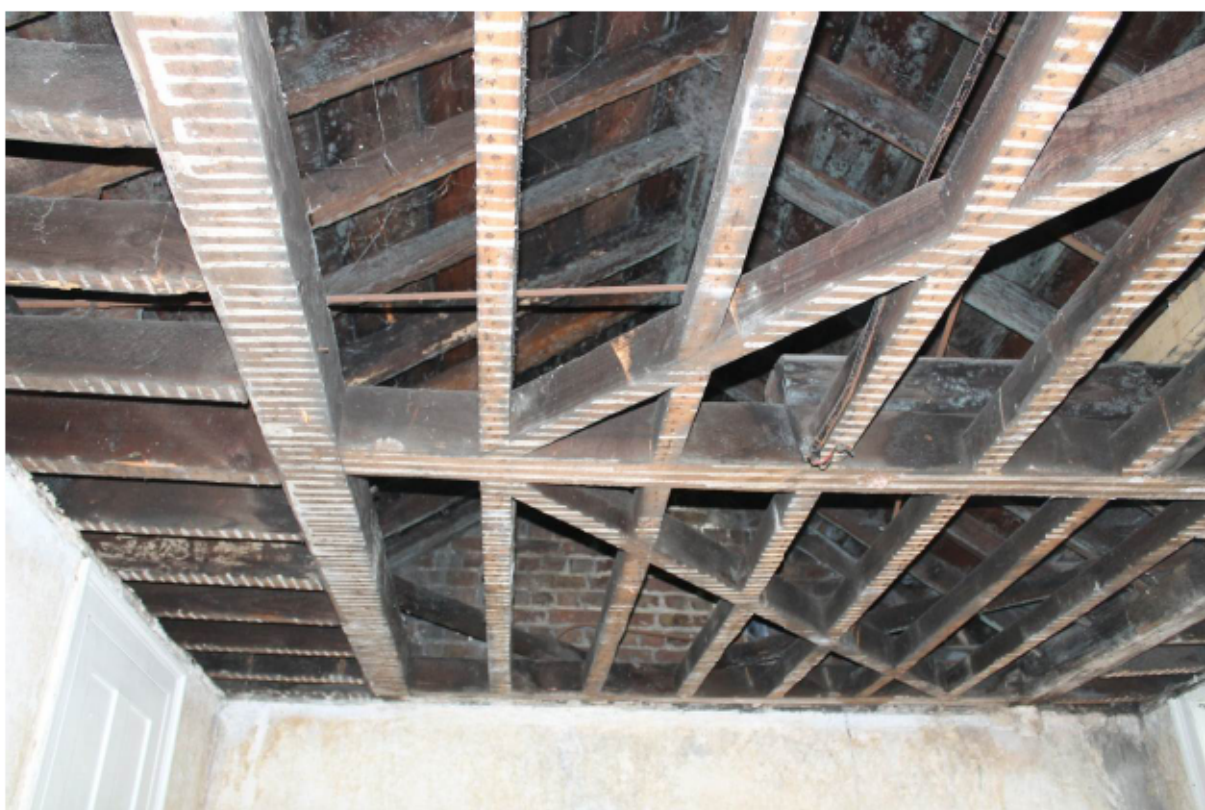
- 7.9.2 The central valley was originally formed by short lengths of timber fixed to the ceiling joists, into which the rafter foot of each pitch were joined using a birds mouth joint. This valley was replaced by a later, raised valley structure, which overlay it and was constructed by nailing short lengths of timber joist between the base of the rafters and covering with deal boards. The outer valleys to the rear of the parapets were built using a similar construction with a short length of joist nailed to the rafter foot and supported by a raised wall plate.

- 7.9.3 A later 19th century strengthening of the ceiling structure saw the addition of a short 6 x 6 inch timber beam bolted to, using heavy wrought iron coach bolts with square heads and nuts, an existing (east-west) beam and bridging the valley to the flank wall. This provided additional strength in an area affected by decay (from the valley) and was recorded in attic room (S11).

**Plate 57** Fully-framed second floor ceiling joists and roof structure, looking north

- 7.9.4 Modern repairs included the replacement of some of the valley joists and the bulking up of the main north-south bridging beam which ran parallel with and along the inner valley of the eastern wall.
