**HISTORIC BUILDING
RECORDING AT
PRIORY FARM,
NO. 41 MAIN STREET,
KIBWORTH HARCOURT,
LEICESTERSHIRE
LE8 0NR**

SITE CODE: PKHL15

PCA REPORT NO. R12332

JANUARY 2016

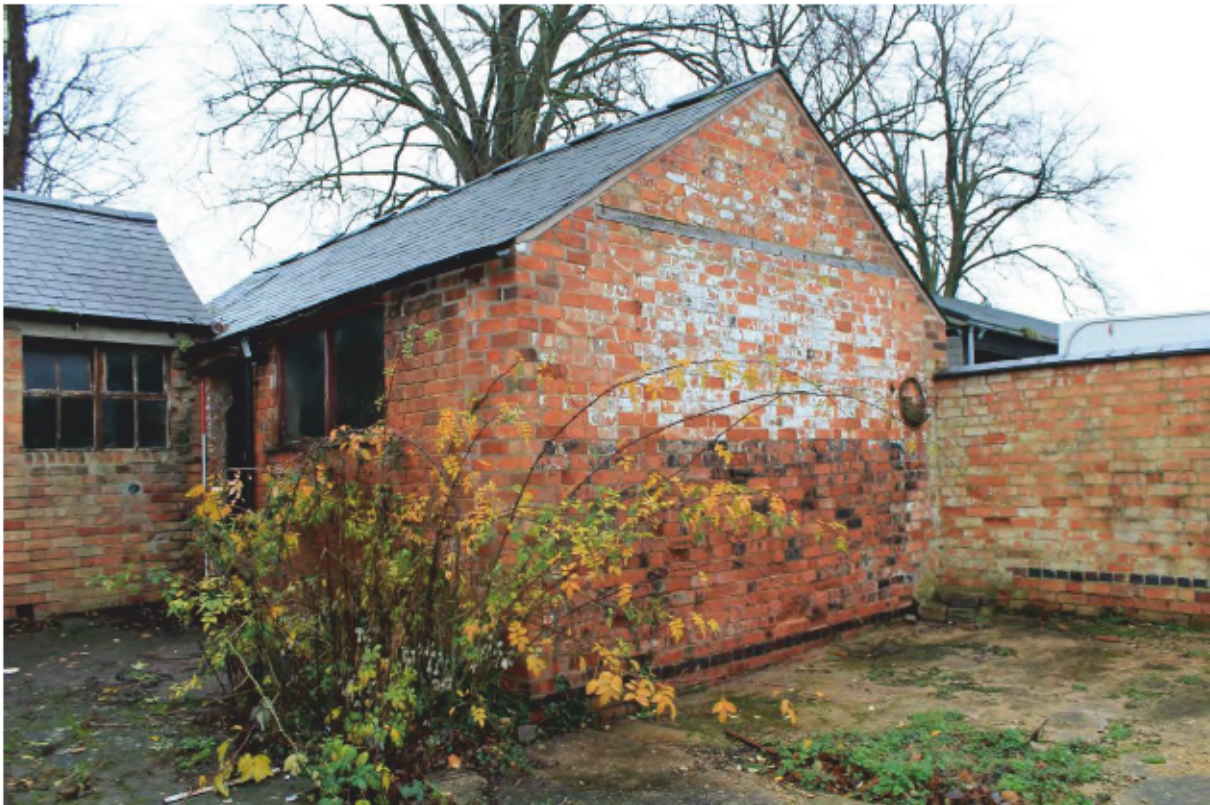
Plate 1 Cow shed (A) looking north-west

- 6.2.1 Building A presents its gable ends to the east and west and long elevations to the north and south (**Figure 10; Plates 1 to 3**). The latter is partly obscured along its western end by the addition of an adjoining range (B) to the south. This addition is clearly seen in a butt joint and a distinct change in the character of the bricks. Single storey building A is built using large red bricks (220 x 70 x 100mm) and incorporates several phases of blocking and repair. The brickwork to the visible south elevation is built in Flemish bond and laid in a beige coloured lime mortar (**Plate 3**). It contains a window and a door opening, the former a modern insertion partly using an original opening (as seen by queen closers to the eastern jamb). The door opening is an original feature, built with a brick segmental arch. Whilst the door had been removed the wrought iron pintles still remain within a recessed closing. Internally the jambs to the door opening are bull-nosed and stopped at three quarter height.

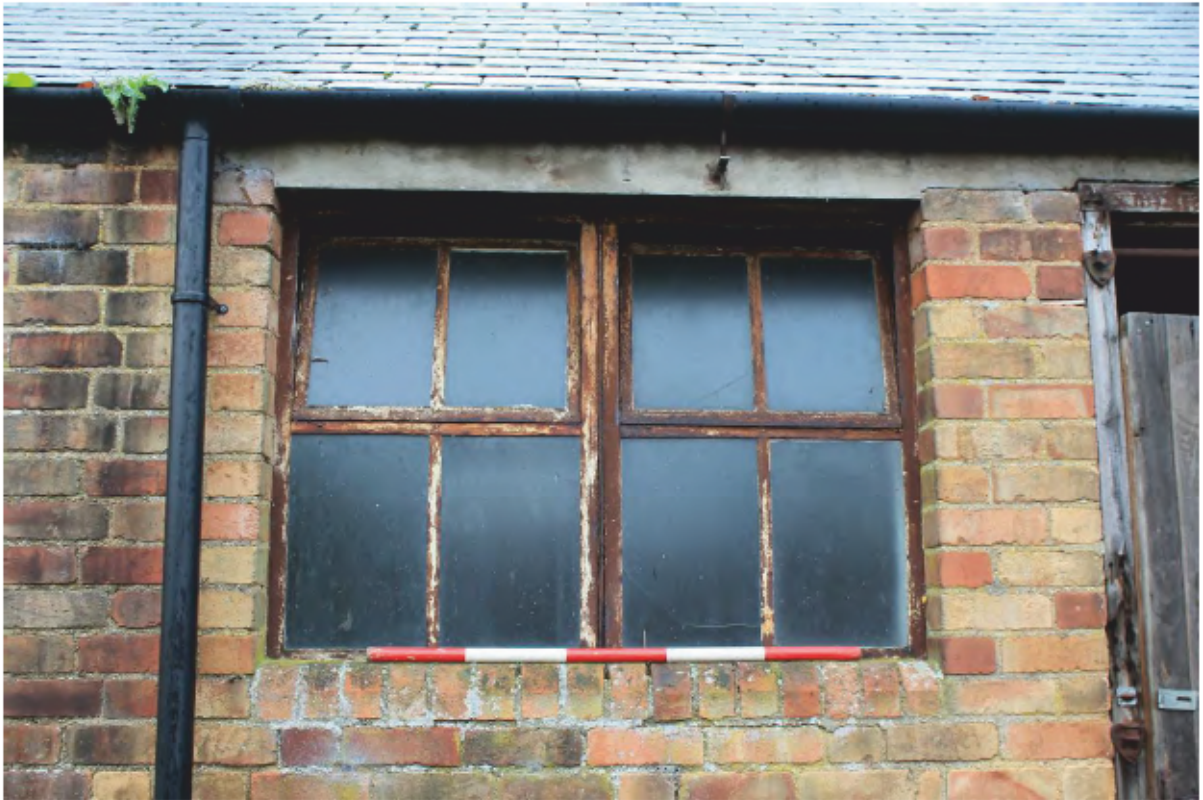
- 6.3.2 Both B1 and B2 were lit by openings in the eastern wall. All three openings were identical in size and used the same fenestration throughout, an 8 light metal-framed casement with fixed lower panes and a pair of two light bottom hung ventilating hoppers to the upper window (**Plate 10**). These window openings used bull nosed sills and large concrete lintels, which, where necessary, also projected over the door openings (**Plate 9**). Both of the softwood plank doors to B1 and B2 were in a poor condition, much repaired and patched up.

Plate 10 Building (B) typical window

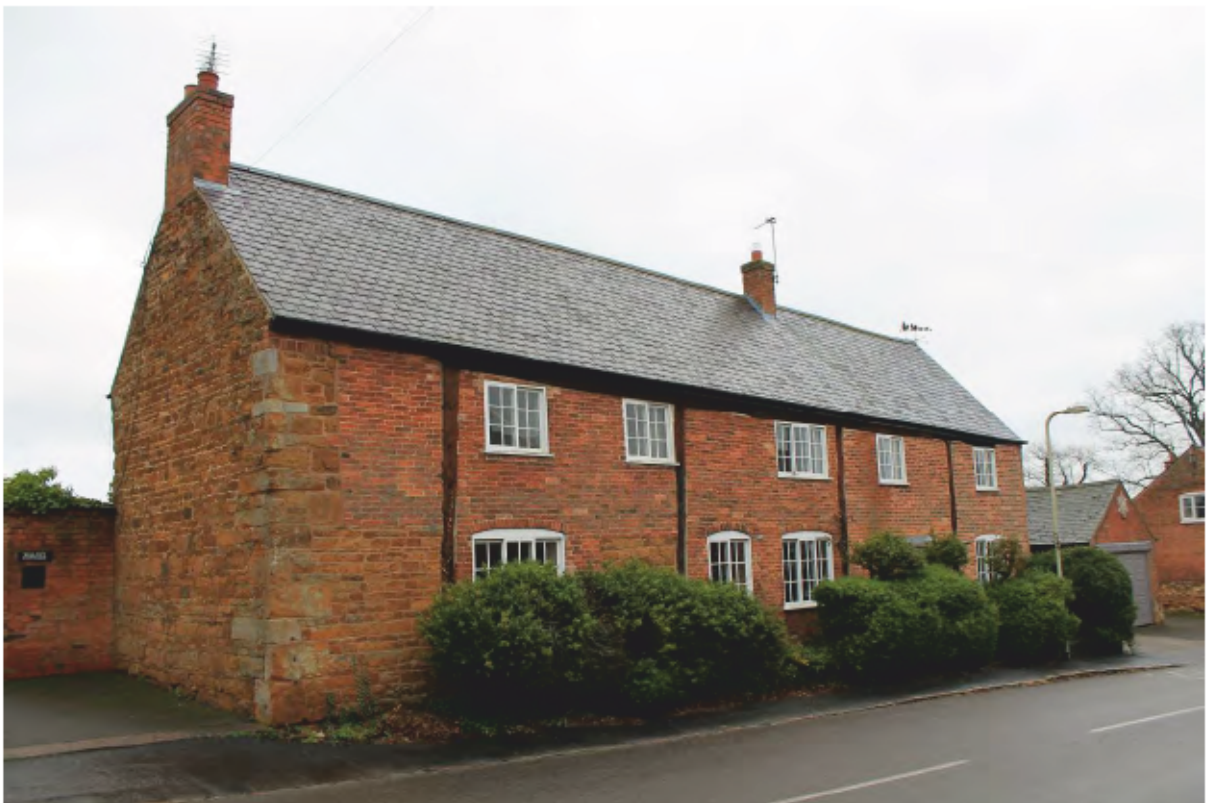
Plate 15 Priory Farmhouse looking north-east

- 6.5.3 The farmhouse is an in-line, two storey, timber-farmed and gable ended house, with later brick noggin to the external elevations but with a coursed rubble stone western gable end and lower stone wall to the western bay (**Plates 15 and 16**). The stone quoining to the south-western corner appears to have been rebuilt or repointed, probably, given the type of mortar, in recent years and sections of the infill brickwork have also been rebuilt and repaired, particularly the two eastern bays (front) and the first floor of the eastern gable end. The brick noggin where 'original' comprises relatively narrow bricks, typically measuring 230-240 x 60 x 110mm, and laid as stretchers in quarter lap. It included some over-fired bricks and some with diagonal kiss marks, but generally the appearance is uniform.

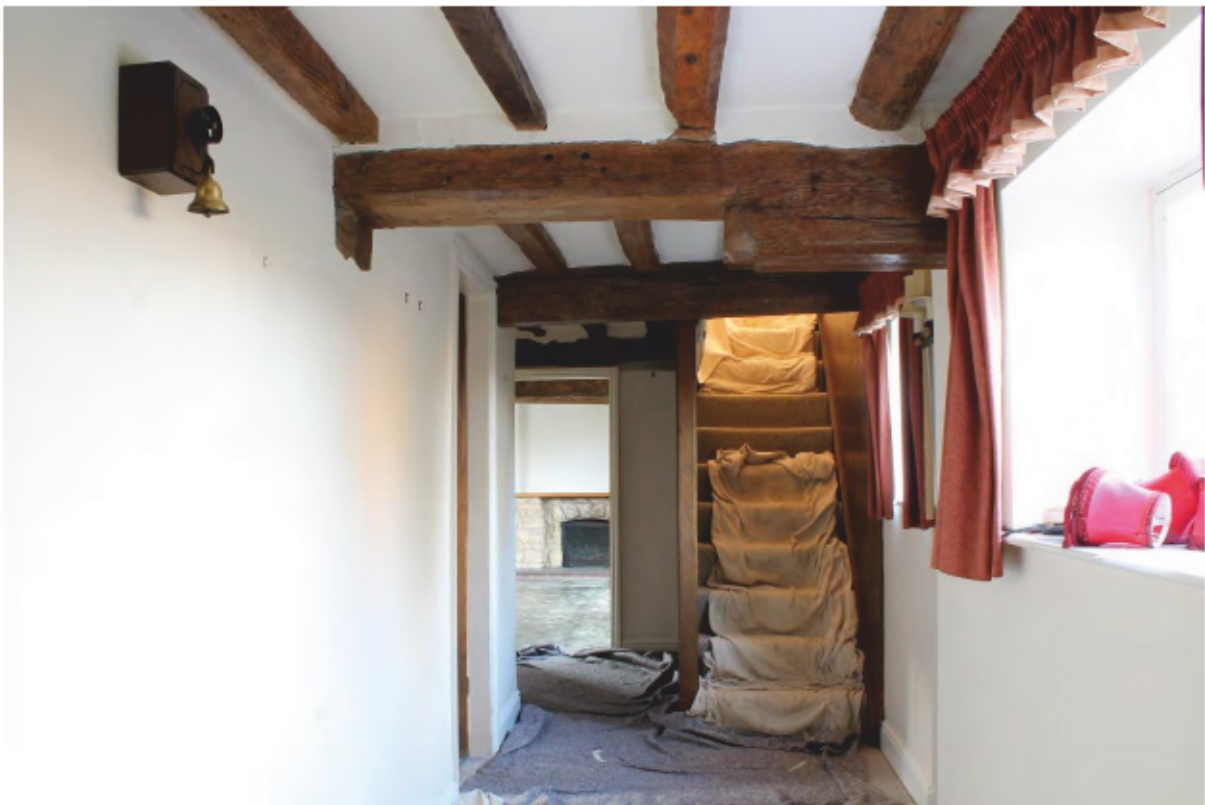
Plate 19 Farmhouse, ground floor looking west, showing cut away beam for head clearance.

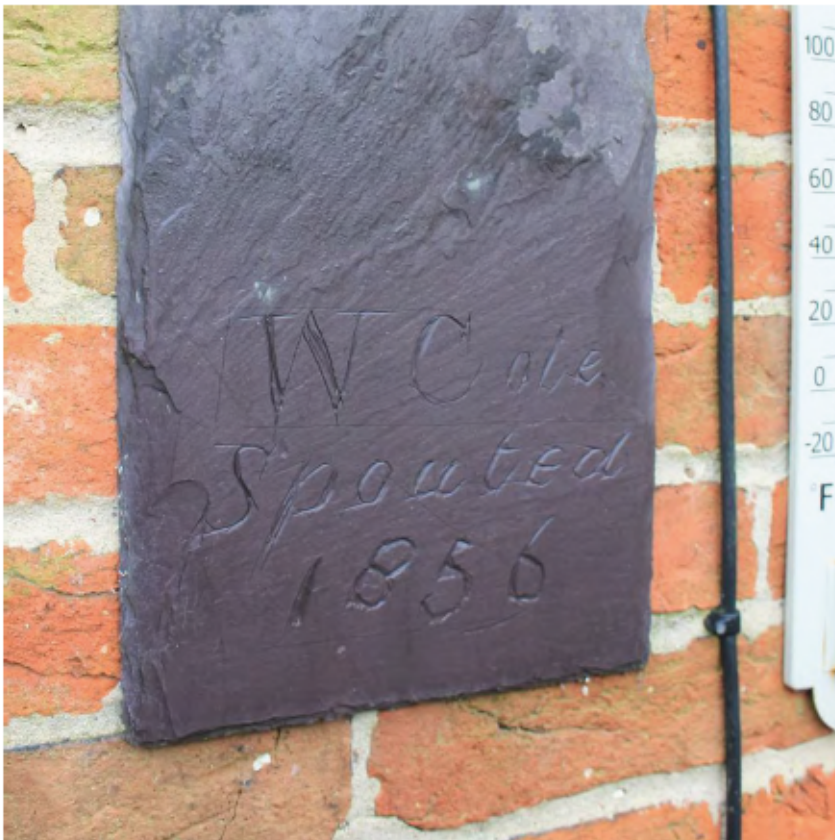
Plate 29 Inscribed slate

rafters, which pinch a thin ridge board, all features synonymous with a mid-late 19th century or 20th century date. A roof slate inscribed with W Cole and 1856 (**Plate 29**) may provide a more accurate date for this re-roofing event. Within this later reworked roof, there are some areas of recent repair.

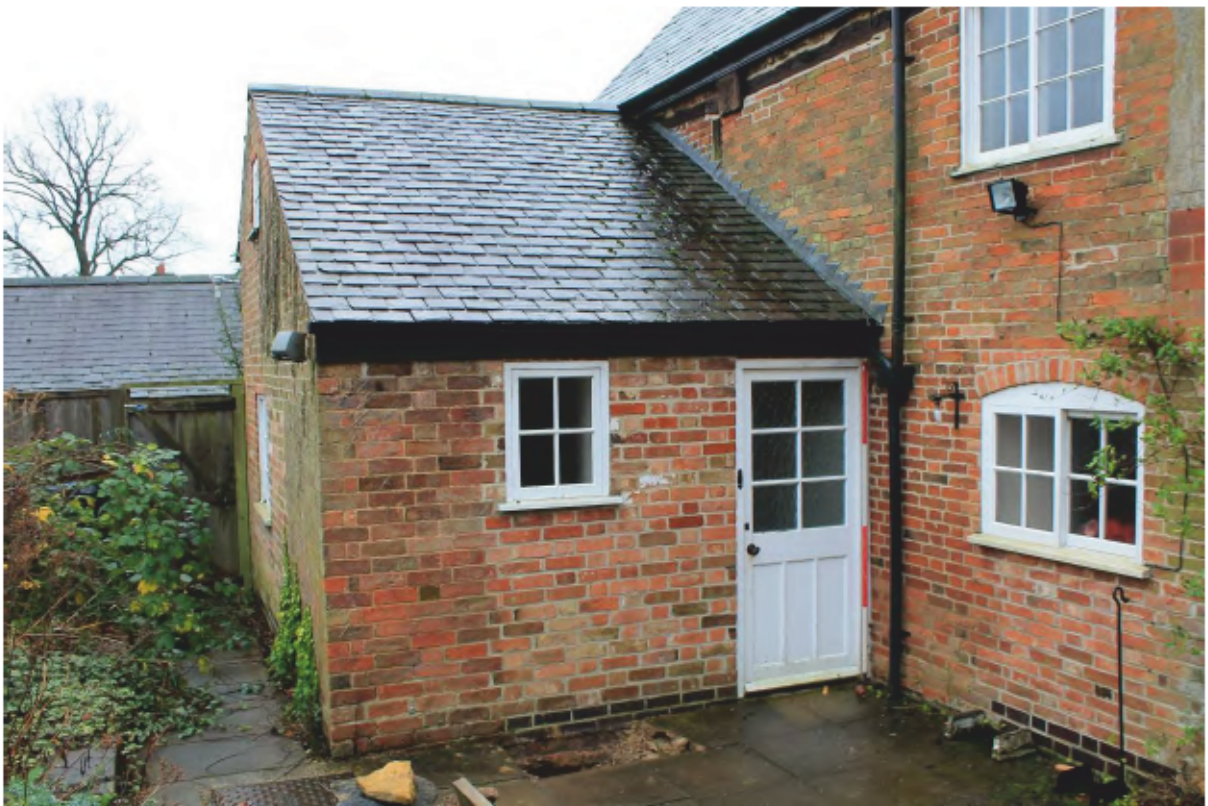
Plate 31 Rear extension looking east, showing modern rebuilding

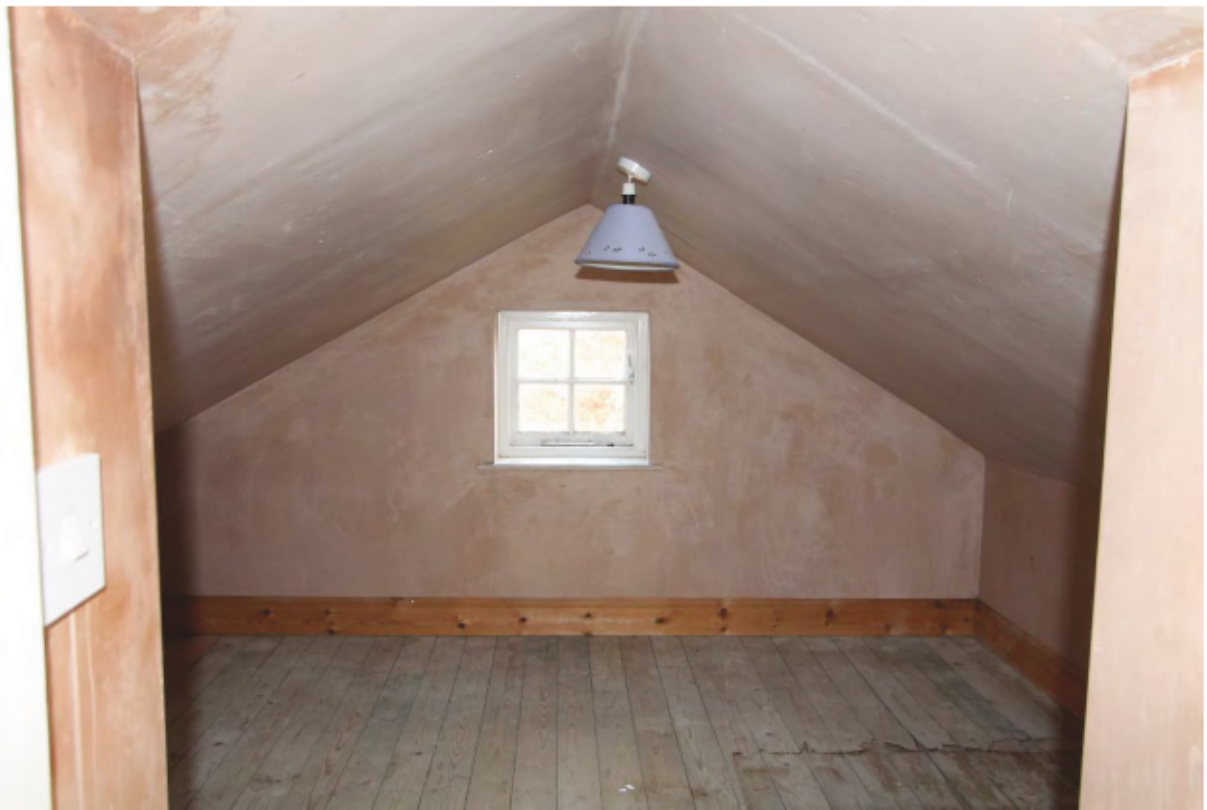
Plate 33 Modern redecoration to rear extension/dairy at first floor level
