**ARCHAEOLOGICAL
BUILDING RECORDING AND
WATCHING BRIEF OF
THE ROOF LANTERNS AND
LEADED FLAT ROOFS AT
KENSINGTON PALACE,
PALACE AVENUE,
ROYAL BOROUGH OF
KENSINGTON AND
CHELSEA,
W8 4PU**

SITE CODE: KEN29

PCA REPORT NO. R12405

MARCH 2016

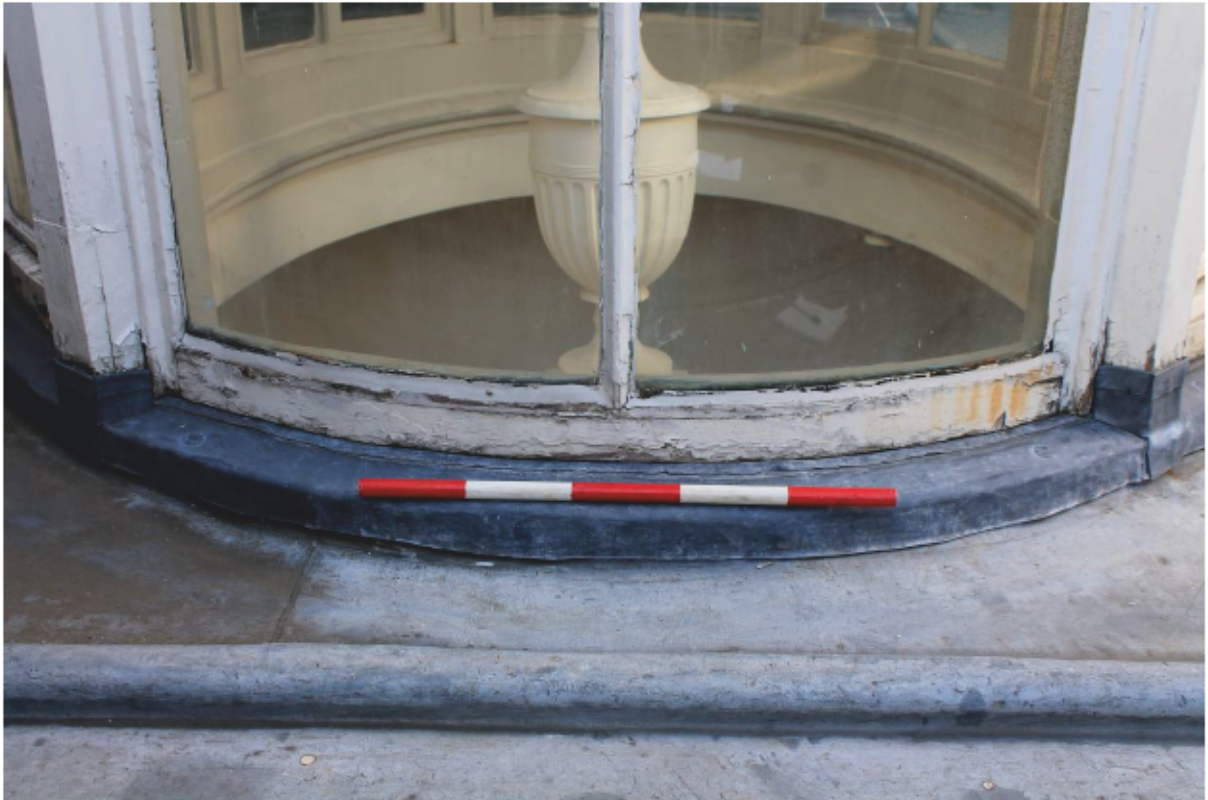
Plate 5 Lantern A: External Repair 1

- 5.2.1 External Repair 1: Repair to Sill (Plates 4 and 5): Length of new timber sill extending the full width of the eastern light (c.1020mm). Appears to have been scarfed into the base of the lantern.

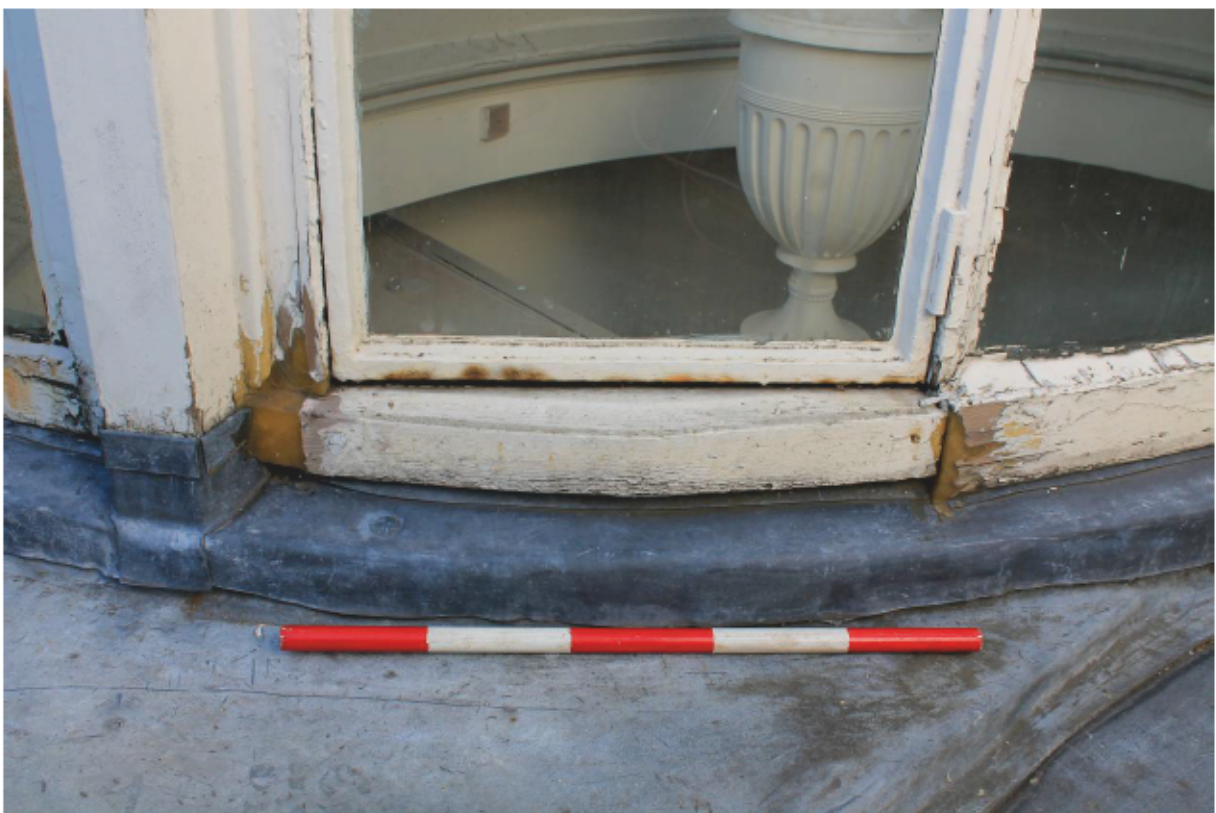
Plate 6 Lantern A: External Repair 3

- 5.2.3 External Repair 3: Repair to sill (Plate 6): Insertion of a length of softwood timber to create a new sill for the inserted modern casement (casement 5). Added by cutting back original sill with vertical cut and diagonal nailing into existing frame. This section of new timber has been crudely shaped to match the curvature of the sill. There is an additional resin repair to the junction with the post and to the base of the window and another resin repair to the sill on the western side of the casement.

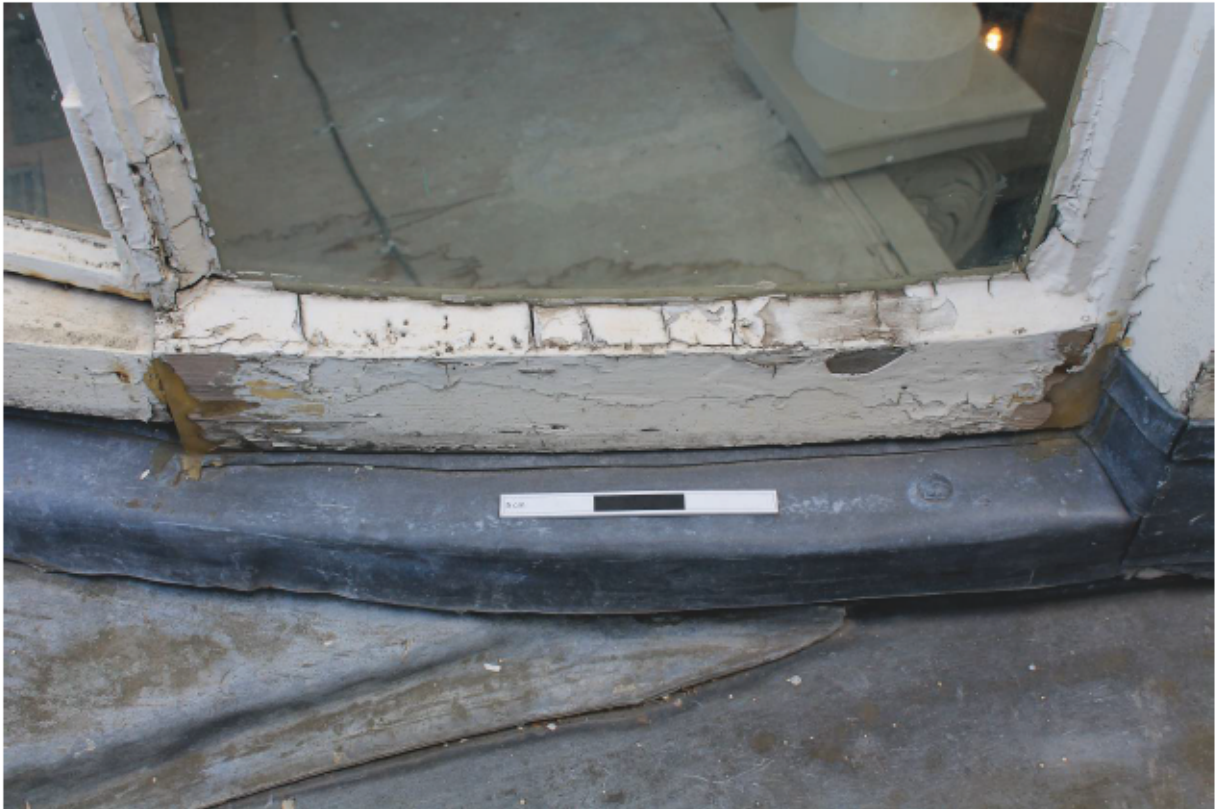
Plate 7 Lantern A: External Repair 4

- 5.2.4 External Repair 4: Repair to sill (Plate 7): Similar insertion of a new section of modern softwood timber sill into the base of the easternmost light. As with (ER3) the inserted sill is much cruder than the original and includes evidence of resin repairs.
- 5.2.5 Casement 5 (Plate 8): Replacement and alteration of glazing bars and insertion of window frame to facilitate introduction of new side hung iron-framed casement window. This also includes the addition of a heavier glazing bar to the top of the casement, which over-sails the window opening to provide a rain drip.
- 5.2.6 External Repair 6: Repair to sill (Plate 9): Resin repair to the sill the window within the central bay/light of the northern elevation, used to consolidate the frame and replace areas of decay within sill.

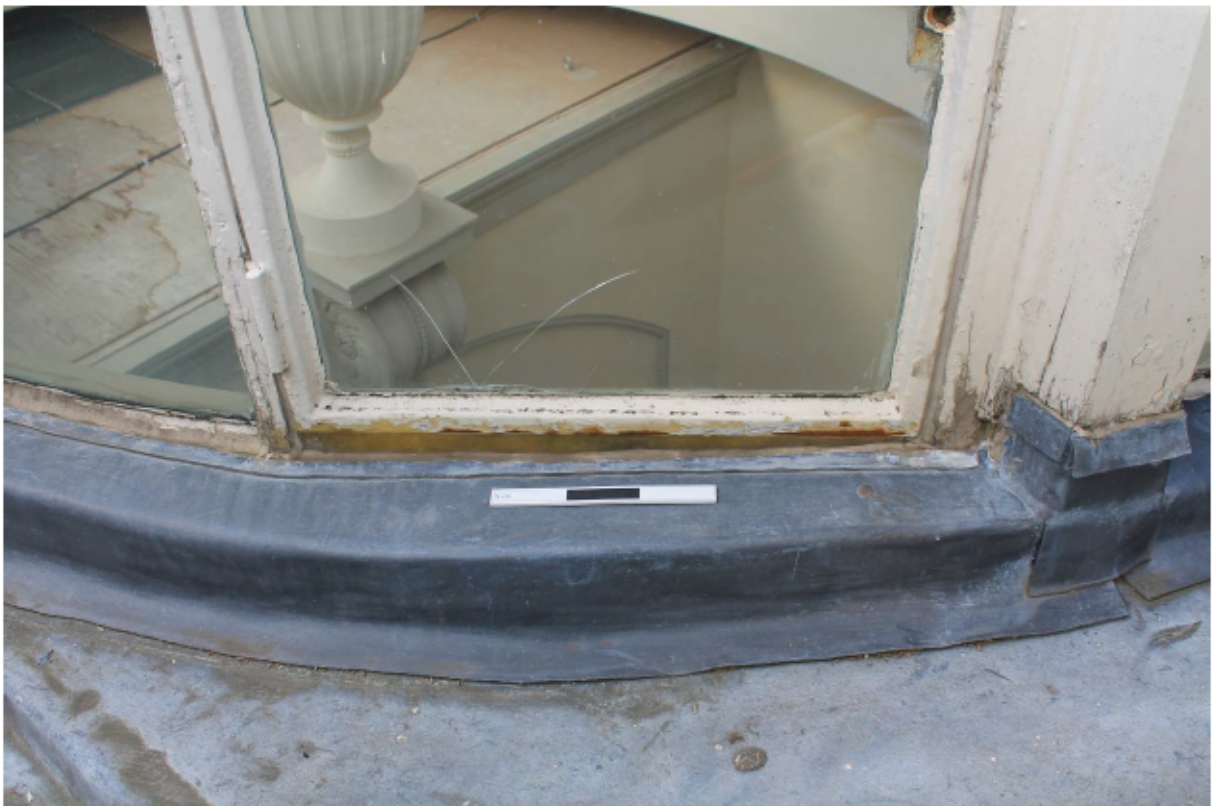
Plate 10 Lantern A: External Repair 7

- 5.2.7 External Repair 7: Repair to sill (Plate 10): The sill of the lantern is less visible (above the level of the roof) in this area due to the step-up and change of roof levels within the surrounding flat roof. The repair is a resin repair made to the full width (light) of the sill and maybe associated with or a consequence of the insertion of casement (8).

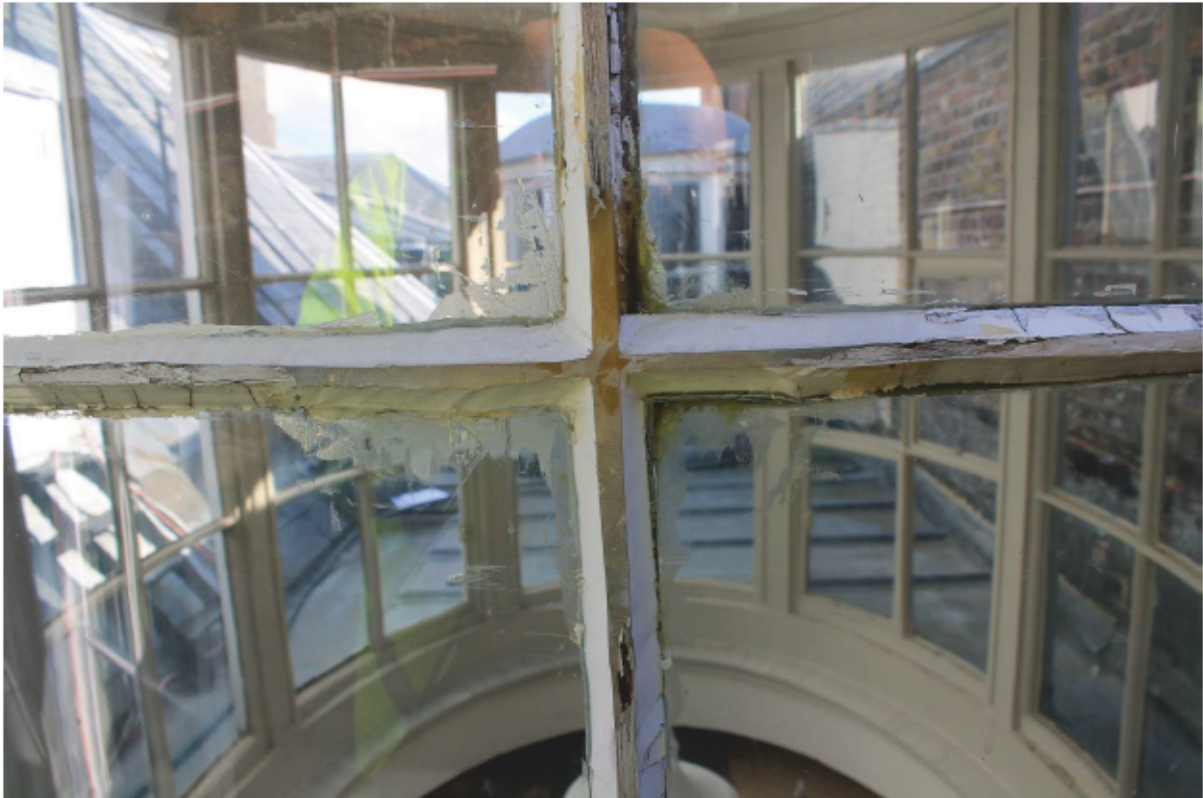
Plate 12 Lantern A: External Repair 9

- West elevation**
- 5.2.9 External Repair 9: Repair to Glazing bar (Plate 12): Resin repair to glazing bars within the western light and at the junction of the upper and central panes. The lower four panes have recently been re-puttied.

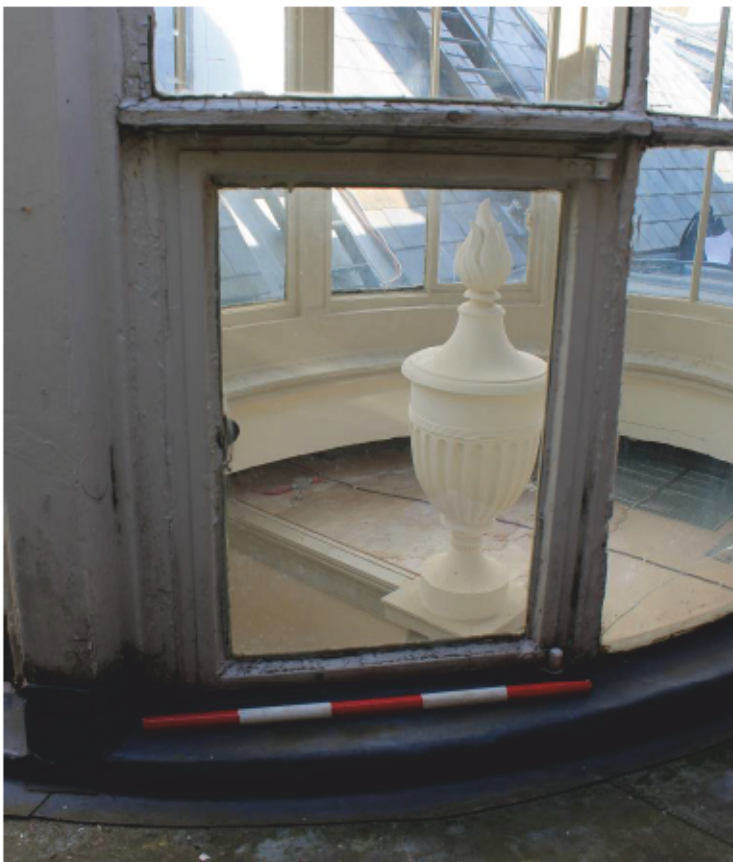
Plate 13 Lantern A: Casement 10

- South Elevation**
- 5.2.10 Casement 10 (Plate 13): The insertion of a side hung, metal framed casement window into the lower pane, west side of the western light. This window insertion has typically involved the addition of a supporting timber frame for the casement to be seated within and an over-sailing hood to act as a rain drip, added to and as part of a replacement glazing bar (see also IR3) along the top of the window.

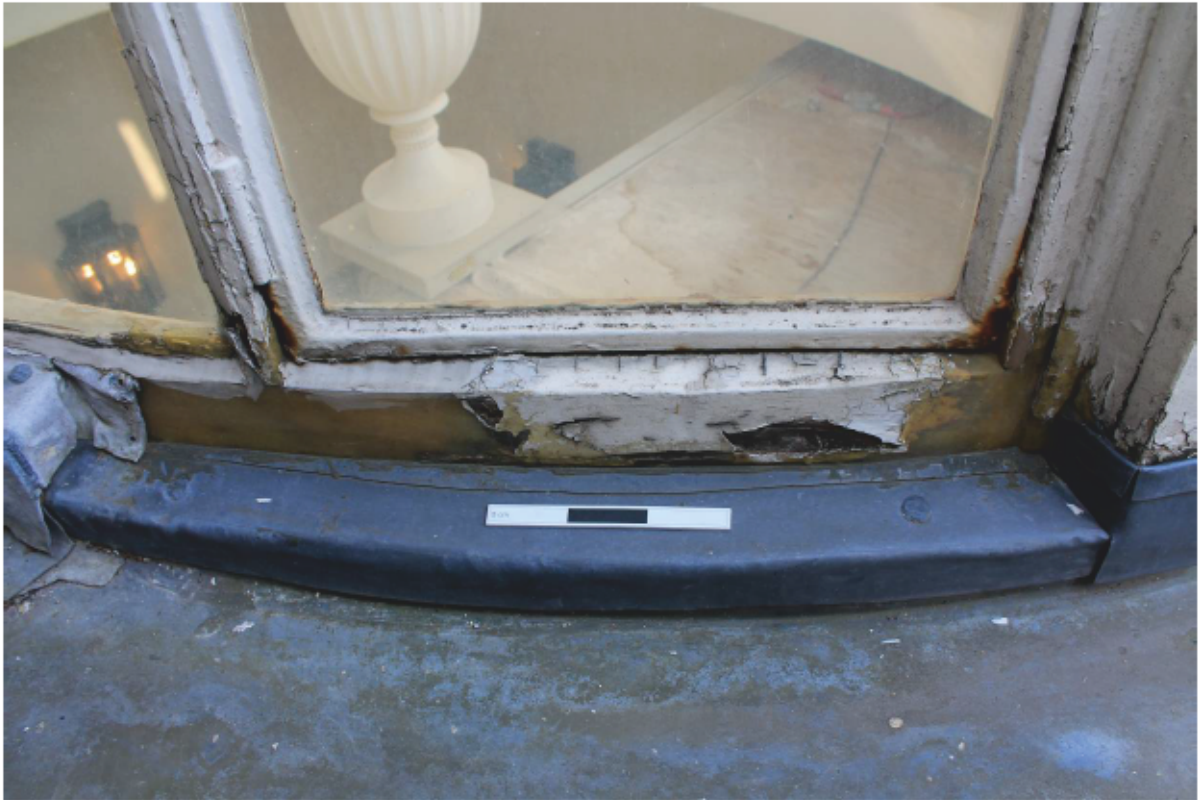
Plate 14 Lantern A: External Repair 11

- 5.2.11 External Repair 11: Repair to sill (Plate 14): The repair is a resin repair covering the greater part of the sill below casement 12 and the adjacent 'light' to the west. The rest of the sill to the west (at this level) is obscured by a step up and heightening of the base sill. The resin repair, undertaken to consolidate the sill, clearly post dates the lead-work added to protect the sill and base of the mullions, in this area. This lead-work, from its good condition looks to be a relatively recent addition. The decay to the sill may be a consequence of the casement 12 above.

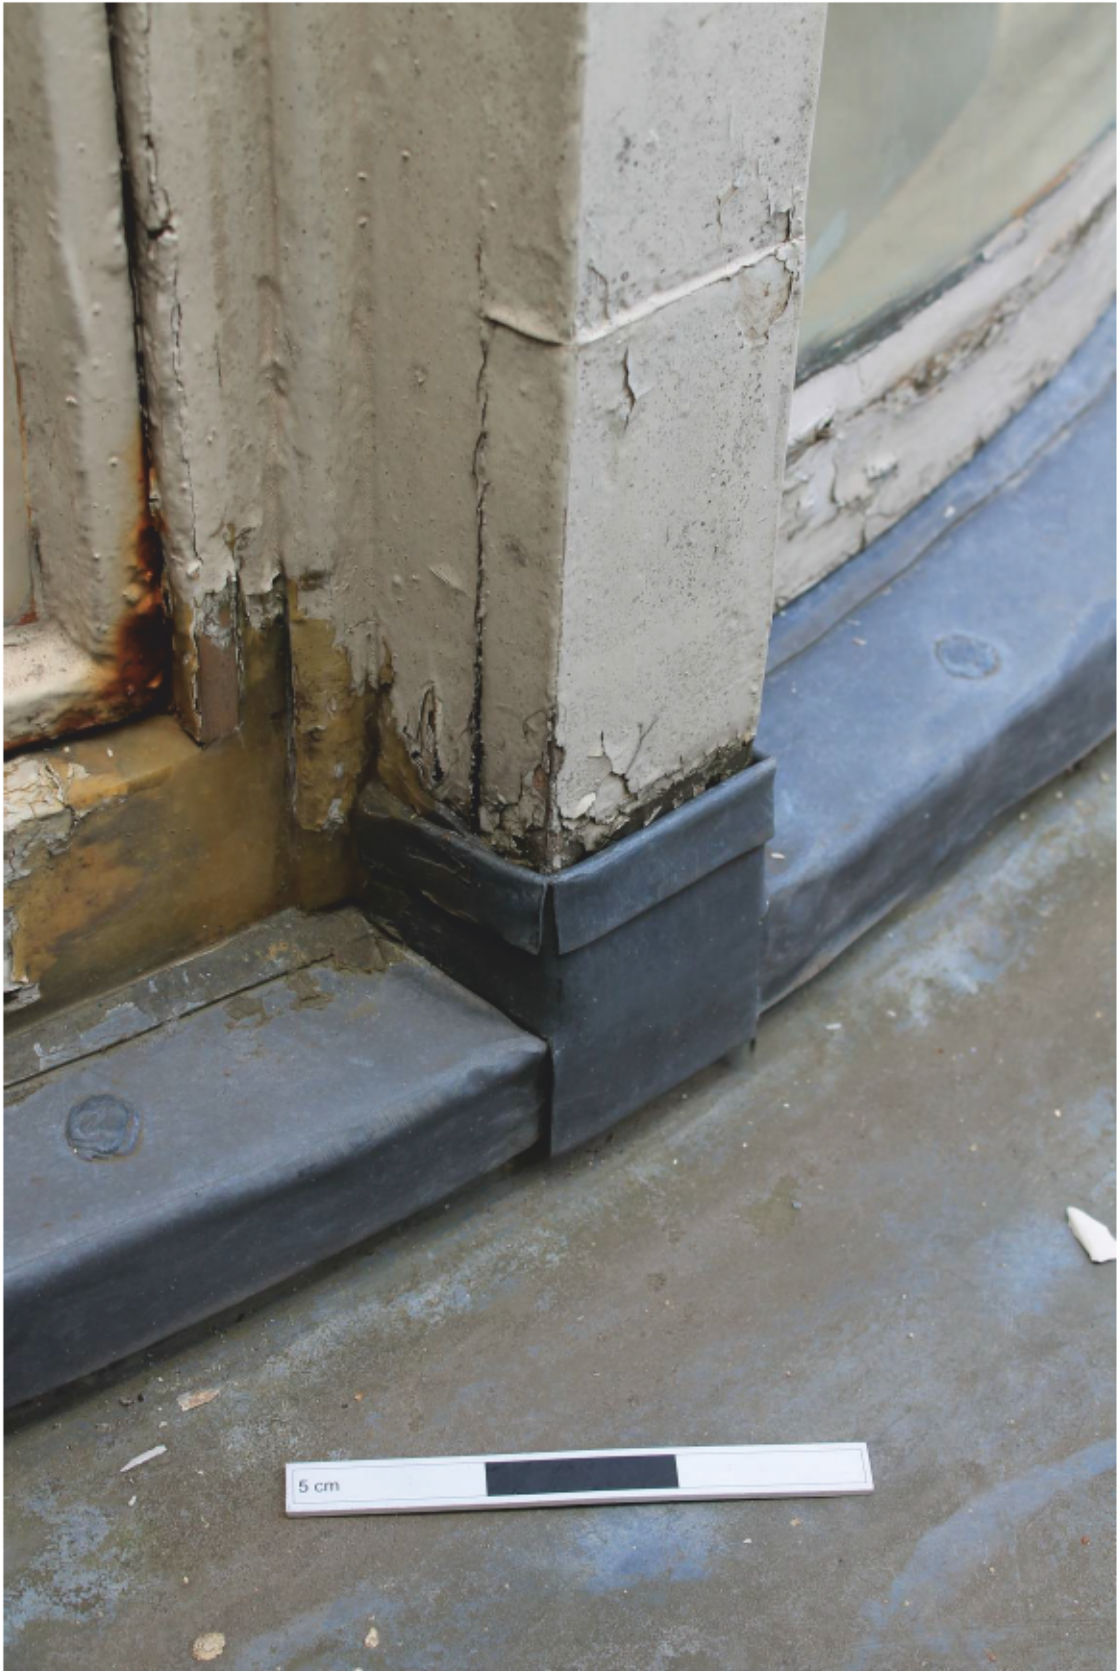
Plate 17 Lantern A: External Repair 14

- 5.2.14 External Repair 14: Repair to Mullion (Plate 17): A timber repair made to the base of the southern-easternmost mullion, eastern elevation. This involved a surface repair to the outward face of the mullion, comprising a section of timber, measuring c.1inch in depth and the full width of the mullion post, let into the base of the mullion. It extended to a height of 15.5cm above the sill (lead covered) and either lapped or rebated into the post.

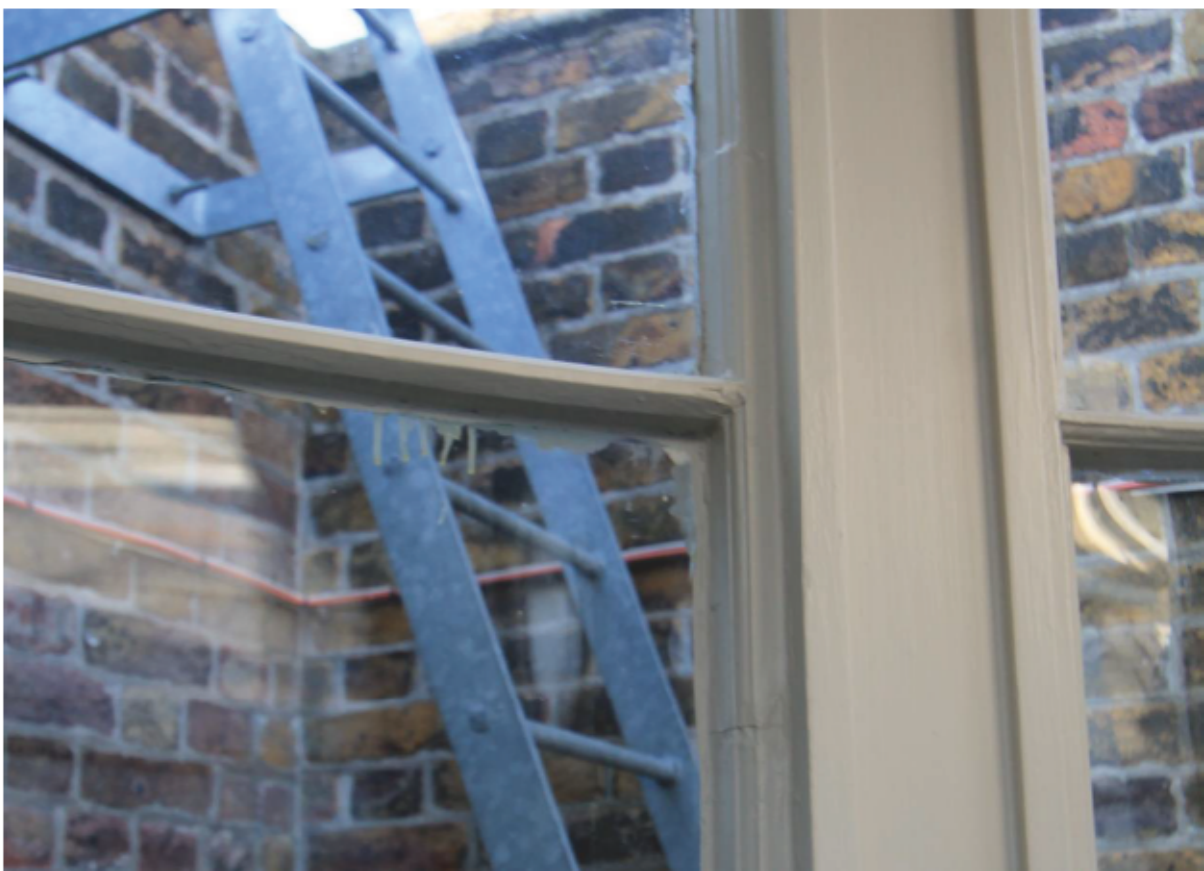
Plate 23 Lantern A: Internal Repair 1 showing plain glazing bar

- 5.3 Lantern A: Internal Repairs and Alterations (Figure 4)**
- 5.3.1 Internal Repair 1: Replacement of bar and repair to jamb (Plates 18 and 23): Replacement of glazing bar within the westernmost light of the southern elevation, between the central and upper panes and a small timber repair to the adjoining jamb, west side. The replacement glazing bar is much plainer in detail (simple chamfer) and lacks the ovolo detailing of the original glazing bars. The glazing bar appears to have been replaced along with a short section of the adjoining window jamb. This repair, which had been let into the window frame, extended to 290mm in height and was moulded, with an ovolo detail, on its inner face to correspond with the detailing of the original frame.

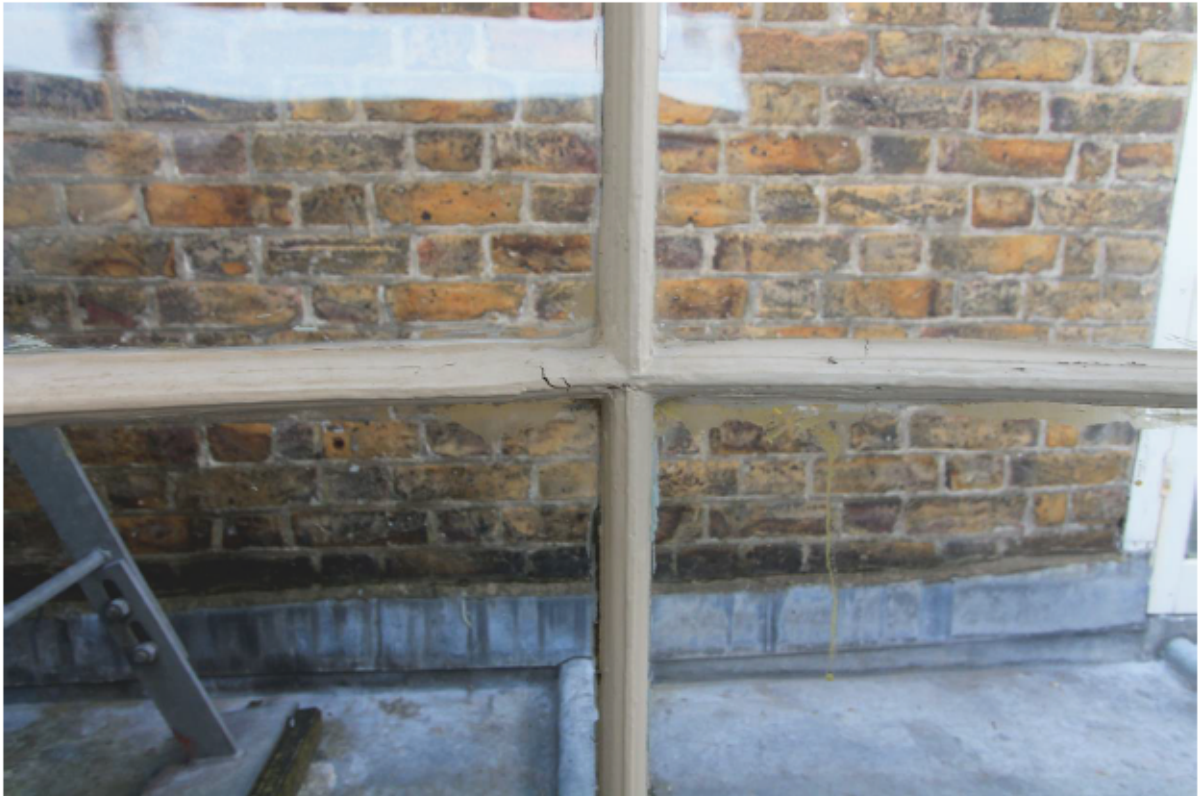
Plate 24 Lantern A: Internal Repair 2

- 5.3.2 Internal Repair 2: Repair to glazing bar (Plate 24): Resin repair to glazing bar between the central and lower panes of the western elevation. The repair is present either side of the central (vertical) glazing bar and extends to c.40cm in width (exact extent unclear due to over-painting). The glazing bar 'gives' noticeably when thumb pressure is applied.

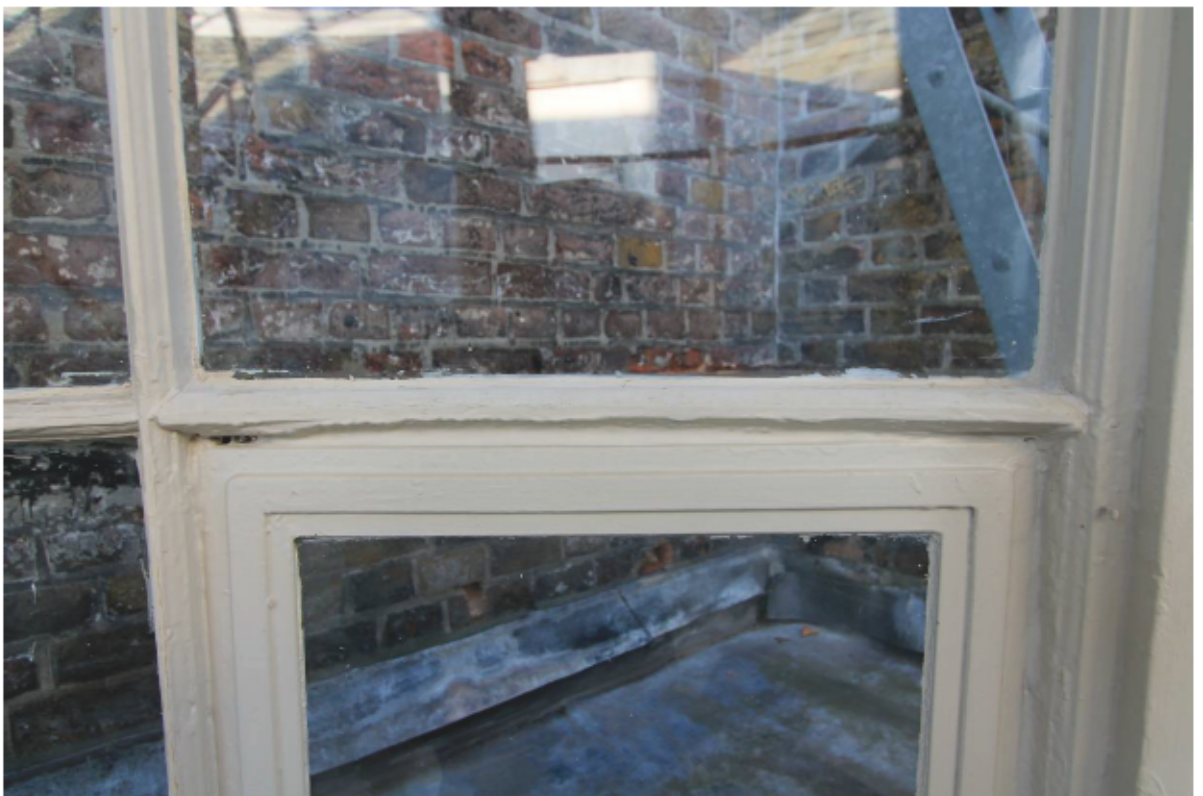
Plate 25 Lantern A: Internal Repair 3

- 5.3.3 **Internal Repair 3: Replacement glazing bar (Plates 18 and 25):** Replacement of a section of glazing bar added above and as part of the insertion of casement 10 into the lower pane, westernmost light of the south elevation. This length of glazing bar extends the full width of the pane (c.45cm wide), is less delicate as the original bars and uses a simple chamfered detail. The casement 10 is set in line with the glazing (biased to the outer face) and incorporates a central mortice, fixed with slot headed screws and closed using a square key.

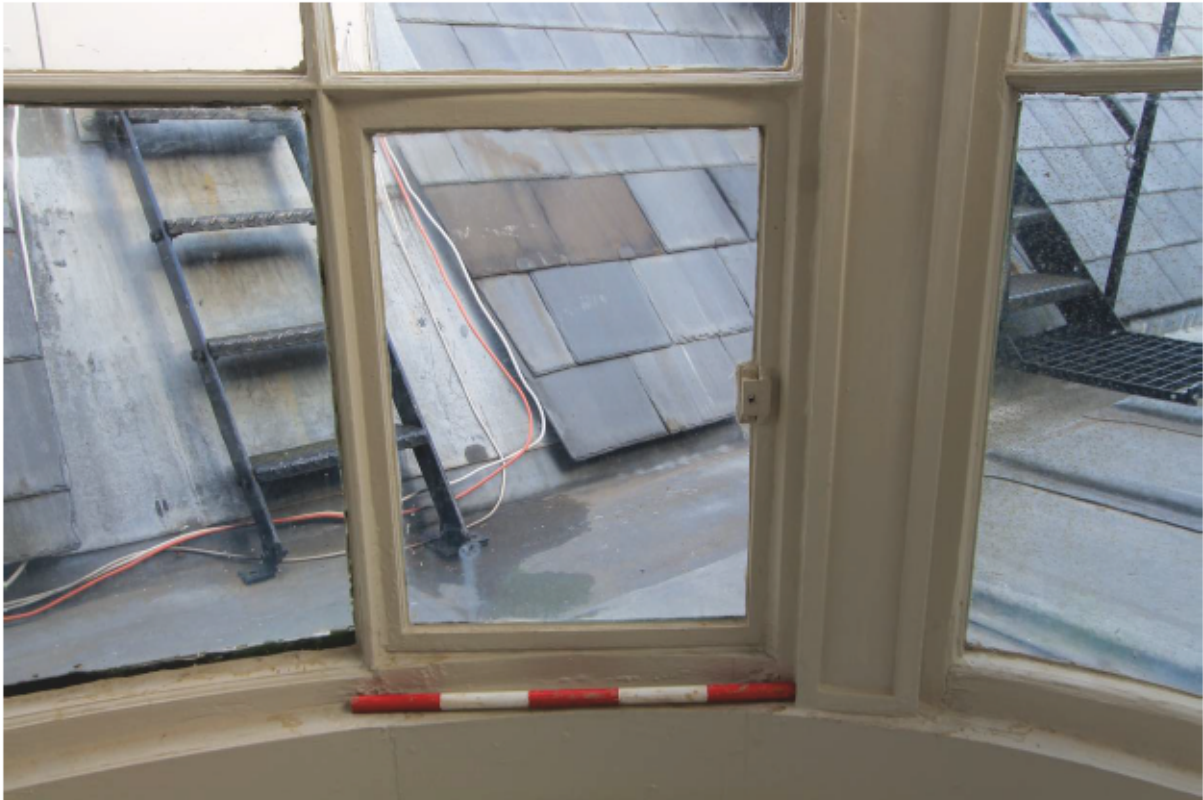
Plate 26 Lantern A: Internal Repair 4

- 5.3.4 **Internal Repair 4: Insertion of sill (Plate 26):** Section of timber sill added as part of the insertion of casement window 5 into the lower pane of eastern light. This timber sill measured 440mm x 45mm and was plain in appearance and lacked the ovolo detailing used on the corresponding length of sill to the west.

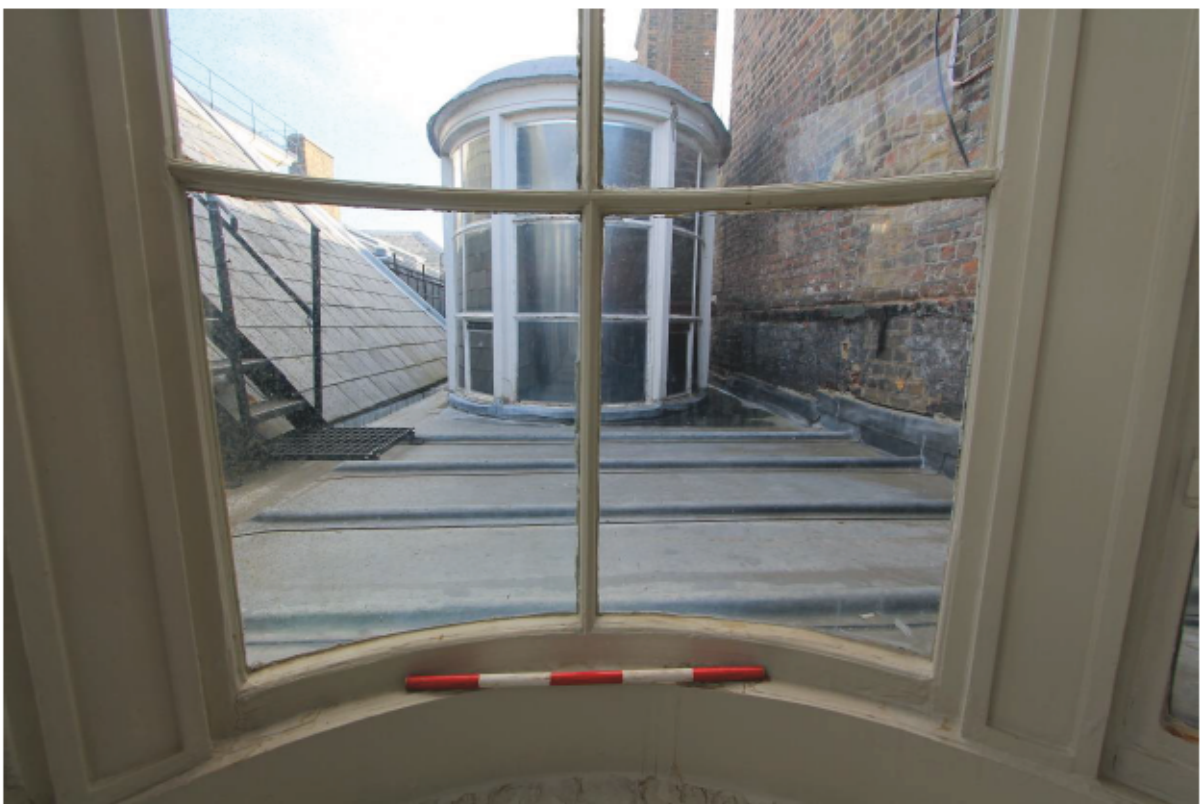
Plate 27 Lantern A: Internal Repair 5

- 5.3.5 **Internal Repair 5: Replacement of glazing bars (Plates 19 and 27):** Replacement of the horizontal glazing bars between the central and lower panes of the central light to the eastern elevation and the replacement of the central vertical glazing bar of this lower window section. These inter-connecting glazing bars (forming a T shape) are clearly later replacements of less fine detailing, using a heavier weight and cruder, ovolo moulding.

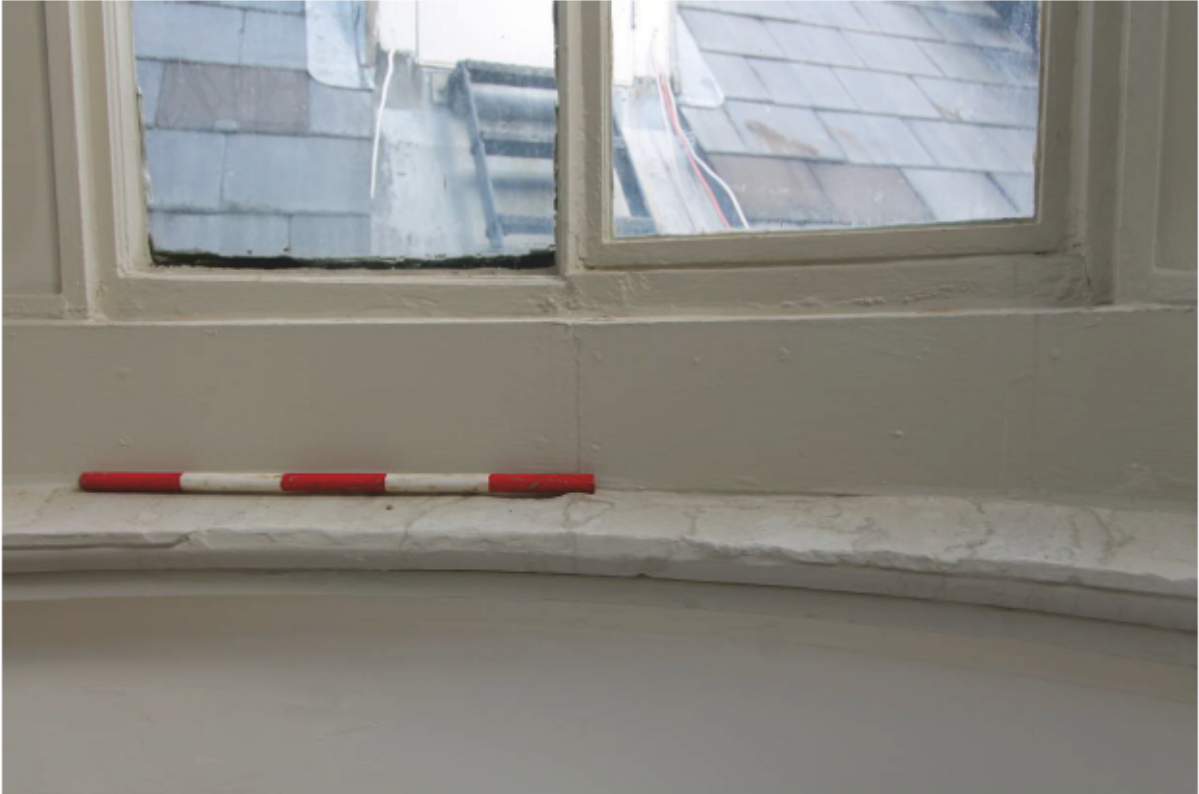
Plate 28 Lantern A: Internal Repair 6 and 6A

- 5.3.6 **Internal Repair 6: Repair to internal mouldings (Plate 28):** Repair of a section of the projecting internal (?plaster) moulded band, level with of the base of the window, which decorates the elliptical opening when viewed from below. This section is located alongside the northern elevation, toward its easternmost light and in part below casement 5. The repair of this section of moulding, which extends for c.740mm, is quite crude, particularly the upper face, and lacks the definition and form of the ovolo detailing that survives elsewhere in the circuit.

- 5.3.7 **Internal Repair 6A: Replacement internal fascia to opening (Plate 28):** Replacement, using painted plywood, of the fascia/band located below the base of the mullions and covering the internal sill of the lantern, above the moulding described above. This fascia was nailed in place and extended the entire circuit of the lantern opening.

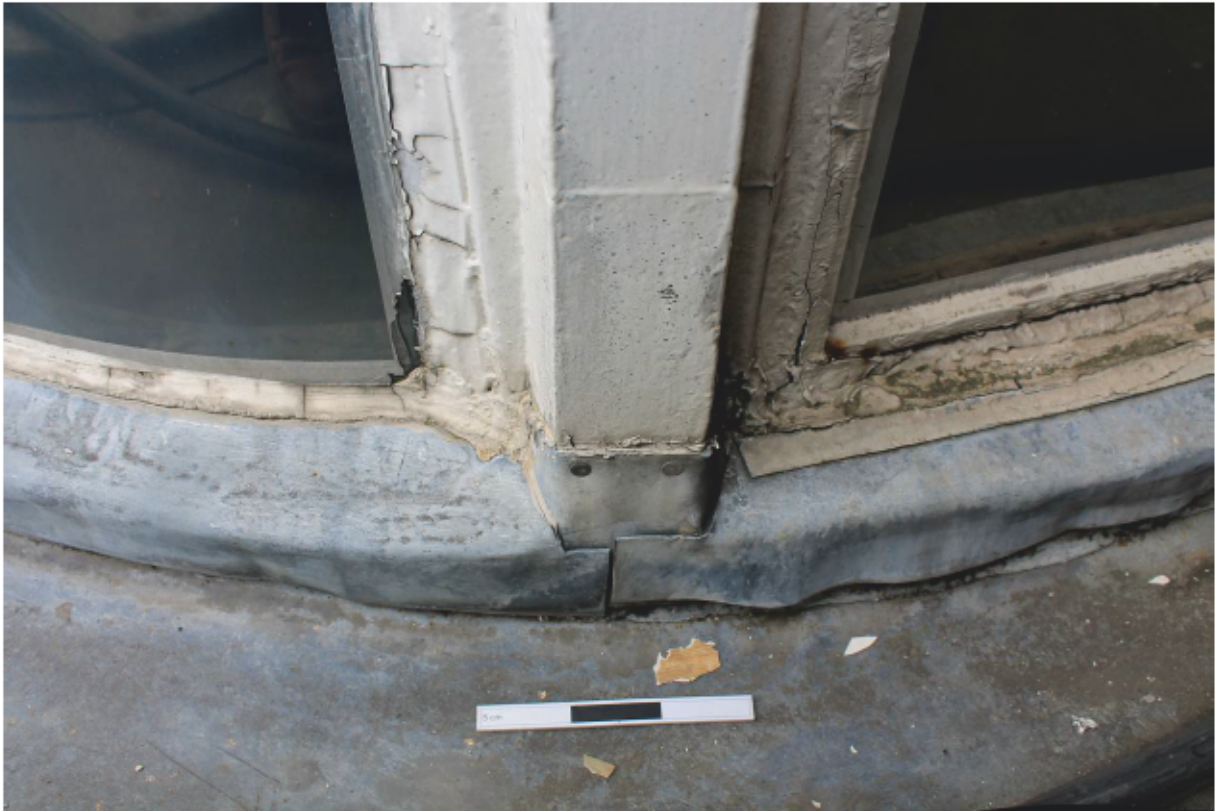
Plate 32 Lantern B: External Repair 15

- 5.4.1 **External Repair 15: Repair to mullion (Plate 32):** A timber repair made to the base of the southern-western mullion of the western elevation. It is a full width (of the mullion) repair which rises, in height, up to 210mm above the upper level of the sill. The base of the mullion and the adjacent sills had been crudely re-covered with lead flashings, either nailed into the base of the mullion or secured below sealant, applied to the base of the window panes.
- 5.4.2 **External Repair 16: Repair to mullion (Plate 33):** A similar, contemporary timber repair to ER15 made to the base of the north-western mullion of the western elevation. The repair rises in height to 190mm from the upper face of the sill and extends the full width of the mullion and back to line of glazing. The repair probably comprises the whole base of the mullion/post.

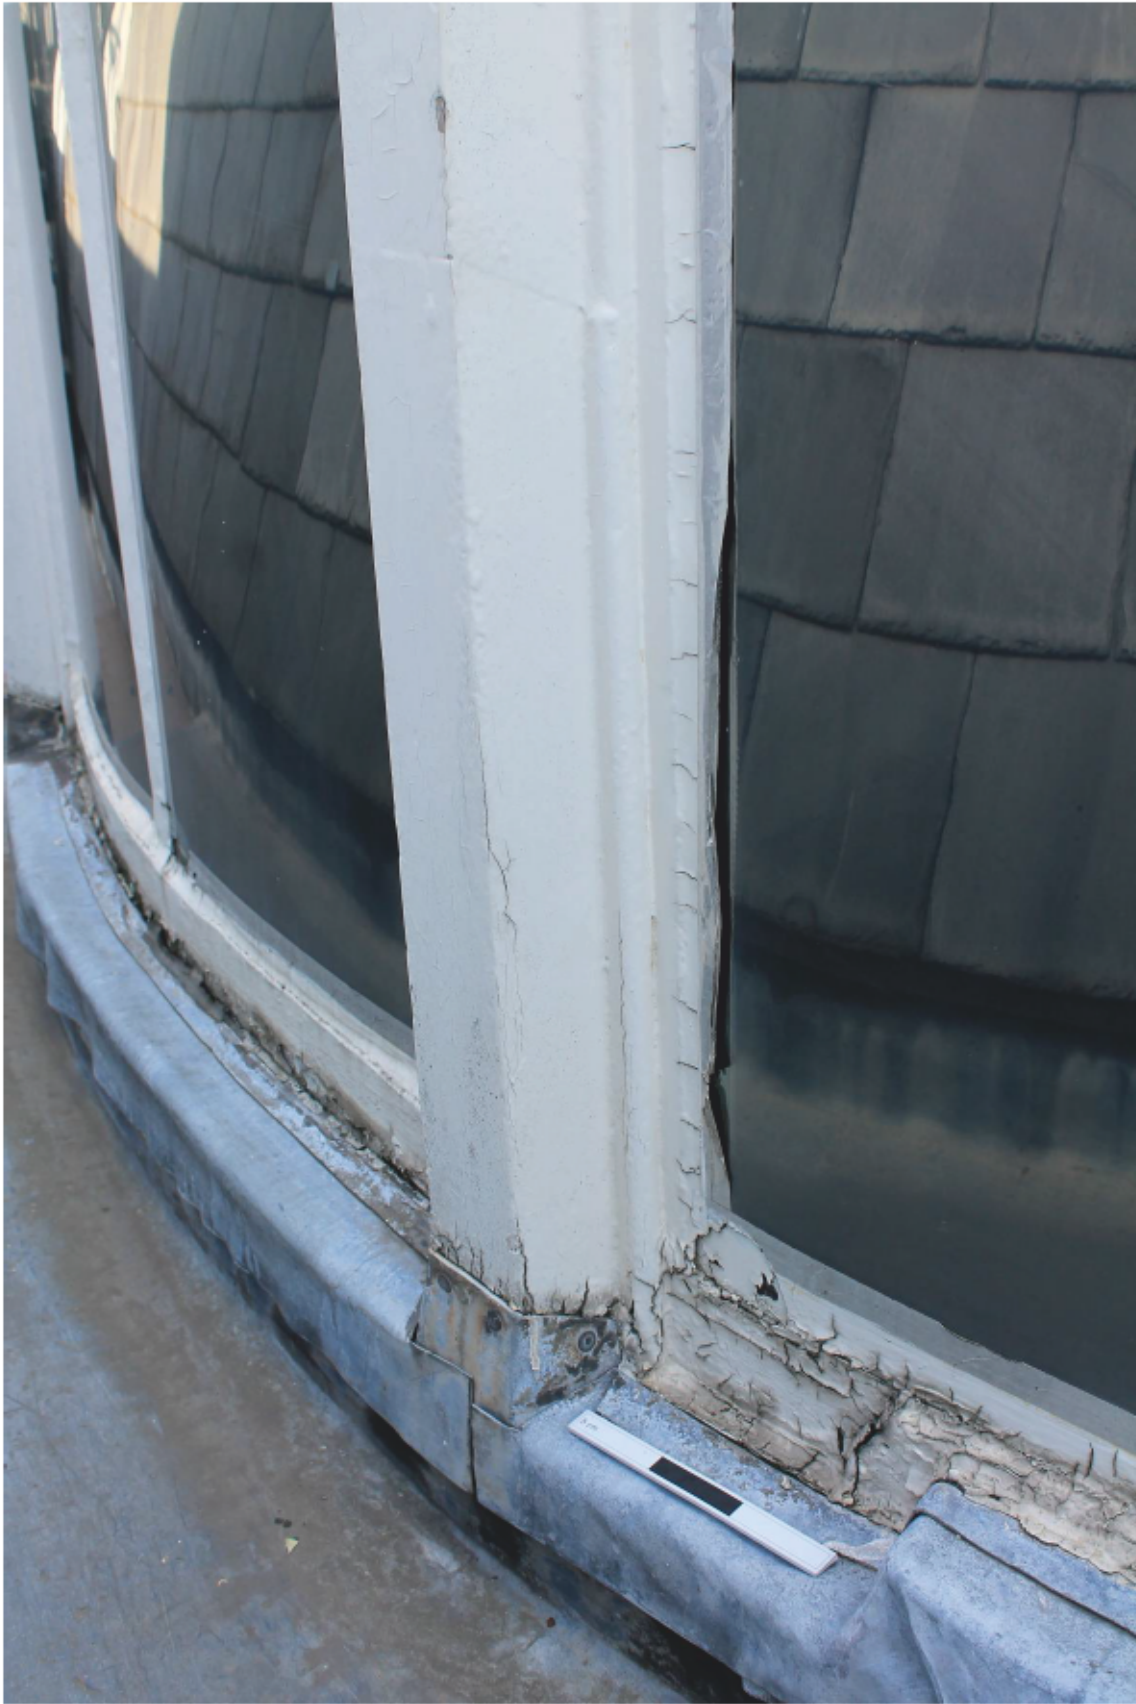
Plate 34 Lantern B: External Repair 17

- 5.4.3 **External Repair 17: Repair to mullion (Plate 34):** Probable contemporary timber scarf repair (with ER15 and ER16) made to the base of the westernmost mullion of the northern elevation. The repair to this mullion was more extensive, rising to a height of 530mm above the upper sill level, and projecting back to the glazing line. The upper joint was married using a simply splay scarf joint (to help inhibit water penetration).

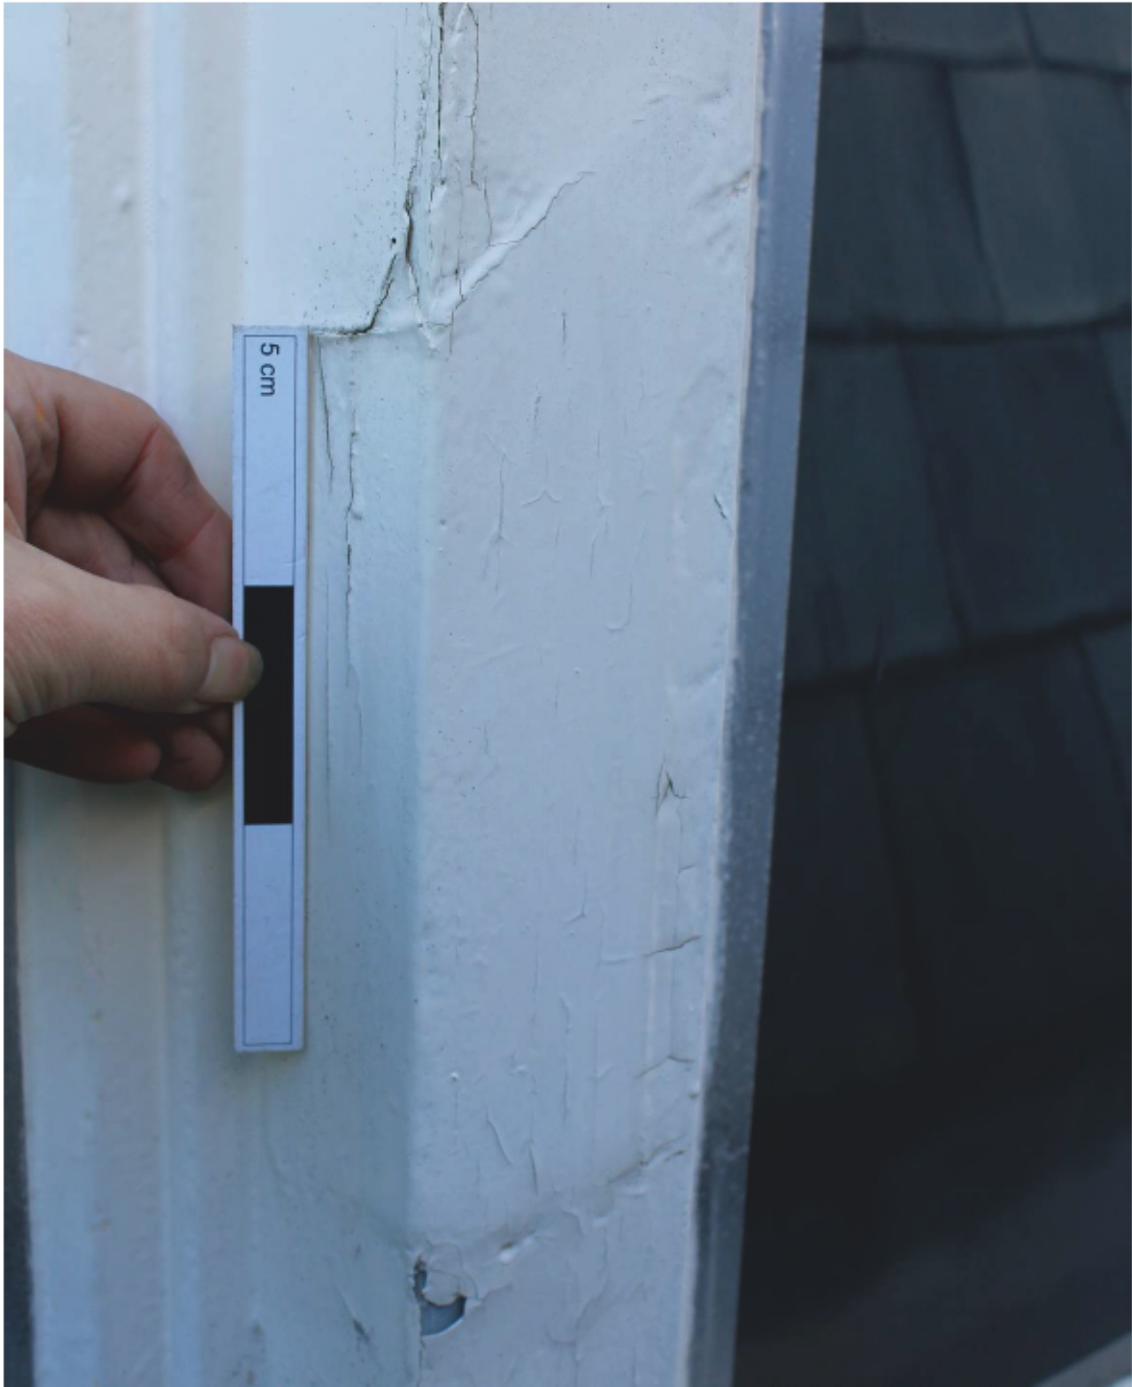
Plate 35 Lantern B: External Repair 18

- 5.4.4 **External Repair 18: Repair to mullion (Plate 35):** Small timber repair made to the easternmost mullion of the northern elevation. It comprised a section of timber scarfed into the mullion, not at the base (as typical) but c.280cm up from the top of the sill. Measuring 200-230mm in height (a diagonal joint to the top), but not extending the full width or depth of the post, it repaired the north-eastern angle of the mullion. It is most likely contemporary with repairs 15-17).

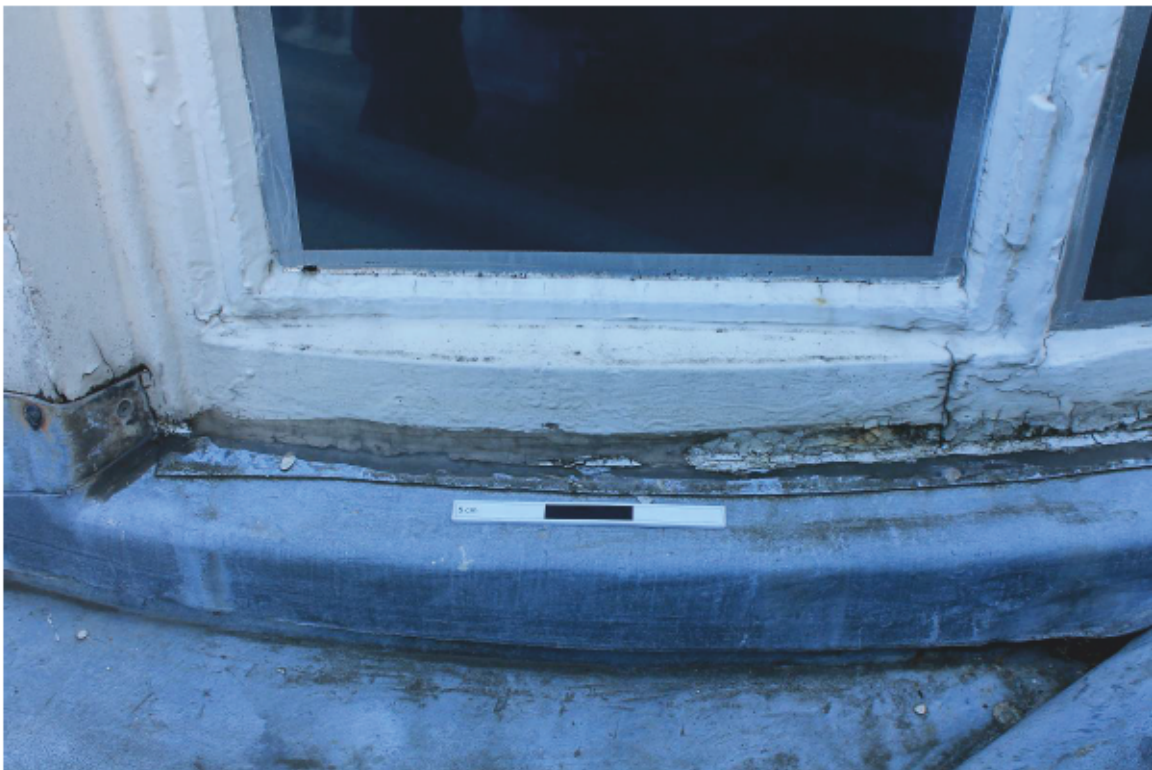
Plate 37 Lantern B: External Repair 20

- 5.4.6 External Repair 20: Replacement sill (Plate 37): An inserted length of timber sill presumably added as part of the introduction of casement window 21 into the lower, eastern pane of the eastern light, north elevation. This section of sill is much heavier (scantling) and cruder and than the original (not so well shaped) and is cut into the existing sill just west of the mullion and east of the glazing bar foot.
