**ARCHAEOLOGICAL
BUILDING RECORDING AND
WATCHING BRIEF OF
THE ROOF LANTERNS AND
LEADED FLAT ROOFS AT
KENSINGTON PALACE,
PALACE AVENUE,
ROYAL BOROUGH OF
KENSINGTON AND
CHELSEA,
W8 4PU**

SITE CODE: KEN29

PCA REPORT NO. R12405

MARCH 2016

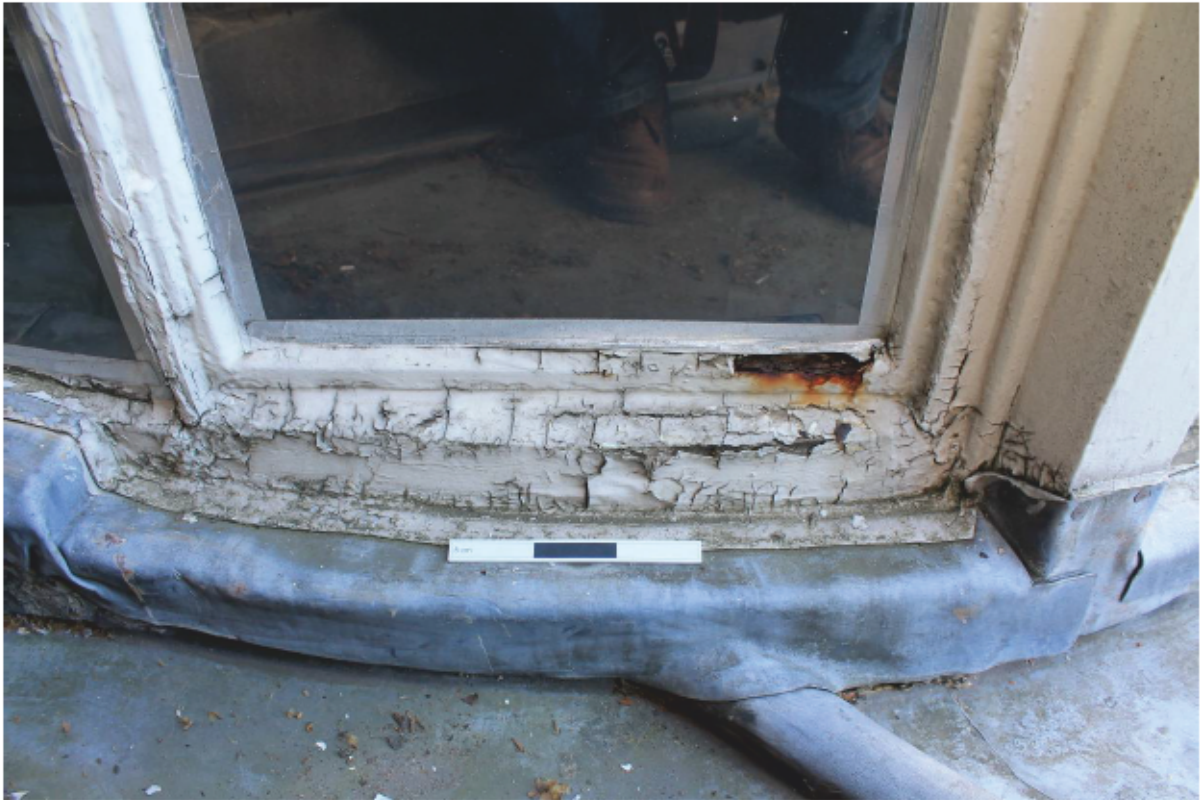
Plate 40 Lantern B: External Repair 23

- 5.4.9 External Repair 23: Replacement sill (Plate 40): The insertion of a length of timber sill added as part of the insertion of casement 24 into the lower pane of the eastern light. The sill extends the full width of the pane, although over-painting obscures much detail.

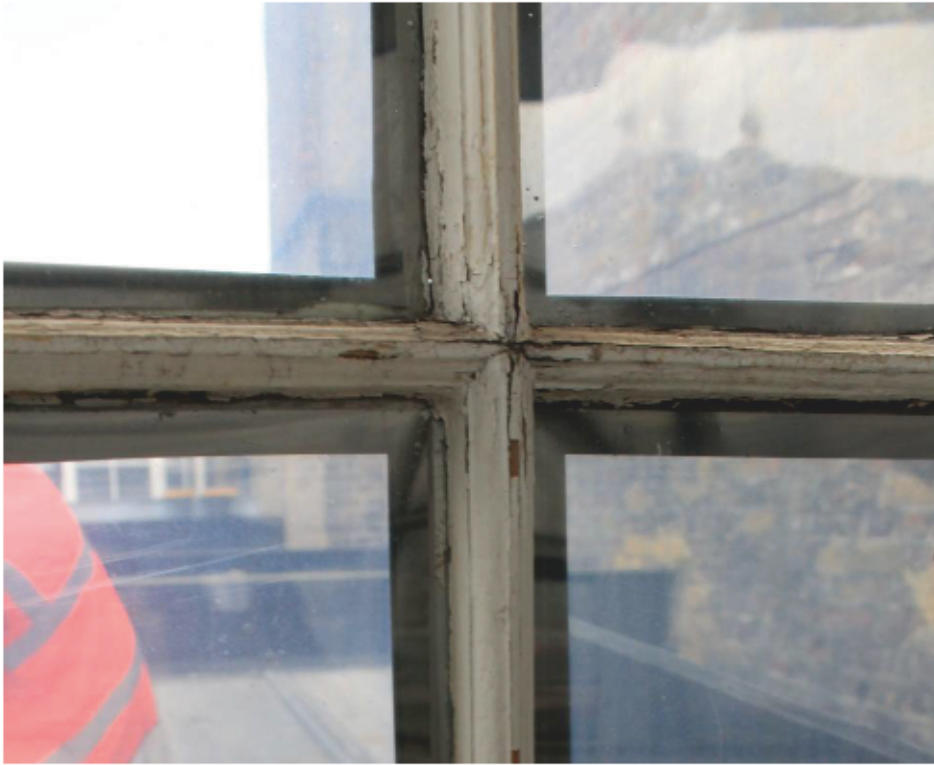
Plate 48 Lantern B: Internal Repair 8

- 5.5.3 Internal Repair 8: Replacement of glazing bar (Plates 45 and 48): Replacement of the vertical glazing to the lower pane of the central light within the eastern elevation. As with IR7, the replacement bar, though using an ovolo mould, was less refined.

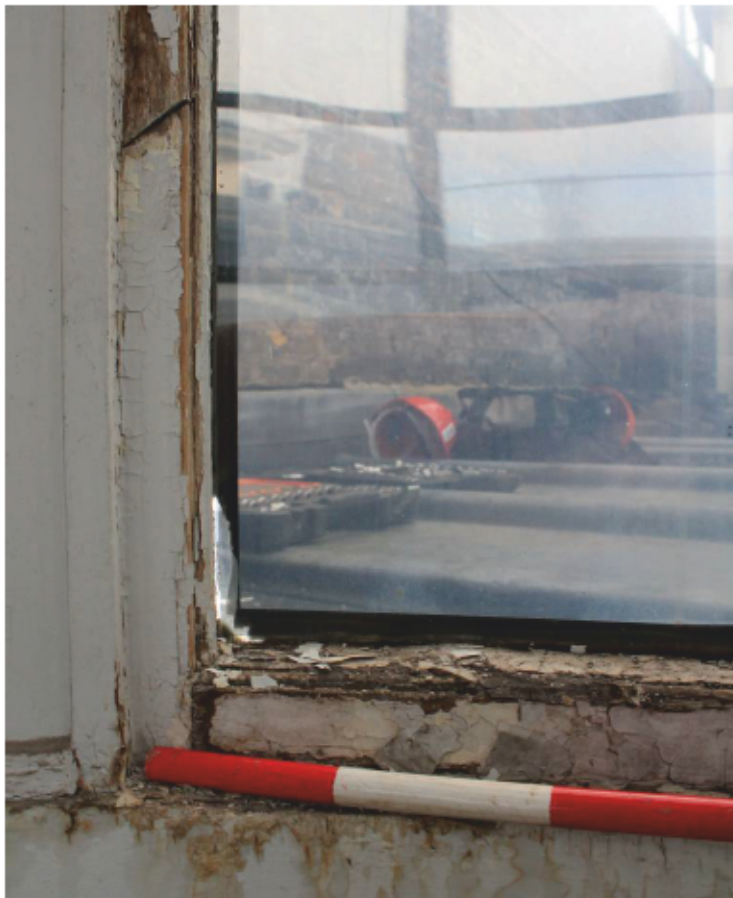
Plate 49 Lantern B: Internal Repair 9

- 5.5.4 Internal Repair 9: Repair to window (Plate 49): Timber repair made to the base of the window jamb (south side) of the central light within the western elevation. The repair is scarfed into the window frame, rising to a height of c.350mm above the level of the sill. Possibly relates to the external repair made to the mullion, recorded as repair ER15.

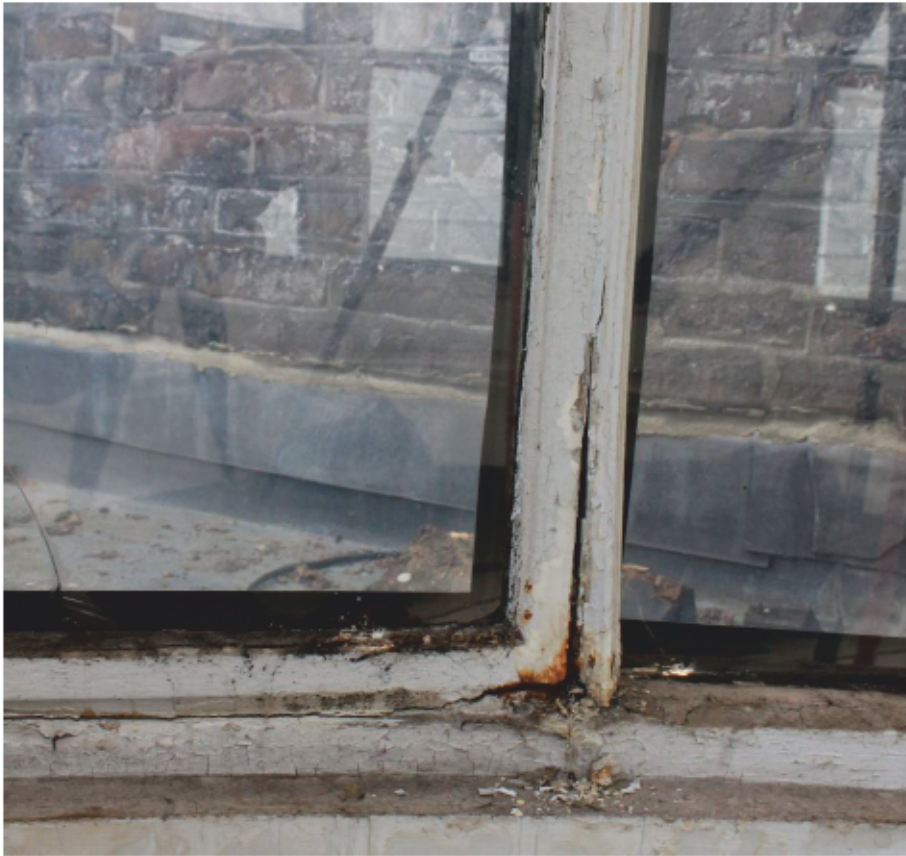
Plate 50 Lantern B: Internal Repair 10

- 5.5.5 Internal Repair 10: Glazing bar (Plate 50): Detachment and distortion of the base of the central glazing bar of the eastern light on the southern elevation, adjacent to casement window 24. This event appears to have been a consequence of the addition of the casement window, in that water intrusion and corrosion of the window has caused the base of the glazing bar to decay and detach. Generally similar corrosion (of the casements) has been seen to have caused consequent decay to the historic joinery in the areas of the casements. This example is one of the more significant in terms of decay.

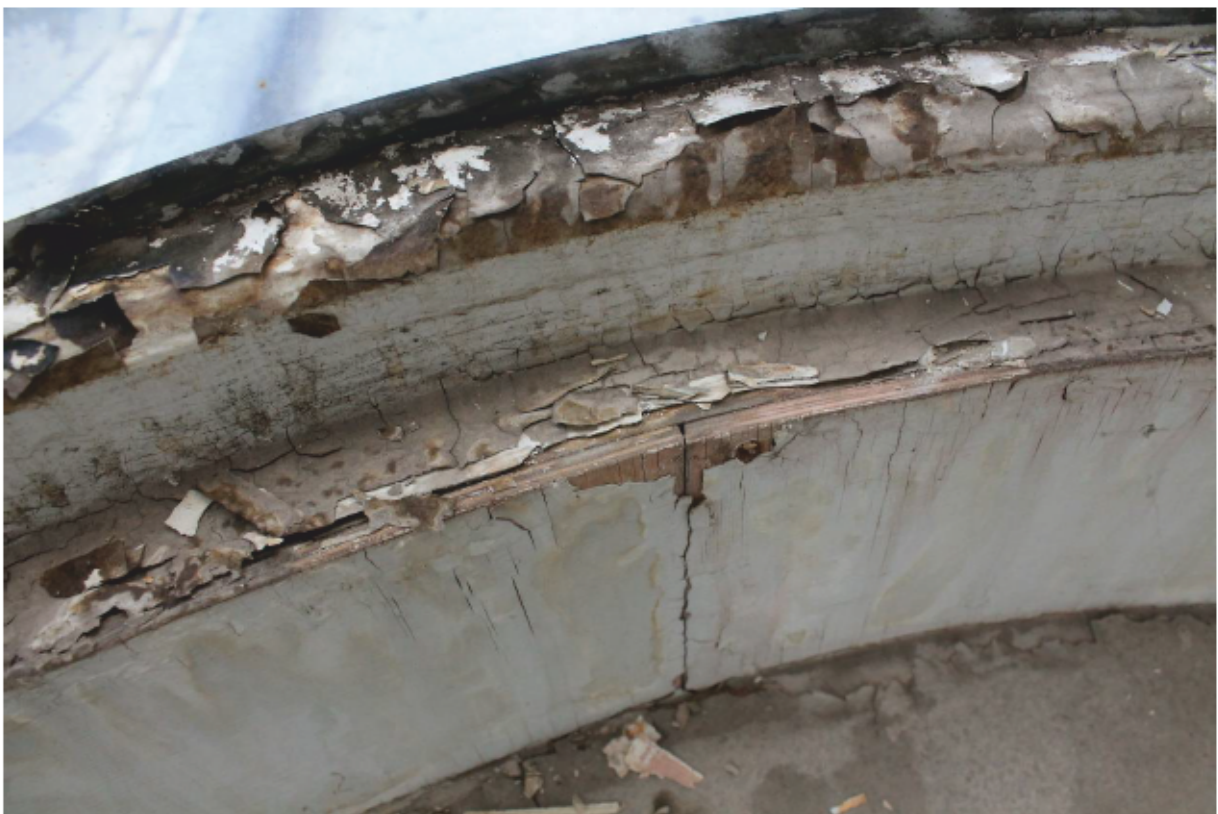
Plate 51 Lantern B: Internal Repair 11

- 5.5.6 Internal Repair 11: Replacement internal fascia board (Plate 51): Replacement fascia/board located below the base of the window mullions and covering the internal side on its entire circuit of the lantern opening. The fascia is formed from shaped and painted 7mm, 4 ply composite board, which is fixed through nailing.

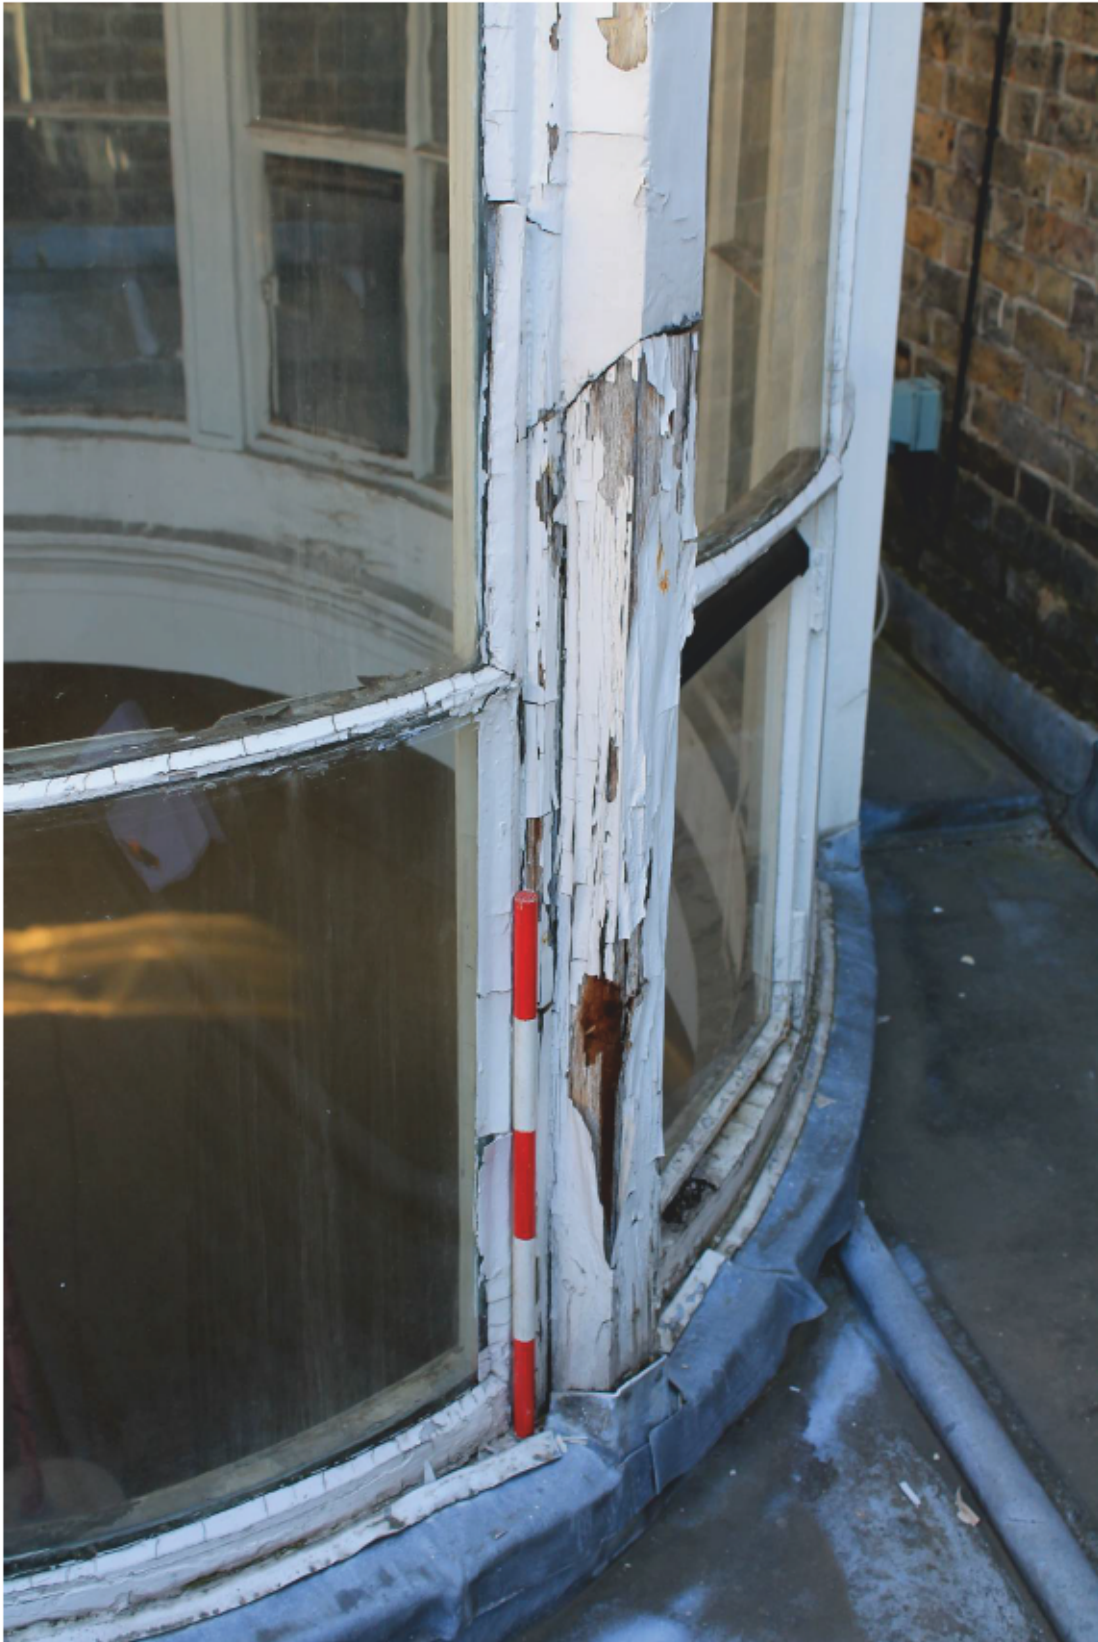
Plate 53 Lantern C: External Repair 27

- 5.6.1 External Repair 27: Repair to mullion (Plate 53): A softwood timber repair made to the base of the southern-western mullion of the western elevation. It is a considerable, full width (of the mullion and adjoining bead) repair which rises in height up to 915mm above the upper level of the sill and is scarfed into the mullion with a diagonal (splay) scarf uppermost. The repair is badly decayed (possibly due to poor jointing) and appears to be more decayed than the original mullion. The base of the mullion and the adjacent sills had been crudely re-covered with lead flashings, either nailed into the base of the mullion or secured below sealant, applied to the base of the window panes. This is all relatively recent work of no historic merit.

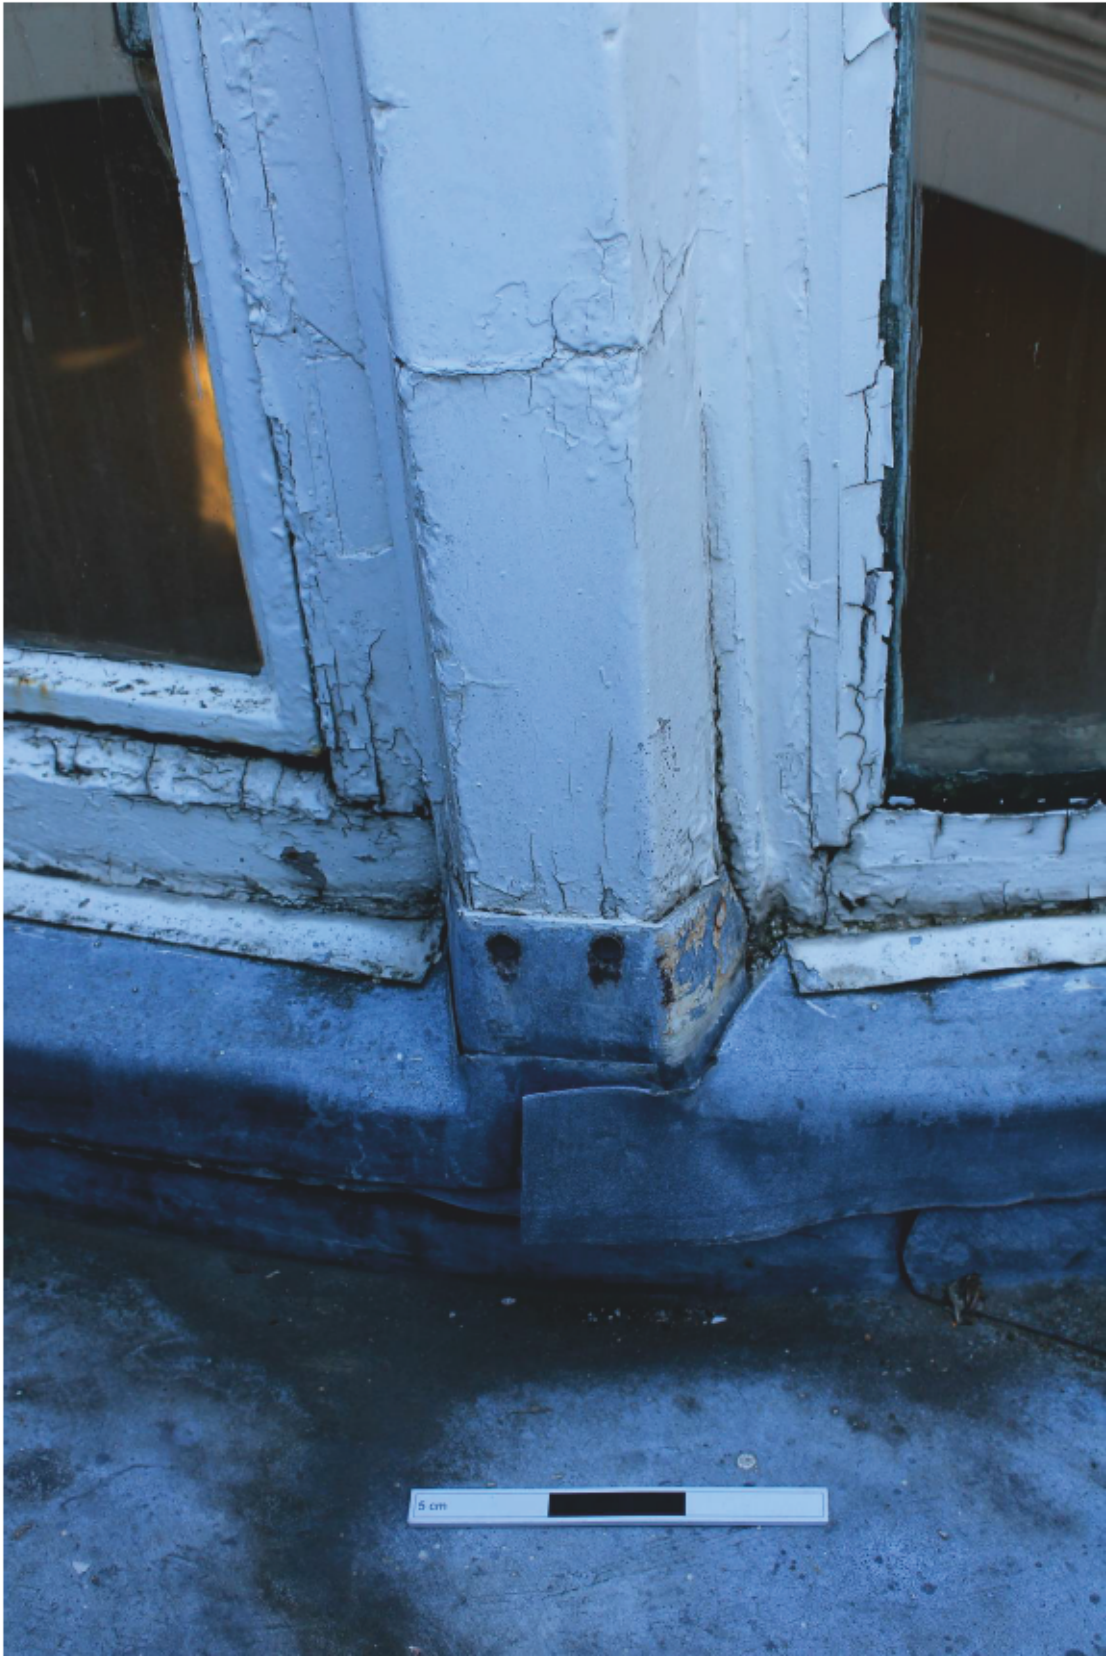
Plate 54 Lantern C: External Repair 28

- 5.6.2 External Repair 28: Repair to mullion (Plate 54): A softwood timber repair made to the base of the north-western mullion of the western elevation. It is a full width (of the mullion) repair which rises in height up to 270mm above the upper level of the sill and is scarfed into the mullion with a diagonal (splay) scarf uppermost. The base of the mullion and the adjacent sills had been crudely re-covered with lead flashings.
