**THE BATH HOUSE,
LANGTONS GARDENS,
BILLET LANE,
HORNCHURCH,
LONDON BOROUGH OF HAVERING
RM11 1XL**

**HISTORIC BUILDING RECORDING,
ARCHAEOLOGICAL EXCAVATION
AND MONITORING**

**MAY 2016
REPORT NO. R12482**

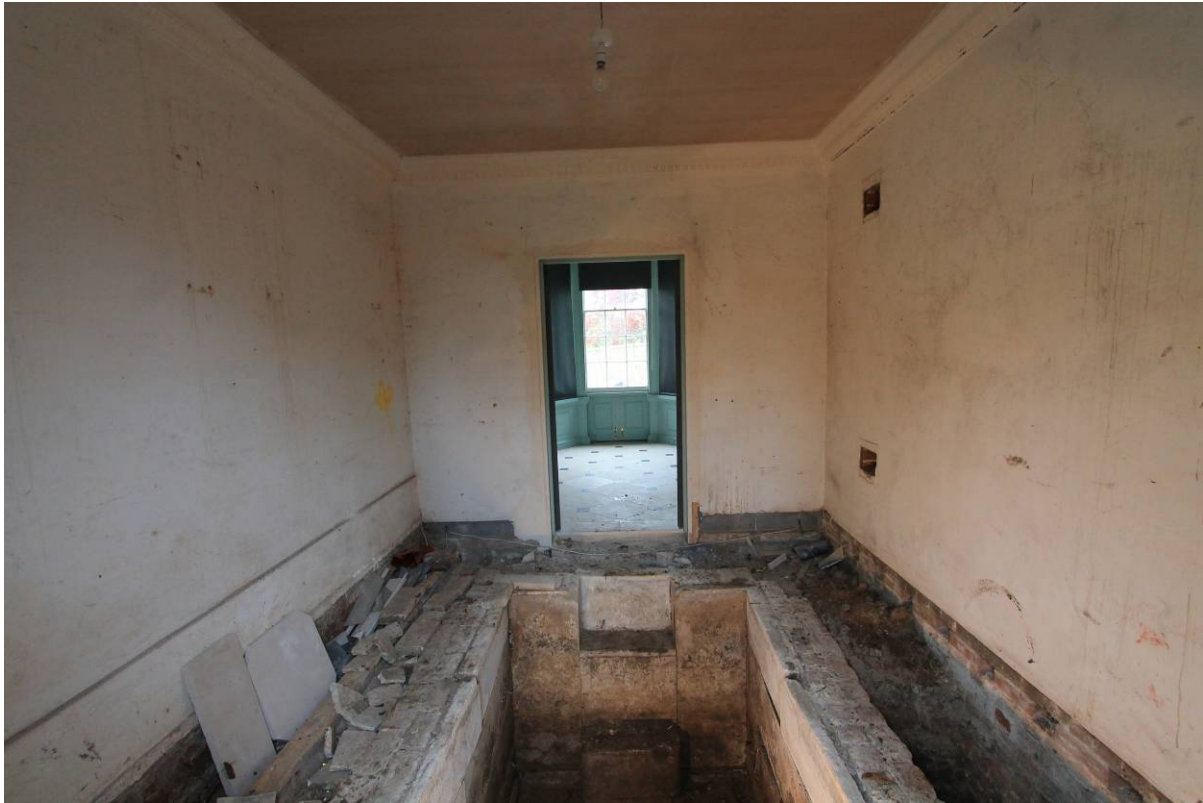
- 6.3.1 The interior of the bathing room comprised plain plastered elevations (in modern plaster; **Plate 7**) with a simple replacement egg and dart cornice (**Plate 8**) to a re-plastered modern ceiling. Evidence of a former modern suspended floor is present at the base of the walls in the form of empty sockets for floor joists within the brickwork and the height of the internal plaster finish (**Plate 9**). The internal wall between the bathing room (A) and the gazebo (B) is a modern construction, built using lightweight construction blocks, with a damp proof membrane at the base. This wall is built off an earlier brickwork foundation (further exposed during the excavations, see section 7). The eastern end wall had also seen some later improvements, with the addition of a damp proof membrane and under-pinning or rebuilding of the internal courses, in Fletton brickwork. The northern and southern flank walls appear to be less altered, the southern wall also incorporating a shallow out-set plinth at the base of the wall.

Plate 7 Bathing room (A), looking west to gazebo

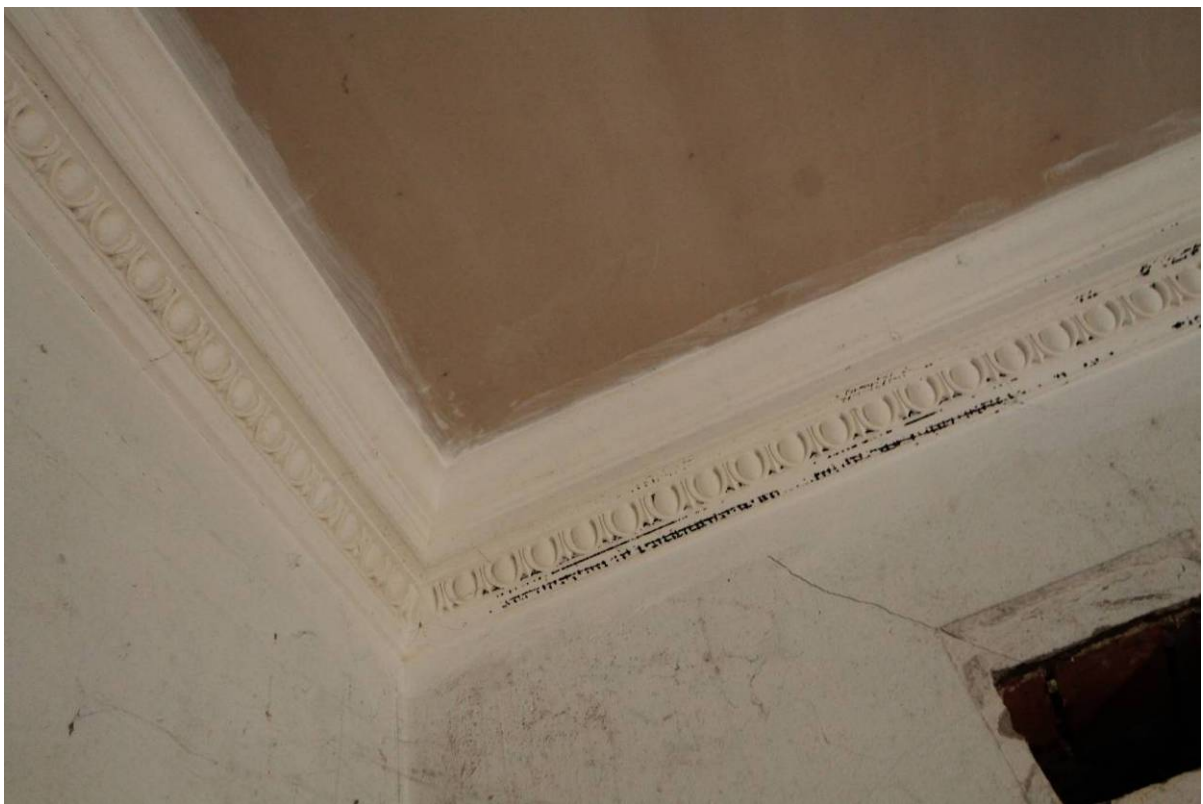
Plate 8 Bathing Room (A) detail of egg and dart cornice, looking south-west

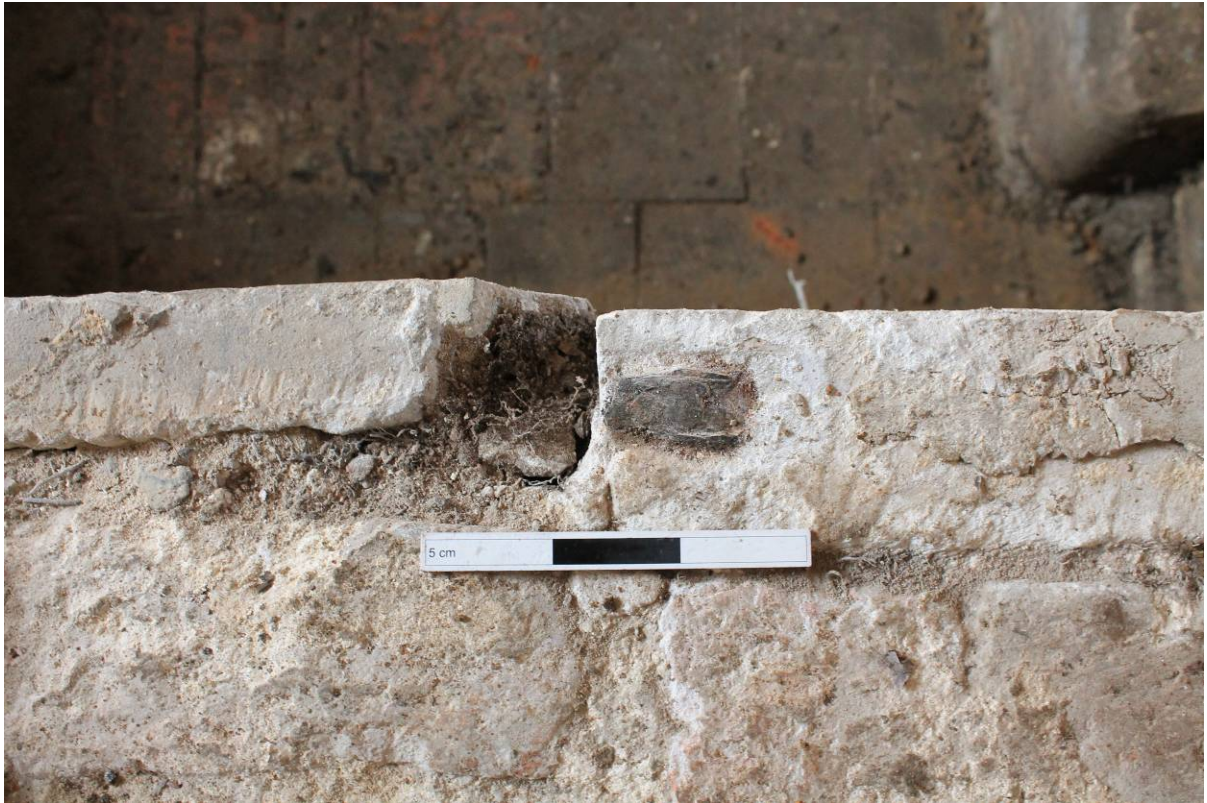
Plate 11 Remains of iron tie or 'staple' between Portland stones in the lining of the bath, looking south

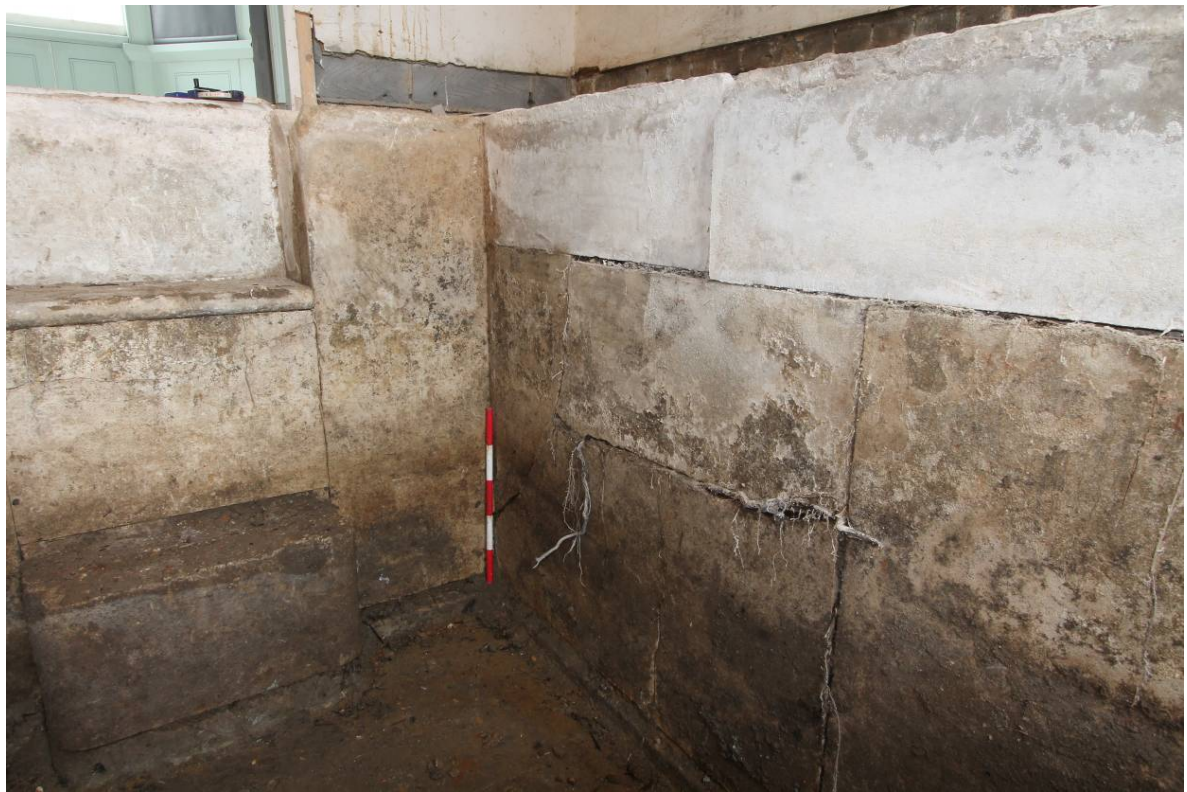
- 6.3.4 The bath is lined with high quality Portland stone, of which all of the original stone survives, although some of the larger slabs used in the lower side walls are now badly cracked (**Figure 12; Plates 12 to 18**). Each of two long side walls comprise an upper, narrower band of three stone slabs at the surface, overlying two larger stone slabs which butt together about the central axis of the wall. A moulded out-set plinth or plinth, also in Portland stone and measuring up to 100mm in height, extends the circuit of the bath. The narrower uppermost slabs measure between 0.82-0.86m in length, 0.3m in depth and 50-80mm thick, held in place and braced to each other by iron 'staples' set into the top of the stone slabs and bridging the joint between the two (**Plate 11**). Evidence of these fixings was observed within both the long side walls and in the edging structure containing the western steps. The deformation of the central upper slab in the north side may have, in part, been due to the failure of one of these fixings.

- 6.3.5 Both of the larger stone slabs that comprise the main area of the northern elevation were badly cracked, the eastern (N1) effected by a large diagonal crack from top to base and the west slab (N2) by two visible adjoining cracks (**Figure 12; Plates 12 and 13**). The narrower upper stones (N3 to N5) were not affected by cracking (any pressure relieved through movement) nor was the plinth. The latter was formed from two sections of unequal length and was shaped with an ogee moulding to the top. The plinth used to extend around the base of the western steps, as seen by a rebate of the same height cut into the base of the lower step. This section of plinth has since been lost.

Plate 12 North wall of bath, looking north-west

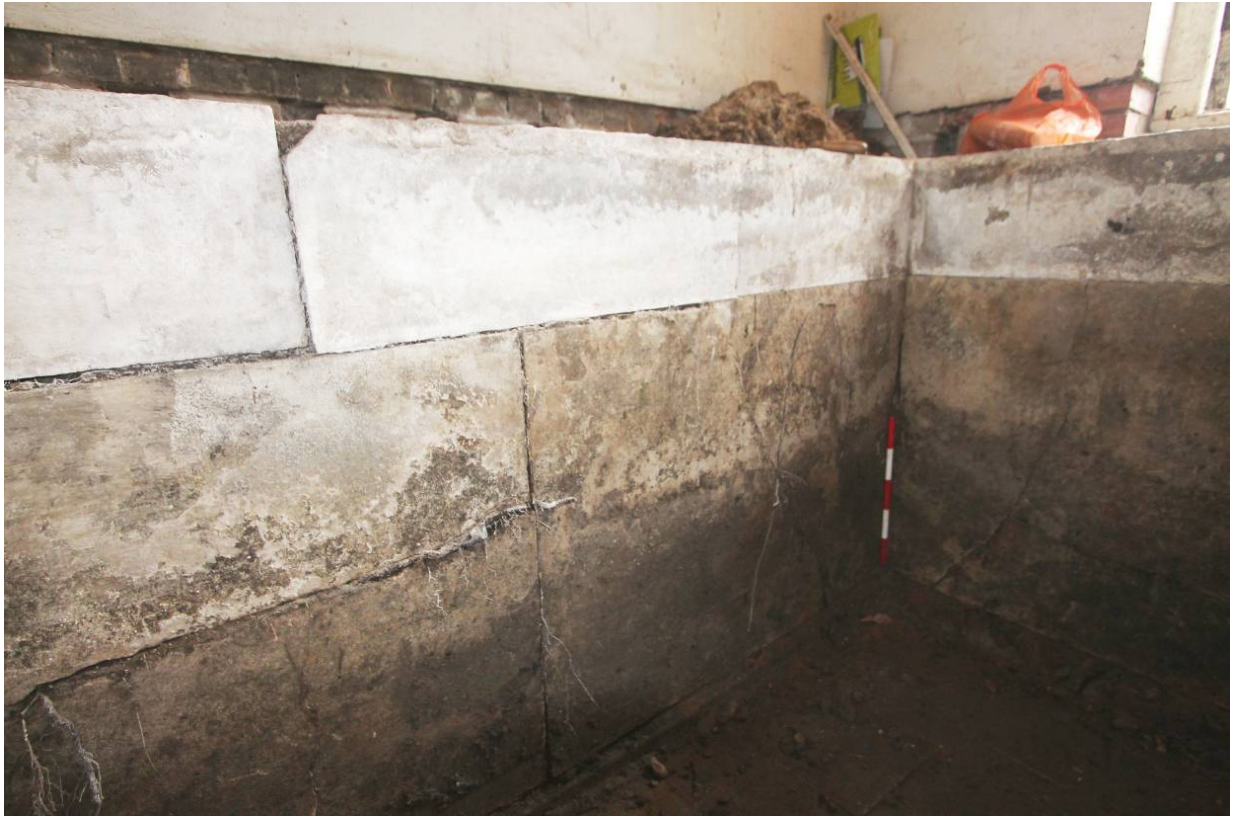
Plate 13 North wall of bath, looking north-east

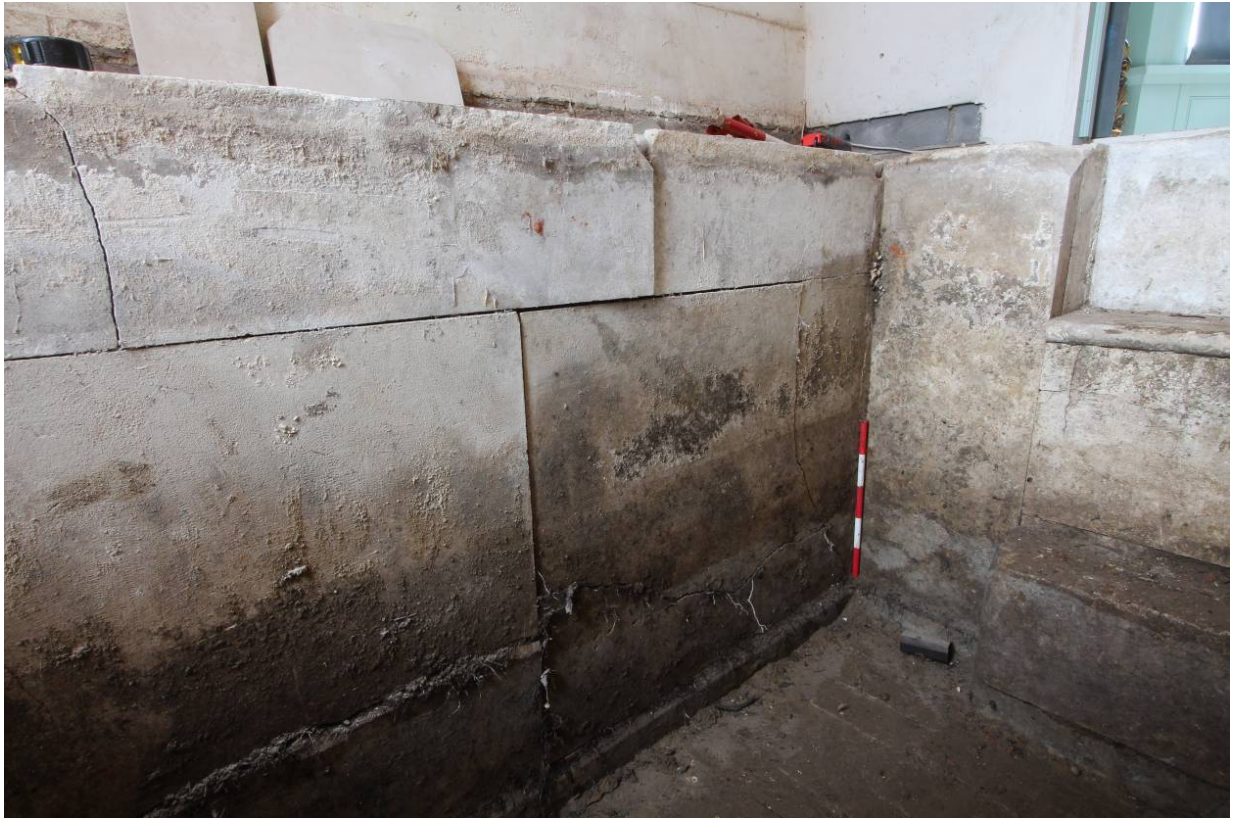
- 6.3.7 The composition of the south wall of the bath closely mirrors that of the north wall, with an upper tier of three narrower slabs (S3 to S5) overlying a pair of larger slabs and a plinth (**Figure 12; Plates 15 to 17**). In common with the corresponding slabs in the north wall, both of the larger stone slabs included large cracks, with a double conjoined crack to the western slab (S2) and a horizontal and vertical crack to (S1). The plinth was in two sections that joined roughly in about the centre of the south wall. A feature, in the form of a small U-shaped cut taken out of the top of the stone lining was present at the west end of the south wall (**Plate 20**). This original feature was presumably cut to house a lead spout used to either fill the bath or alternatively as an overflow.

Plate 15 South wall of bath, looking south-west

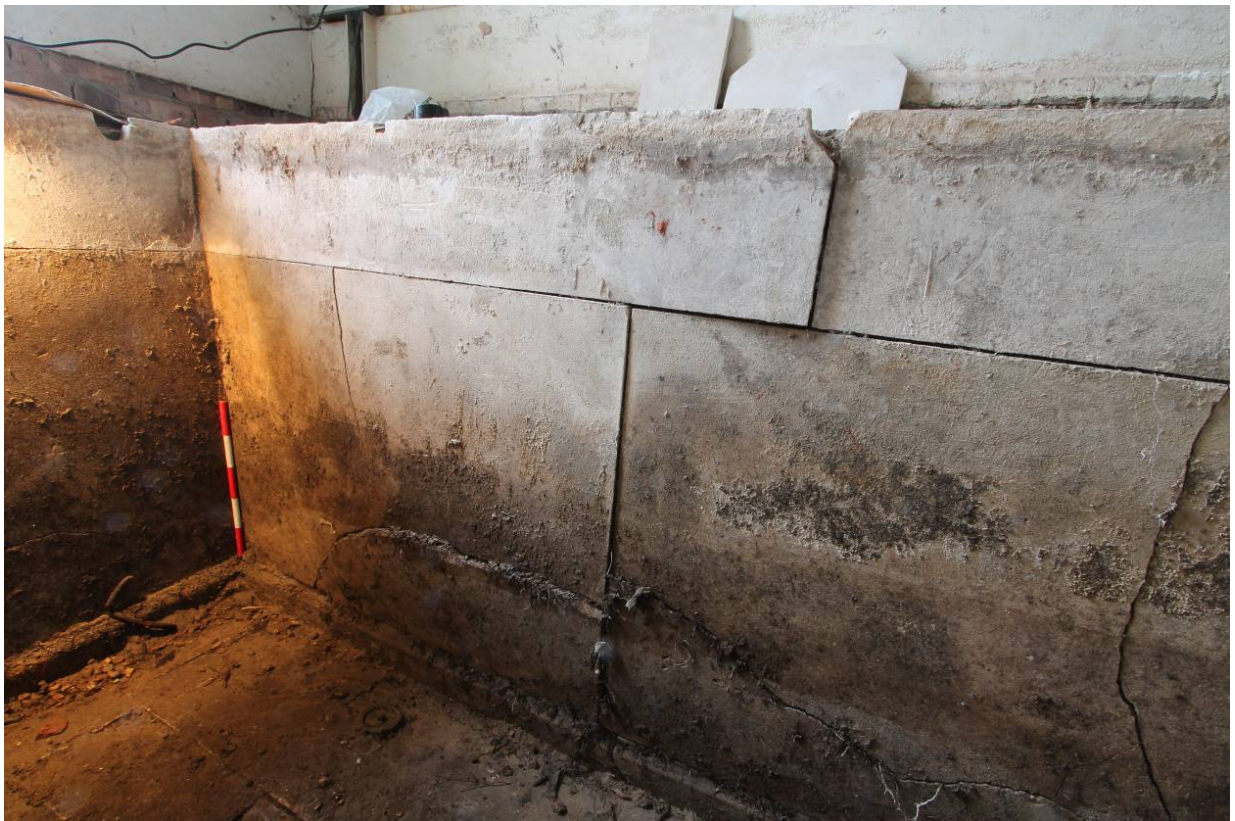
Plate 16 South wall of bath, looking south-east

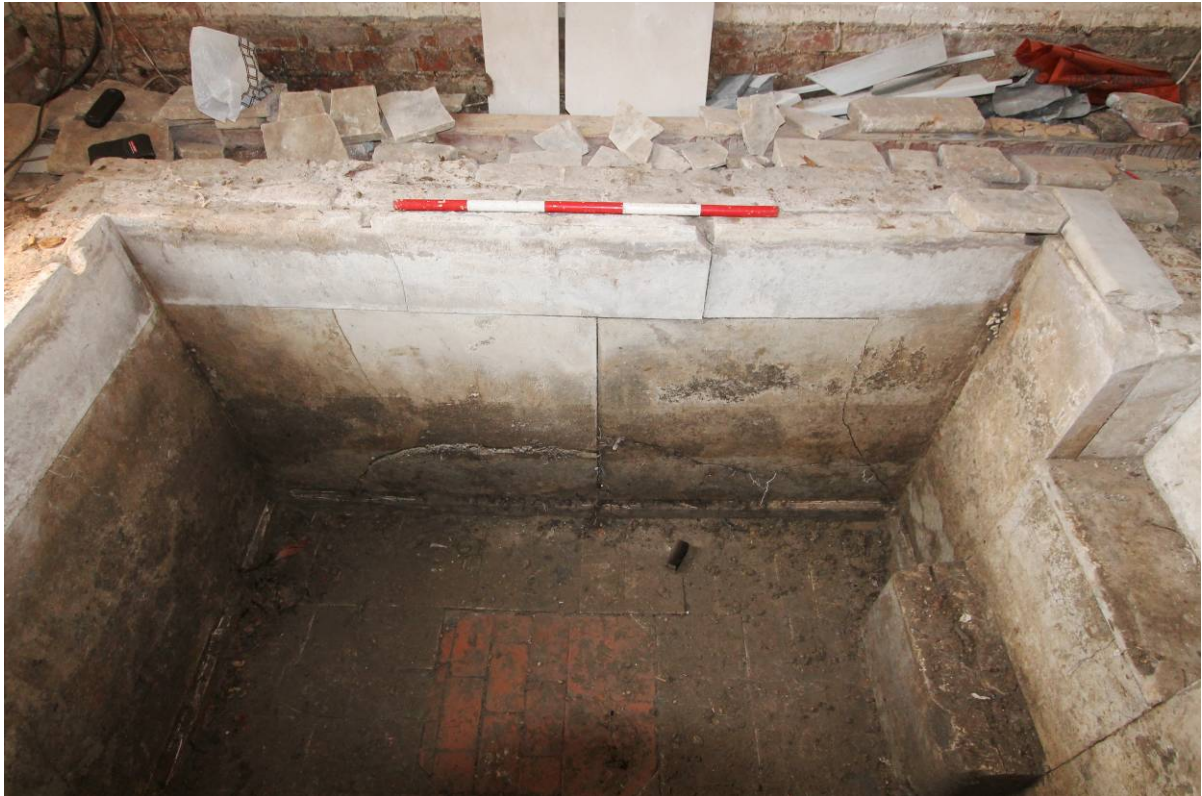
Plate 17 South wall of bath, looking south

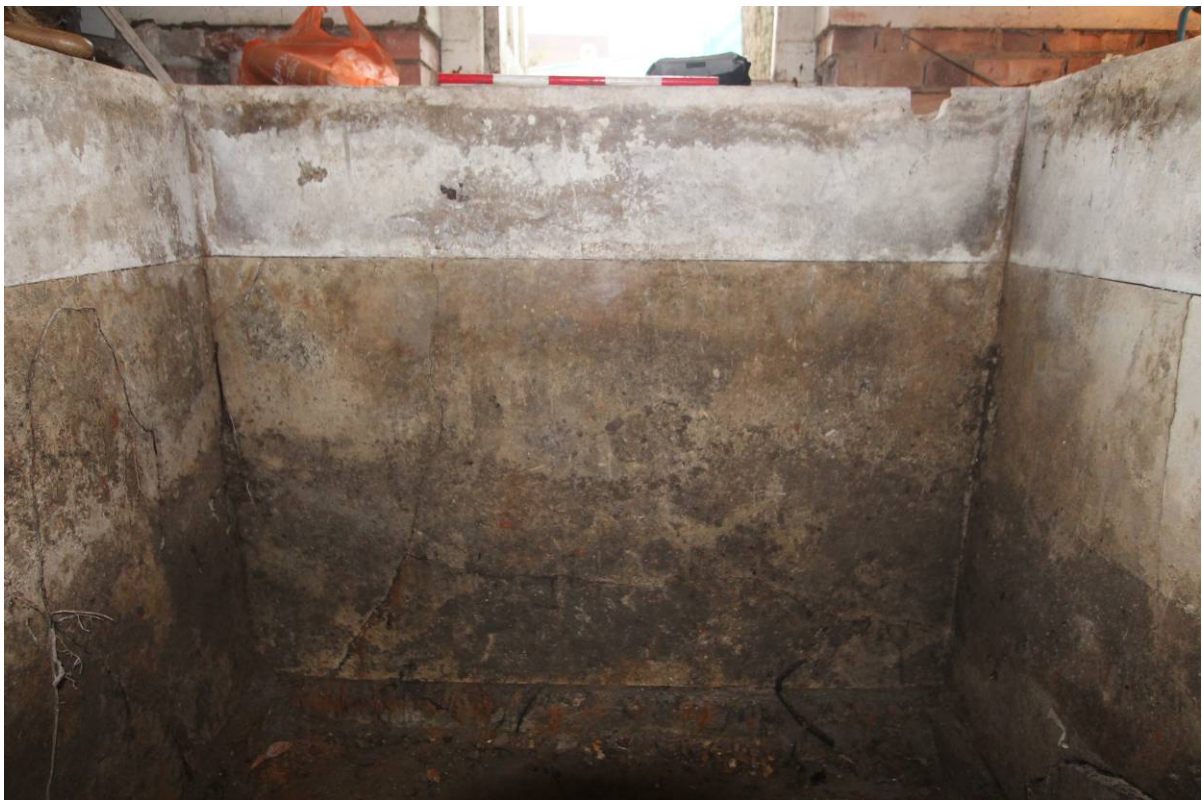
- 6.3.8 The eastern end wall conforms with the general design of a narrow upper stone lining (E2) overlying a much larger single slab (E1) and a single length of plinth (**Figure 12; Plate 18**). The larger slab (E1) had a vertical crack biased to the north side and the single section, upper lining (E2) was also cracked centrally. A U-shaped notch cut out of the top of this section, located towards the south end of the east wall, is interpreted an original feature cut to house a lead spout used to either fill the bath or alternatively as an overflow (**Plates 10, 16 to 19**). A short length of the lead pipe was previously uncovered during the removal of debris from the bath (**Plates 10 and 25**).

Plate 18 East wall of bath, looking east

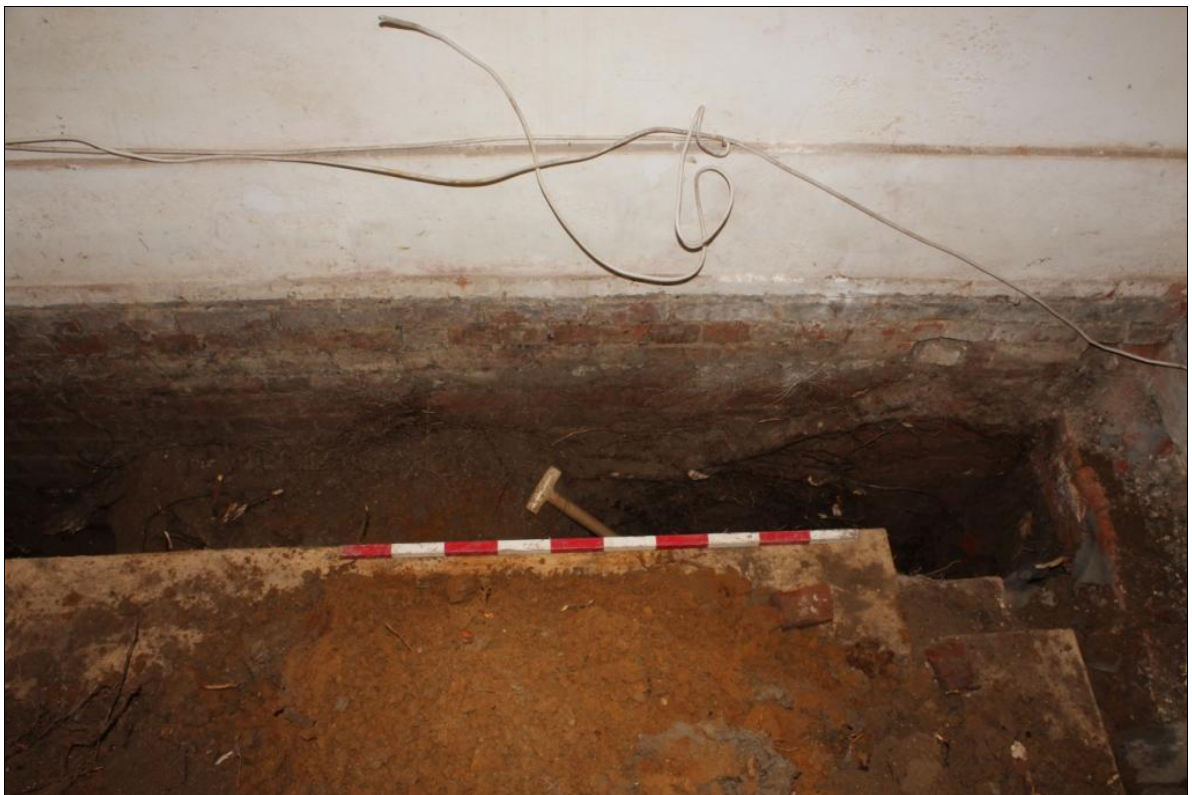
7.1.1 Between 2nd and 12th November 2015, PCA excavated and monitored the excavation of trenches within the bath house at Langtons Gardens. Both the walls of the building and the bath structure have historically suffered from tree root damage and consequently the initial phase in the restoration process was to install a root barrier in the space between the bath structure and external building walls. Accordingly PCA hand-excavated and monitored the hand excavation of areas between the bath structure and external walls, down to the base of the bath house walls and bath foundations (**Figure 13**). This was carried out prior to the installation of a flexible root barrier and the backfilling and compaction of excavated spoil.

Plate 26 Roots in the excavated area to the south of the bath structure, looking south-west

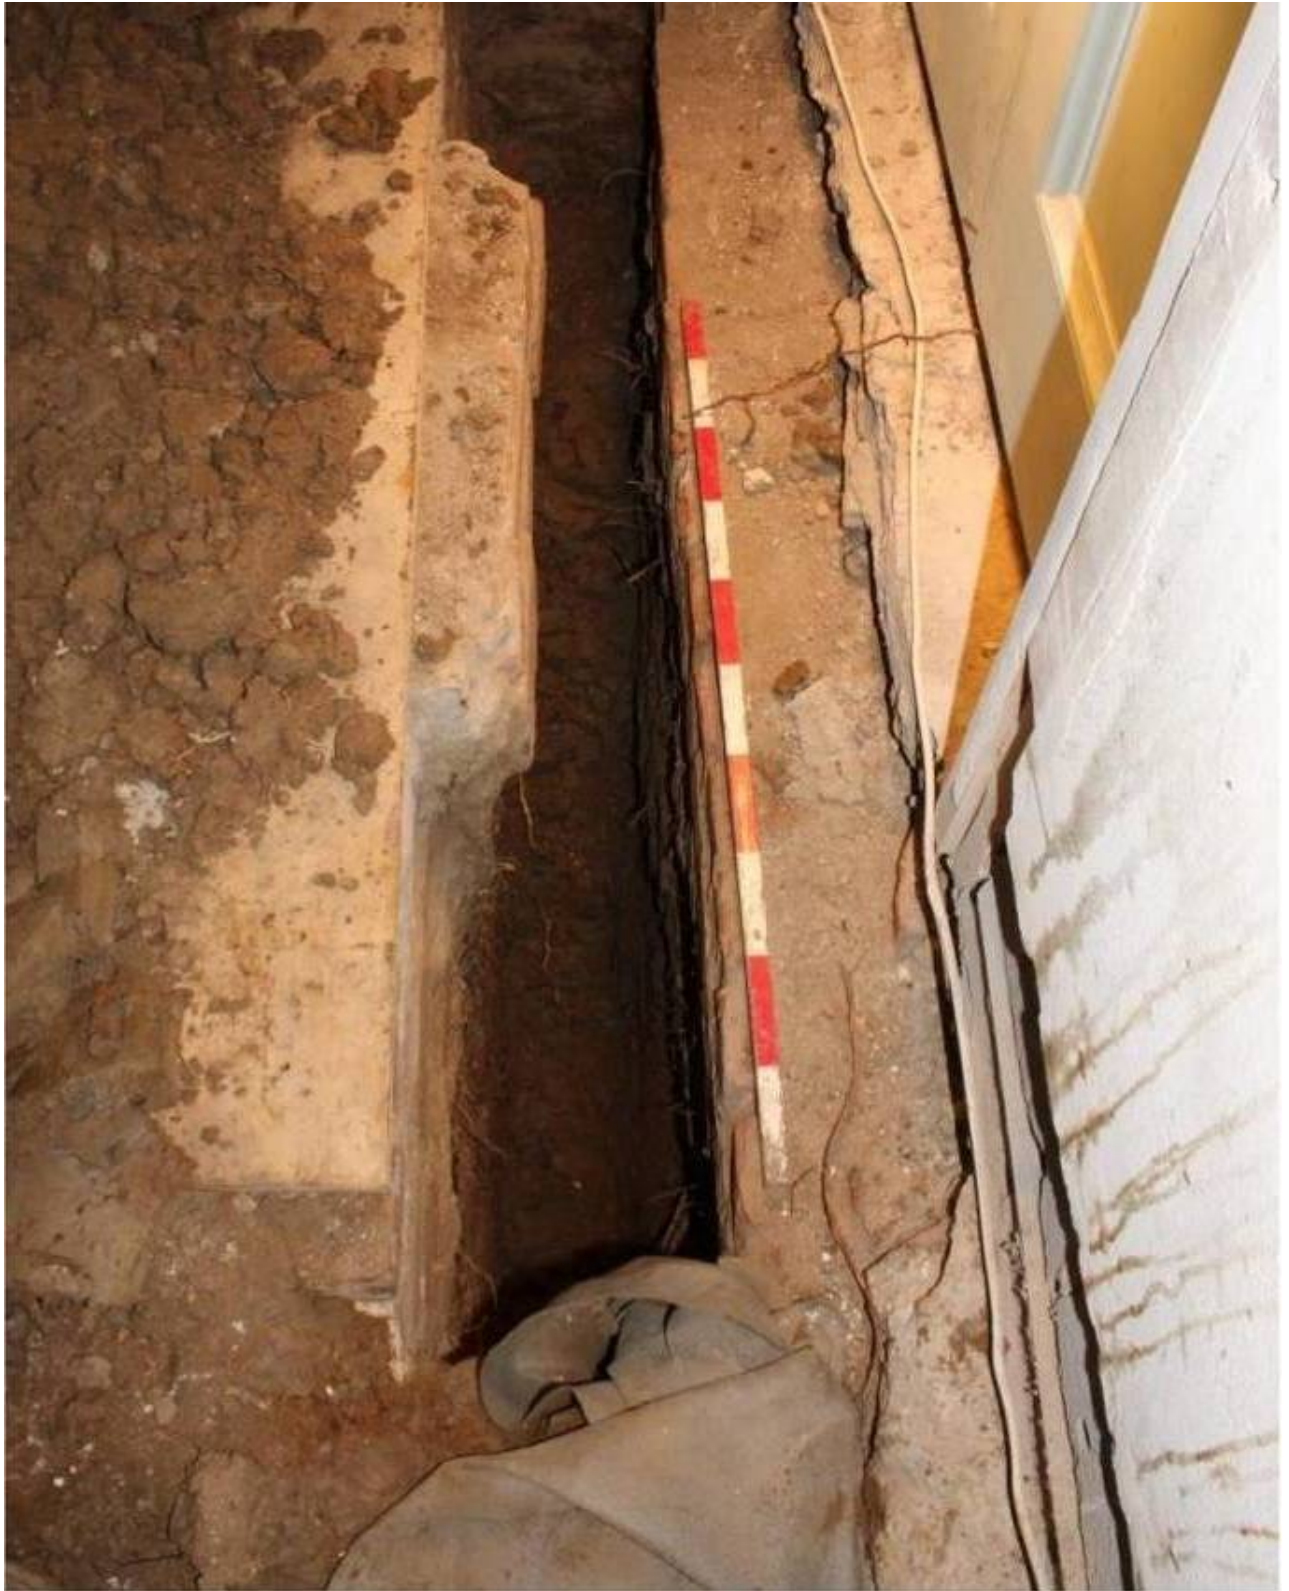
- 7.3.3 West of the bath structure, removal of the modern concrete layer revealed that the existing internal partition wall had been constructed on an earlier concrete plinth, which itself lay on an earlier foundation [11]. This was constructed from just two courses of unfrogged red bricks, bonded with a slightly friable, pale yellow, lime mortar, lying on a bed of crushed rubble; the lower course of bricks laid as all stretchers and the upper course as all headers. This earlier foundation extended 0.19m east of the existing internal wall, resulting in there being a very narrow gap to the western edge of the bath (**Plate 28**).

Plate 28 Narrow gap to the west of the bath, looking south

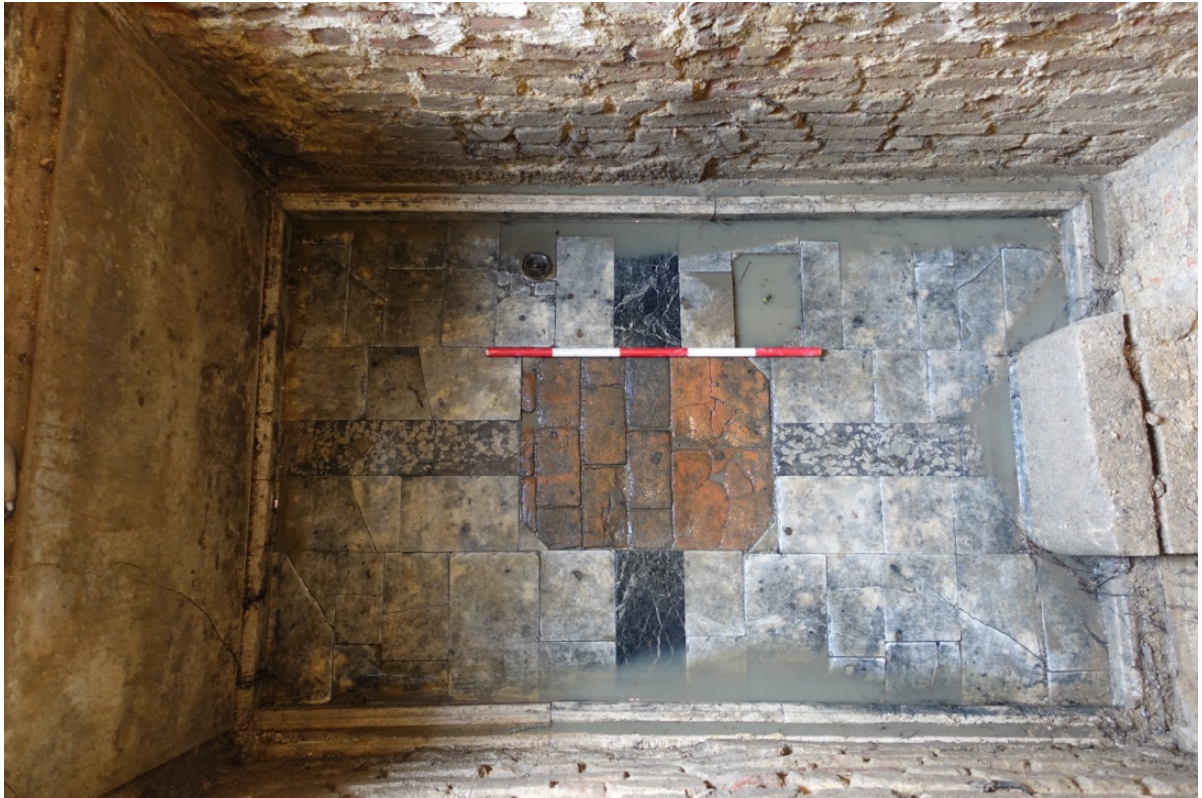
8.1.6 Detail of the composition and design of the marble bath floor was revealed after it was fully exposed and cleaned (**Figure 11; Plates 34 and 35**). This showed that the floor comprised three different types of marble tile, with a pale grey/white Italian Carrara marble forming the majority of the floor, and two single courses or bands of black stone tiles forming a cross, orientated roughly north-south and east-west through the centre of the bath. These two tile bands were formed from different marble, the east-west band comprising Frosterley marble, a polished black limestone containing fossilised corals, mined in County Durham (**Plate 37**) and the north-south band using Nero Marquina, a dense black marble with white veins, imported from Spain (**Plate 36**). A rectangular panel, in-filled with brick and red clay tiles, lies at the centre of the floor and at the crossing of the black marble bands. As already discussed (in Section 6), these plain ceramics represent a secondary replacement or infill, of possibly a decorative panel or mosaic. Original triangular marble pieces surviving at the corners of the rectangular panel show that the replaced 'decorative feature' was set within an eight sided opening (**Plates 34 and 35**).

Plate 34 Decorative marble tiling to the floor of the bath, looking south

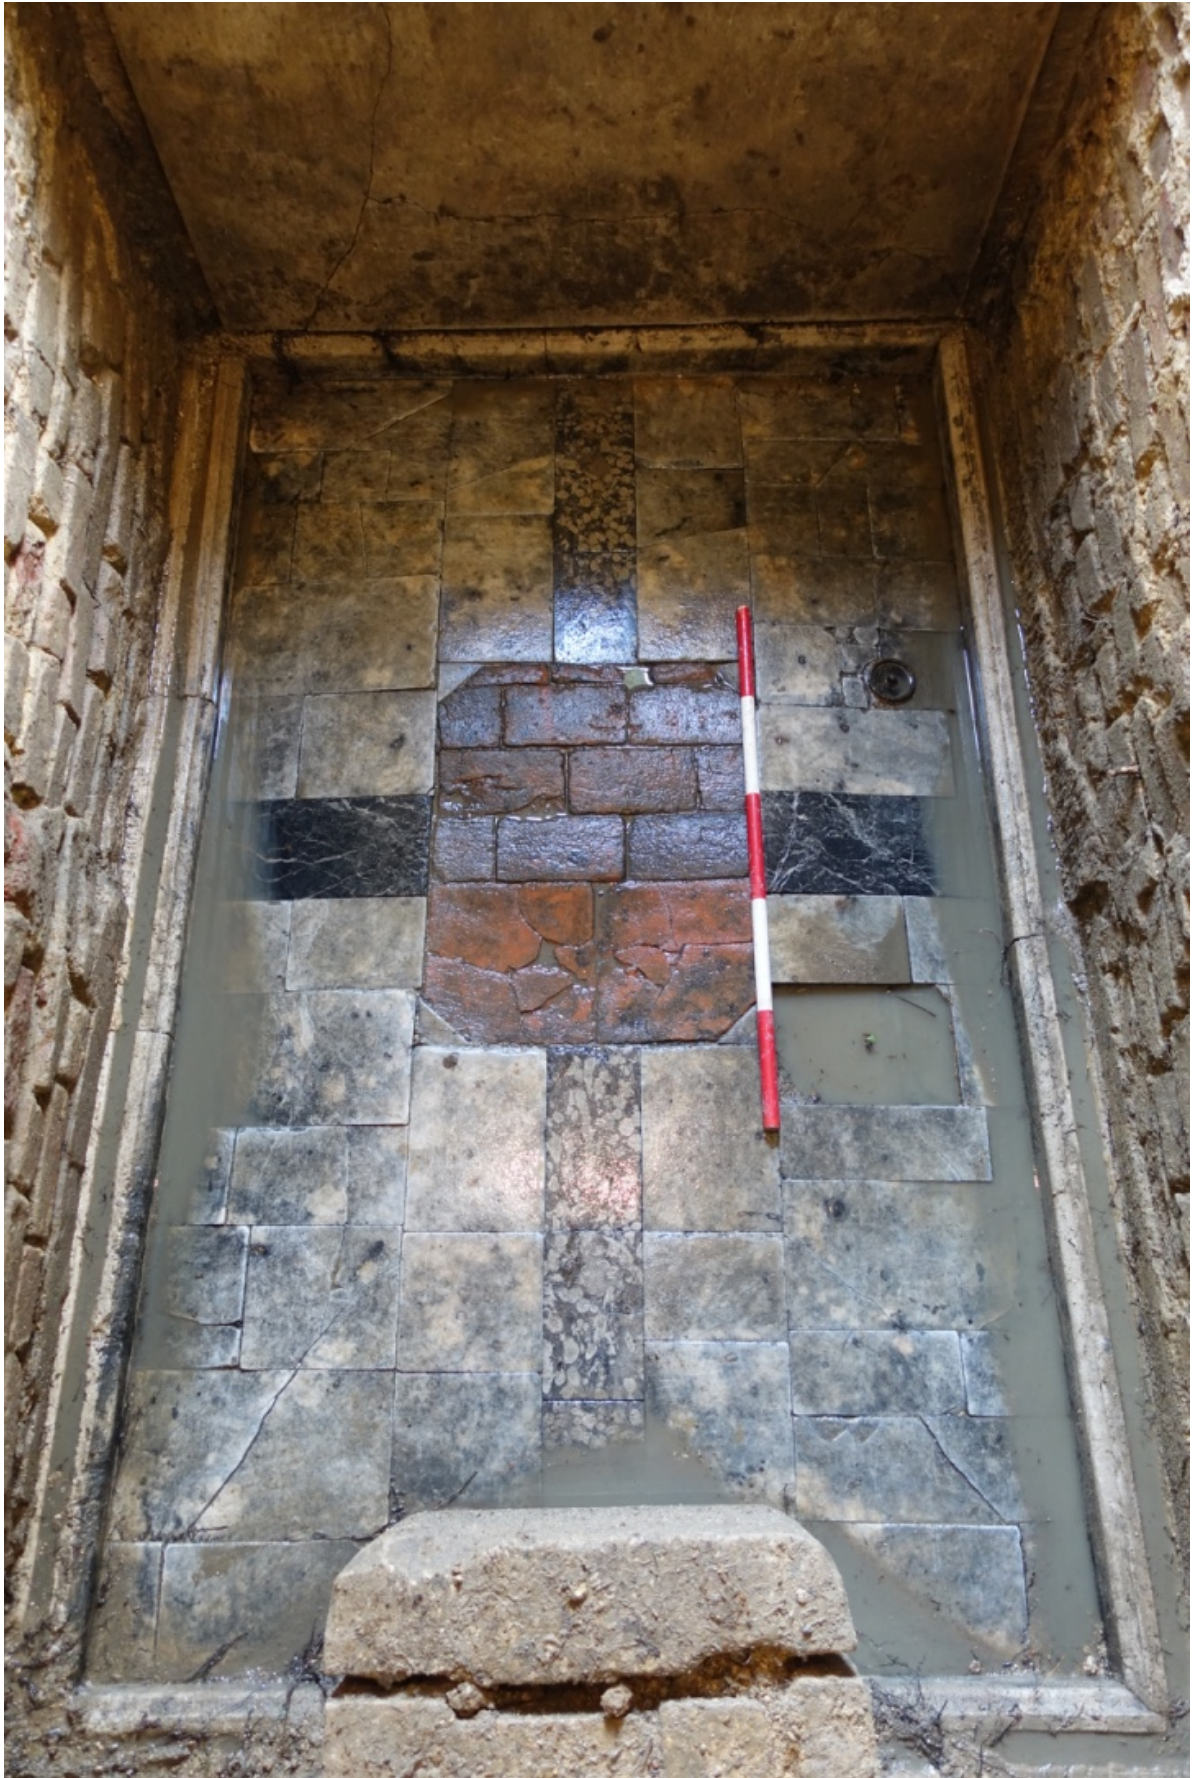
Plate 35 Decorative marble tiling to floor of the bath, looking east
