A Historic Building Survey at St Nicholas' Church, Deptford, London Borough of Lewisham

Written and researched by Victoria Osborn and Alex Rose-Deacon

Pre-Construct Archaeology Ltd November 2006

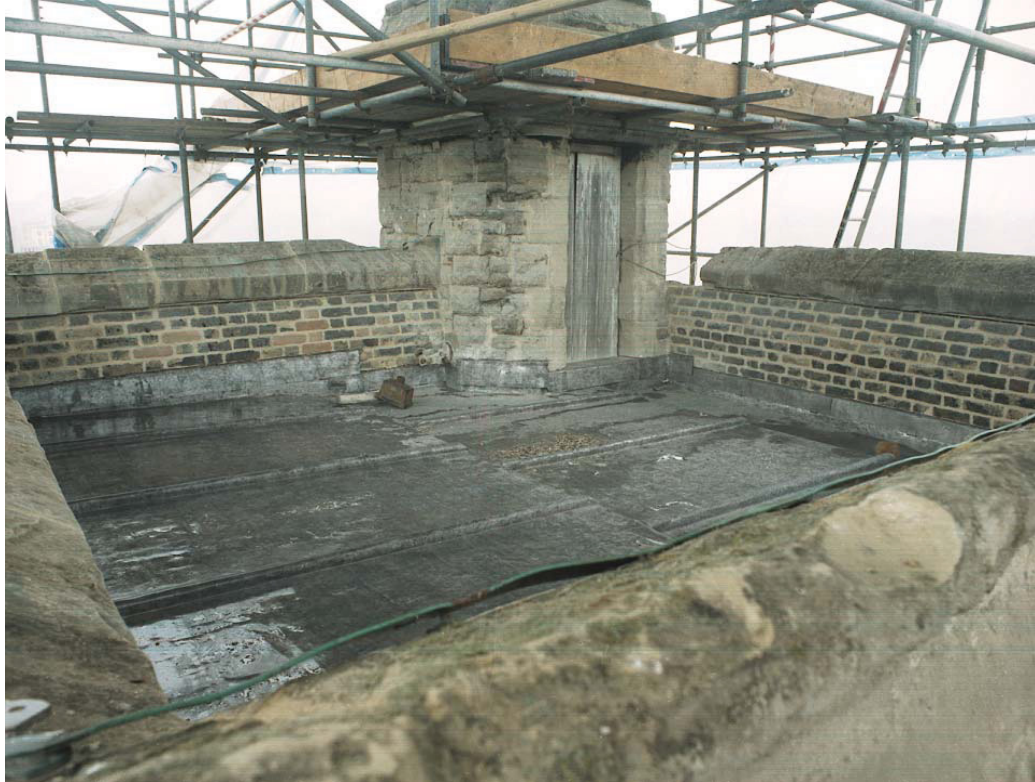
FIGURE 5: View of the roof post-conservation

lead sheet covering falling into a new parapet edge gutter on the east side. The parapet wall is 1.00m wide with an offset of simple moulding at the top. A down pipe is attached to the west elevation, with the projecting gutter overhanging a square rainwater head. Adjacent to the down pipe is a 20th century oak flagstaff (Figures 5 & 28).

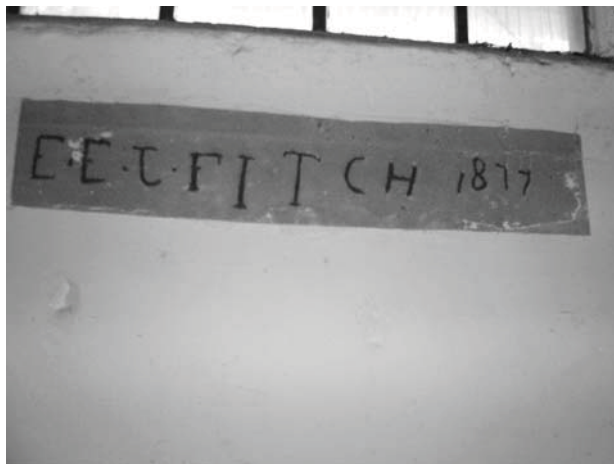
- 6.1.3 The walls of the tower space have been whitewashed, except for patches where names, initials and dates are scratched into the south and west walls. The graffiti is roughly scratched into the stone using a knife and appears in two places, adjacent to the west window and on the south walls. The graffiti on the west window (Figure 6) is later ('E.E.J. FITCH 1877'), than the graffiti on the south wall ('IK 1765') (Figure 7). A row of three small shield shaped plaques with crosses decorate the south wall. Three metres above the ground floor level on the south and north walls are a pair of mortise holes measuring 0.60m x 0.42m. These may have held a floor beam of the former gallery. Concrete inserted underneath the west window has obscured any evidence of further putlock holes or mortises.

FIGURE 6: View of 'E.E.J. FITCH 1877' graffiti below the west Y tracery window

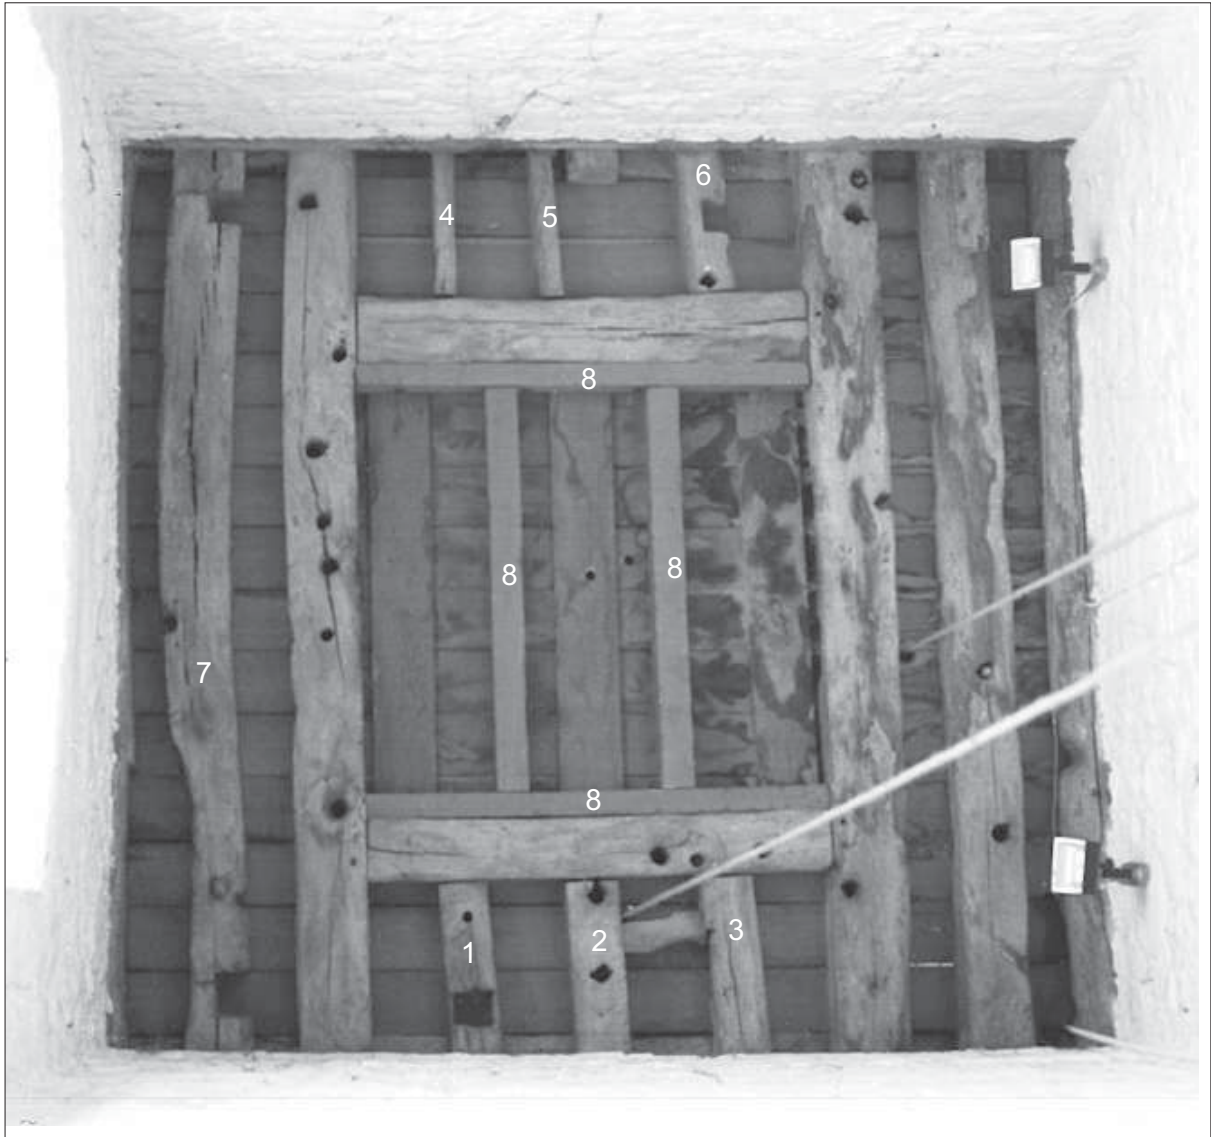
Figure 8: View of the first floor beams and joists from beneath

6.1.5 The timber used for the joists is extremely knotty, but in good condition. The roughly square profiles indicate an early late medieval to late post medieval date (Brunskill, 1988). The following table records the first floor timbers as seen in Figure 8:

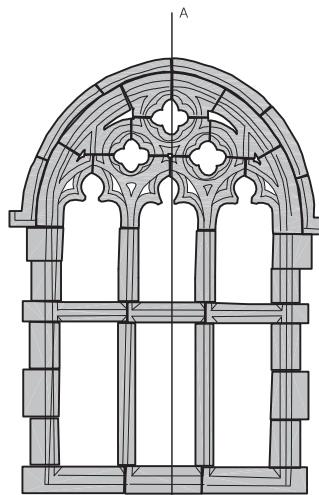
South Opening Tracery - completely replaced
Second Floor

- 6.4.4 The openings of the west, south and east elevations are larger openings, but of similar construction with two mullions instead of one (Figure 12). The tracery on each of these openings consists of nine moulded blocks of limestone forming three quatrefoils and three foils below. The simple hoodmould is formed of two stops and springers with four voussoirs. The east elevation opening is in good condition and has suffered less weathering than the west and south openings, although one mullion has been replaced during the conservation works and is now composed of two limestone blocks. The south window was in very poor condition and the whole tracery opening was replaced during the survey.

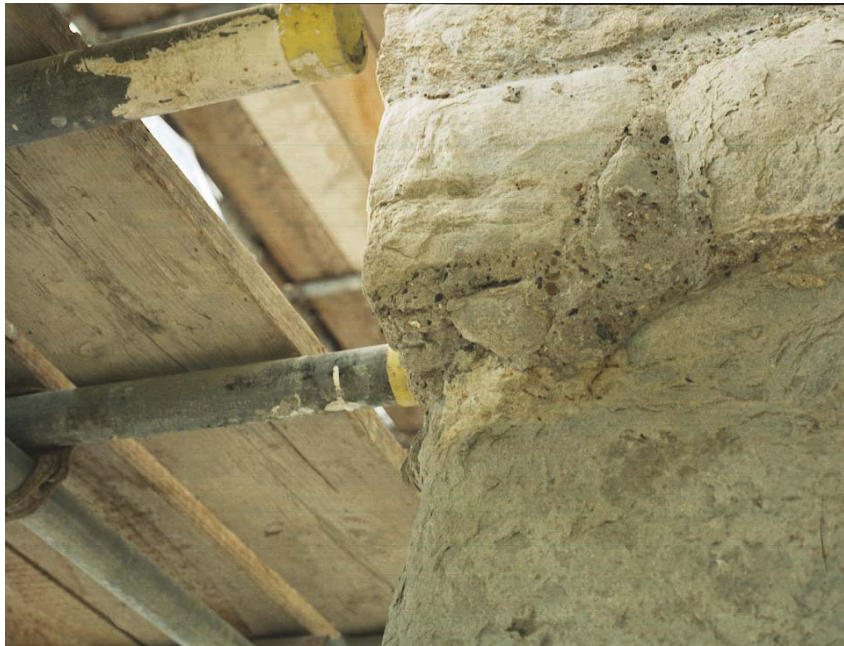
FIGURE 15: View of the southeast buttress showing the Kentish ragstone set in Portland cement-based mortar

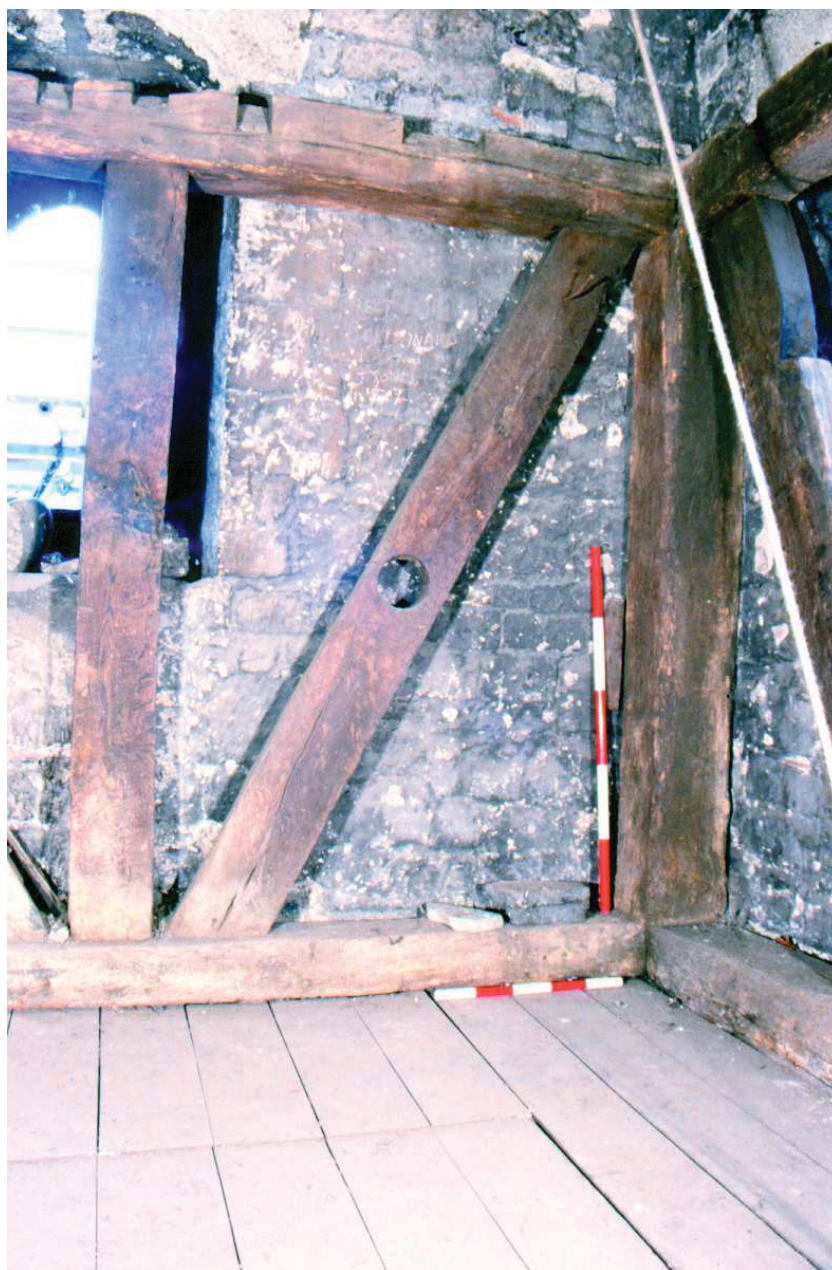
Figure 18: View Of The West Timber Frame

The west timber frame is joined by the sill beam to the north and south frames with simple mortise and tenon joints, visible at the south end of the frame (Figures 9 & 18). The frames are joined with a top plate, but the joint is not visible. The frame members are in good condition. The top plate has five single cogged joints and is fixed to the diagonal posts with a square flat headed nail. A timber peg joins the top plate to the post. The diagonal braces bear evidence of re-use from a timber framed building. The top of the south post is jowled with a longitudinal bevelled half joint, and there is a circular cut in the north post.

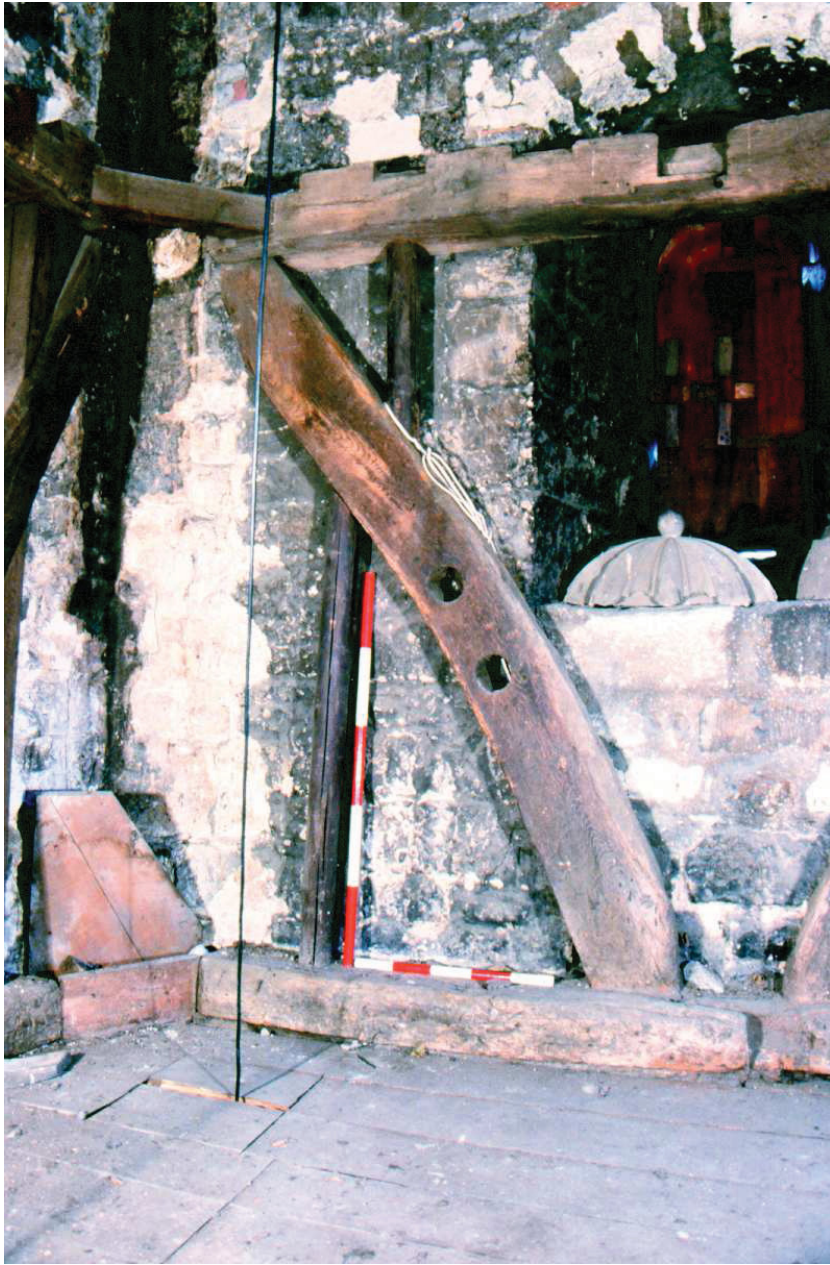
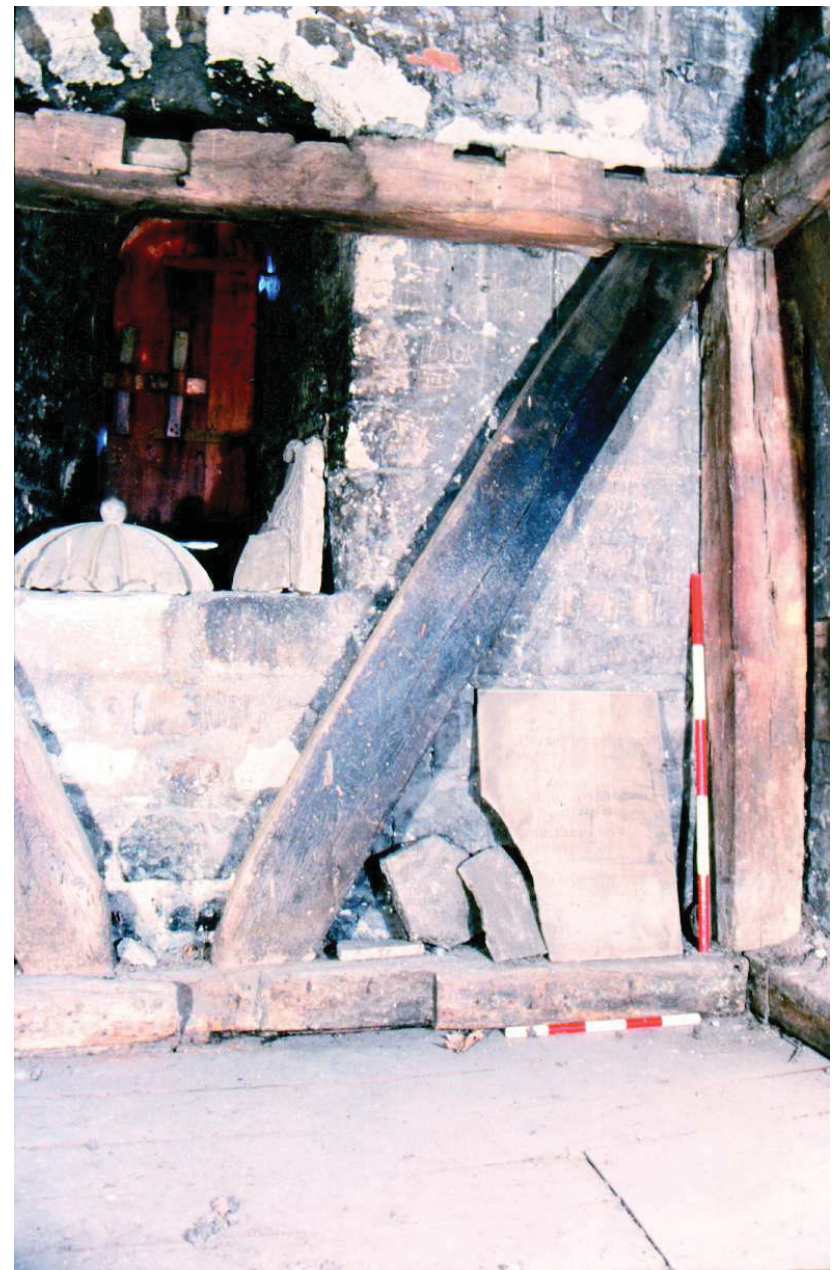
Figure 19 : View Of The South Timber Frame

Opposite the four-centred arch of the first floor doorway, the south timber frame is in fairly poor condition (Figures 9 & 19). Recent studs support the east tension brace, which is heavily marked with circular holes and chisel marks. The sill beam is also in quite poor condition and bears evidence of secondary use with a prominent halved lap joint facing towards the centre of the room. The wall plate is heavily joined, with six single cogged joints and a notched house joint [B] in the face below one of the single cogged joints [A] (see Figure 9). Chisel marks are evident to the west as tool scars and a carpenter's mark with two scratches scored into the west side of the top plate.

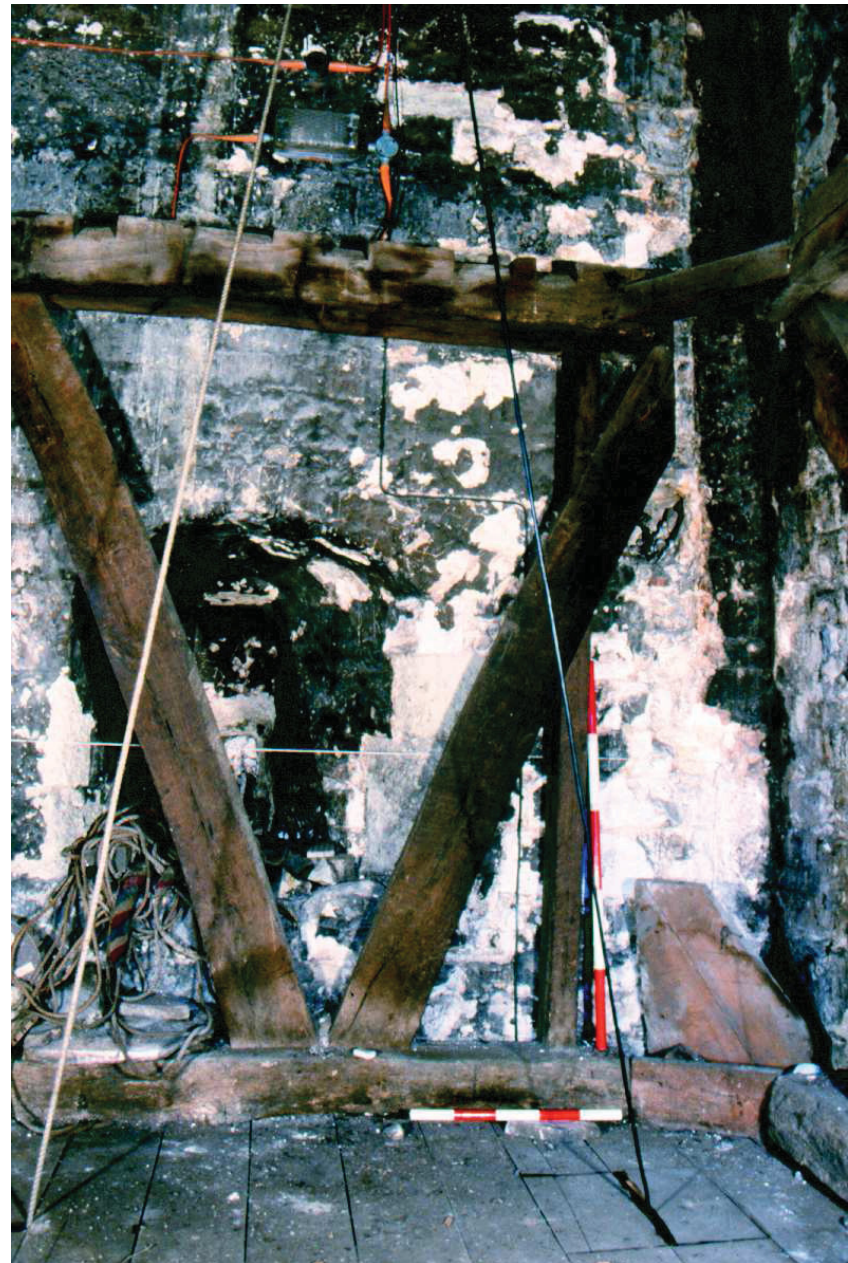
Figure 20: View Of The East Timber Frame

The east timber frame is in front of the squint and is in very poor condition, particularly as it is truncated to the south by the installation of the early 20th century down pipe (Figures 9 & 20). The top plate is heavily jointed from previous uses with seven single cogged joints and a very worn half joint visible above the north brace. The bracing is supported with two modern struts, where the frame has been truncated at its south end, and the southern strut is cut with a dovetail joint. A later arch brace has been added for extra support in the north and is affixed by a round-headed nail to the top plate and by timber pegs to the post.

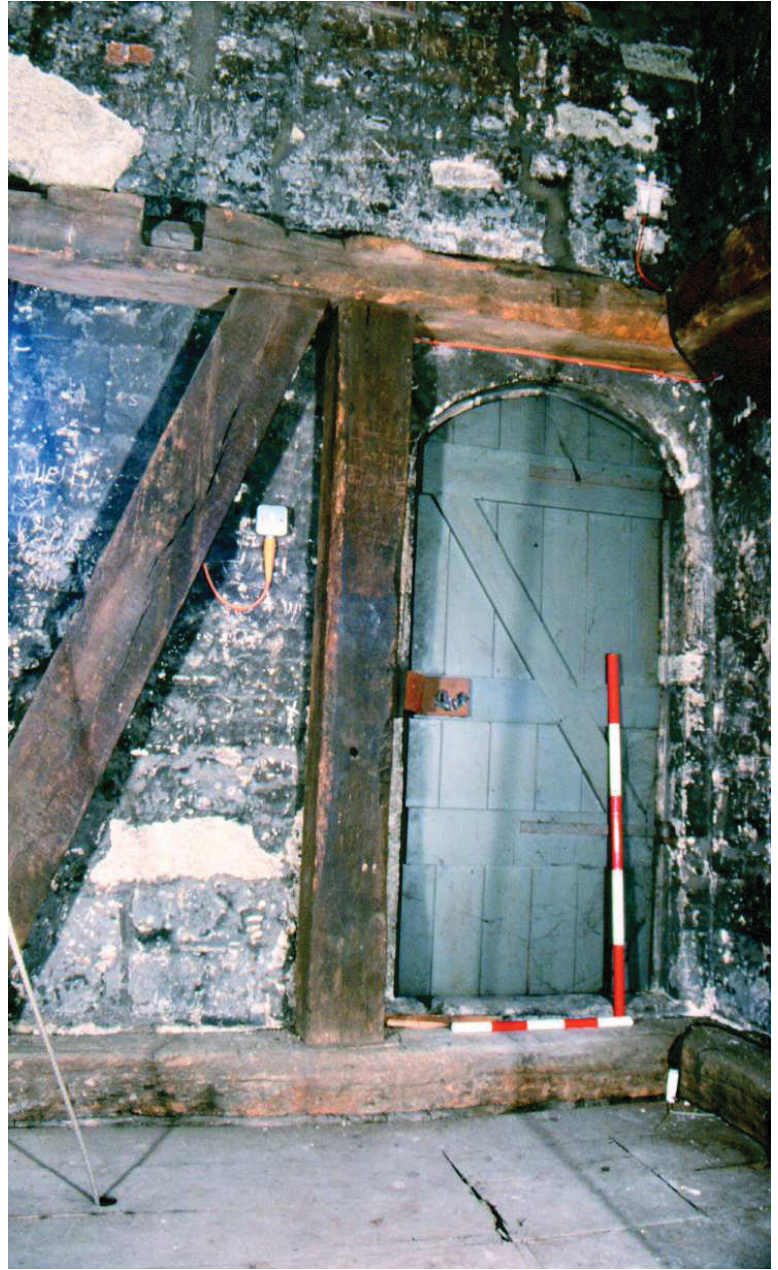
Figure 21: View Of The North Timber Frame

The staircase doorway is incorporated in the north frame, which is in good condition (Figures 9 & 21). The east post has become the doorjamb, and consequently has a late 20th century lock fitted into it. The sill beam is attached to the east and west frames and runs underneath the door, acting as a threshold. The top plate, which acts as a lintel over the doorway, is attached to the west top plate with a double mortise and tenon joint. It has four single cogged joints and a notched lap joint, which may be associated with the bevelled halved joint in the west frame, and a carpenter's mark with three scratches scored into the west side.
