ARCHAEOLOGICAL MONITORING
IN ASSOCIATION WITH REFURBISHMENT OF THE
COMMONDALE TO CASTLETON ELECTRICITY SUPPLY,
DANBY LOW MOOR, NORTH YORK MOORS NATIONAL PARK

Central National Grid Reference: NZ 6649/1063 - 6849/0853

Site Code: GUC 06

Commissioning Client: NEDL Cargo Fleet Lane Middlesbrough TS3 8DG

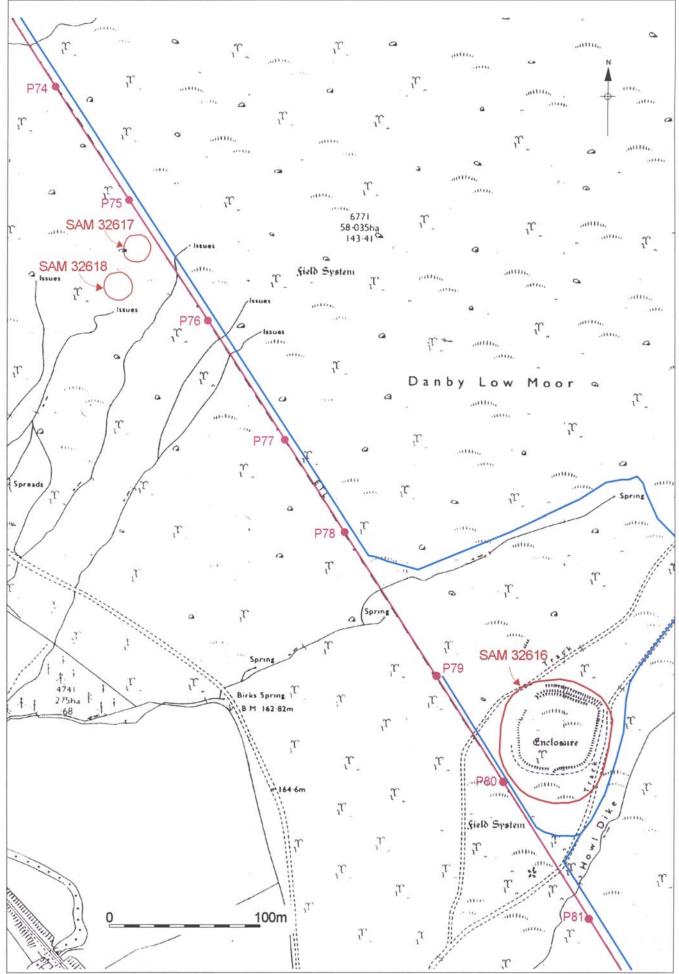
Figure 3. Detail of route, between Poles 75 and 81 Scale 1:2,500

- 4.2.2 Despite the vegetation cover, the two scheduled round barrows (SAMs 32617 and 32618) west of the supply route between Poles 75 and 76 were relatively easily identifiable (Figure 3). At least two other possible barrows or cairns were noted in the immediate vicinity of the scheduled monuments (Plates 2, 3 and 4). The SMR contained relatively recent, but undated, Ordnance Survey (OS) maps at 1:2,500 scale, which had been annotated with additional archaeological detail. A large circular 'feature' on this map was identified to the east of the supply route in this area, this being a possible cairn or another round barrow. Several hollows identified in this area during the preliminary site visit possibly represent grouse butts.⁵

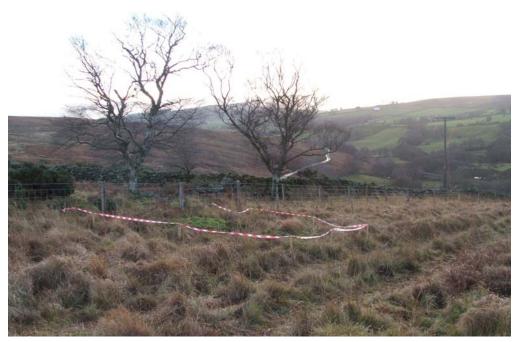
- 4.1.2 Archaeological remains in the presumed ancient cairn field straddled by Poles 66 and 67 could not be easily identified for the reasons stated above. However, one cairn was observed immediately to the east of the proposed access route for Pole 67 (Plate 1). During the route walk-over, this was identified as needing to be clearly marked to prevent disturbance by vehicles. Demarcation was undertaken using barrier tape affixed to wooden stakes on the monitoring visit on 5 December. The subsequent monitoring visits confirmed that the demarcation had been respected by the groundwork crews. During the route walk-over, it was noted the portion of the route between Poles 66 and 67 was very uneven, due to earth-fast boulders.

Plate 1. Cairn to the east of access route to Pole 67. Looking south-east.

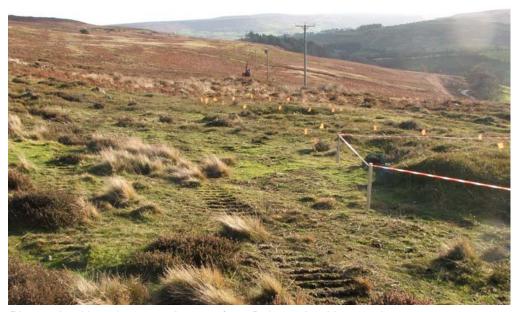
Plate 2. Looking along supply route from Pole 75. Looking south-east.

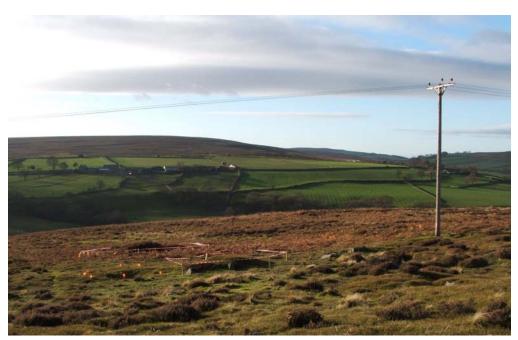
Plate 3. Features, including SAM 32617 in the rearground, at Pole 75. Looking south-west.

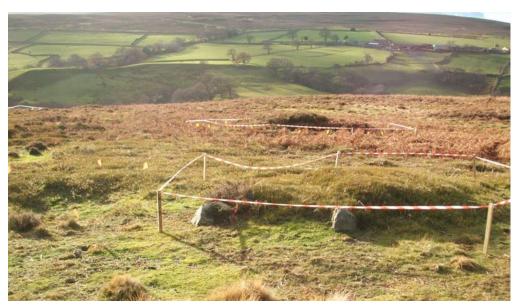
Plate 4. Detail of cairn east of Pole 75, with SAM 32617 in the rearground. Looking south-west.

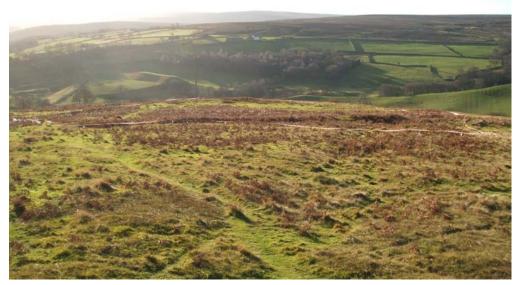
- 4.2.3 The Box Hall enclosure (SAM 32616) was generally easily identifiable on the moorland immediately to the north-east of Pole 80 (Plate 5). Two small circular 'features' shown on the annotated OS map from the SMR to the south-west of Pole 80 were also identified and these appeared to be stone clearance cairns. A large circular 'feature' shown on the annotated OS map to the south-east of Pole 80 and due south of SAM 32616, potentially represented a large hut circle or small enclosure. However, this 'feature' could not be identified due to vegetation cover. Immediately to the south of this location was what appeared to be a natural hillock, annotated as 'Tumulus' on the aforementioned OS maps, but possibly a natural outcrop of rock.

Plate 5. SAM 32616, with Pole 80 in the rearground. Looking south-west.

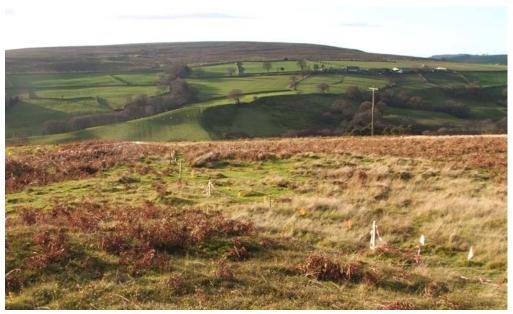
- 4.2.7 The subsequent monitoring visits confirmed that all demarcation of archaeological monuments in this portion of the supply route had been respected by the groundwork crews. Where wind damage had occurred to barrier tape demarcations (Plate 6), the barriers were reinstated, where possible, during the monitoring visits.

Plate 6. Wind damage to barrier around SAM 32616, with Pole 79 to the right. Looking west.

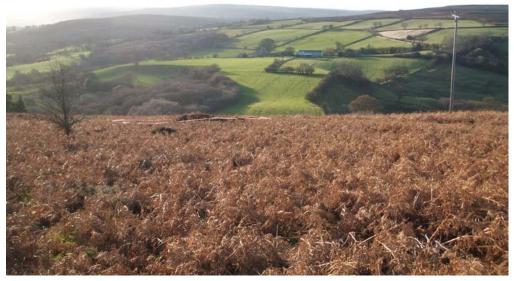
- 4.3.1 When inspected during the route walk-over, a known funerary cairn close to Pole 86 was relatively easily identifiable, despite the vegetation cover on the moor. The proposed access route diverged to the west of the line of supply route at Pole 85 and it was considered, therefore, that this monument was highly unlikely to be affected by installation of new poles, dismantling of existing poles or by vehicular movements associated with the refurbishment scheme. Nevertheless, during the monitoring visit on 5 December, the cairn was surrounded with barrier tape affixed to wooden stakes to prevent vehicular access (Plate 7).

Plate 7. Cairn, with Pole 86 to the right. Looking south-west.

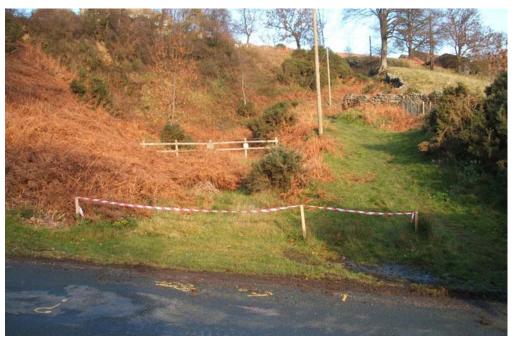
- 4.3.3 When inspected during the route walk-over, the dismantled mineral tramway lying close to, but to the west of, Pole 95 was fairly easily identifiable. No vehicular access to the supply route was possible from the west and the proposed access to Pole 95 was from a road to the south-east of the route. Again, therefore, it was considered highly unlikely that this monument would be affected by installation of new poles, dismantling of existing poles or by vehicular movements associated with the refurbishment scheme. Nevertheless, during the monitoring visit on 5 December, the monument was delineated with barrier tape affixed to wooden stakes to prevent vehicular access (Plate 8).

Plate 8. South-west end of mineral tramway, near Pole 95. Looking north-east.
