**HISTORIC BUILDING RECORDING  
OF FARM BUILDINGS  
TO THE REAR OF  
SCHOOL HILL FARM HOUSE,  
CHURCH STREET,  
FENNY COMPTON,  
WARWICKSHIRE,  
CV47 2YE**

**PCA REPORT NO: R13125**

**DECEMBER 2017**

Historic Building Recording

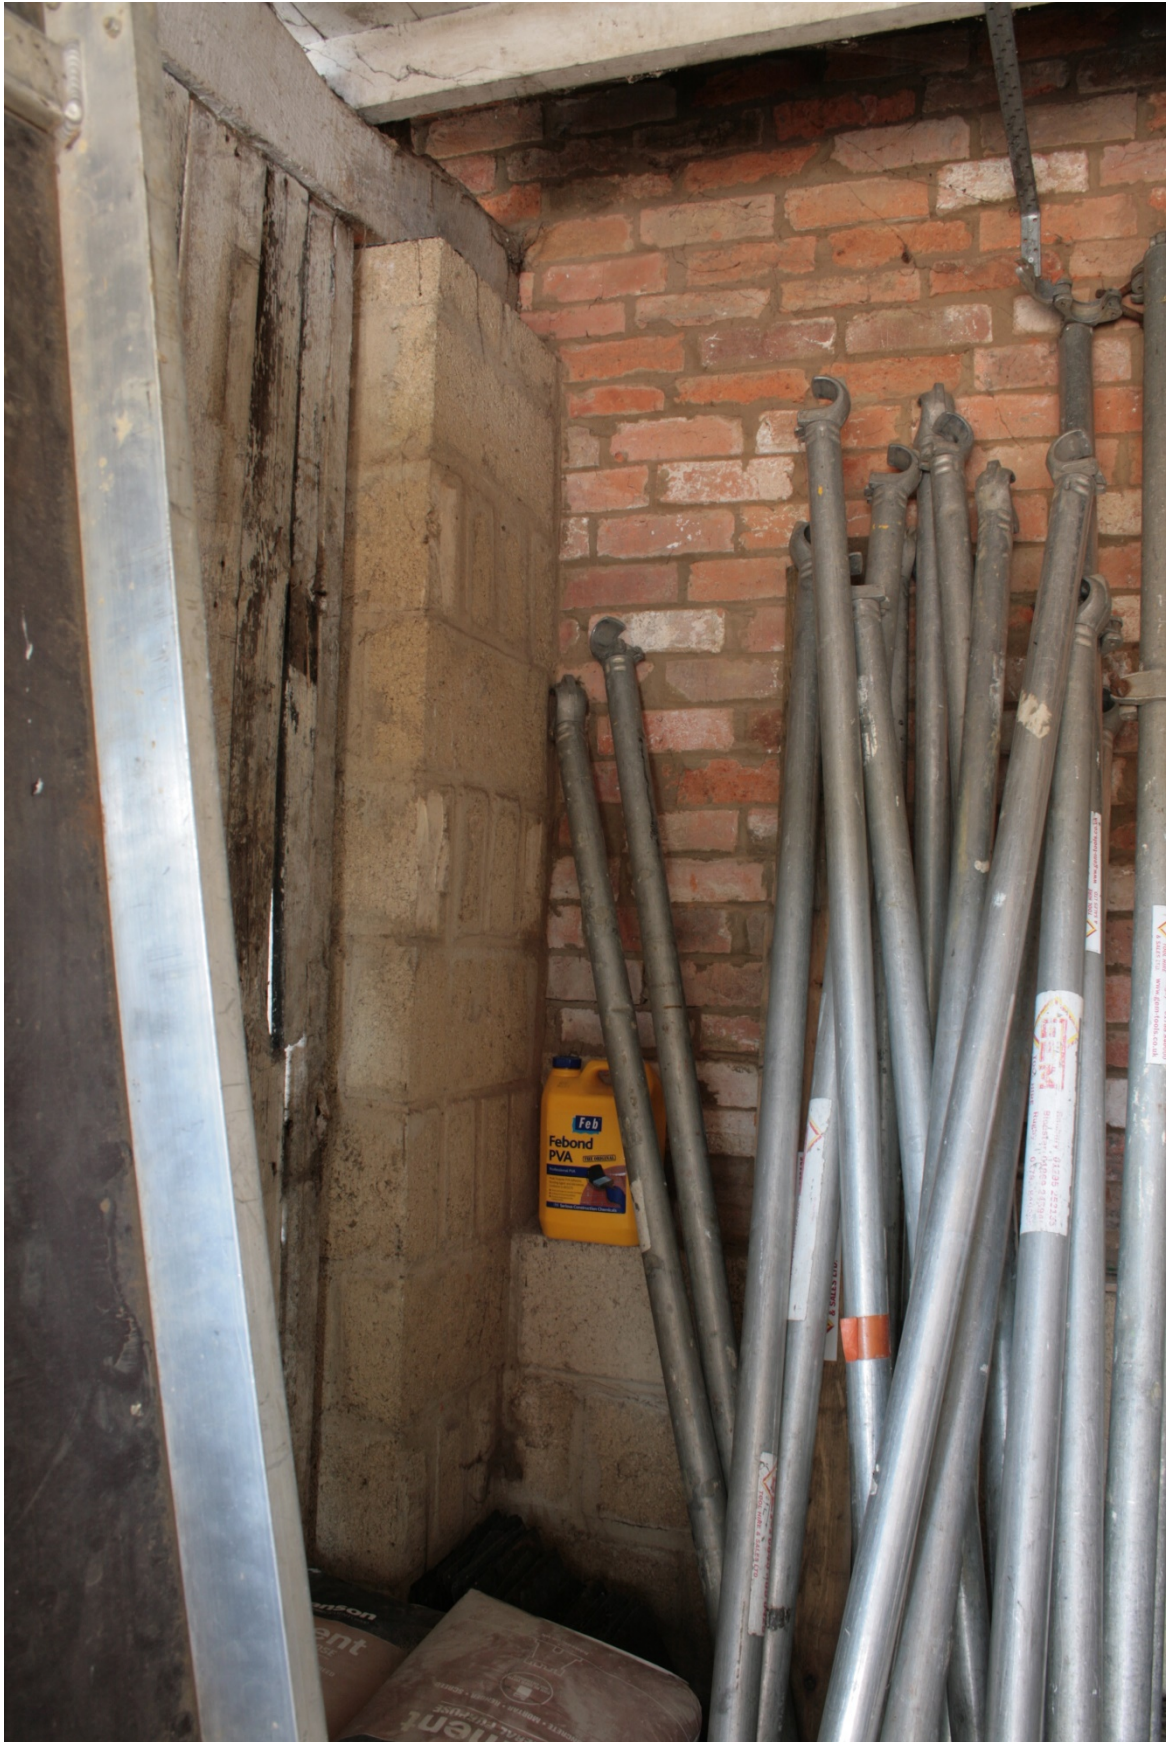
Plate 10: North side of ground floor of Building A, looking west (CSFS17 D100 (87) (viewpoint on Figure 10)

6.2.3 The rear (west) wall of the building was only recorded internally and was not observed externally. This wall was constructed in red brick in stretcher bond (**Plates 10, 12, 13 and 17**). The north side of this wall appears to have been rebuilt and again, some of the bricks had been white washed suggesting that they were reused. The brickwork in the south side of the wall is late 18<sup>th</sup>/early 19<sup>th</sup> century in appearance.

- 6.2.7 The primary floor joists rest on brick piers in the west wall (the northern pier replaced in late 20<sup>th</sup> century concrete block; **Plate 10**) and timber posts in the east wall. They are both supported centrally by a large vertical post with a wrought iron strap tying the two together (**Figure 10; Plates 12 to 14 and 16**).

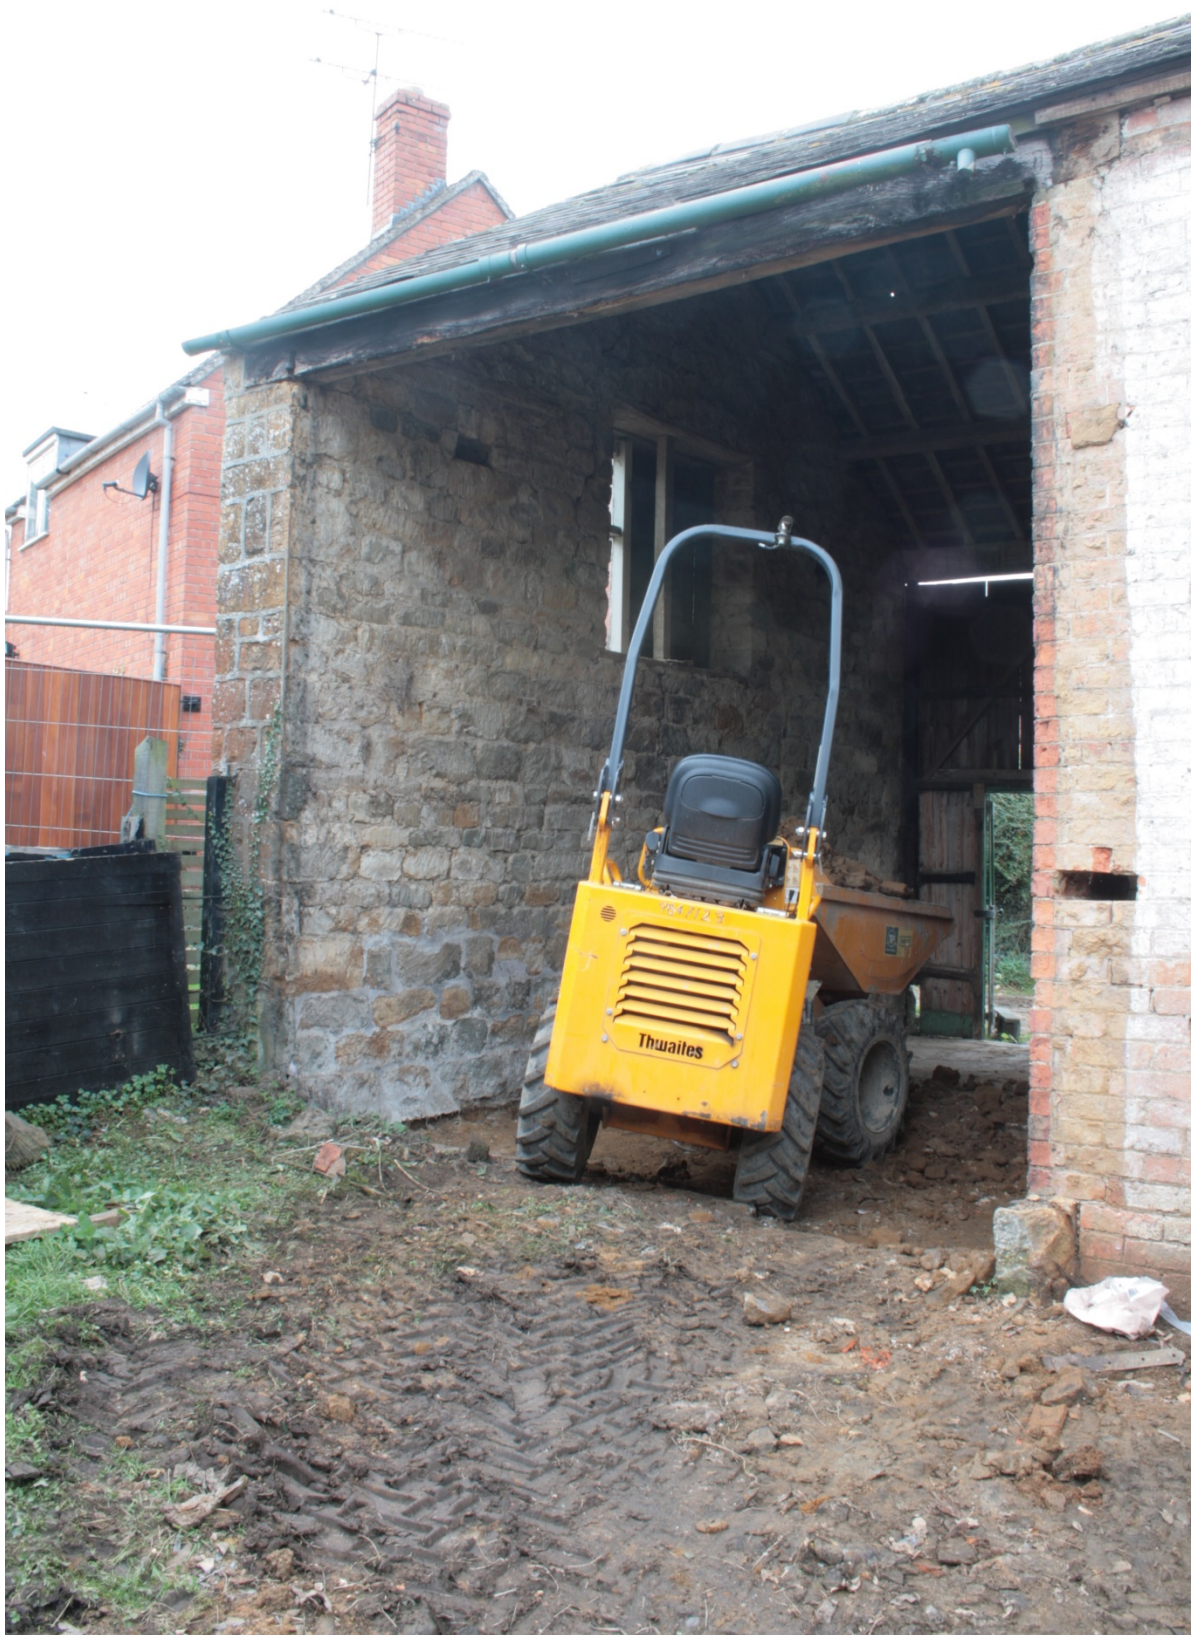
Plate 26: Rear entrance into main barn (Building B) from rear yard area, looking south-west (CSFS17 D100 (68)) (viewpoint on Figures 9 and 11)

6.3.4 A straight vertical construction joint was visible between the ironstone (and lower brickwork) at the north end of the east elevation and the brickwork in the rest of this elevation (**Plate 28**). Another straight joint was visible between the lower brickwork and the ironstone. This lower part of the wall was broken showing that it had until recently continued to the east. The east elevation has a large opening at its south end opposite the double doors in the west elevation (**Figure 11; Plate 26**).
