**CHURCH OF ST DENIS, EAST  
HATLEY, CAMBRIDGESHIRE, SG19  
3JA.**

**BUILT HERITAGE RECORDING**

**REPORT NO. 13186**

**Built Heritage Recording at the Church of St Denis, East Hatley,  
Cambridgeshire, SG19 3JA.**

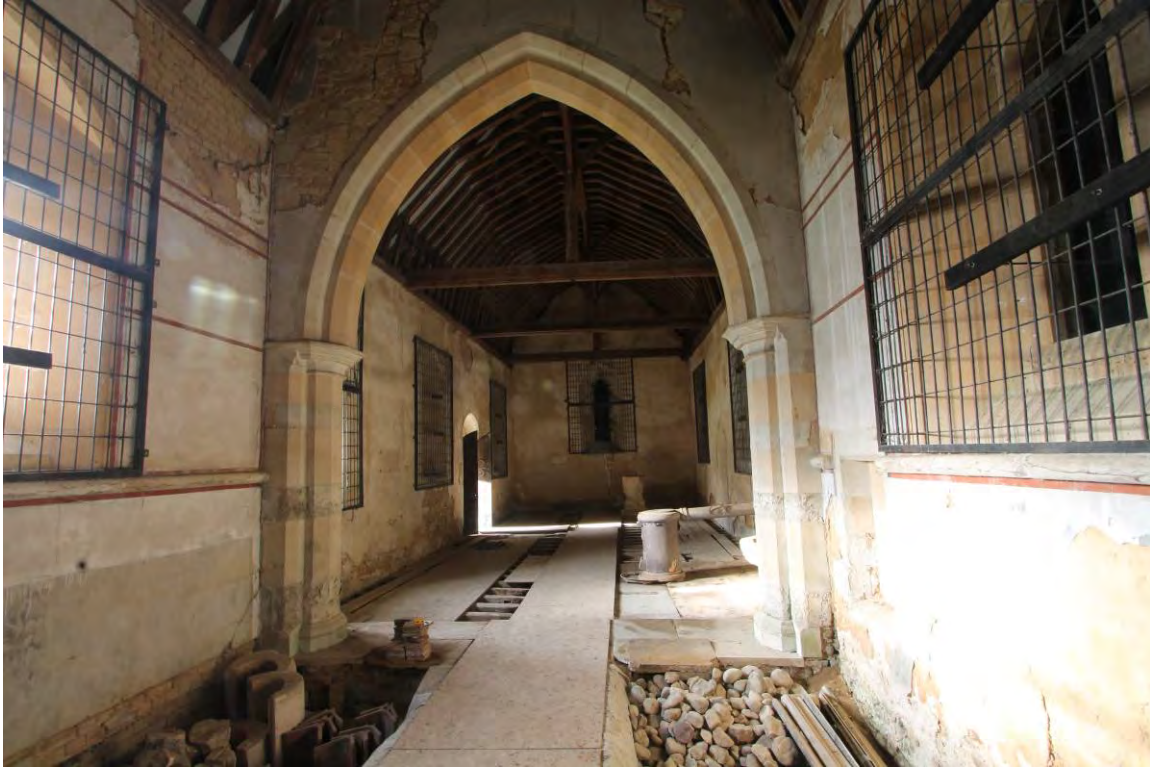
Plate 12 Floor voids in chancel used for storing building materials

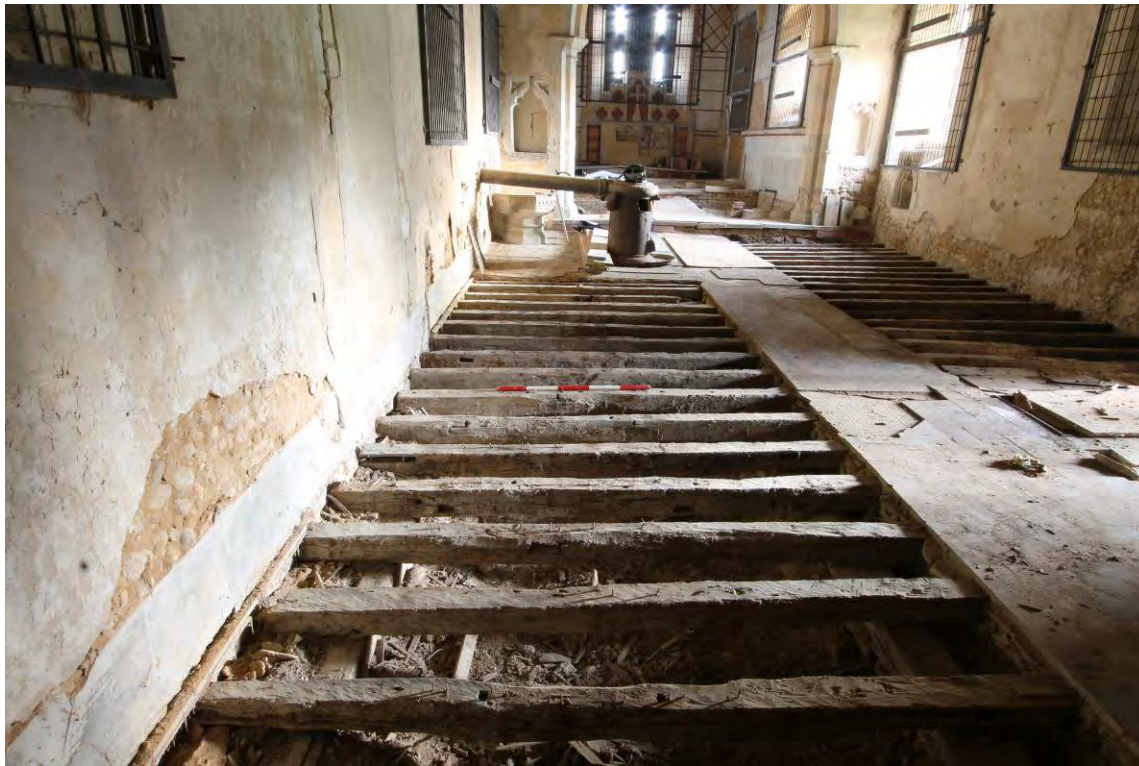
Plate 13 Nave, floor section (1) after the removal of boards, looking east

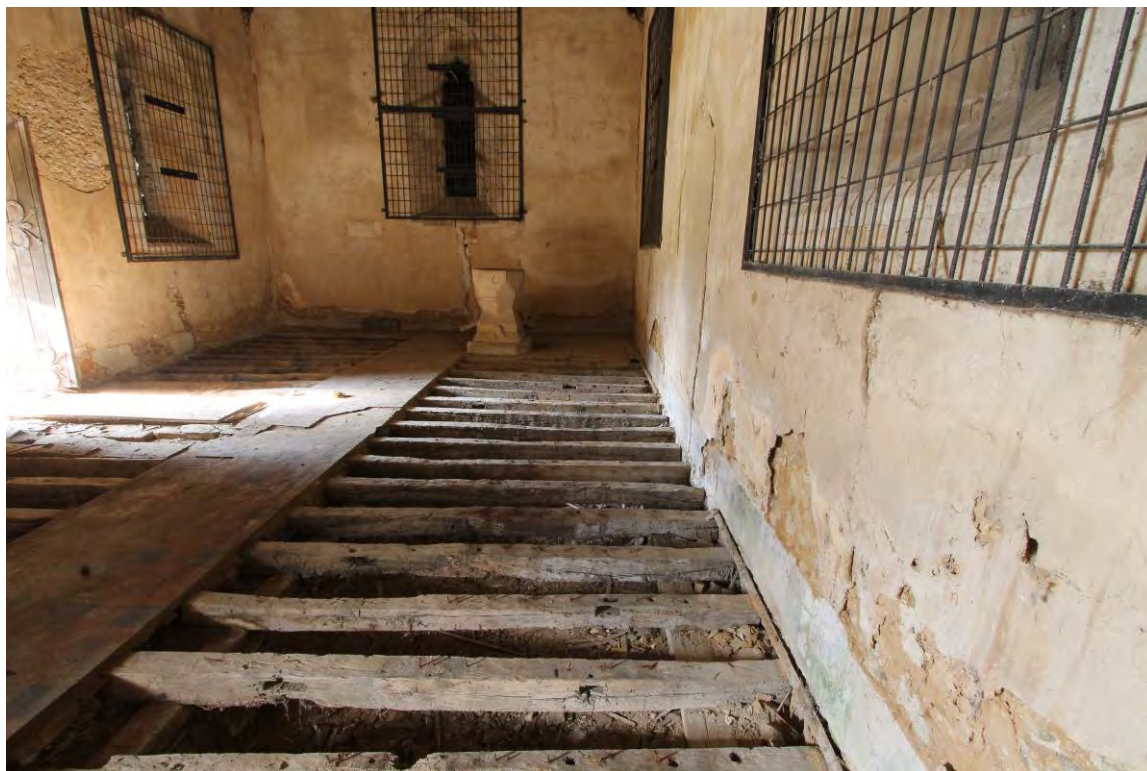
Plate 14 Nave, floor section (1) after the removal of boards, looking west

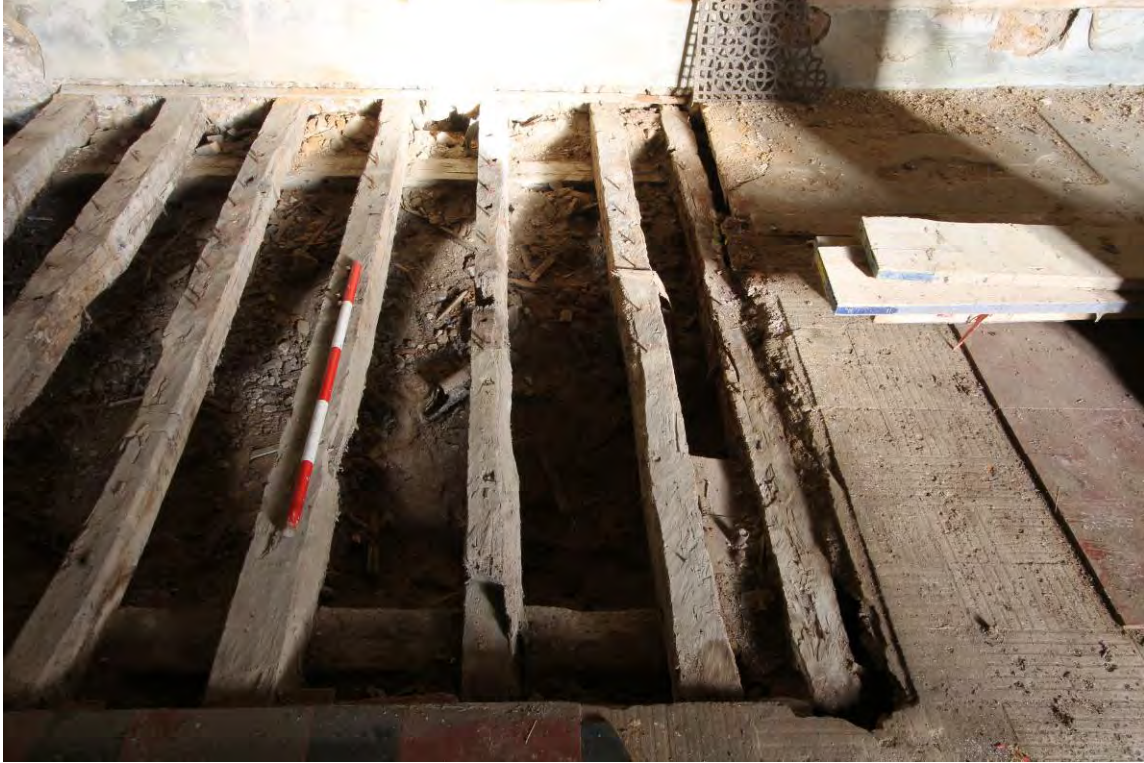
Plate 15 Floor section 1, east end, joists 1:14-1:18

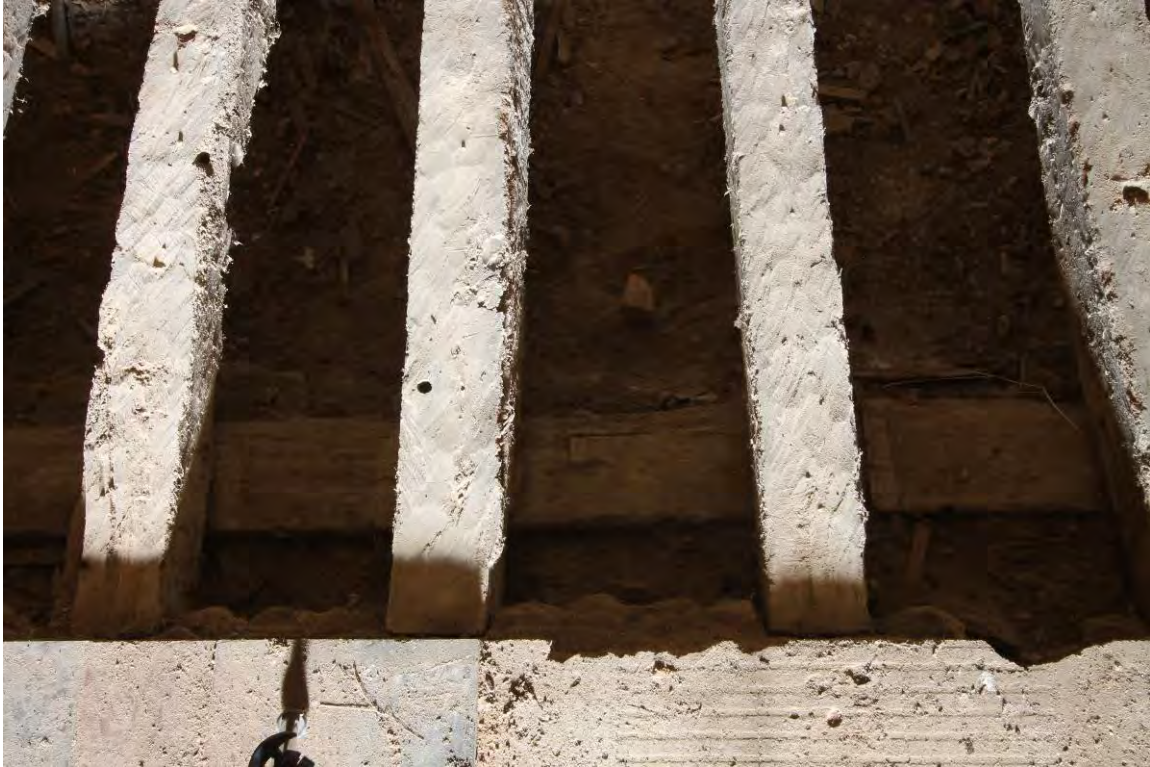
6.3.2 The floor structure in this section comprised 18 individual floor joists (numbered west to east, 1-18) laid north-south and predominantly regularly spaced between at 300-450mm centres. All of the joists show evidence of re-use, either by the presence of empty peg holes or from former mortices, the latter as both empty sockets or as mortices still retaining a cut off tenon. The joists were all of oak and of similar scantling typically ranging between 120 x 150mm (4 x 5 inch) although a few slightly lighter joists were also present (see appendix 2 for dimensions). The joists were relatively straight, but were not sawn, many showing marks synonymous with facing-up using an adze or

Plate 20 Floor section 1, detail of adze marks

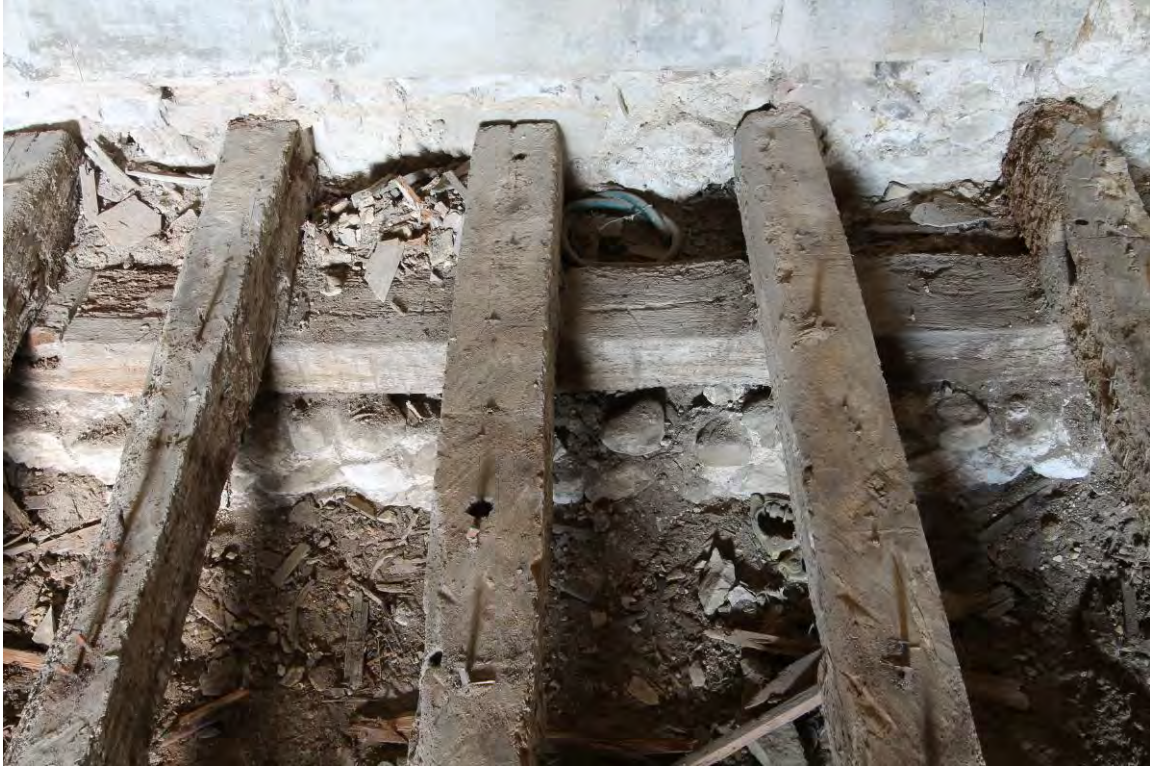
6.3.3 Most of the joists were simply laid over the sill plates, the deeper joists, such as (1:2 & 1:16) lapped over the plate to maintain a consistent floor level. The northernmost plate was formed from four timbers joined end on using a simple half lap joint and the southern plate from three sections. Apart from the easternmost scarf (east of 1:12) their positions did not correlate, although both rows showed evidence of re-use with redundant mortices in their upper faces. The plates were similar in character and size ranging from 160 x 120mm (N) to 150 x 130mm (S). Both, as already described, were set upon in-line sleeper walls simply built from re-used fieldstones, probably readily available following the Butterfields remodelling works.

Plate 21 Floor section 1, detail of sleeper wall and plate

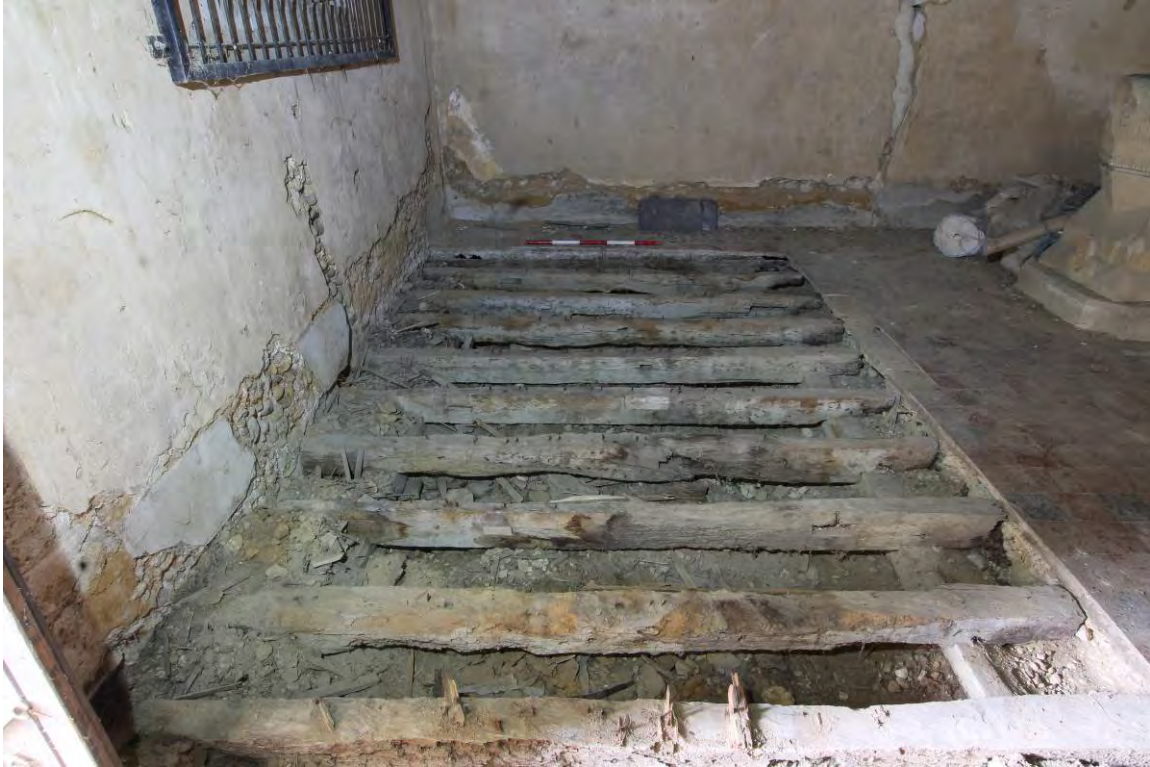
6.4.2 The floor structure was formed from 10 individual floor joists (numbered west to east 1-10) laid north-south and at 340-440mm centres. The joists closely matched those used in the adjacent floor (1), showing, through the presence of empty peg holes and former mortices, of re-use. The joists were all oak and hand reduced using an axe or adze, some not quite fully 'squared up'. The scantlings were similar averaging about c.140-160mm in dimension and many of the joists (2:3, 2:5 to 2:10) were lapped over the top of the underlying plate or sill. Due to their re-use there was no correlation between the positions and distribution of the peg holes and mortices. As floor (1) these comprised a mix of empty mortices trenched part way into the joist, with smaller mortices measuring c.100-120mm and much larger mortices up to 400-500mm. Floor joist (2:4) included a long diagonal-cut mortice with evidence for three pegs along its western side (possibly once carrying a horizontal timber such as a collar), while joist (2:7) included a series of four small notches cut out of its western edge and (2:6) the extant remains of a timber lapped over the face of the joist, in the manner of a passing brace. Unusually perhaps is that the inner (northern) ends of the joists were in a poorer condition than those that butted up against the external wall. Many, if not all of the joists, showed clear evidence of a weathered face.

Plate 22 Floor section 2, looking west

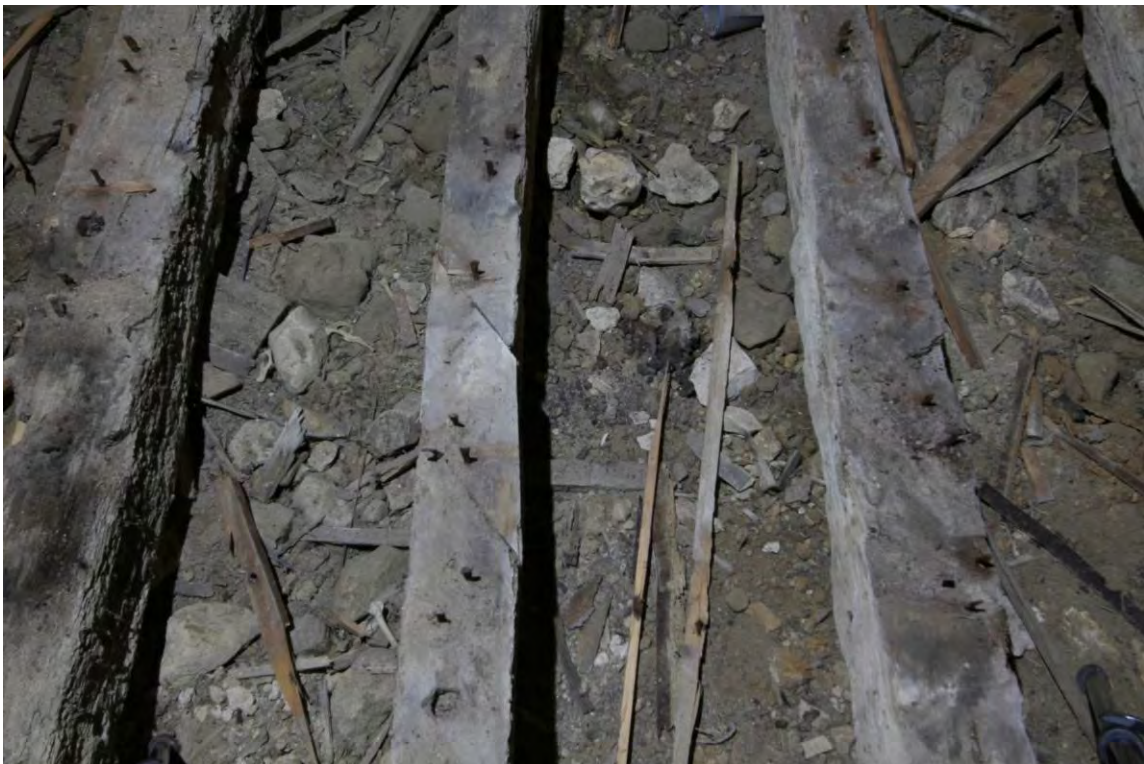
2:5	120 x 150	2 pegs, lapped over sill plate, notch	2
2:6	100 x 150	3 pegs, diagonal lap joint, lapped over sill plate	2
2:7	130 x 160	3 pegs, 4 notches w. side	2

Plate 26 Floor section 2, joist 2:6, lap joint

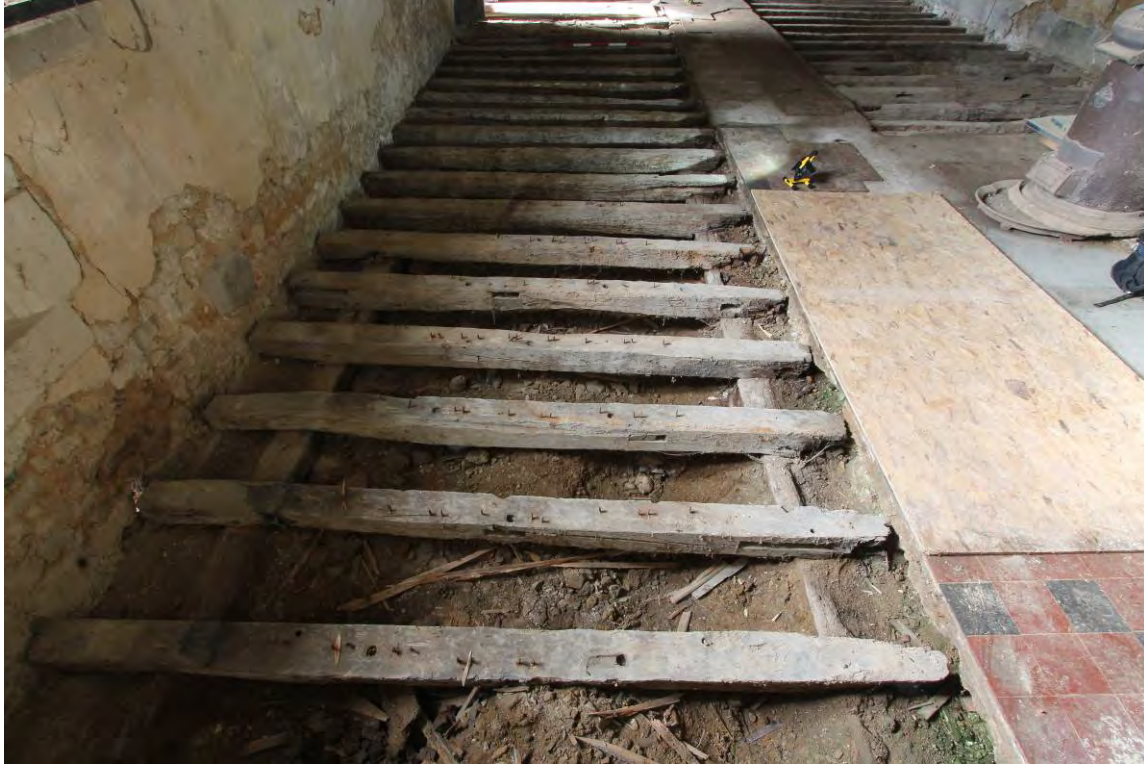
6.5.2 This longer section of floor is comprised of 17 north-south orientated floor joists (1-17 numbered east to west) set at c.400-440mm centres. The character of the floor joists matched that already described for floors 1 & 2 and these joists undoubtedly originate from the same structure and were re-used at a contemporary date. Many show

Plate 27 Floor section 3, looking west

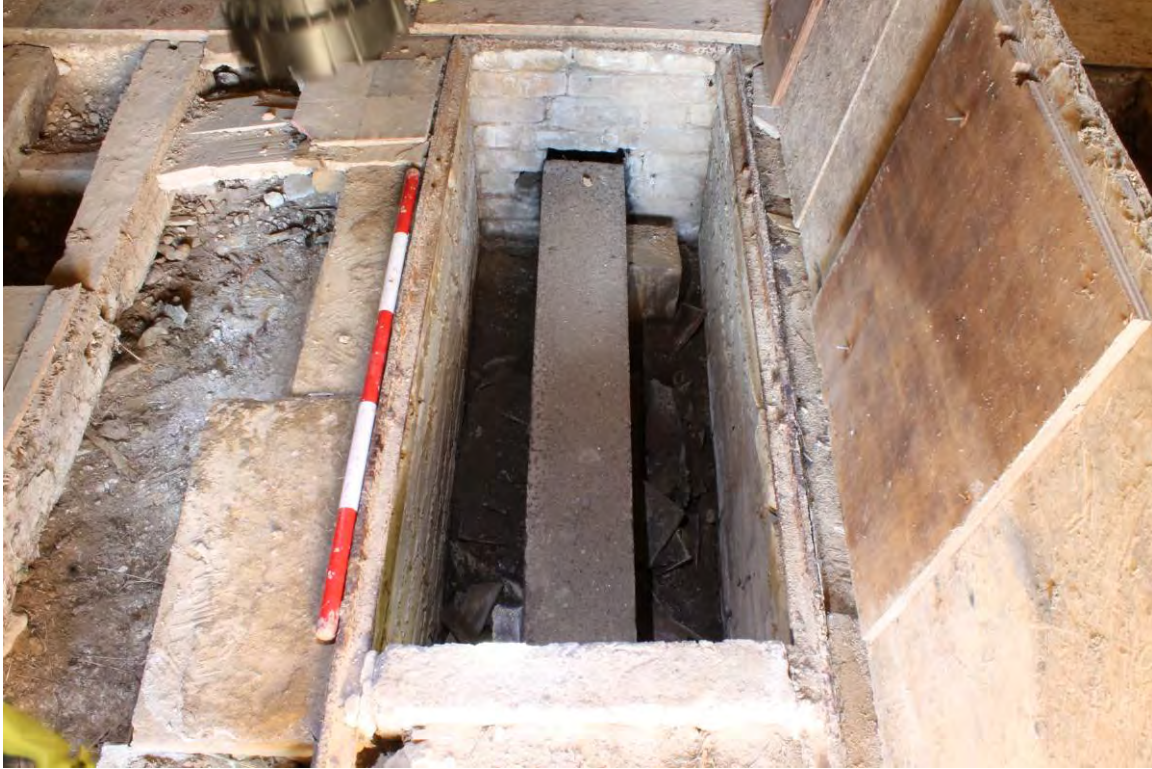
Plate 33 Sub floor chamber adjacent to south nave door

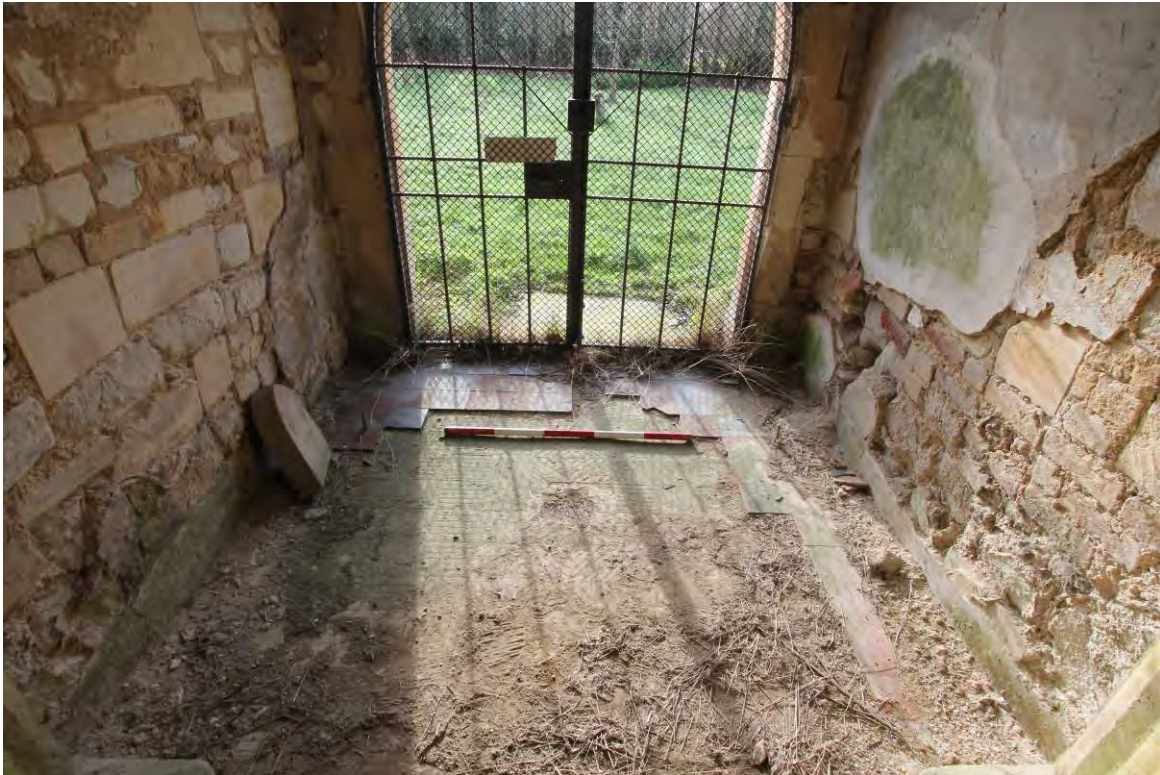
Plate 34 Remains of quarry tiles in south porch

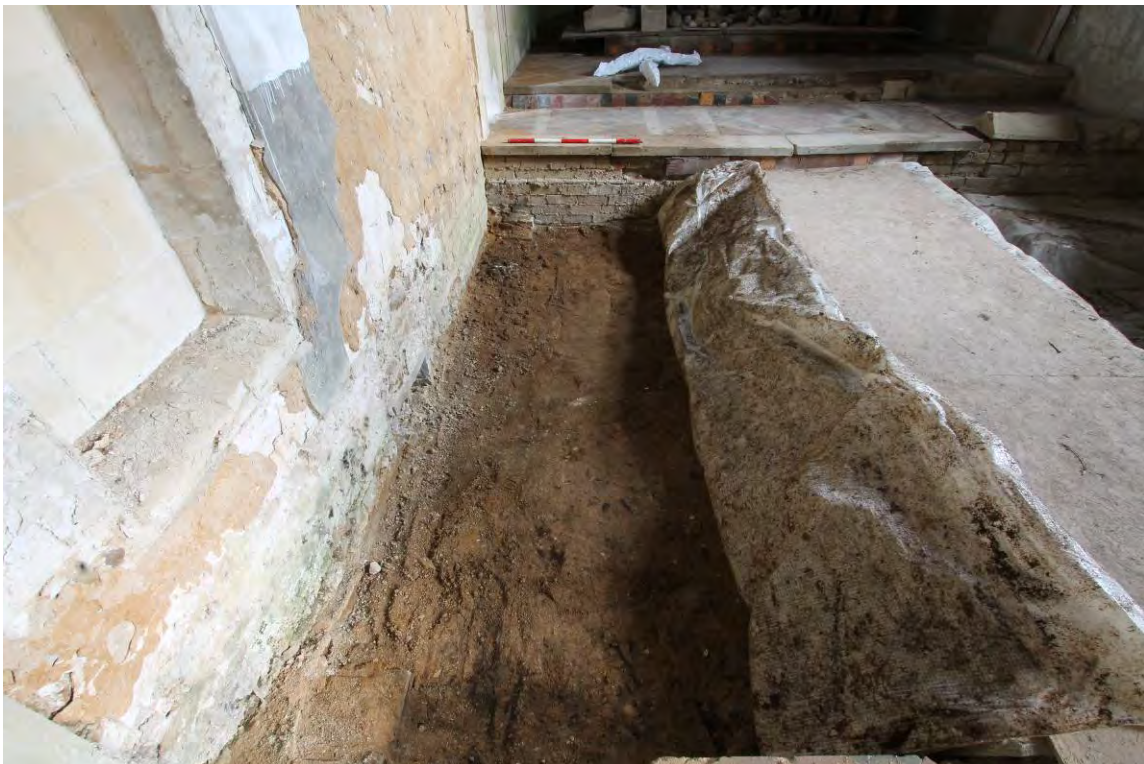
Plate 36 Floor void, chancel, north side

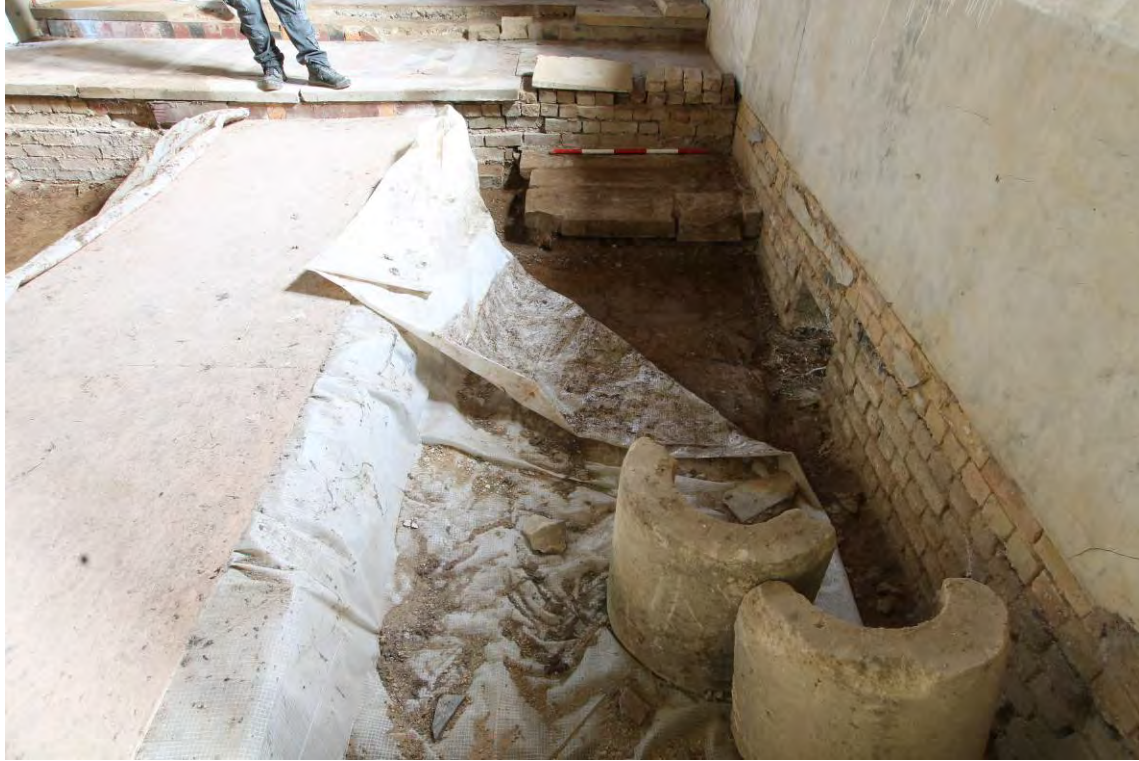
Plate 37 Floor void, chancel, south side
