**NORTHERN OUTFALL SEWER
AND ASSOCIATED STRUCTURES**
Greenway Bridge over the River Lea
Greenway Bridge over Marshgate Lane
and Pudding Mill Lane
Pedestrian Subway
Abbey Lane Pedestrian Bridge
Pedestrian Bridge Spanning the Channelsea River
Viaduct of the Northern Outfall Sewer
London E15

A standing building survey report

November 2008

Site Code: OL-02507, OL-04507, OL-04607, OL-04707, OL-02207, OL-02307 and OL-04107
National Grid Reference: 53710 18390 to 53920 18310

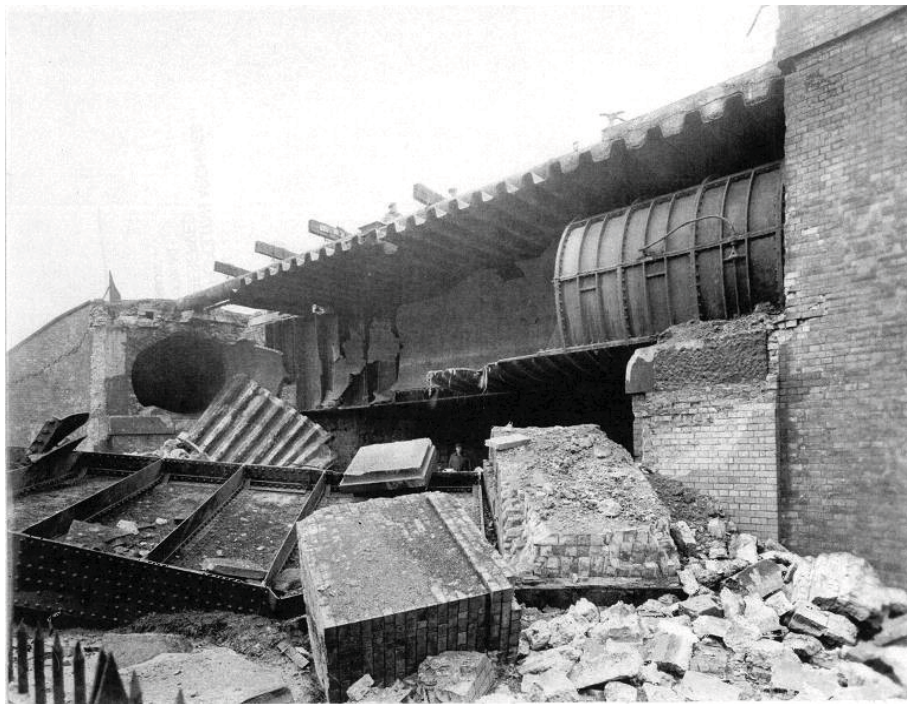
Plate 13 View of bomb damage affecting Abbey Lane Pedestrian Bridge, looking west, 1940

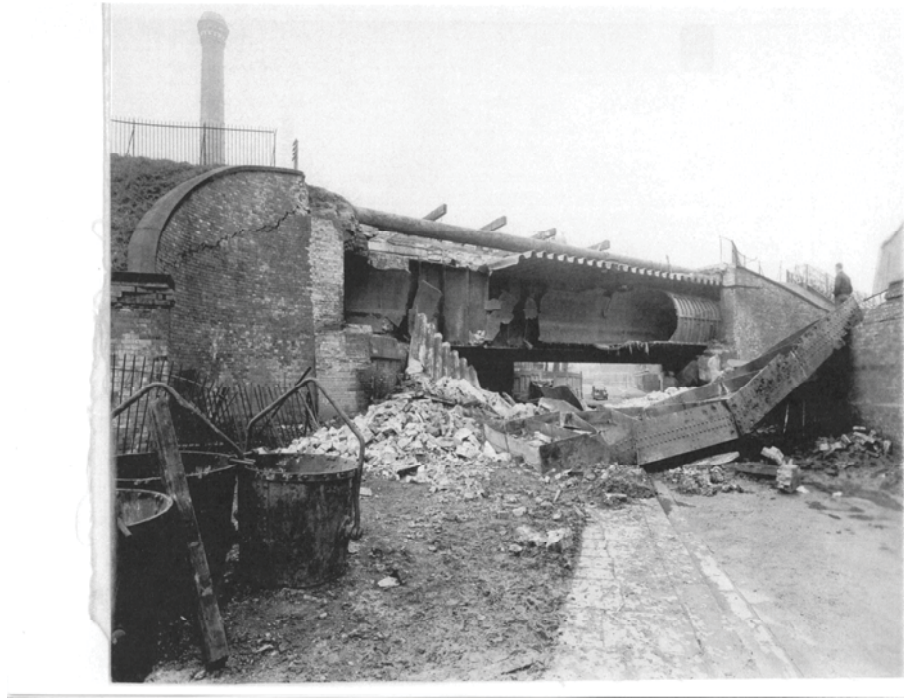
Plate 14 View of bomb damage affecting Abbey Lane Pedestrian Bridge, looking west, 1940

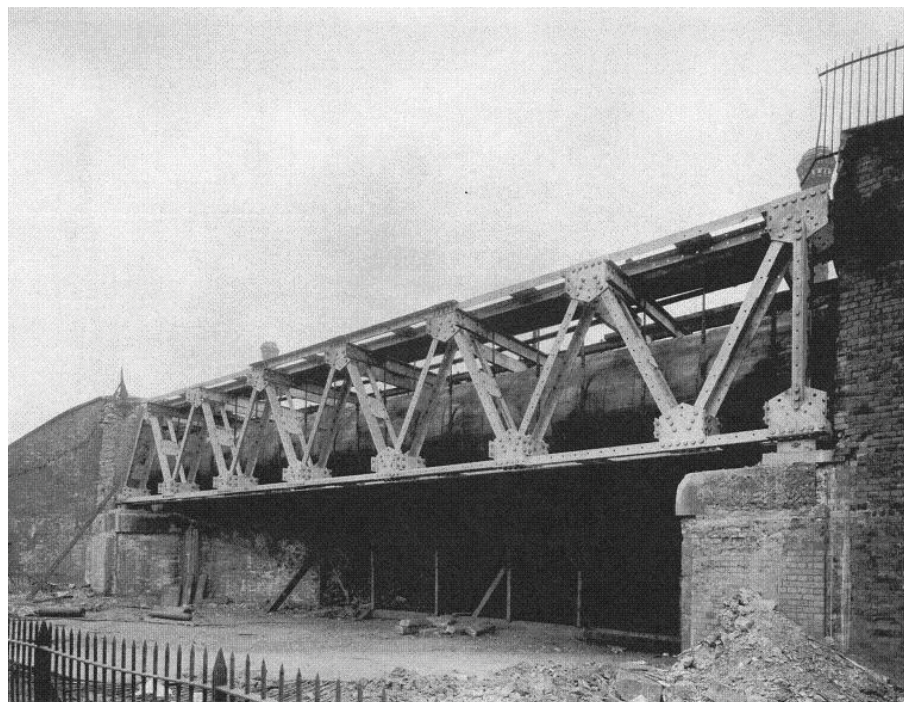
Plate 15 View of bomb damage affecting Abbey Lane Pedestrian Bridge, looking west, 1940

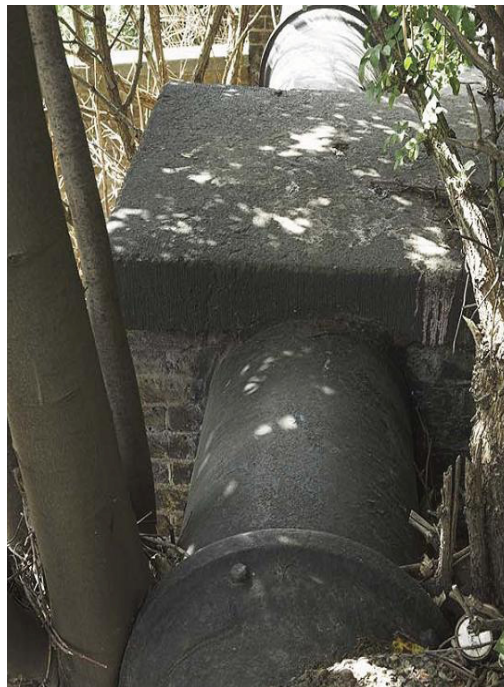
Plate 41 View of damage brick built platform on south embankment of Greenway looking north
